## FIELD INSPECTION REPORT

| <b>Project Name:</b> | Mountain Valley Pipeline | <b>Inspector:</b> | Marshall Willis |
| <b>Inspection Date:</b> | Friday, April 23, 2021 | <b>Project Contact:</b> | Brian Clauto, Cory Chalmers |
| <b>Spread H:<br/>Roanoke County<br/>Franklin County</b> | STA 12994+02 – 13065+00<br>MVP-FR-290 | <b>Weather:</b> | Dry |

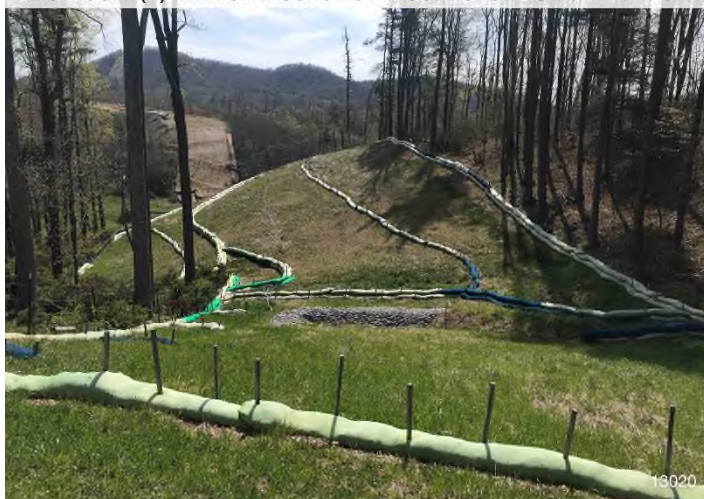
**Figure 1: STA 13020+00** – Controls in place and functioning properly.

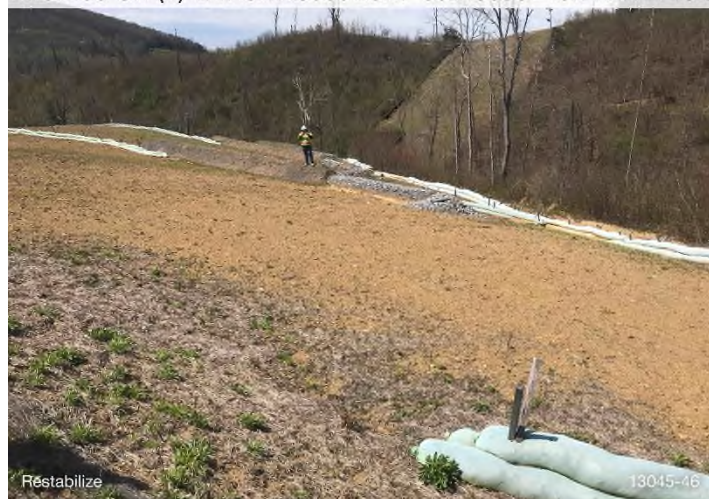
**Figure 2: STA 13045+00 to 13046+00** – Re-stabilization needed.

- STA 13045+00 to 13046+00: Re-stabilize area and repair rill erosion.
- STA 13050+50 to 13051+00: Re-stabilize area and repair rill erosion.

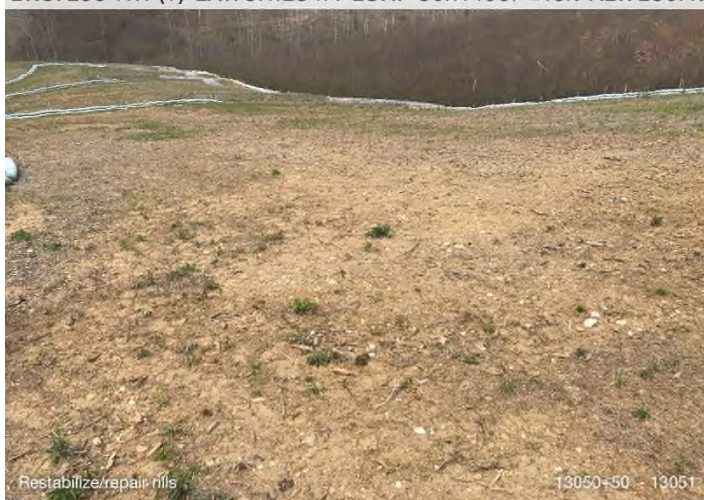
**Figure 3: STA 13050+50 to 13051+00** – Re-stabilization needed.

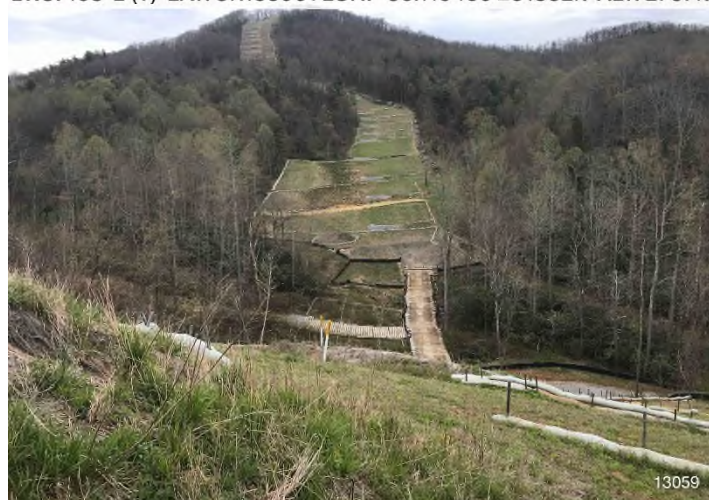
**Figure 4: STA 13059+00** – Controls in place and functioning properly.
