## FIELD INSPECTION REPORT

<b>Project Name:</b>	Mountain Valley Pipeline	<b>Inspector:</b>	Marshall Willis
<b>Inspection Date:</b>	Tuesday, April 20, 2021	<b>Project Contact:</b>	Brian Clauto, Cory Chalmers
<b>Spread H: Roanoke County</b>	STA 13000+00 – 13015+13 STA 12964+64 – 12980+00 STA 12690+43 – 12708+00 MVP-RO-288/280	<b>Weather:</b>	Dry

## FIELD INSPECTION PHOTO LOG

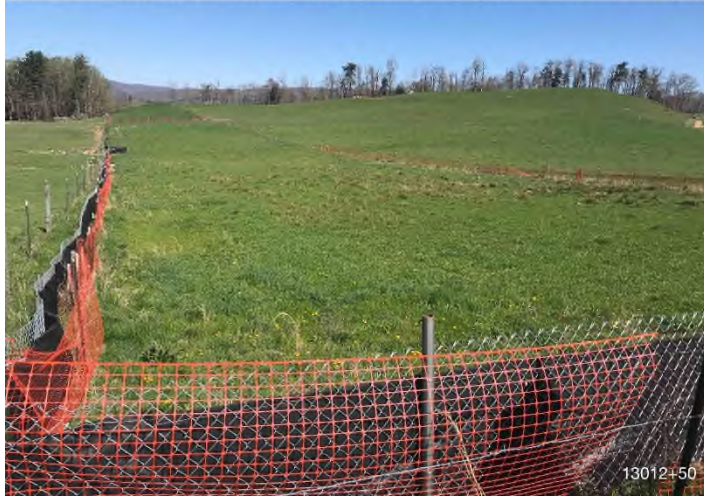
**Figure 1: STA 13012+50** – Controls in place and functioning properly.

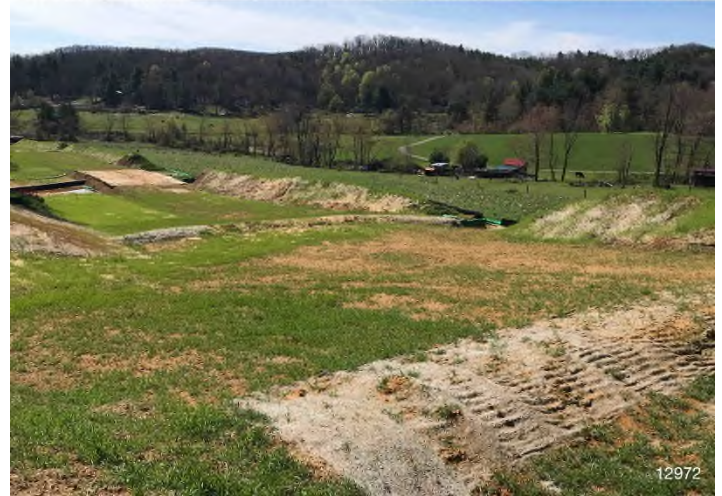
**Figure 2: STA 12972+00** – Controls in place and functioning properly.

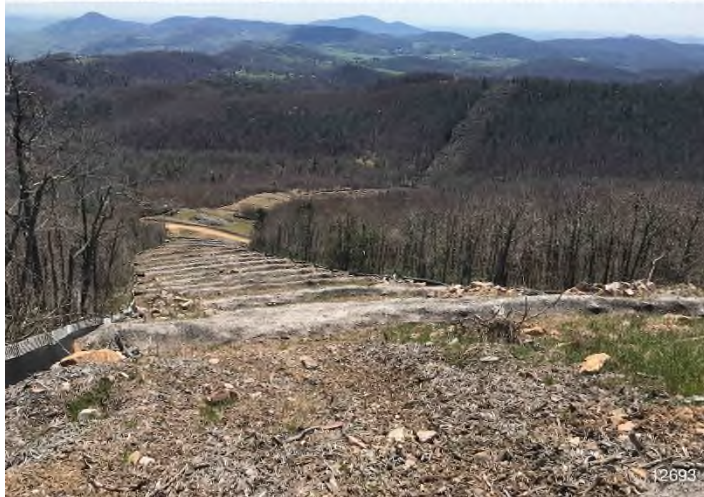
**Figure 3: STA 12693+00** – Controls in place and functioning properly.

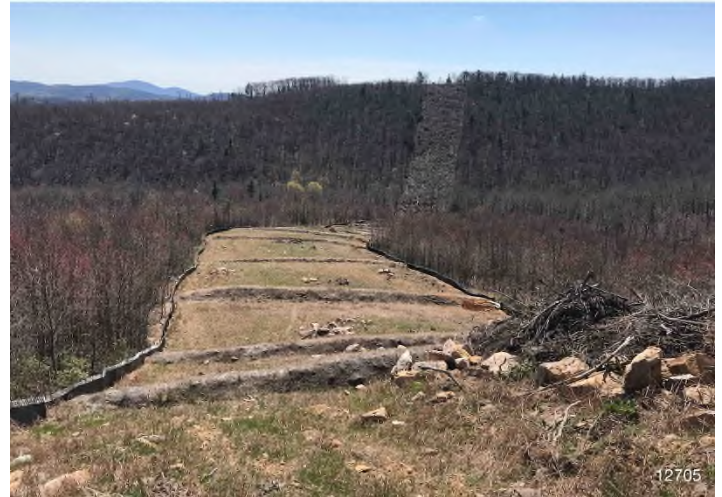
**Figure 4: STA 12705+00** – Controls in place and functioning properly.
