## FIELD INSPECTION REPORT

| Project Name: | Mountain Valley Pipeline | Inspector: | Marshall Willis |
| Inspection Date: | Thursday, April 15, 2021 | Project Contact: | Brian Clauto, Cory Chalmers |
| Spread I:<br>Pittsylvania County | STA 15370+62 – 15487+60 | Weather: | Wet |

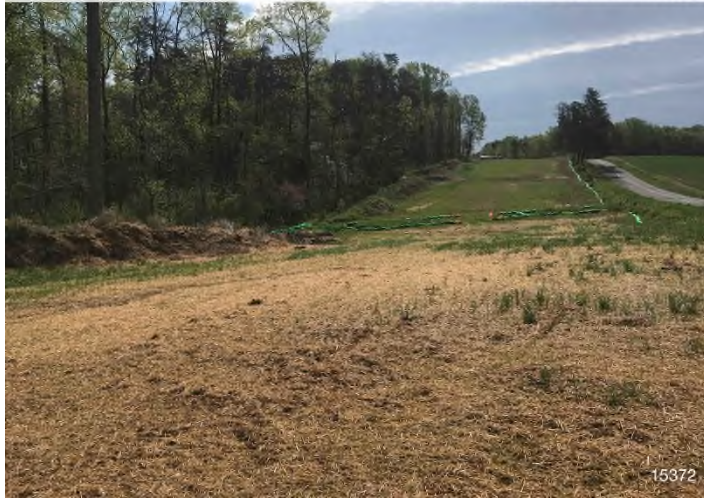
**Figure 1: STA 15372+00** – Controls in place and functioning properly. Area stabilized with Earth-Guard and straw.  
BRG: 118°SE (T) LAT: 36.922348 LON: -79.510340 ±16ft ALT: 780ft

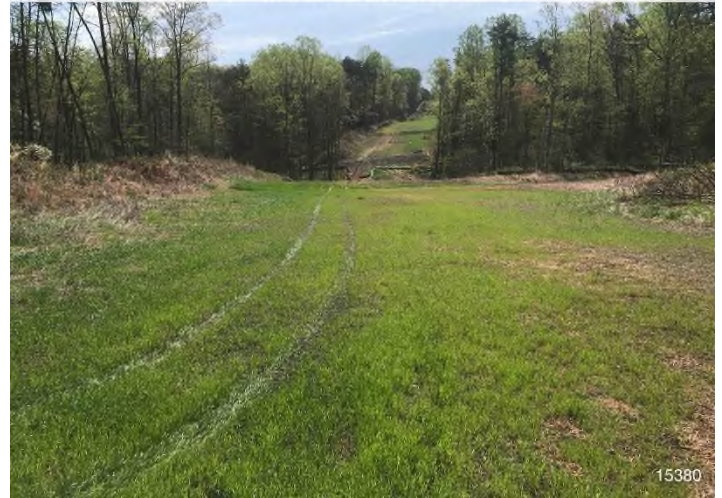
**Figure 2: STA 15380+00** – Controls in place and functioning properly.  
BRG: 103°E (T) LAT: 36.920934 LON: -79.507462 ±98ft ALT: 808ft

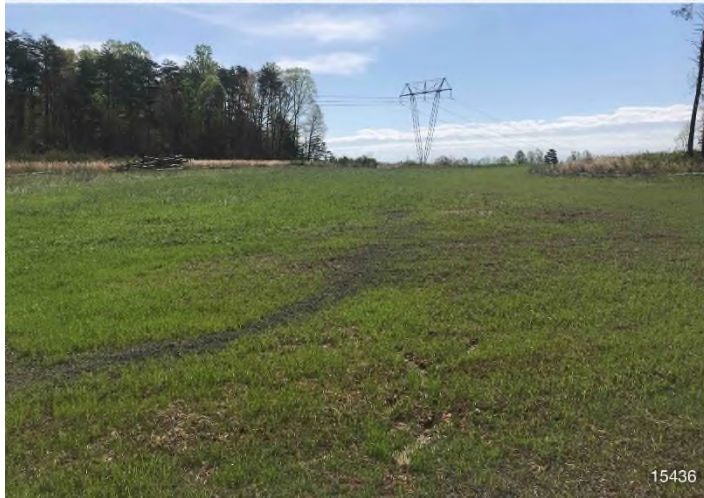
**Figure 3: STA 15436+00** – Controls in place and functioning properly.  
BRG: 116°SE (T) LAT: 36.915567 LON: -79.489889 ±4097ft ALT: 800ft

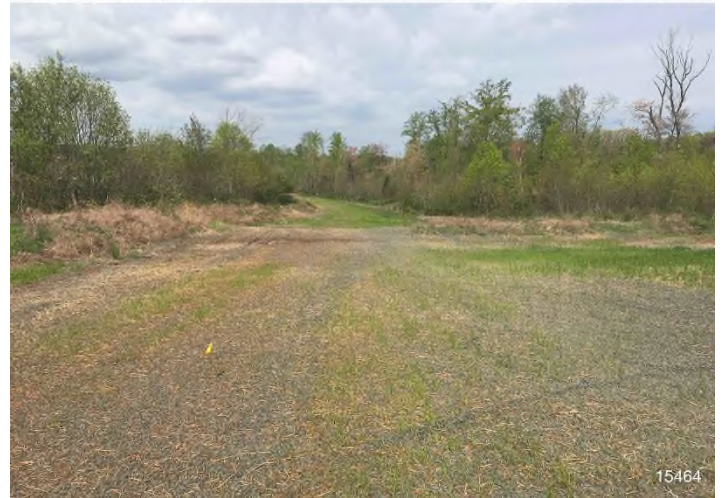
**Figure 4: STA 15464+00** – Controls in place and functioning properly. Area stabilized with Earth-Guard and straw.  
BRG: 295°NW (T) LAT: 36.912470 LON: -79.482609 ±98ft ALT: 1059ft
