## FIELD INSPECTION REPORT

| <b>Project Name:</b> | Mountain Valley Pipeline | <b>Inspector:</b> | Marshall Willis |
| <b>Inspection Date:</b> | Wednesday, April 14, 2021 | <b>Project Contact:</b> | Brian Clauto, Cory Chalmers |
| <b>Spread H:<br/>Franklin County</b> | STA 13061+44 – 13115+97<br>MVP-FR-290<br>MVP-FR-291 | <b>Weather:</b> | Dry |

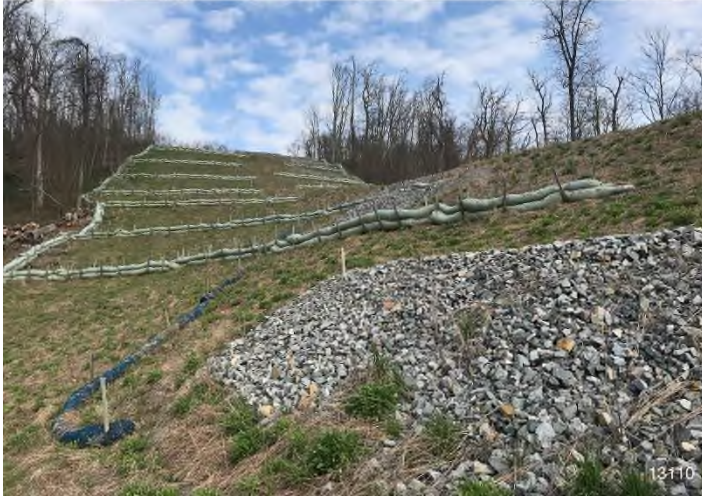
**Figure 1: STA 13110+00** – Controls in place and functioning properly.

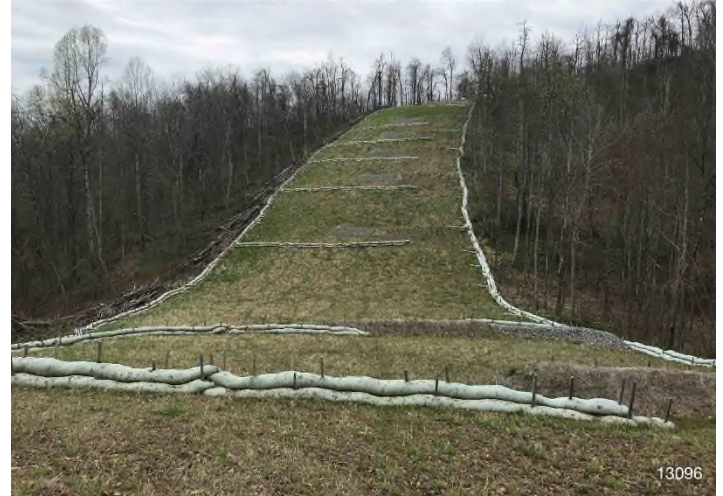
**Figure 2: STA 13096+00** – Controls in place and functioning properly.

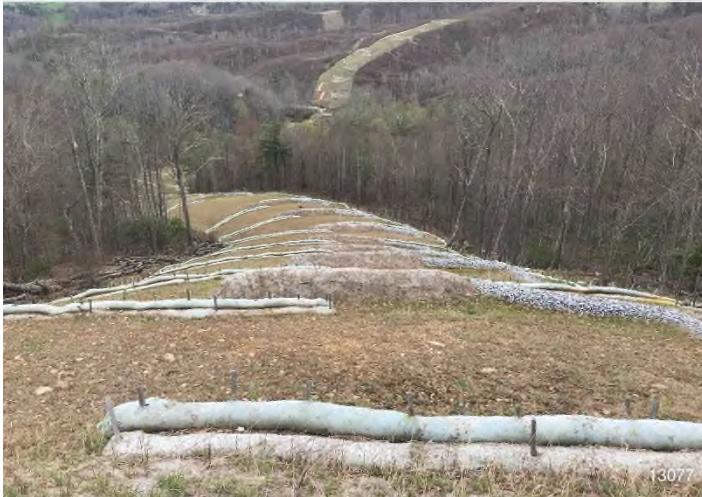
**Figure 3: STA 13077+00** – Controls in place and functioning properly.

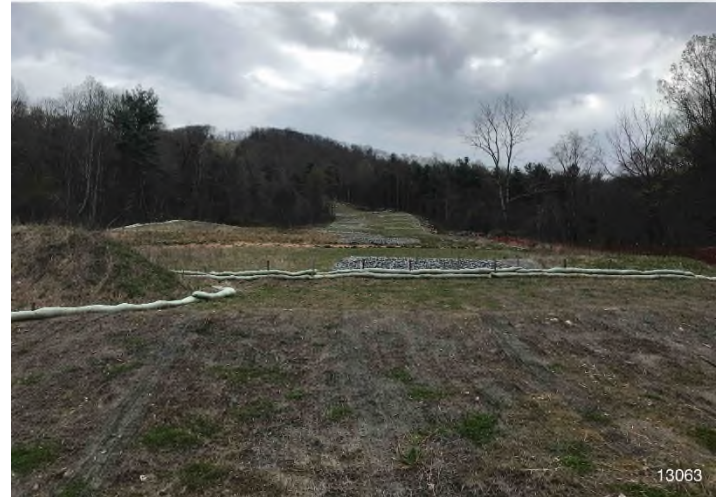
**Figure 4: STA 13063+00** – Controls in place and functioning properly.
