FIELD INSPECTION REPORT

Project Name:	Mountain Valley Pipeline	Inspector:	Marshall Willis
Inspection Date:	Thursday, June 10, 2021	Project Contact:	Brian Clauto, Cory Chalmers
Spread G: Giles County	STA 10675+39 – 10667+00 STA 11765+00 – 11788+43 MVP-GI-240 MVP-MLV-AR-25	Weather:	Rainy

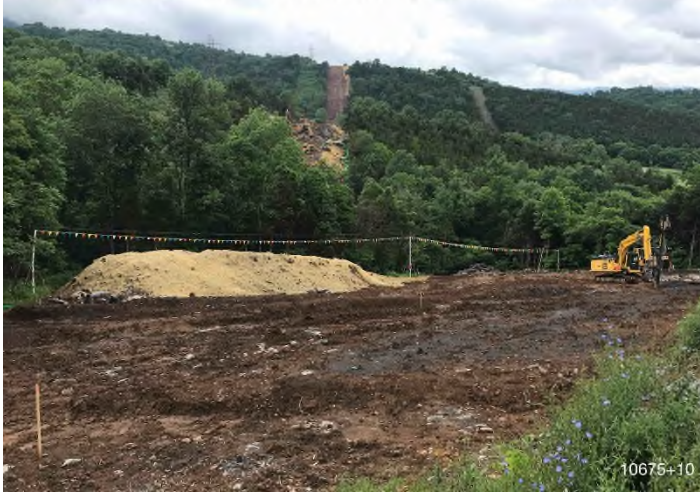
Figure 1: STA 10675+00 – Controls in place and functioning properly.
BRG: 100°E (T) LAT: 37.350634 LON: -80.659512 ±16ft ALT: 2156ft

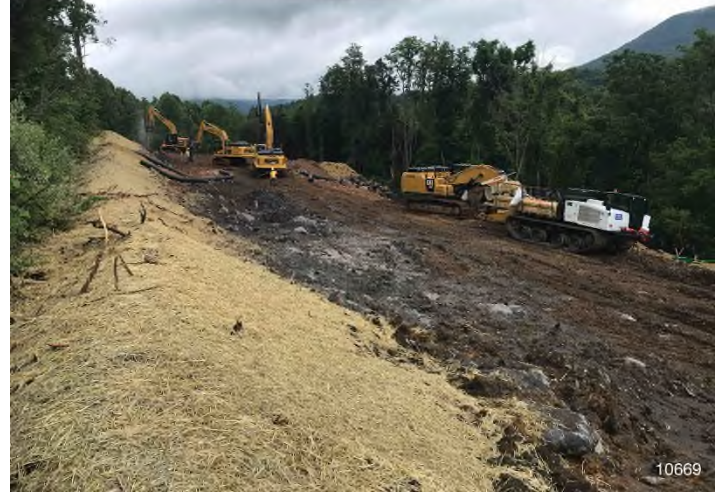
Figure 2: STA 10669+00 – Controls in place and functioning properly.
BRG: 22°NE (T) LAT: 37.345776 LON: -80.673701 ±42813ft ALT: 2272ft

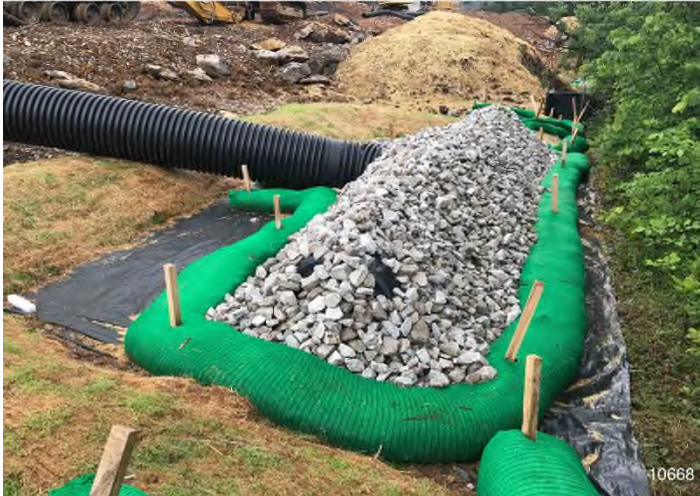
Figure 3: STA 10668+00 – Controls in place and functioning properly.
BRG: 316°NW (T) LAT: 37.351774 LON: -80.660598 ±16ft ALT: 2224ft

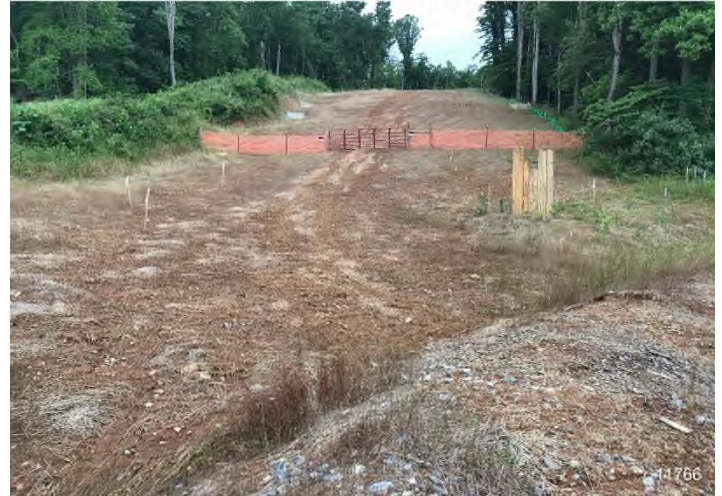
Figure 4: STA 11766+00 – Controls in place and functioning properly.
BRG: 290°W (T) LAT: 37.296027 LON: -80.368025 ±16ft ALT: 1949ft
