## FIELD INSPECTION REPORT

<b>Project Name:</b>	Mountain Valley Pipeline	<b>Inspector:</b>	Marshall Willis
<b>Inspection Date:</b>	Tuesday, June 8, 2021	<b>Project Contact:</b>	Brian Clauto, Cory Chalmers
<b>Spread H:</b> Roanoke County Franklin County	STA 13159+13 – 13195+79 STA 12690+43 – 12715+79 MVP-RO-280 MVP-FR-292.01	<b>Weather:</b>	Dry

## FIELD INSPECTION PHOTO LOG

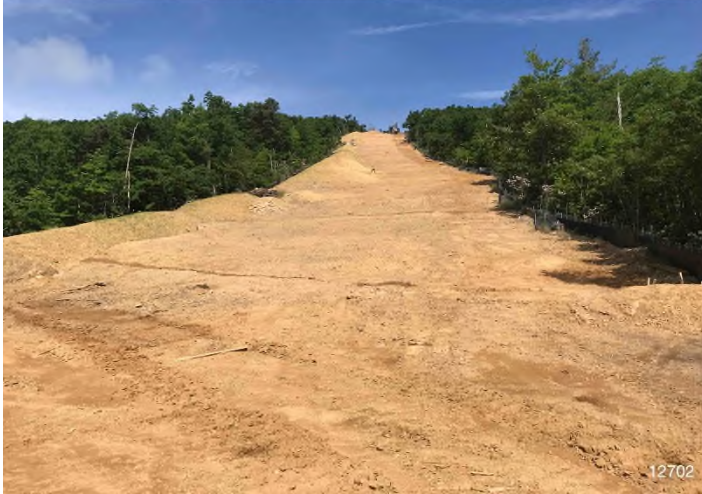
**Figure 1: STA 12702+00** – Controls in place and functioning properly.  
BRG: 287°W (T) LAT: 37.190865 LON: -80.153850 ±32ft ALT: 3383ft

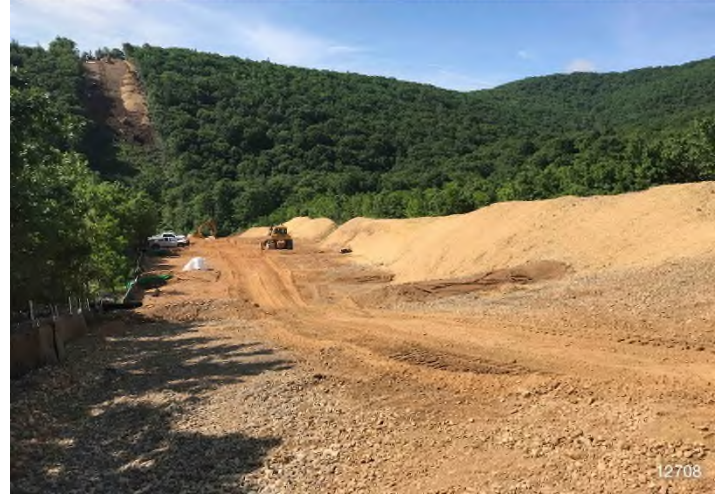
**Figure 2: STA 12708+00** – Controls in place and functioning properly.  
BRG: 182°S (T) LAT: 37.189582 LON: -80.151996 ±98ft ALT: 3069ft

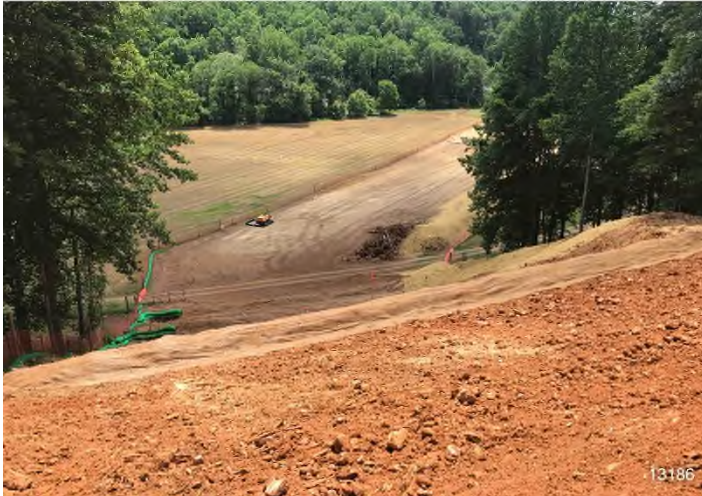
**Figure 3: STA 13186+00** – Controls in place and functioning properly.  
BRG: 116°SE (T) LAT: 37.124961 LON: -80.077298 ±16ft ALT: 1487ft

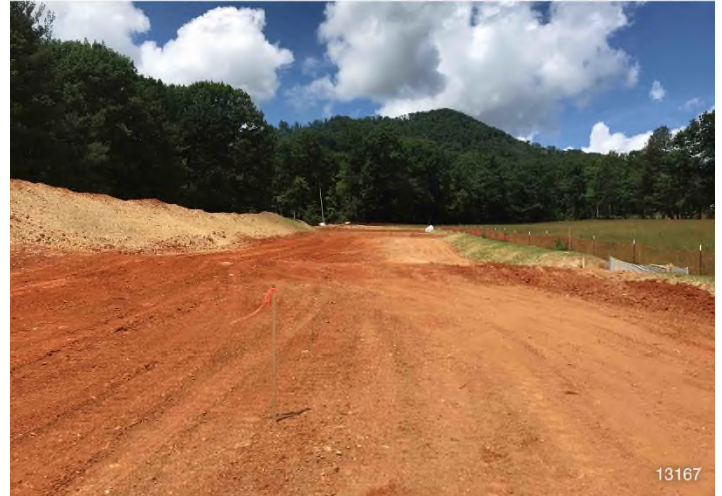
**Figure 4: STA 13167+00** – Controls in place and functioning properly.  
BRG: 255°W (T) LAT: 37.108141 LON: -80.041600 ±15141ft ALT: 1549ft
