FIELD INSPECTION REPORT

Project Name:	Mountain Valley Pipeline	Inspector:	Marshall Willis
Inspection Date:	Thursday, June 3, 2021	Project Contact:	Brian Clauto, Cory Chalmers
Spread G: Giles County	STA 10707+22 – 10749+71 Laydown Yard 029 MVP-GI-241.01/.04	Weather:	Dry

FIELD INSPECTION PHOTO LOG

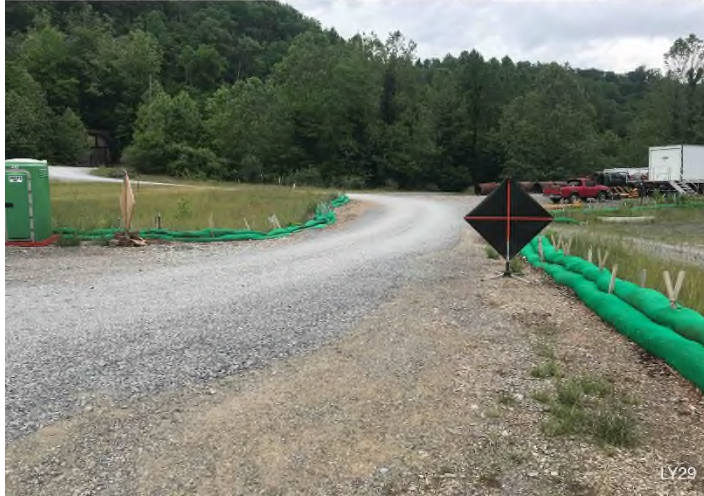
Figure 1: Laydown Yard 029 – Controls in place and functioning properly.

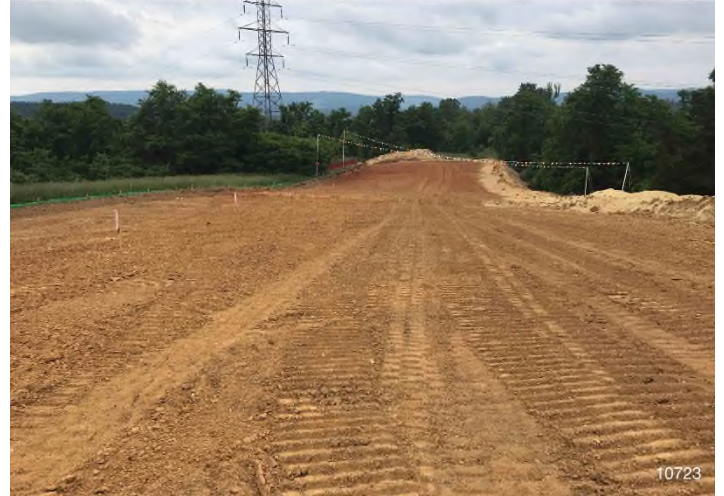
Figure 2: STA 10723+00 – Controls in place and functioning properly.

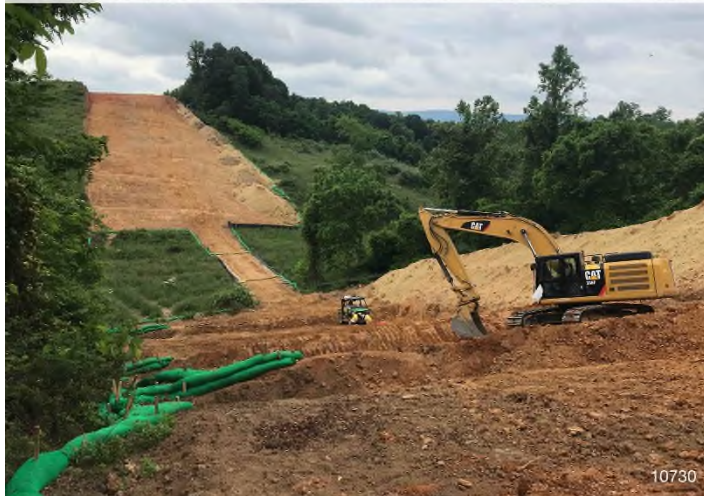
Figure 3: STA 10730+00 – Controls in place and functioning properly.

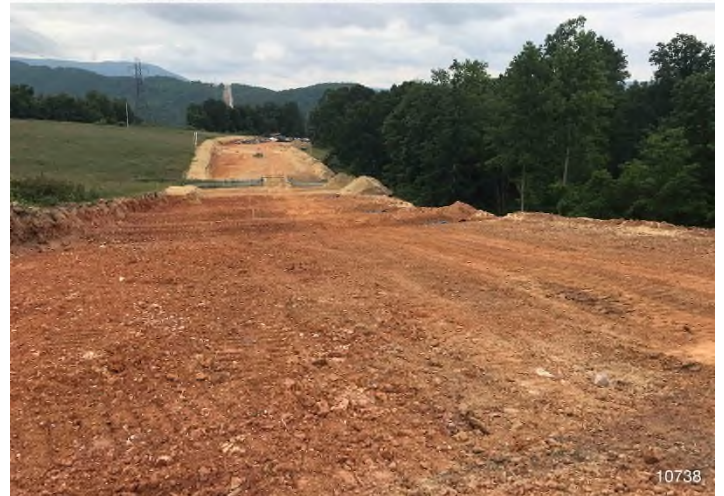
Figure 4: STA 10738+00 – Controls in place and functioning properly.
