FIELD INSPECTION REPORT

Project Name:	Mountain Valley Pipeline	Inspector:	Marshall Willis
Inspection Date:	Wednesday, June 2, 2021	Project Contact:	Brian Clauto, Cory Chalmers
Spread H: Roanoke County	STA 12690+43 – 12715+79 MVP-RO-280 MVP-RO-281	Weather:	Dry

FIELD INSPECTION PHOTO LOG

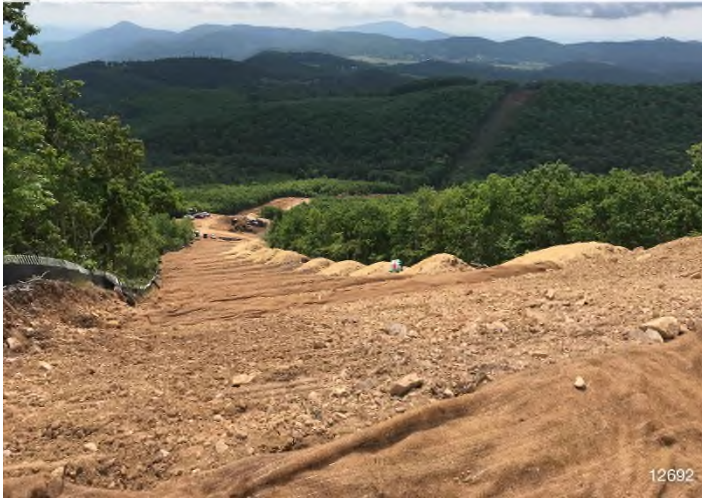
12692

Figure 1: STA 12692+00 – Controls in place and functioning properly.

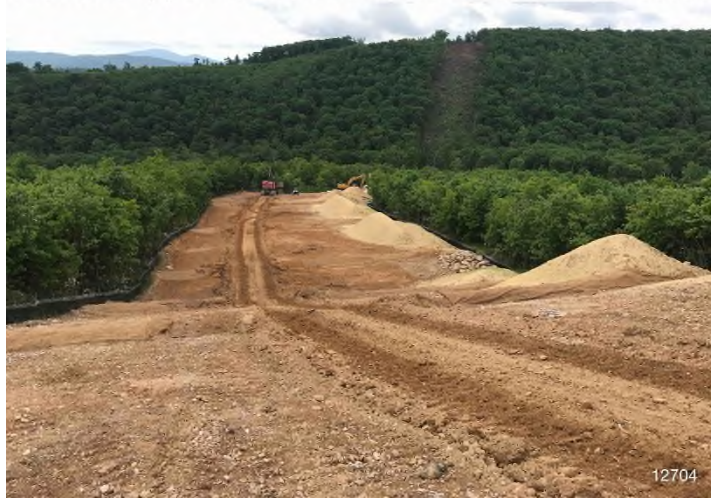
12704

Figure 2: STA 12704+00 – Controls in place and functioning properly.

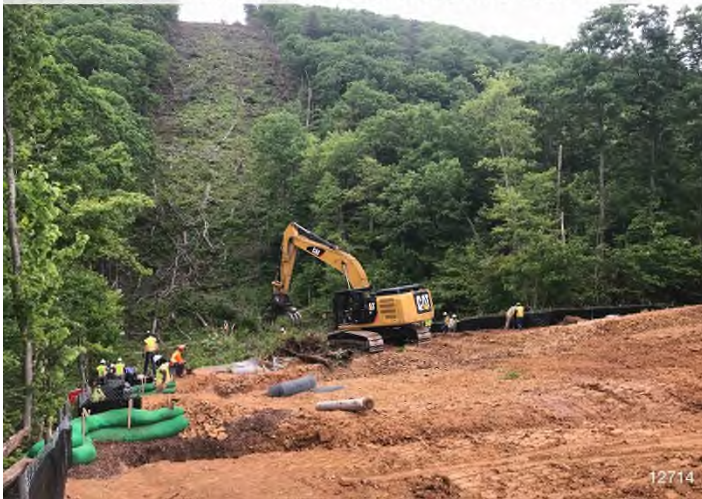
12714

Figure 3: STA 12714+00 – Controls in place and functioning properly.

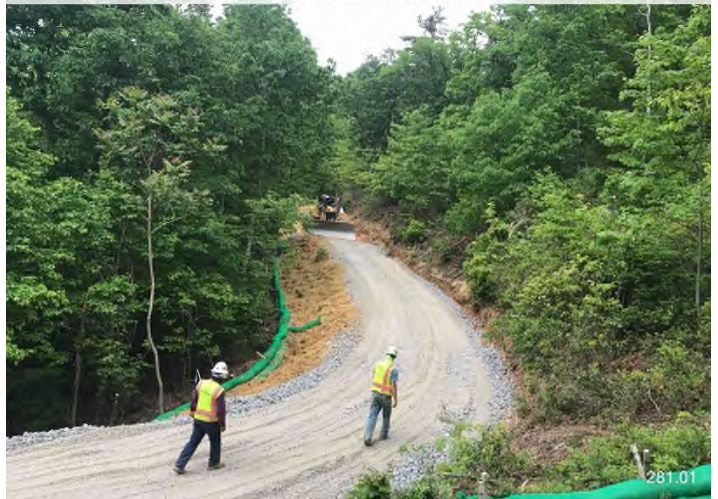
281.01

Figure 4: MVP-RO-281 – Controls in place and functioning properly. PPL installing MVP-RO-281.01.
