## FIELD INSPECTION REPORT

| Project Name: | Mountain Valley Pipeline | Inspector: | Marshall Willis |
| Spread H:<br>Montgomery County | STA 12284+75 – 12300+00<br>MVP-MN-276.03 | Weather: | Dry |

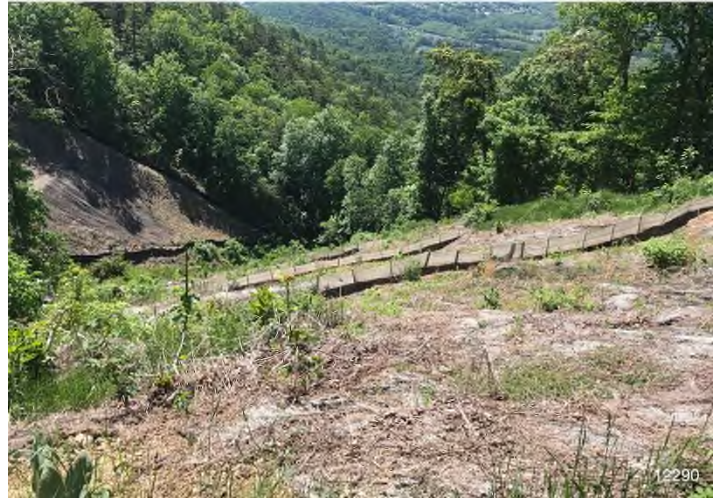
**Figure 2: STA 12290+00** – Controls in place and functioning properly. Area stabilized with erosion control matting.  
BRG: 135°SE (T) LAT: 37.254997 LON: -80.228838 ±32ft ALT: 2407ft

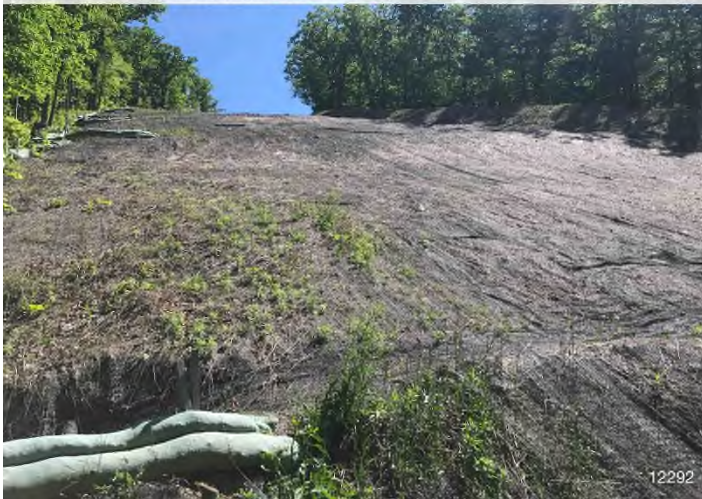
**Figure 3: STA 12292+00** – Controls in place and functioning properly. Area stabilized with erosion control matting.  
BRG: 44°NE (T) LAT: 37.254998 LON: -80.228017 ±32ft ALT: 2281ft

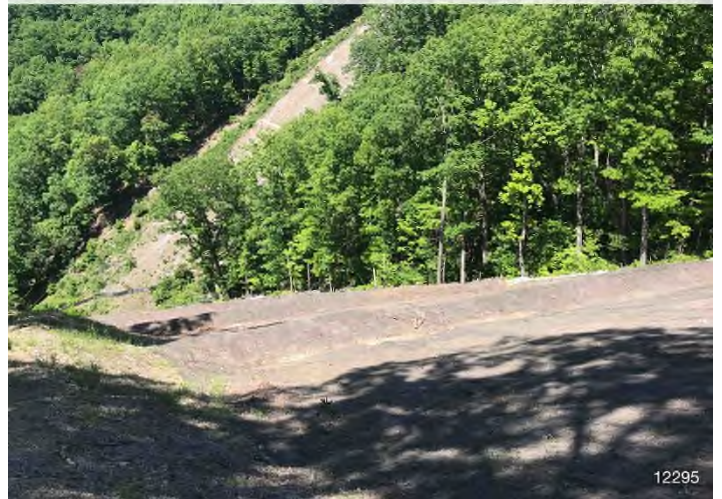
**Figure 4: STA 12295+00** – Controls in place and functioning properly. Area stabilized with erosion control matting.  
BRG: 262°W (T) LAT: 37.255363 LON: -80.226695 ±328ft ALT: 2391ft
