FIELD INSPECTION REPORT

Project Name:	Mountain Valley Pipeline	Inspector:	Marshall Willis
Inspection Date:	Thursday, May 13, 2021	Project Contact:	Brian Clauto, Cory Chalmers
Spread I: Franklin County	STA 15496+70 – 15619+48 MVP-FR-293.02	Weather:	Dry

FIELD INSPECTION PHOTO LOG

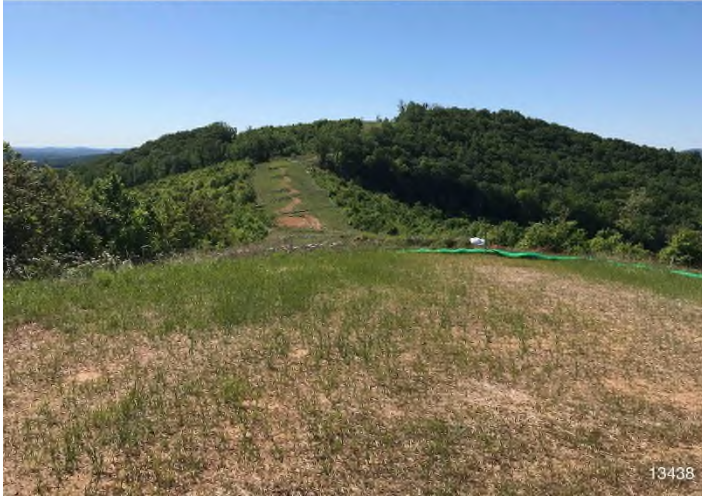
Figure 1: STA 13438+00 – Controls in place and functioning properly.

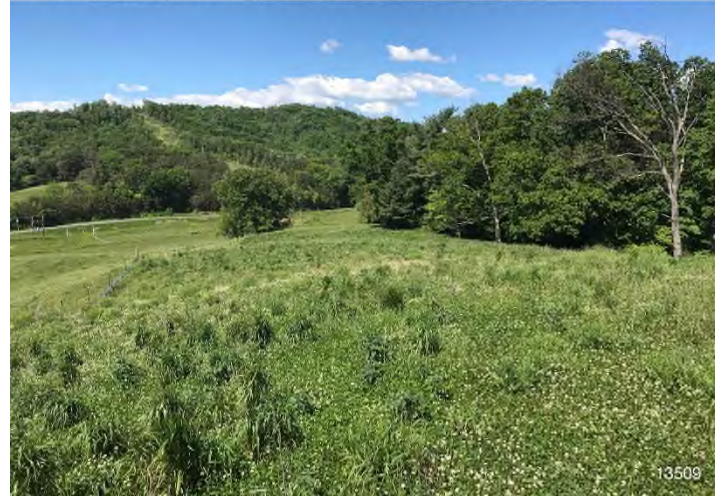
Figure 2: STA 13509+00 – Controls in place and functioning properly.

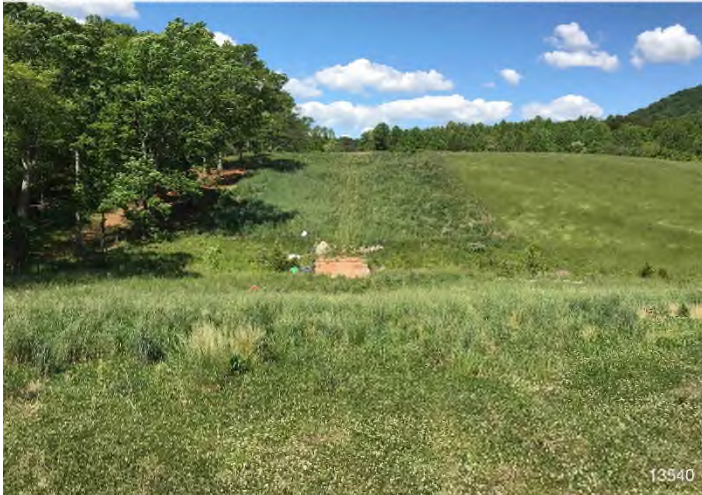
Figure 3: STA 13540+00 – Controls in place and functioning properly.

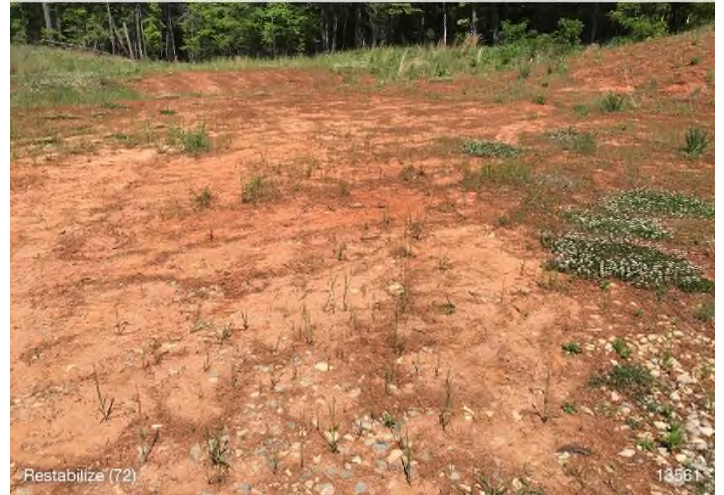
- STA 13561+00: Re-stabilization needed.

Figure 4: STA 13561+00 – Re-stabilization needed.

Recommended Corrective Action: Maintain and install all controls per the approved PSS&S.

Deadline: Within 72-Hour of Notification
