## FIELD INSPECTION REPORT

| Project Name: | Mountain Valley Pipeline | Inspector: | Marshall Willis |
| Spread H:<br>Roanoke County | STA 12638+24 – 12690+43<br>MVP-RO-279.01 | Weather: | Dry |

## FIELD INSPECTION PHOTO LOG

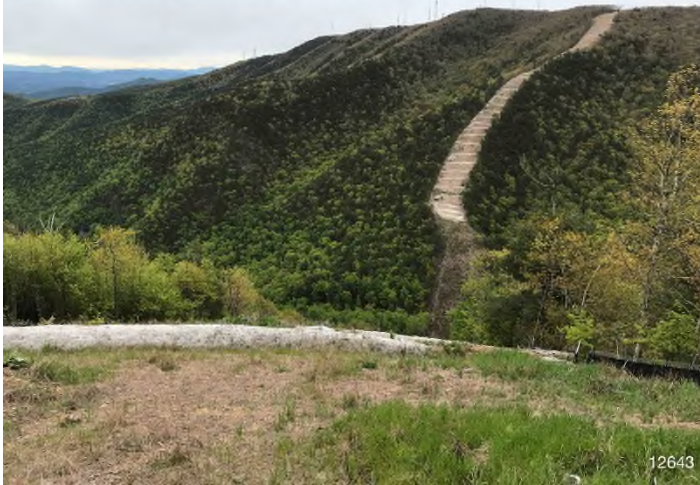
**Figure 1: STA 12643+00** – Controls in place and functioning properly. Area stabilized with erosion matting.  
BRG: 55°NE (T) LAT: 37.193509 LON: -80.173139 ±7241ft ALT: 3435ft

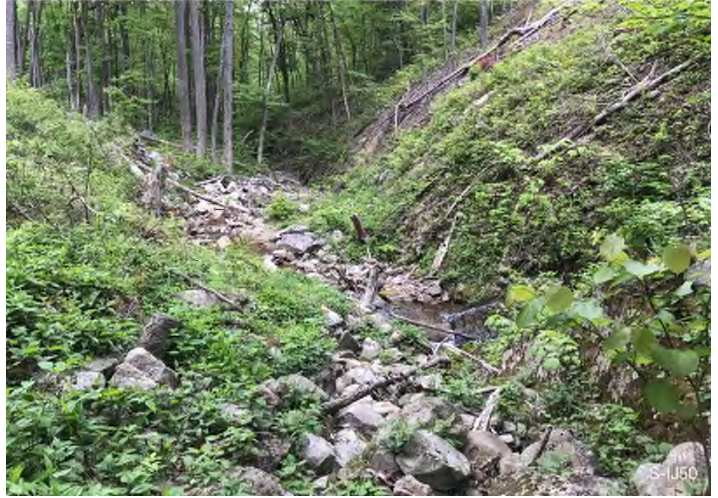
**Figure 2: Stream S-IJ50** – No ground disturbance present.

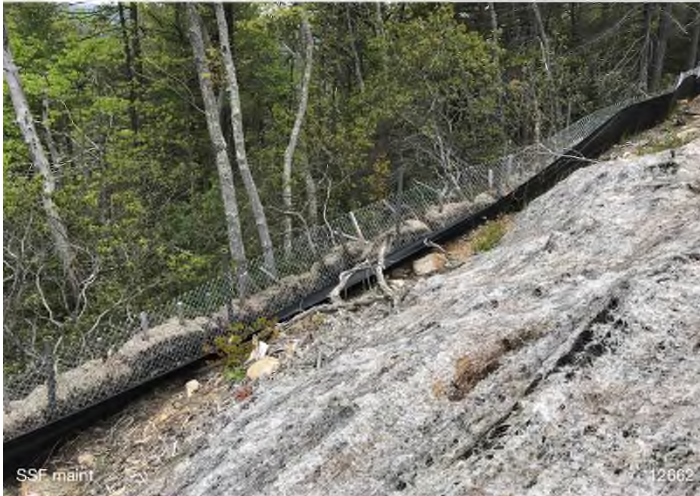
**Figure 3: STA 12662+00** – SSF maintenance needed.

**Recommended Corrective Action:** Maintain and install all controls per the approved PSS&S.

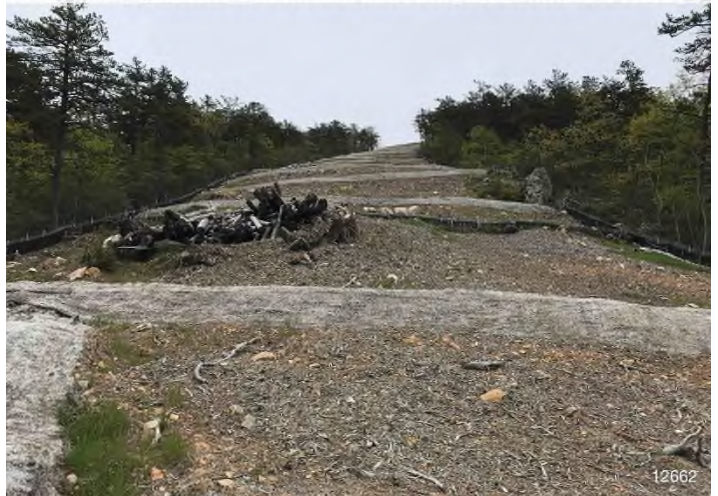
**Figure 4: STA 12662+00** – Controls in place and functioning properly. Area stabilized with erosion matting.
