FIELD INSPECTION REPORT

Project Name:	Mountain Valley Pipeline	Inspector:	Marshall Willis
Inspection Date:	Monday, May 10, 2021	Project Contact:	Brian Clauto, Cory Chalmers
Spread I: Pittsylvania County	STA 15496+70 – 15619+48	Weather:	Dry

FIELD INSPECTION PHOTO LOG

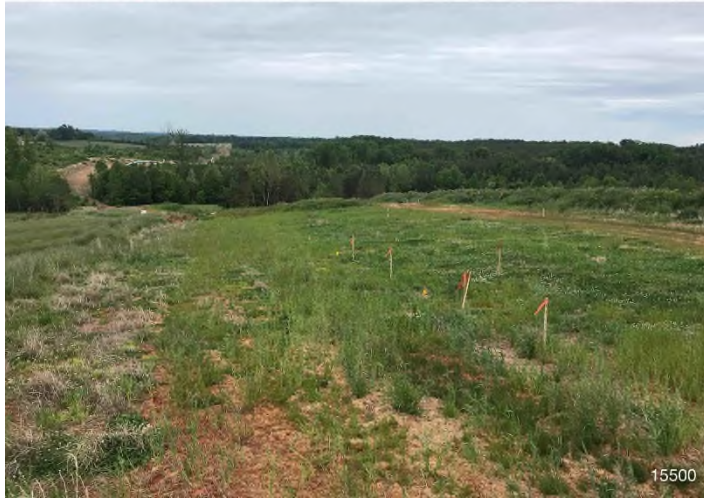
Figure 1: STA 15500+00 – Controls in place and functioning properly. Area stabilized with Earth-Guard.
BRG: 149°SE (T) LAT: 36.906191 LON: -79.474077 ±16ft ALT: 927ft

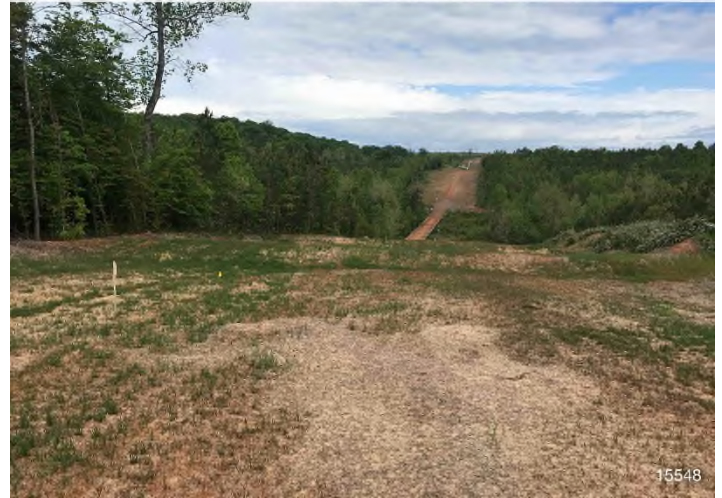
Figure 2: STA 15548+00 – Controls in place and functioning properly. Area stabilized with Earth-Guard.
BRG: 304°NW (T) LAT: 36.898366 LON: -79.461016 ±32ft ALT: 796ft

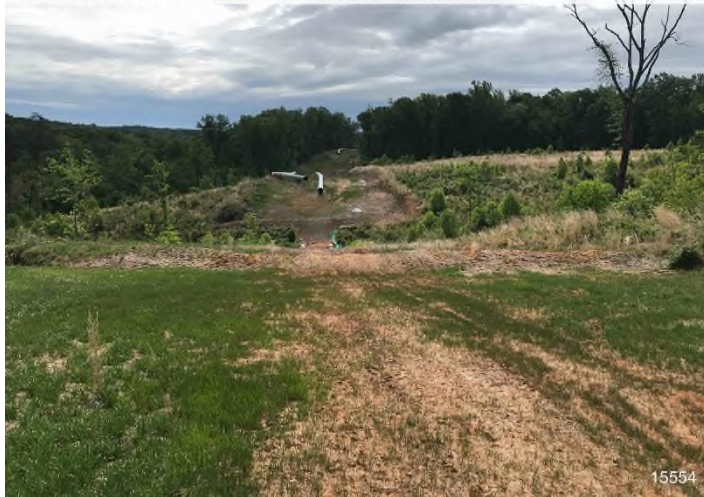
Figure 3: STA 15554+00 – Controls in place and functioning properly. Area stabilized with Earth-Guard.
BRG: 118°SE (T) LAT: 36.896103 LON: -79.451283 ±13586ft ALT: 841ft

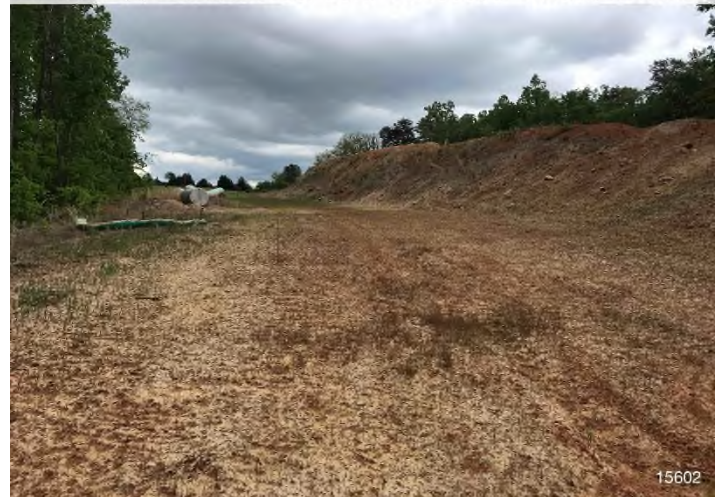
Figure 4: STA 15602+00 – Controls in place and functioning properly. Area stabilized with Earth-Guard.
BRG: 91°E (T) LAT: 36.892507 LON: -79.438882 ±13593ft ALT: 813ft
