## FIELD INSPECTION REPORT

Project Name:	Mountain Valley Pipeline	Inspector:	Marshall Willis
Inspection Date:	Tuesday, May 4, 2021	Project Contact:	Brian Clauto, Cory Chalmers
Spread H: Montgomery County	STA 12298+39 – 12372+10 MVP-MN-276.03	Weather:	Dry

## FIELD INSPECTION PHOTO LOG

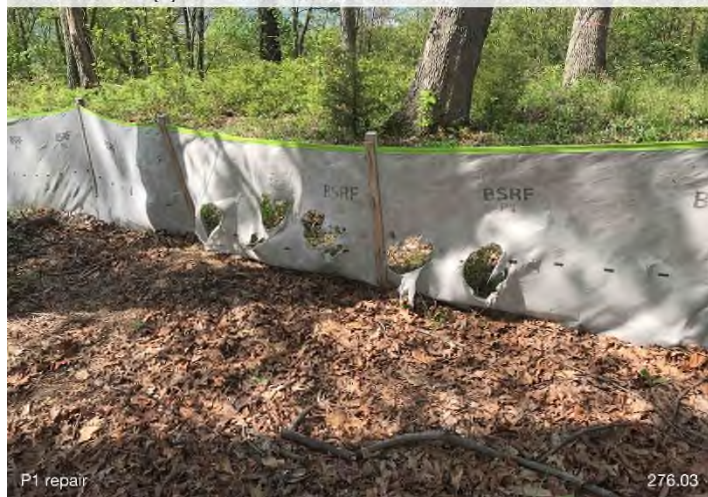
**Routine Maintenance:** (72-Hour Deadline from Notification)  
 - MVP-MN-276.03: P1 maintenance needed.

**Figure 1: MVP-MN-276.03** – P1 repair needed.

**Recommended Corrective Action:** Maintain and install all controls per the approved PSS&S.

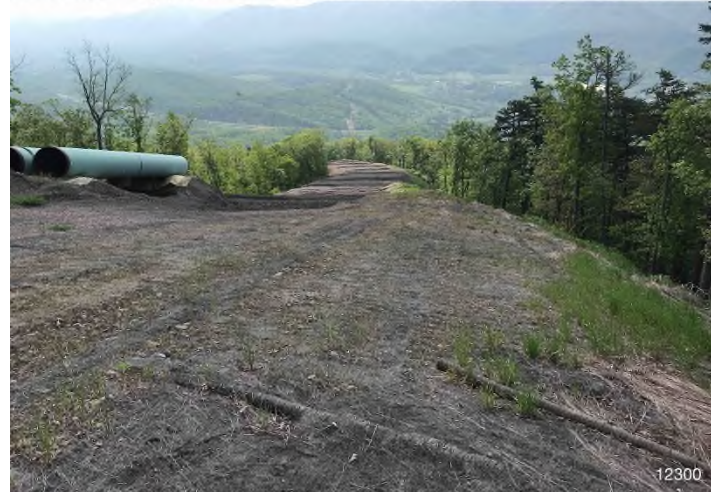
**Figure 2: STA 12300+00** – Controls in place and functioning properly. Area stabilized with erosion matting.

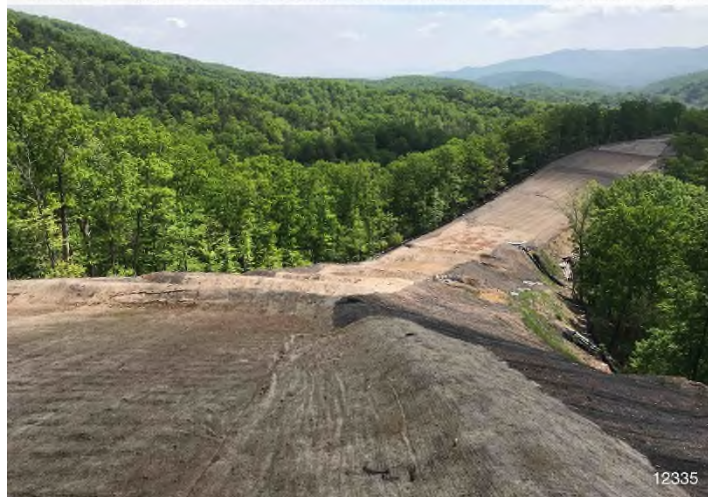
**Figure 3: STA 12335+00** – Controls in place and functioning properly. Area stabilized with erosion matting.

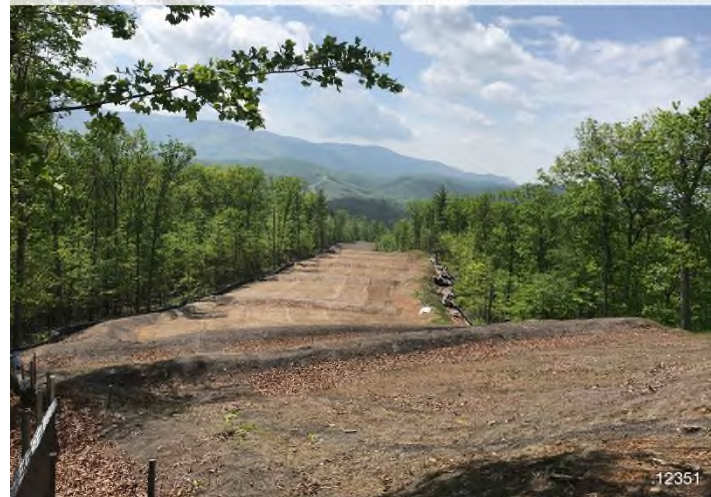
**Figure 4: STA 12351+00** – Controls in place and functioning properly. Area stabilized with erosion matting.
