FIELD INSPECTION REPORT

| Project Name: | Mountain Valley Pipeline | Inspector: | Marshall Willis |
| Spread I: Franklin County | STA 14546+75 – 14599+25 | Weather: | Rainy |

FIELD INSPECTION PHOTO LOG

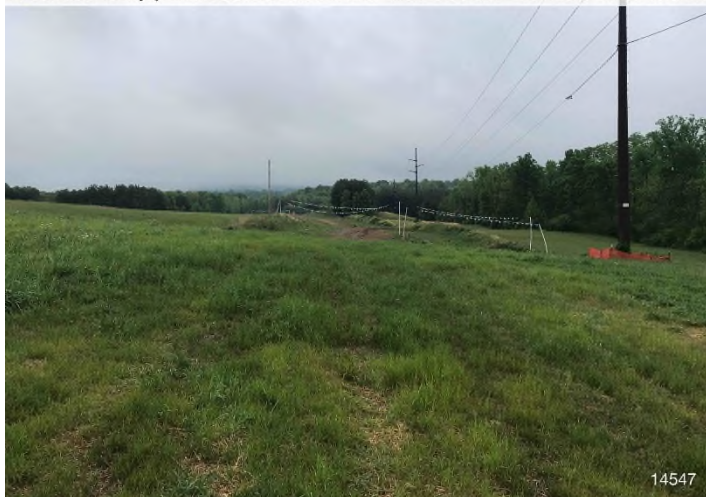
14547

Figure 1: STA 14547+00 – Controls in place and functioning properly.

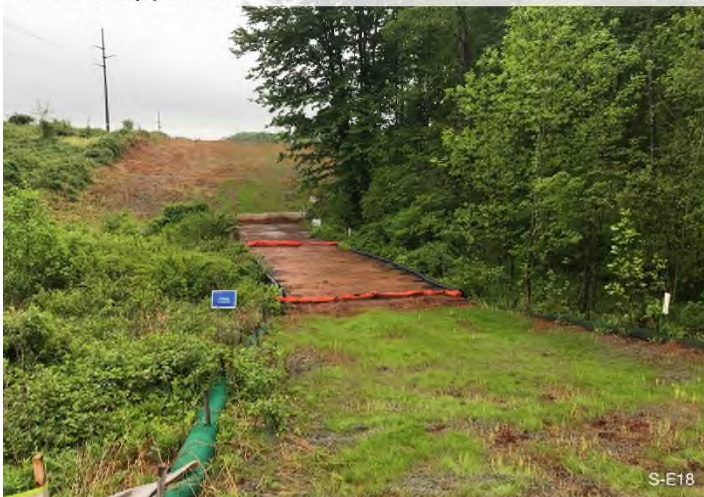
Figure 2: Stream S-E18 – Controls in place and functioning properly around stream crossing.

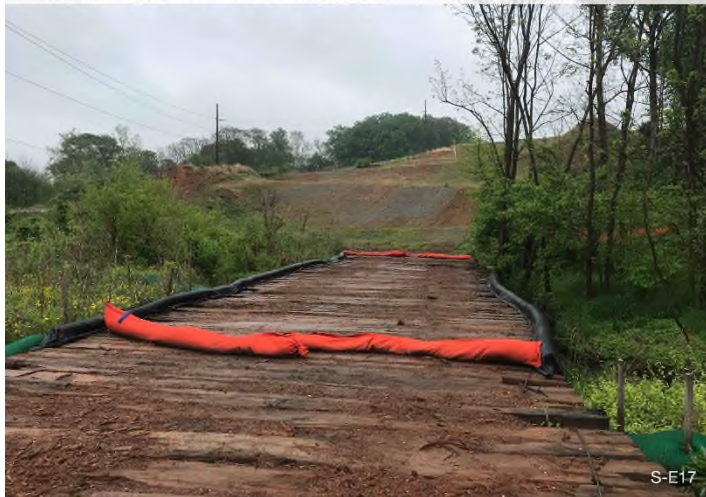
Figure 3: Stream S-E17 – Controls in place and functioning properly around stream crossing.

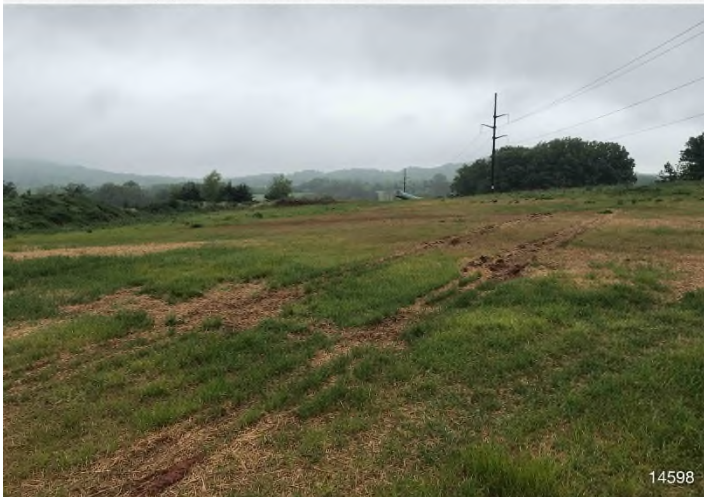
14598

Figure 4: STA 14598+00 – Controls in place and functioning properly.
