## FIELD INSPECTION REPORT

Project Name:	Mountain Valley Pipeline	Inspector:	Marshall Willis
Inspection Date:	Thursday, June 24, 2021	Project Contact:	Brian Clauto, Cory Chalmers
Spread I: Pittsylvania County	STA 15480+08 – 15584+23	Weather:	Dry

## FIELD INSPECTION PHOTO LOG

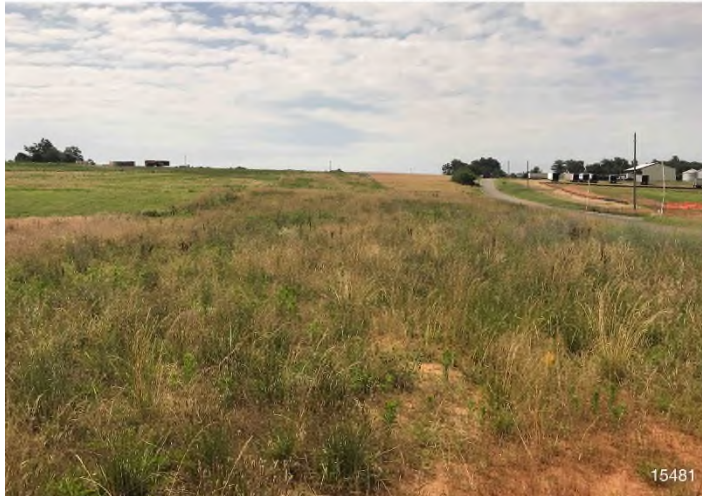
15481

**Figure 1: STA 15481+00** – Controls in place and functioning properly.

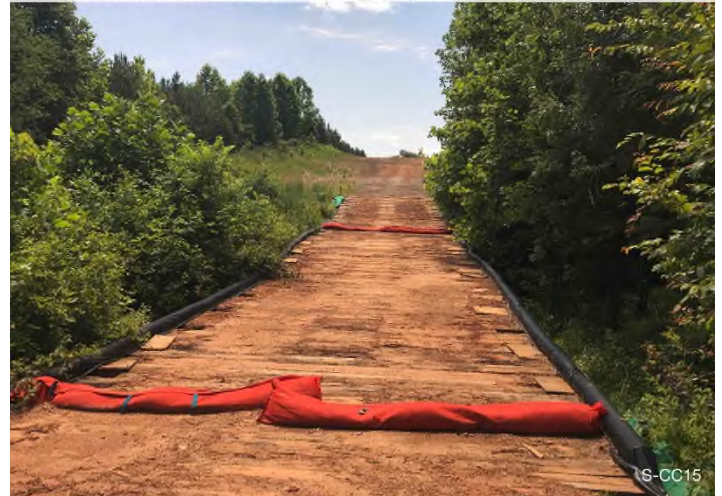
S-CC15

**Figure 2: Stream S-CC15** – Controls in place and functioning properly.

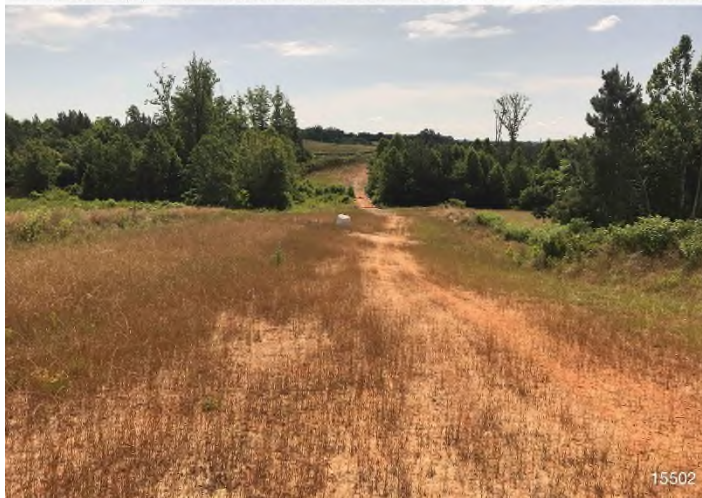
15502

**Figure 3: STA 15502+00** – Controls in place and functioning properly. Area stabilized with Earth Guard and straw.

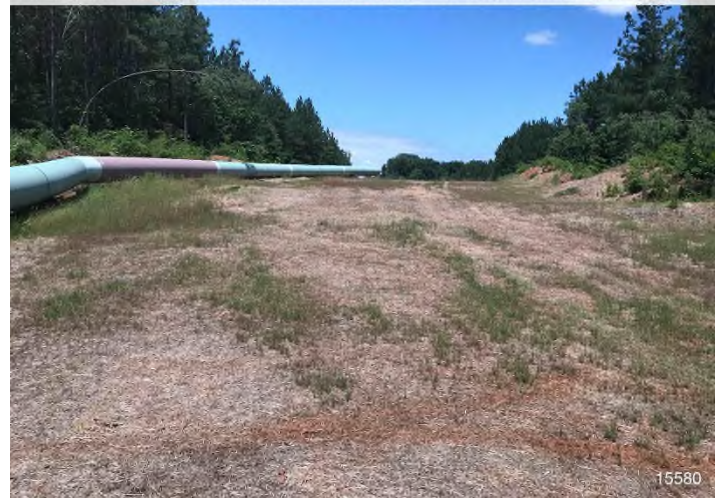
15580

**Figure 4: STA 15580+00** – Controls in place and functioning properly. Area stabilized with Earth Guard and straw.
