FIELD INSPECTION REPORT

Project Name:	Mountain Valley Pipeline	Inspector:	Marshall Willis
Inspection Date:	Wednesday, June 23, 2021	Project Contact:	Brian Clauto, Cory Chalmers
Spread I: Franklin County	STA 13415+51 – 13450+00 STA 14010+76 – 14062+17 MVP-FR-293.02	Weather:	Dry

FIELD INSPECTION PHOTO LOG

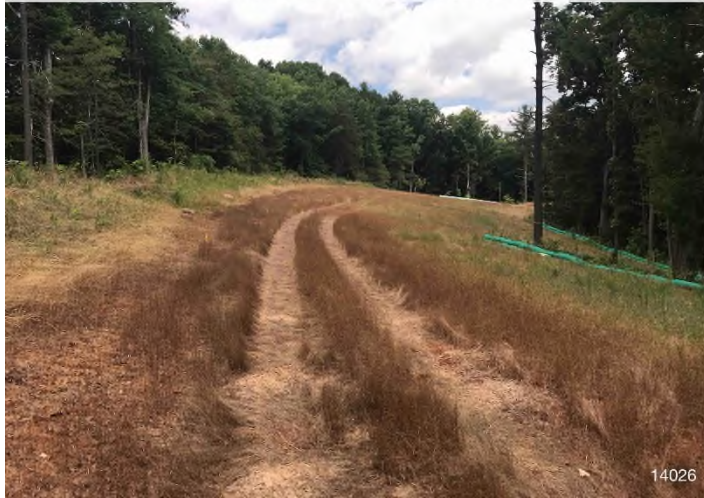
Figure 1: STA 14026+00 – Controls in place and functioning properly.

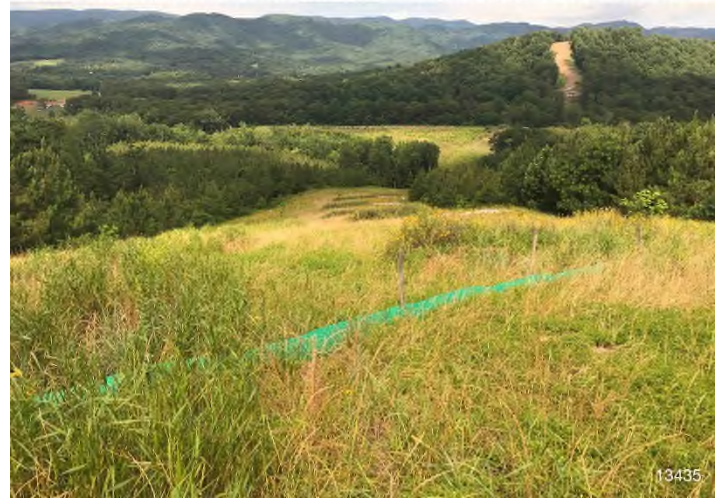
Figure 2: STA 13435+00 – Controls in place and functioning properly.

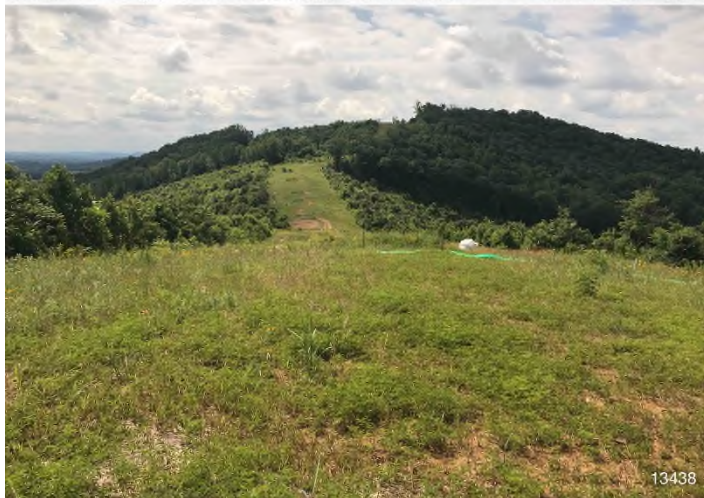
Figure 3: STA 13438+00 – Controls in place and functioning properly.

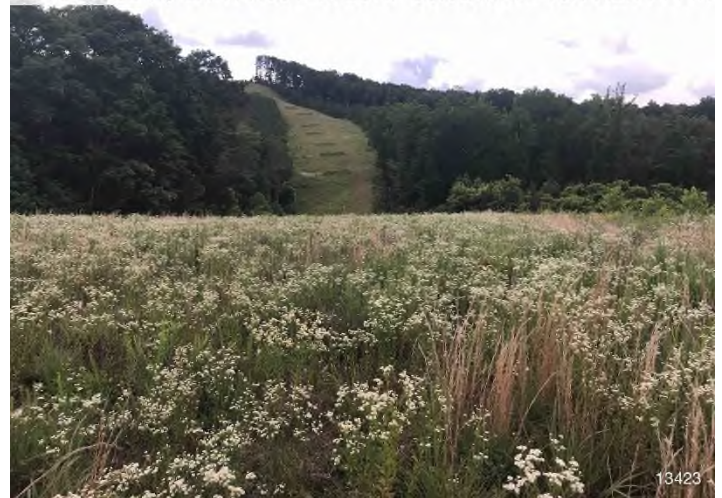
Figure 4: STA 13423+00 – Controls in place and functioning properly.
