FIELD INSPECTION REPORT

Project Name:	Mountain Valley Pipeline	Inspector:	Marshall Willis
Inspection Date:	Tuesday, June 22, 2021	Project Contact:	Brian Clauto, Cory Chalmers
Spread H: Roanoke County Franklin County	STA 12725+00 – 12735+00 STA 13141+00 – 13145+00 MVP-RO-281/281.01 MVP-FR-292/292.01	Weather:	Rainy

FIELD INSPECTION PHOTO LOG

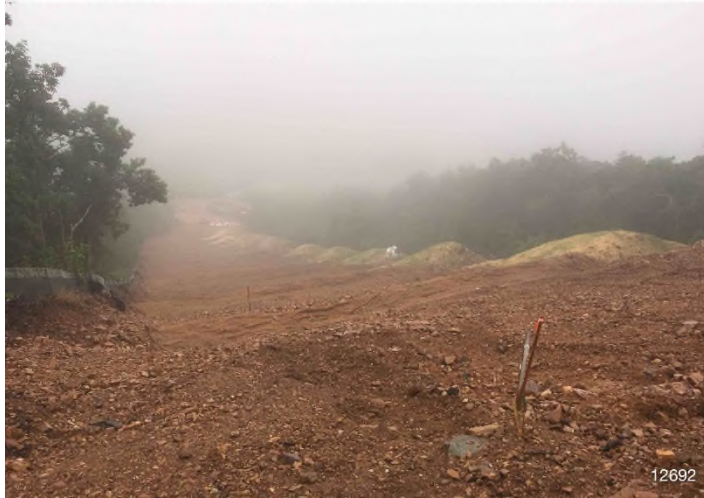
Figure 1: STA 12692+00 – Controls in place and functioning properly.
BRG: 130°SE (T) LAT: 37.191400 LON: -80.156797 ±16ft ALT: 3723ft

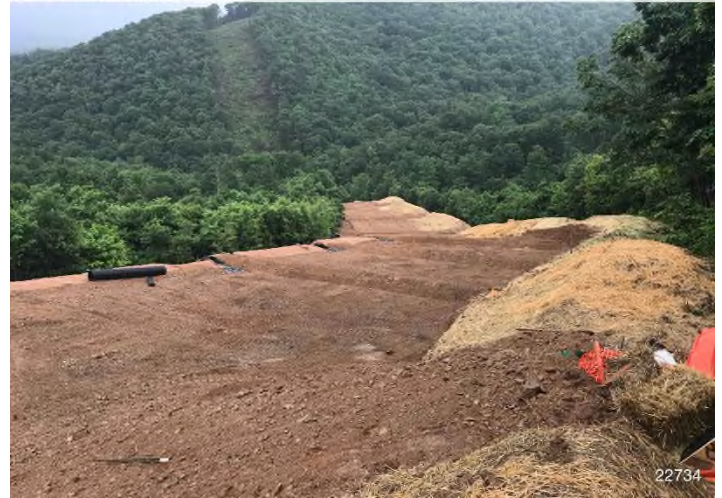
Figure 2: STA 12734+00 – Controls in place and functioning properly.
BRG: 182°S (T) LAT: 37.184078 LON: -80.149100 ±213ft ALT: 3193ft

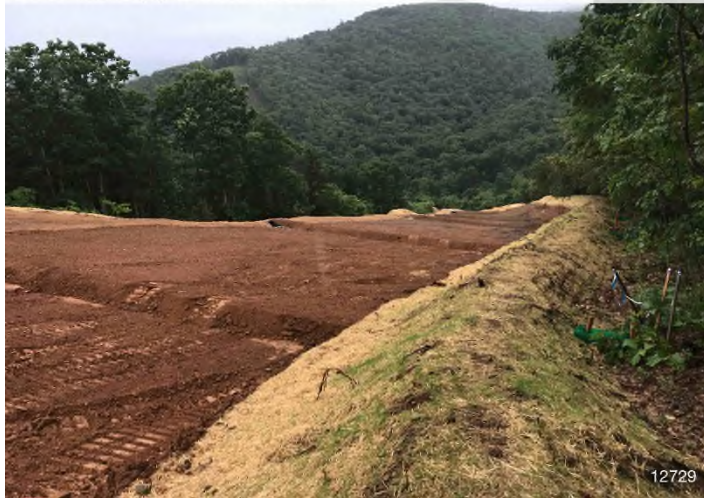
Figure 3: STA 12729+00 – Controls in place and functioning properly.
BRG: 189°S (T) LAT: 37.185128 LON: -80.148823 ±16ft ALT: 3329ft

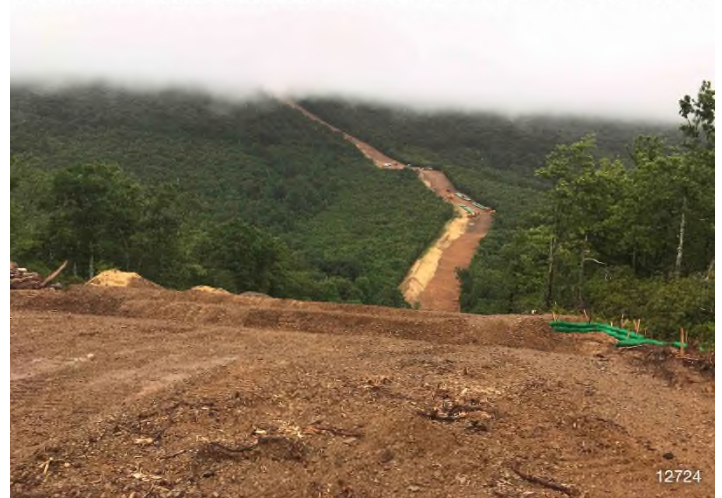
Figure 4: STA 12724+00 – Controls in place and functioning properly.
BRG: 307°NW (T) LAT: 37.185643 LON: -80.149857 ±16ft ALT: 3375ft
