FIELD INSPECTION REPORT

Project Name:	Mountain Valley Pipeline	Inspector:	Marshall Willis
Inspection Date:	Thursday, June 17, 2021	Project Contact:	Brian Clauto, Cory Chalmers
Spread H: Montgomery County	STA 12180+00 – 12194+23 STA 12420+43 – 12443+25 MVP-MN-274/279/279.02	Weather:	Dry

FIELD INSPECTION PHOTO LOG

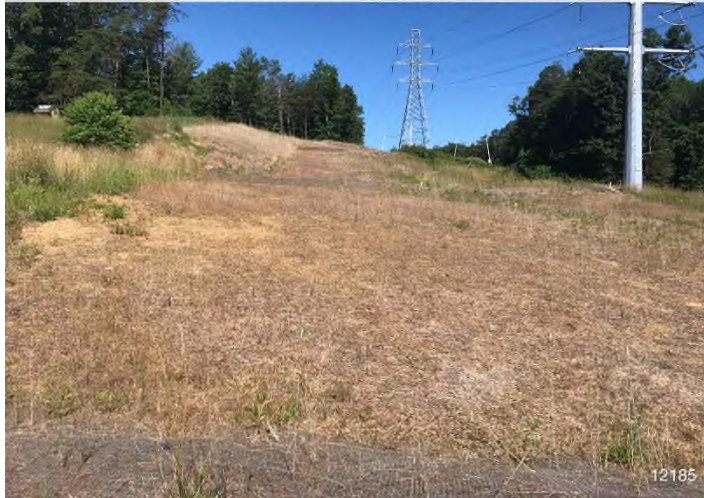
Figure 1: STA 12185+00 – Controls in place and functioning properly.

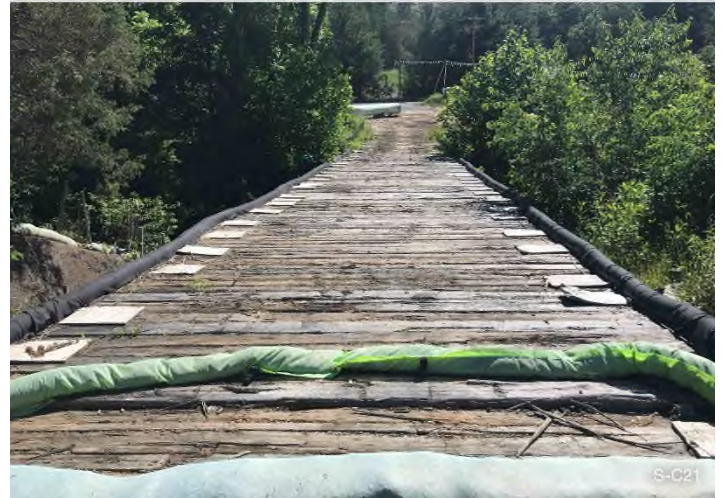
Figure 2: Stream S-C21 – Controls in place and functioning properly along Bradshaw Creek crossing.

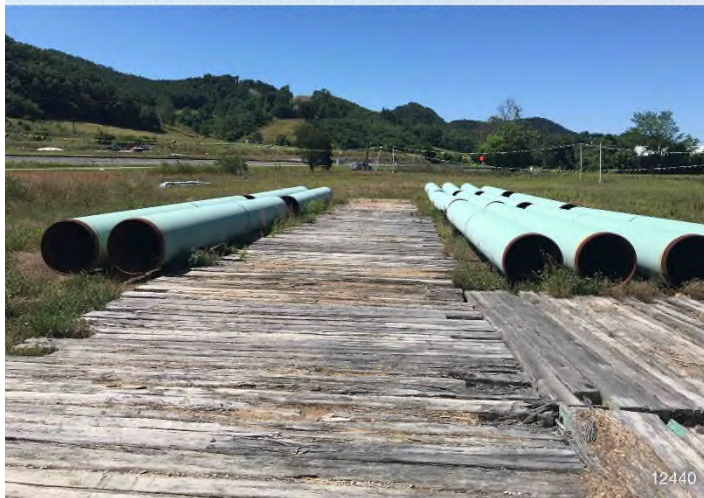
Figure 3: STA 12440+00 – Controls in place and functioning properly.

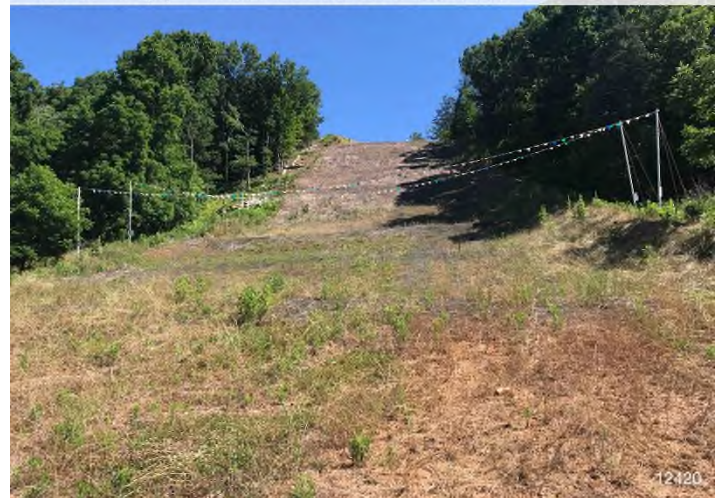
Figure 4: STA 12420+00 – Controls in place and functioning properly.
