Machicomoco State Park Shoreline Management Plan

May 2022

**Shoreline Studies Program
Virginia Institute of Marine Science
William & Mary**

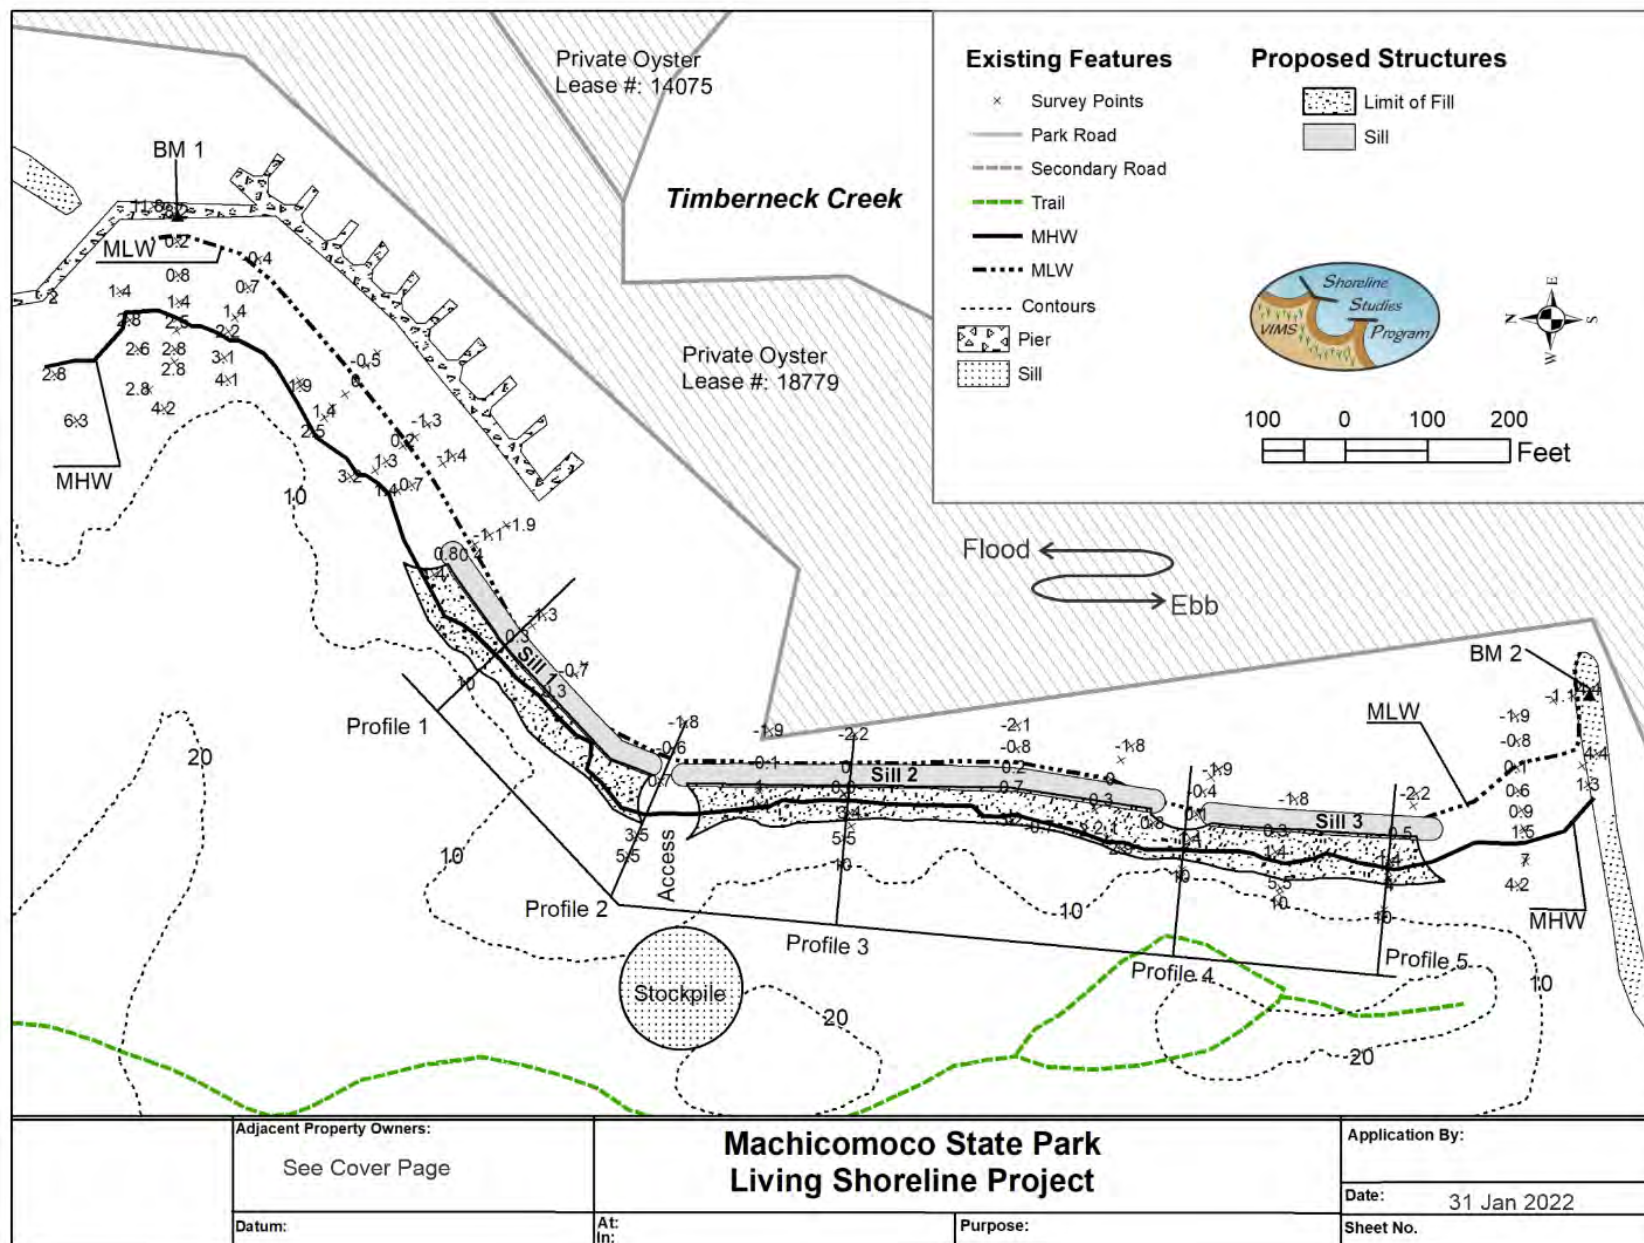
Figure 22. Planform for the living shoreline design for Site 12.

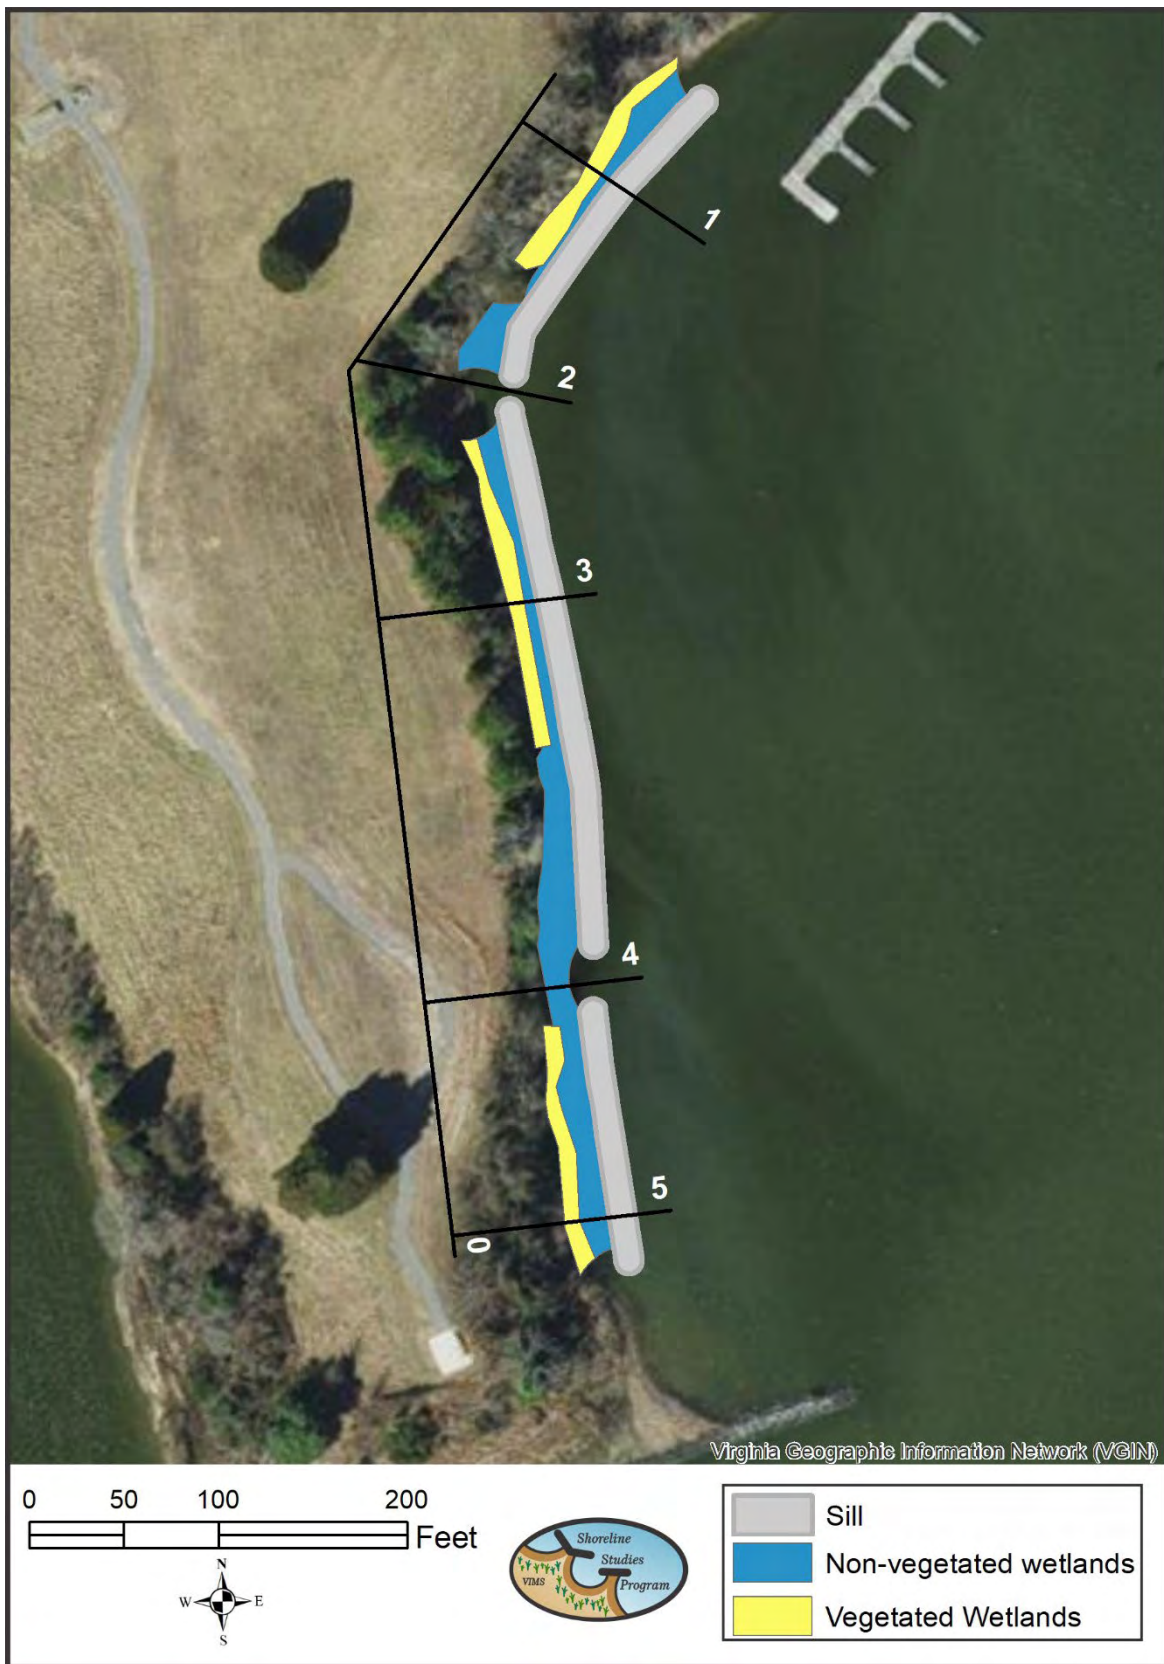
Figure 24. Planform showing the impact of the sand fill on the existing habitats. The shoreline along this reach varies between marsh fringe and no marsh fringe with a scarped, eroding bank.

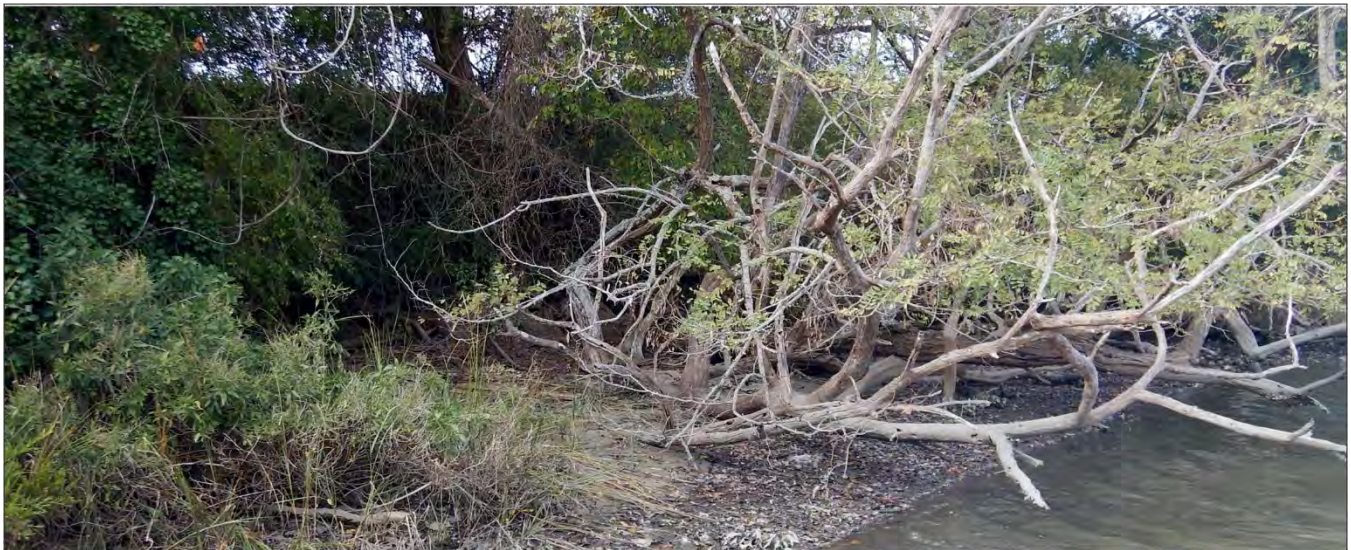
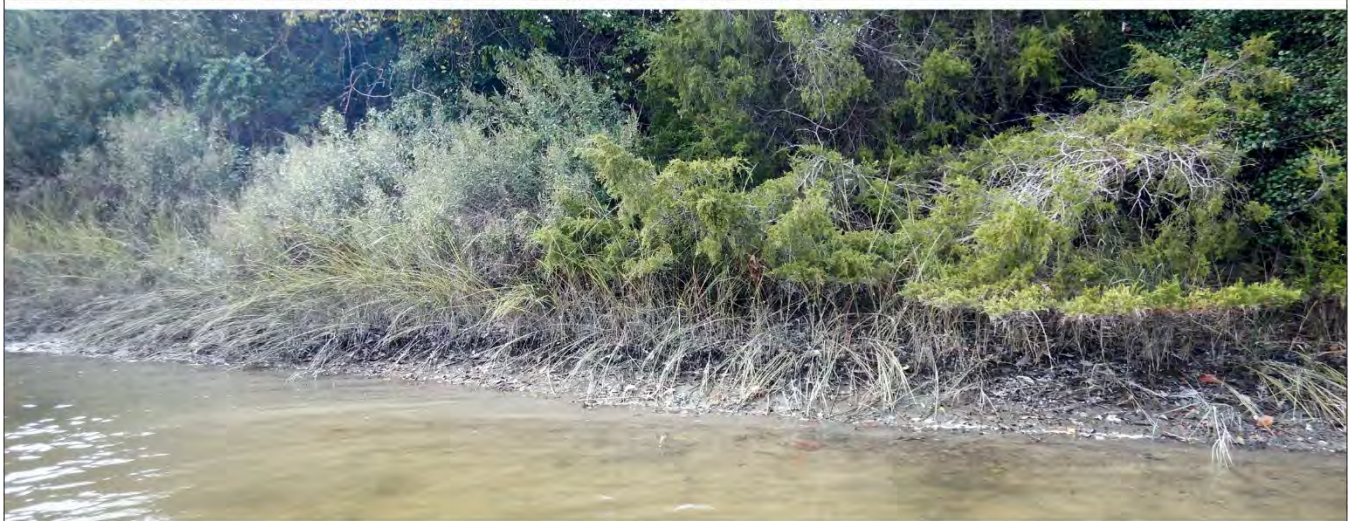
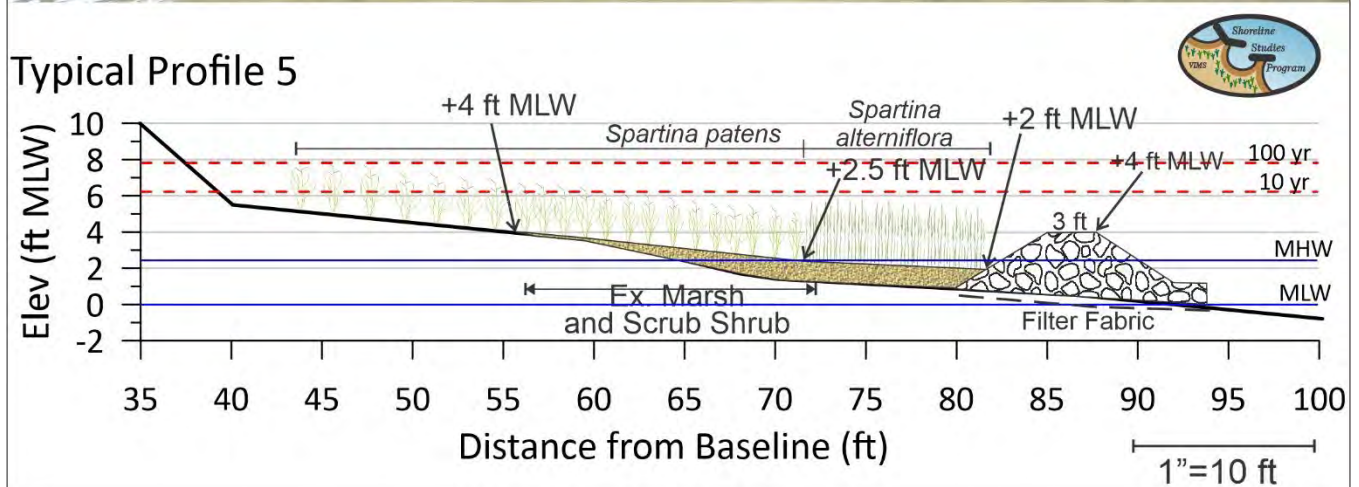
Figure 29. Photos showing the (top) northern section of sill 3 where no marsh exists and (middle) the southern section of sill 3 with its marsh and scrub shrub. The bottom is the typical profile of sill 3. However, it shows the southern section, not the northern section.
