FIELD INSPECTION REPORT

Project Name:	Mountain Valley Pipeline	Inspector:	Marshall Willis
Inspection Date:	Friday, May 14, 2021	Project Contact:	Brian Clauto, Cory Chalmers
Spread H: Roanoke County Franklin County	STA 13140+00 – 13195+71 MVP-FR-292.01 MVP-RO-281	Weather:	Dry

FIELD INSPECTION PHOTO LOG

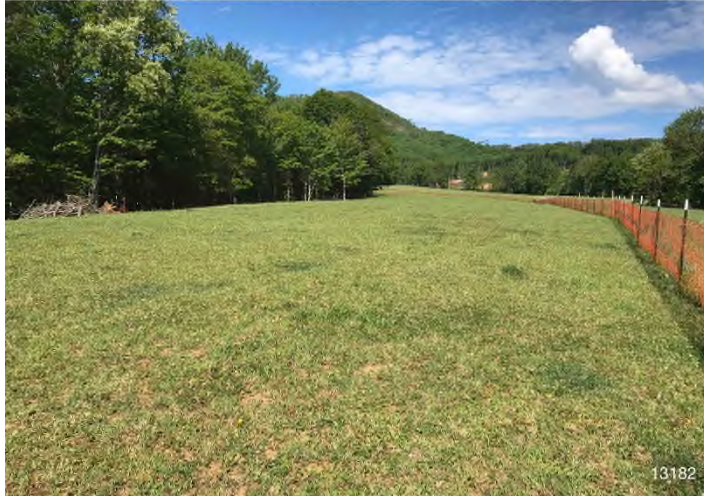
Figure 1: STA 13182+00 – No ground disturbance present at the time of inspection.

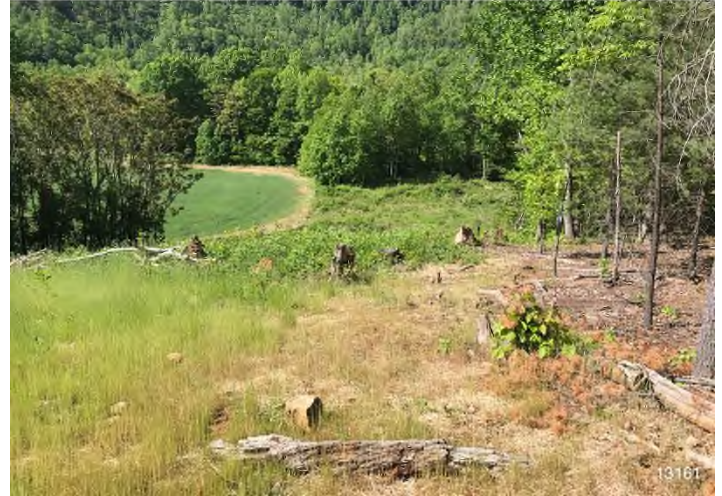
Figure 2: STA 13161+00 – No ground disturbance present at the time of inspection.

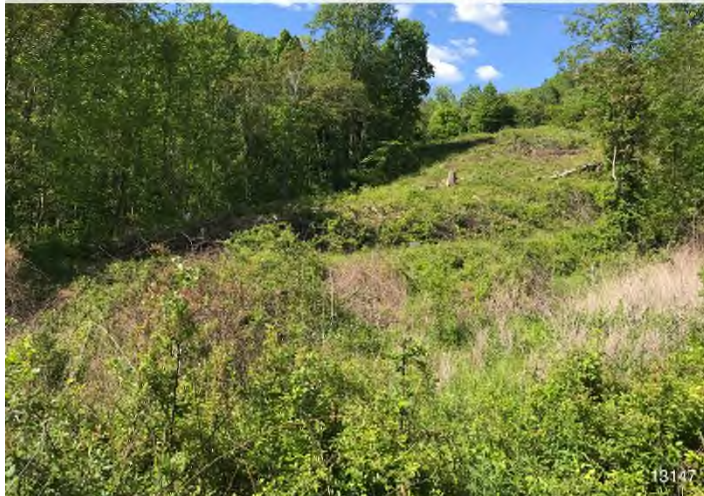
Figure 3: STA 13147+00 – No ground disturbance present at the time of inspection.

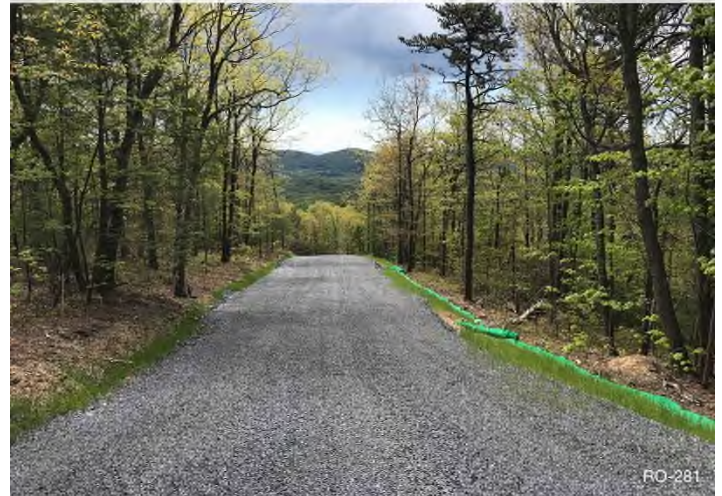
Figure 4: MVP-RO-281 – Controls in place and functioning properly.
