*Targeted Living Shoreline  
Management Planning for  
Virginia State Parks  
in Chesapeake Bay*

*Summary Report*

# Targeted Living Shoreline Management Planning for Virginia State Parks in Chesapeake Bay Summary Report

Shoreline Studies Program  
Virginia Institute of Marine Science  
William & Mary

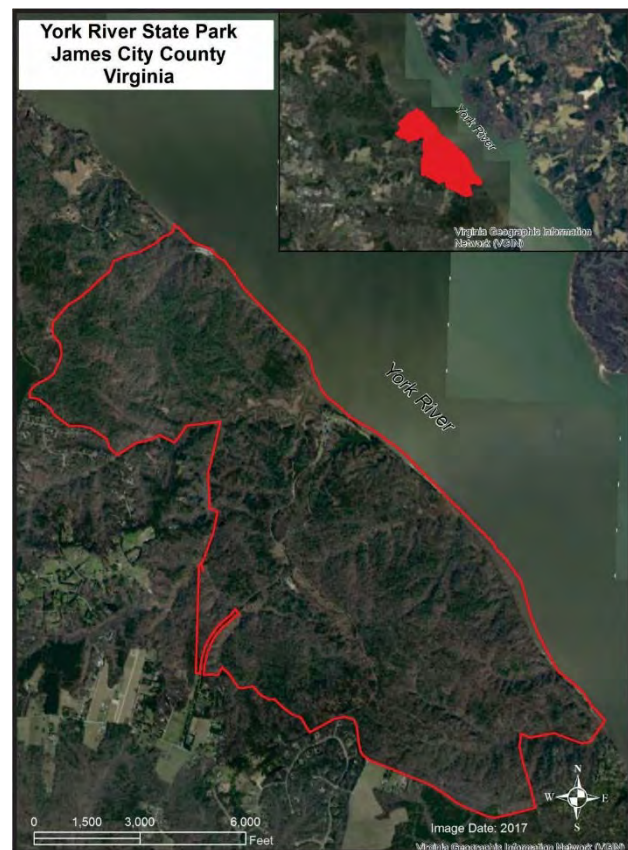
Figure 4-1. Location of York River State Park in the Chesapeake Bay estuarine system

York River State Park is located on the south shore of the York River in James City County, Virginia (Figure 4-1). The Park has about 4.7 miles of shoreline along the York River. The primary focus of the plan will be the eroding shorelines along the York River; Taskinas Creek shoreline was not included. Along the York River, the shorelines are either eroding marsh protecting uplands or eroding upland banks with little or no protective marsh fringe. Intermittent marsh headlands provide minimal upland bank protection but may represent headland control opportunities.

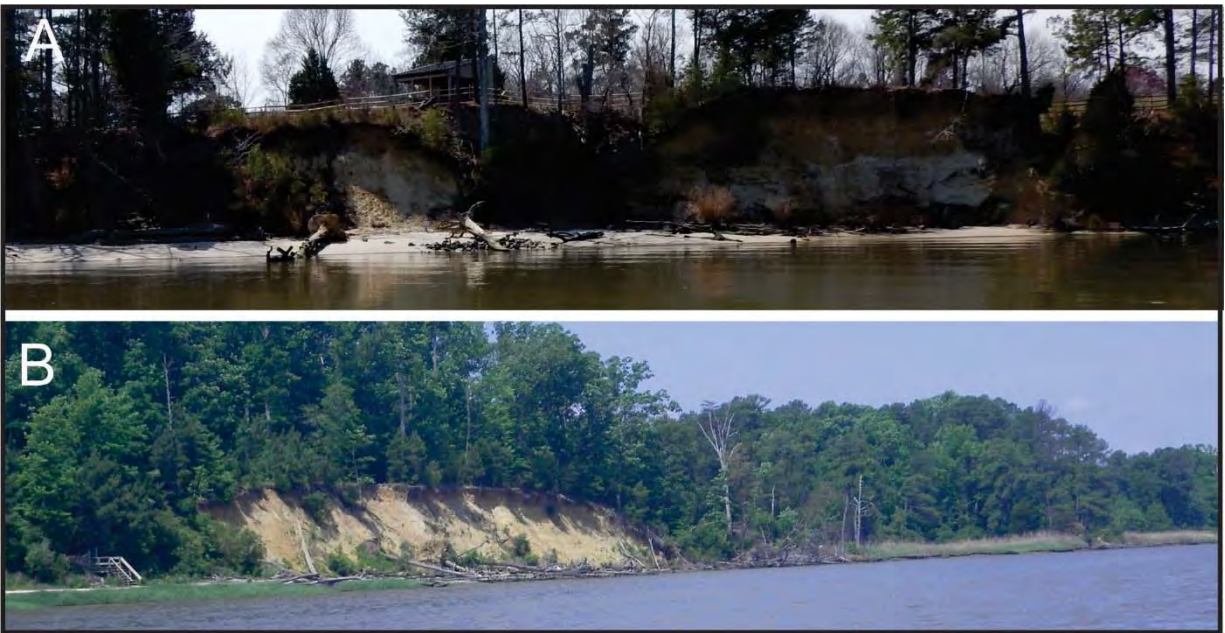
Figure 4-4. A) Eroding banks at the Visitor's Center along Reach 2. B) Reach 2 is a mix of intermittent eroding uplands and marsh shorelines.

The Reach 2 shoreline beginning at Taskinas Creek is an eroding tidal marsh that transitions to upland banks without marsh fringe in front of the Visitor Center complex (Figure 4-4A). Most of Reach 2 has been identified for shoreline stabilization due, in part, to threatened infrastructure and archeological sites. Continuing downriver, the shoreline is again a mix of mostly eroding upland banks and intermittent marsh fringes (Figure 4-4B). The shore planform occurs as a series of undulating headlands created by intermittent marsh fringe and fallen trees. Reach 2 ends at the tidal drainage where two creeks enter the York River.

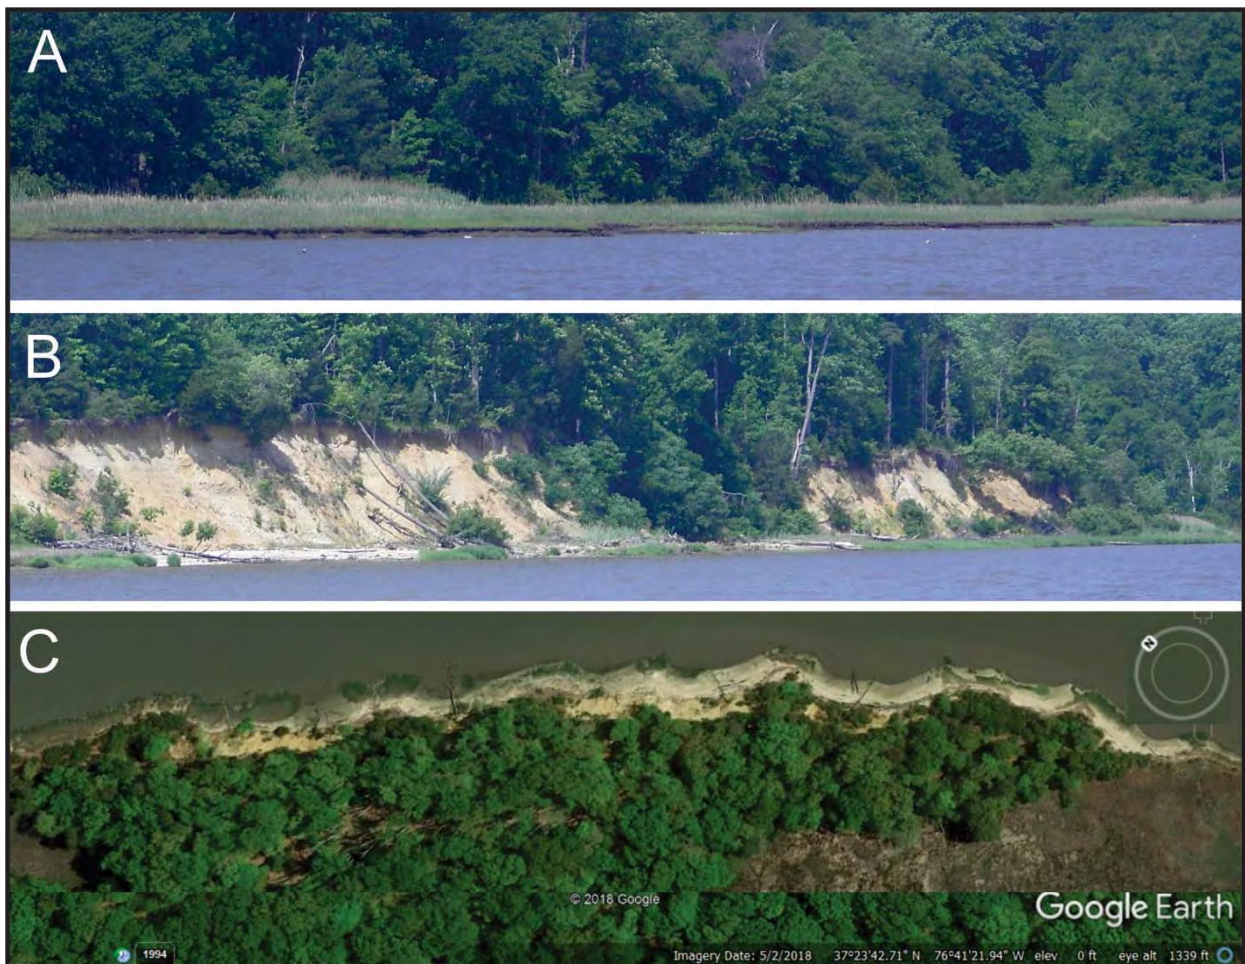
Figure 4-5. A) A wide, eroding marsh protects the upland along Reach 3. B) Farther downriver, the marsh no longer exists in many areas and the upland banks are eroding. C) The section of shoreline at the downriver end of the park occurs as a series of headlands due to remnant marshes or downed trees.

Reach 3 extends downriver from the boundary with Reach 2. The first half of Reach 3, about 4,000 feet, is mostly eroding marsh fringe that is wide enough for upland bank protection (Figure 4-5A). Then the marsh narrows downriver and becomes very intermittent and missing as the upland banks have become exposed and actively eroding for another 3,000 ft (Figure 4-5B). The shoreline planform occurs as series of undulating headlands created by marshes and fallen trees (Figure 4-5C) This transitions to the marsh shoreline associated with the unnamed tidal drainage at the park boundary.

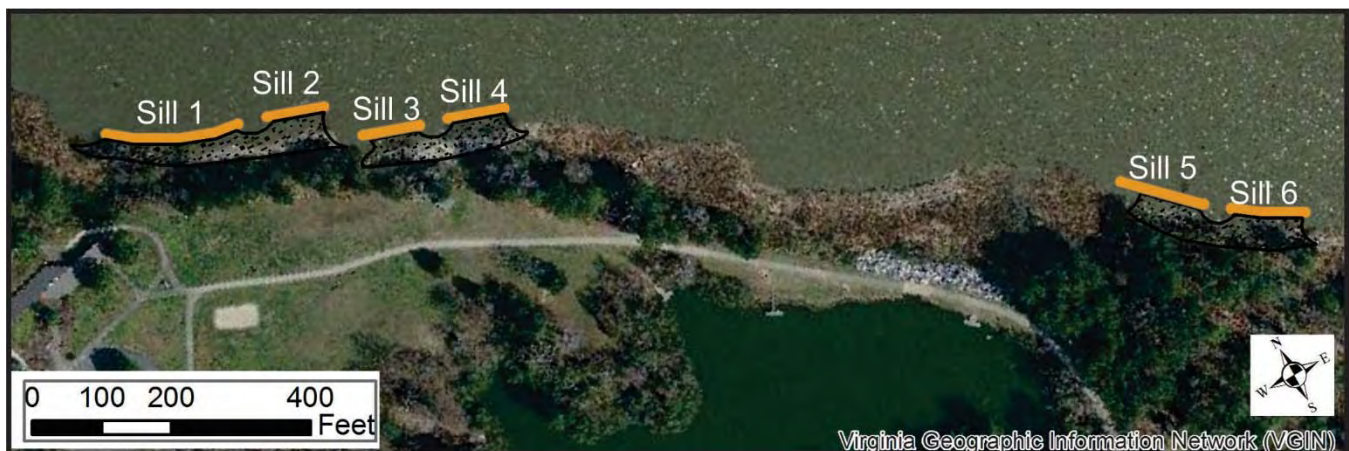
Figure 4-6. Conceptual plan for the living shoreline demonstration project at the York River State Park Visitor's Center. Six sills are recommended along the shoreline to protect the narrow, existing marsh and the eroding upland banks.

The site chosen for the development of a conceptual plan is in front of the Visitor's Center due to the threatened infrastructure and visibility as a demonstration site. A series of gapped sills is recommended in front to the Visitor Center and along the eroding marsh and upland banks just downriver (Figure 4-6). Labeled sills 1 to 6, these structures will provide both shore protection and habitat by using stone sills, sand fill and marsh plantings. Sill 1 is 210 ft long, Sills 2, 3, and 4 are 95 ft long, Sill 5 is 140 ft, and Sill 6 is 120 ft. The typical cross-section is shown in Figure 4-7. Estimated encroachment calculations are shown in Table 3. These values are estimated for the shore position in 2017 and may not accurately reflect the plan farther into the future because of the high erosion rate. The estimate cost (based on the typical cross-section) of installed rock, sand, and plants is \$226,500,

\$235,200, and \$25,200, respectively. The total estimated cost of the project with 20% design work, mobilization and demobilization is approximately \$584,280. These values also are sensitive to time and may not be applicable into the future.

No bank grading is recommended so once the base of bank is protected, the bank face will continue to slump or sough to a more stable gradient and allow vegetation to become established and further stabilizing the slump material. This project can be constructed in phases as funding becomes available.

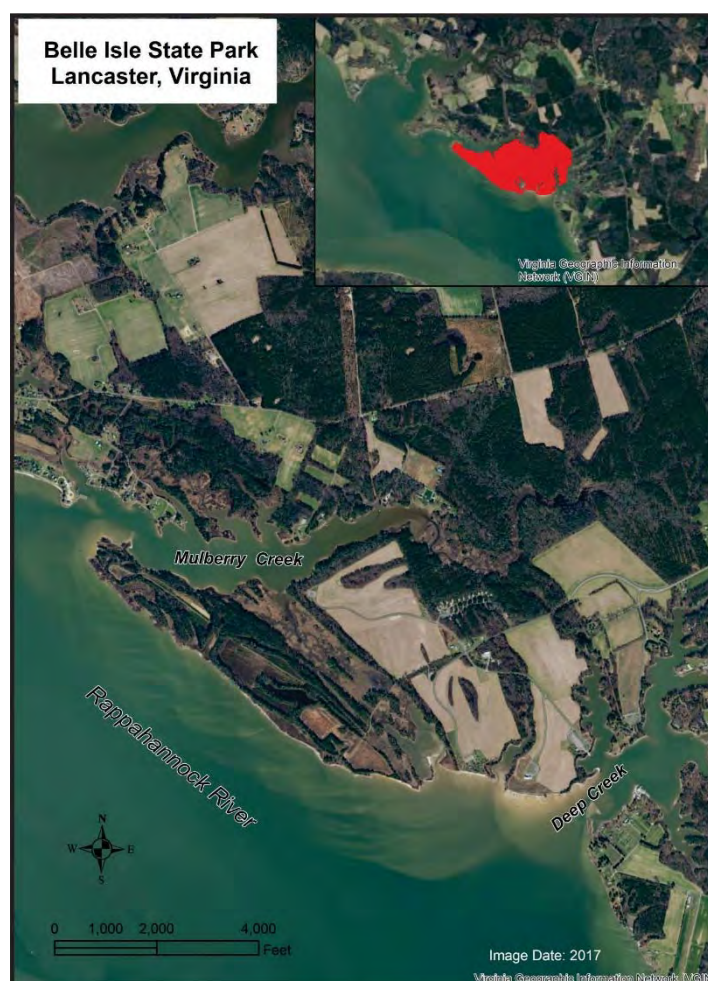
Figure 4-8. Location of Belle Isle State Park within the Chesapeake Bay estuarine system.

Belle Isle State Park is located on the Rappahannock River in Lancaster County, Virginia. The Park has about 8.6 miles of shoreline along the Rappahannock River, Deep Creek, and Mulberry Creek (Figure 4-8). Over the years, several shore protection systems have been designed for the Visitor Center and picnic area including plans created by the Department of Conservation and Recreation's Shoreline Erosion Advisory Service (SEAS), the Army Corps of Engineers (USACE), and more recently, by Stantec, Inc. for the Virginia Department of Transportation (VDOT). These efforts are recognized as viable shore protection strategies at those sites. However, based on a site visit and analysis, more recent plans have been developed for these shorelines as well as other reaches of shoreline identified in the Park's Master Plan (DCR, 2017) and those identified as erosional through this project. These plans are

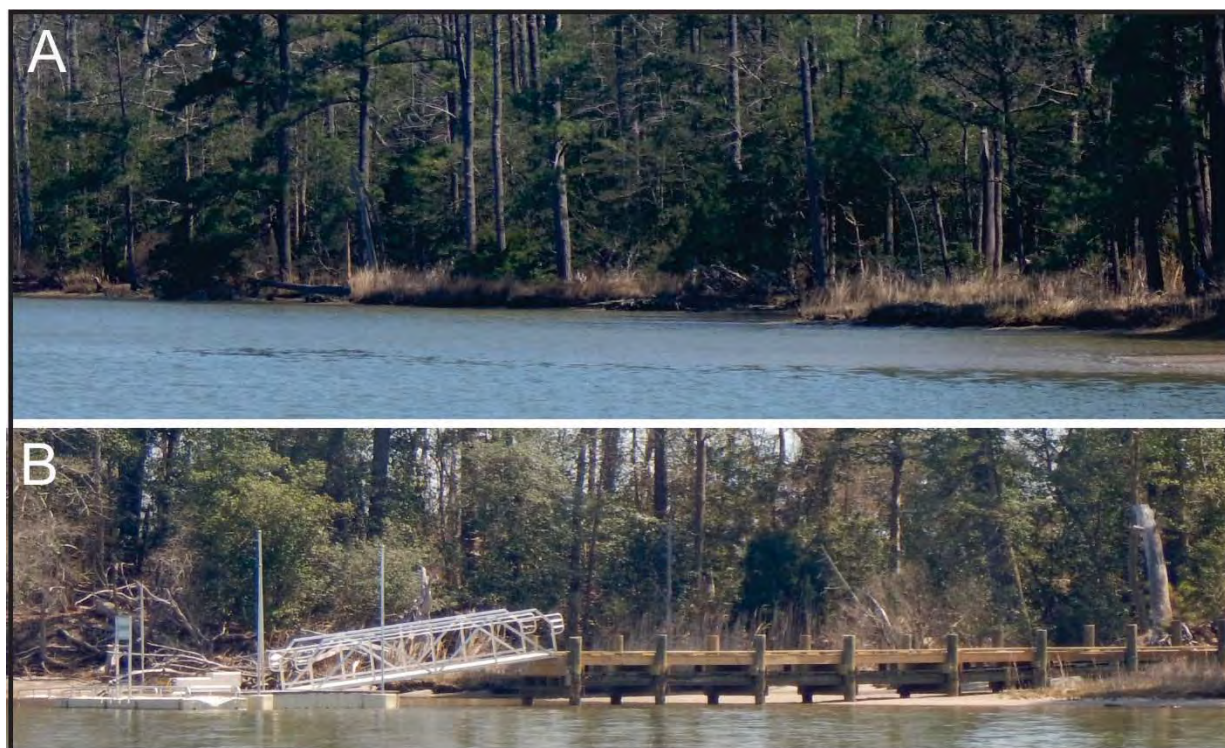
Figure 4-10. A) Low, undercut upland banks with intermittent eroding marsh fringes occur along much of Reach 1 along Mulberry Creek. B) An access pier along Reach 1.

The shorelines along Mulberry Creek, Reach I, are mostly very low, undercut upland banks with intermittent eroding marsh fringes (Figure 4-10A). Erosion rates are low due to limited fetch exposures of less than 1 mile. The uplands are wooded with mostly pine forest that buffer farmland along the upper half of the Mulberry Creek. There is an access dock adjacent to a small tidal creek (Figure 4-10B) that flows north into Mulberry Creek. From there toward the mouth of Mulberry Creek, the Reach IB shoreline is very similar with low eroding banks and intermittent marsh fringe. The upland areas that lack marsh fringe are the most erosive. At the northern point of Belle Isle, bank erosion increases with increased fetch exposure.

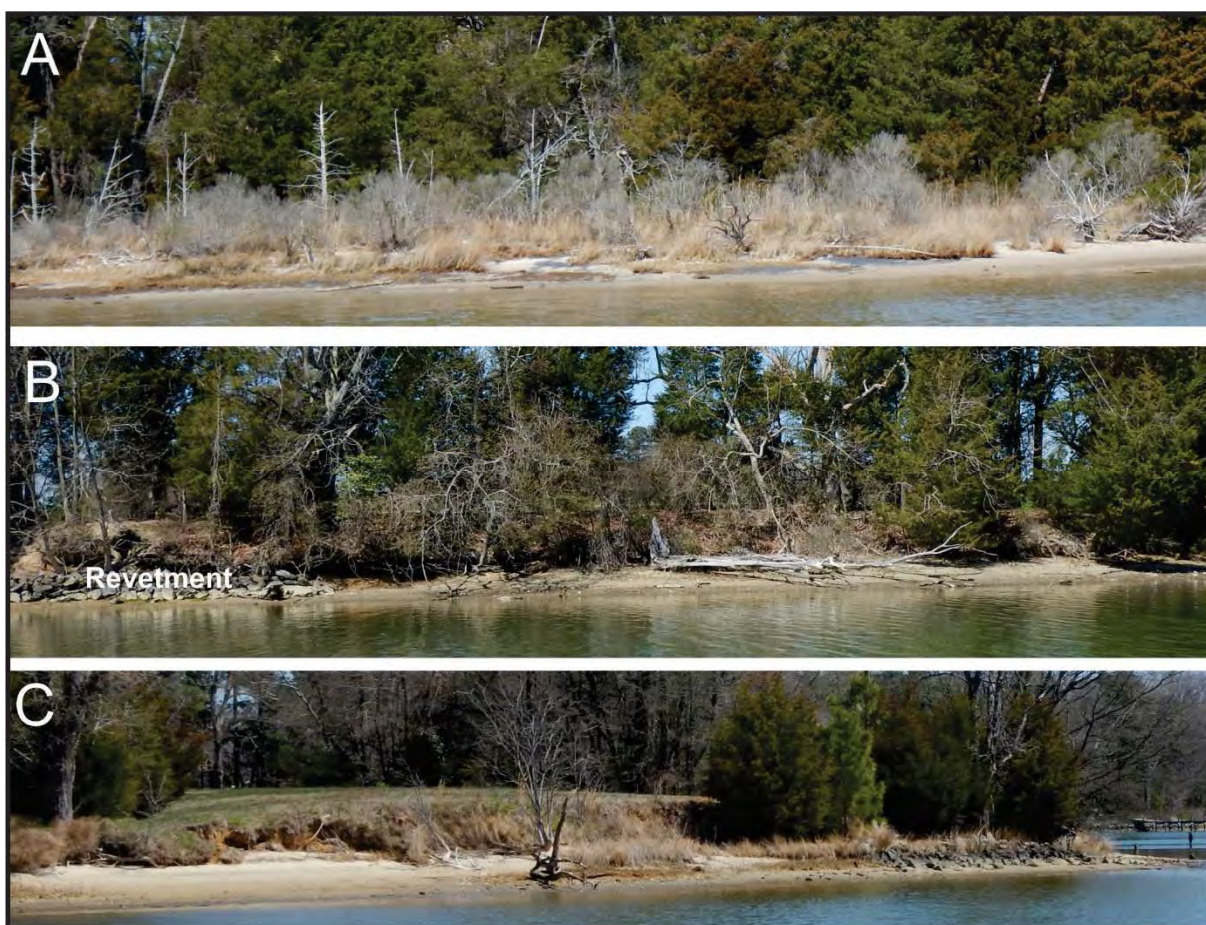
Figure 4-12. A) Reach IIIA shoreline is a low eroding marsh fringe on sandy spit. B) Eroding upland adjacent to boat ramp. Note existing rock for shore erosion control. C) Eroding point at Bel Air Guest House on Deep Creek.

Along the next neck of land, the Bel Air Guest House resides, and the shoreline is more exposed and erosional (Figure 4-12C). Farther up Deep Creek, the undercut bank condition and fallen trees continues.

Reach III extends along the Deep Creek shoreline and begins as a low eroding spit feature (Figure 4-12A). The low upland bank has increased and is slightly erosional and undercut adjacent to the boat ramp (Figure 4-12B). This bank condition continues along much of Reach III with undercut banks and intermittent marsh fringes. Along the next neck of land,

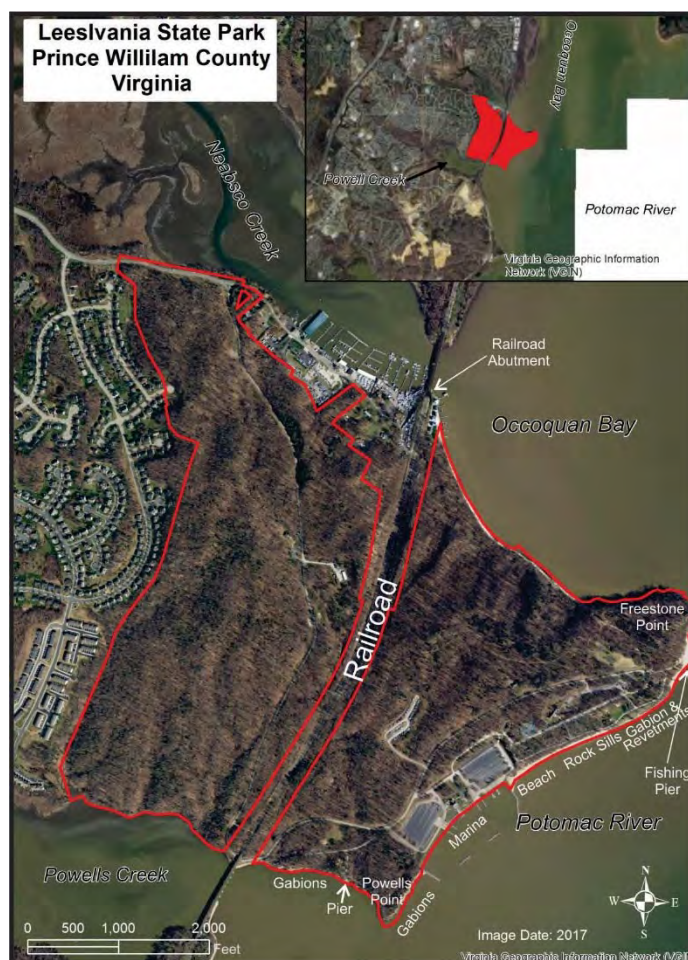
Figure 4-15. Location of Leesylvania State Park within the Chesapeake Bay estuarine system. Shoreline structures also are indicated.

Leesylvania State Park is located on the Potomac River in Prince William County, VA (Figure 4-15). Although not specifically listed in the Master Management Plan, 2010, shoreline erosion has since become an issue, especially on the open Potomac River shoreline. Recently, shoreline structures have been installed to abate the shore area just upriver of Park Marina.
