FIELD INSPECTION REPORT

Project Name:	Mountain Valley Pipeline	Inspector:	Matthew Grant
Inspection Date:	Tuesday, April 12, 2022	Project Contact:	Brian Clauto
Spread H: Montgomery	St12544+16-12450 ATWS 645A AR-MN278.01	Weather:	Dry

FIELD INSPECTION PHOTO LOG

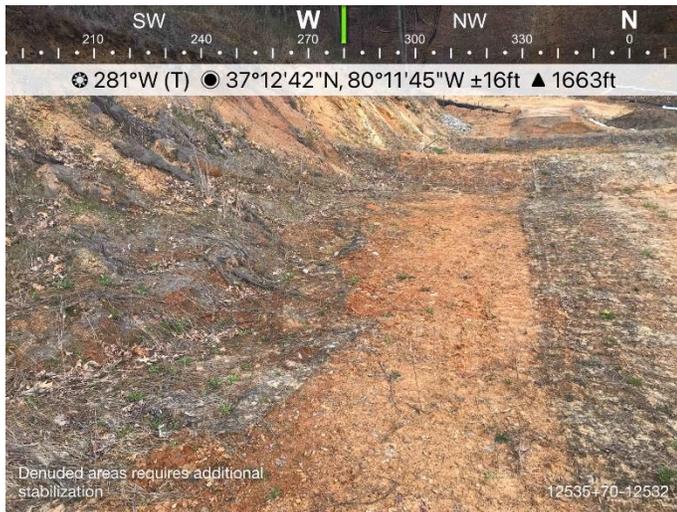
Routine Maintenance: (72-Hour Deadline from Notification)
 - 12535+70-12532 additional stabilization on denuded areas required.

Figure 1: Additional stabilization required near stations 12535+70-12532.

Recommended Corrective Action: Maintain and install all controls per the approved PSS&S.

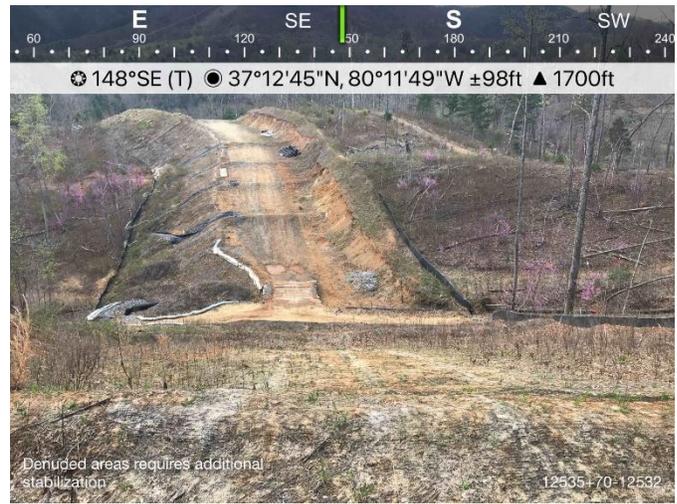
Figure 2: Additional stabilization required near stations 12535+70-12532.

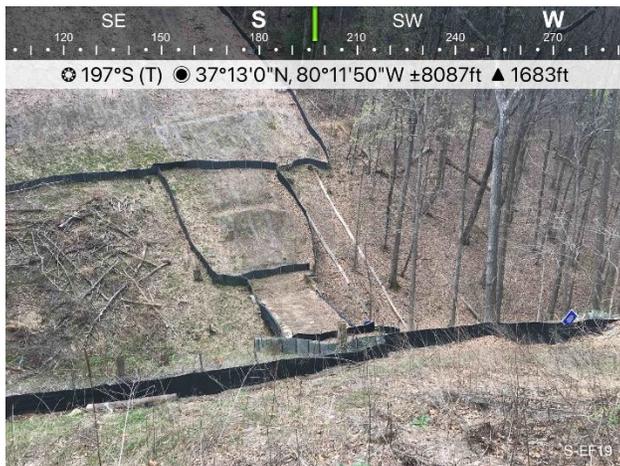
- Comments: Inspected the following resources: S-EF54, S-EF19, W-KL58, S-CD12b
- ECD's were in place and functioning at the designated crossings.

Figure 3: Above designated crossing S-EF19, ECD's are in place and functioning.

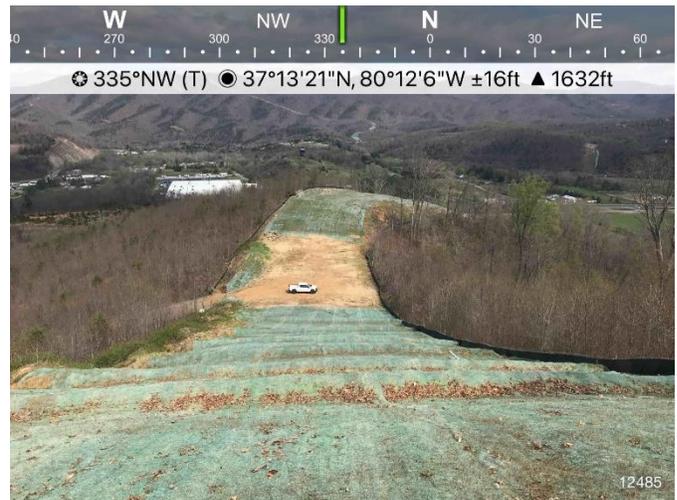
Figure 4: St 12485, ECD's are in place and functioning.
