Living Shoreline Design Guidelines for Shore Protection in Virginia's Estuarine Environment

Living Shoreline Design Guidelines for Shore Protection in Virginia's Estuarine Environments

Version 3.0

Special Report in Applied Marine Science and Ocean Engineering #473

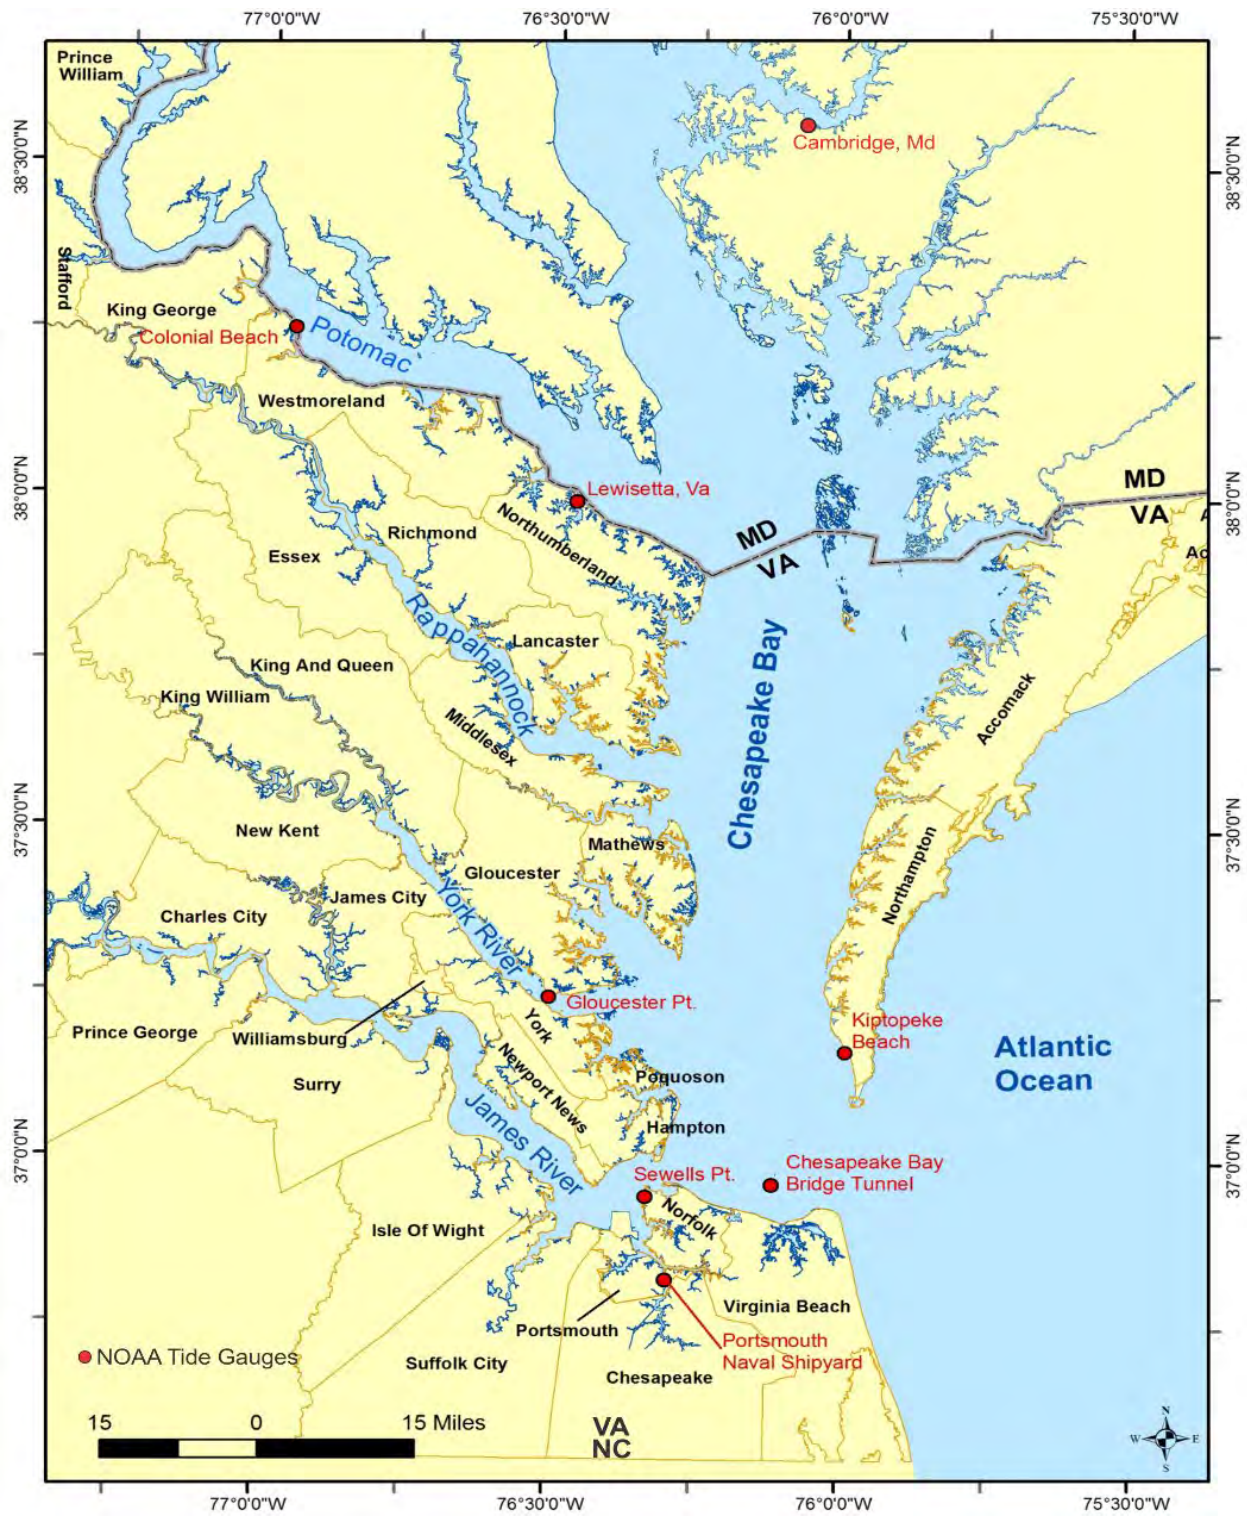
Figure 1-1. Virginia Portion of the Chesapeake Bay estuary and location of tide gauges.

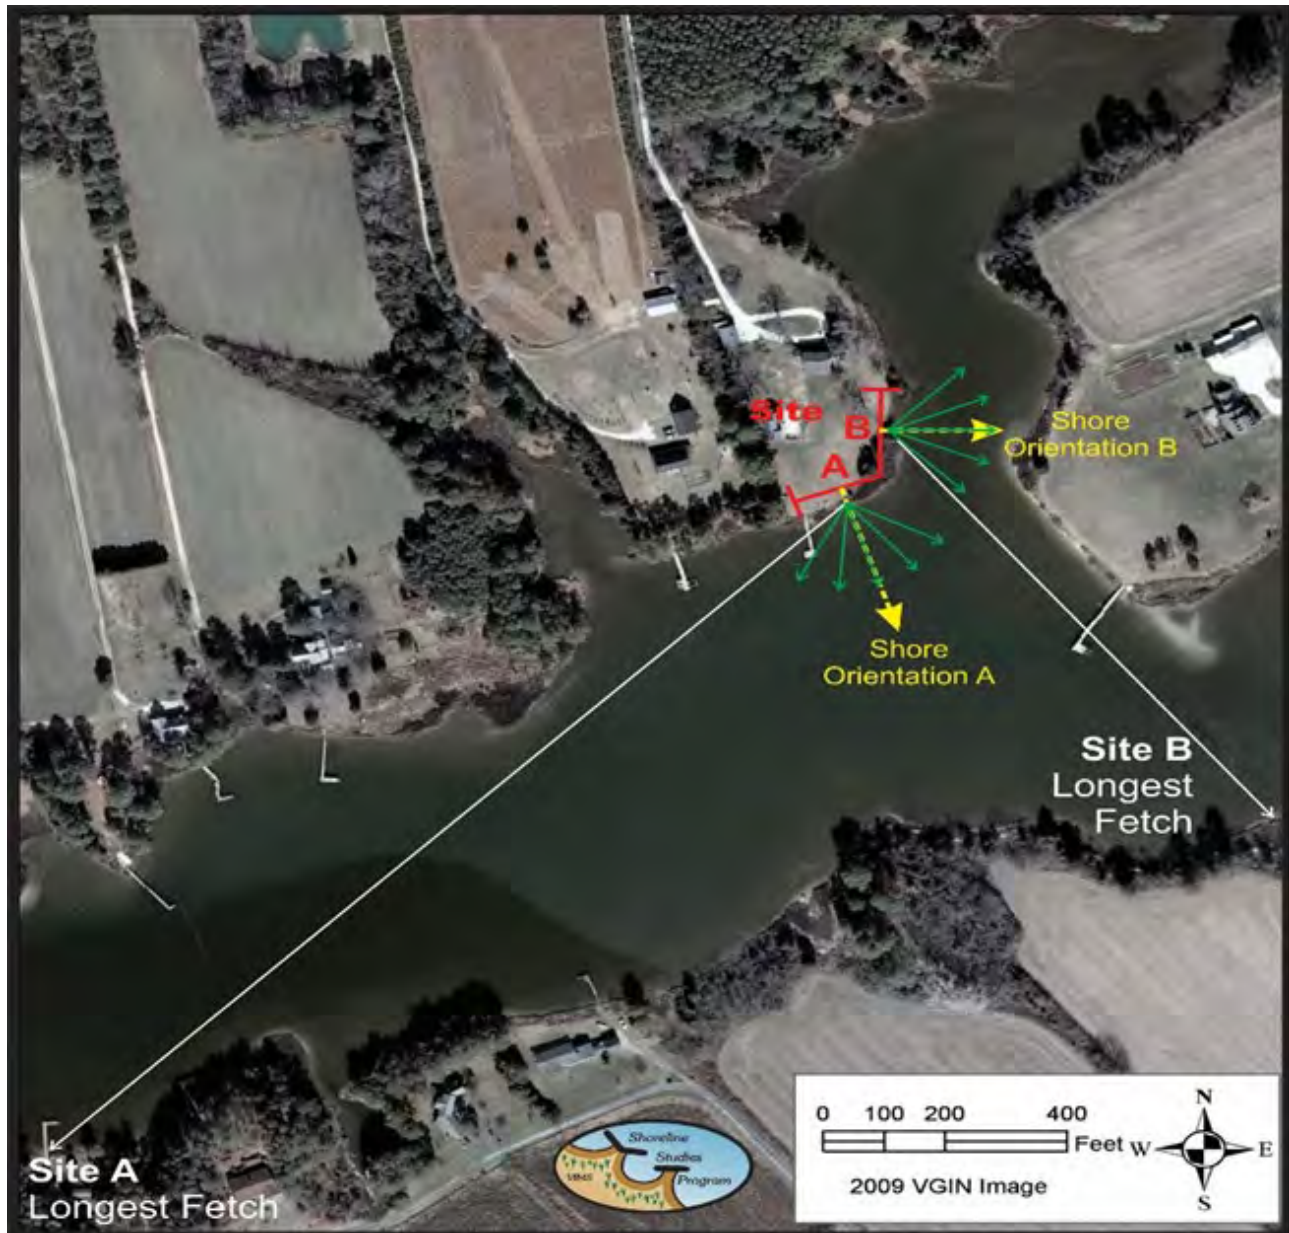
Figure 2-1. Photo depicting the longest fetch for two sections of a site. Section A's shore orientation (direction of face) is southeast while Section B's orientation is east. The green arrows show the vectors measured to determine average fetch while the white arrows show the vector of the longest fetch. Average fetches are measured from the shoreline to the opposite shoreline along the vector line.

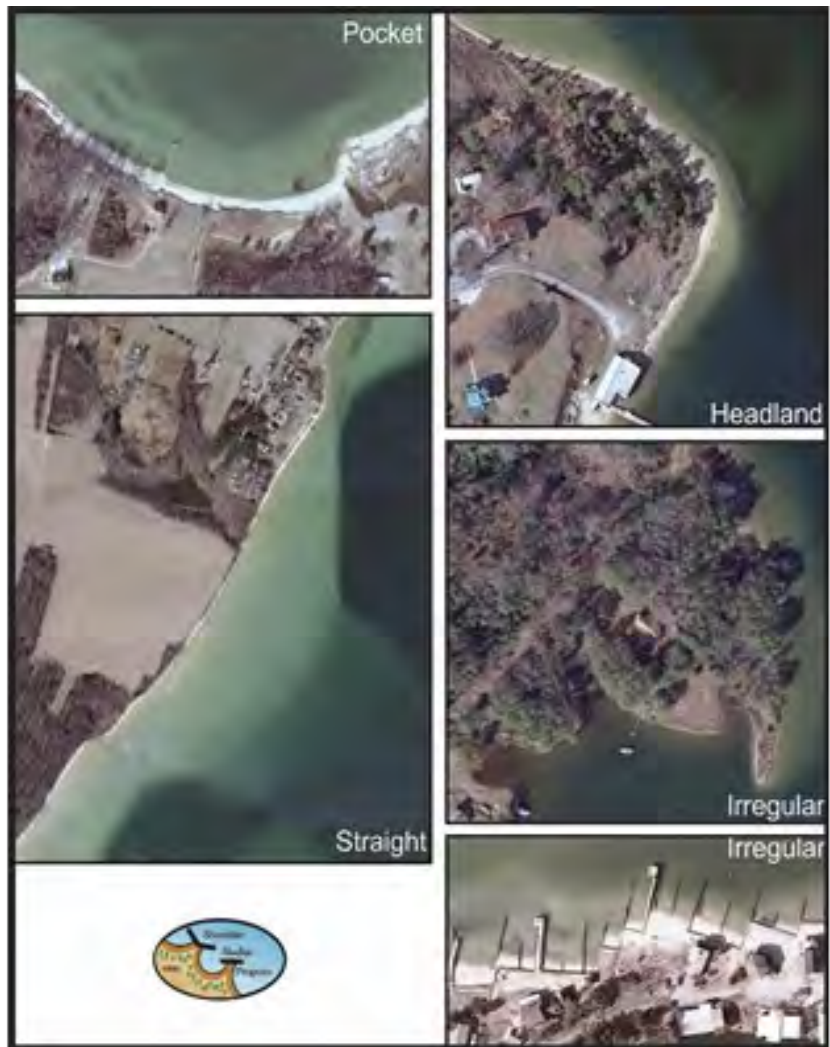
Figure 2-2. Photo illustrating four different kinds of shoreline morphology in Chesapeake Bay. Photos: VGIN 2009.

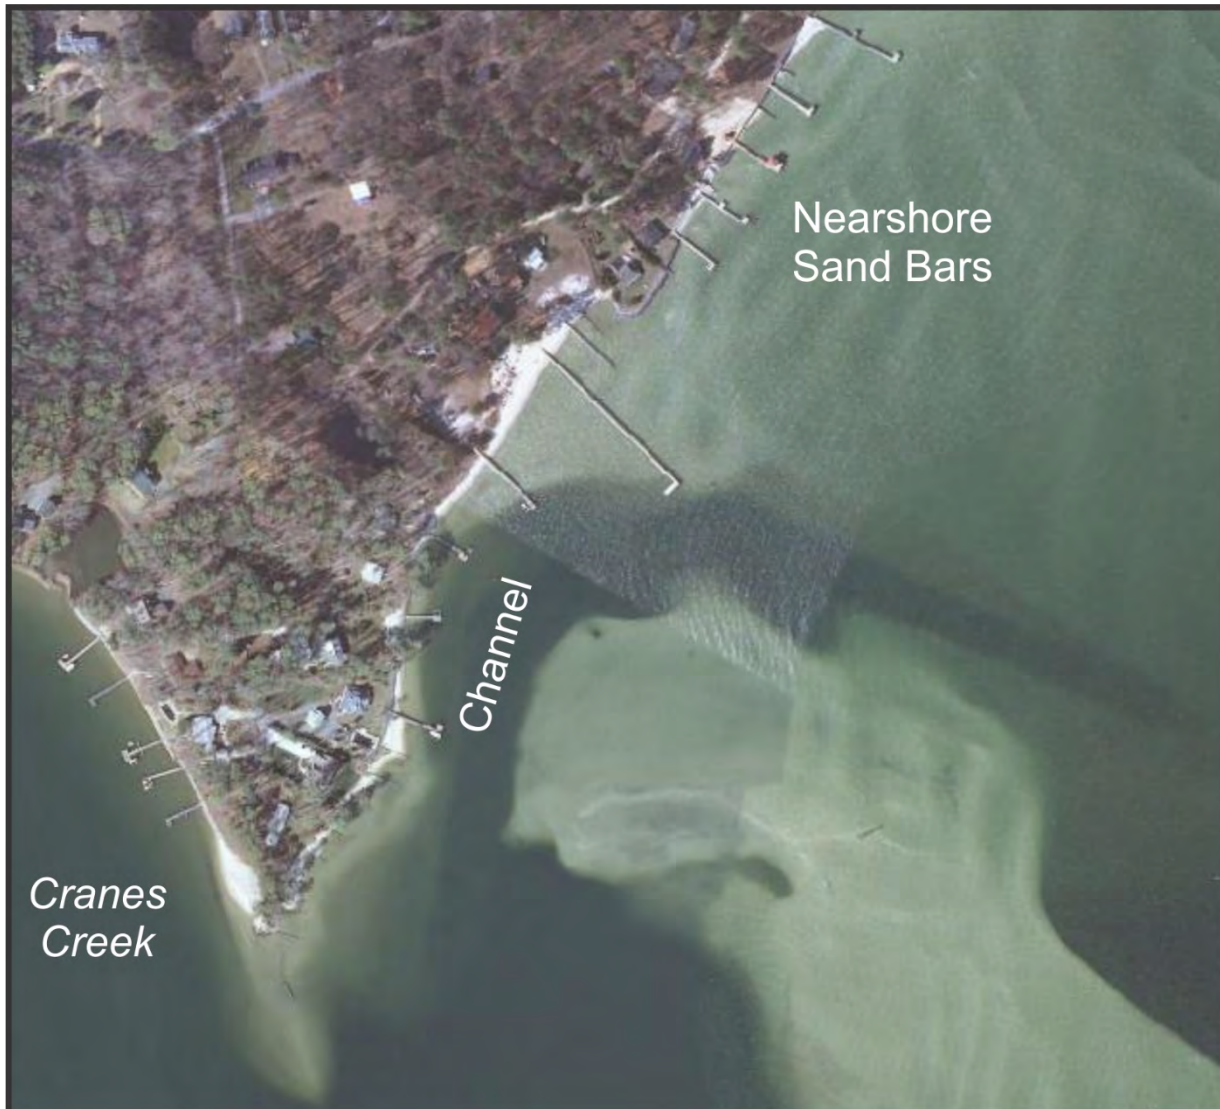
Figure 2-4. A VGIN 2009 photo shows the channel into Cranes Creek in Northumberland County, VA. Sand bars north of the channel will attenuate waves while the shoreline adjacent to the channel has no bars and will feel the full effect of the waves impacting the shoreline.

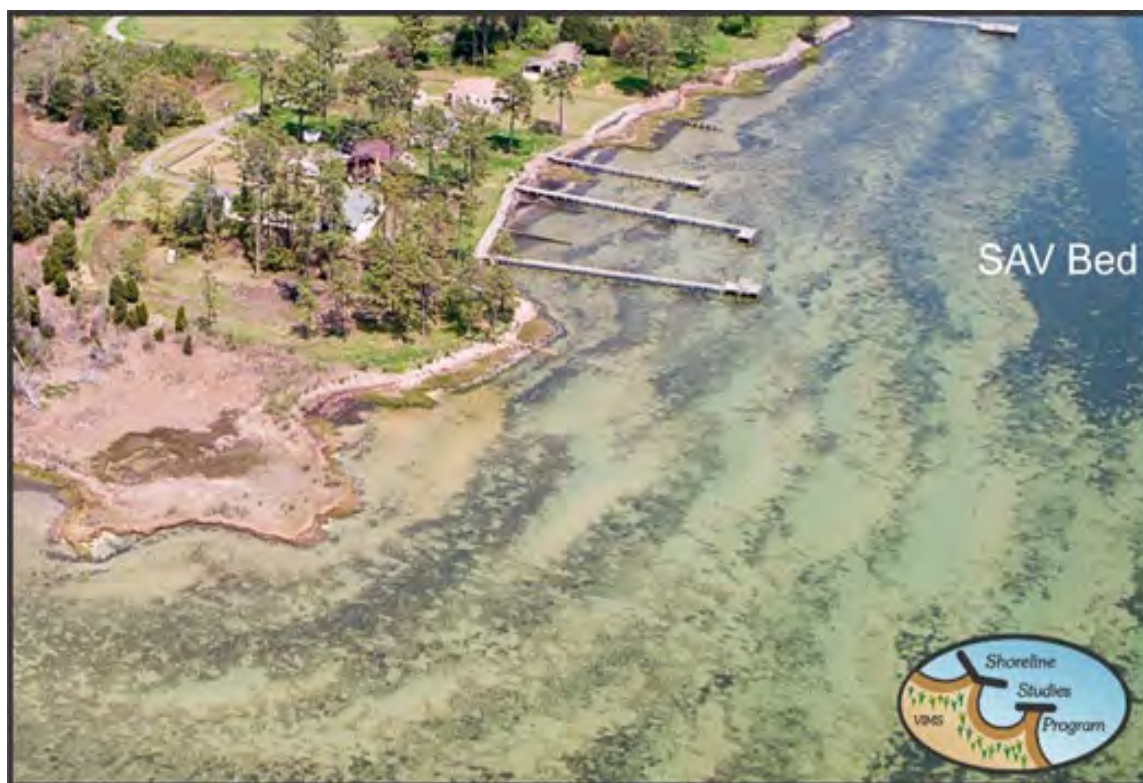
Figure 2-5. A VIMS aerial photo of Pond Point on the East River in Mathews County, VA (dated 21 April 2009) showing extensive SAV in the nearshore, as well as sandbars.

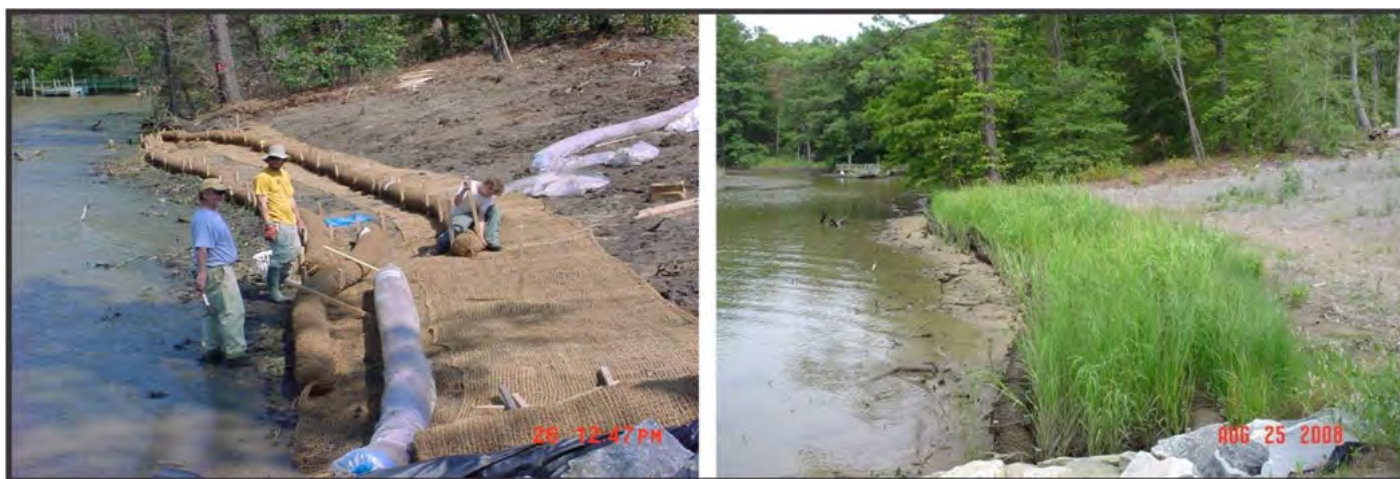
Figure 3-3. Coir logs and mats placed at toe of a graded bank for temporary stabilization while planted tidal marsh and riparian buffer become established. Photos by P. Menichino.

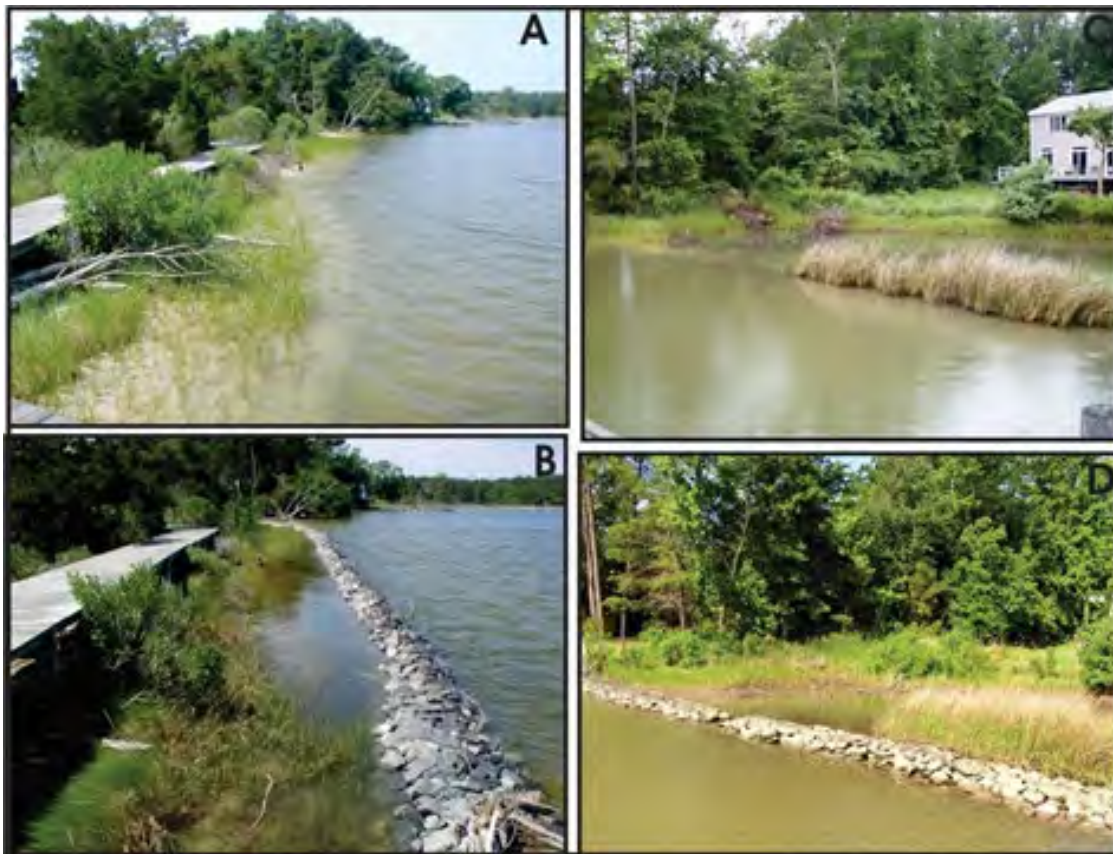
Figure 3-6. Photos showing marsh toe revetments A) before and B) after a project on Cranes Creek in Northumberland County and C) before and D) after a project on Mosquito Creek in Lancaster County, Virginia.

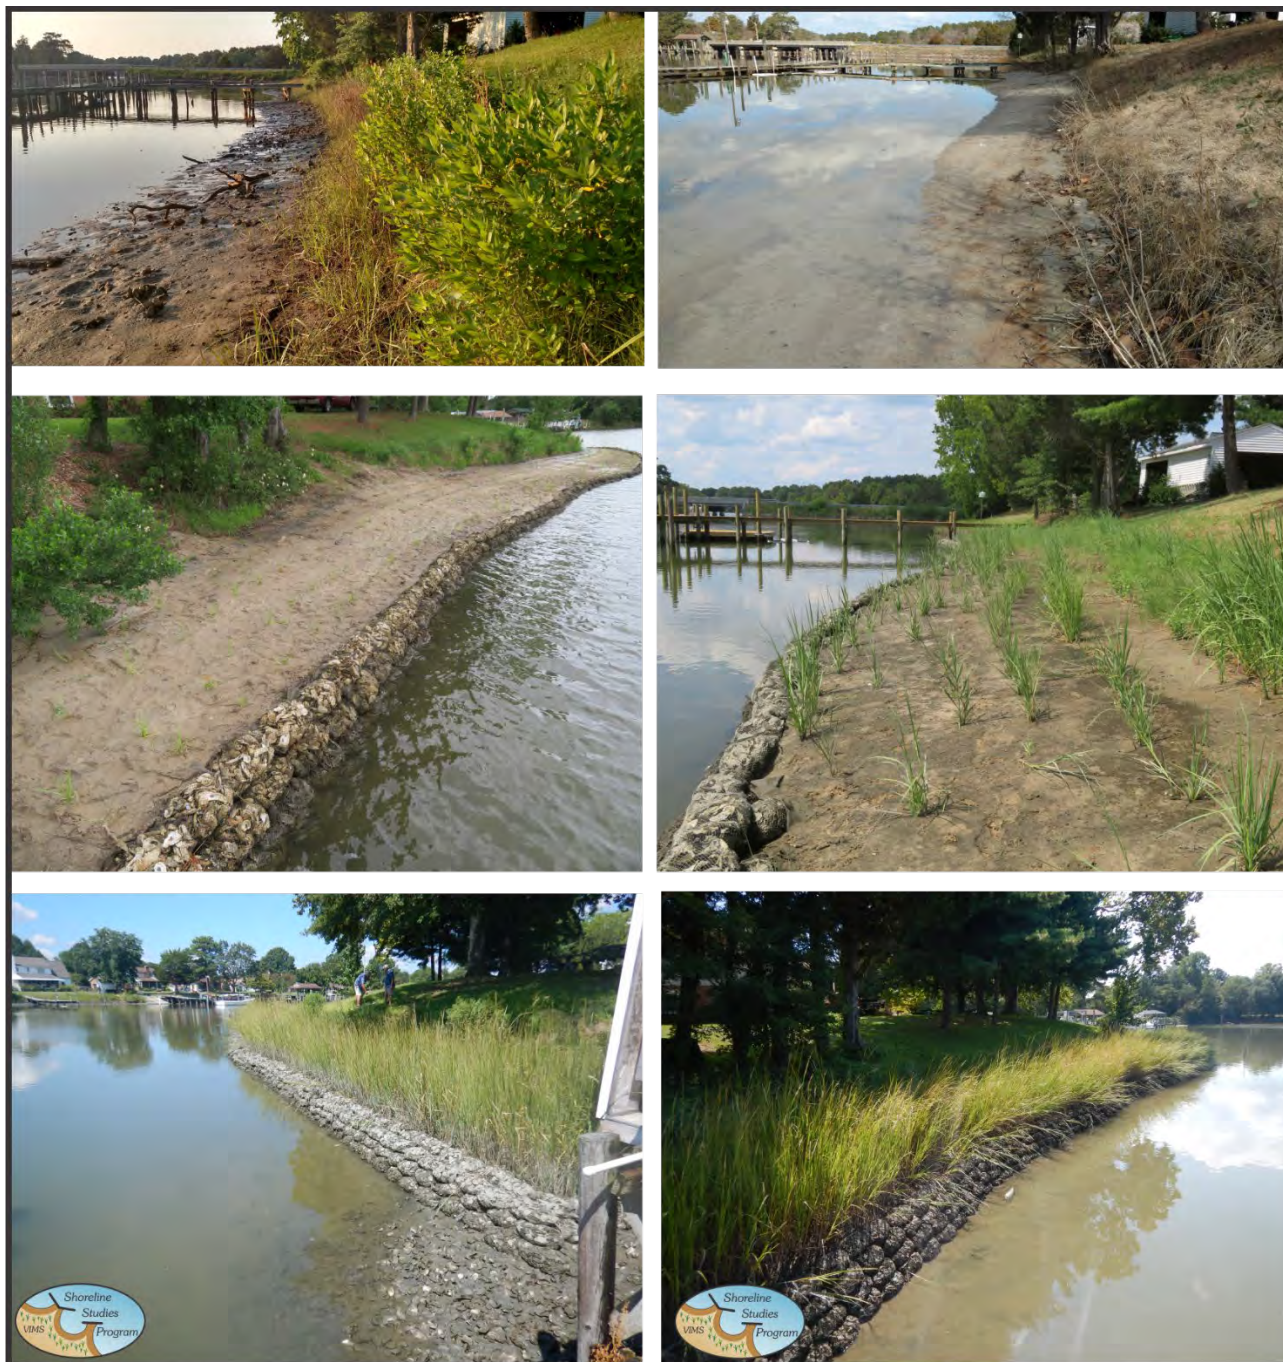
Figure 3-7. An example of the construction of oyster reef bags with sand fill and marsh grasses planted behind the structures. Top left: Shoreline prior to the project on 26 May 2016; Top right: after the sand fill was placed May 2017; Middle left: after bags were placed in May 2017; and Middle Right: after the grass was planted in July 2017. Photo credit: Walter Priest. Bottom right and left: Site about 1.5 years after construction.

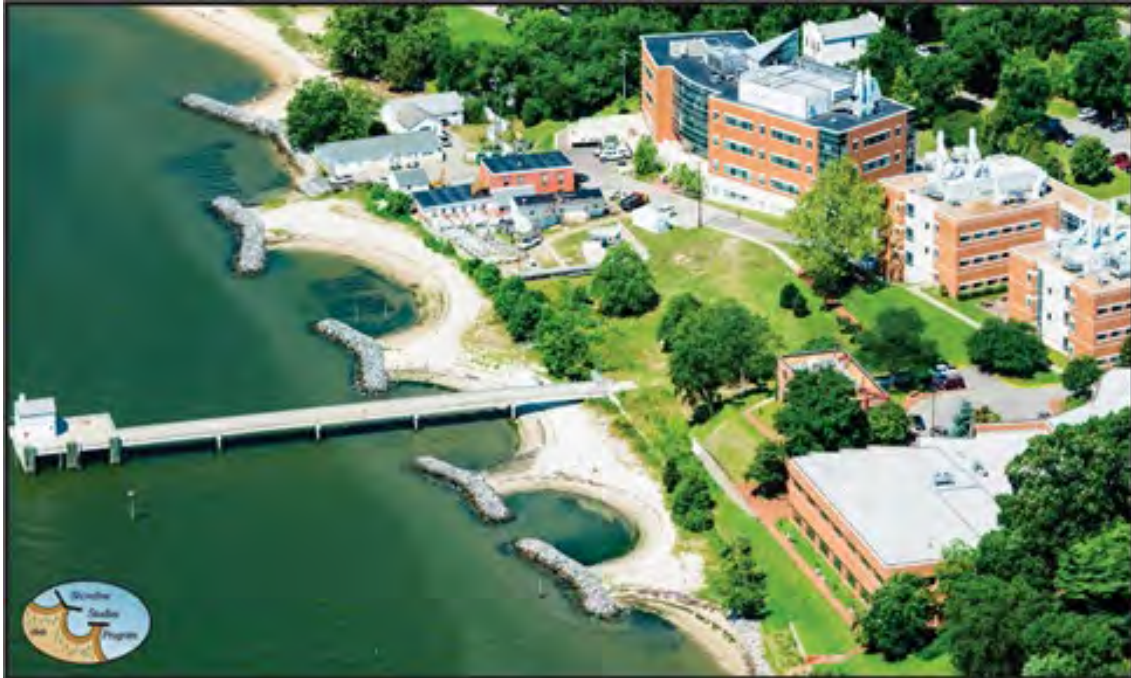
Figure 3-8. Aerial photos of breakwaters at the Virginia Institute of Marine Science campus on the York River. While the physical characteristics of breakwater sites differ, the goals are the same: protect the upland bank/marsh with a wide recreational/ protective beach.

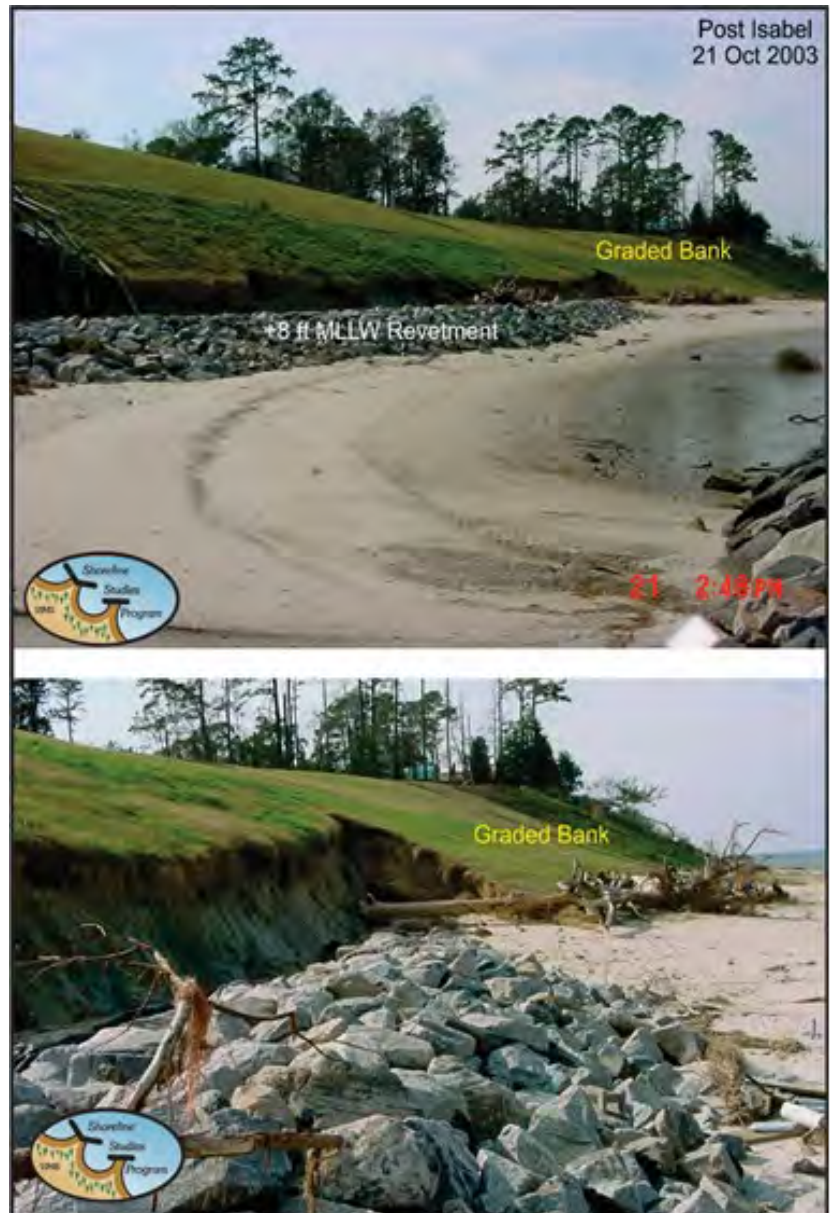
Figure 3-11. Revetment on the James River that was overtopped by storm surge and waves during Hurricane Isabel. Photo dates 21 October 2003.

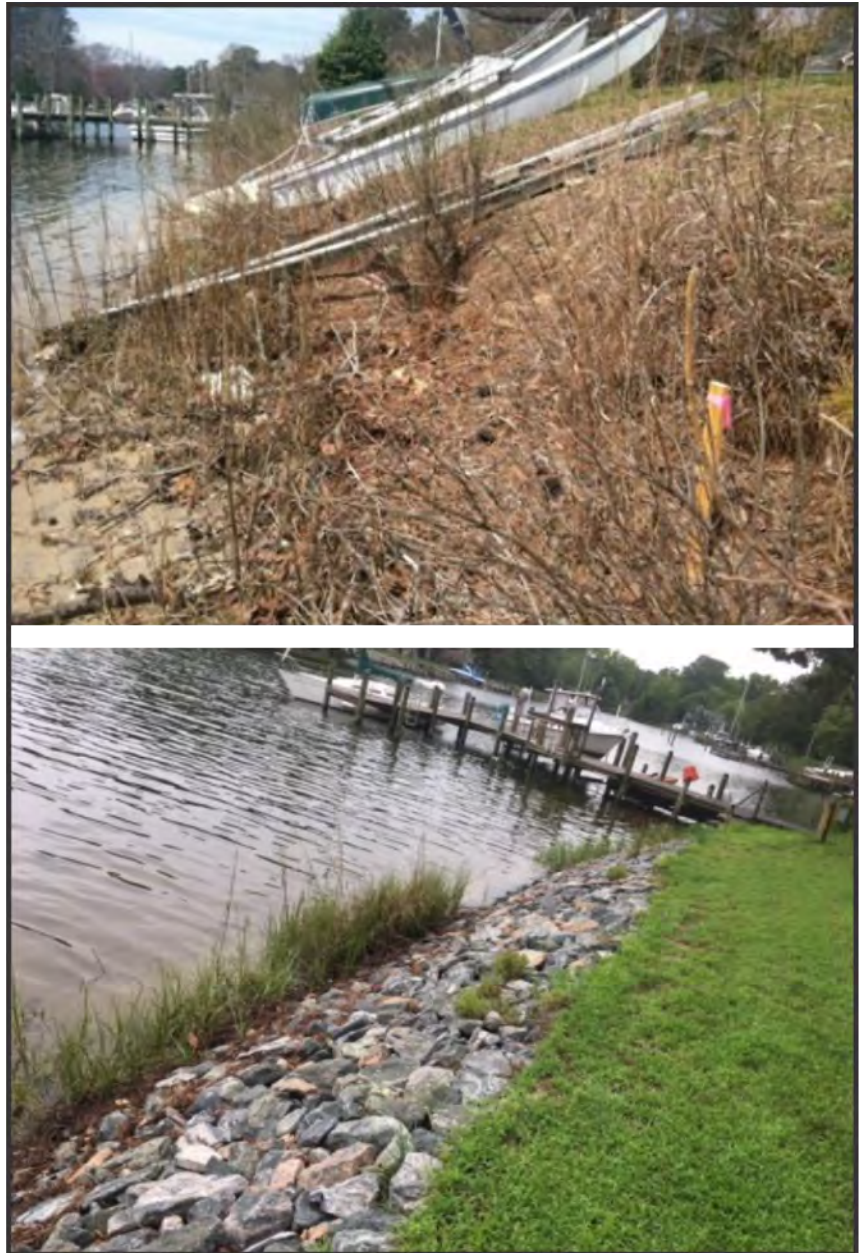
Figure 4-1. The Poole site in 2016 (top) showing the loss of much of the intertidal marsh fringe, and in 2018 (bottom) after the construction of a riprap revetment along the bank above mean high water. Photos from the VMRC permit (#20160366) report.

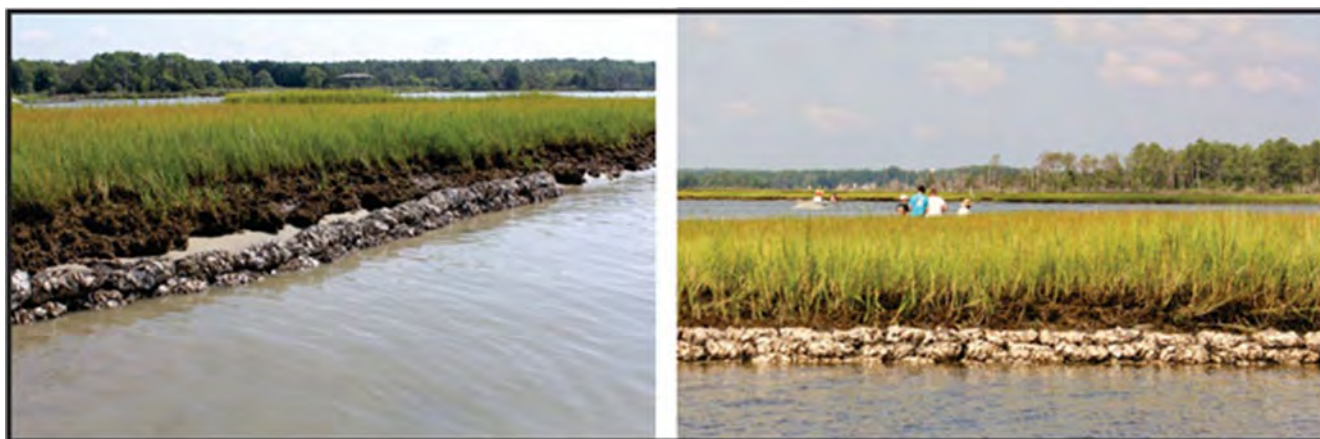
Figure 4-2. Construction of the 3-bag sill (left) and 6-bag sill (right) in August 2017. From Milligan et al. (2018). Photo credit: Linda Tjossem

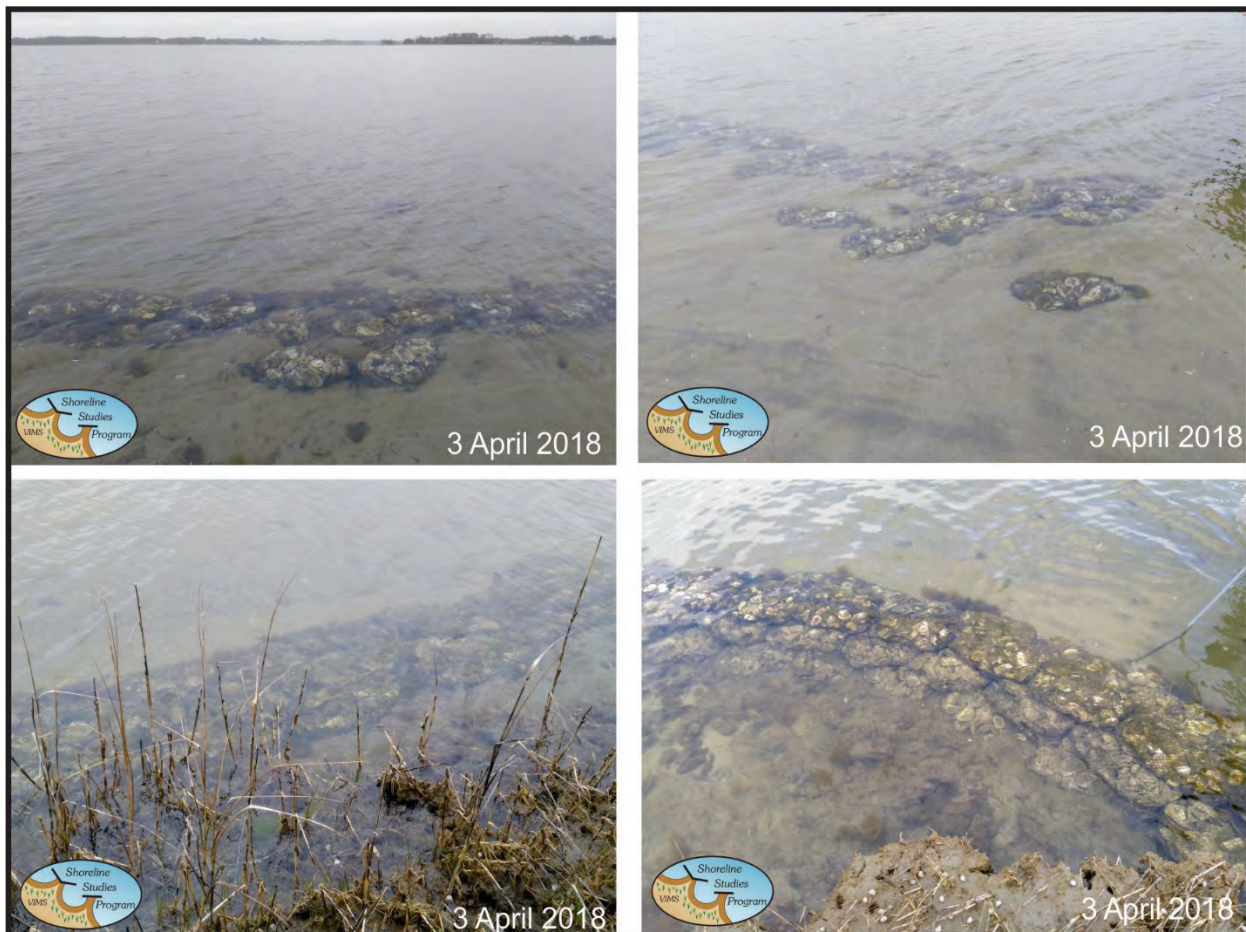
Figure 4-3. Captain Sinclair's Recreational Area oyster bag sill. The three-bag sill (top) that was placed on the southwest-facing shoreline has not been as stable. The top bag of some sections were rolled toward the shoreline. The six-bag sill (bottom) on the point and the southeast-facing shoreline has remained intact. From Milligan et al. (2018).

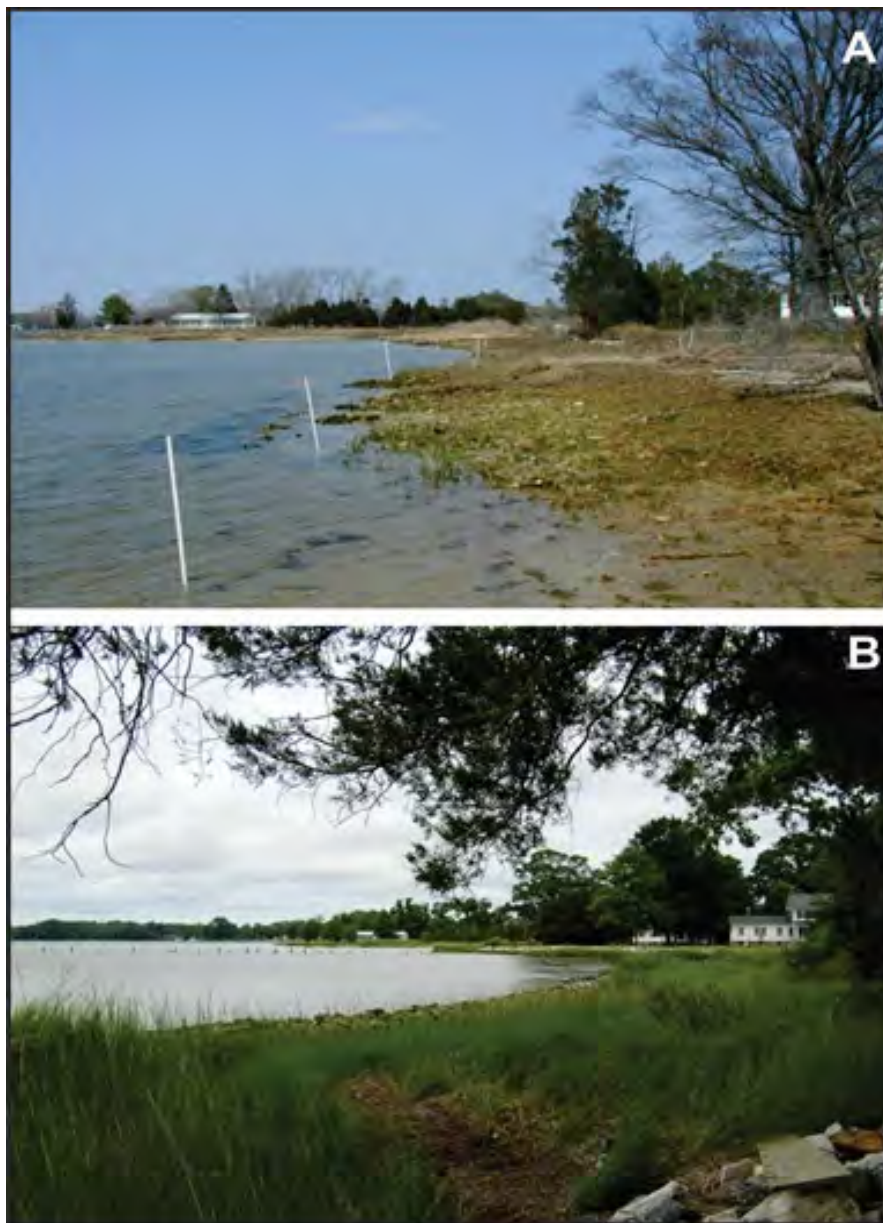
Figure 4-4. Hollerith marsh toe revetment/sill site A) before project with eroding fringing marsh in winter and B) after construction.

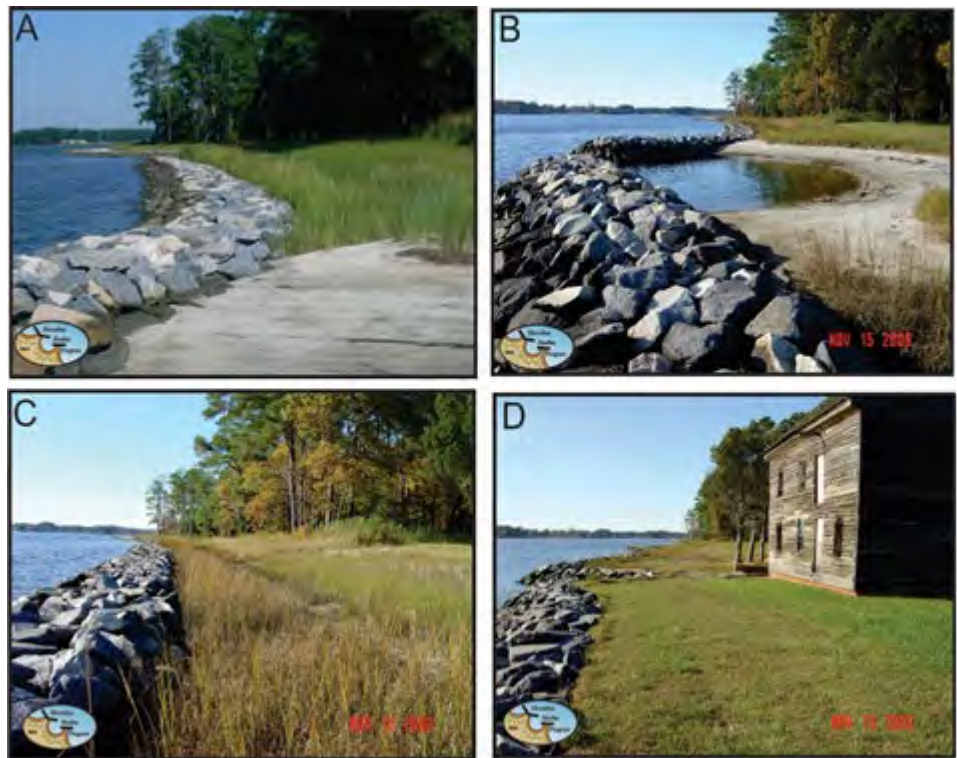
Figure 4-5. Sill system at Poplar Grove on the East River in Mathews County, Virginia six years after completion. A) The sill and marsh fringe provide a wide buffer between the water and the upland. B) The wide gap in the sill provides a pocket beach access area along the shoreline. C) The project zones are clearly visible: stone sill, *S. alterniflora*, *S. patens*, and upland/wooded. D) The old mill sits close to the shoreline. In this area, a revetment was chosen to protect the shoreline.

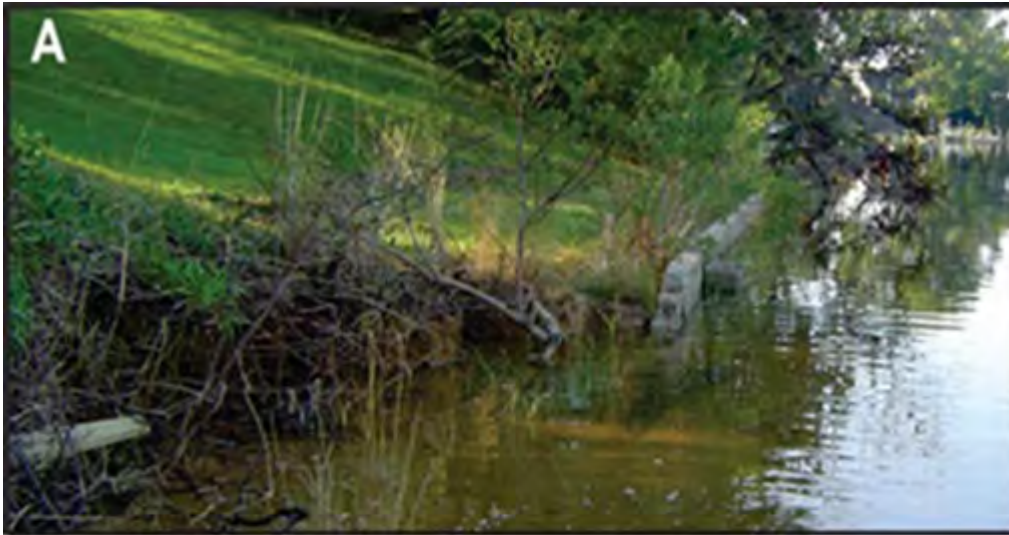
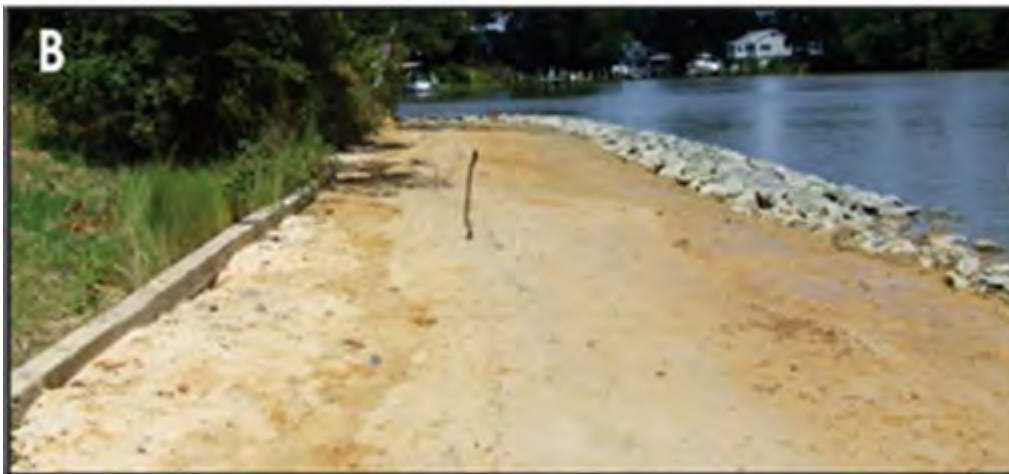
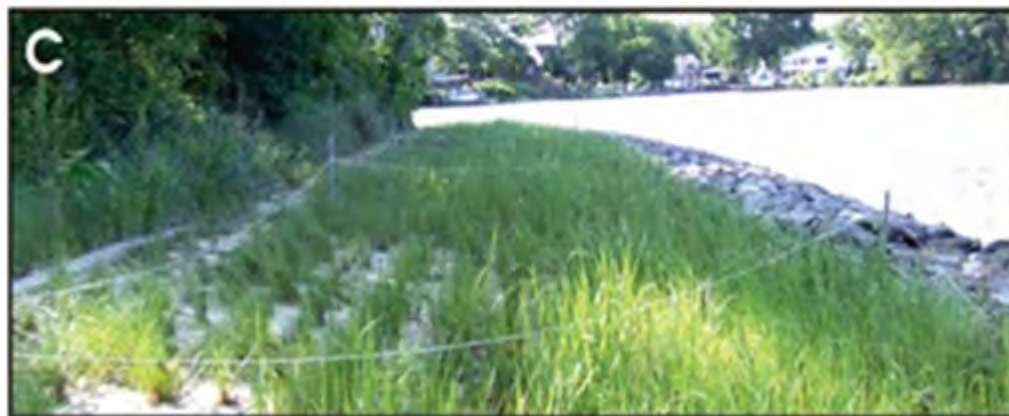
Figure 4-9. Hull Springs Farm shoreline A) before construction, B) after construction of the sill and placement of sand, and C) after planting.

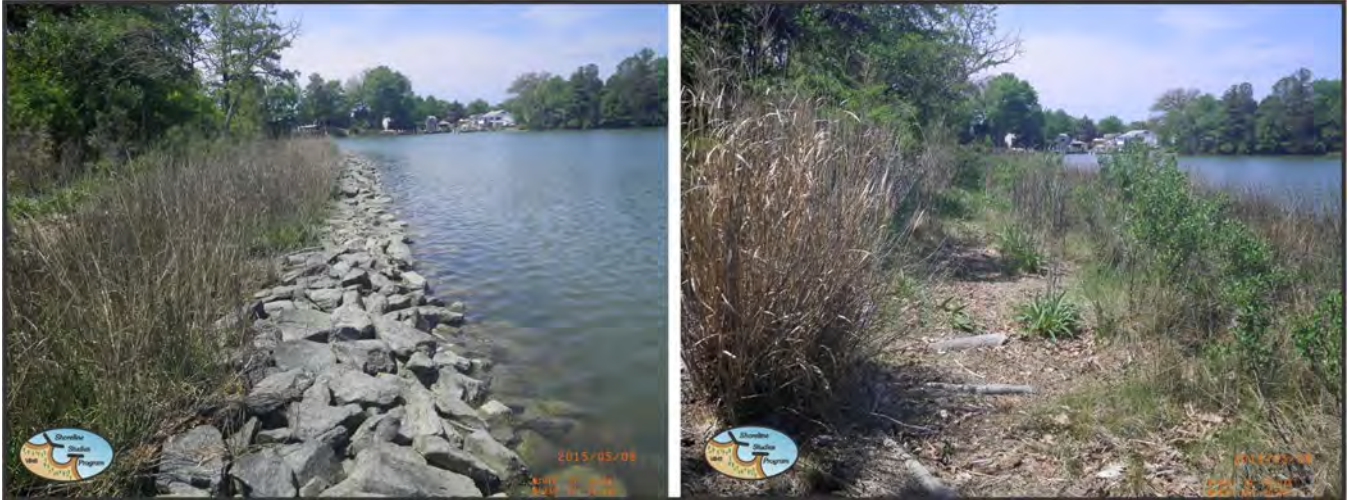
Figure 4-12. Photos of Hull Springs Farm in May 2015, seven years after construction.

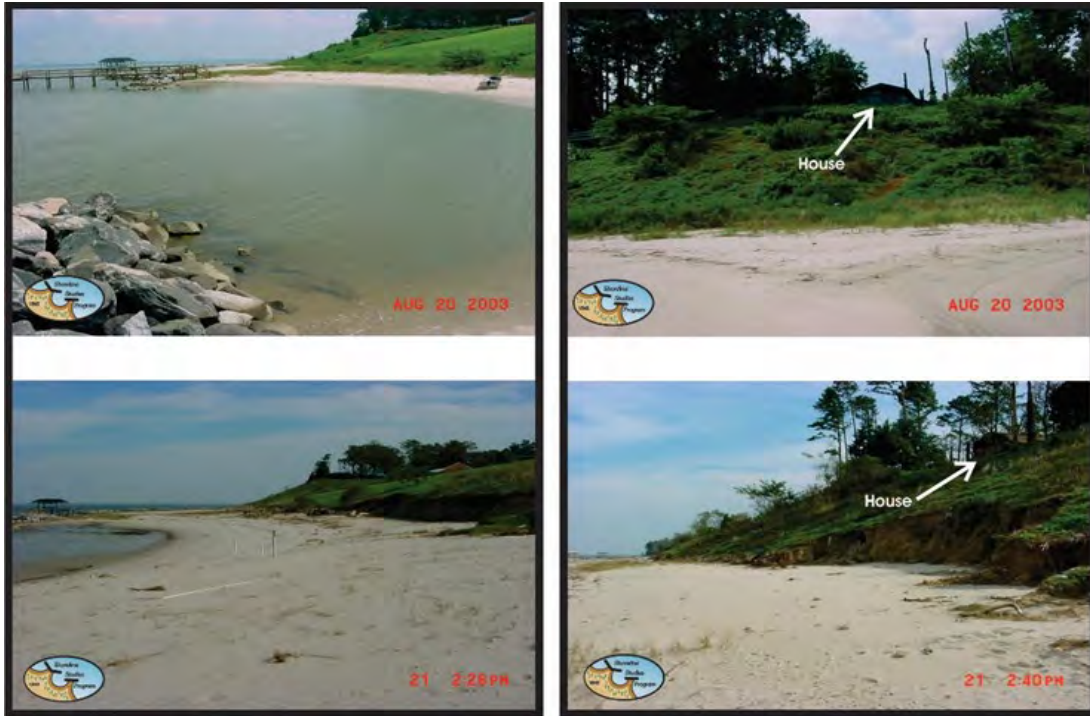
Figure 4-14. Photos of Hull Springs Farm in May 2015, seven years after construction.

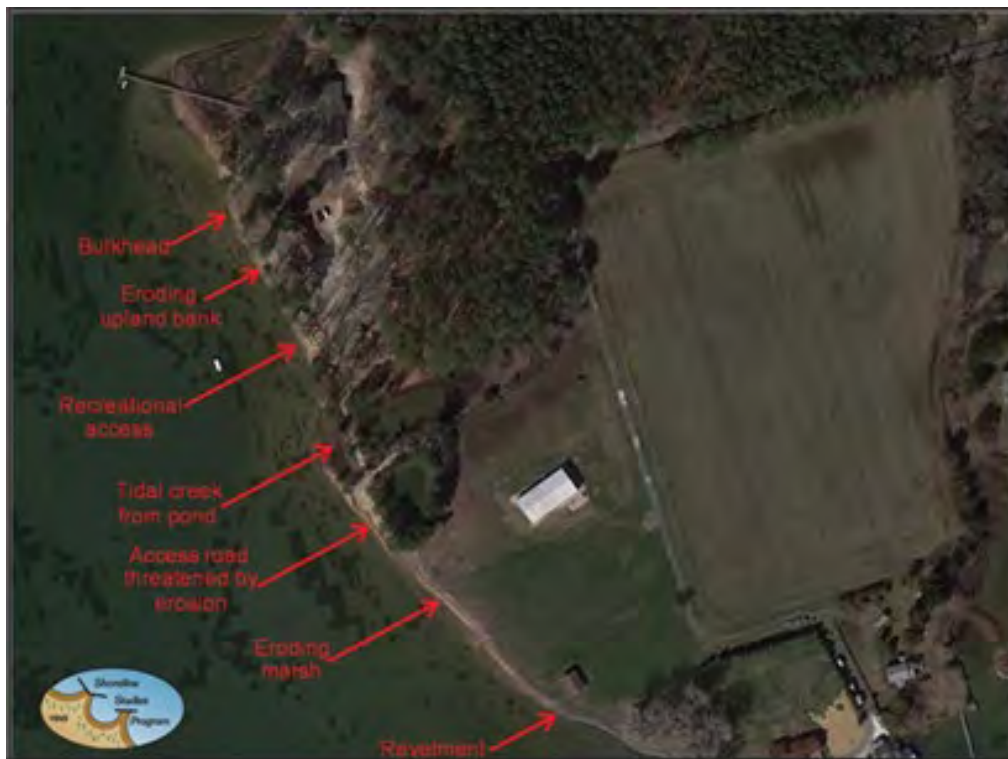
Figure 5-2. Considerations for shore protection design along the project area.

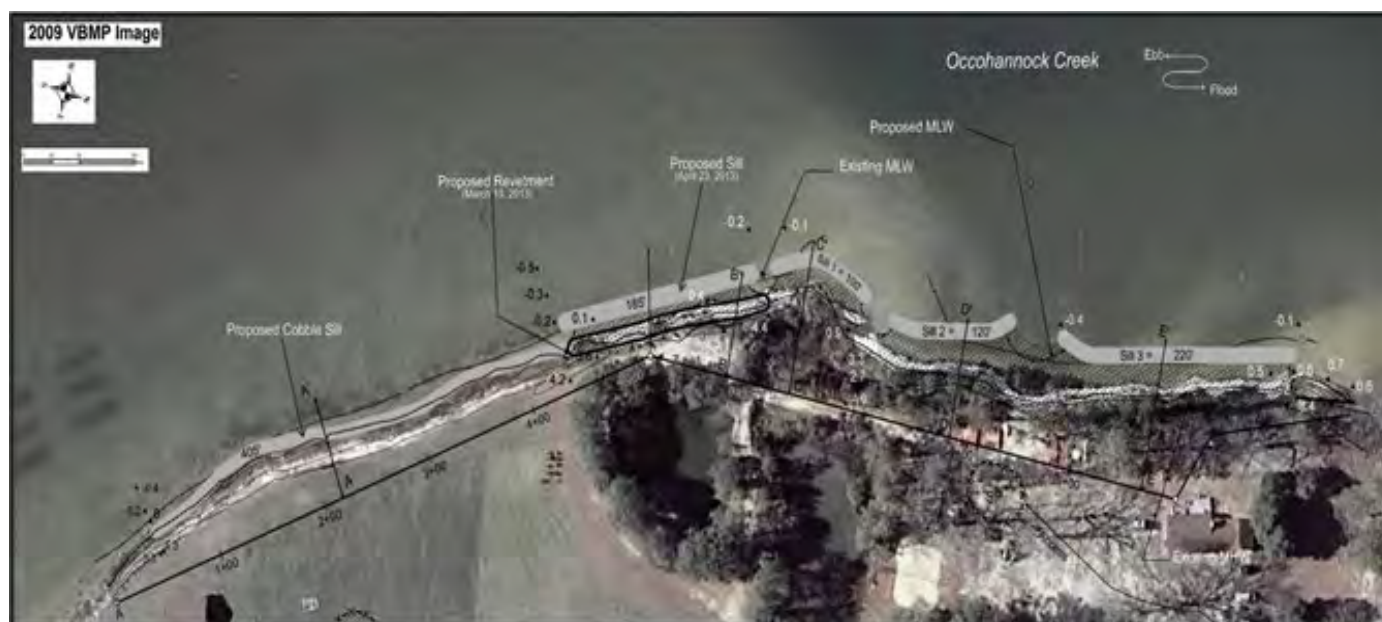
Figure 5-4. Design for shore structures at Occohannock on the Bay.

Three distinct treatment segments were designed on the original Occohannock on the Bay Shore Plan (Figure 5-4):

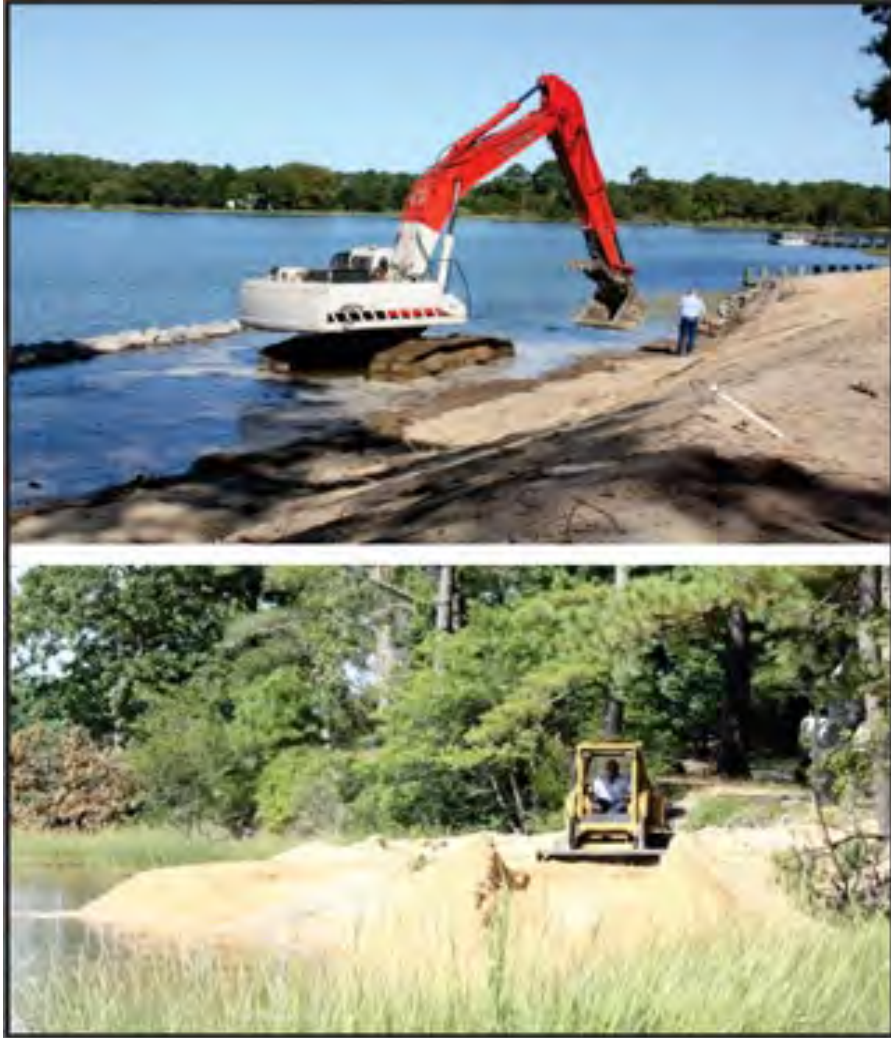
Figure 5-5. Construction of the shore structures at Occohannock on the Bay.
