Living Shoreline Design Guidelines for Shore Protection in Virginia's Estuarine Environment

Living Shoreline Design Guidelines for Shore Protection in Virginia's Estuarine Environments

Version 3.0

Special Report in Applied Marine Science and Ocean Engineering #473

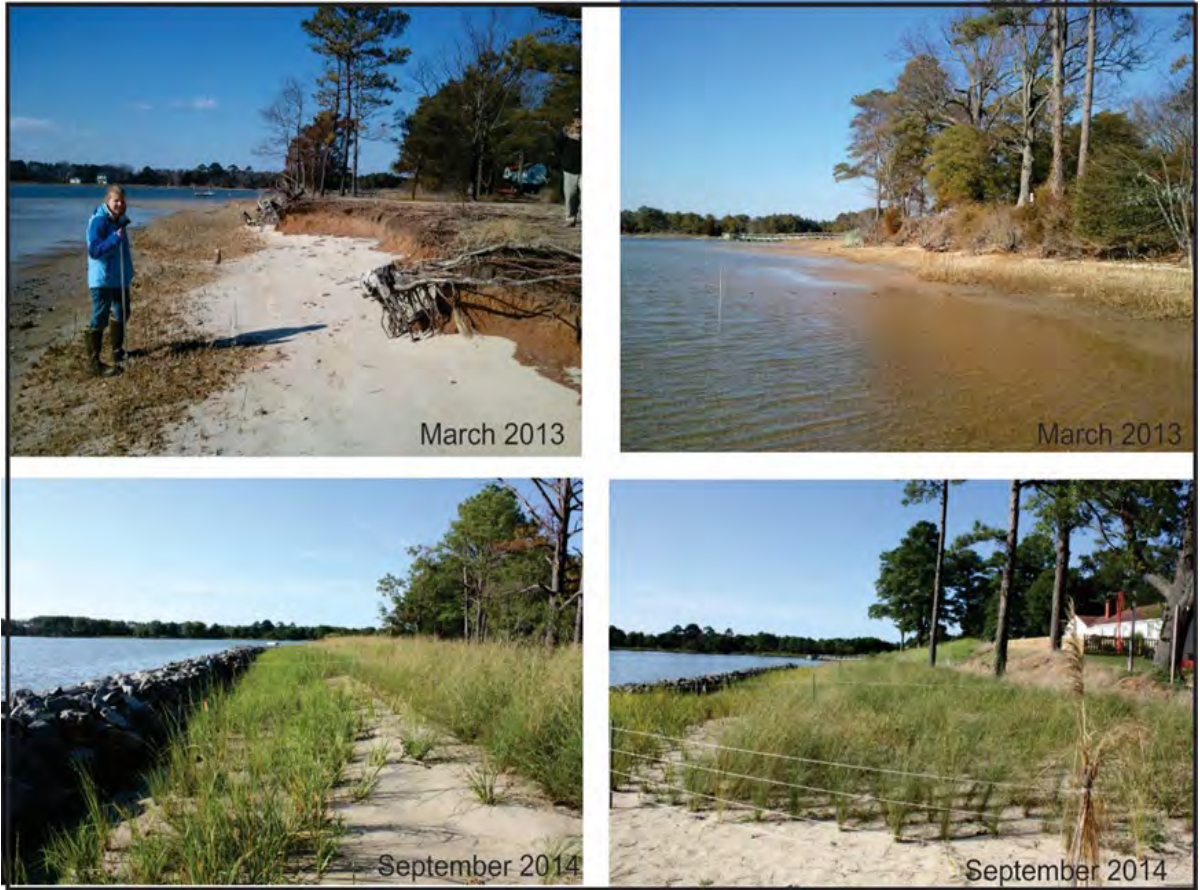
Figure 5-6. Occohannock on the Bay shoreline before (top) sill construction and after (bottom) construction.

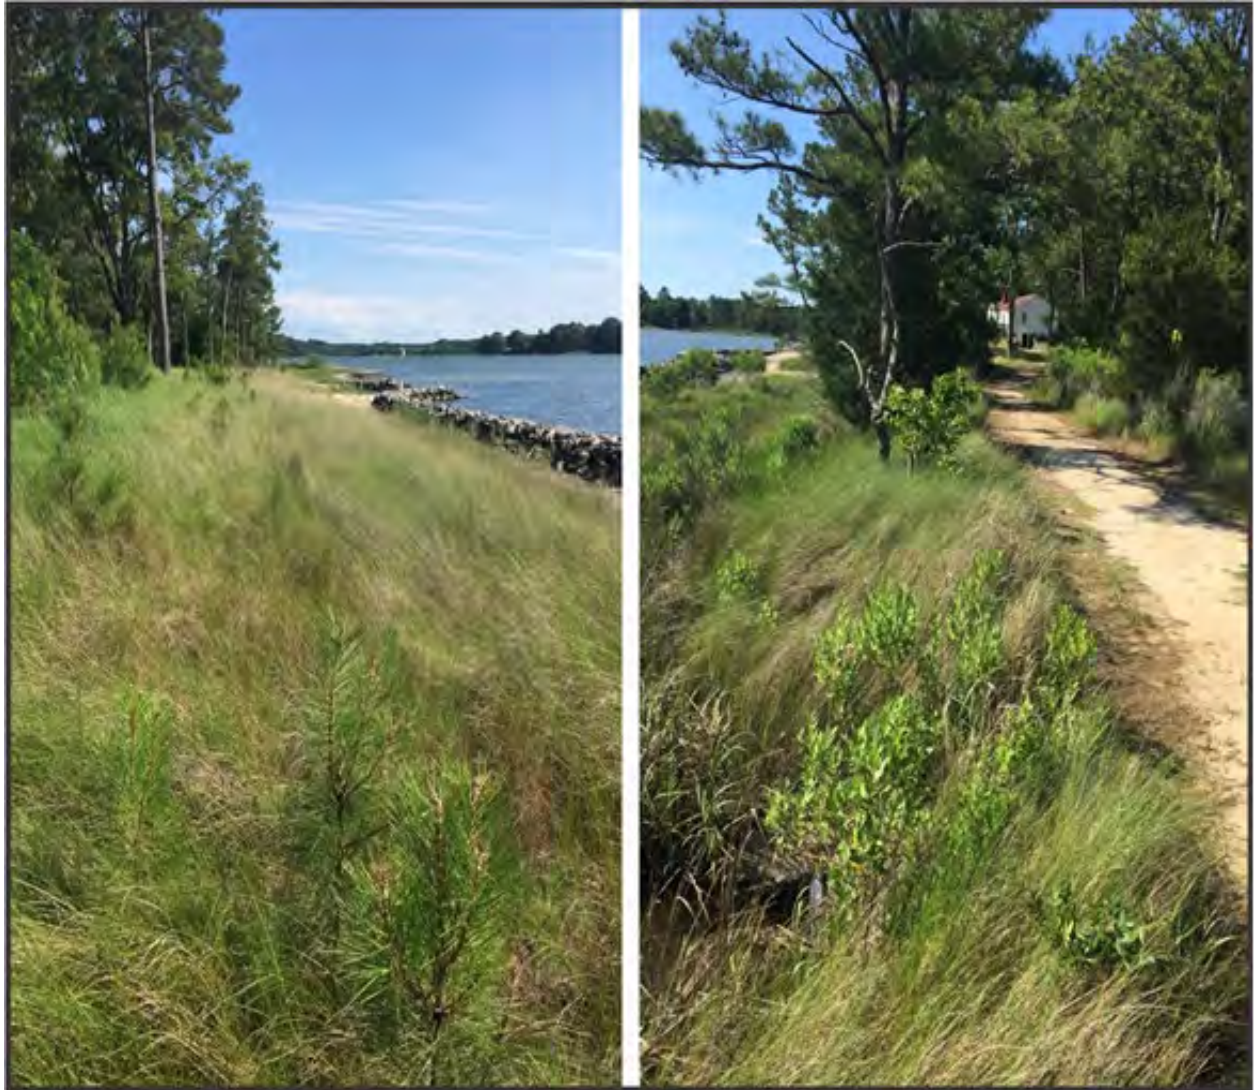
Figure 5-7. Photos of the project three years after installation in May 2017. The marsh behind the sill is expansive (left) and the access road is no longer threatened (right).

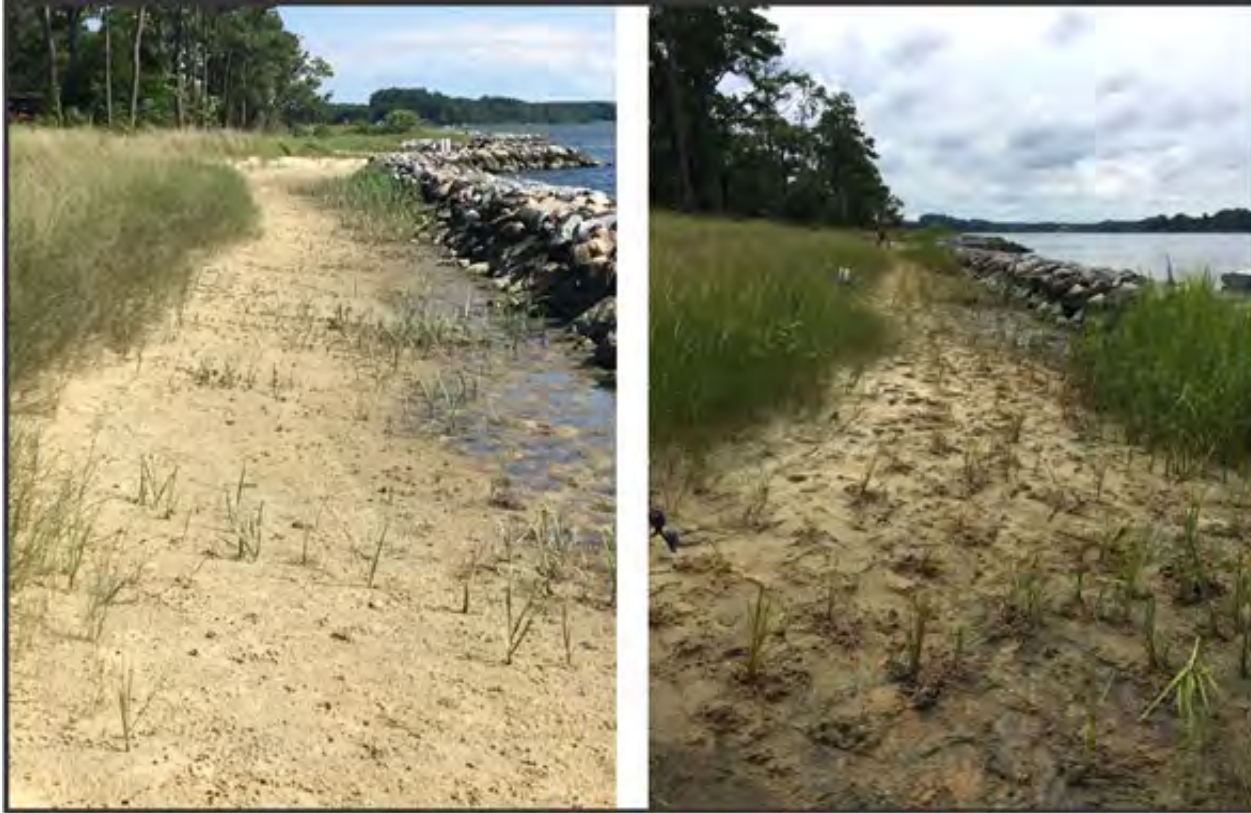
Figure 5-8. Photos showing a bare spot behind the sill (left) in May 2017, and the grasses replanted in July 2017 (right).

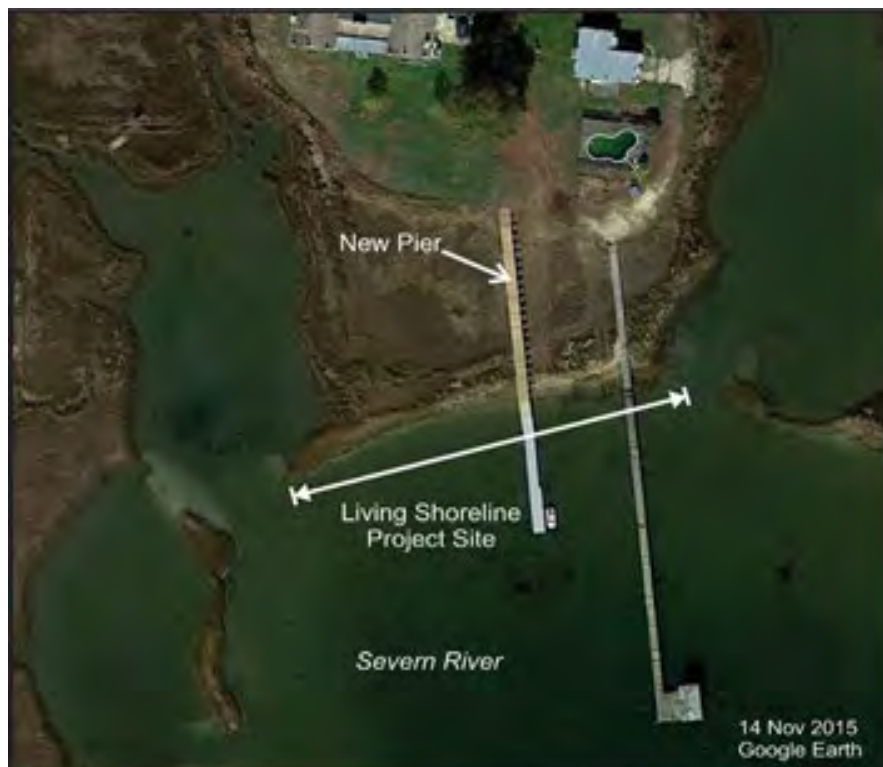
Figure 5-9. Captain Sinclair's Recreational Area pre-construction.

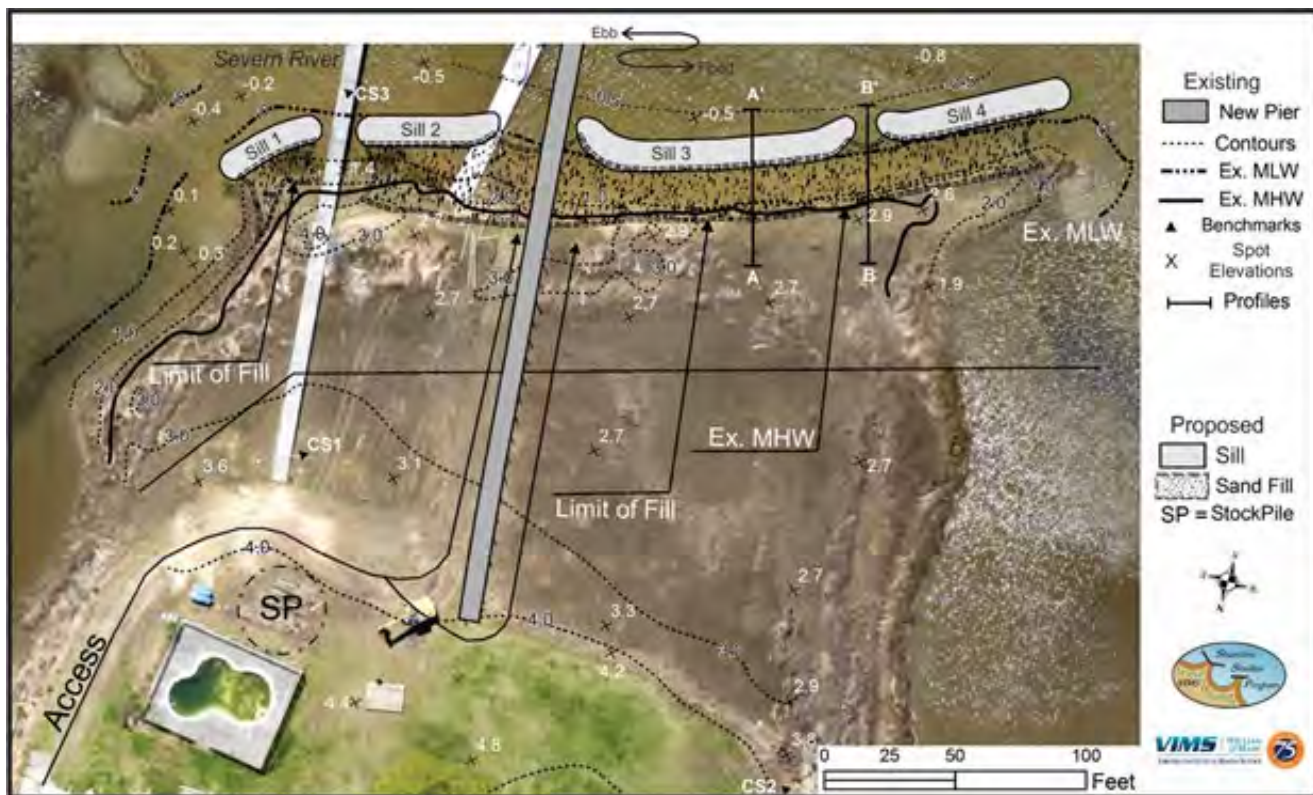
Figure 5-11. Plan design for Captain Sinclair's Recreational Area.

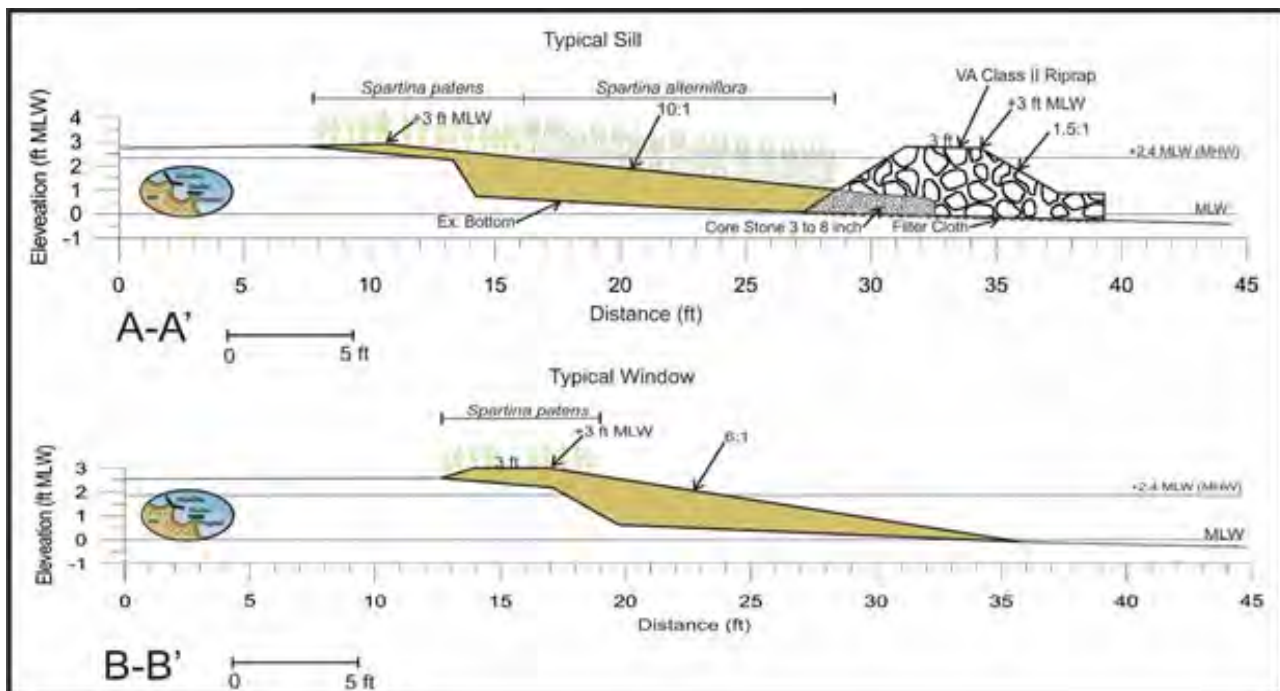
Figure 5-12. Typical cross-section of shore protection structures proposed at Captain Sinclair's Recreational Area.

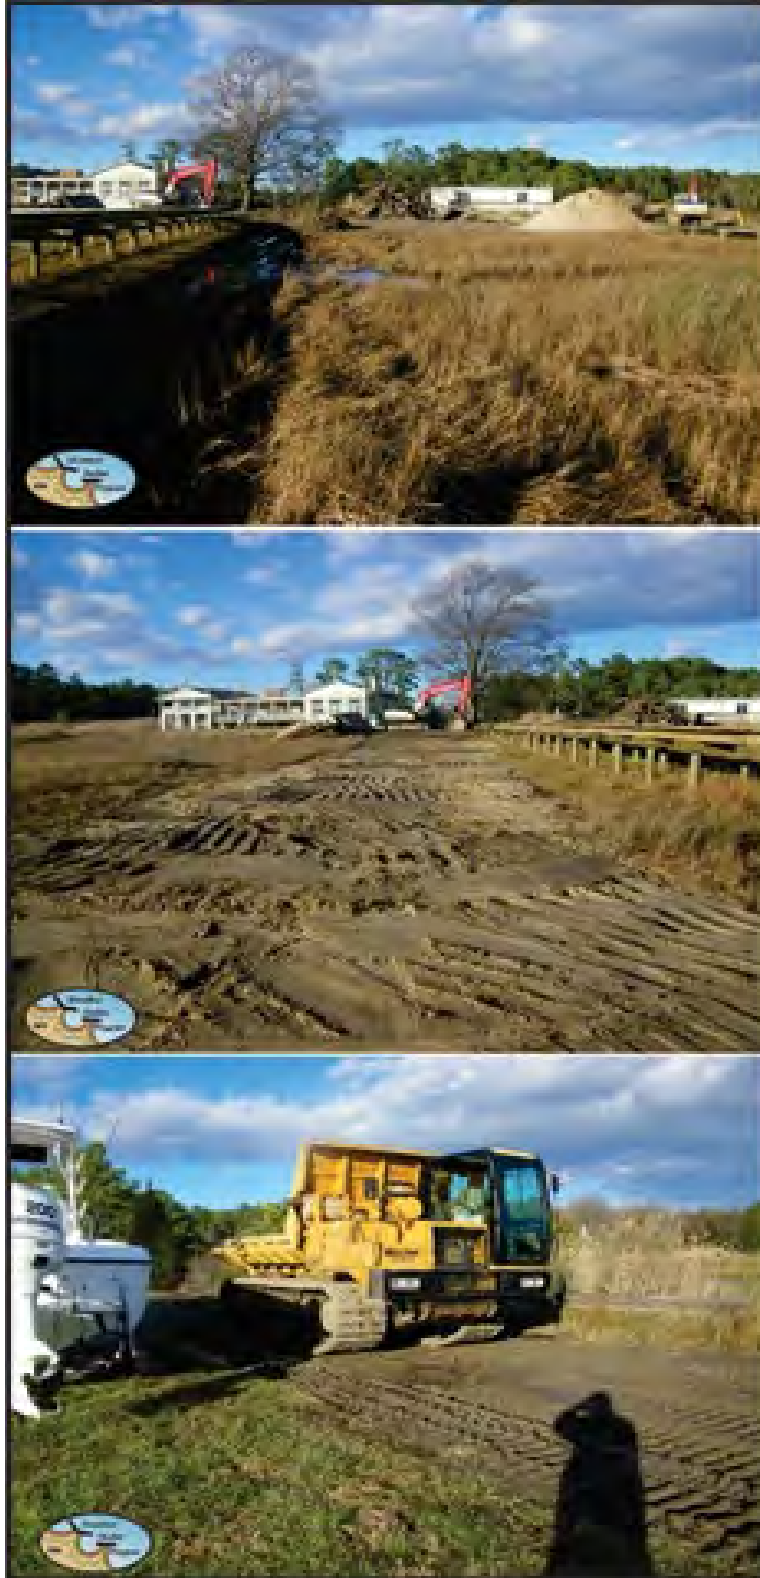
Figure 5-13. Photos taken during construction at Captain Sinclair's Recreational Area on 29 Jan 2016.

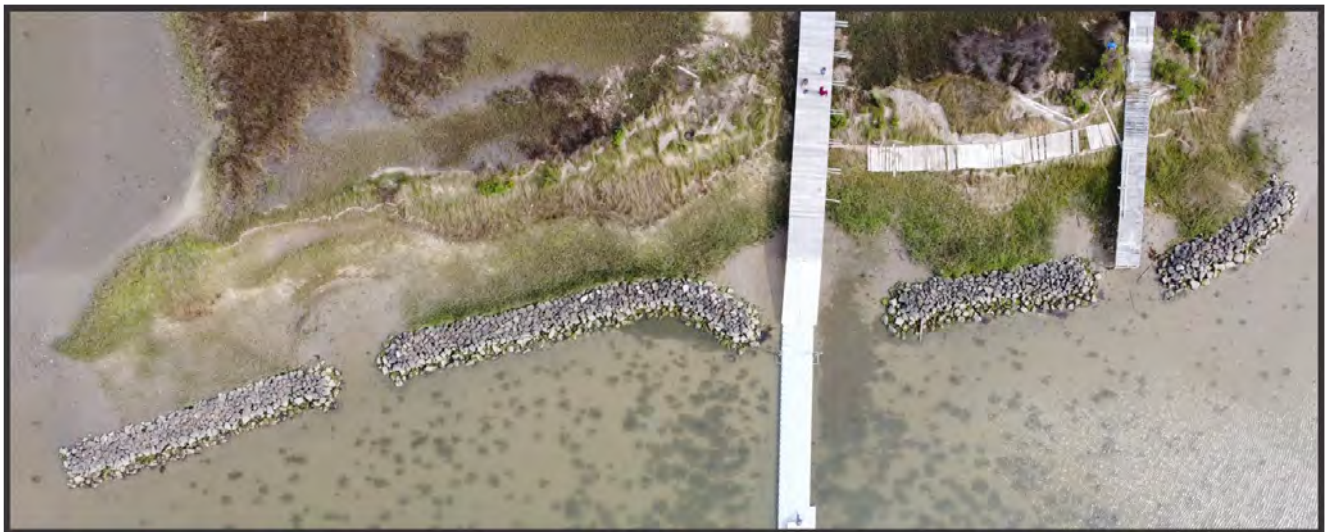
Figure 5-14. Drone imagery of the Captain Sinclair sills taken about 4 years after project installation (12 May 2020).
