EVALUATION OF IMPACT RESULTING FROM HOME HEATING OIL TANK DISCHARGES

Final Report Submitted to:

Virginia Department of Environmental Quality
Office of Spill Response and Remediation
Richmond, VA

Mark A. Widdowson, P.I.
Gabriel Isaacman-VanWertz, co-P.I.

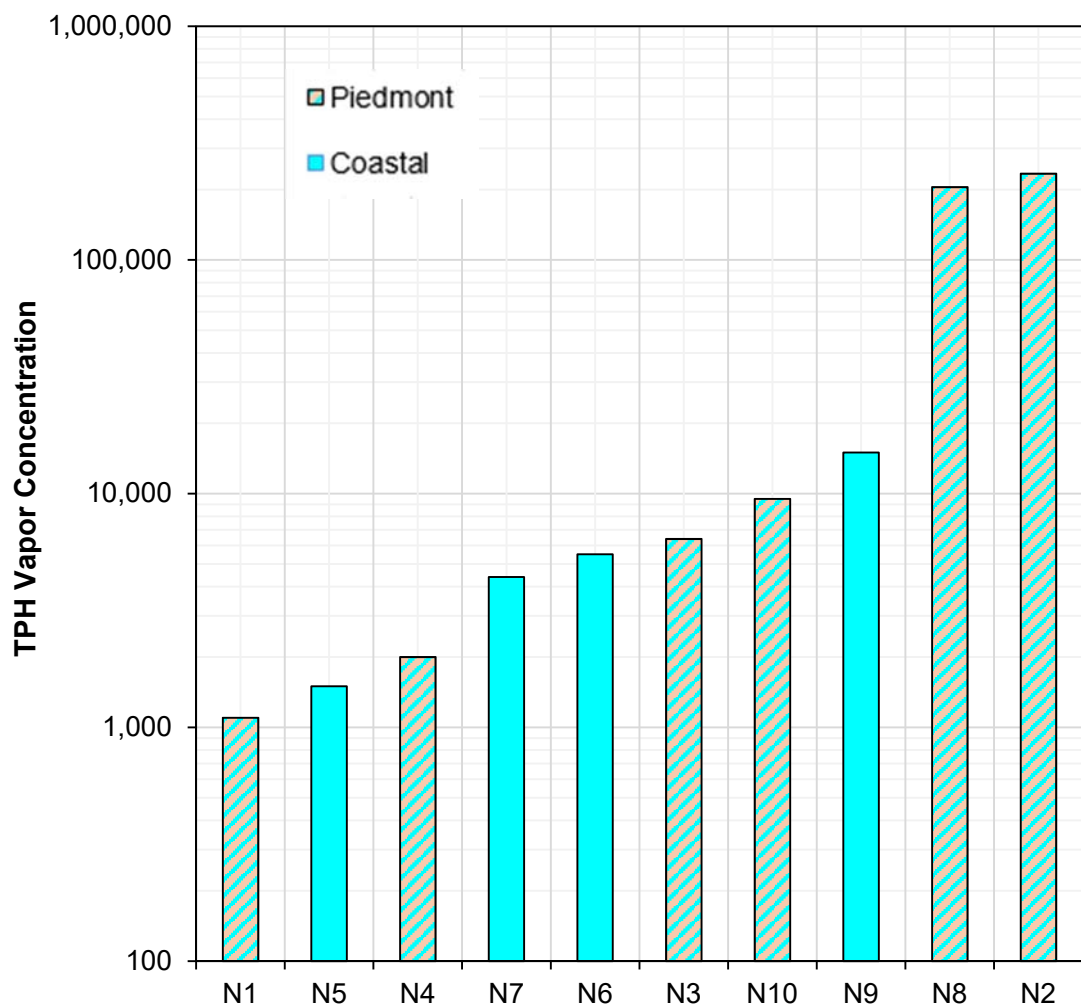
Figure 15. Range of TPH concentrations ($\mu\text{g}/\text{m}^3$) in soil gas collected in the UST Area at No Further Action sites sorted by physiographic region.

Figures 15, 16, and 17 show the range of TPH, naphthalene, and benzene concentrations, respectively, by rank in soil gas samples collected in the UST areas measured at NFA sites. Although TPH concentrations were generally low ($<16,000 \mu\text{g}/\text{m}^3$) and at or below TPH concentrations observed at most Piedmont and Coastal Plain sites, two Piedmont sites exhibited TPH concentrations above a threshold of $140,000 \mu\text{g}/\text{m}^3$. An elevated level of naphthalene above a concentration threshold of $2.8 \mu\text{g}/\text{m}^3$ was observed at four NFA sites. An elevated naphthalene concentration above a threshold of $10.4 \mu\text{g}/\text{m}^3$ was observed at two Piedmont NFA sites, one of which was above the screening level concentration of $72 \mu\text{g}/\text{m}^3$. Benzene concentrations at all NFA sites were generally below values observed at other PVI study sites. Benzene and naphthalene were not detected in soil gas samples in the UST areas at seven and four sites, respectively.

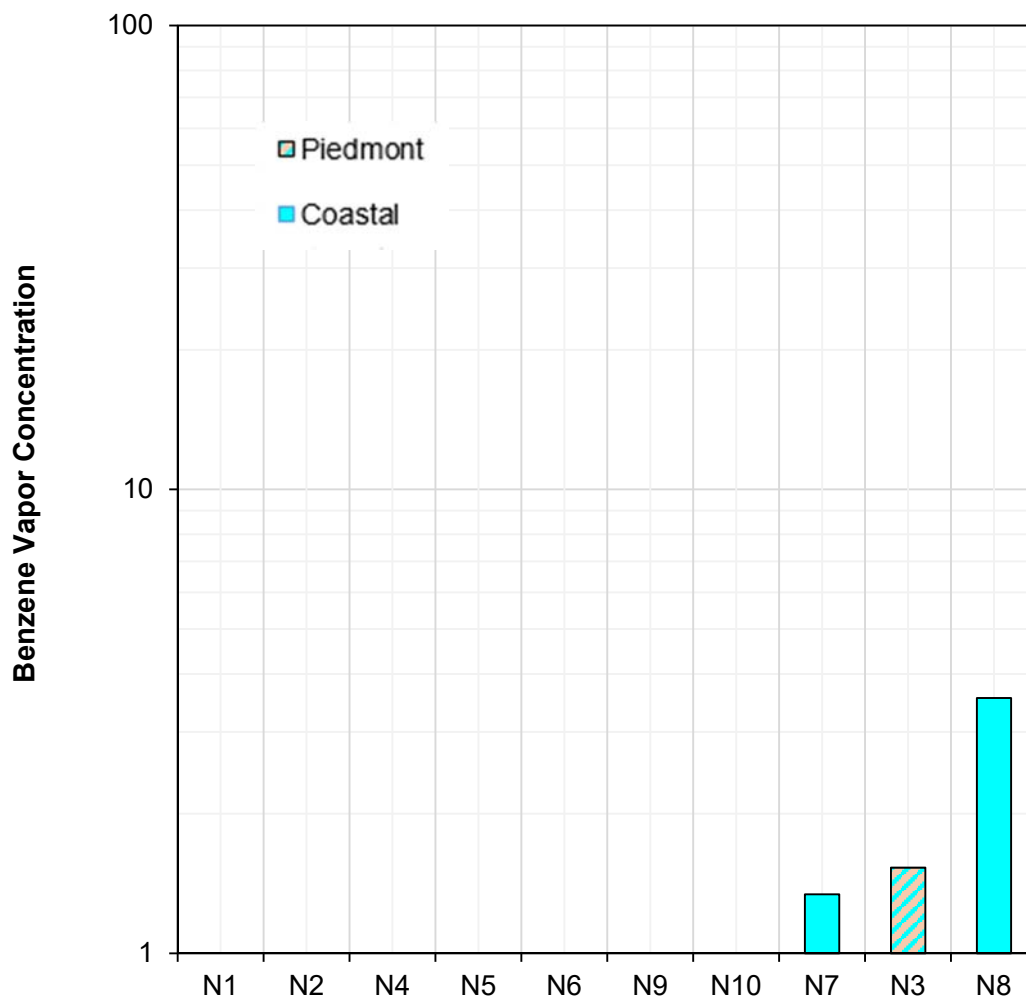
Figure 17. Range of benzene concentrations ($\mu\text{g}/\text{m}^3$) in soil gas collected in the UST Area at No Further Action sites sorted by physiographic region.

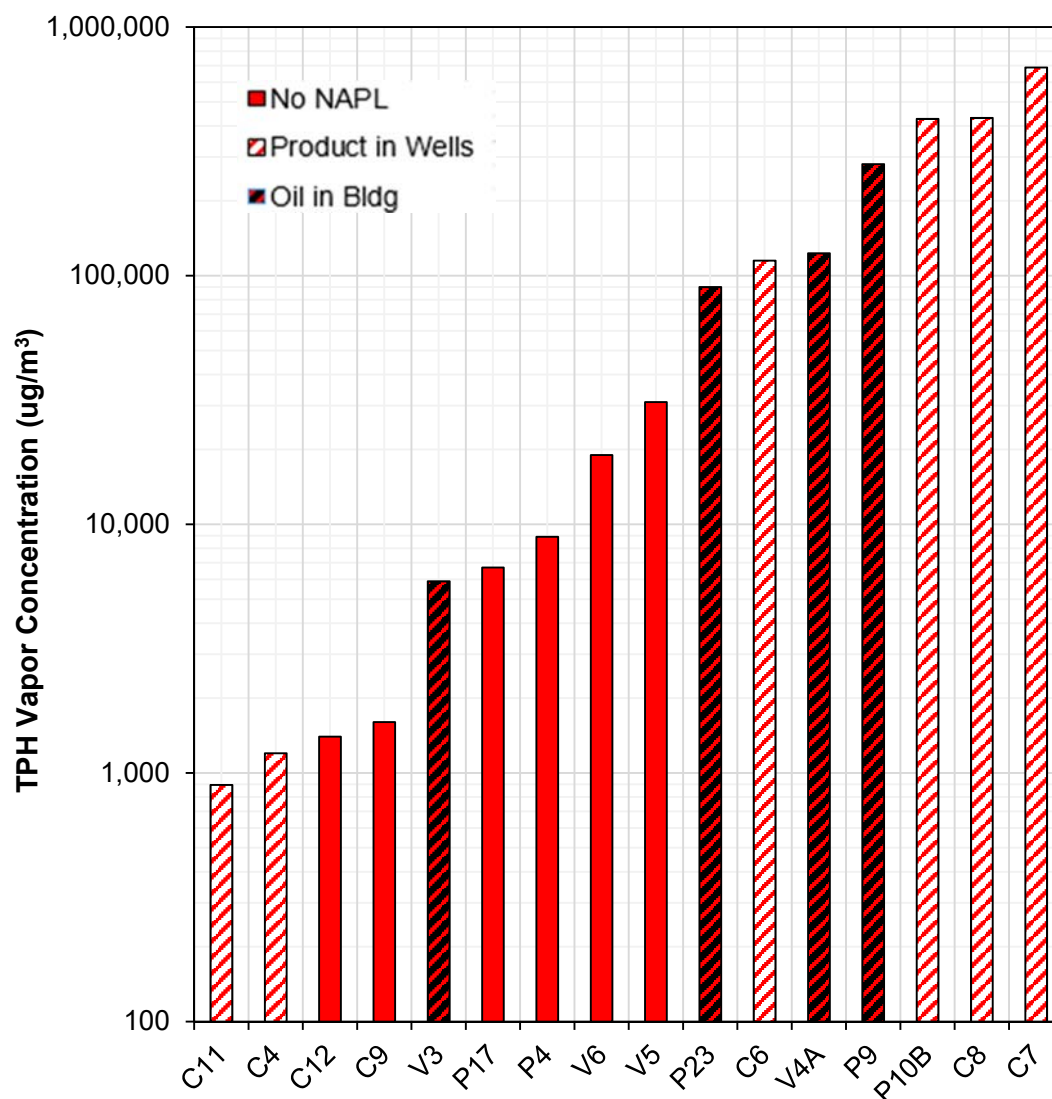
Figure 23. TPH concentrations ($\mu\text{g}/\text{m}^3$) in soil gas collected in the UST Area at Category 3 sites. USTs were removed at each site.

To assess the relationship between the presence of a separate oil phase and TPH concentrations, plots of TPH concentrations are reconstituted in rank order for each DEQ Category in **Figures 21, 22, and 23** (Category 1, 2, and 3, respectively). As shown in **Figure 21**, a wide range of TPH concentrations were observed at Category 1 sites. Unfortunately, there was no clear trend between the TPH concentrations and site variables including TPH soil concentrations or volume of fluid removed from the tank. Only one tank was replaced at the 12 Category 1 sites investigated. Otherwise, the original tanks were decommissioned below ground. It may useful to reiterate that soil gas samples were typically collected between buildings and decommissioned USTs at Category 1 sites. The positioning of soil gas probes adjacent to residences was designed to identify the potential for PVI and was not necessarily designed to measure TPH and BTEXN concentrations in oil-contaminated soil that may be present below decommissioned USTs at these Category 1 sites.

Figure 23 indicates that while elevated TPH concentrations were not observed at all Category 3 cases, the majority of sites that experienced impacts to groundwater or where oil directly penetrated into or below residences are associated with the largest TPH vapor concentrations. Three of the six sites impacted by a separate oil phase or free product on the water table showed TPH concentrations above $140,000 \mu\text{g}/\text{m}^3$ including one Piedmont site. In all three cases the water table was relatively shallow placing the free product in proximity to the soil probes. Only one of four sites where oil had previously impacted either the basement or crawl space showed TPH concentrations at or above $140,000 \mu\text{g}/\text{m}^3$.

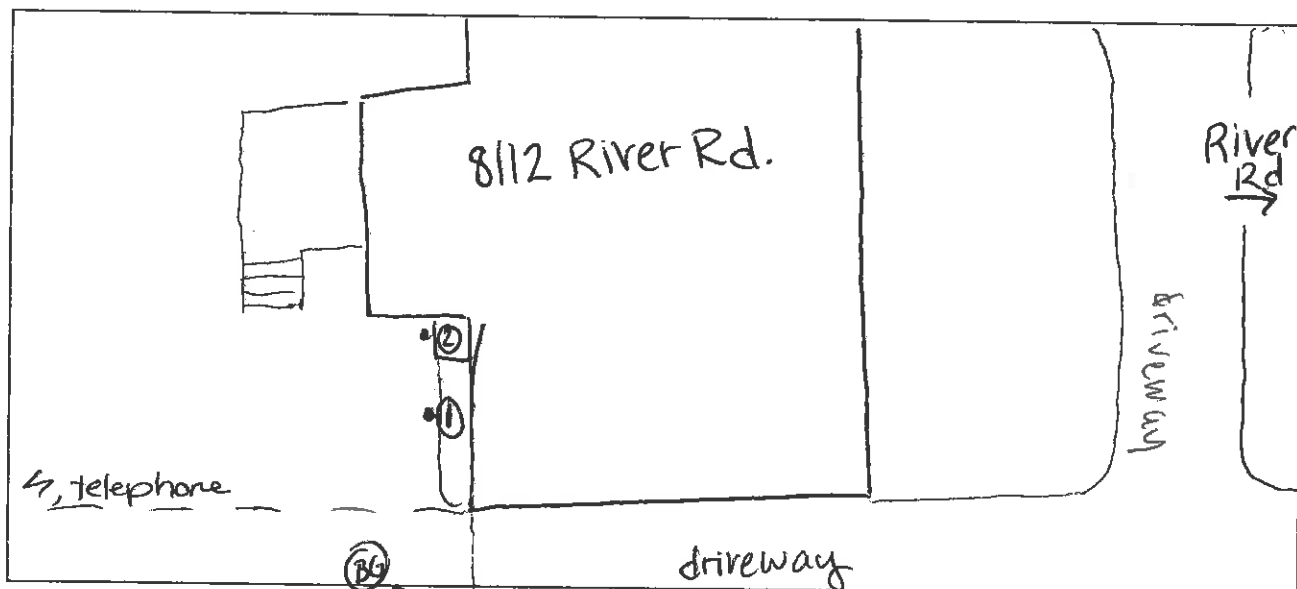
Case #	2013-4061
Address	8112 River Rd Richmond (P)
Category	3
Date	10/20/2017
Time	4:00
Weather

Max TPH-DRO	
ID	
Concentration	
Depth

Sample ID	Tube #	Depth (ft)	Q (ccm)	Start Time	End Time	Pump #	Tube #
8112-1-H	B29698	3'4"	100	-	30	1	7'
8112-1-L	B28369	3'4"	35			2	8
8112-2-H	B29709	3'4"	100			4	4
8112-2-L	B28455	3'4"	35			5	3
8112-3	B28464	3'3"	35	-	↘	7	7

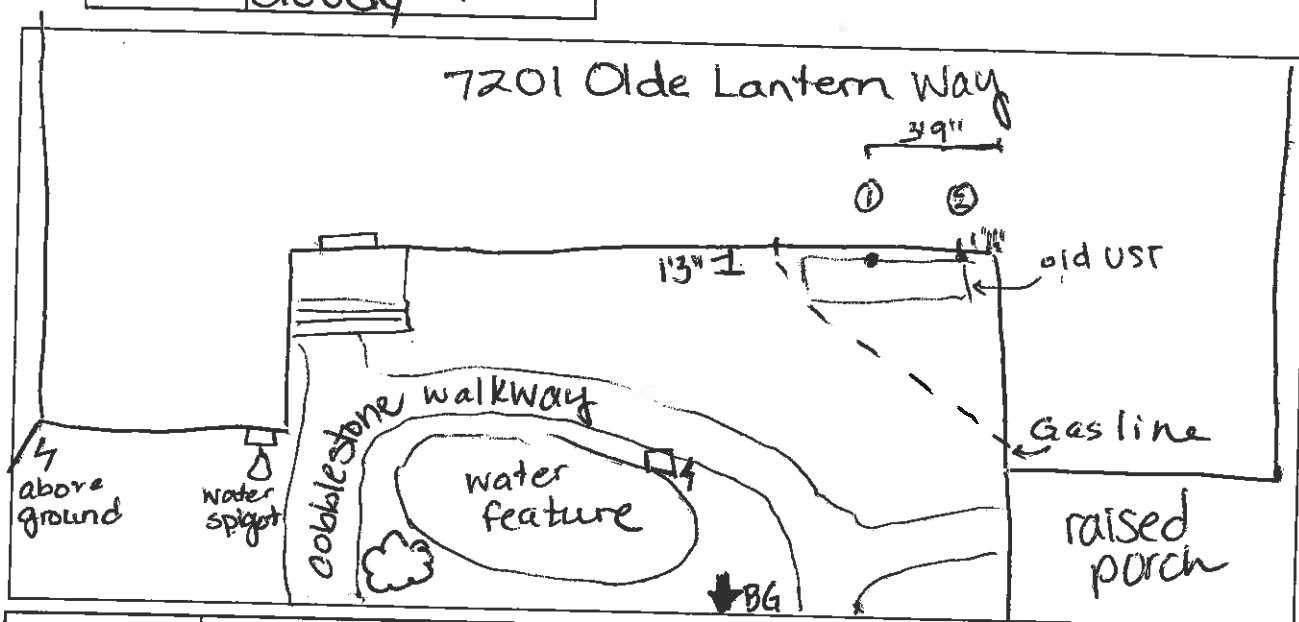
Max TPH-DRO	
ID	
Concentration	
Depth

basement

Sample ID	Tube #	Depth (ft)	Q (ccm)	Start Time	End Time	Pump #	Tube #
7201-1							
7201-BG	B25311 T	2'9"	35	11:41		7	7
7201-1-1	B28375 T	1'5"	↓	30 min		5	7'
7201-1-2	B24242 C	1'5"	↓			2	4
7201-2	B29698 T	1'4"	↓			1	9
