# Fairview Beach Watershed Plan

## King George County, Virginia

**Prepared by**  
**Interstate Commission on the Potomac River Basin (ICPRB)**  
**30 W. Gude, Suite 450**  
**Rockville, MD 20850**

**September 2014**

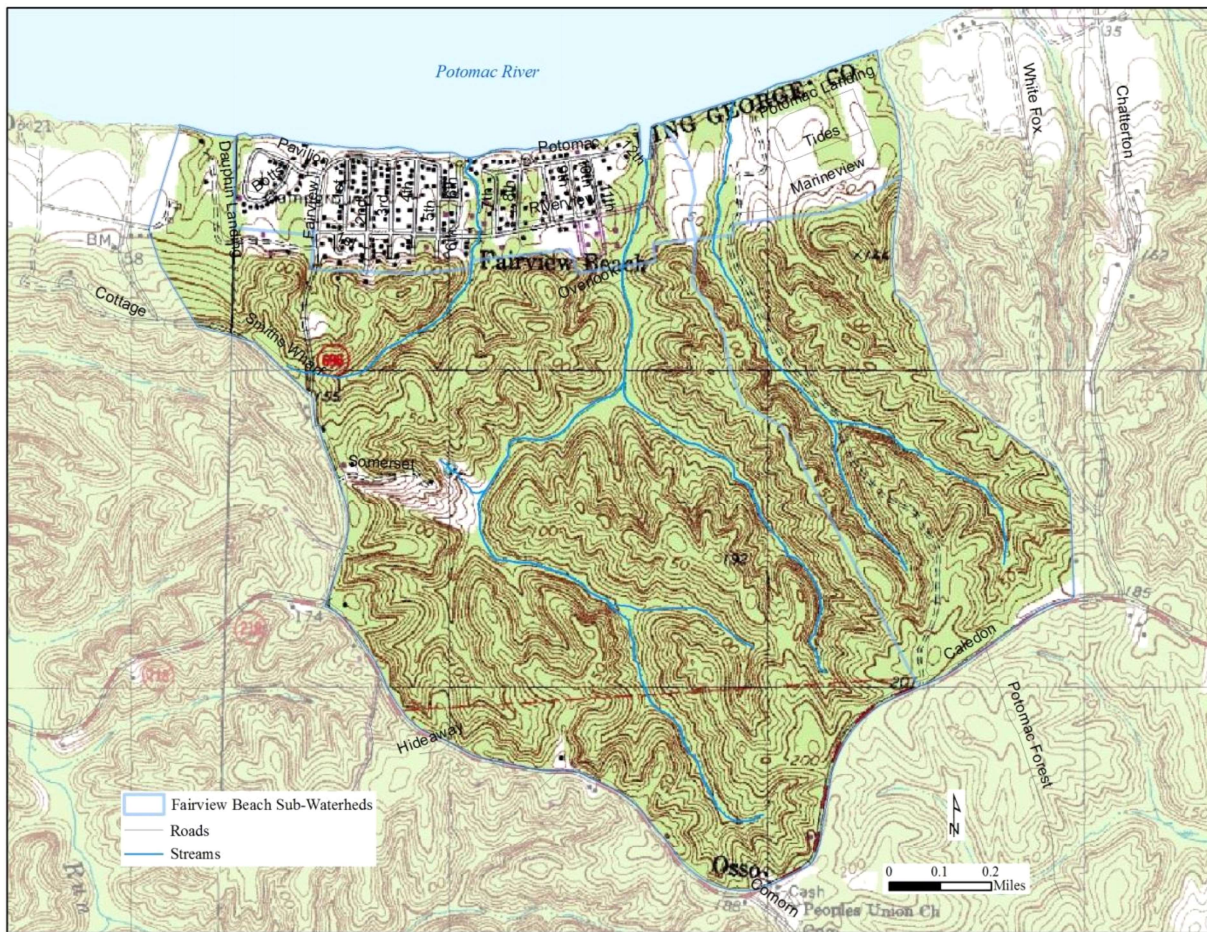
**Figure 2-3.** Fairview Beach topography.

Fairview Beach is in the Coastal Plain. **Figure 2-3** shows the topography of the Fairview Beach PSA and contributing watersheds. The original subdivisions are set in a marine terrace. Elevation ranges from 0 to 100 ft. The average elevation is 28 ft. In the Potomac Landing subdivision, elevations range from 0 to 70 ft., with an average elevation of 24 ft. Slopes in the PSA range from 0 to 6%. Overlooking the PSA are bluffs rising to an elevation of 215 ft. with 15 to 30% slopes.

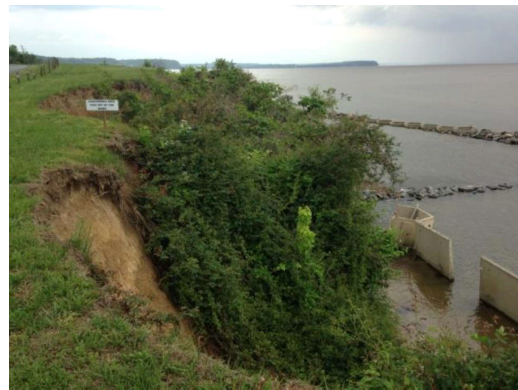
*Beach erosion structures.*

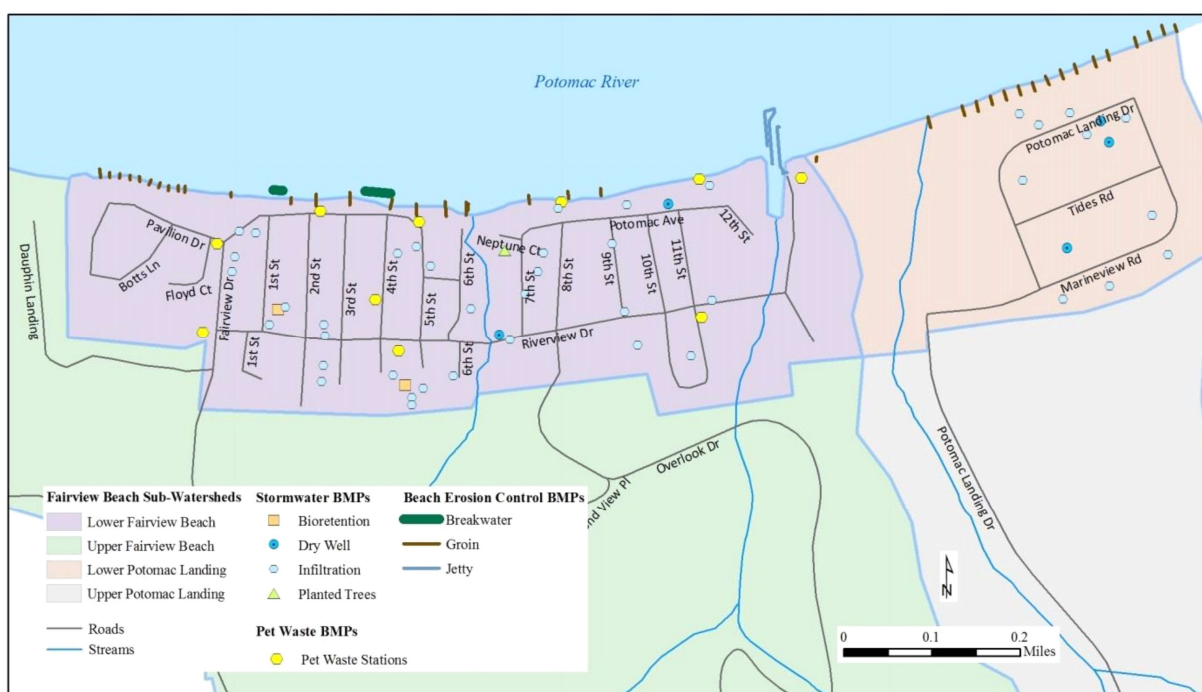
**Figure 5-1.** Locations of existing BMPs in the Fairview Beach plan area.

Stormwater BMPs have also been successfully installed in the plan area (**Figure 5-1**). The King George County Comprehensive Plan (King George County 2013) requires stormwater BMPs to be installed on properties with greater than 16% impervious cover, a CBPA Overlay Zoning District threshold. To date, 36 stormwater BMPs have been installed in the Lower Fairview Beach sub-watershed and 13 in the Lower Potomac Landing watershed. Measures installed in the Lower Fairview Beach sub-watershed include bioretention, dry wells, infiltration BMPs, and planted trees. Dry wells and infiltration BMPs were installed in the Potomac Landing sub-watershed. Load reductions associated with existing stormwater BMPs are provided in **Section 5.4.1**.

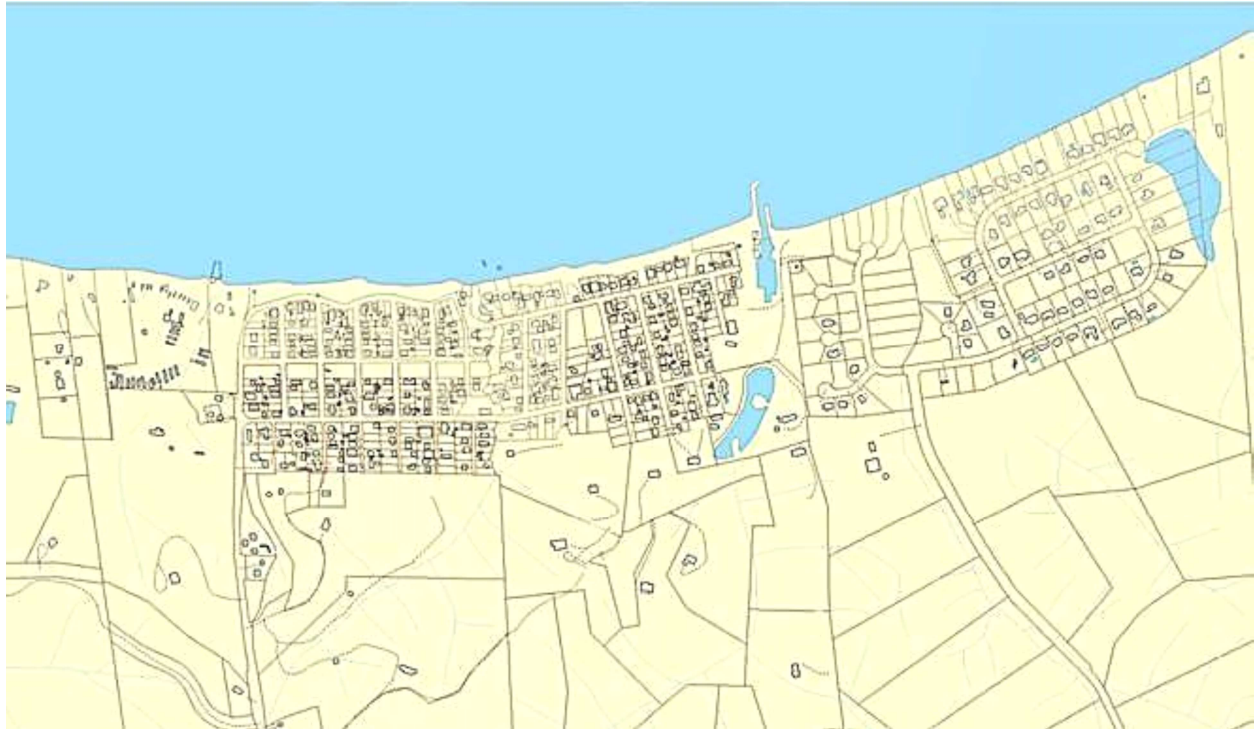
**Figure 5-5.** Parcels, buildings, and driveways. Parcel polygons are outlined in brown. Buildings are displayed as polygons with black boundaries. Hashed lines represent the driveways. This view was captured on the county's online GIS data viewer, 6/12/2014.
