FIELD INSPECTION REPORT

Project Name:	Mountain Valley Pipeline	Inspector:	Matthew Grant
Inspection Date:	Tuesday, October 3, 2023	Project Contact:	Brian Clauto
Spread I: Franklin	Sta 13997+79-14000, 13853-13888+58 ATWS1466, 697, 1040, 1041, 518, 519 AR FR303.01	Weather:	Dry

FIELD INSPECTION PHOTO LOG

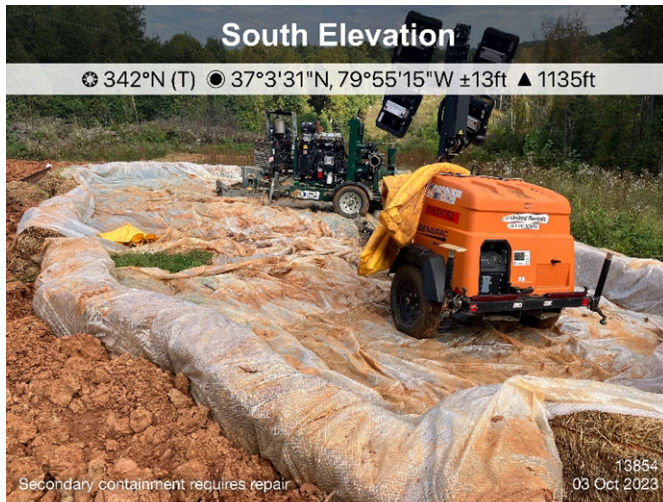
- Figure 1: Sta 13584 secondary containment is torn and requires repair.

Recommended Corrective Action: Maintain and install all controls per the approved PSS&S. Ensure approved environmental auditor monitors crossing work.

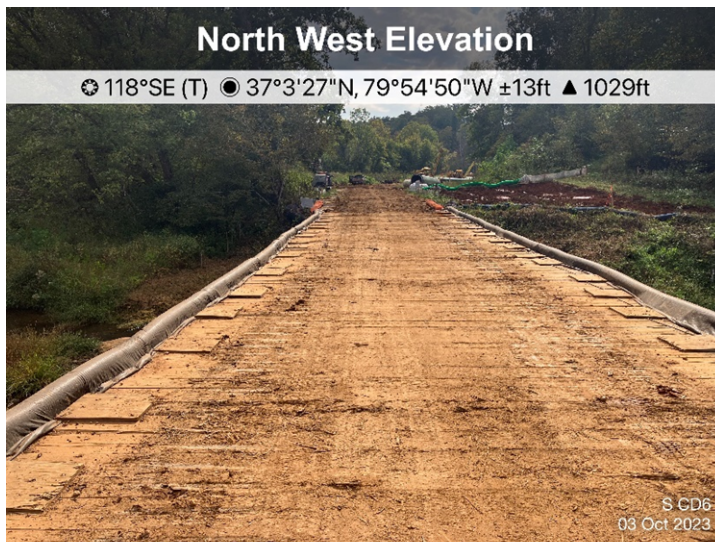
- Figure 3: Designated crossing S-CD6, ESC are in place for active construction.

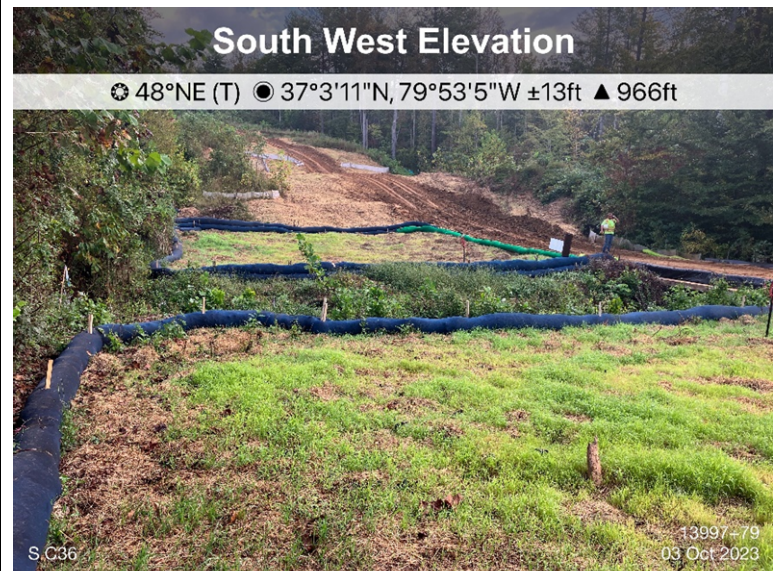
- Figure 4: Sta 13997+79 near designated crossing S-C36, ESC is in place.
