FIELD INSPECTION REPORT

Project Name:	Mountain Valley Pipeline	Inspector:	Marshall Willis
Inspection Date:	Monday, October 16, 2023	Project Contact:	Brian Clauto, Cory Chalmers
Spread I: Franklin County	MVP-FR-311 STA 14220+00 – 14233+12 MVP-FR-309.05 STA 14062+17 – 14083+73	Weather:	Dry

FIELD INSPECTION PHOTO LOG

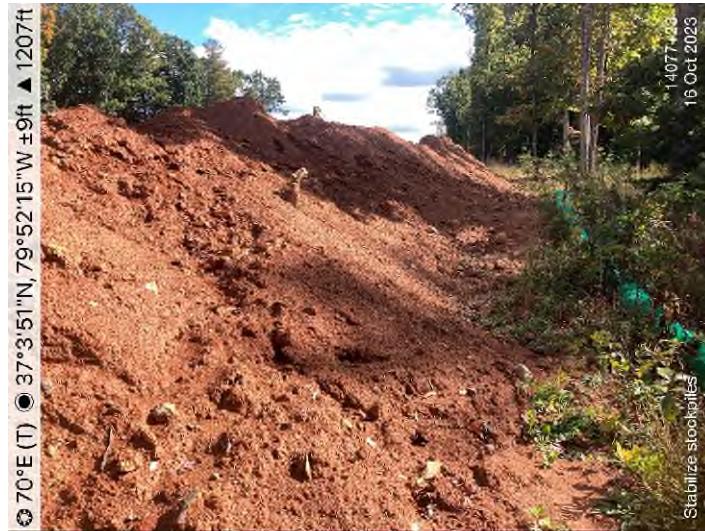
Figure 1: STA 14077+23 – Stabilize stockpiles around hydrostatic testing site.

- STA 14077+23: Stabilize stockpiles around testing site.
- STA 14078+44: Stabilize stockpiles around testing site.

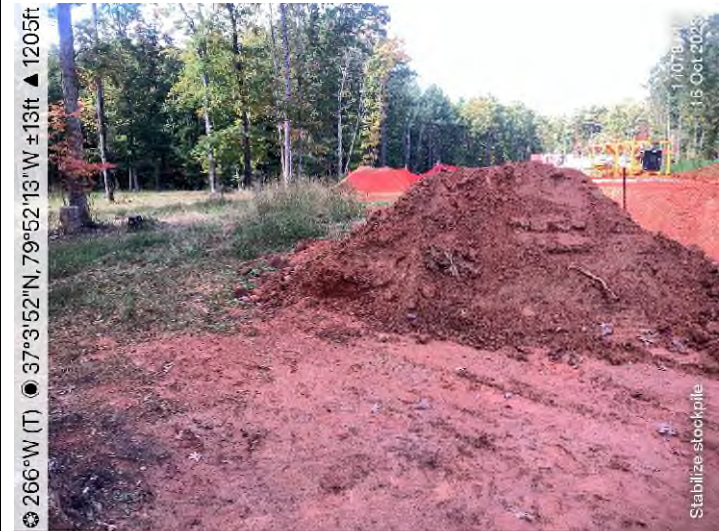
Figure 2: STA 14078+44 – Stabilize stockpiles around hydrostatic testing site.

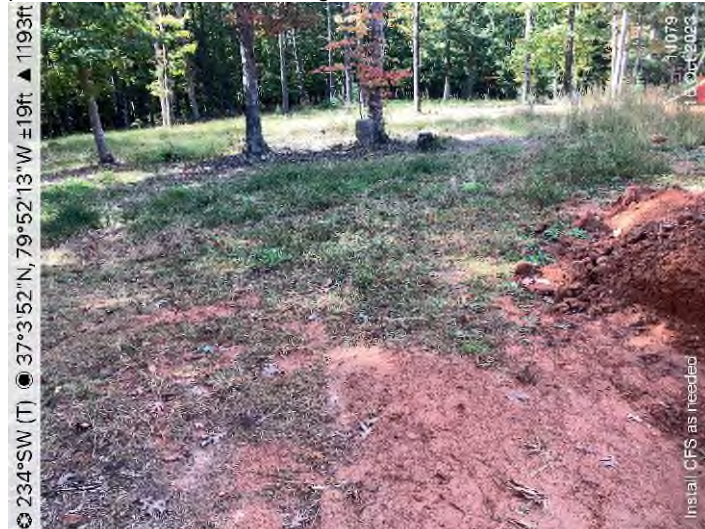
Figure 3: STA 14079+00 – Install additional perimeter controls to prevent sediment from leaving ROW.

- STA 14078+44: Install additional controls along perimeter to prevent sediment from getting outside LOD.

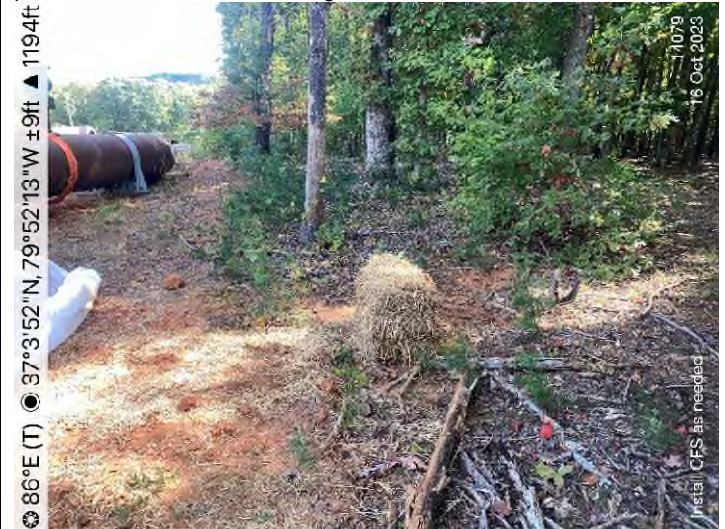
Figure 4: STA 14079+00 – Install additional perimeter controls to prevent sediment from leaving ROW.
