Project Name:	Mountain Valley Pipeline	Inspector:	Matthew Grant
Inspection Date:	Wednesday, January 3, 2024	Project Contact:	Brian Clauto
Spread I: Franklin	Sta 13437+65-13420 Sta 14720-14730 AR FR 293.02	Weather:	Dry

FIELD INSPECTION PHOTO LOG

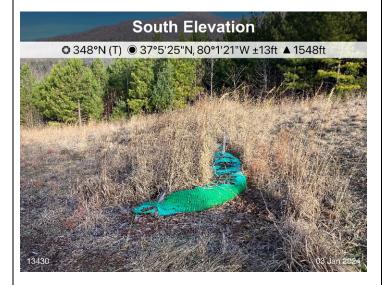
Figure 1: Sta 13430 CFS requires repair or removal.

3.	Areas of o	ffsite s	sediment deposition o	bserve	ed?				\boxtimes	
	Comments:	Inspected t	the foll	lowing resources: S-I	J4, W-A	A8, S-A15, S-A19, S-	-A20				
Poi	ıtino Mainto	nanco: (73	2-Hour	<u> Deadline</u> from Notific	cation)						
IXO	- Sta13	437-13430) CFS	B Needs maintenan	ce or to	o be remove in cer	nter of F	Row that are not in	use.

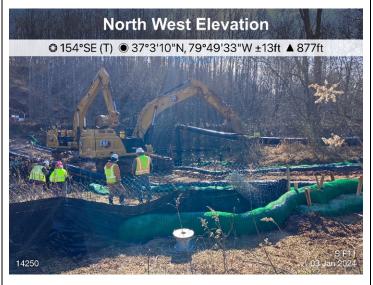
Figure 3: Designated crossing S-F11, ECD's are in place.
