COMPLAINT INVESTIGATION REPORT

Project Name:	Mountain Valley Pipeline	Inspector:	Matthew Grant
Inspection Date:	Tuesday, February 13, 2024	Project Contact:	Brian Clauto
Spread G: Giles	215 & 217 Zells Mill Rd, Newport VA	Weather:	Wet

FIELD INSPECTION PHOTO LOG

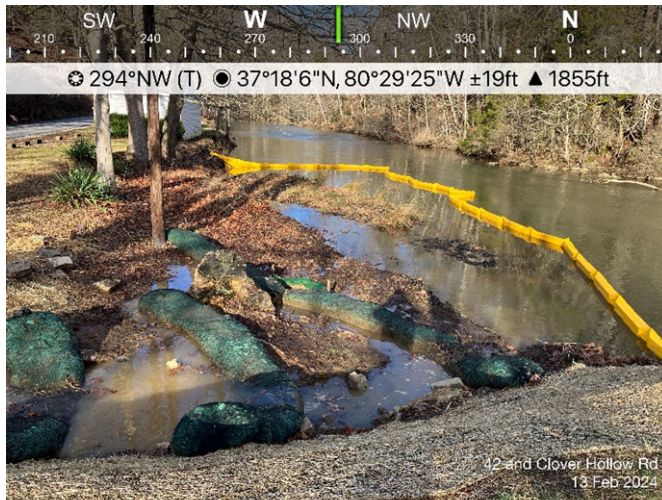
Figure 1: Area near the intersection of 42 and Clover Hollow Rd.

1. DEQ inspectors inspected the ROW between MVP ROW stations 11255+77-11254+04. All ESC's were in place and functioning.
2. DEQ inspectors inspected the impacted area off site near the intersection of 42 and Clover Hollow Rd, crews were on site continuing sediment cleanup and ESC removal per PREP #312517.
3. DEQ inspectors along with Mr. Quinn observed clear water entering the spring screen box and exiting the spring house.

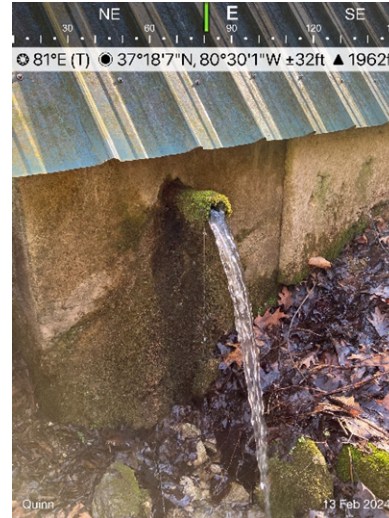
Figure 2: Quinn property spring box.

Comments: DEQ inspectors Matthew Grant and Marshall Willis met with Mr. Quinn at 215 Zells Mill Rd in Newport VA which is approximately 1.2 miles from the MVP pipeline ROW Blue Grass Trail Road crossing. Mr. Quinn stated his well water was his drinking source and no discoloration had occurred, only that the spring well house water had been discolored during rain events and was the source of water at the barn location.

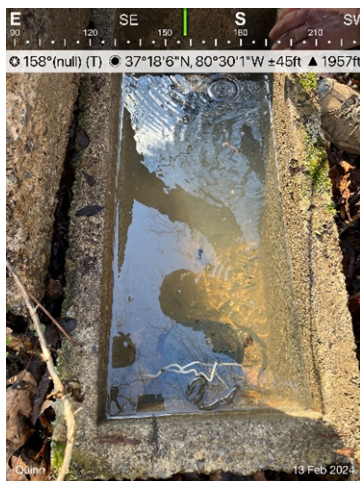
Figure 3: Quinn property prescreen spring box.

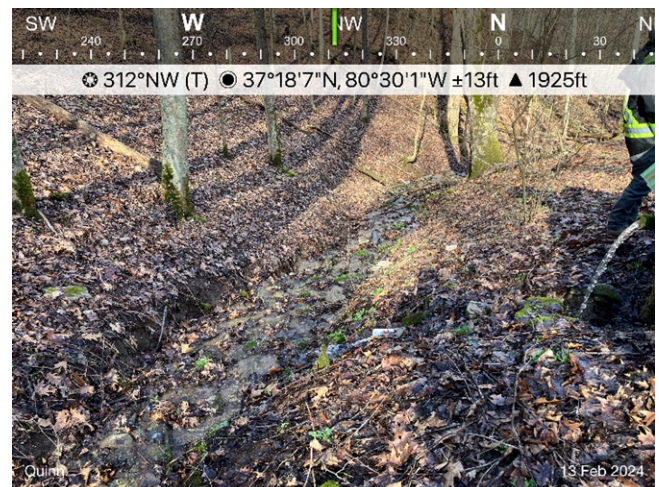
Figure 4: Quinn property spring box outfall channel.
