Water Quality Study Report

Niagara Hydroelectric Project
(FERC No. 2466)

December 6, 2021

Appalachian Power Company

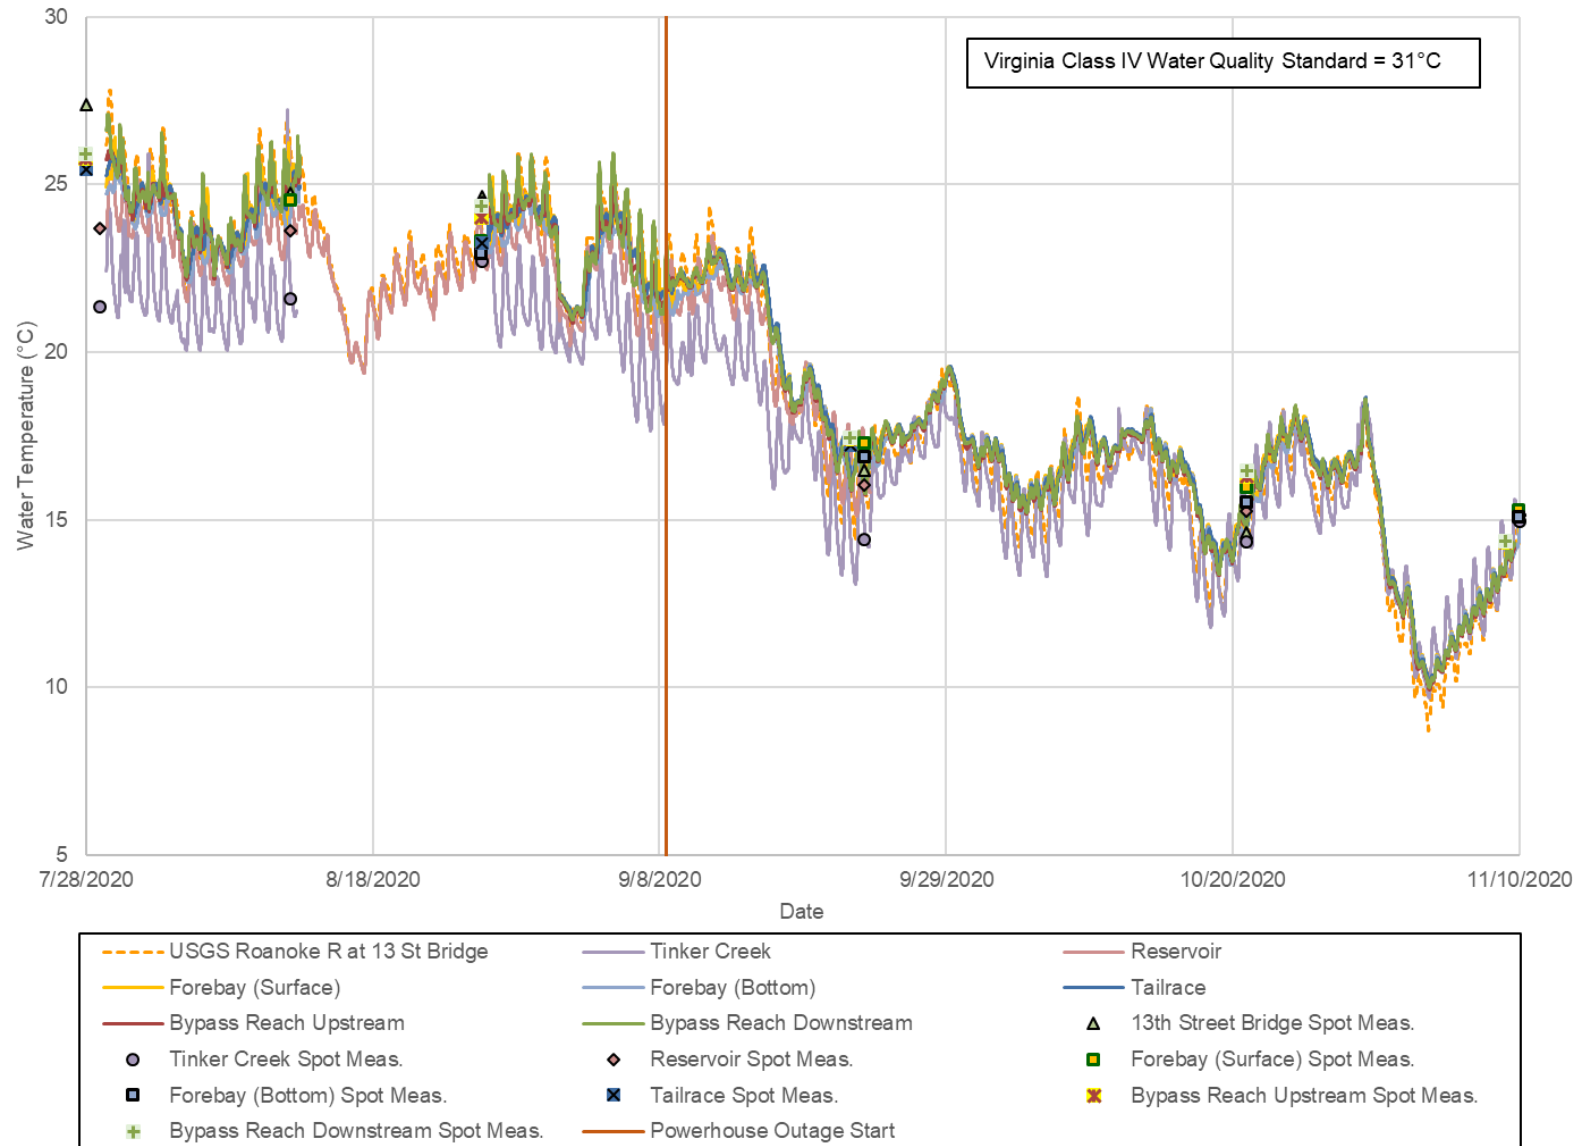
Figure 1-1. Continuous and Discrete Temperature Measurements at All Water Quality Monitoring Locations (2020)

Figure 1-1 and Figure 1-2 in Attachment 1 provide continuous and discrete water temperature data at all water quality locations for 2020 and 2021, respectively. At the time of initial data sonde deployment on July 29, 2020, water temperatures were in the 24 – 27°C range at the Roanoke River monitoring locations and in the 20 – 25°C range at the Tinker Creek monitoring location. Water temperatures recorded at the USGS 02055080 (Roanoke River at the Thirteenth Street Bridge in Roanoke) water quality monitoring station (immediately upstream of the reservoir) peaked at 28.7°C on July 20, 2020; approximately one week prior to initial deployment of the data sondes. Water temperatures generally decreased during the 2020 study period and dropped to approximately 10°C by early November 2020. Tinker Creek water temperatures were several degrees cooler and exhibited larger daily fluctuations compared to the Roanoke River monitoring locations. The Tinker Creek monitoring location is heavily canopied which may contribute to the cooler temperatures, and the drainage area is relatively small¹ which may contribute to the larger daily fluctuations.

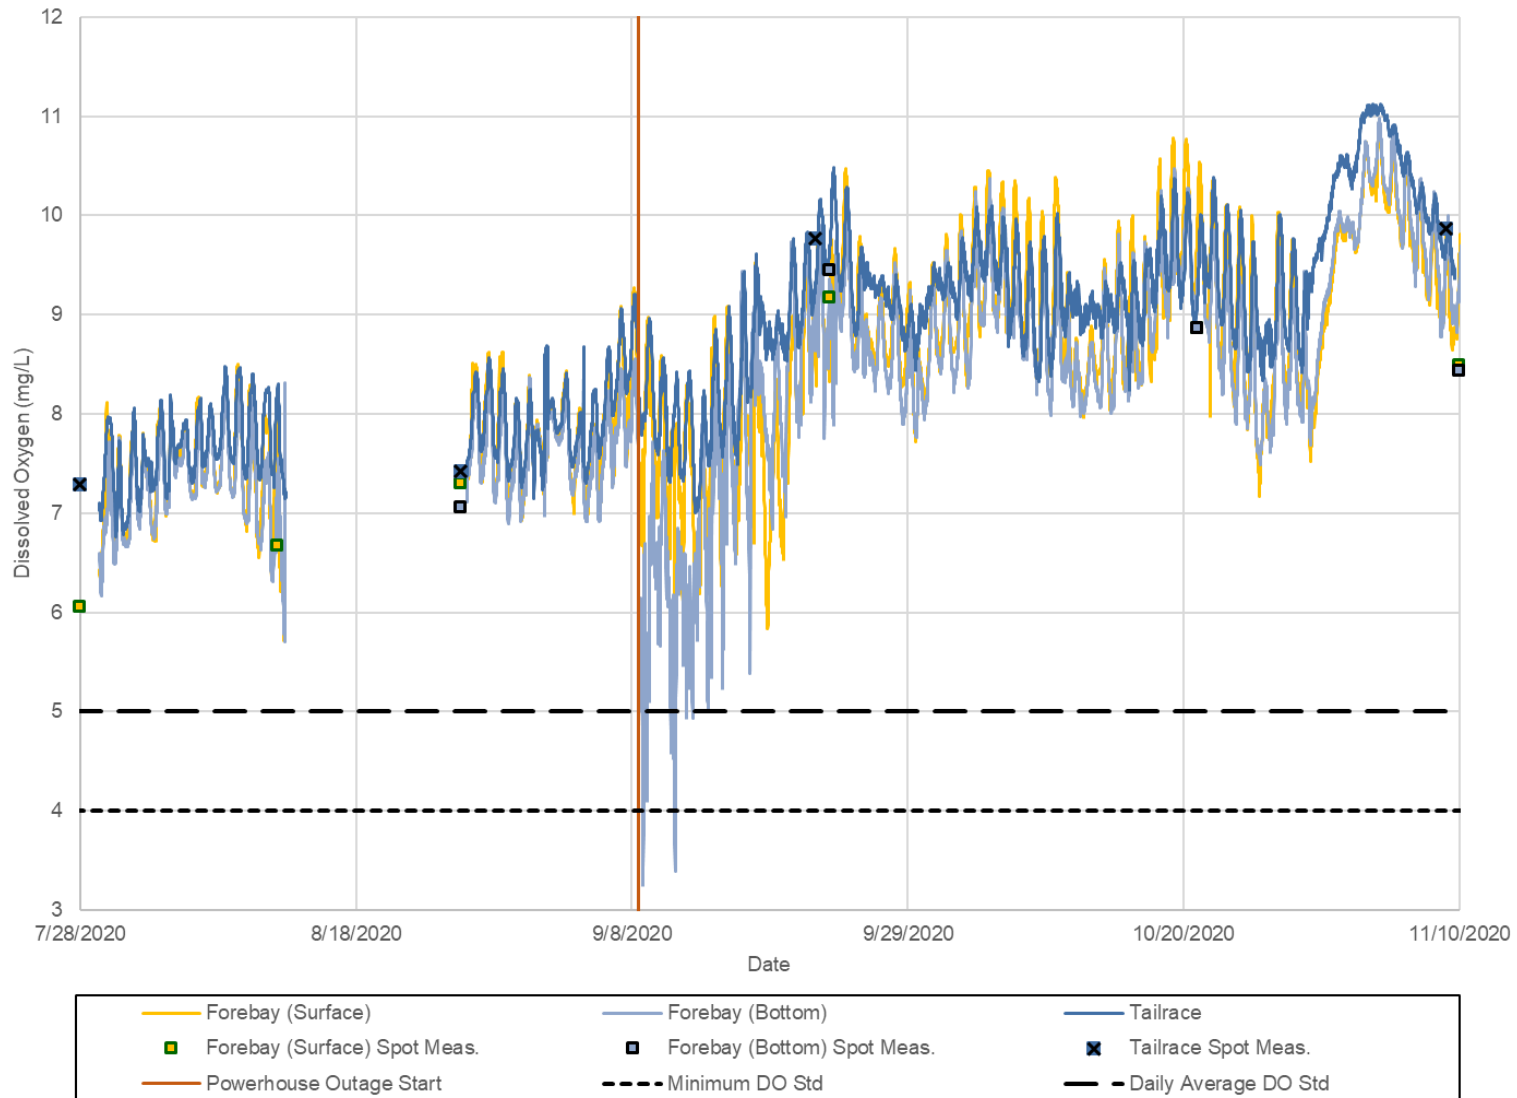
Figure 1-5. Continuous and Discrete Dissolved Oxygen Concentrations at the Forebay and Tailrace Water Quality Monitoring Locations (2020)

Figure 1-5 (Attachment 1) provides continuous and discrete DO concentration data at the Project's forebay and tailrace monitoring locations in 2020. DO values exceeded the 4.0 mg/l instantaneous and 5.0 mg/l daily average standard (9 VAC 25-260-50) except in the Project's forebay on September 8 and 11, 2020. Instantaneous DO concentrations on these dates (recorded at the sonde near the reservoir bottom) were 3.3 mg/l and 3.4 mg/l, respectively. Each occurrence of instantaneous DO concentrations below 4.0 mg/l lasted less than 1.5 hours in duration. Also, both dates coincided with the start of a planned outage at the Niagara plant, which began on September 8, 2020 and continued throughout the end of the monitoring period. Because there was no flow through the powerhouse, instantaneous DO concentrations fluctuated (albeit very short-lived) between the forebay surface and bottom elevations. During these two events, DO concentrations near the surface remained above 5.0 mg/l and as a result, overall DO concentrations in the forebay met the state's DO criteria.² Daily fluctuations in DO concentrations were in the 1.0 – 2.0 mg/l range at the forebay and tailrace monitoring locations; slightly less than the daily fluctuations at the two upstream monitoring locations. Similar to water temperature profile trends, there was little (i.e., < 0.5 mg/l) difference in DO concentrations between the forebay surface and bottom sonde locations (with the exception of the two events noted above); indicating little to no stratification of DO concentrations throughout the forebay water column. DO concentrations in the tailrace were generally higher (by less than 0.5 mg/l) compared to the surface forebay monitoring location during both periods of generation and non-generation (see data pre- and post- powerhouse outage on September 8, 2020).
