RE: Bremono Bluff Power Station, Solid Waste Permit (SWP) 618  
Closure by Removal Construction Report – East Ash Pond  
Fluvanna County, Virginia

## Closure by Removal Construction

May 23, 2019

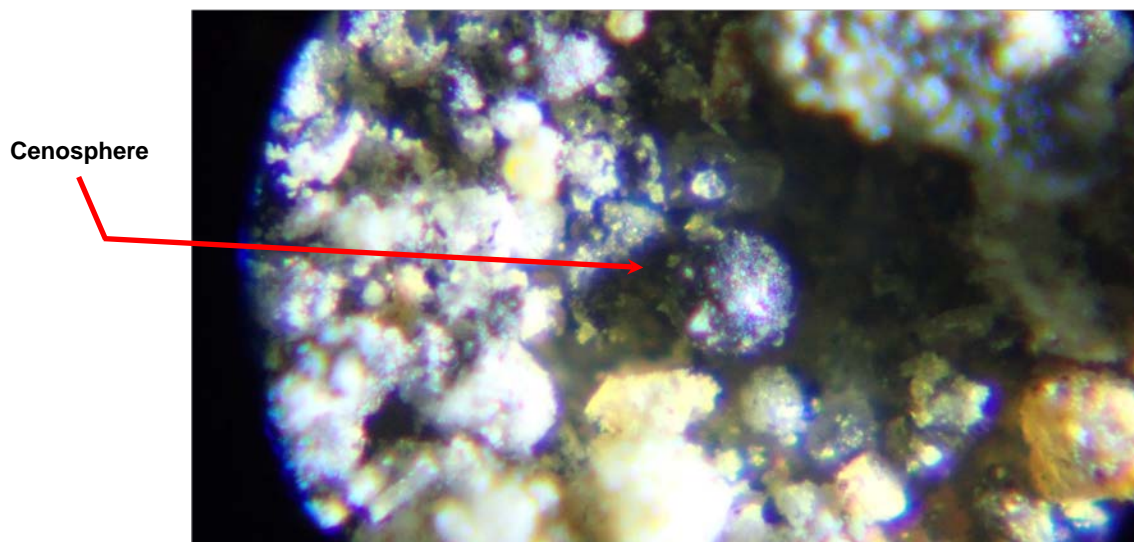
Figure 1: Cenospheres in Soil Matrix

Golder provided full-time observation of the CCR excavation in the East Ash Pond. Following achievement of visually clean conditions in an area, Golder inspected the soil surface for evidence of CCR materials. Areas identified as still containing CCR were identified for further excavation and re-inspection. Underlying soils in the pond area included light-colored sands and clays, dark-colored organic layers, light to dark grey clay layers, and light to dark weathered rock and sand. In areas where darker material was observed, a hand microscope was used to verify the absence of cenospheres (shown below), which are a unique identifier for CCR.

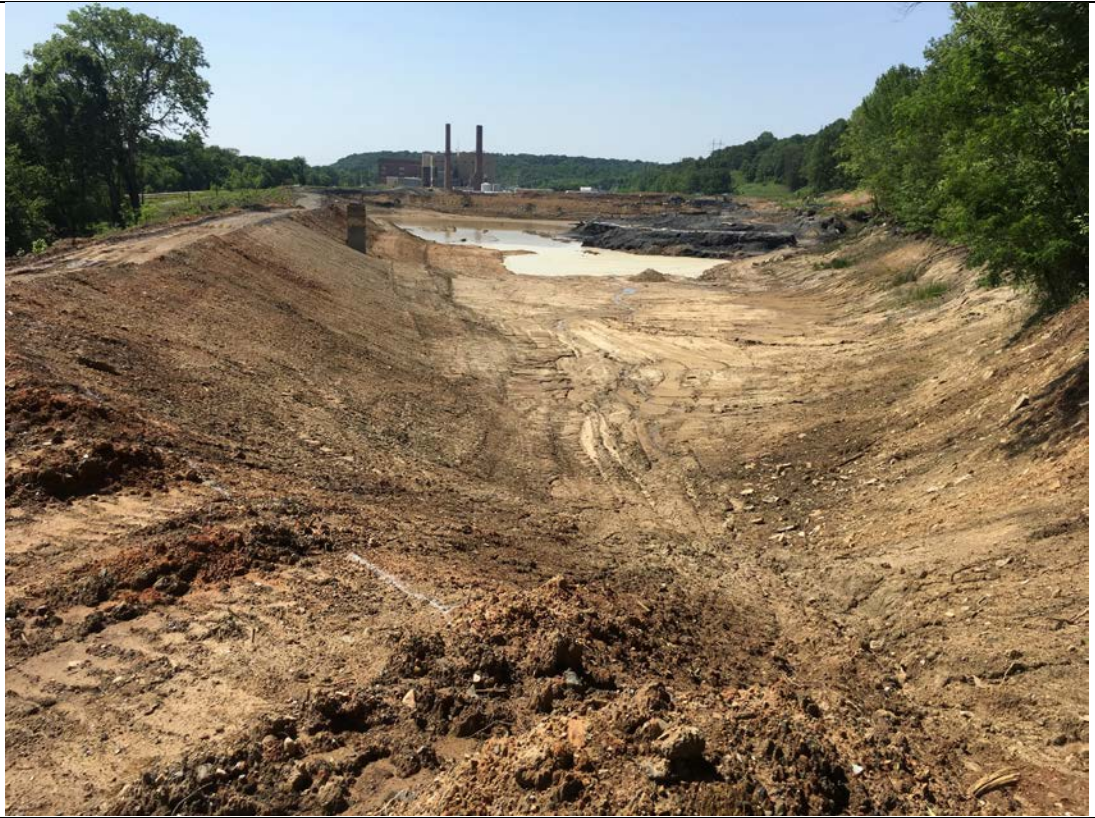
**Photo #2**  
**Observation:**

Southern limit of Subject Area looking east, showing the existing riser structure.

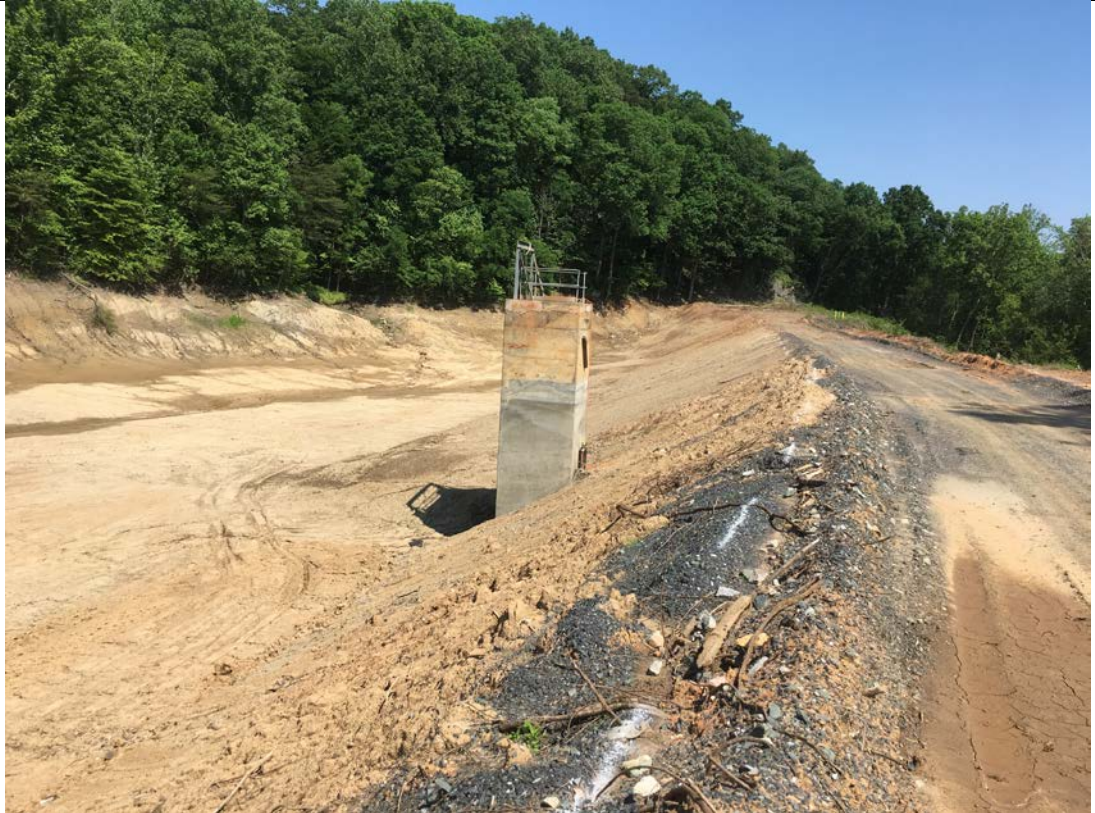
Photo #3  
Observation:

Western limit of  
Subject Area  
looking east.

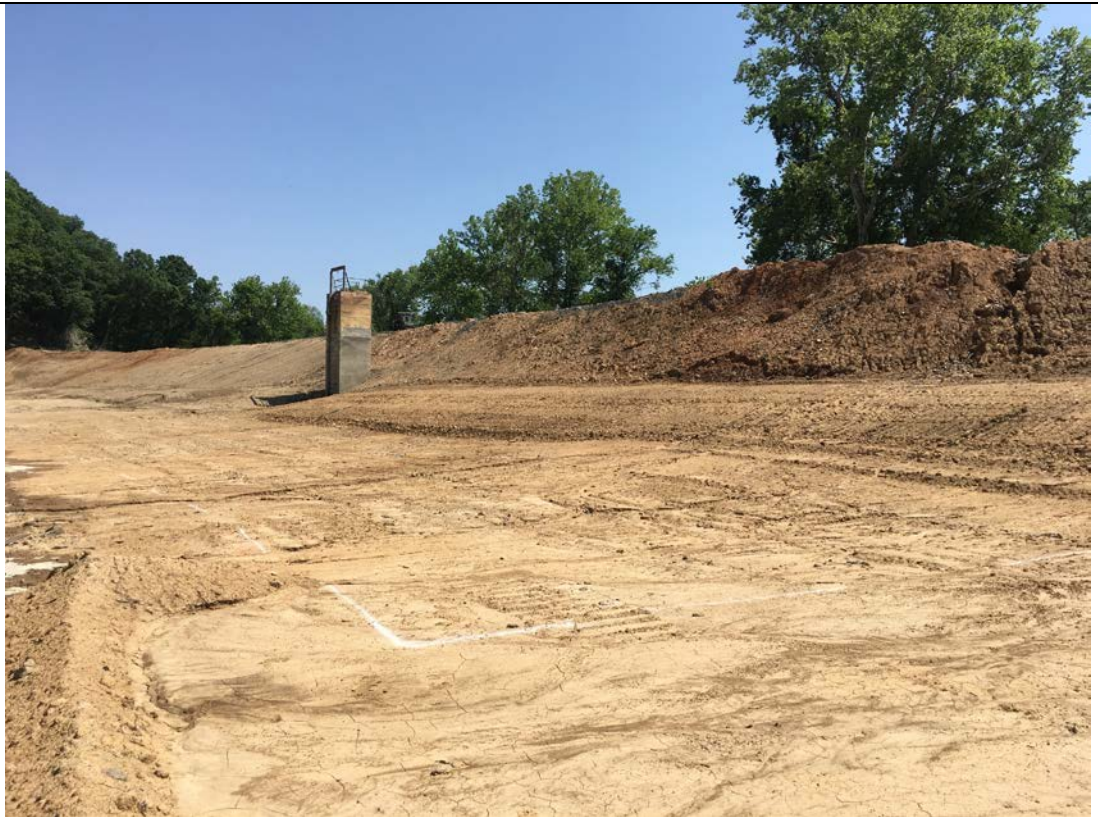
Photo #4  
Observation:

Bottom of Subject  
Area looking east.

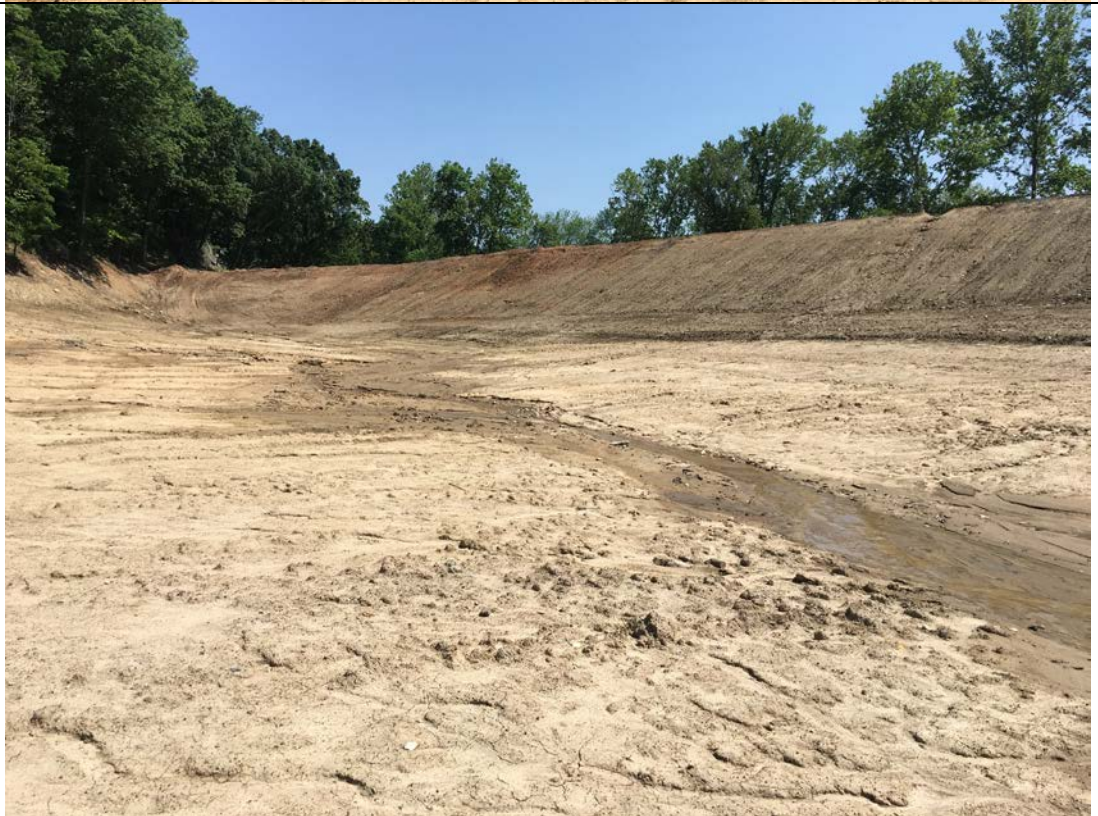
**Photo #5**  
**Observation:**

Bottom of Subject Area looking south. Riser has been power washed to remove CCR material.

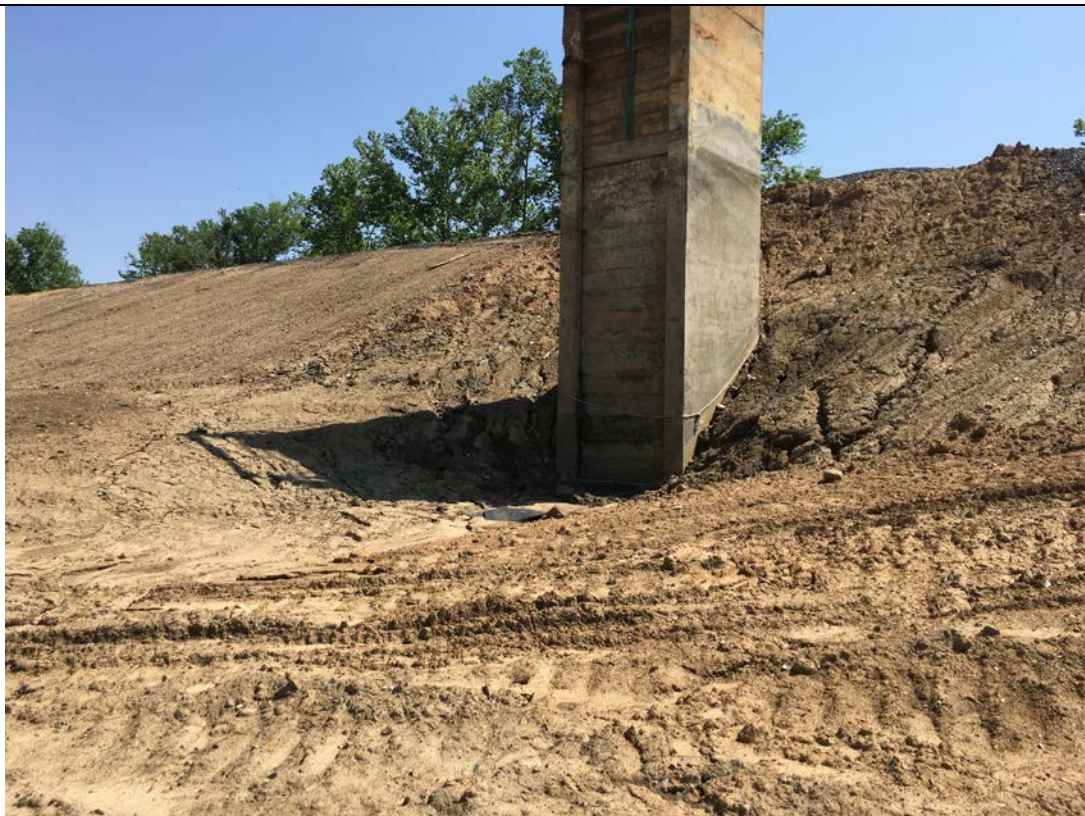
**Photo #6**  
**Observation:**

Eastern limit of Subject Area looking west, showing the northern limit of area along treeline.

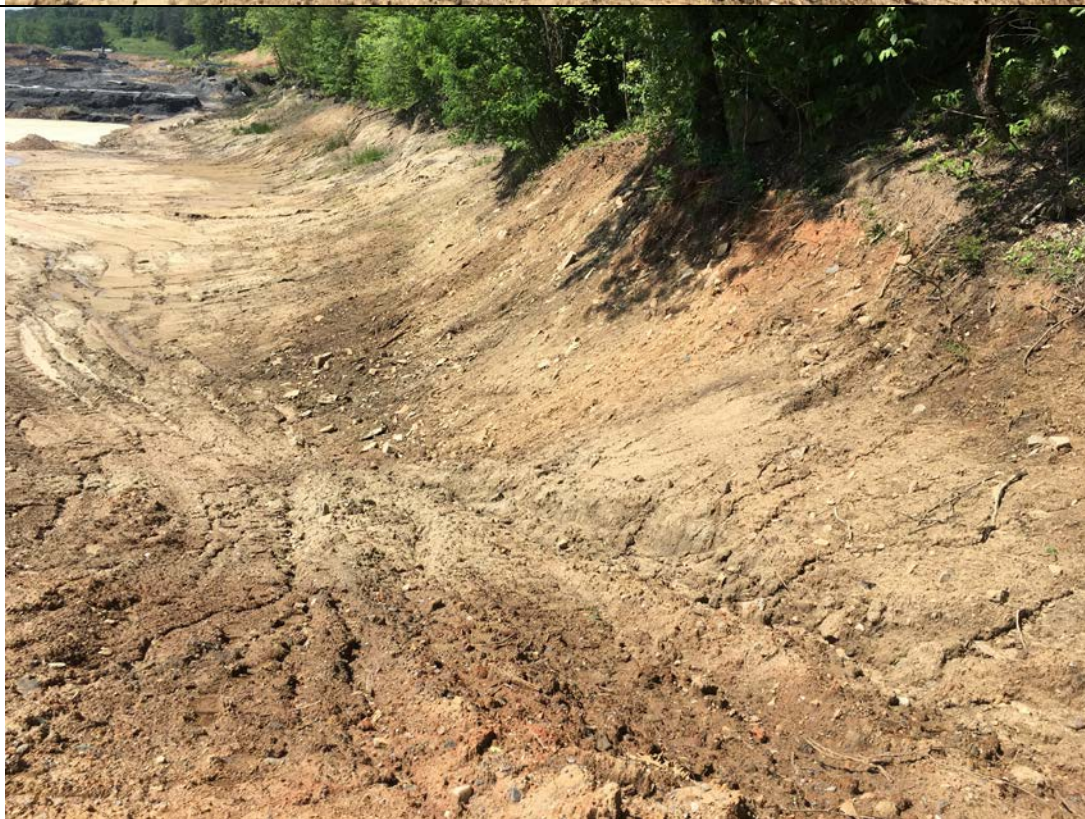
**Photo #7**  
**Observation:**

Bottom of Subject Area looking west, showing removal of CCR from the southern embankment.

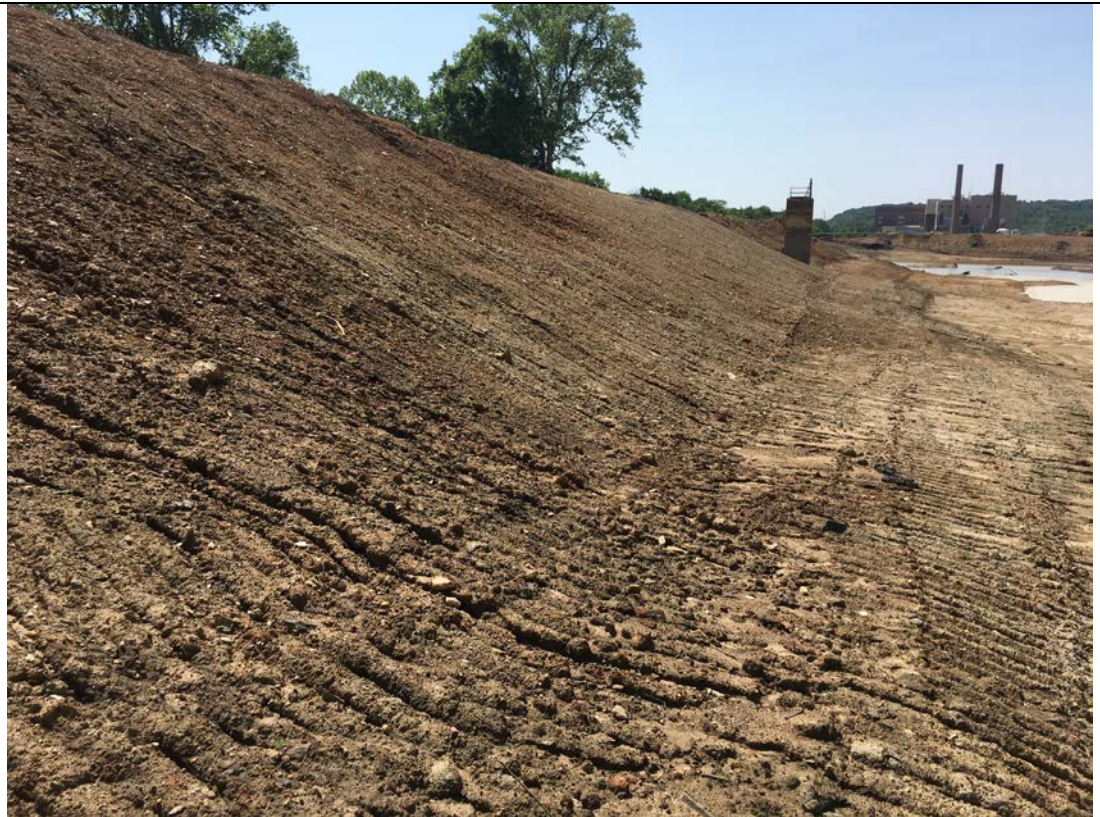
**Photo #1**  
**Re-Observation:**

Eastern end of Subject Area looking north, showing area where CCR has been Visually removed.

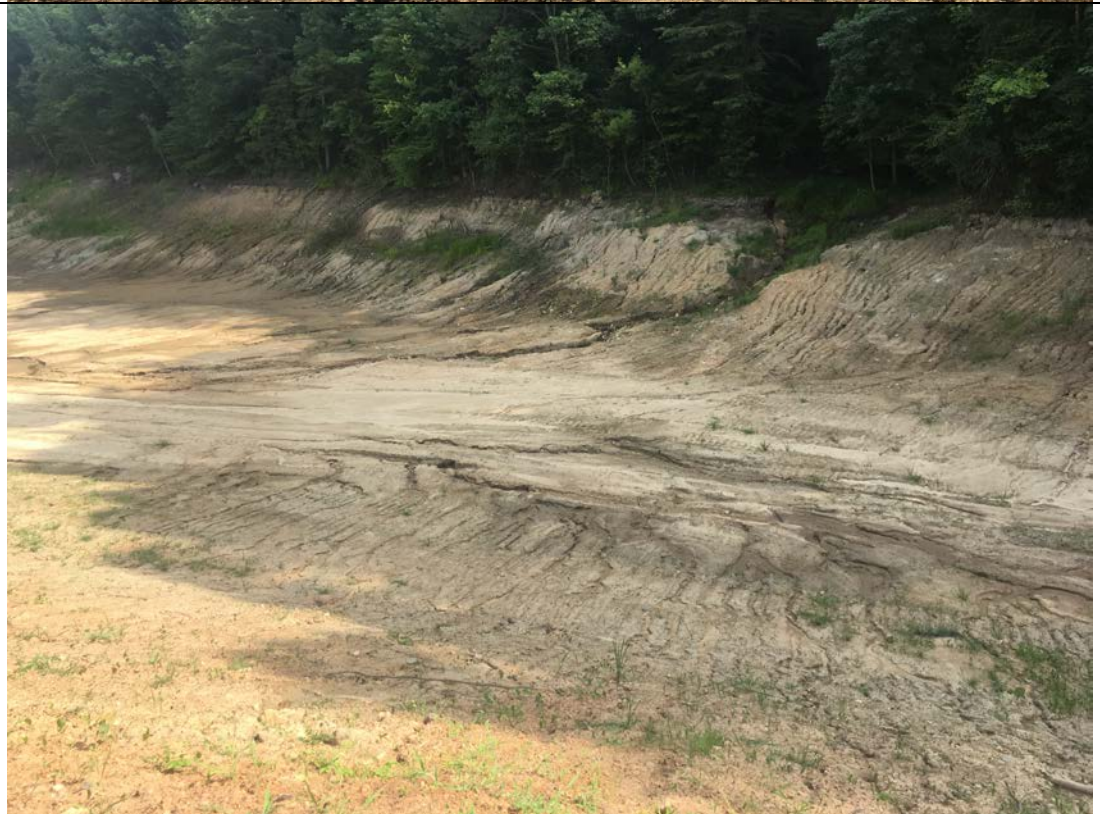
**Photo #2**  
**Re-Observation:**

Eastern end of  
Subject Area  
looking northwest,  
showing area  
where CCR has  
been Visually  
removed.

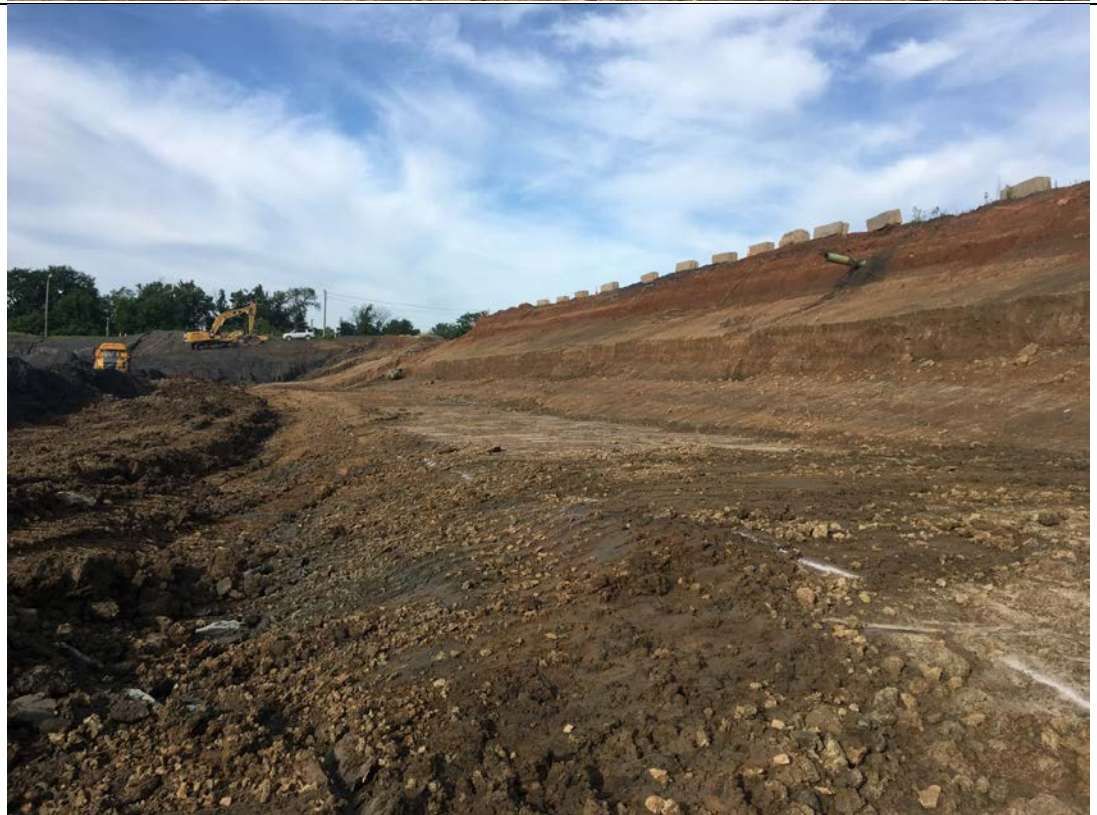
**Photo #3**  
**Observation:**

Bottom of Subject  
Area looking west.

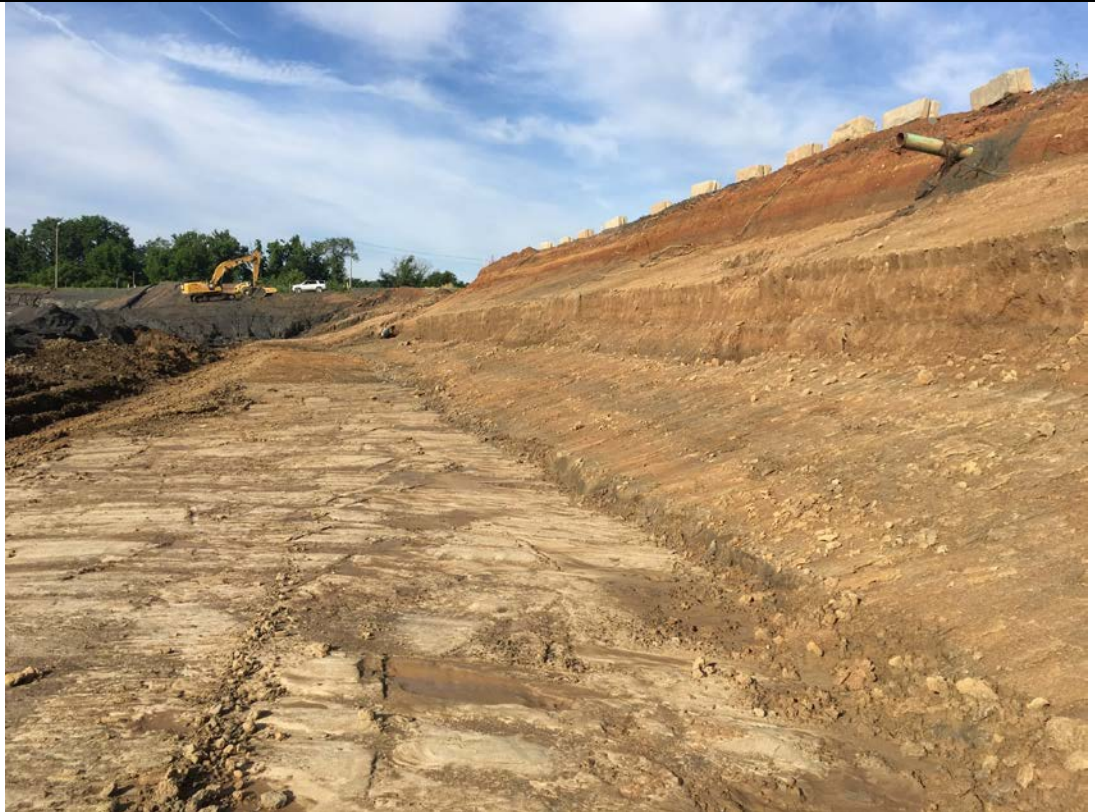
**Photo #5**  
**Observation:**

Bottom of Subject Area looking north.

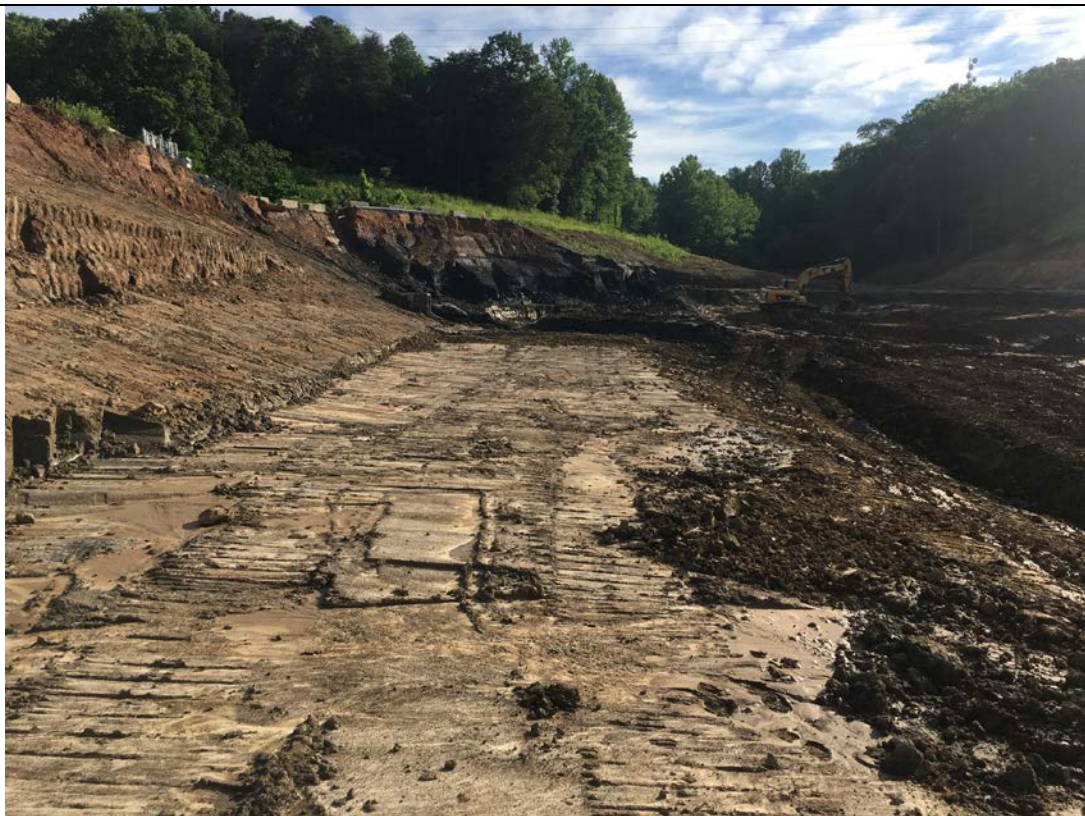
**Photo #6**  
**Observation:**

Bottom of Subject Area showing removal of CCR material.

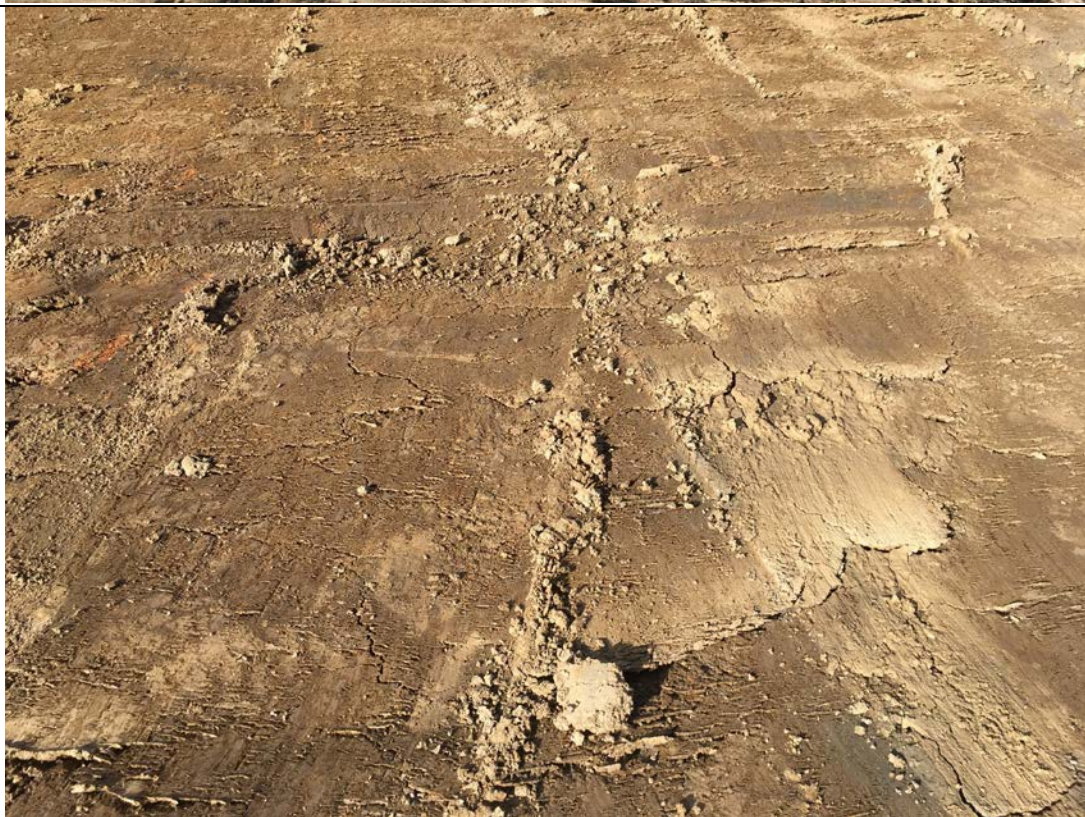
**Photo #7**  
**Observation:**

Bottom of Subject  
Area looking west.

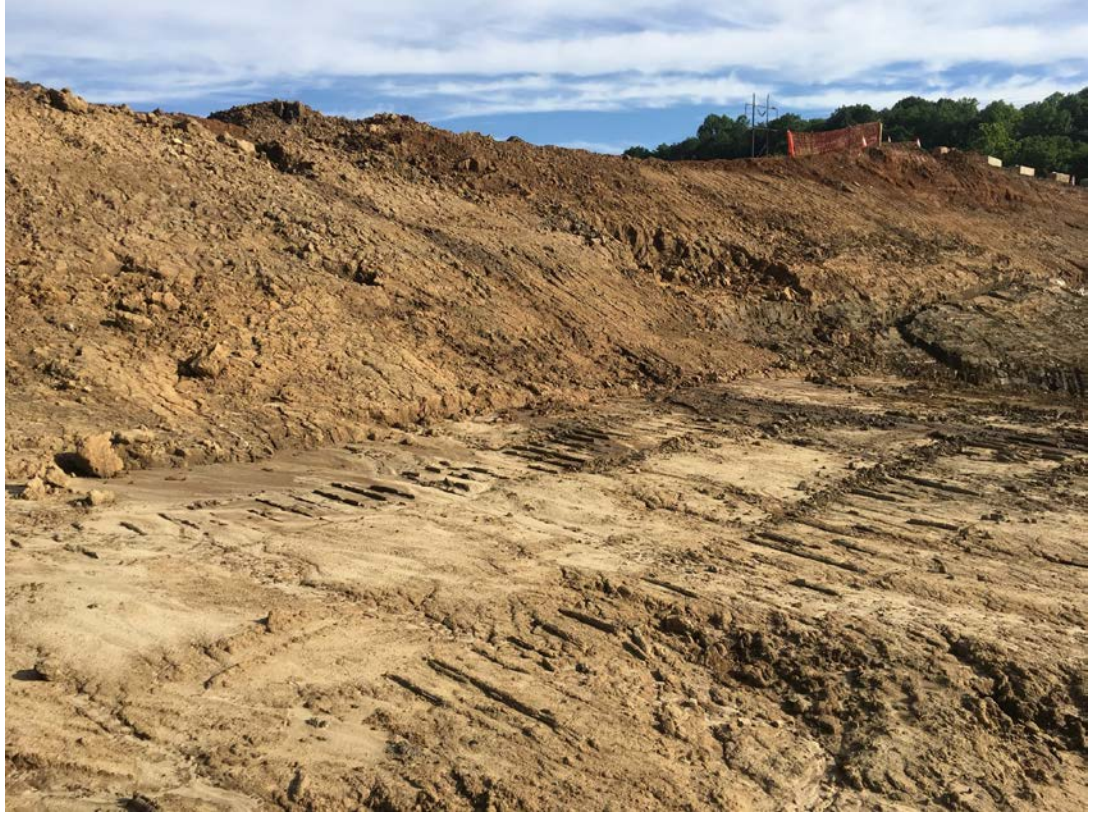
**Photo #8**  
**Observation:**

Bottom of Subject  
Area looking west.

**Note:**  
The white line  
denotes the limits  
of Visual  
Removal.

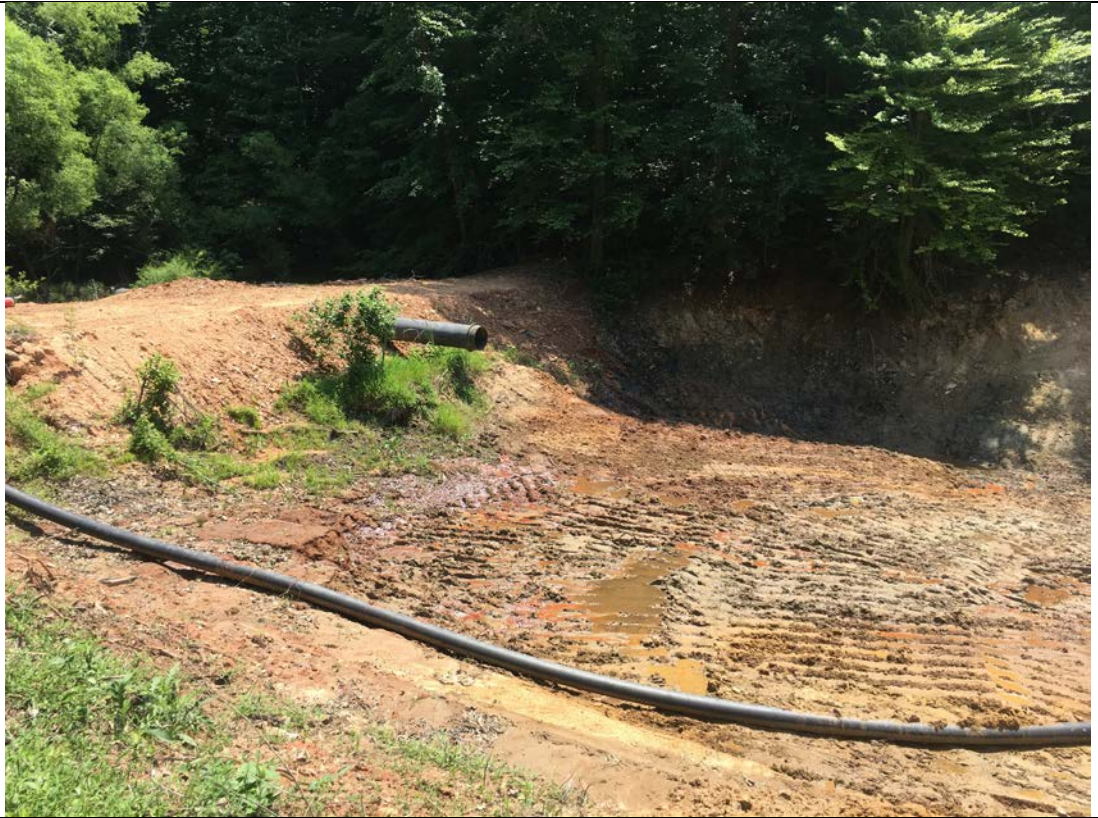
Photo #2  
Observation:

East side of Subject Area looking east, showing area where CCR has been Visually removed.

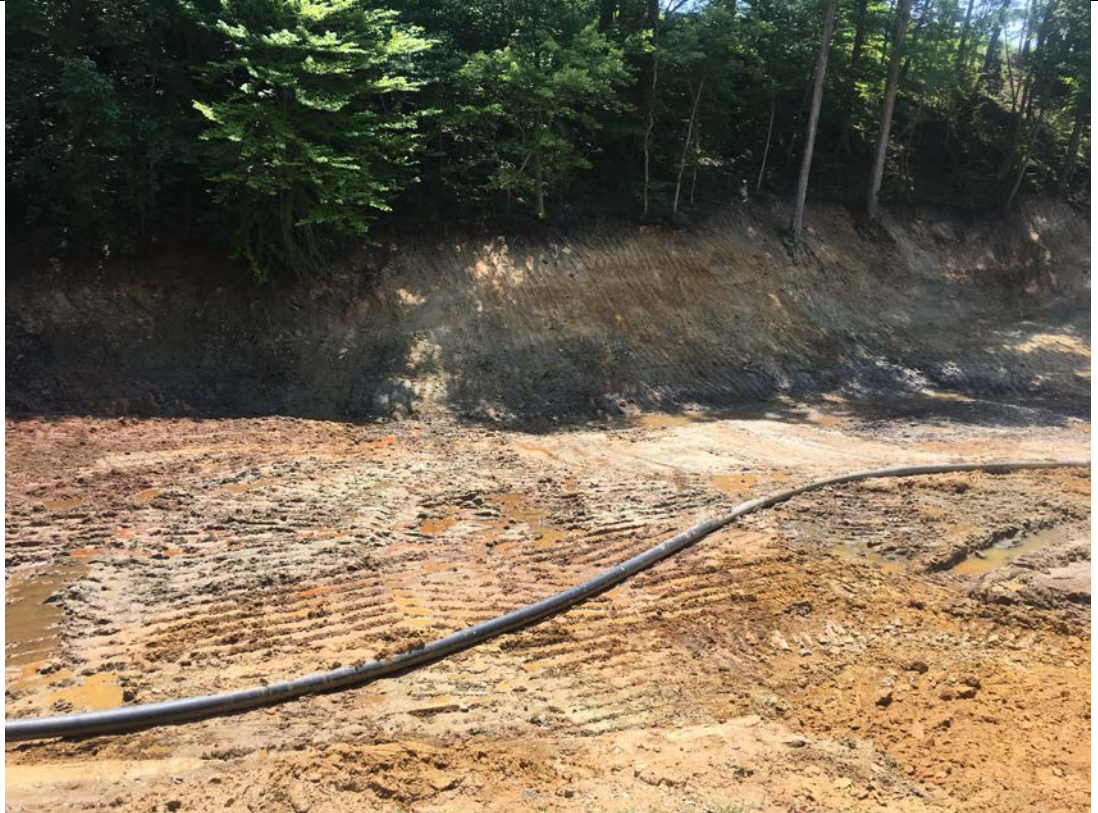
**Photo #3**  
**Observation:**

East side of Subject Area looking southeast, showing area where CCR has been Visually removed.

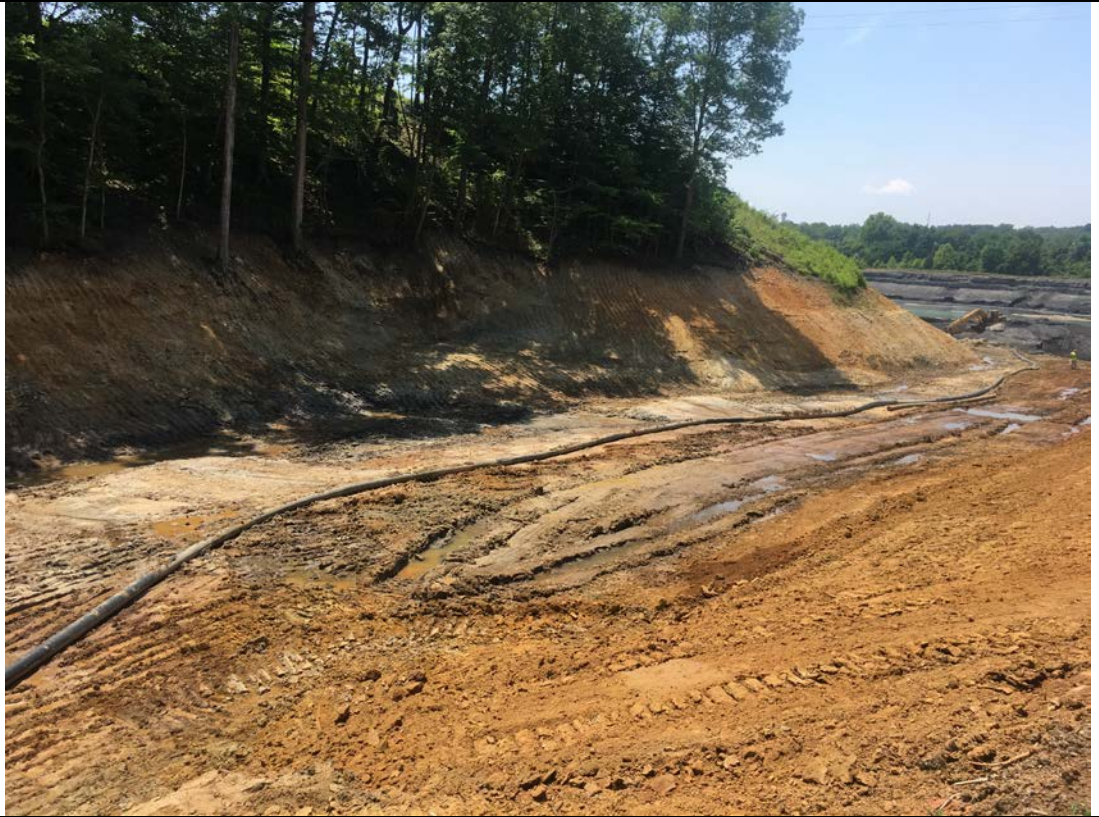
**Photo #4**  
**Observation:**

Western limit of Subject Area looking south, showing area where CCR has been Visually removed.

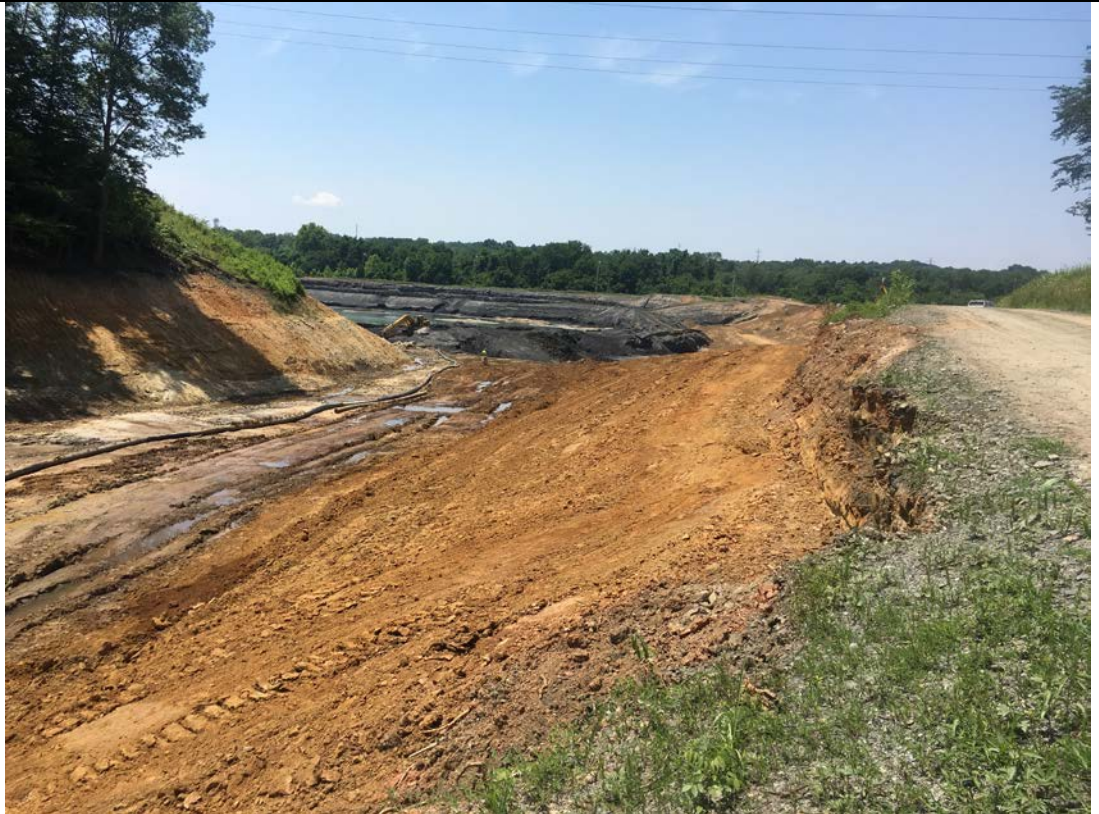
Photo #5  
Observation:

Bottom of Subject Area looking northeast.

Note:  
The white line denotes the limits of Visual Removal.

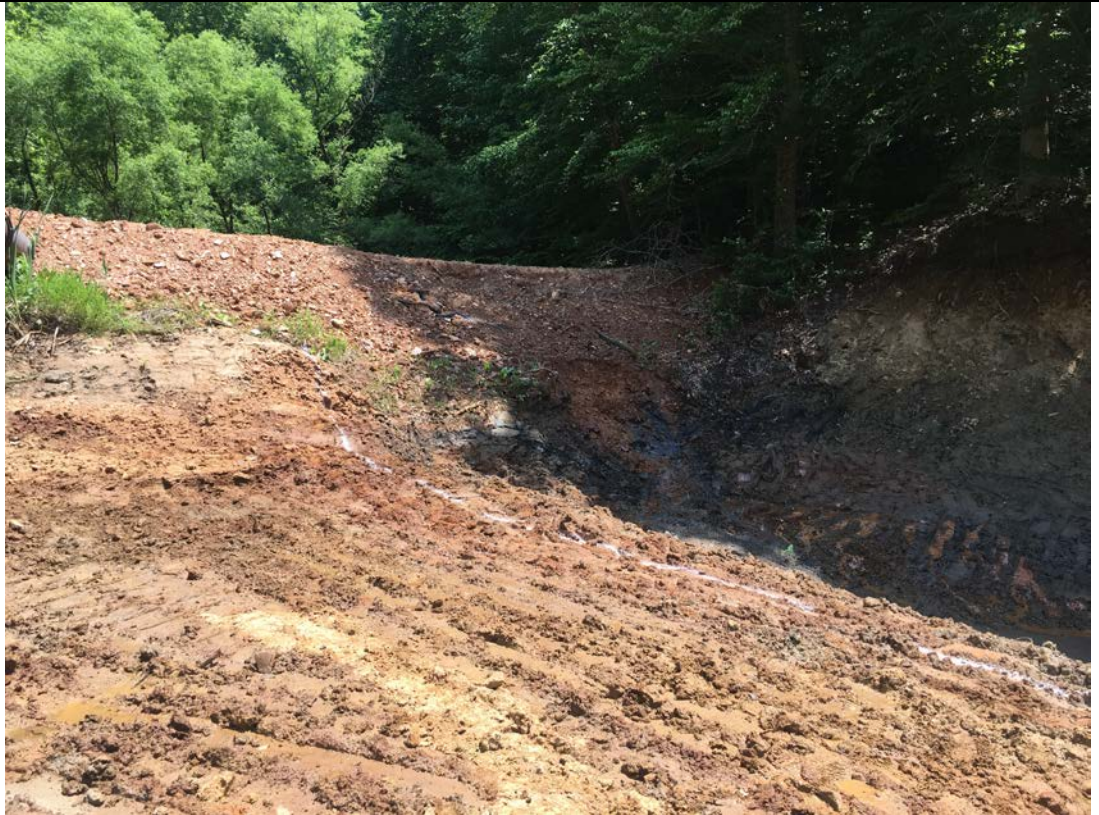
Photo #6  
Observation:

Western limit of Subject Area looking east.

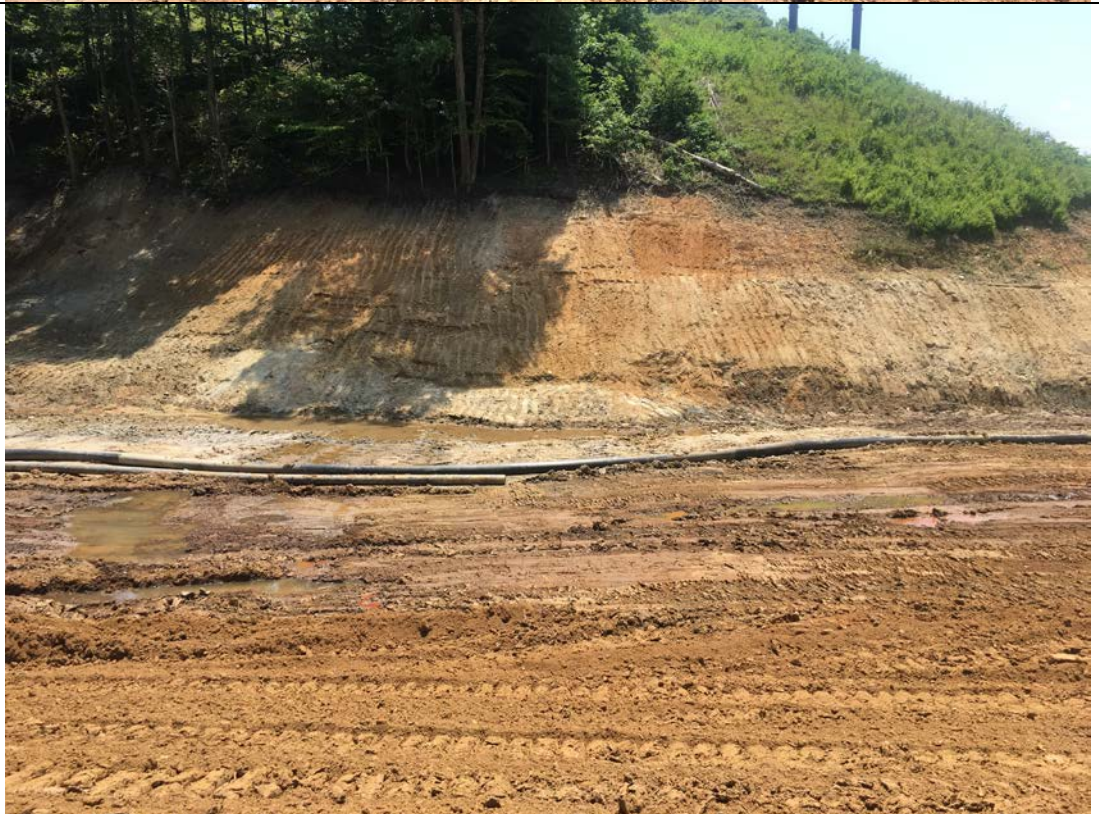
**Photo #7**  
**Observation:**

Western limit of  
Subject Area  
looking south.

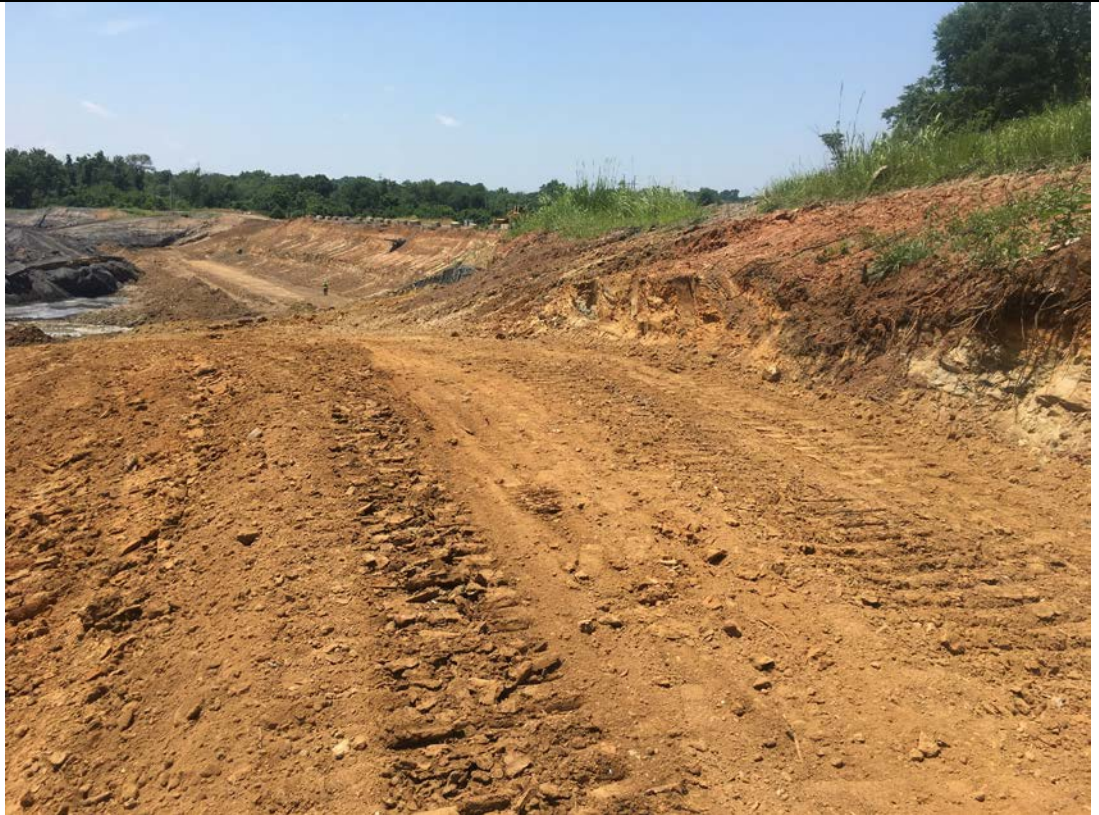
**Photo #8**  
**Observation:**

Bottom of subject  
Area looking  
south.

Note:  
The white line  
denotes the limits  
of Visual  
Removal.

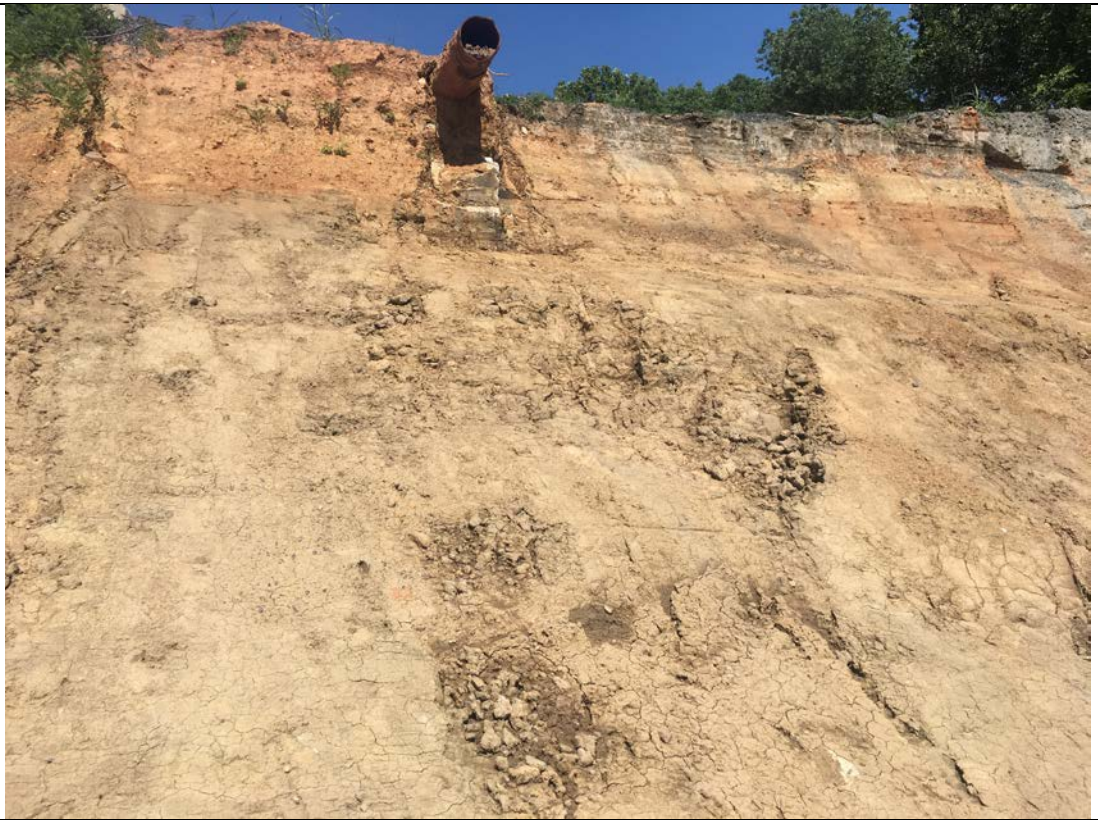
Photo #1  
Observation:

Bottom of Subject Area looking west, showing area where CCR has been Visually removed from the embankment.

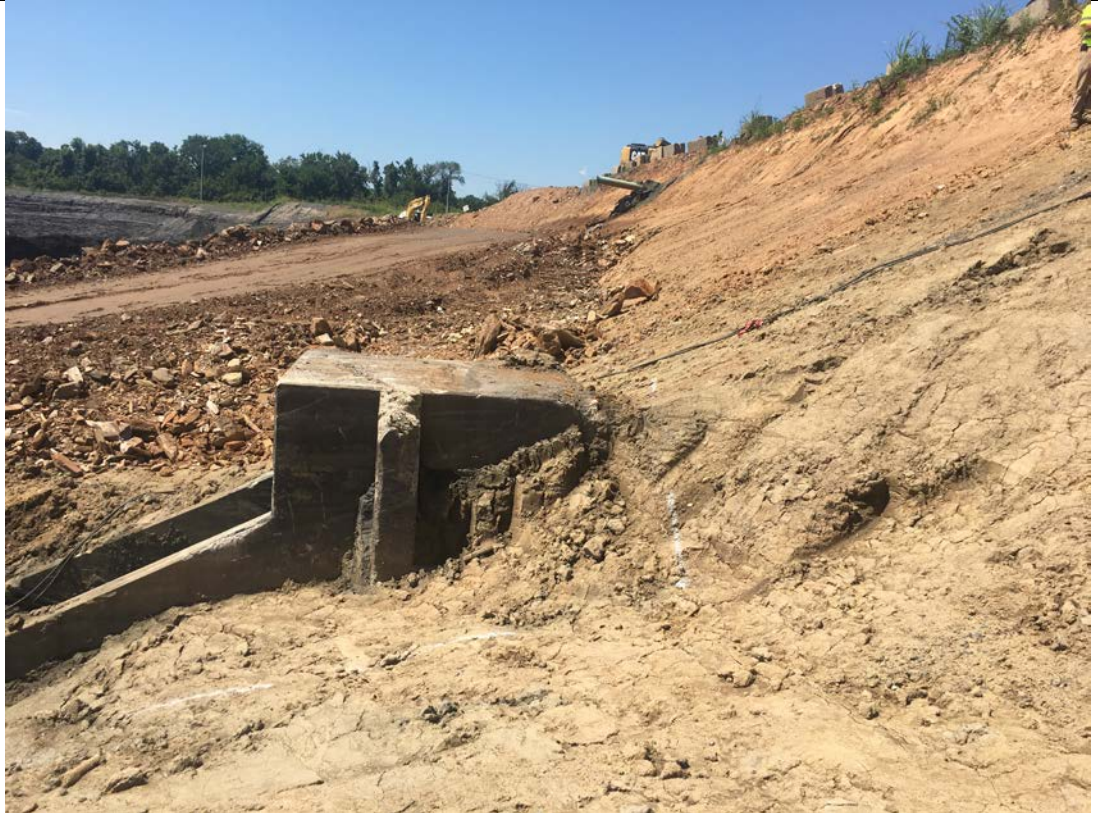
Photo #2  
Observation:

Bottom of Subject Area looking south, showing area where CCR has been Visually removed from the embankment.

Note:  
The white line denotes the limits of Visual Removal.

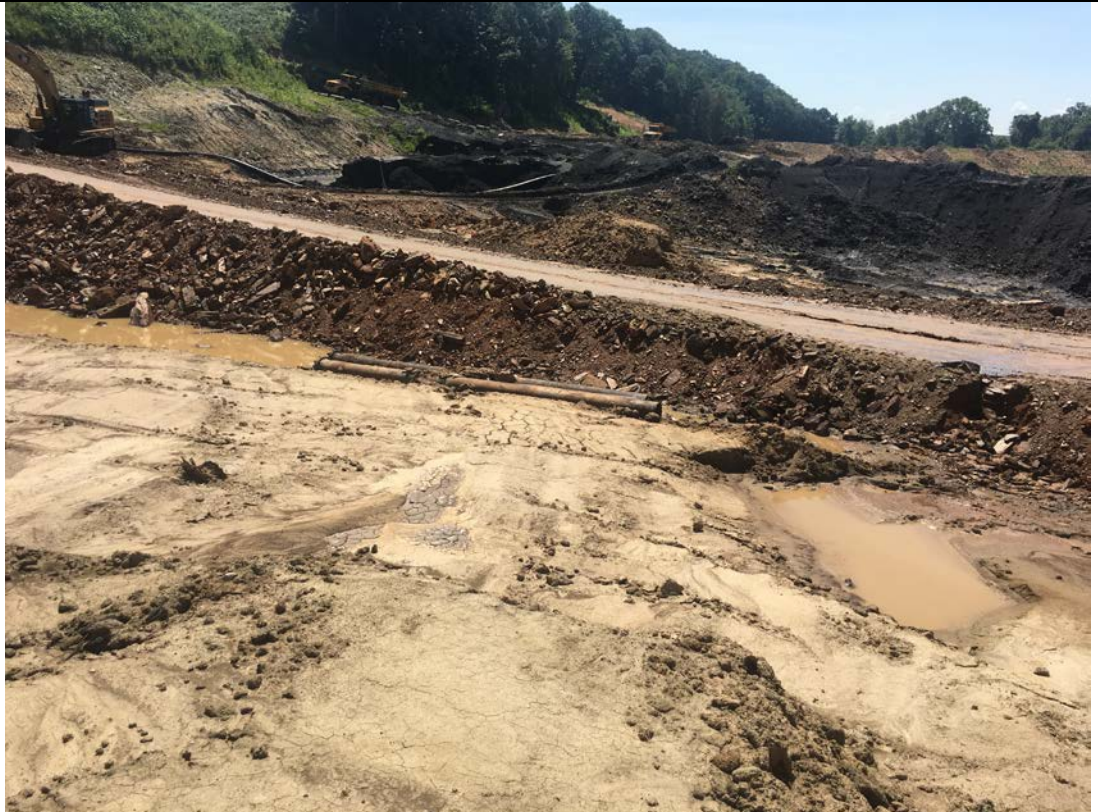
Photo #3  
Observation:

Bottom of Subject Area looking east, showing area where CCR has been Visually removed.

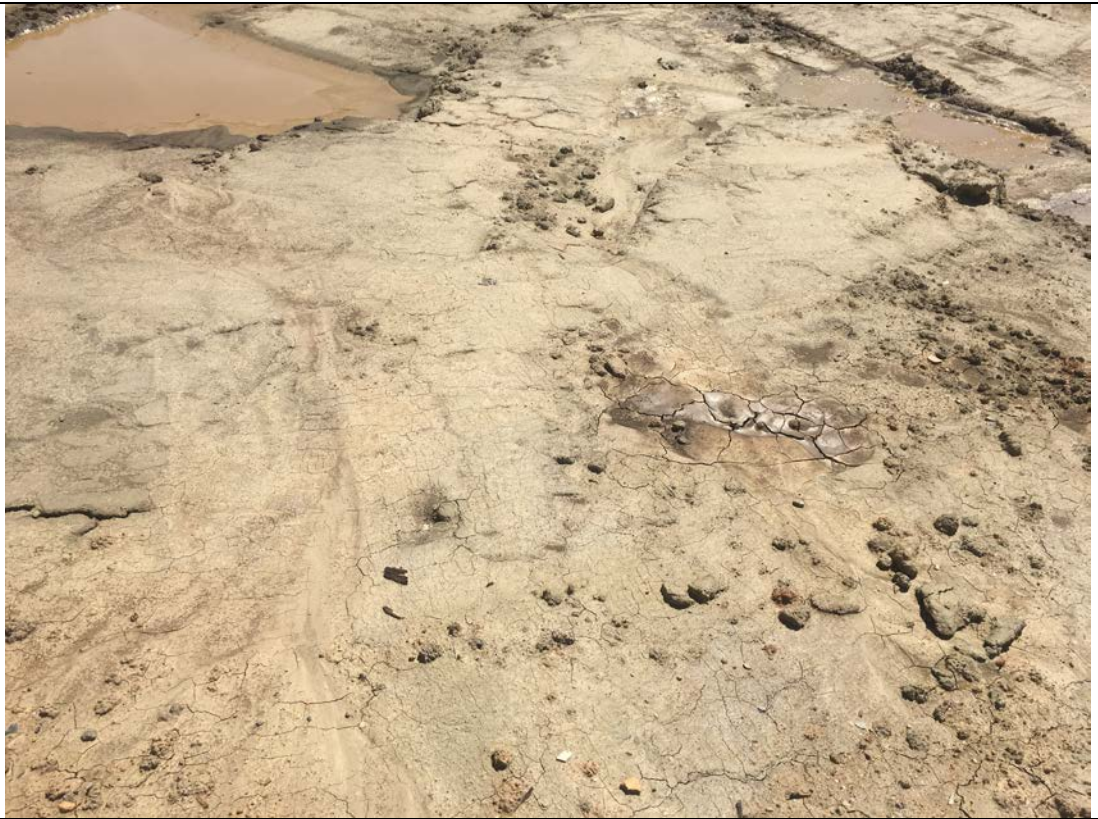
**Photo #5**  
**Observation:**

Bottom of Subject  
Area.
