RE: Bremono Bluff Power Station, Solid Waste Permit (SWP) 618  
Closure by Removal Construction Report – East Ash Pond  
Fluvanna County, Virginia

## Closure by Removal Construction

May 23, 2019

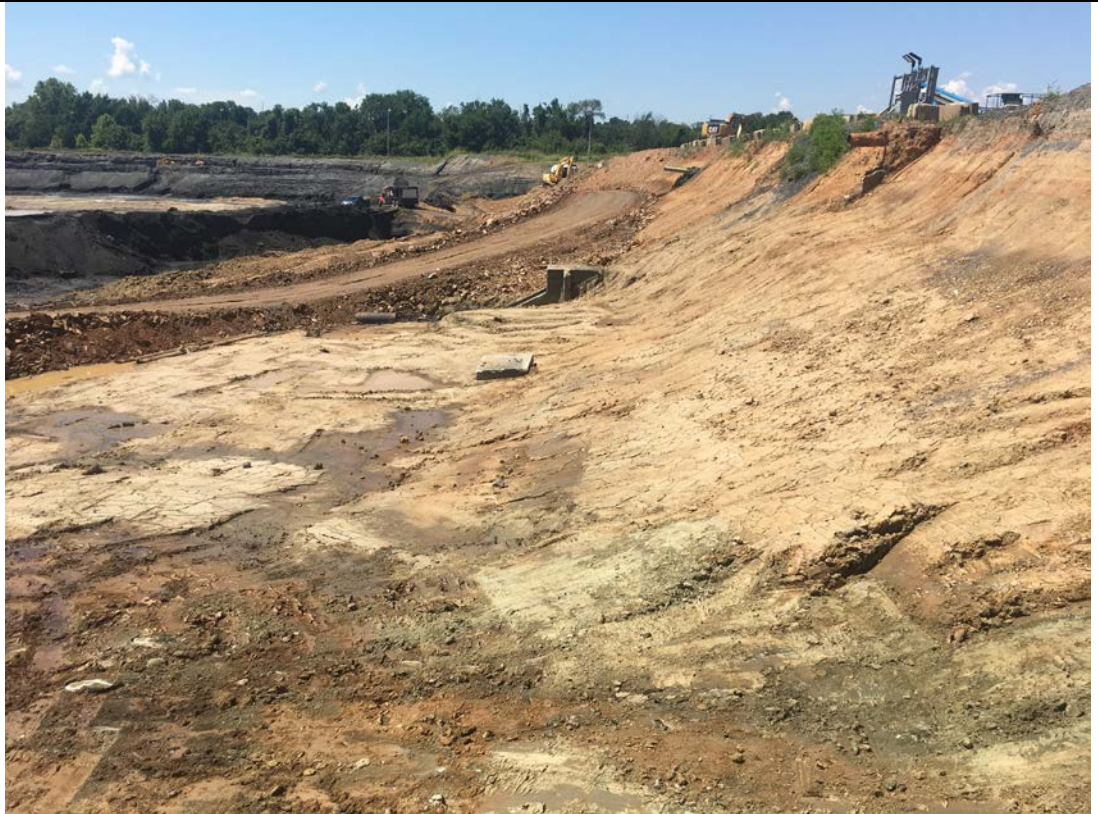
**Photo #6**  
**Observation:**

Bottom of Subject  
Area looking  
south, showing  
area where CCR  
has been Visually  
removed.

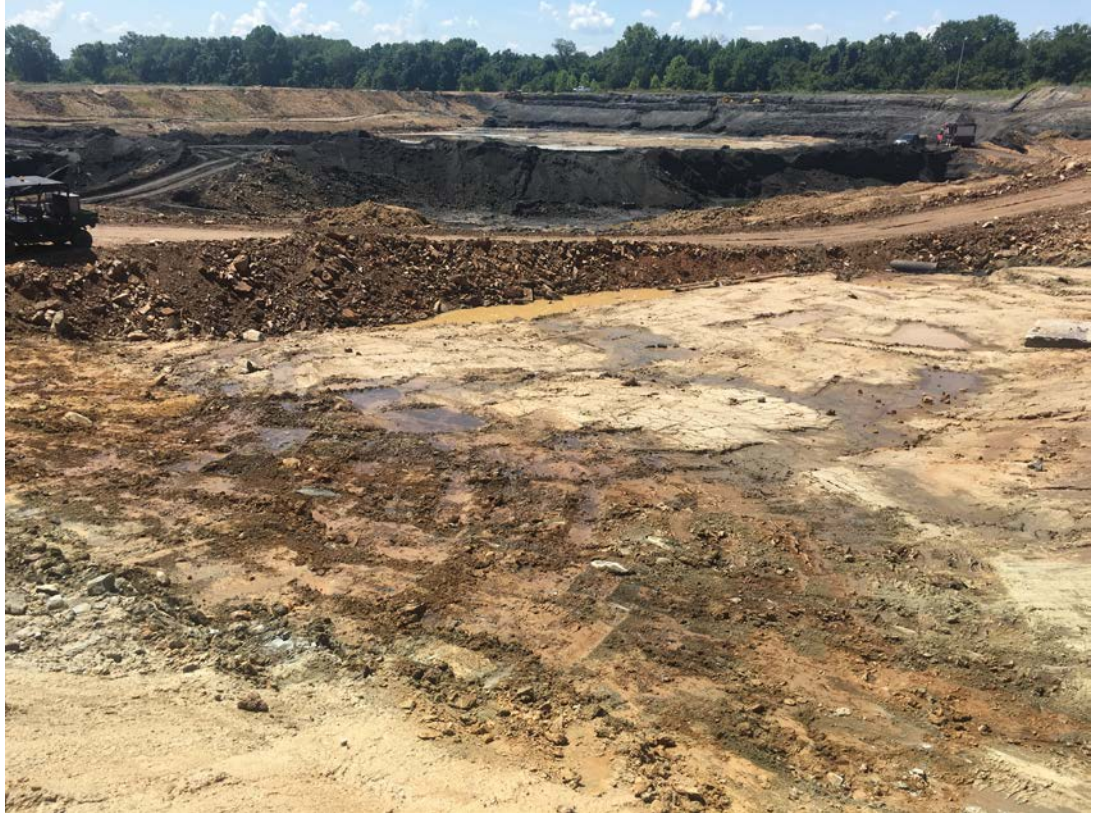
**Photo #7**  
**Observation:**

Bottom of Subject Area looking southeast, showing area where CCR has been Visually removed.

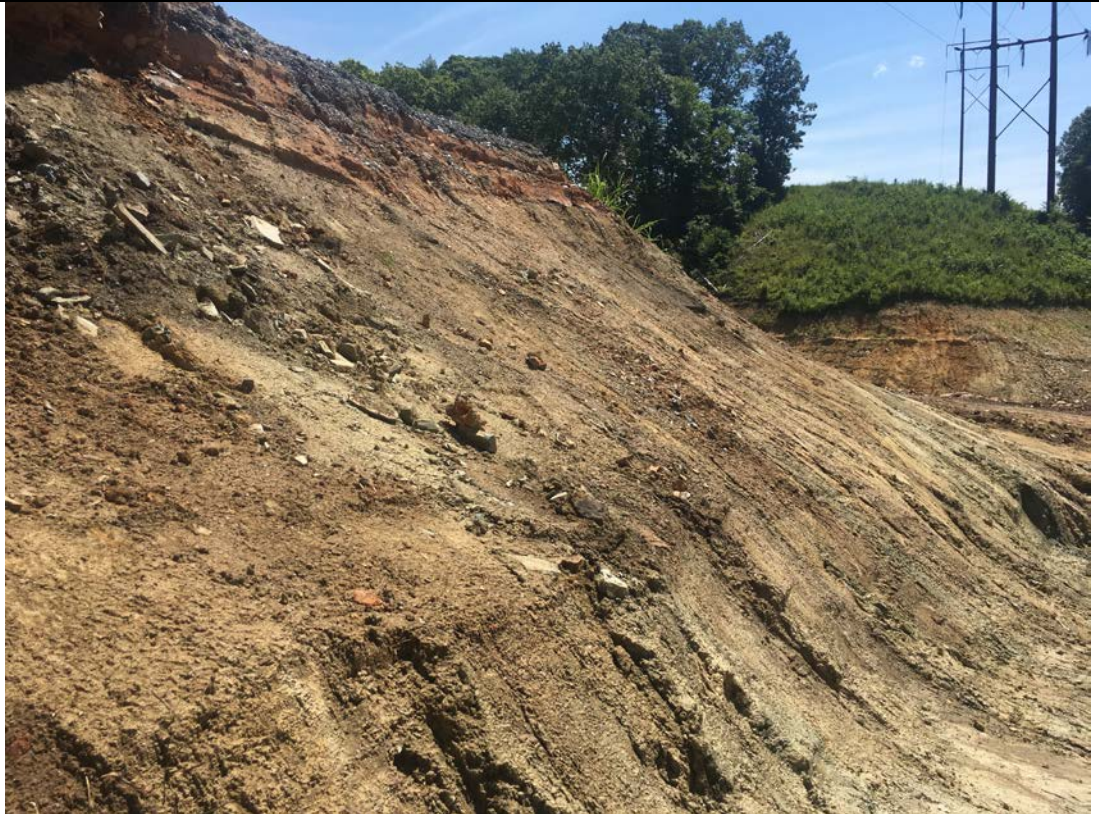
**Photo #8**  
**Observation:**

Northern end of Subject Area looking northeast, showing area where CCR has been Visually removed from the embankment.

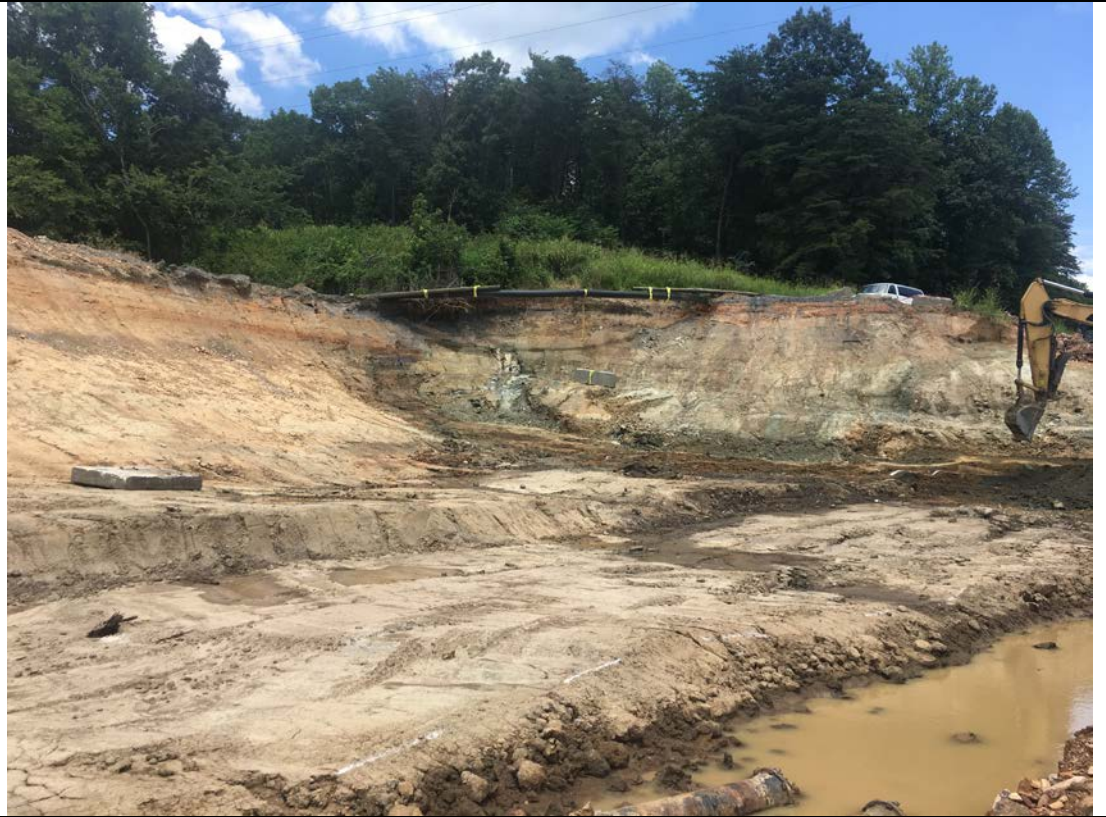
**Photo #9**  
**Observation:**

Eastern limit of Subject Area looking northwest, showing area where CCR has been Visually removed.

**Note:**  
The white line denotes the limits of Visual Removal.

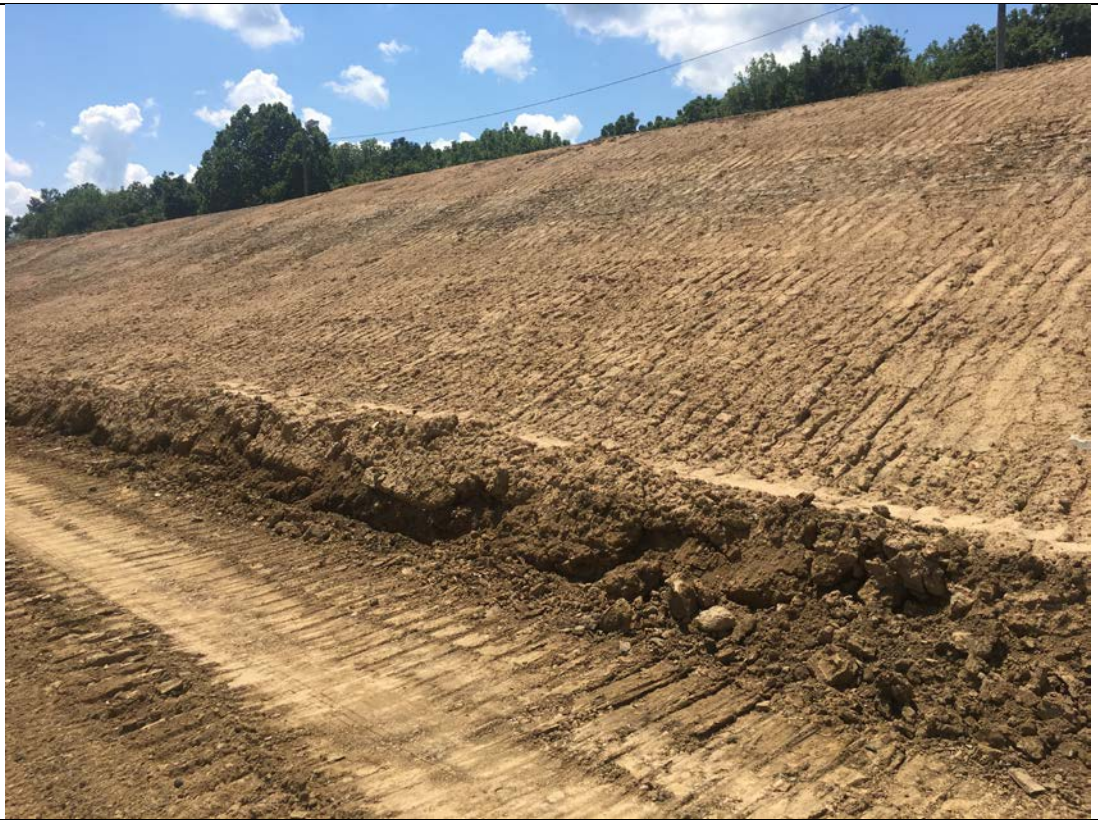
Photo #1  
Observation:

Bottom of Subject Area looking southeast, showing area where CCR has been Visually removed from the embankment.

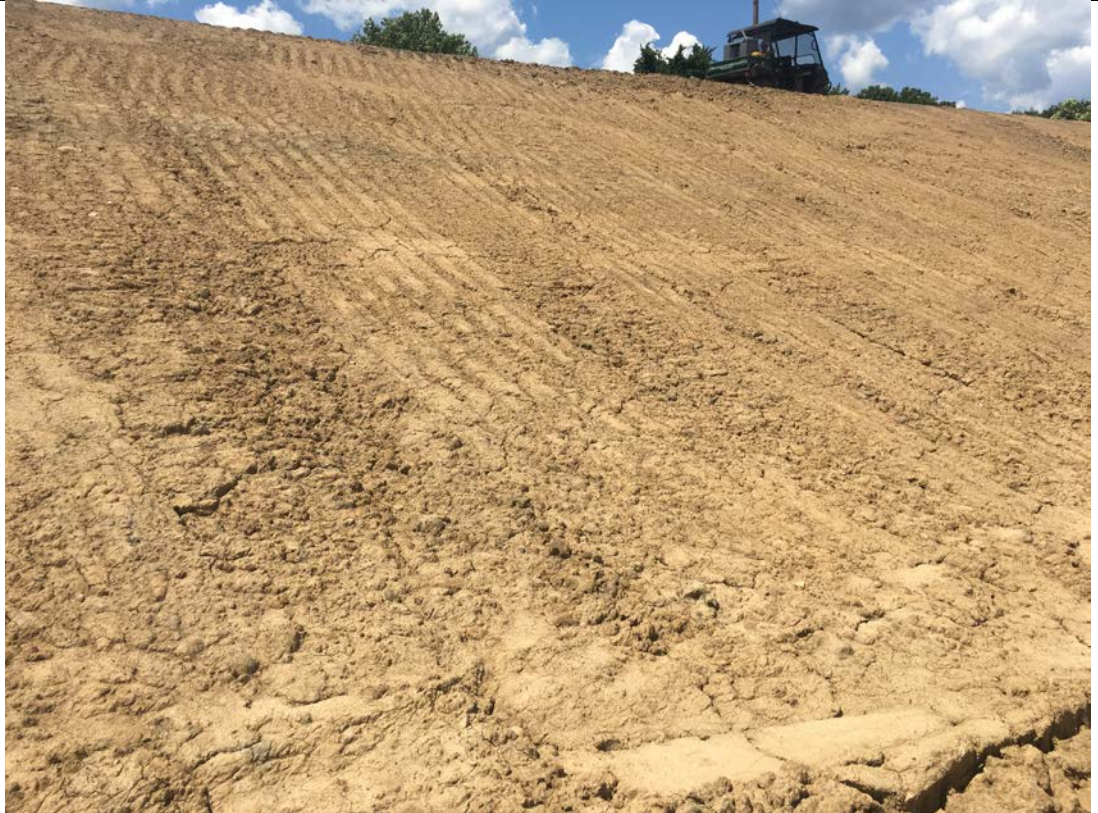
Photo #2  
Observation:

Bottom of Subject Area looking southwest, showing area where CCR has been Visually removed from the embankment.

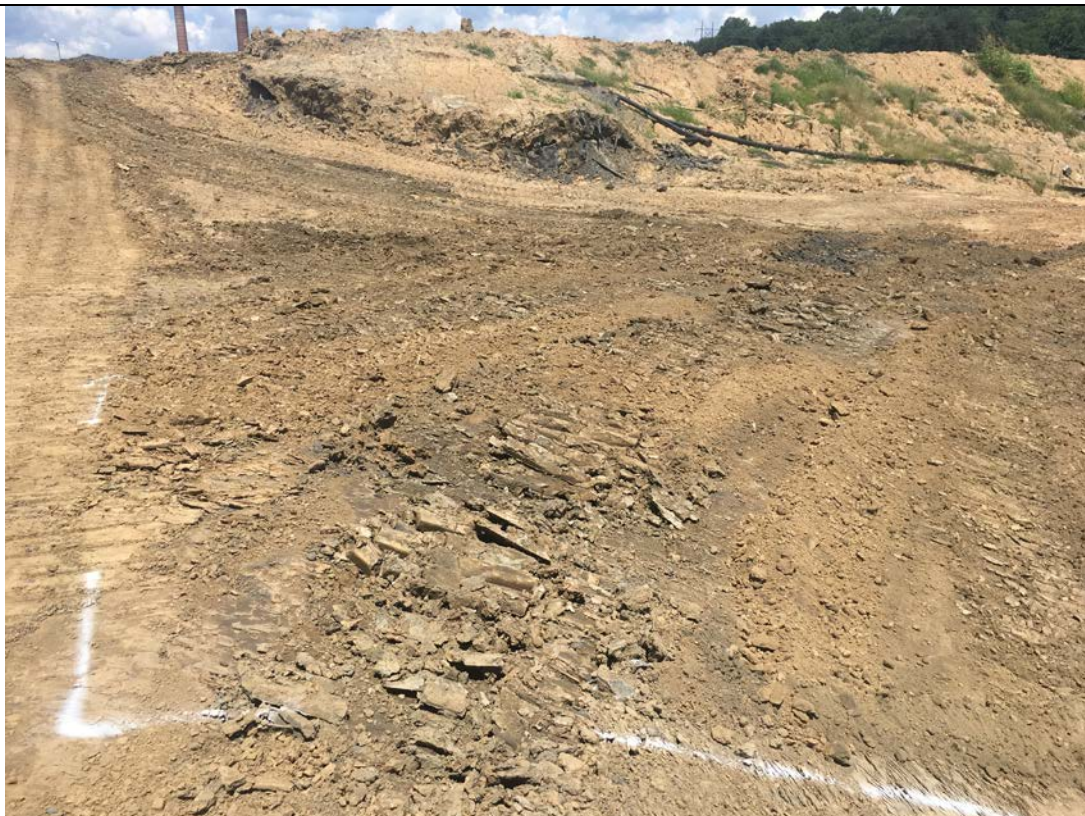
**Photo #3**  
**Observation:**

Bottom of Subject Area looking west, showing area where CCR has been Visually removed.

Note:  
 The white line denotes the limits of Visual Removal.

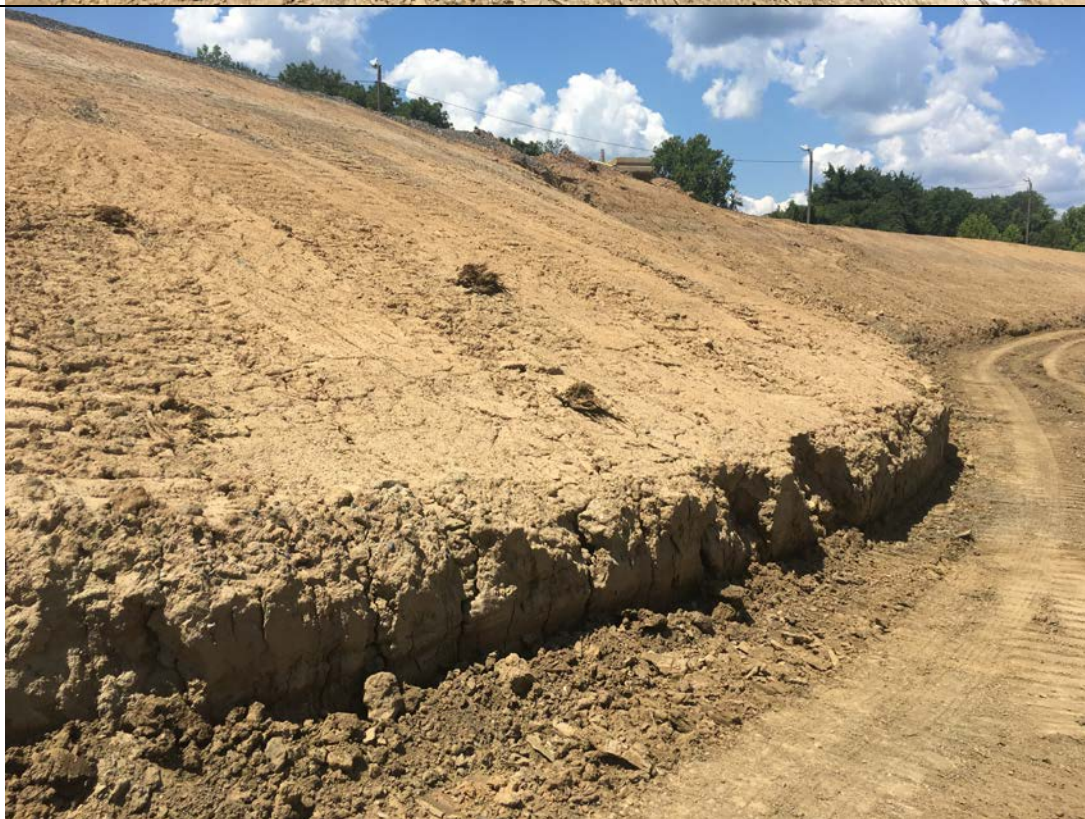
**Photo #4**  
**Observation:**

Bottom of Subject Area looking southwest, showing area where CCR has been Visually removed from the embankment.

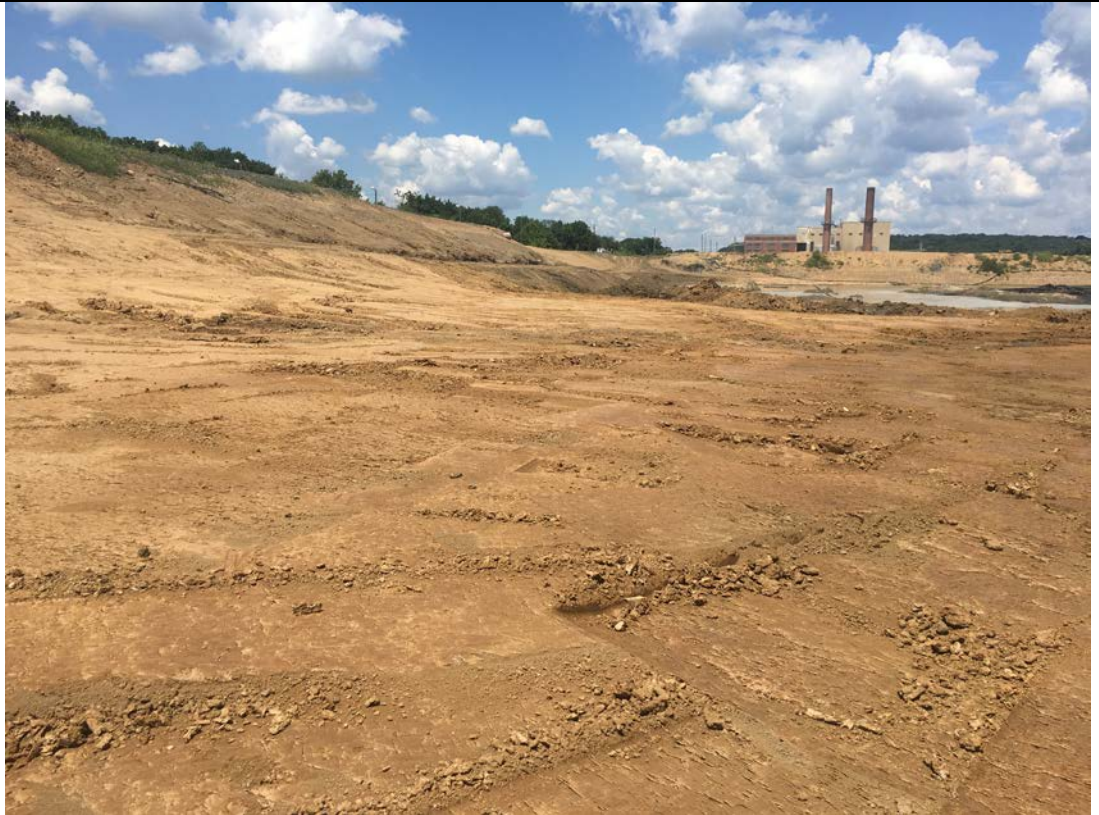
**Photo #5**  
**Observation:**

Bottom of Subject Area looking west, showing area where CCR has been Visually removed.

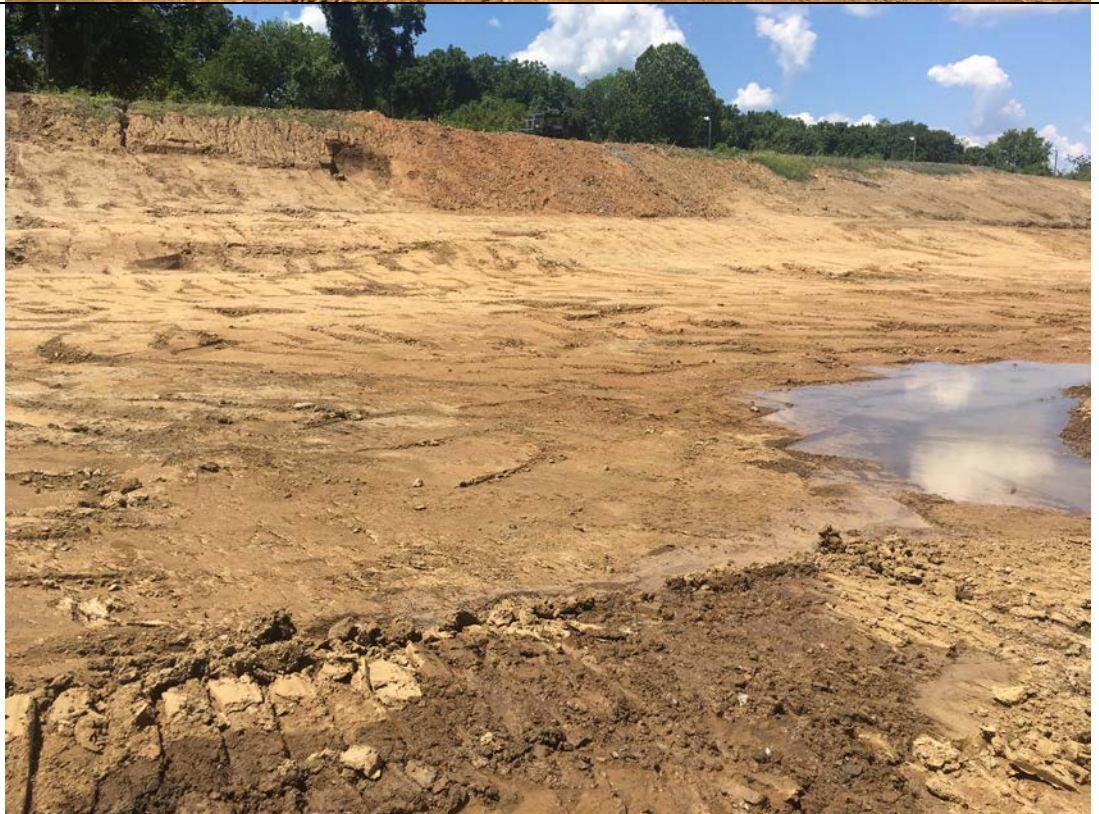
**Photo #6**  
**Observation:**

Bottom of Subject Area looking southwest, showing area where CCR has been Visually removed.

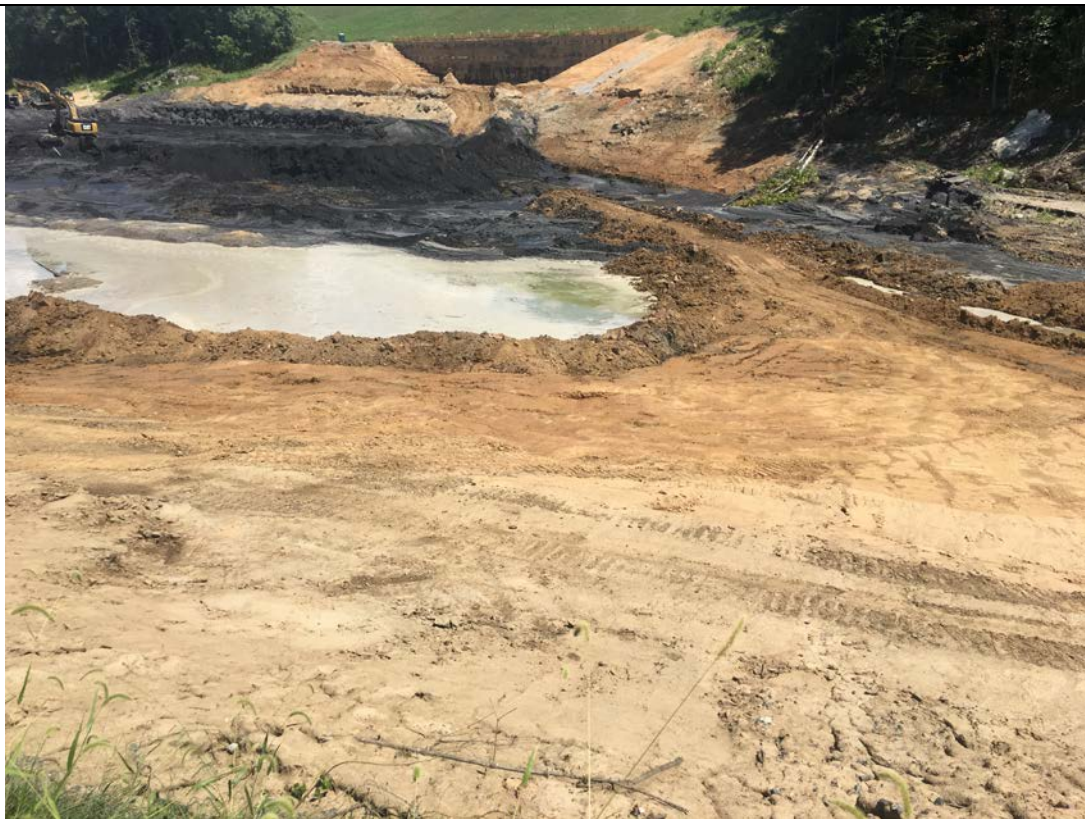
**Photo #7**  
**Observation:**

Southern limit of Subject Area looking north, showing area where CCR has been Visually removed.

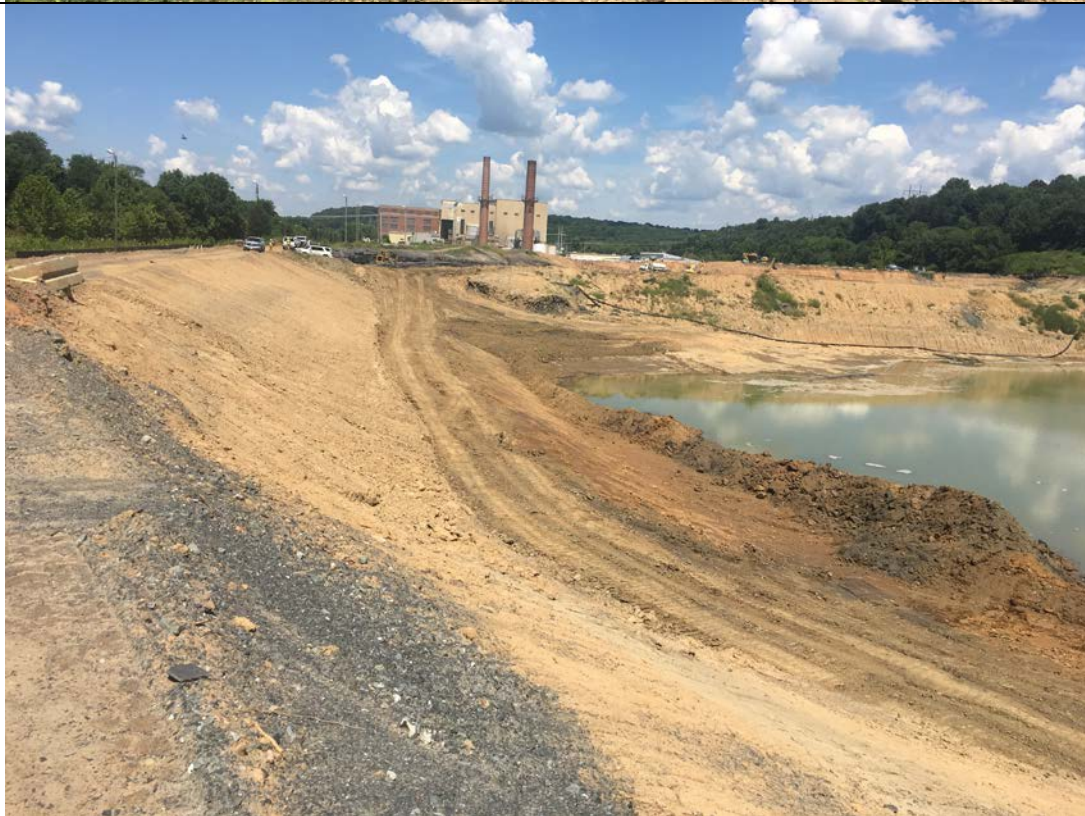
**Photo #8**  
**Observation:**

Southern limit of Subject Area looking west, showing area where CCR has been Visually removed.

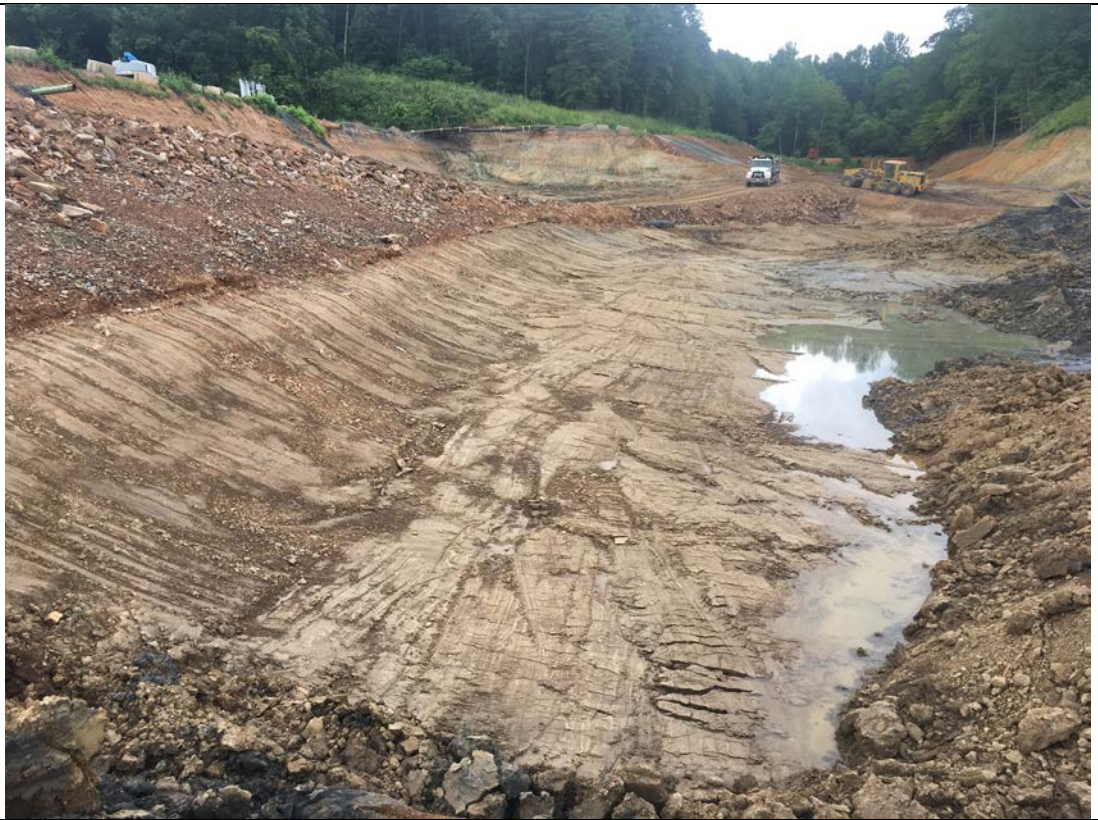
Photo #1  
Observation:

Bottom of Subject Area looking southeast, showing area where CCR has been Visually removed from the embankment.

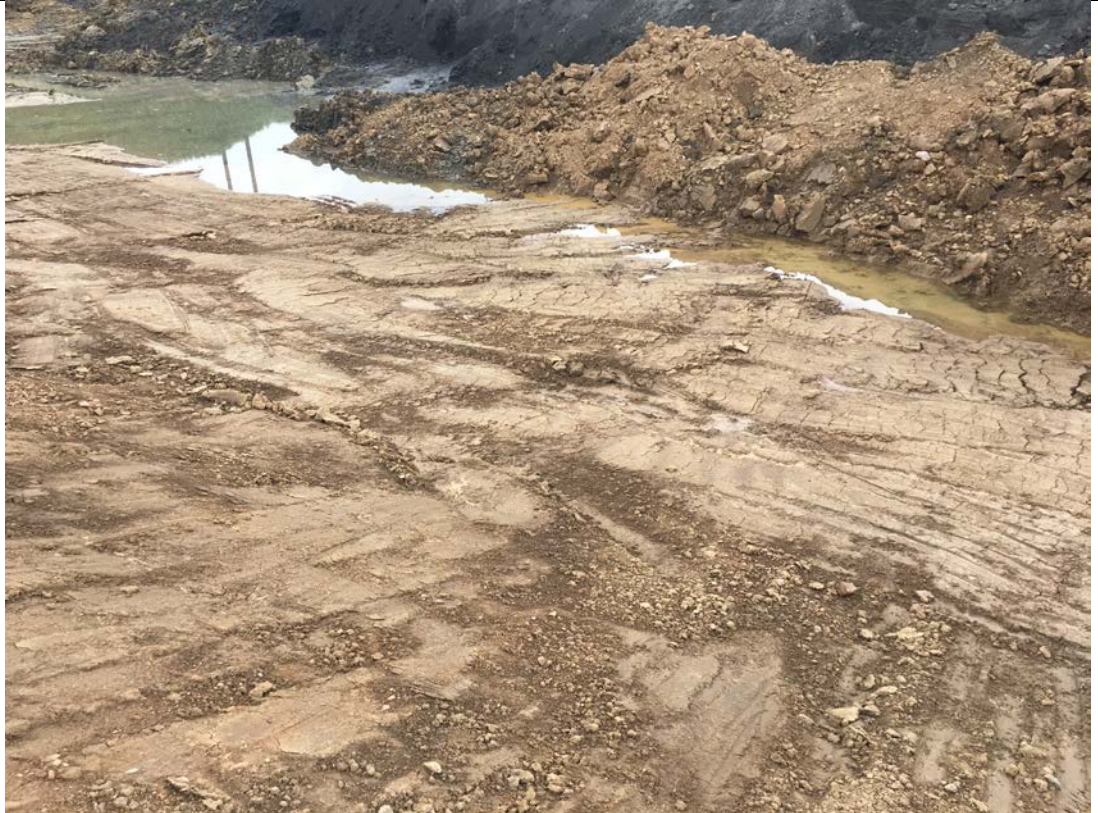
Photo #2  
Observation:

Bottom of Subject Area looking southwest, showing area where CCR has been Visually removed from the embankment.

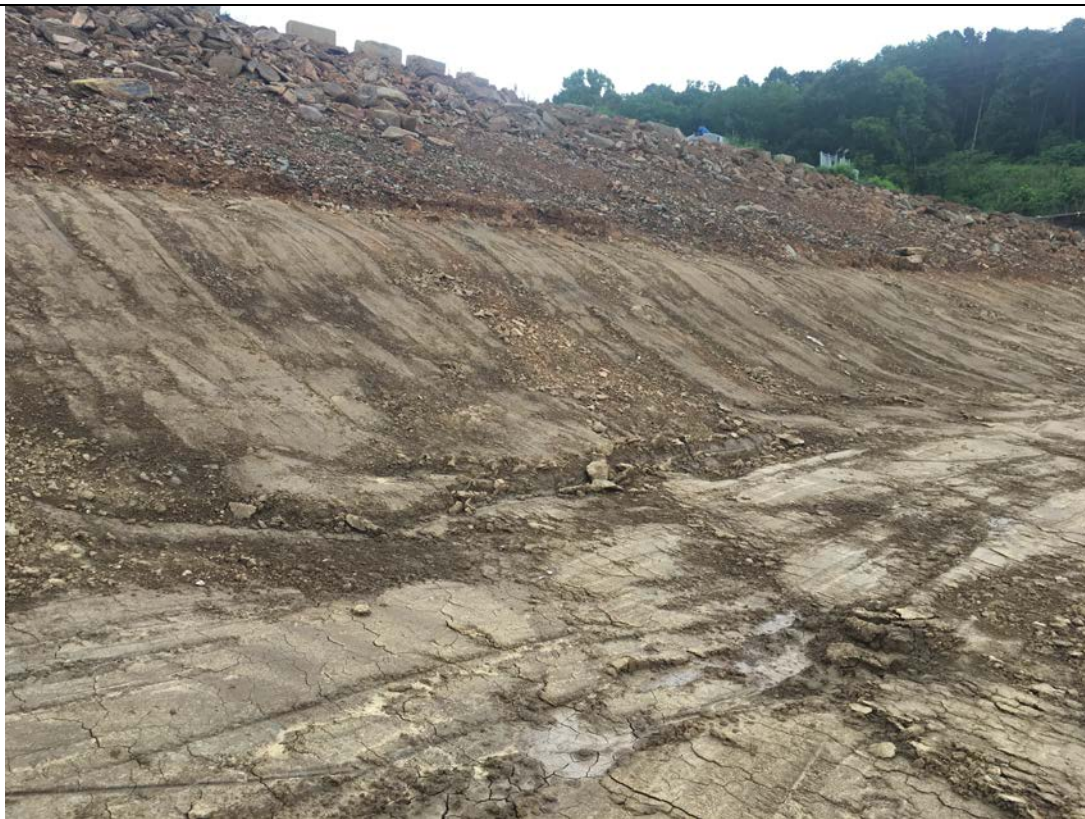
**Photo #3**  
**Observation:**

Bottom of Subject Area looking northwest, showing area where CCR has been Visually removed.

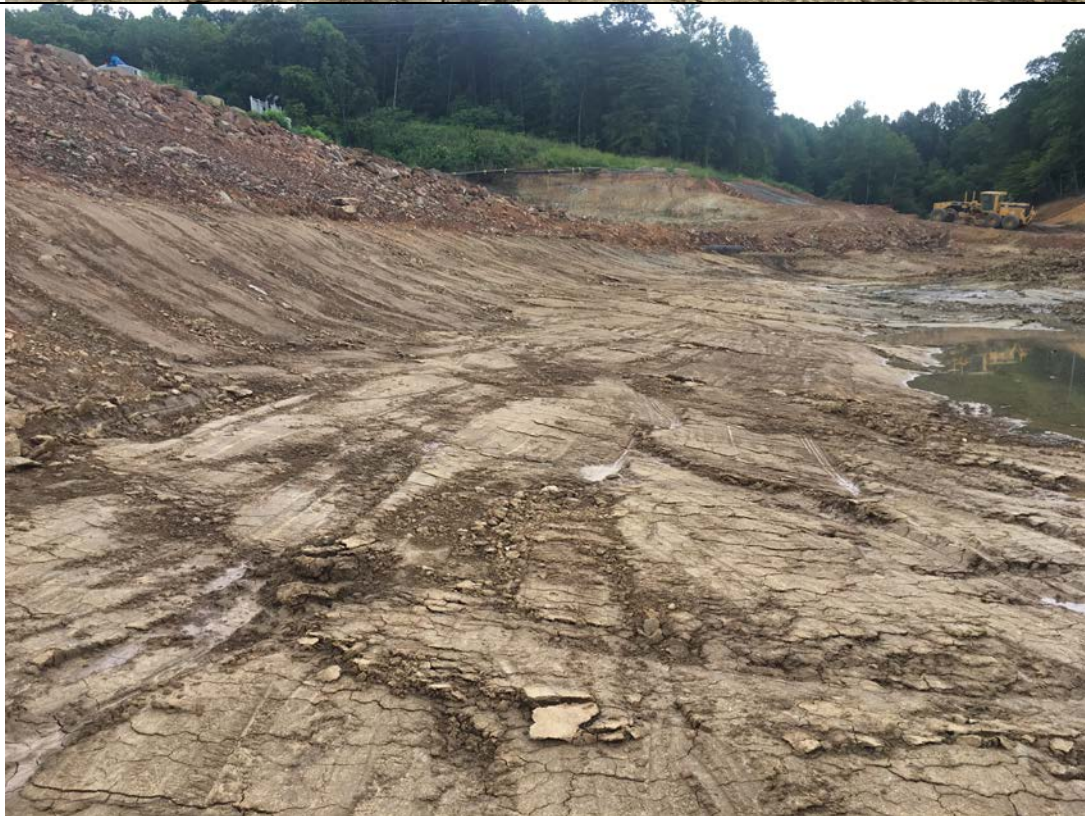
**Photo #4**  
**Observation:**

Bottom of Subject Area looking north, showing area where CCR has been Visually removed.

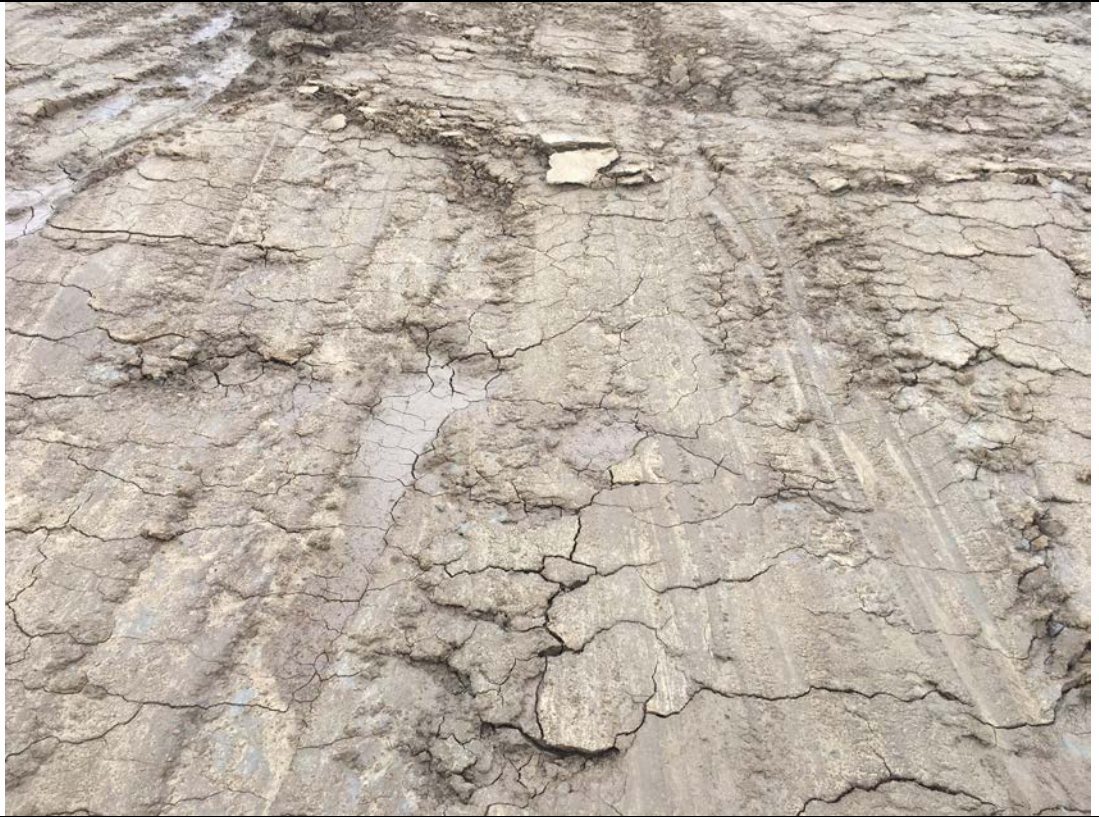
**Photo #5**  
**Observation:**

Bottom of Subject Area, where CCR has been Visually removed.

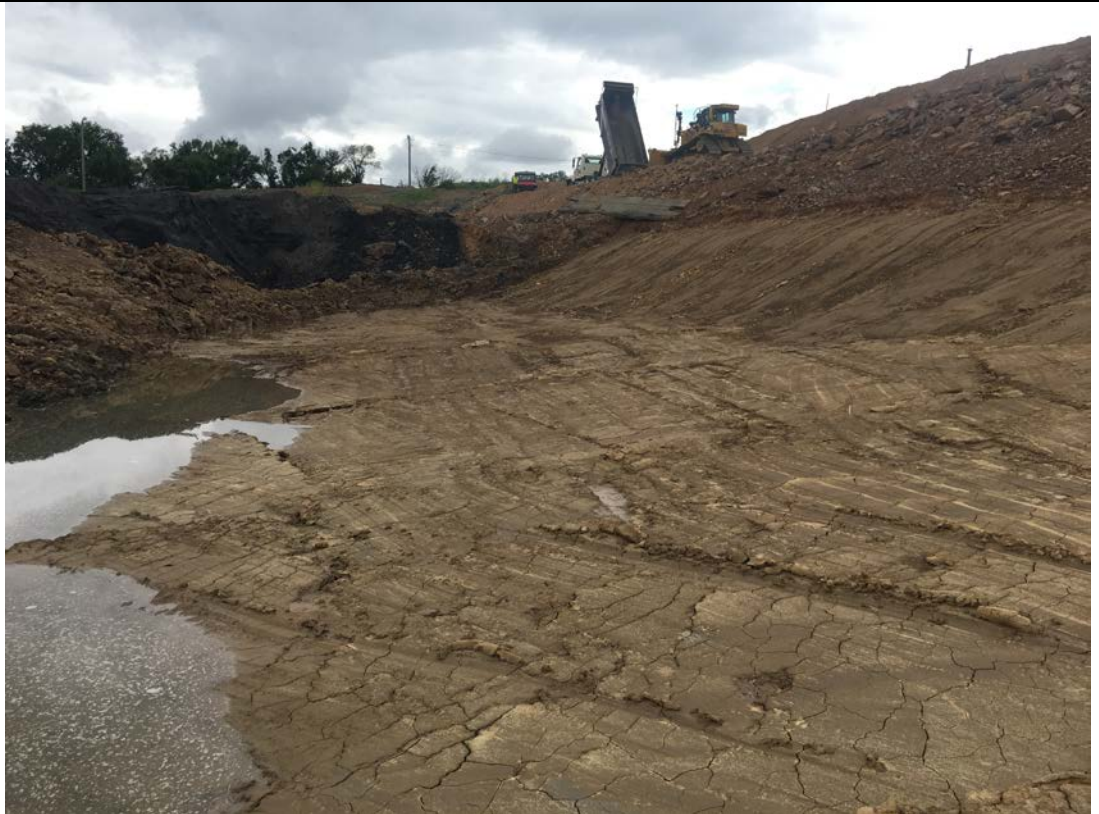
**Photo #6**  
**Observation:**

Bottom of Subject Area looking south, showing area where CCR has been Visually removed.

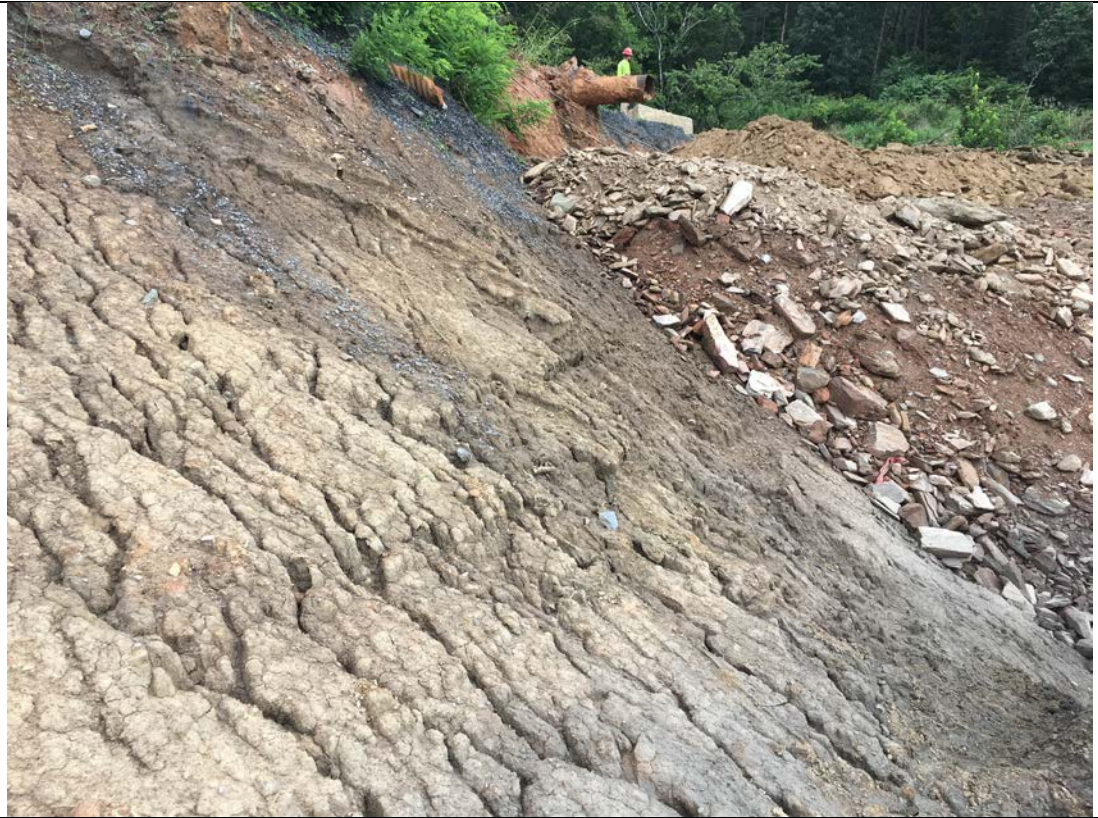
Photo #1  
Observation:

Western limit of Subject Area looking north, showing the area where CCR has been Visually removed from the embankment.

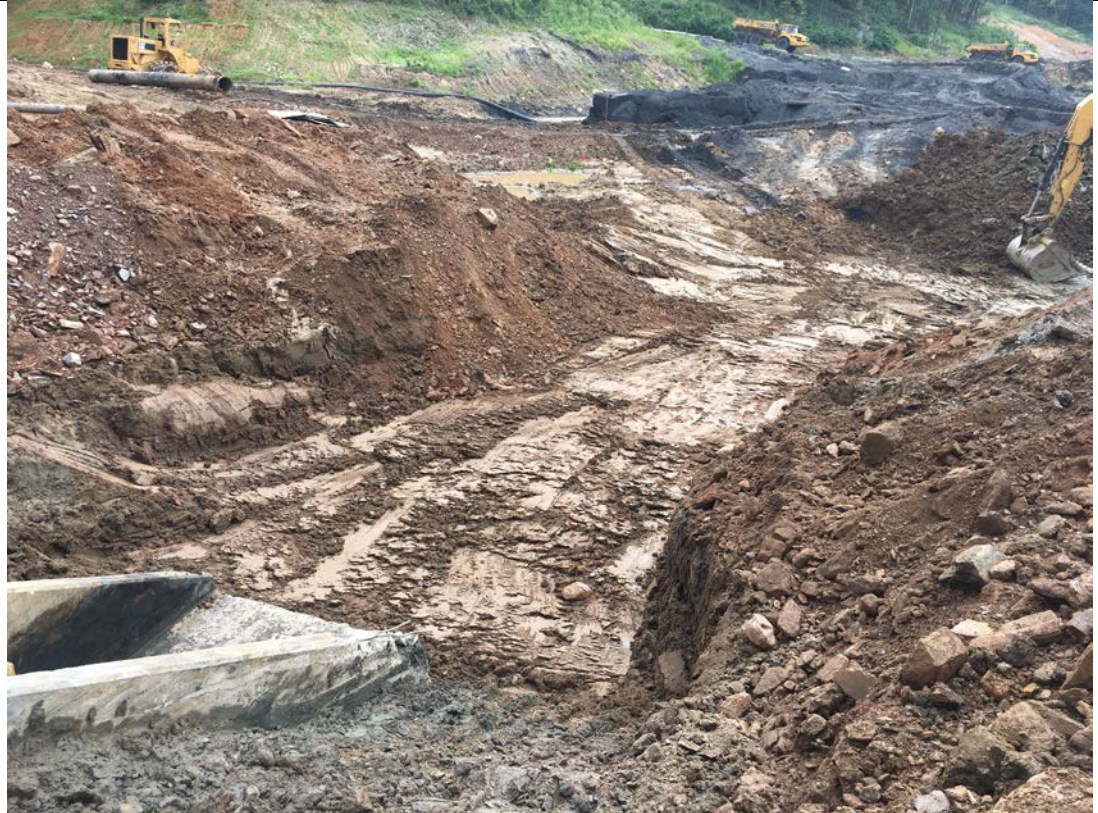
Photo #2  
Observation:

Western limit of Subject Area looking northeast, showing the area where CCR has been Visually removed.

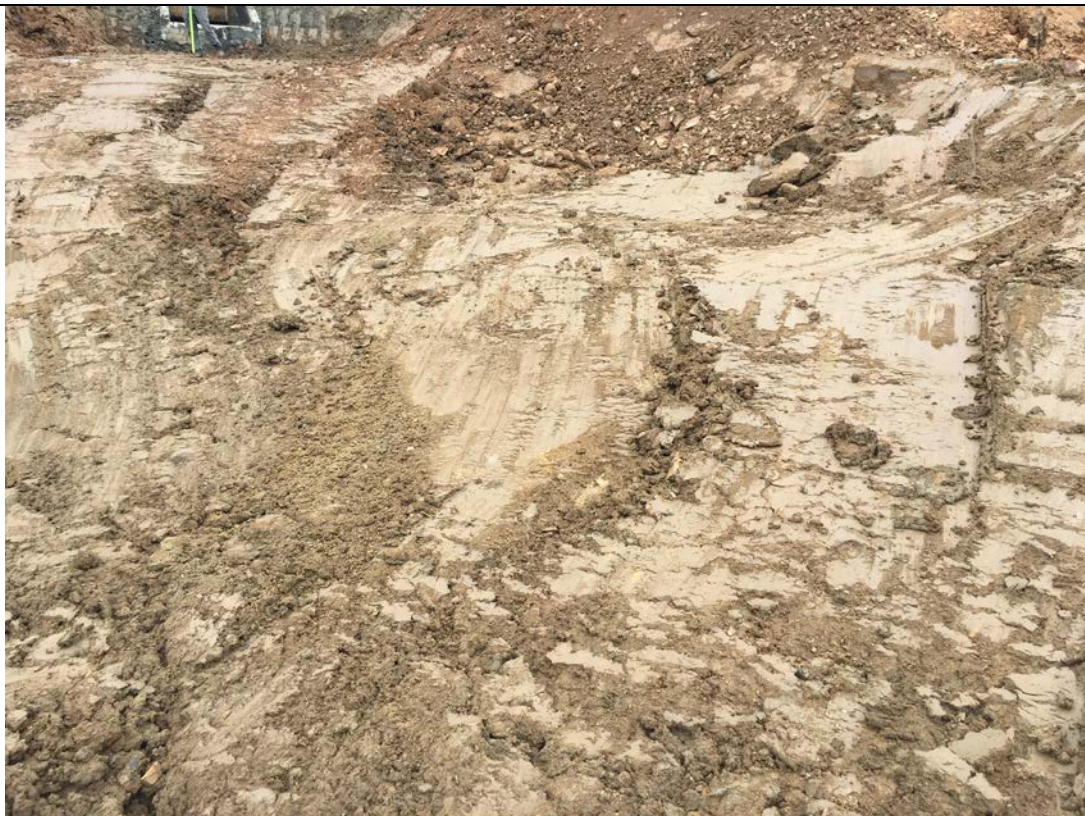
**Photo #3**  
**Observation:**

Bottom of Subject Area where CCR has been Visually removed.

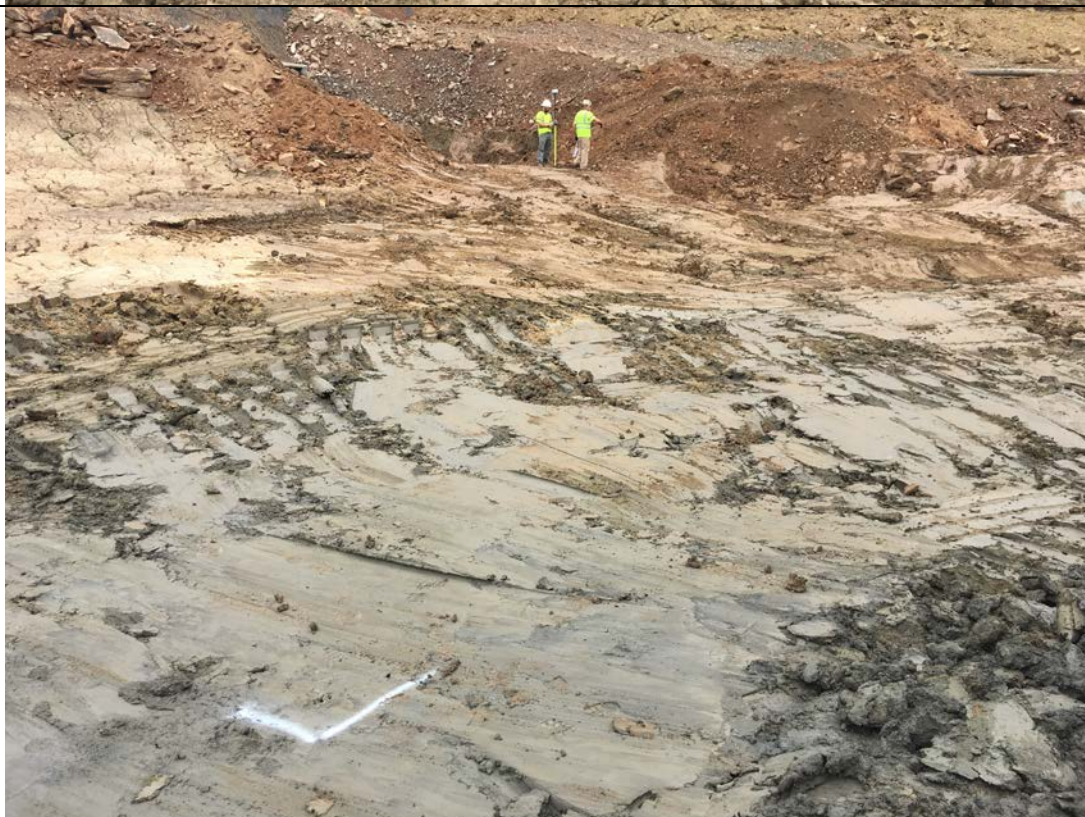
**Photo #4**  
**Observation:**

Bottom of Subject Area looking northwest, showing the area where CCR has been Visually removed.

**Note:**  
 The white line denotes the limits of Visual Removal.

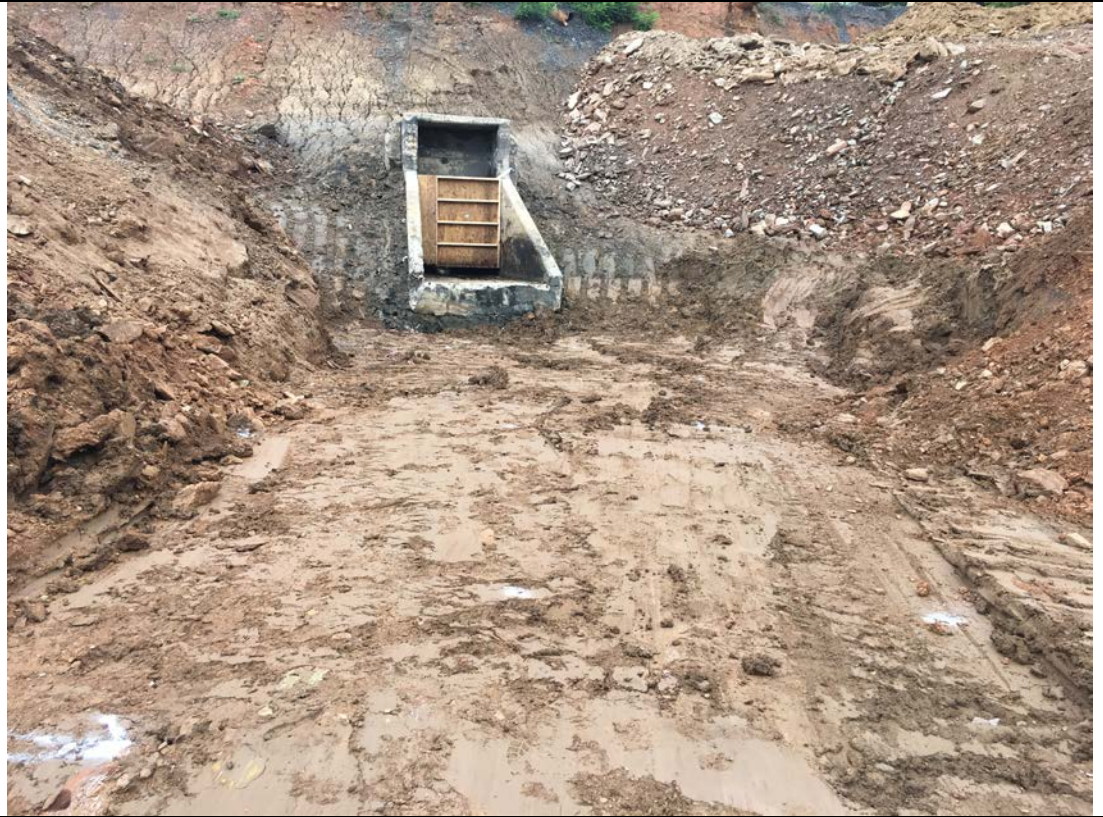
**Photo #5**  
**Observation:**

Bottom of Subject Area looking west at the abandoned culvert, showing the area where CCR has been Visually removed.

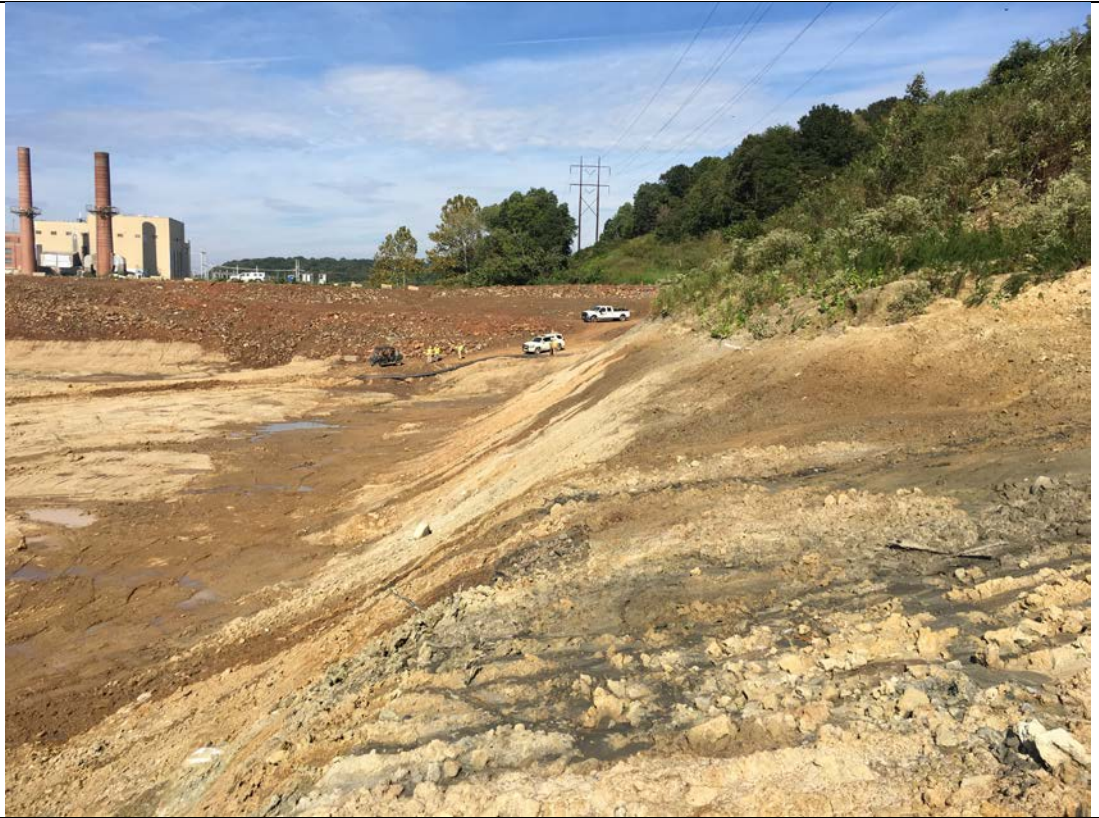
Photo #1  
Observation:

Northern limit of Subject Area looking west, showing the area where CCR has been Visually removed.

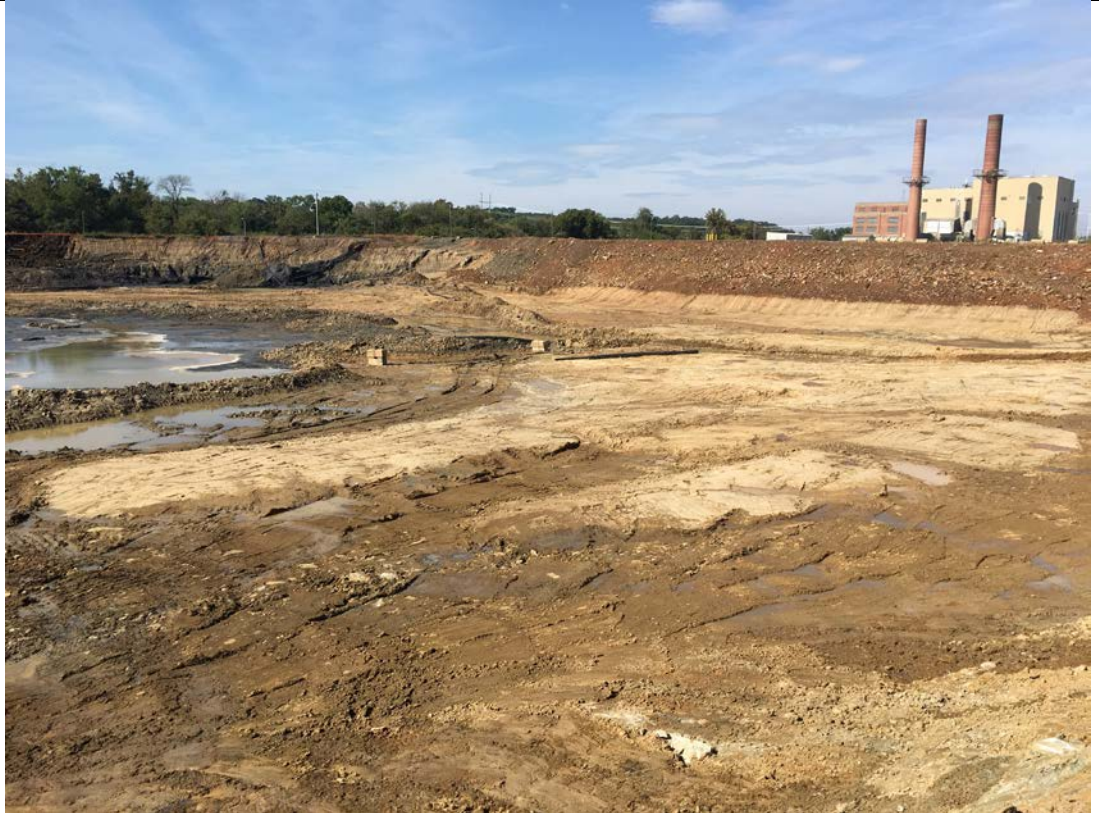
Photo #2  
Observation:

Northern limit of Subject Area looking southwest, showing the area where CCR has been Visually removed.
