RE: Bremono Bluff Power Station, Solid Waste Permit (SWP) 618  
Closure by Removal Construction Report – East Ash Pond  
Fluvanna County, Virginia

## Closure by Removal Construction

May 23, 2019

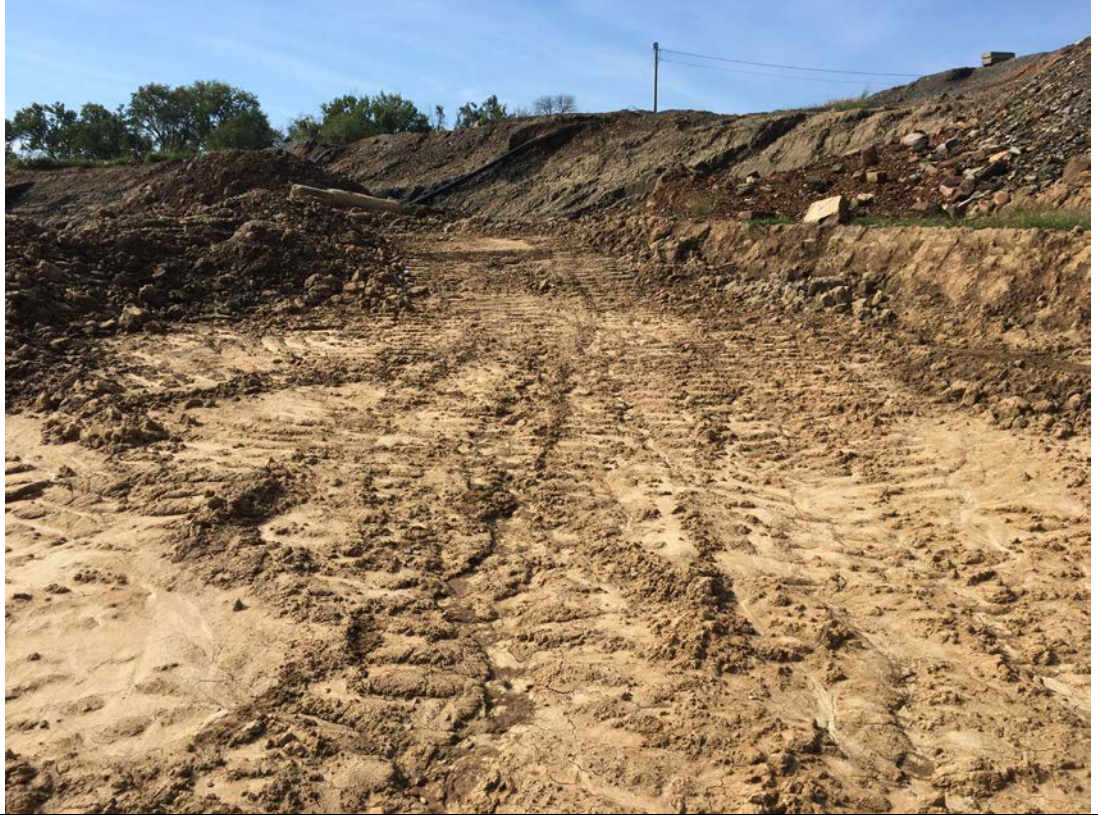
Photo #3  
Observation:

Bottom of Subject Area looking south, showing the area where CCR has been Visually removed.

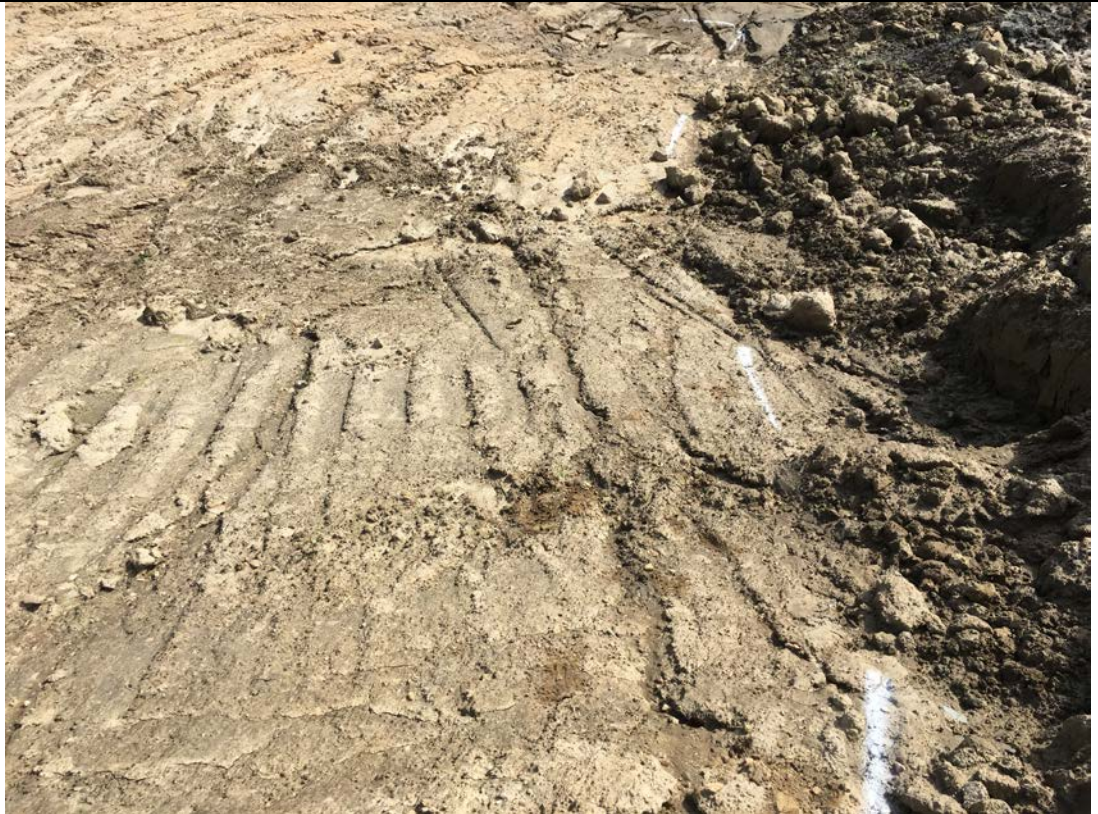
Photo #4  
Observation:

Bottom of Subject Area showing the area where CCR has been Visually removed.

Note:  
The white line denotes the limits of Visual Removal.

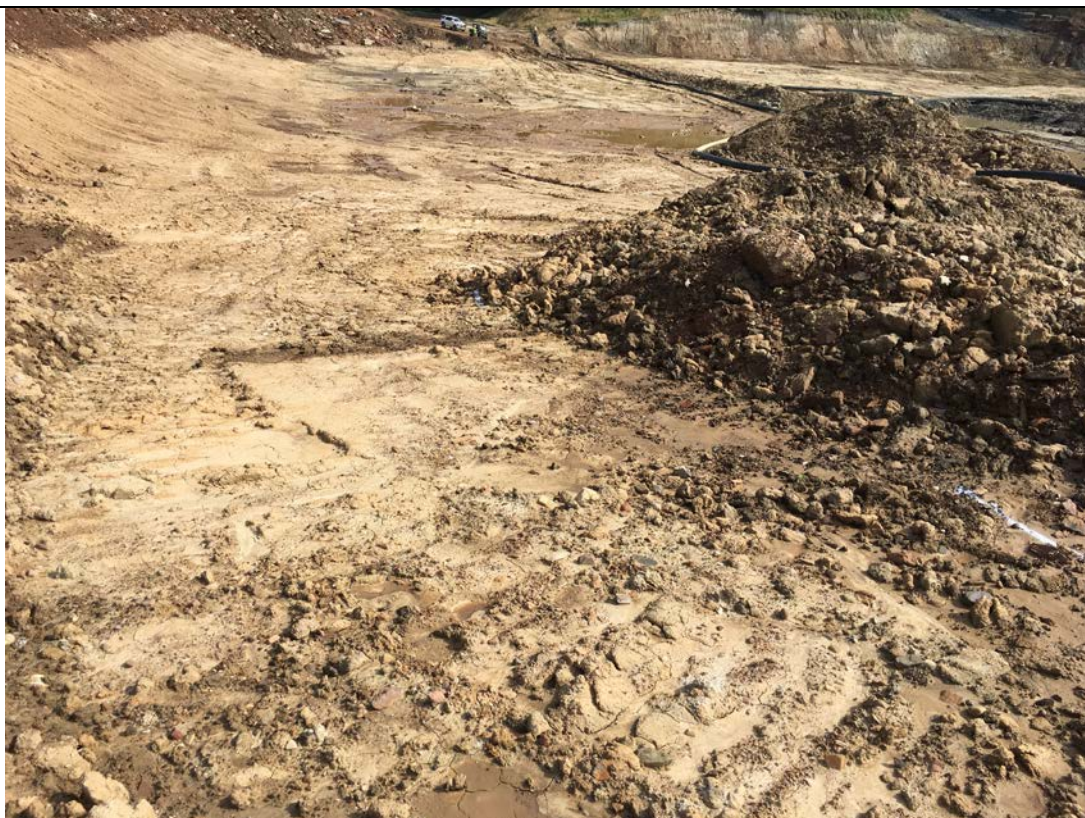
**Photo #5**  
**Observation:**

Bottom of Subject Area looking north, showing the area where CCR has been Visually removed.

Note:  
 The white line denotes the limits of Visual Removal.

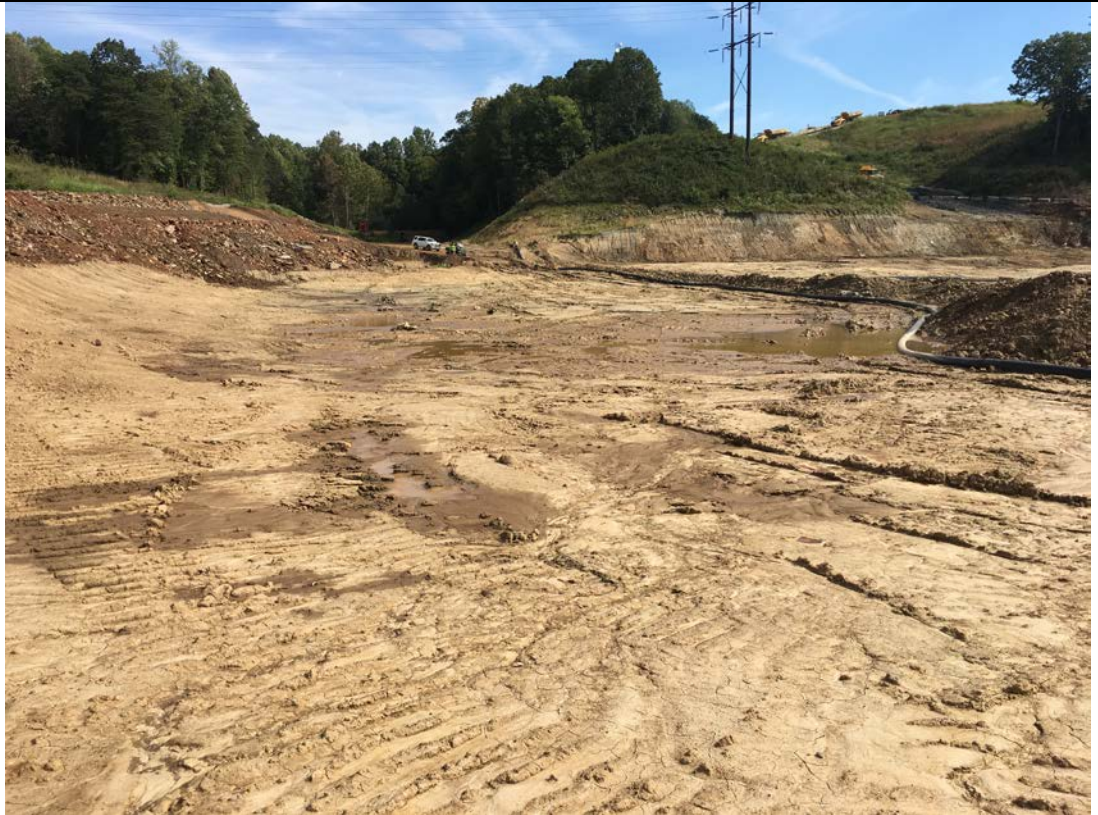
Photo #7  
Observation:

Bottom of Subject Area looking north, showing the area where CCR has been Visually removed.

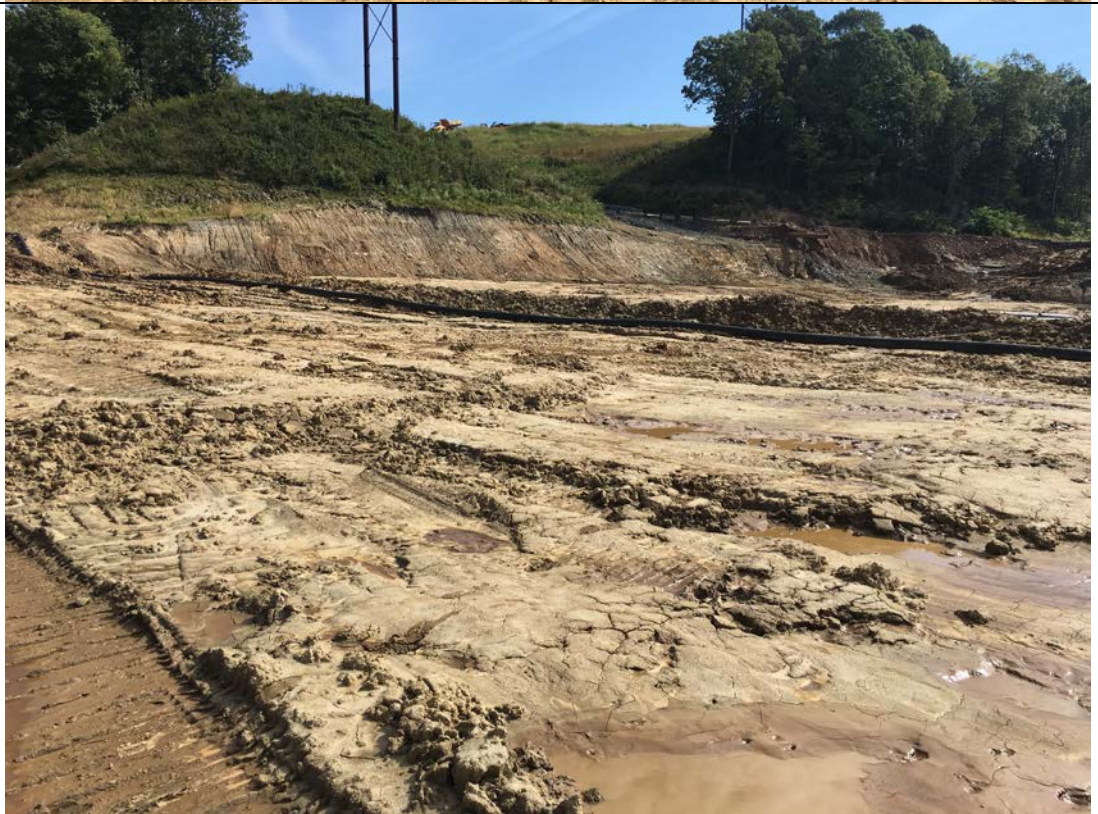
Photo #8  
Observation:

Bottom of Subject Area looking northwest, showing the area where CCR has been Visually removed.

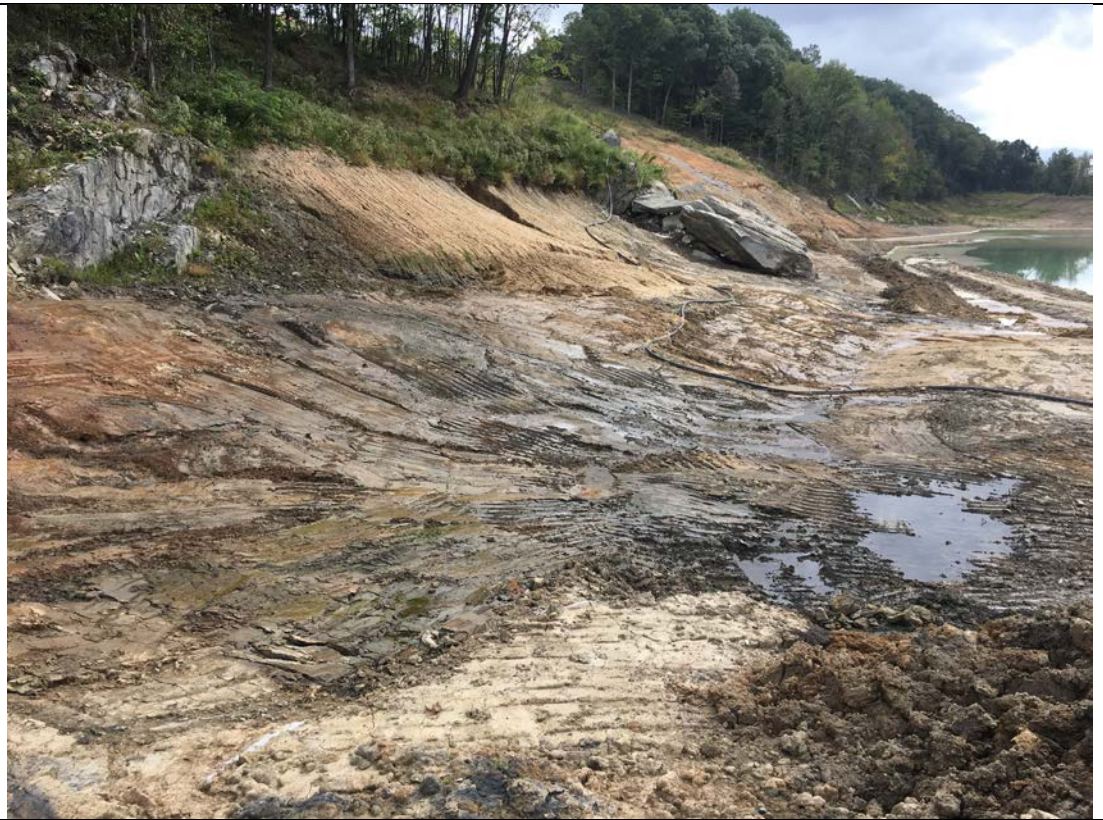
Photo #2  
Observation:

Southern limit of Subject Area looking northeast, showing the area where CCR has been Visually removed.

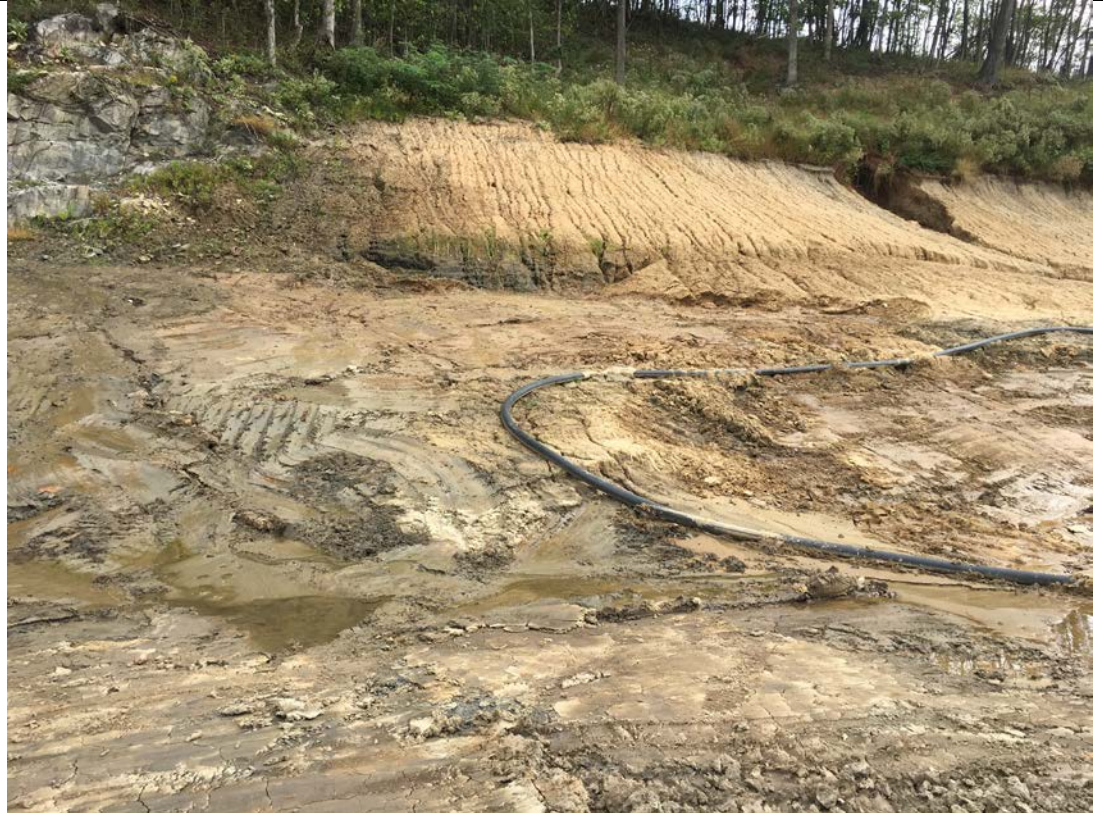
**Photo #3**  
**Observation:**

Bottom of Subject Area looking east, showing the area where CCR has been Visually removed.

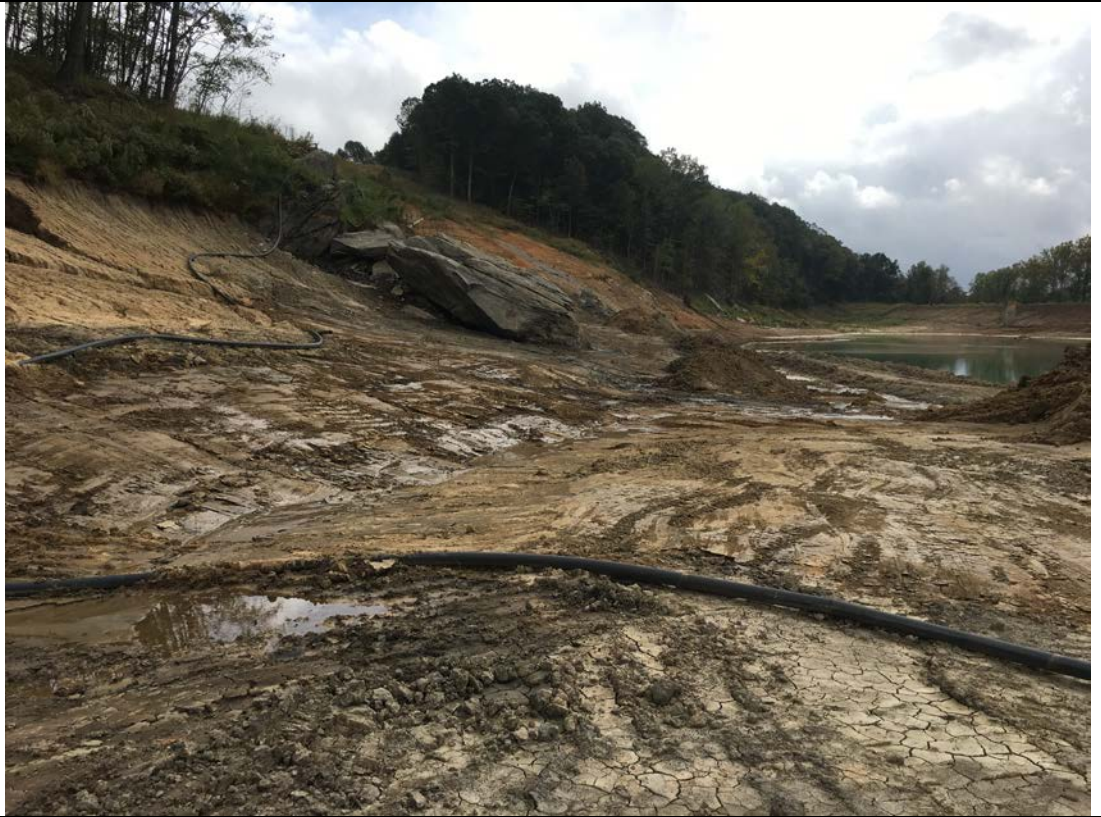
**Photo #4**  
**Observation:**

Bottom of Subject Area looking east, showing the area where CCR has been Visually removed.

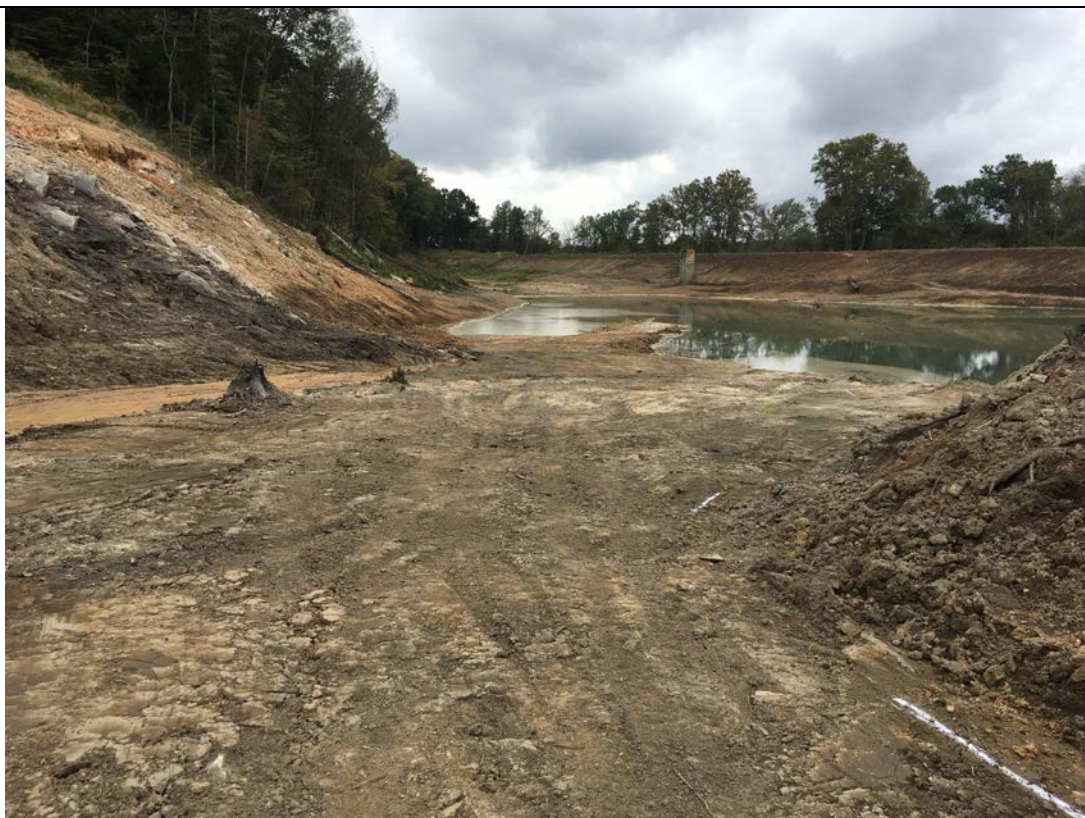
**Photo #5**  
**Observation:**

Bottom of Subject Area looking east, showing the area where CCR has been Visually removed.

Note:  
 The white line denotes the limits of Visual Removal.

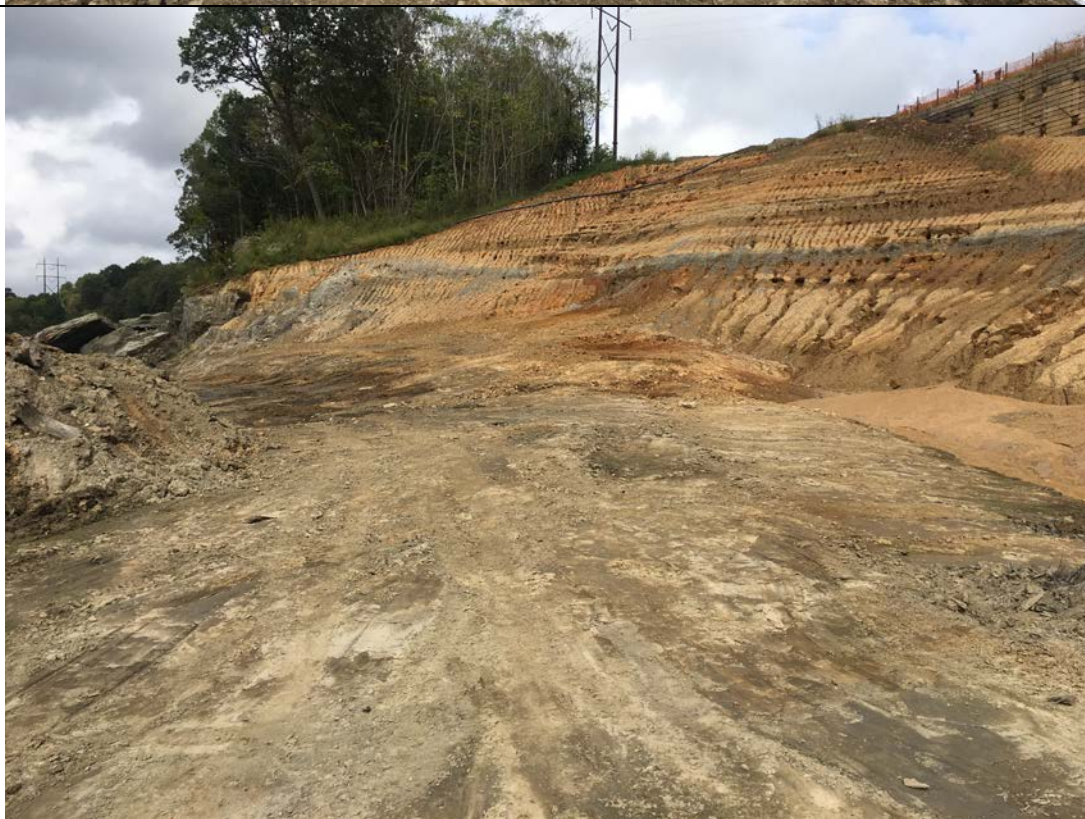
**Photo #6**  
**Observation:**

Bottom of Subject Area looking northwest, showing the area where CCR has been Visually removed.

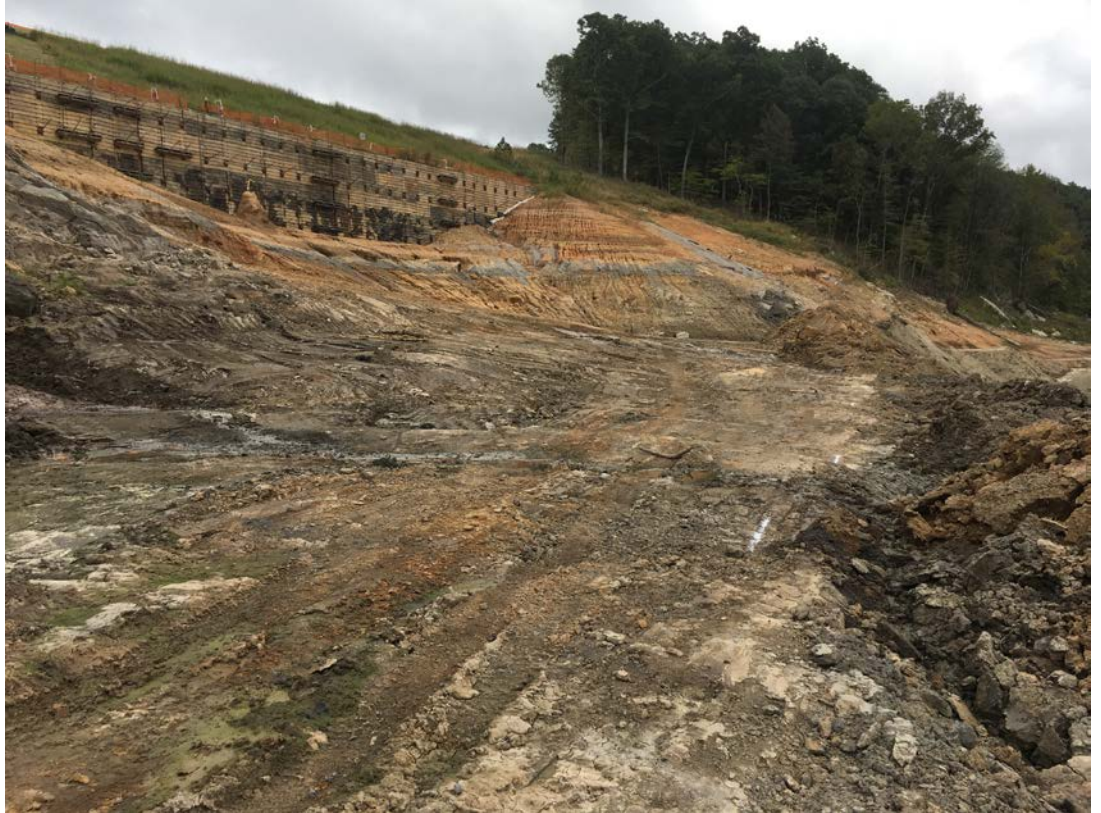
Photo #7  
Observation:

Bottom of Subject Area looking northeast, showing the area where CCR has been Visually removed.

Note:  
The white line denotes the limits of Visual Removal.

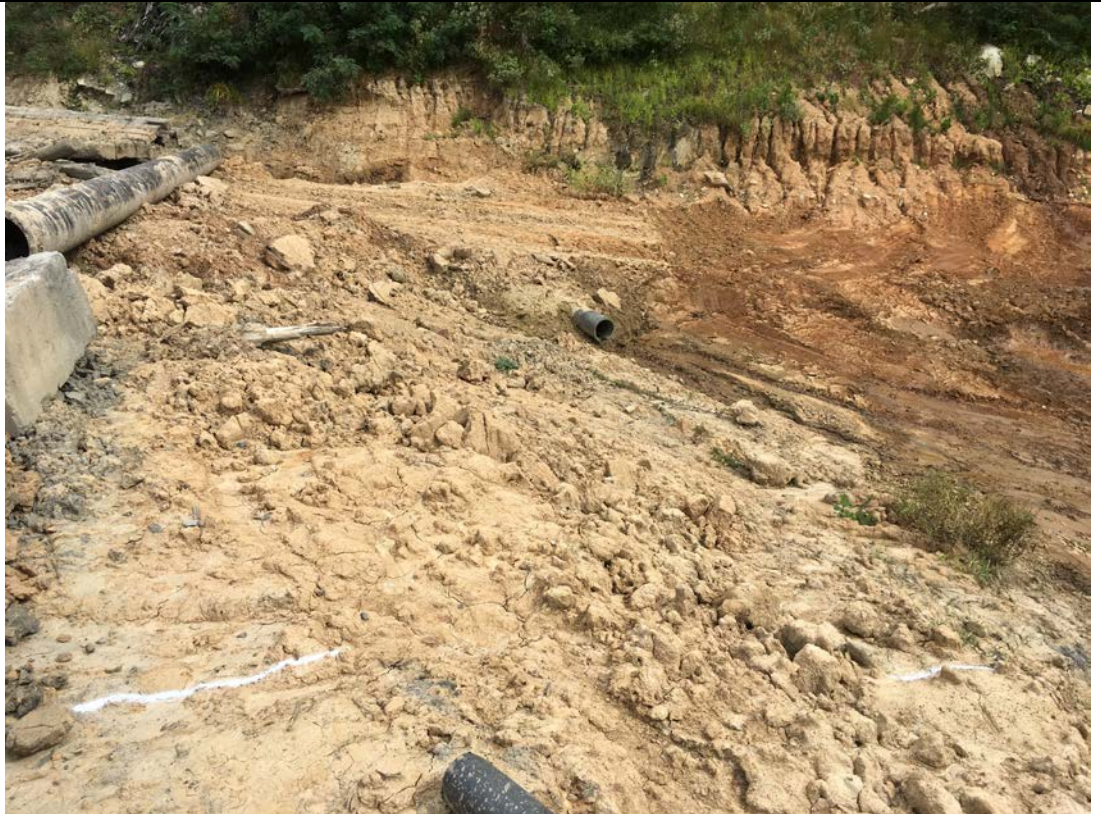
Photo #8  
Observation:

Bottom of Subject Area looking north, showing the area where CCR has been Visually removed.

Note:  
The white line denotes the limits of Visual Removal.

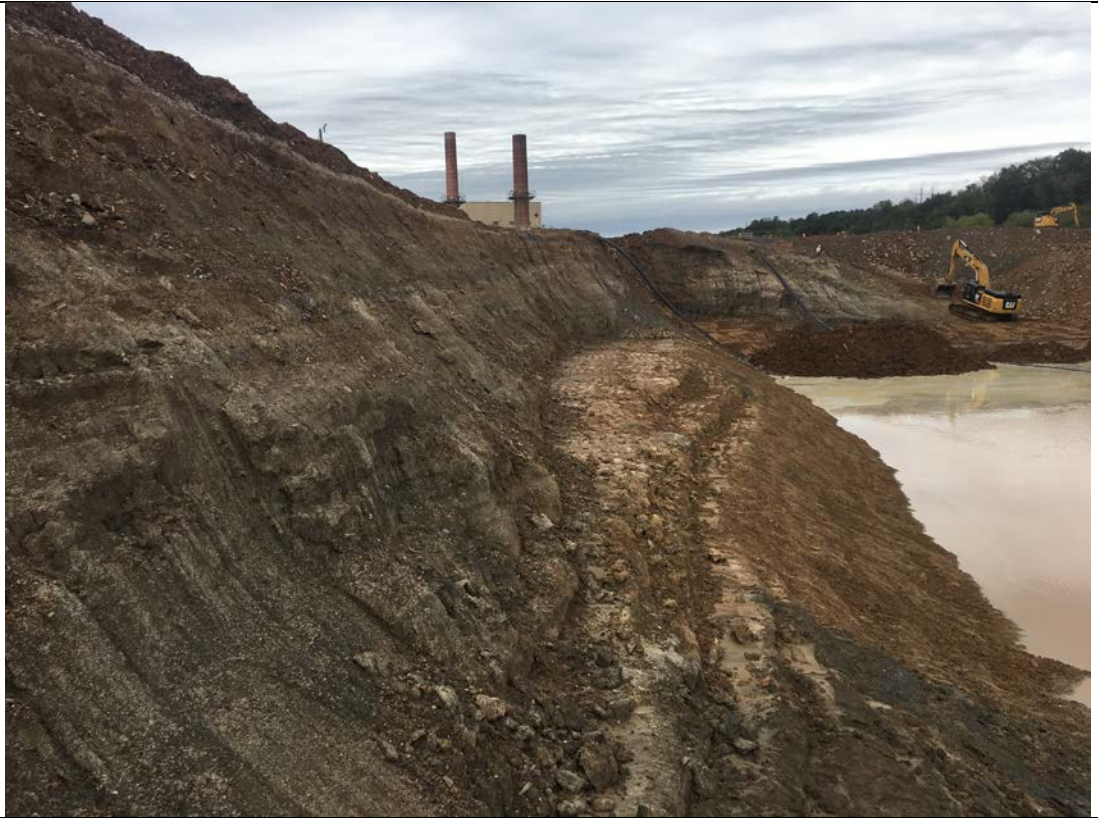
Photo #1  
Observation:

Eastern limit of Subject Area looking west, showing the area where CCR has been Visually removed.

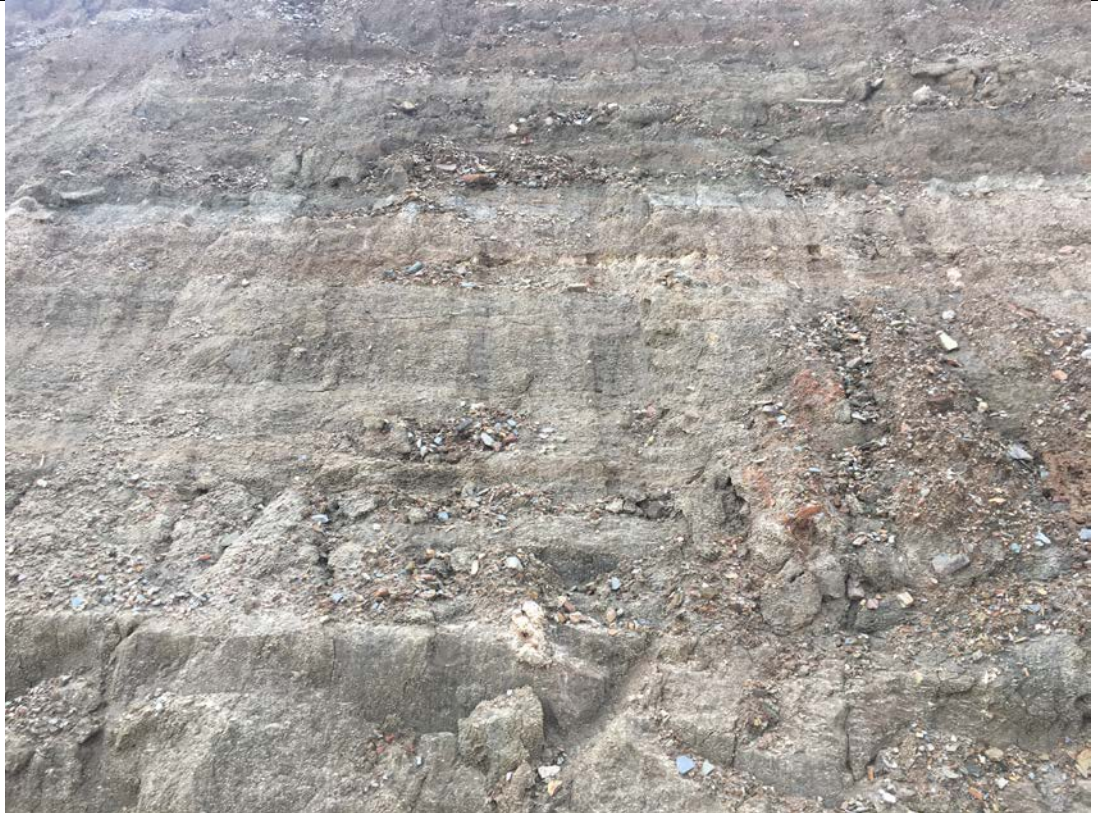
Photo #2  
Observation:

Bottom of Subject Area looking south, showing the area where CCR has been Visually removed from the embankment.

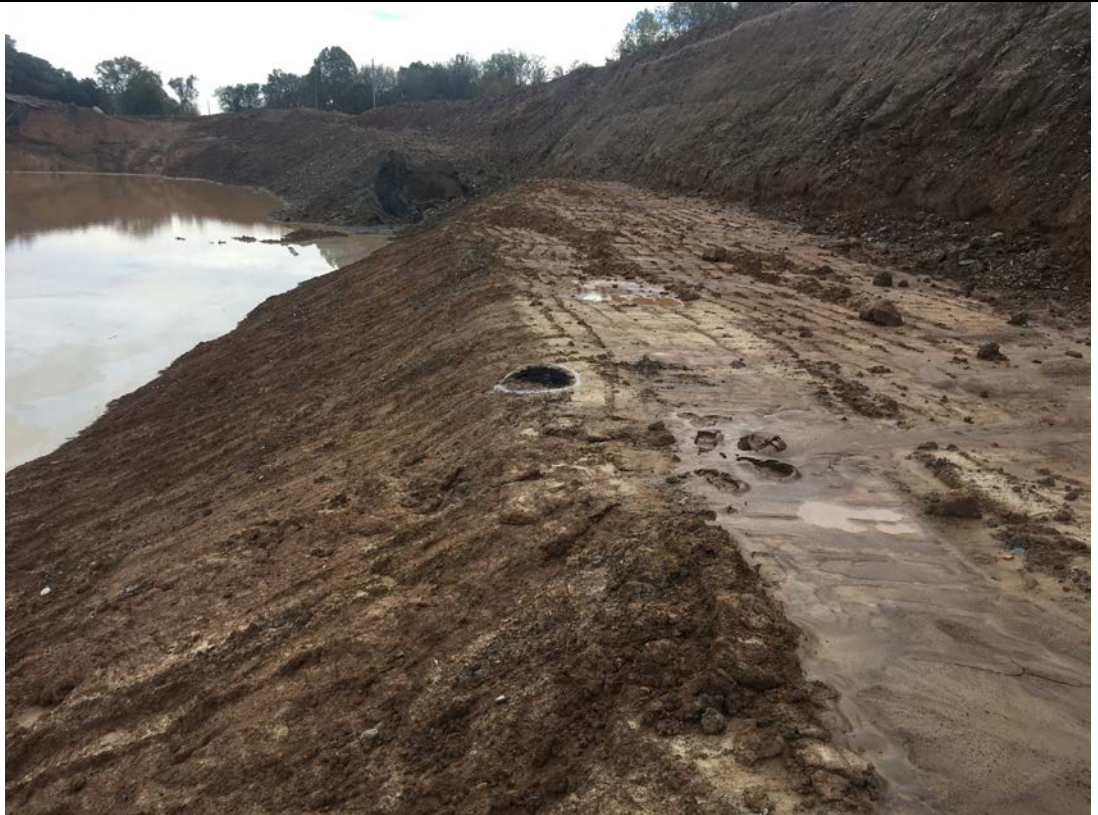
Photo #3  
Observation:

Bottom of Subject Area looking west, showing the area where CCR has been Visually removed.

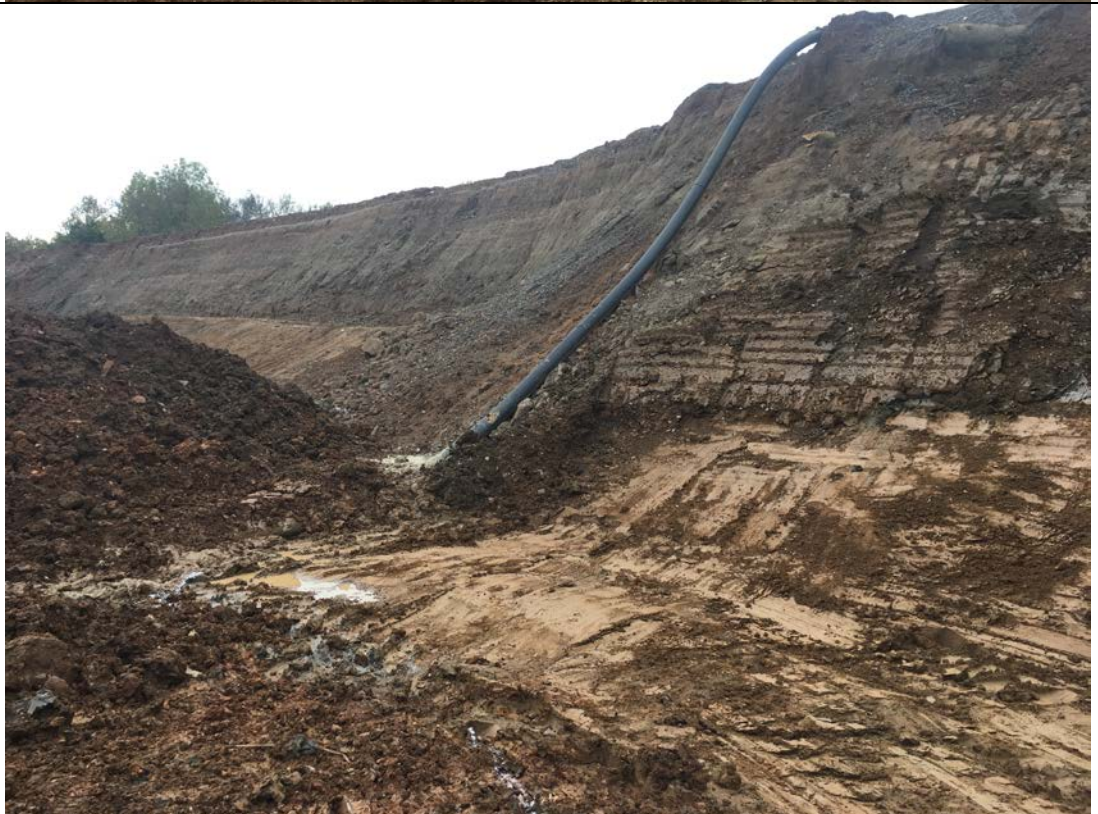
Photo #4  
Observation:

Bottom of Subject Area looking southwest, showing the area where CCR has been Visually removed.

Note:  
The white line denotes the limits of Visual Removal.

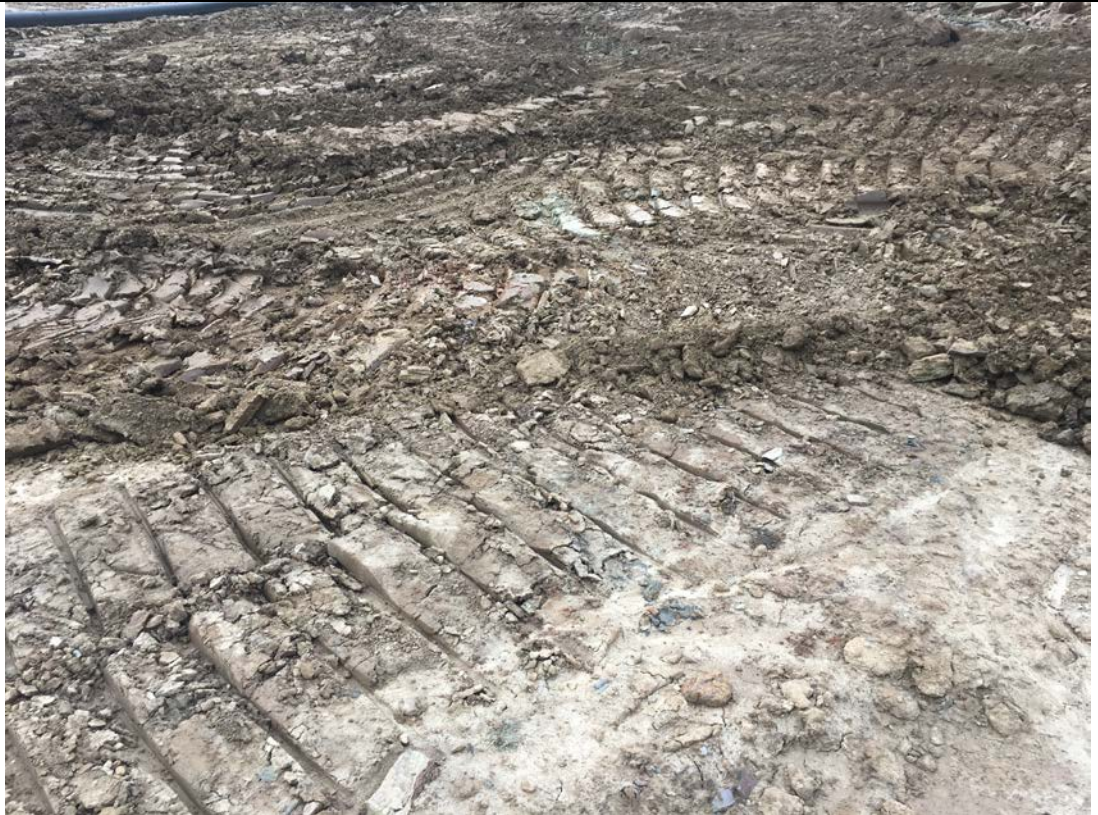
Photo #5  
Observation:

Bottom of Subject Area showing the area where CCR has been Visually removed.

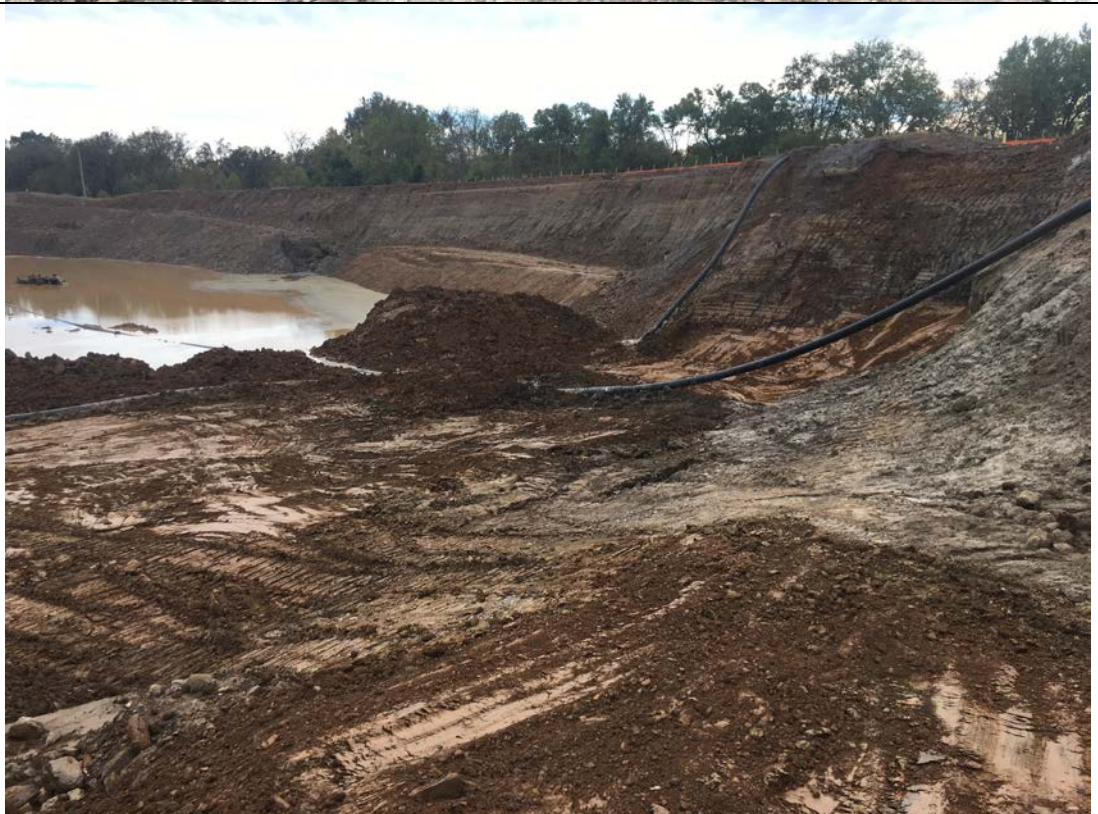
Photo #6  
Observation:

Bottom of Subject Area looking southwest, showing the area where CCR has been Visually removed.

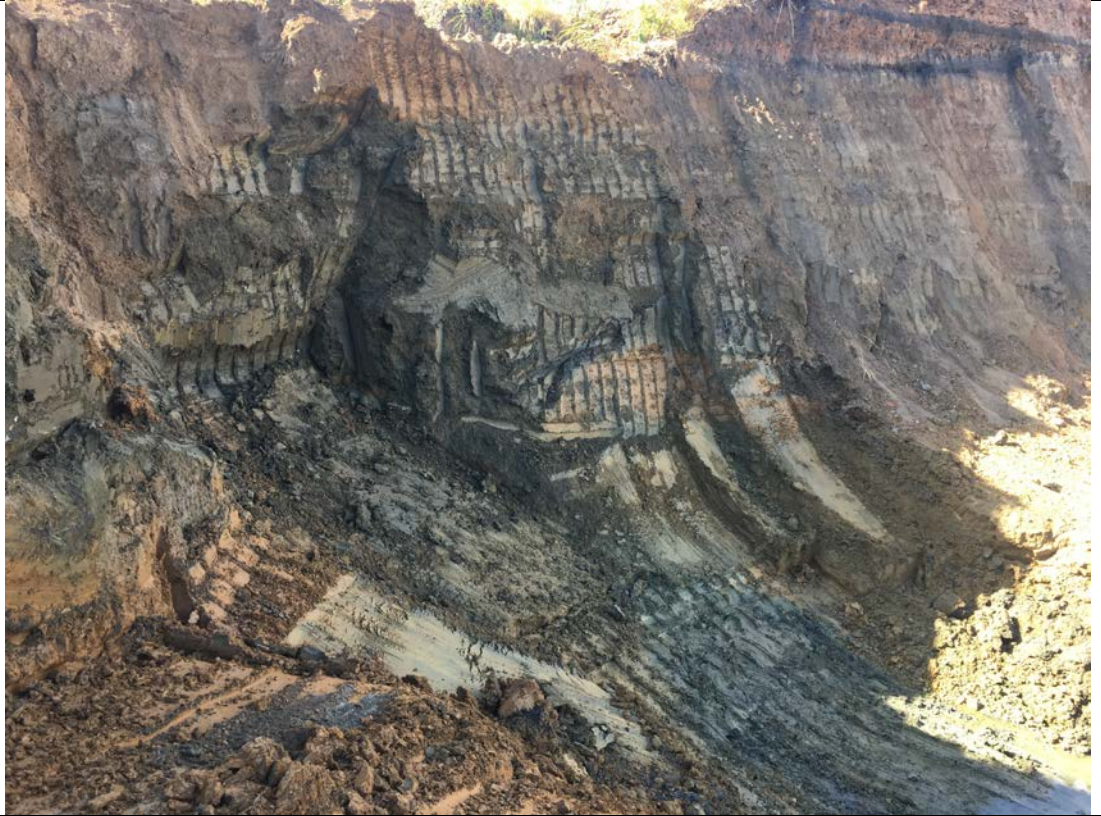
**Photo #1**  
**Observation:**

Eastern limit of Subject Area looking southwest, showing the area where CCR has been Visually removed.

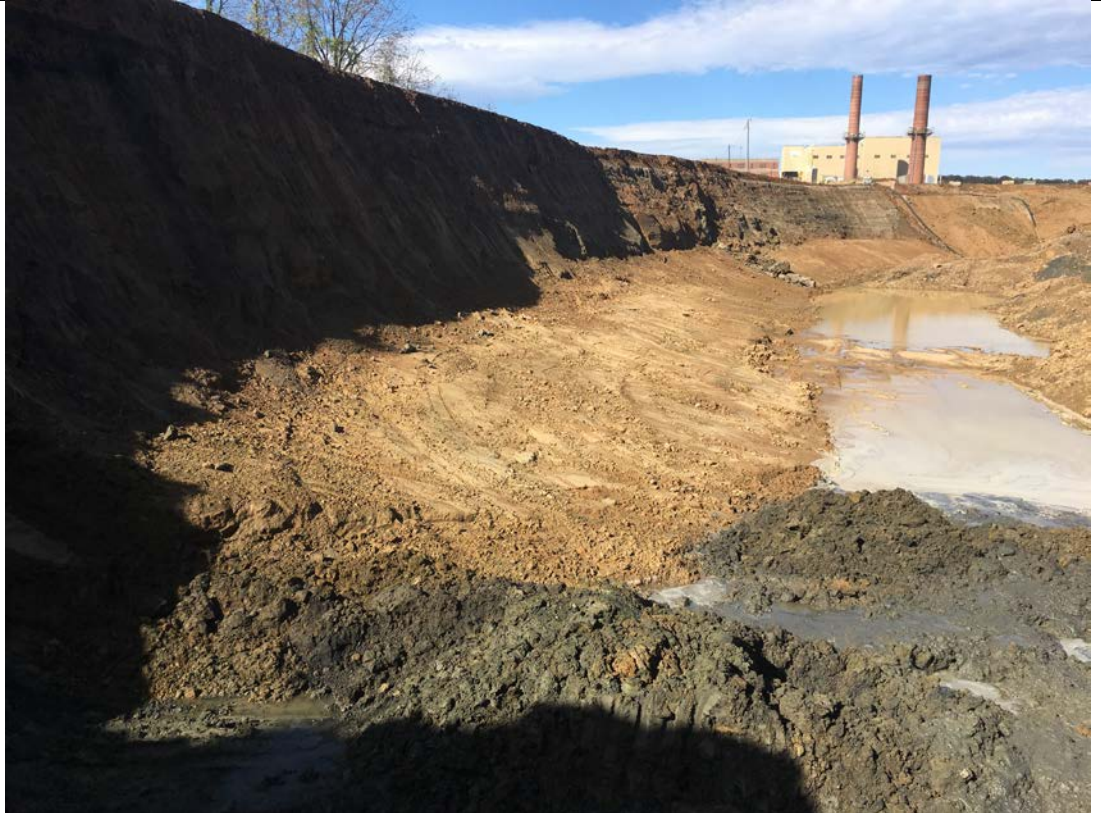
**Photo #2**  
**Observation:**

Bottom of Subject Area looking west, showing the area where CCR has been Visually removed.

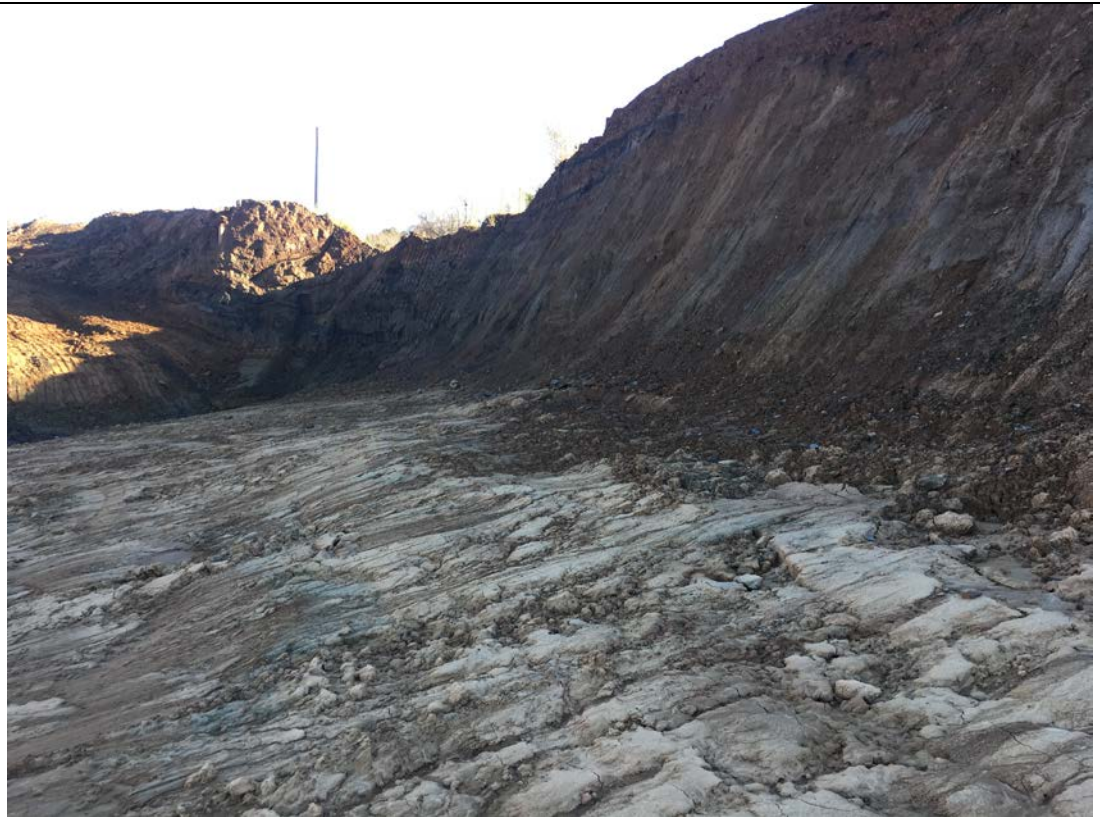
**Photo #3**  
**Observation:**

Bottom of Subject Area looking west, showing the area where CCR has been Visually removed.

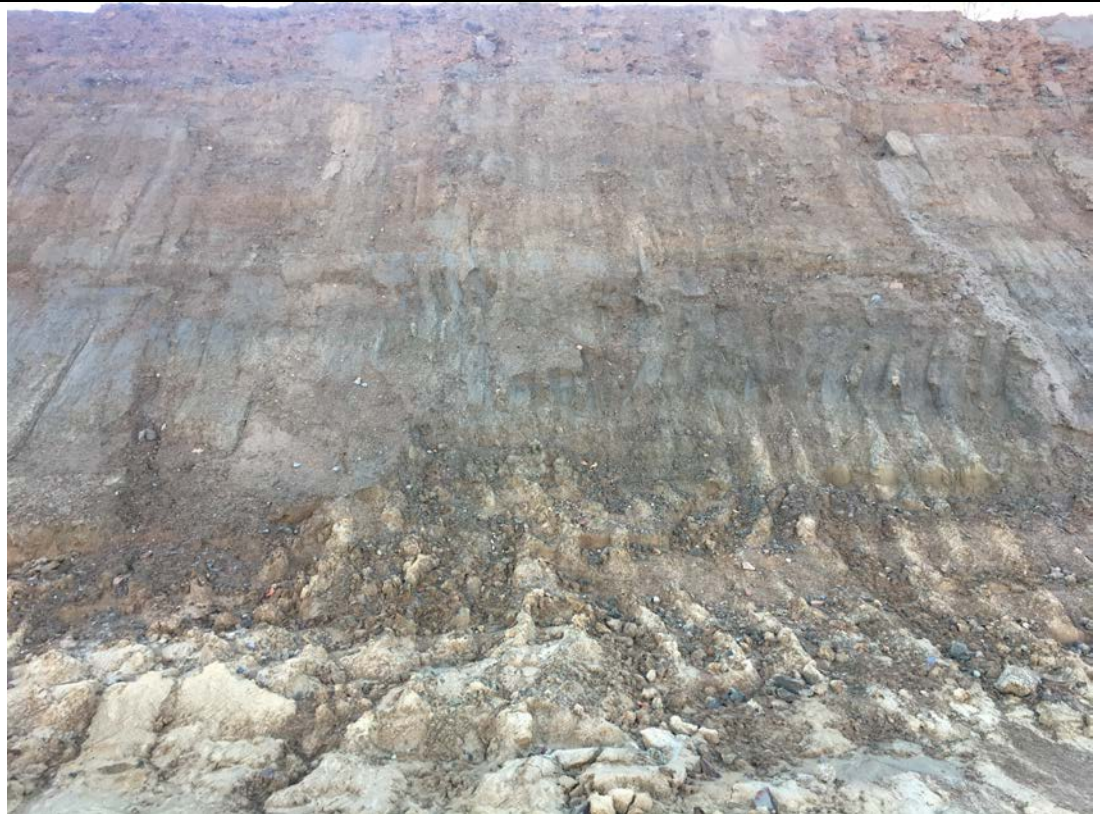
**Photo #4**  
**Observation:**

Bottom of Subject Area looking south, showing the area where CCR has been Visually removed from the embankment.

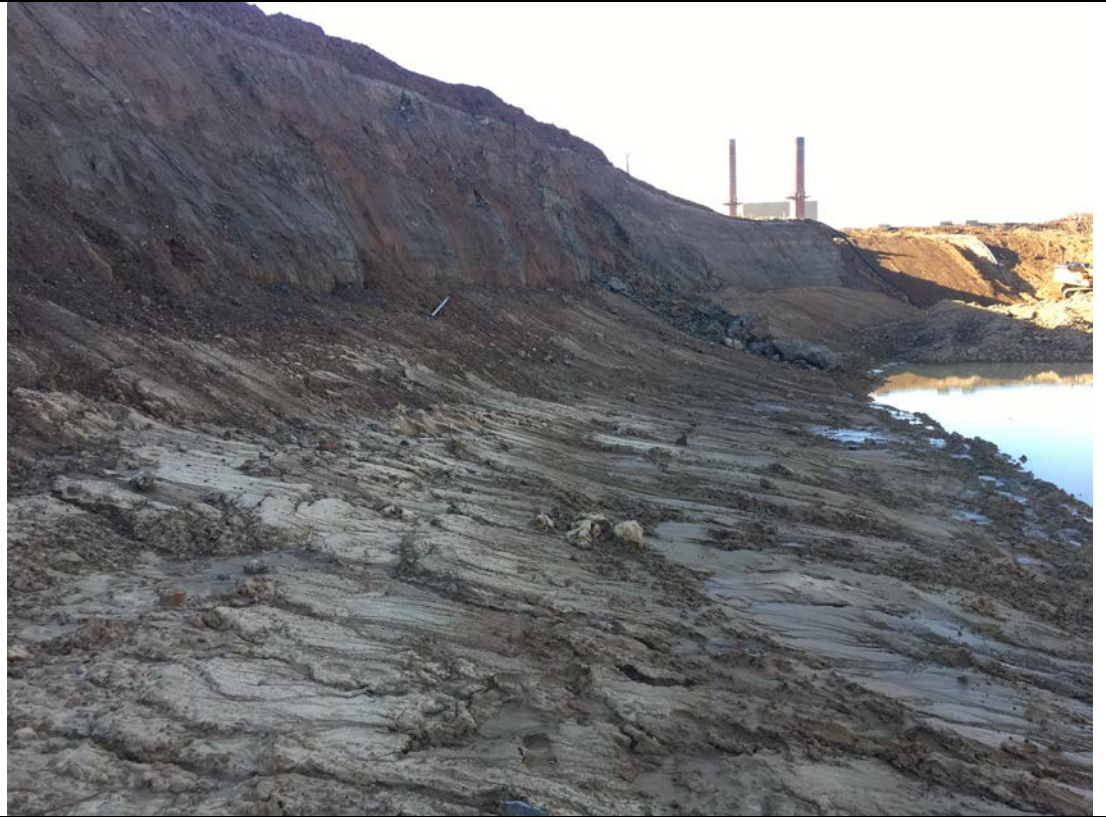
**Photo #5**  
**Observation:**

Bottom of Subject Area looking west, showing the area where CCR has been Visually removed.

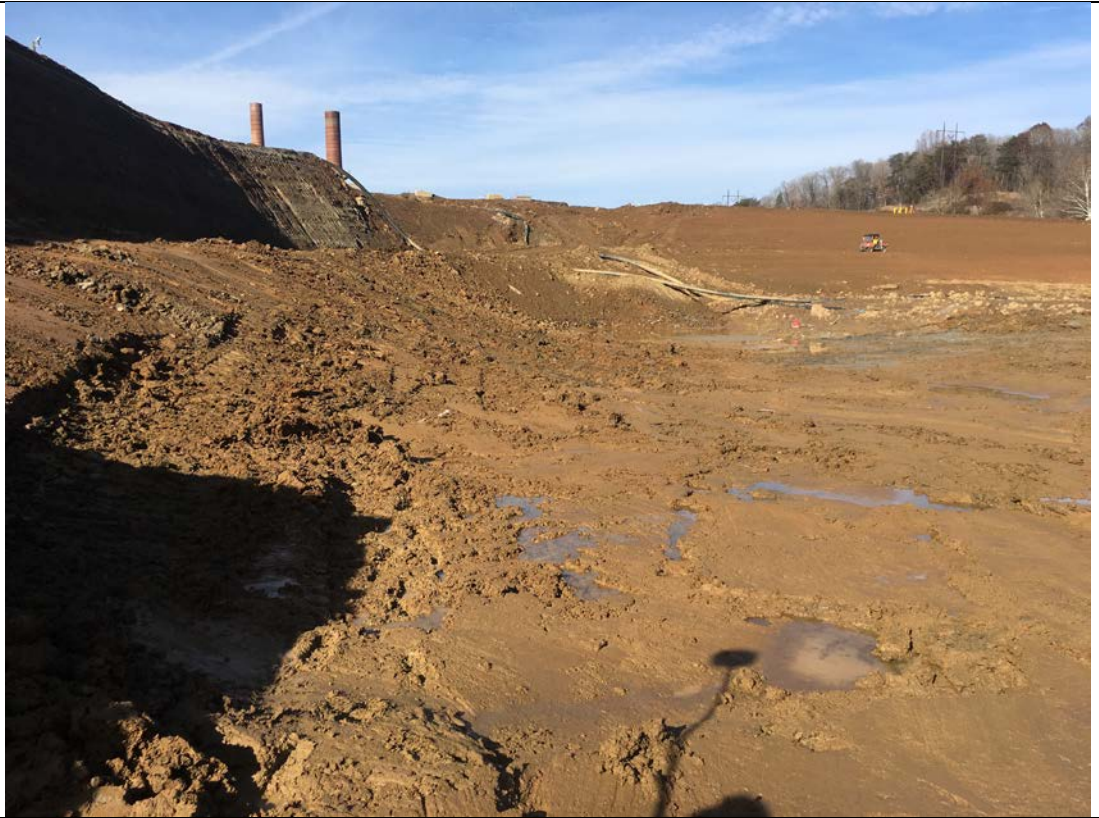
Observation:

Bottom of Subject Area looking west, showing the area where CCR has been Visually removed.

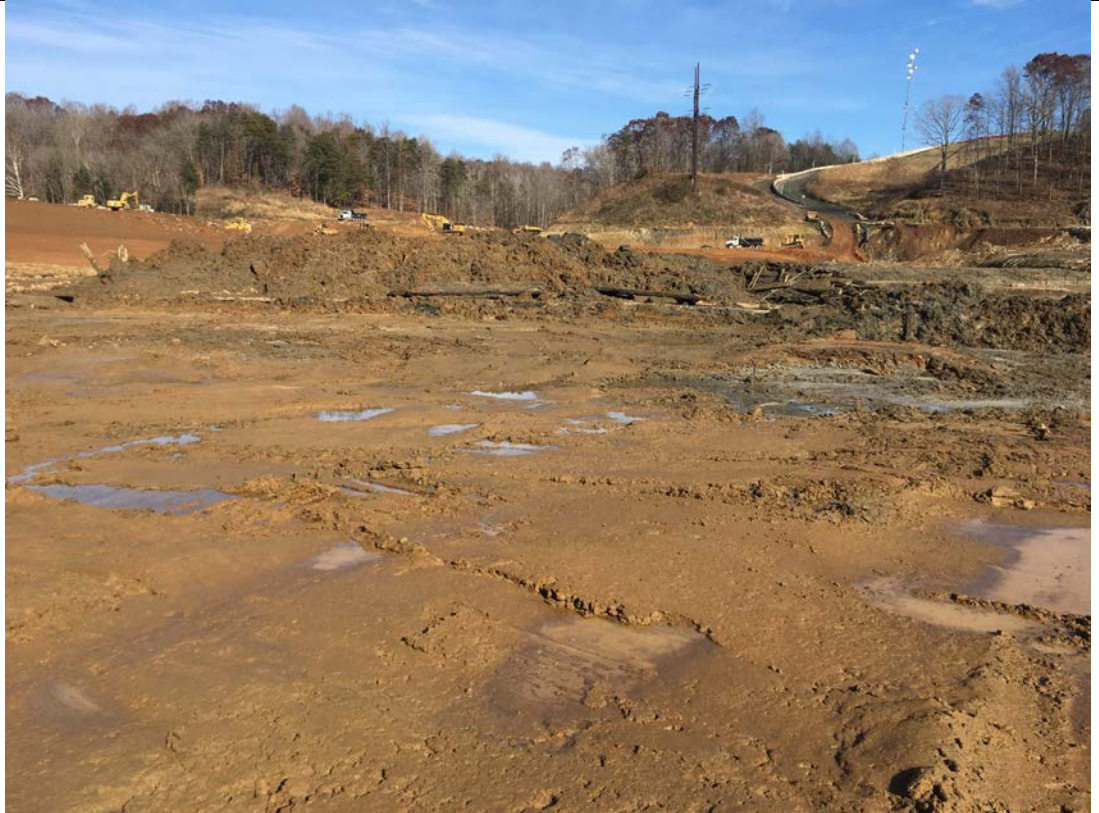
Photo #2

Bottom of Subject Area looking northwest, showing the area where CCR has been Visually removed.
