RE: Bremono Bluff Power Station, Solid Waste Permit (SWP) 618  
Closure by Removal Construction Report – East Ash Pond  
Fluvanna County, Virginia

## Closure by Removal Construction

May 23, 2019

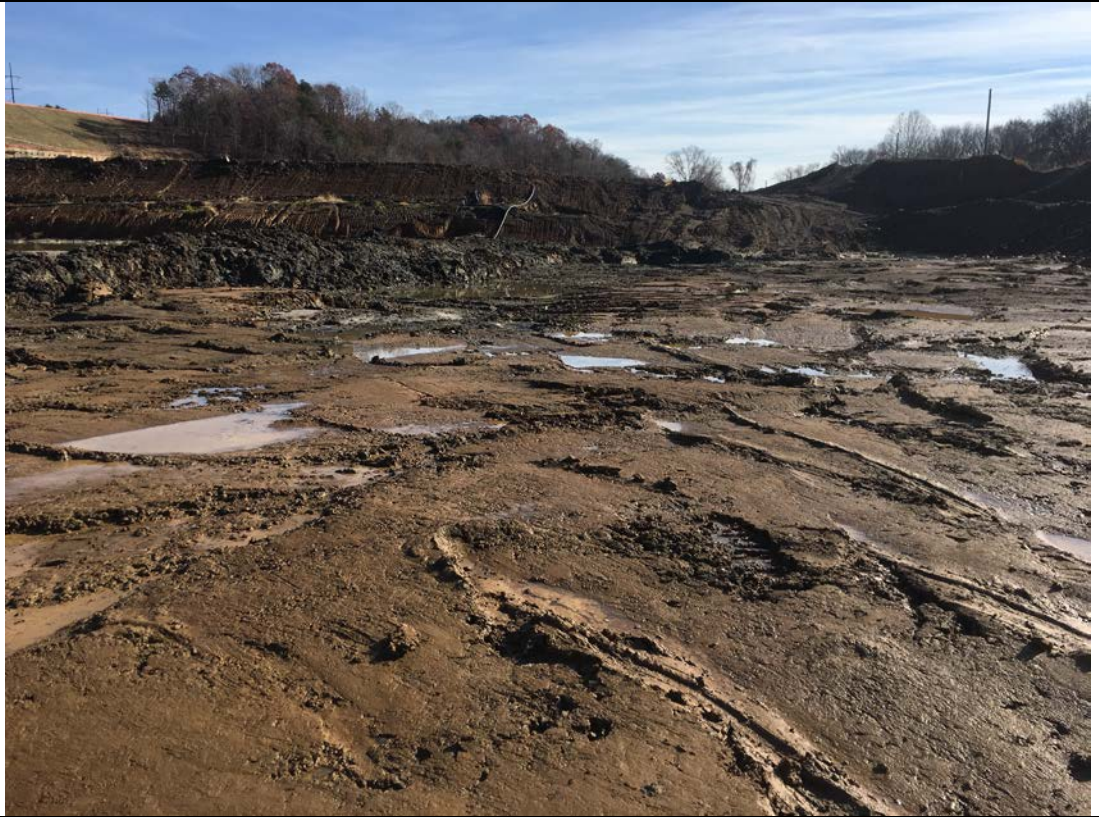
**Photo #3**  
**Observation:**

Bottom of Subject Area looking northwest, showing the area where CCR has been Visually removed.

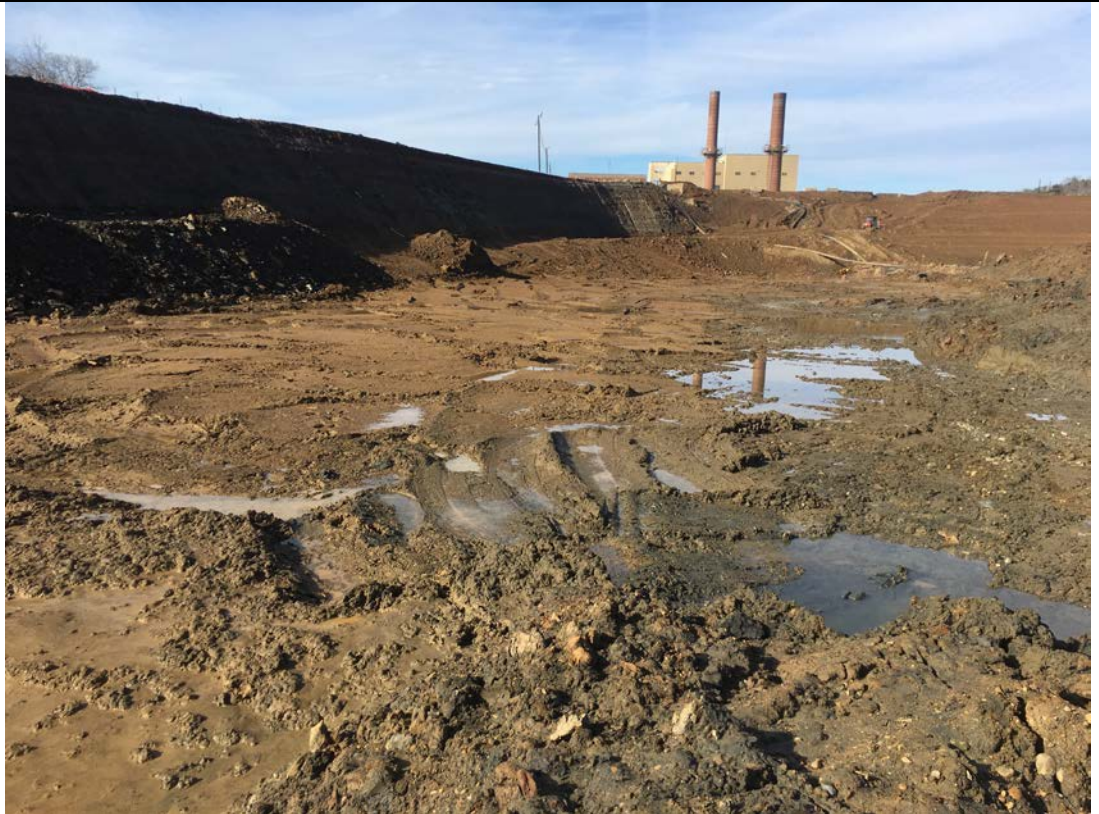
**Photo #4**  
**Observation:**

Bottom of Subject Area looking southwest, showing the area where CCR has been Visually removed.

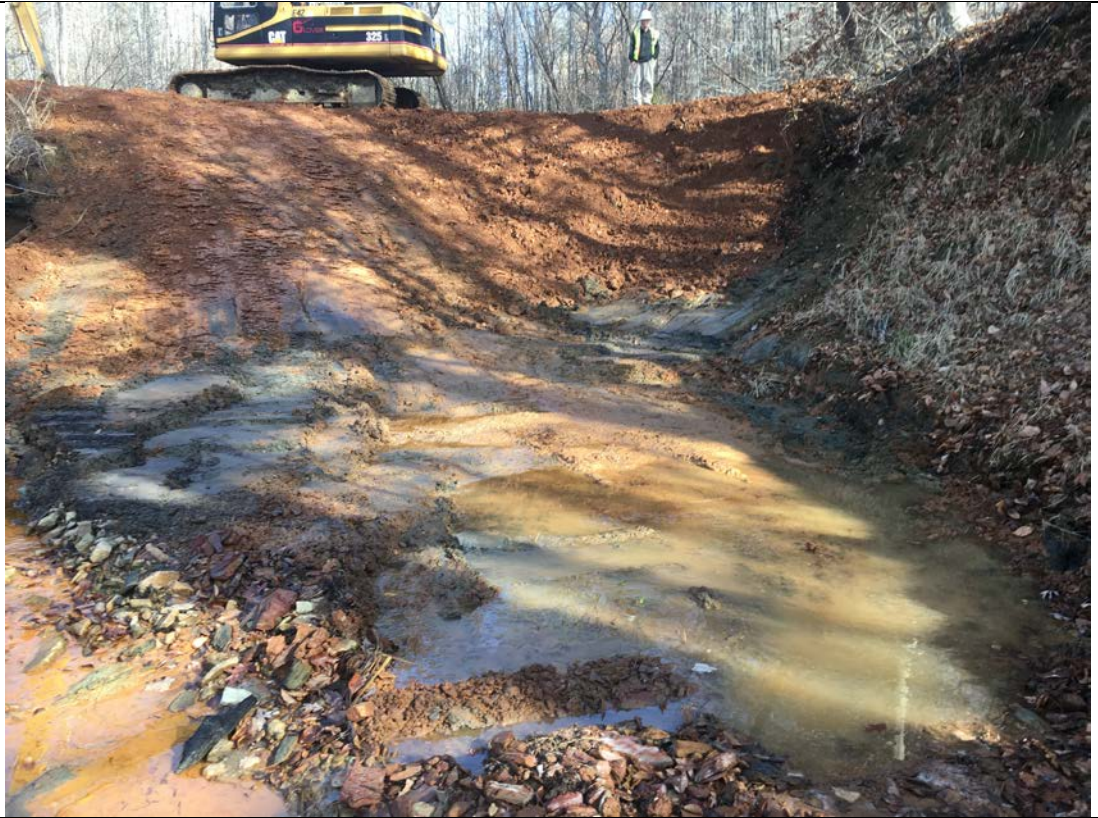
Photo #1  
Observation:

Bottom of Subject Area looking north, showing the area where CCR has been Visually removed.

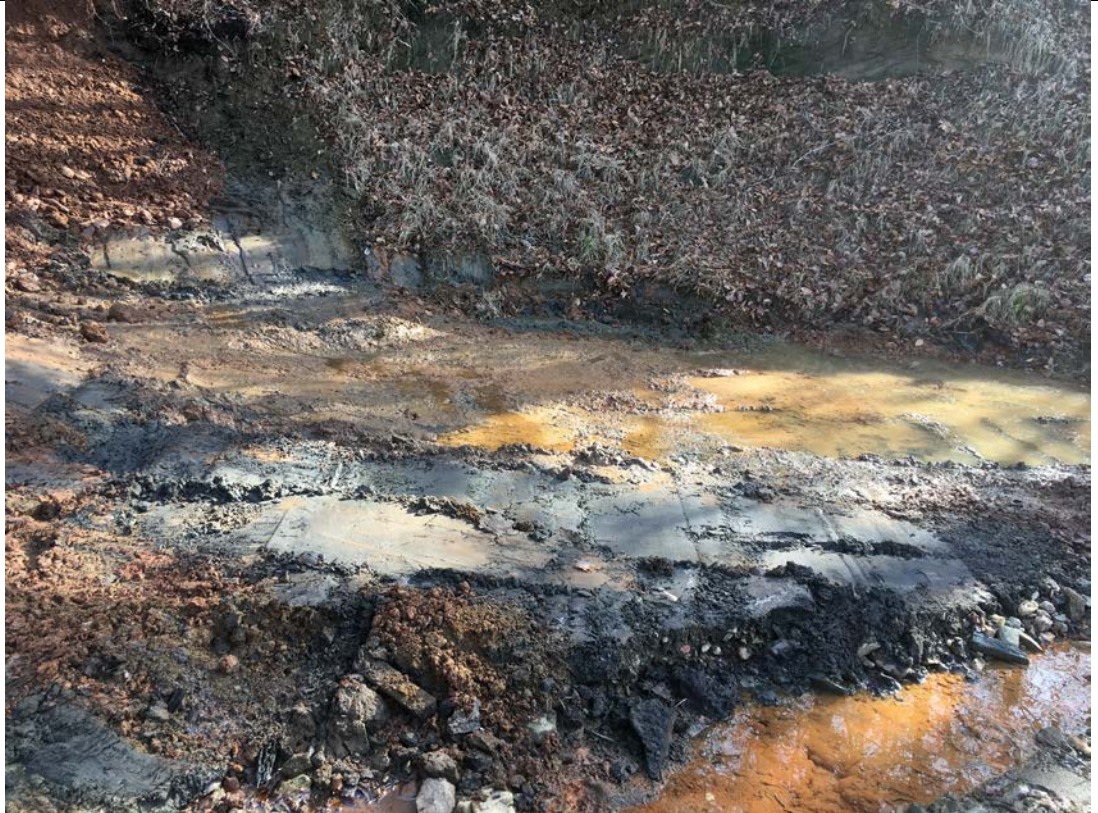
Photo #2  
Observation:

Bottom of Subject Area looking east, showing the area where CCR has been Visually removed.

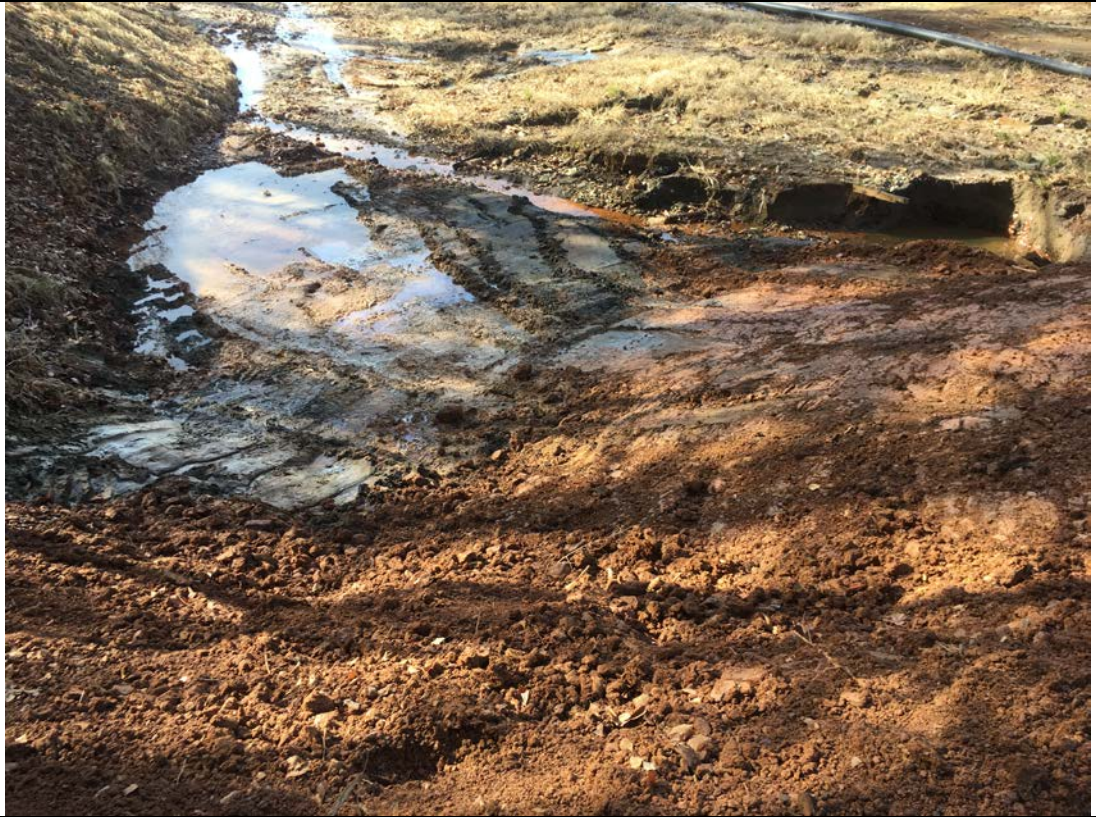
**Photo #3**  
**Observation:**

Bottom of Subject Area looking south, showing the area where CCR has been Visually removed.

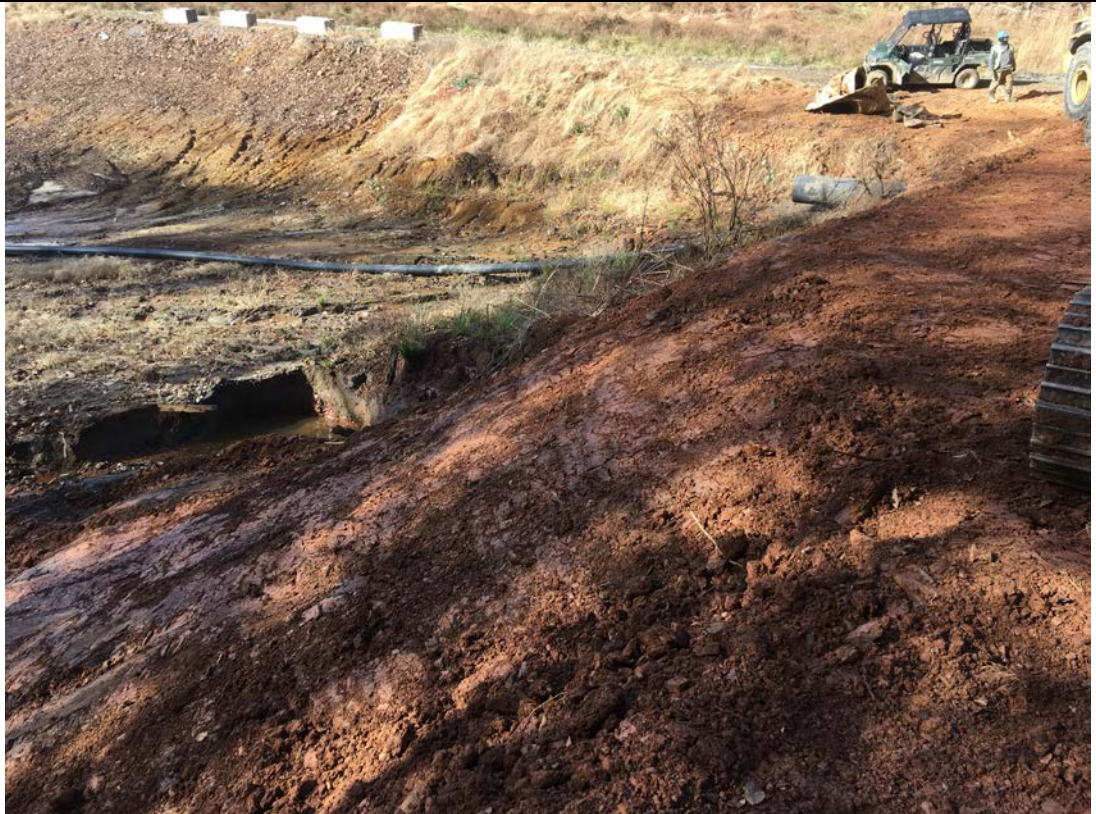
**Photo #4**  
**Observation:**

Bottom of Subject Area looking southwest, showing the area where CCR has been Visually removed.

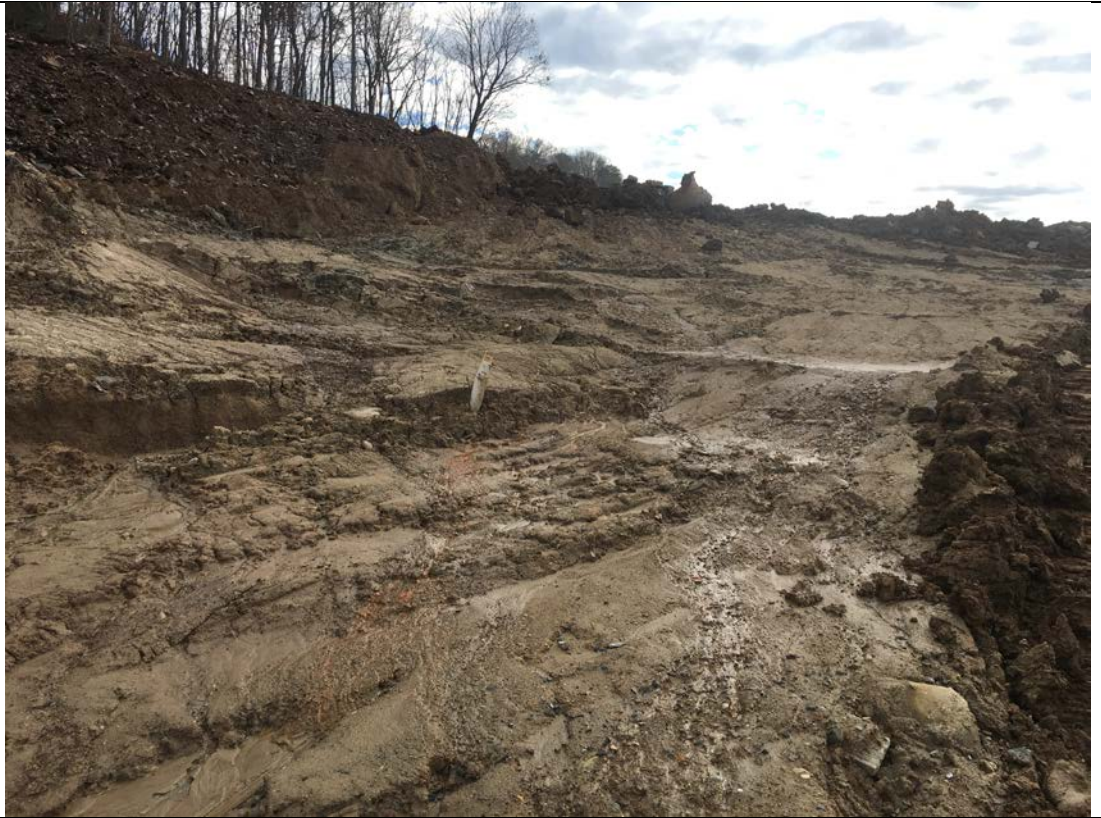
Photo #1  
Observation:

Bottom of Subject Area looking west, showing the area where CCR has been Visually removed.

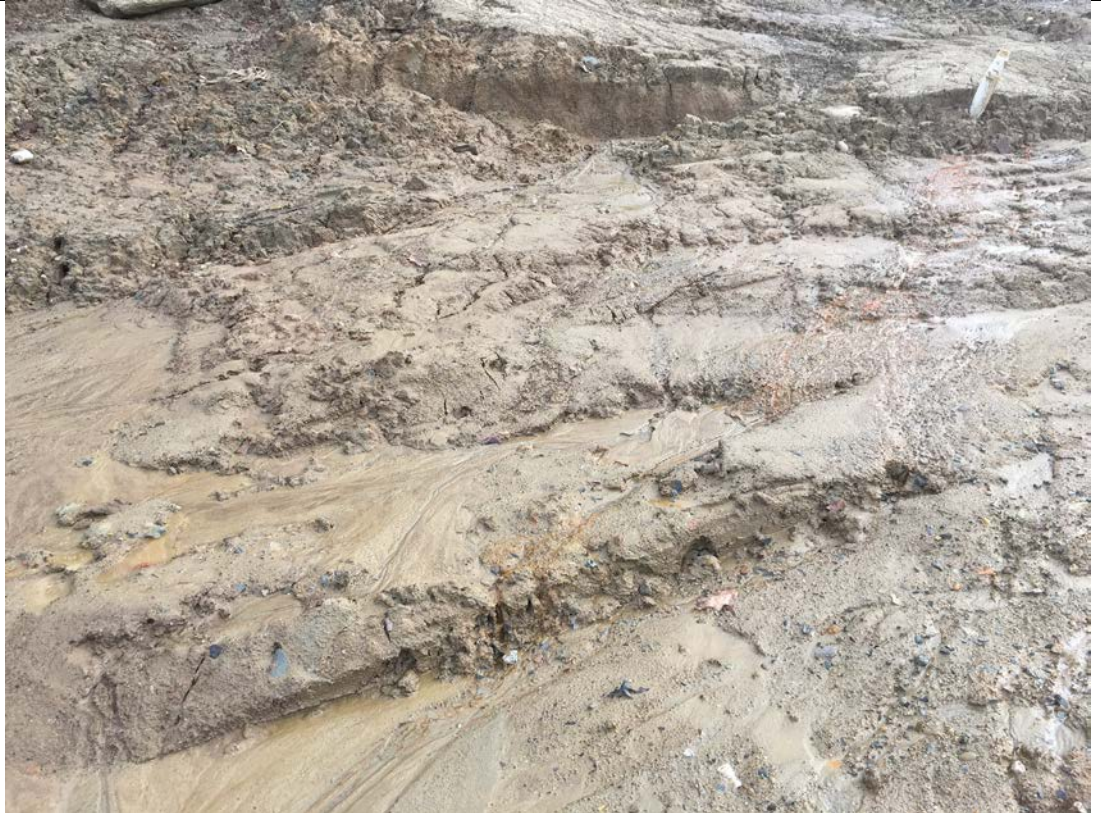
Photo #2  
Observation:

Bottom of Subject Area showing the area where CCR has been Visually removed.

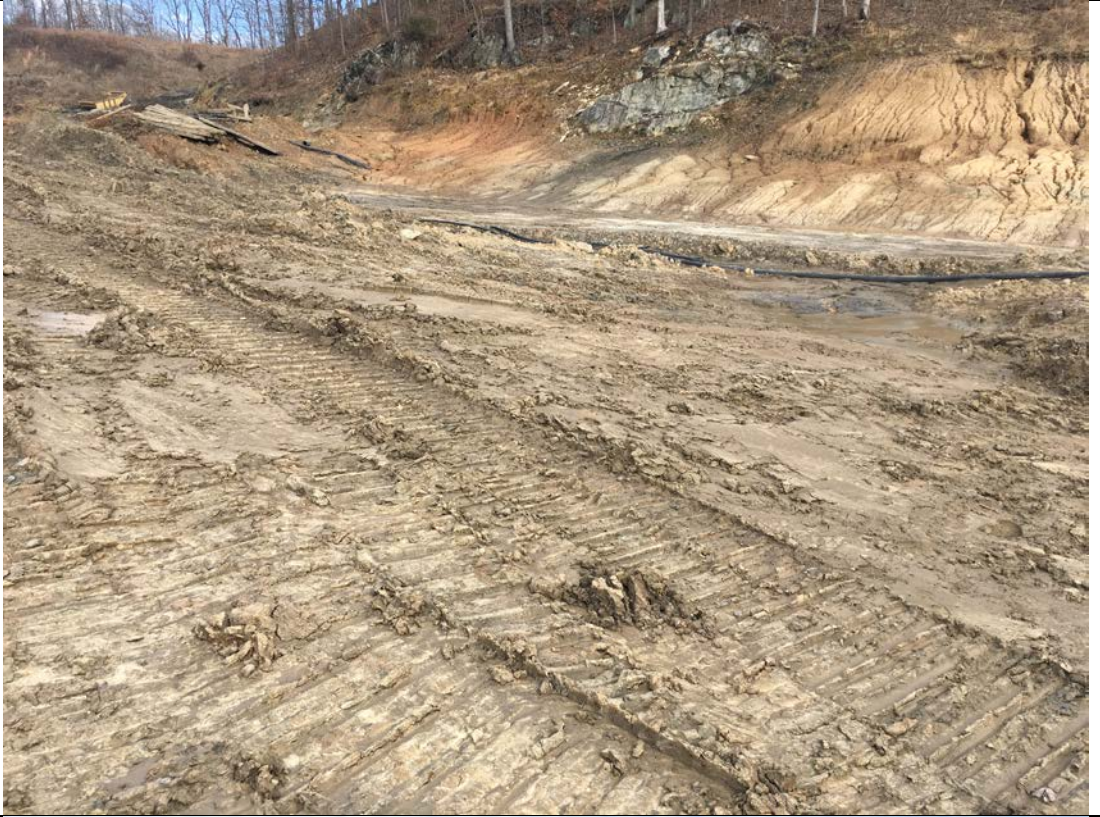
Photo #1  
Observation:

Bottom of Subject Area looking northwest, showing the area where CCR has been Visually removed.

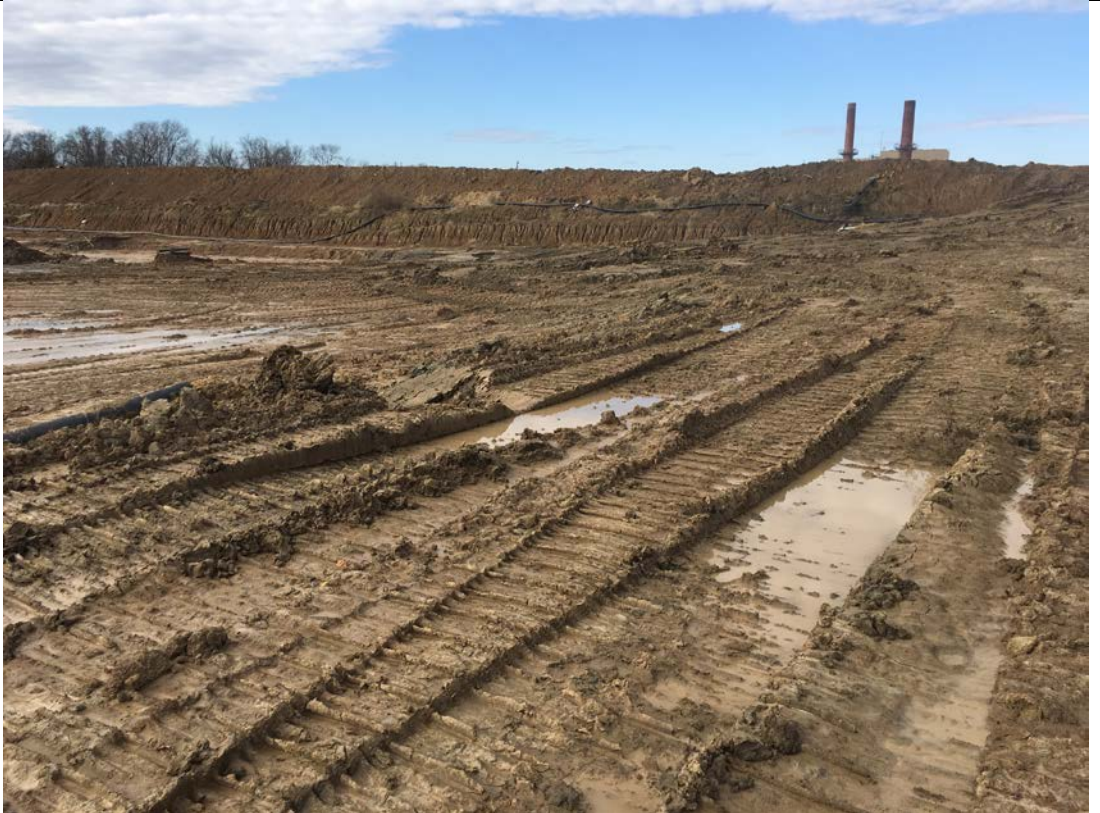
Photo #2  
Observation:

Bottom of Subject Area looking southwest, showing the area where CCR has been Visually removed.

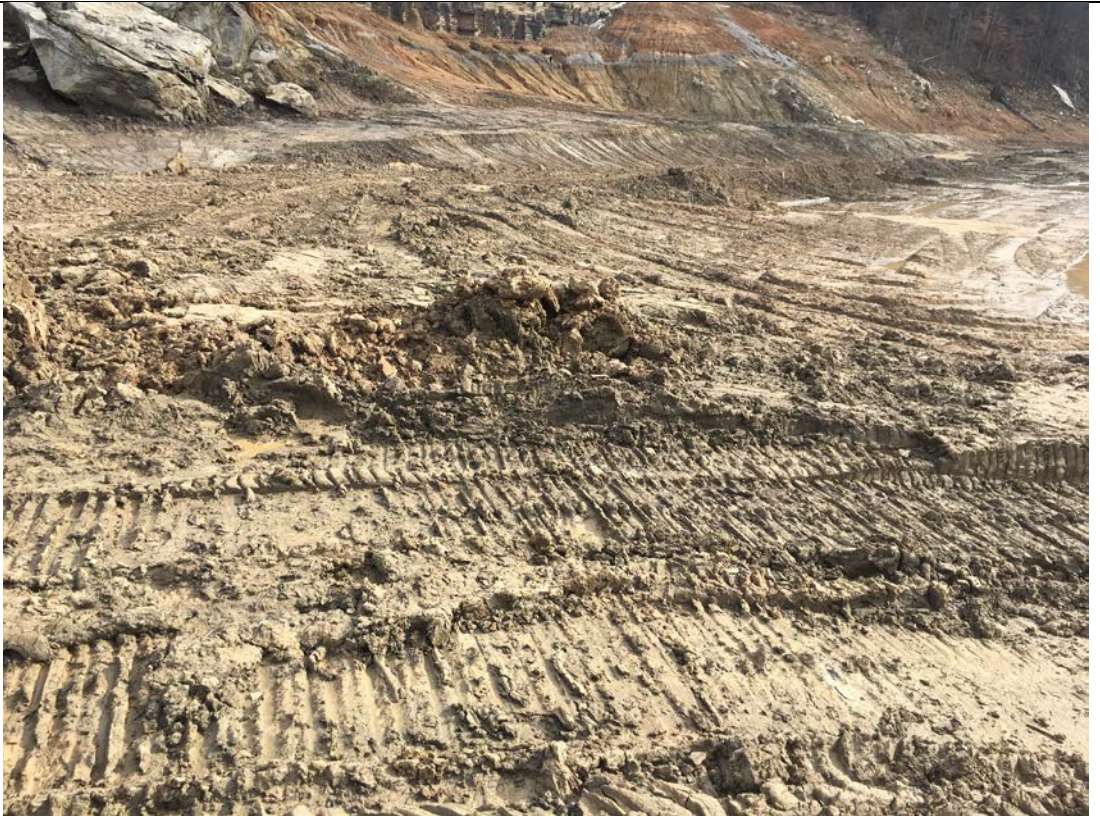
**Photo #3**  
**Observation:**

Bottom of Subject Area looking northeast, showing the area where CCR has been Visually removed.

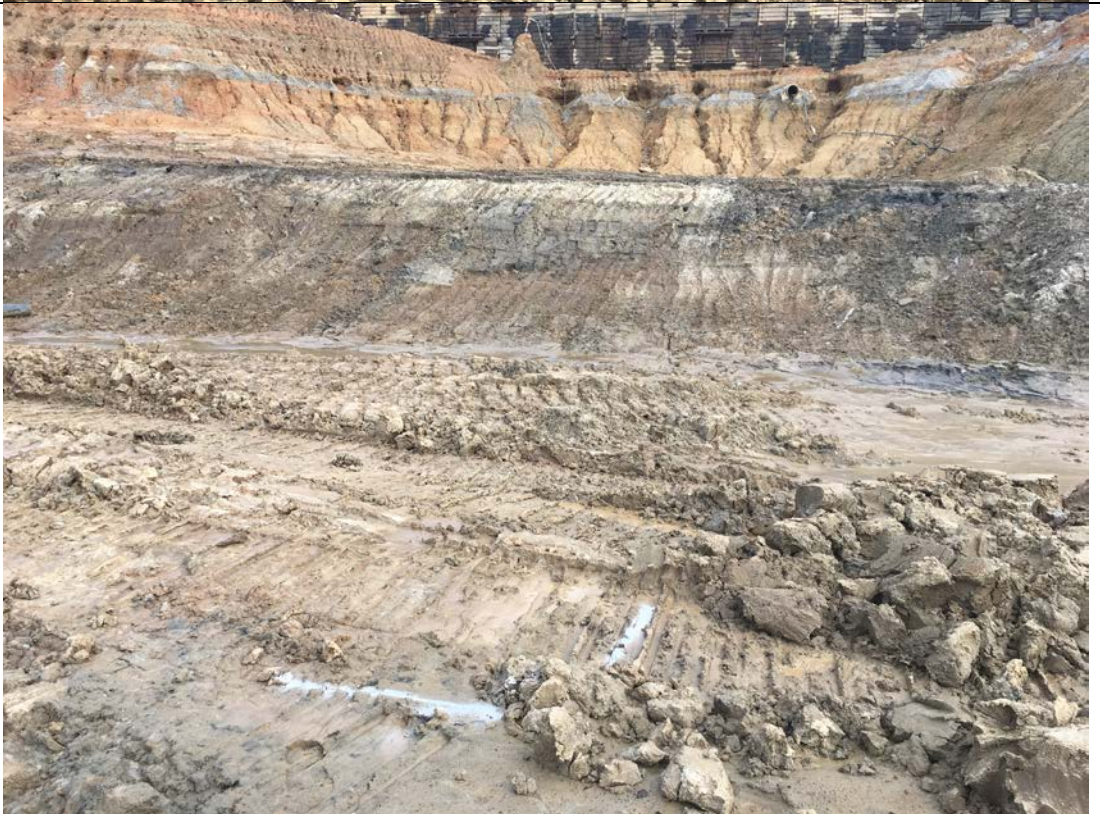
**Photo #4**  
**Observation:**

Bottom of Subject Area looking north, showing the area where CCR has been Visually removed.

**Note:**  
 The white line denotes the limits of Visual Removal.

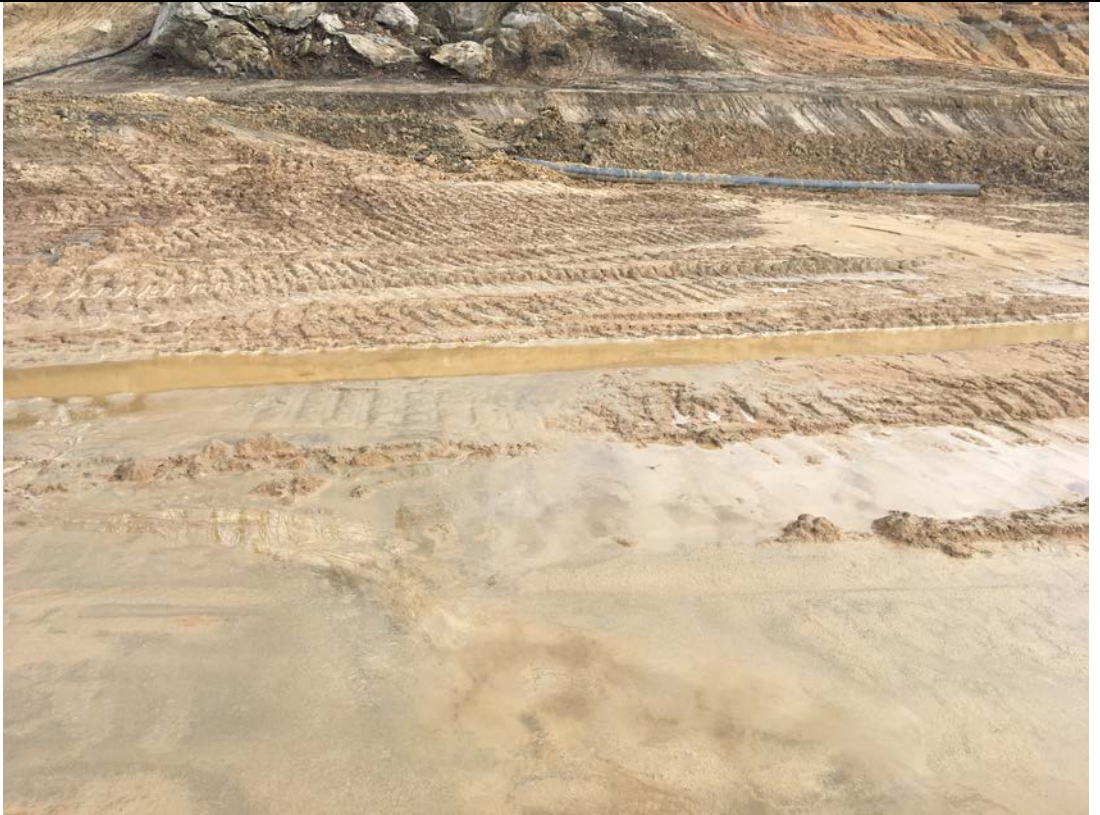
**Photo #5**  
**Observation:**

Bottom of Subject Area looking north, showing the area where CCR has been Visually removed.

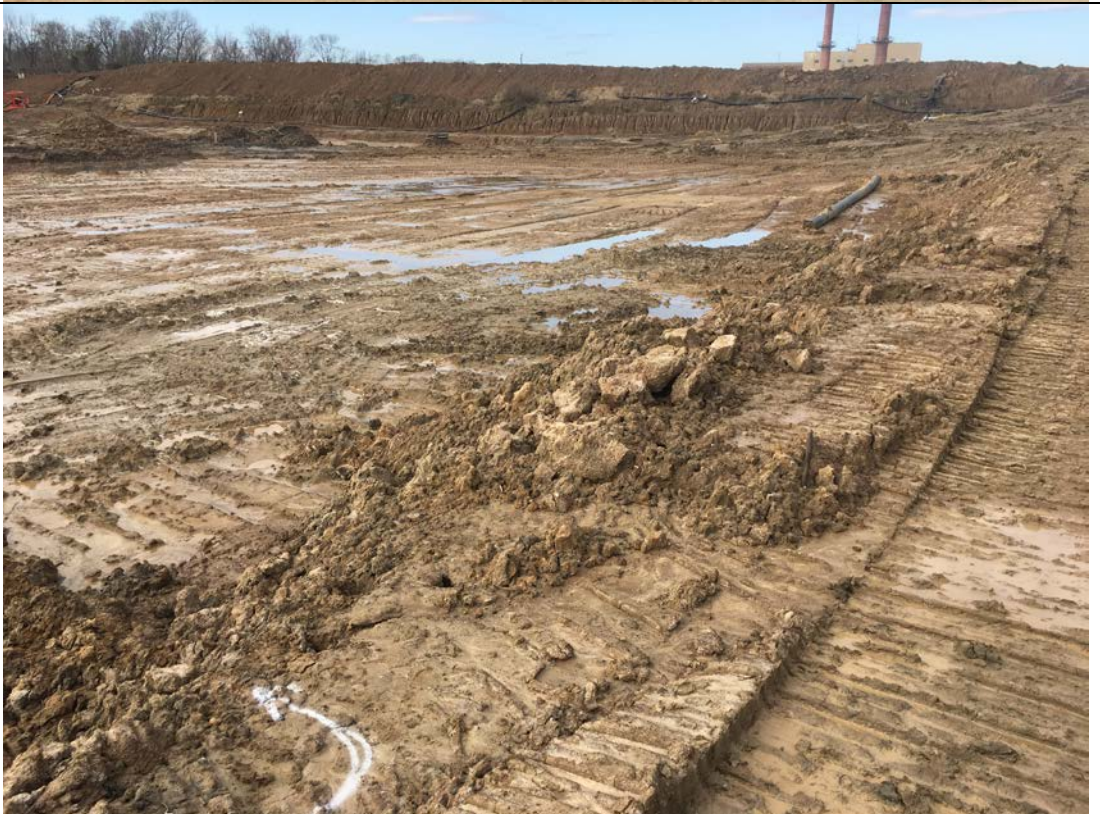
**Photo #6**  
**Observation:**

Bottom of Subject Area looking southwest, showing the area where CCR has been Visually removed.

**Note:**  
 The white line denotes the limits of Visual Removal.

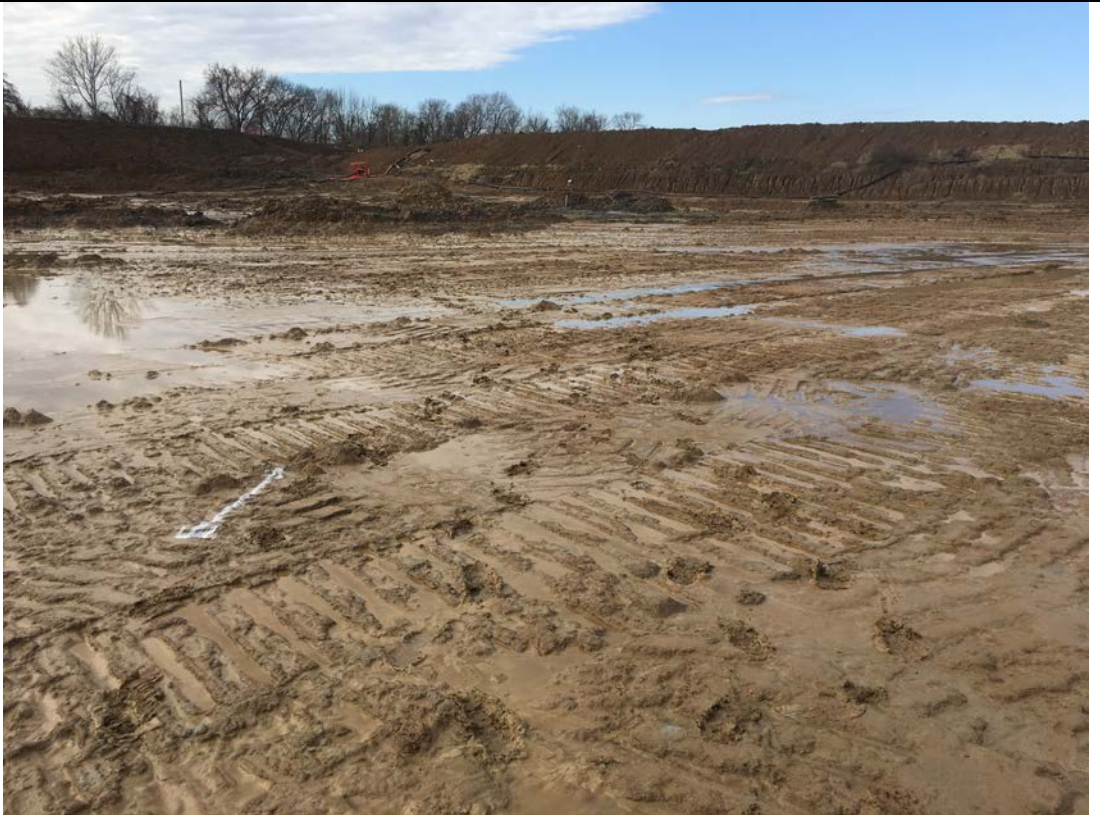
**Photo #7**  
**Observation:**

Bottom of Subject Area looking southwest, showing the area where CCR has been Visually removed.

**Note:**  
 The white line denotes the limits of Visual Removal.

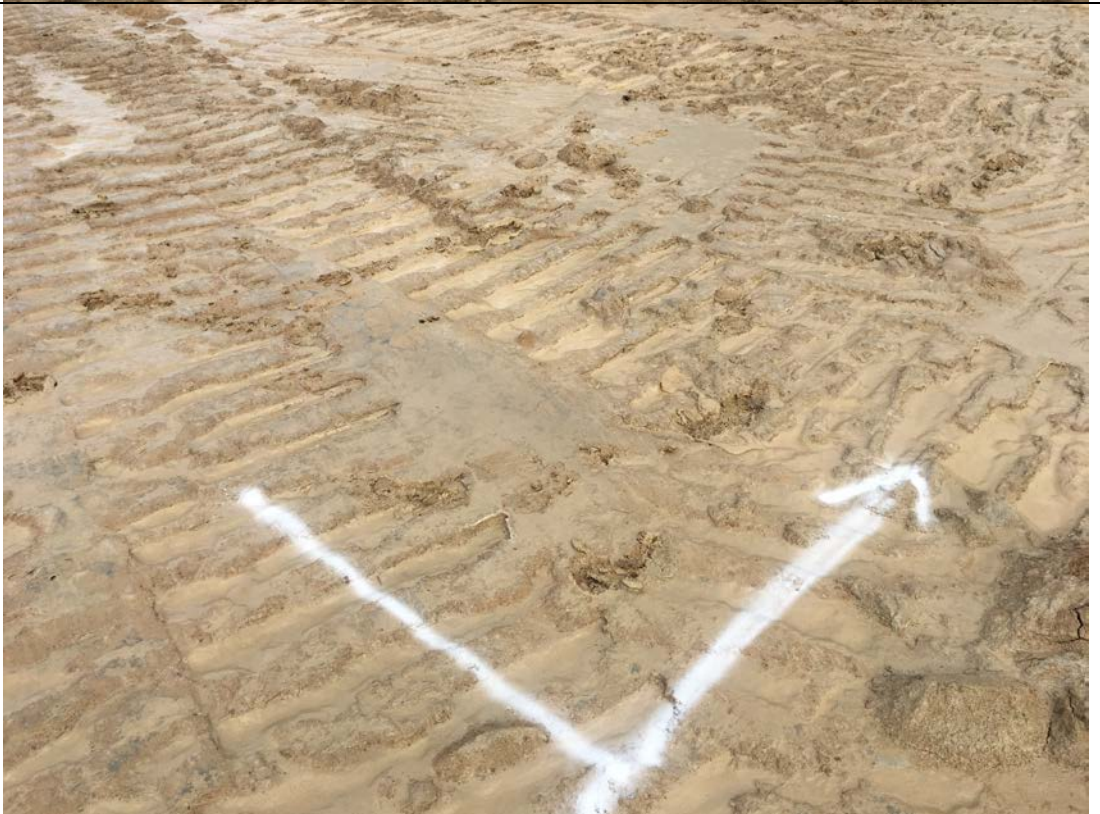
**Photo #8**  
**Observation:**

Bottom of Subject Area showing the area where CCR has been Visually removed.

**Note:**  
 The white line denotes the limits of Visual Removal.

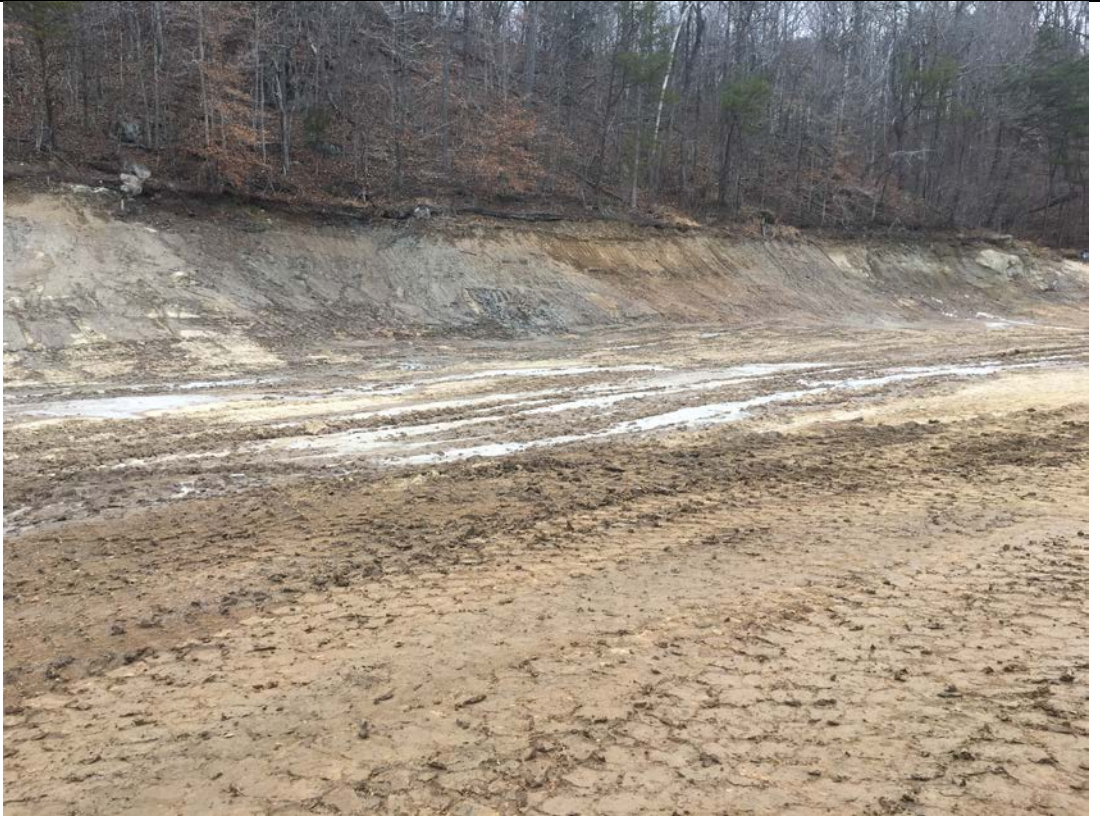
Photo #1  
Observation:

Bottom of Subject Area looking northeast, showing the area where CCR has been Visually removed.

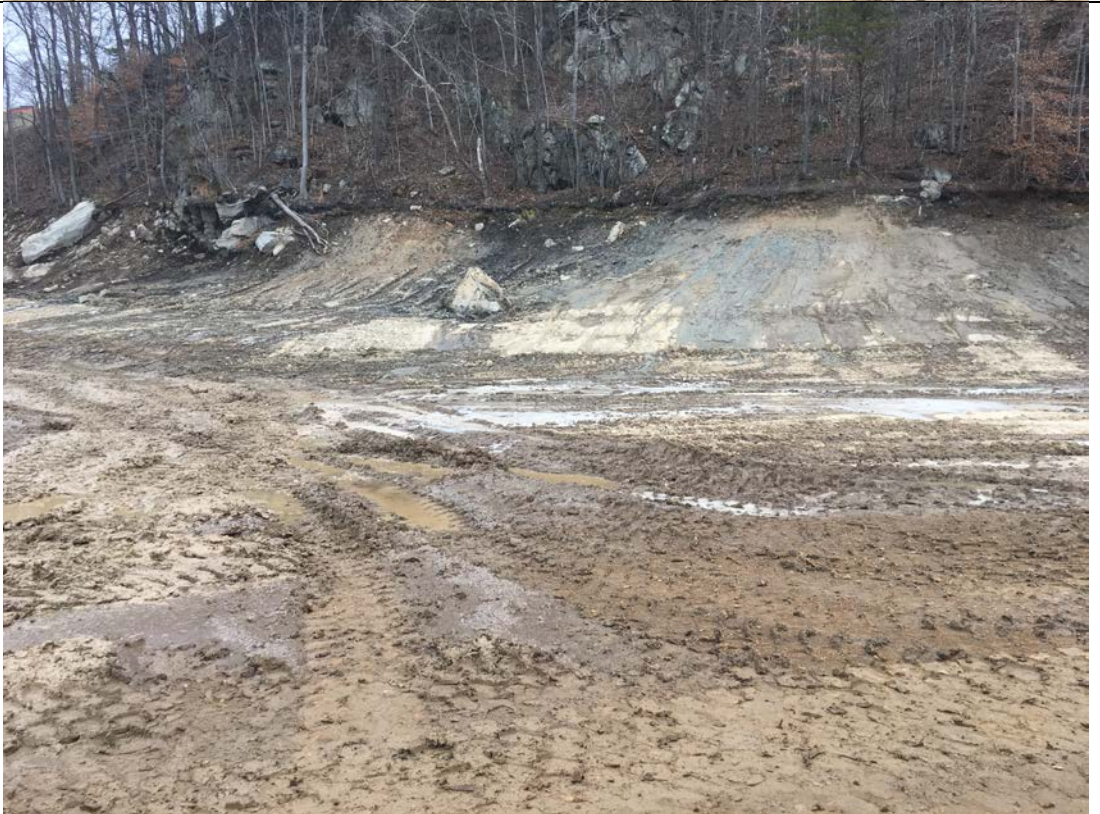
Photo #2  
Observation:

Bottom of Subject Area looking north, showing the area where CCR has been Visually removed.

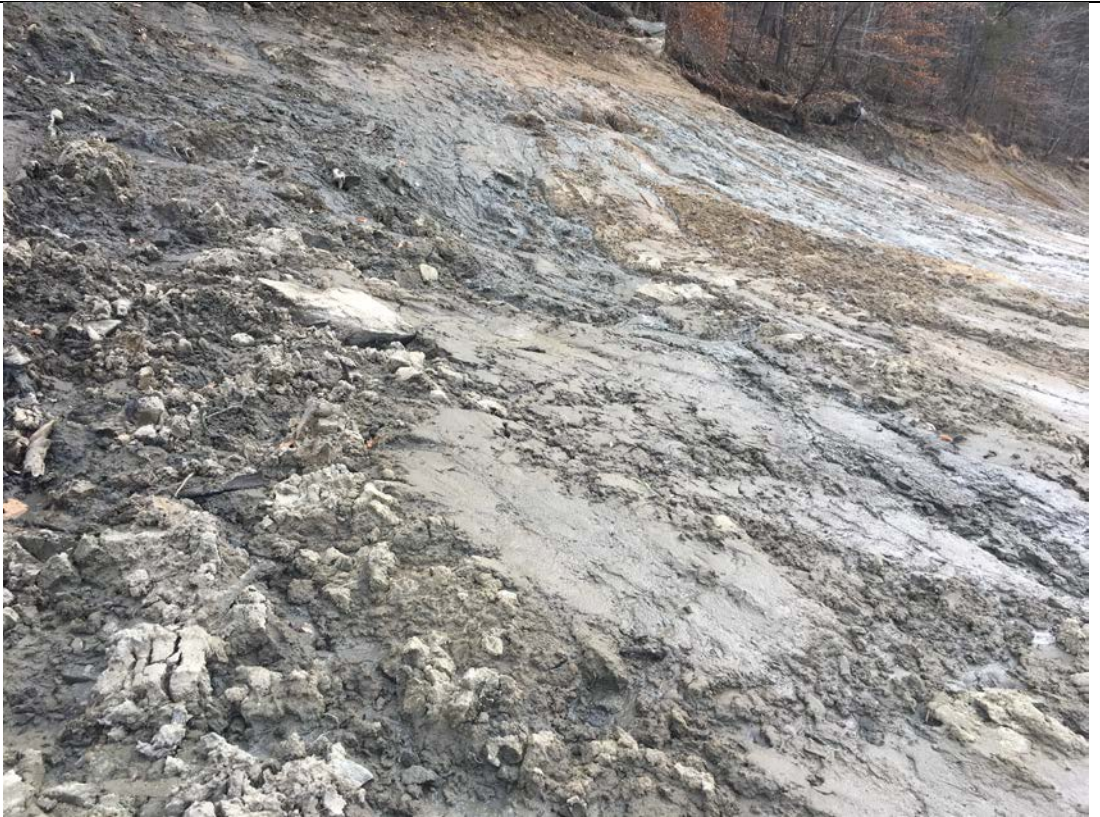
**Photo #3**  
**Observation:**

Bottom of Subject Area looking east, showing the area where CCR has been Visually removed.

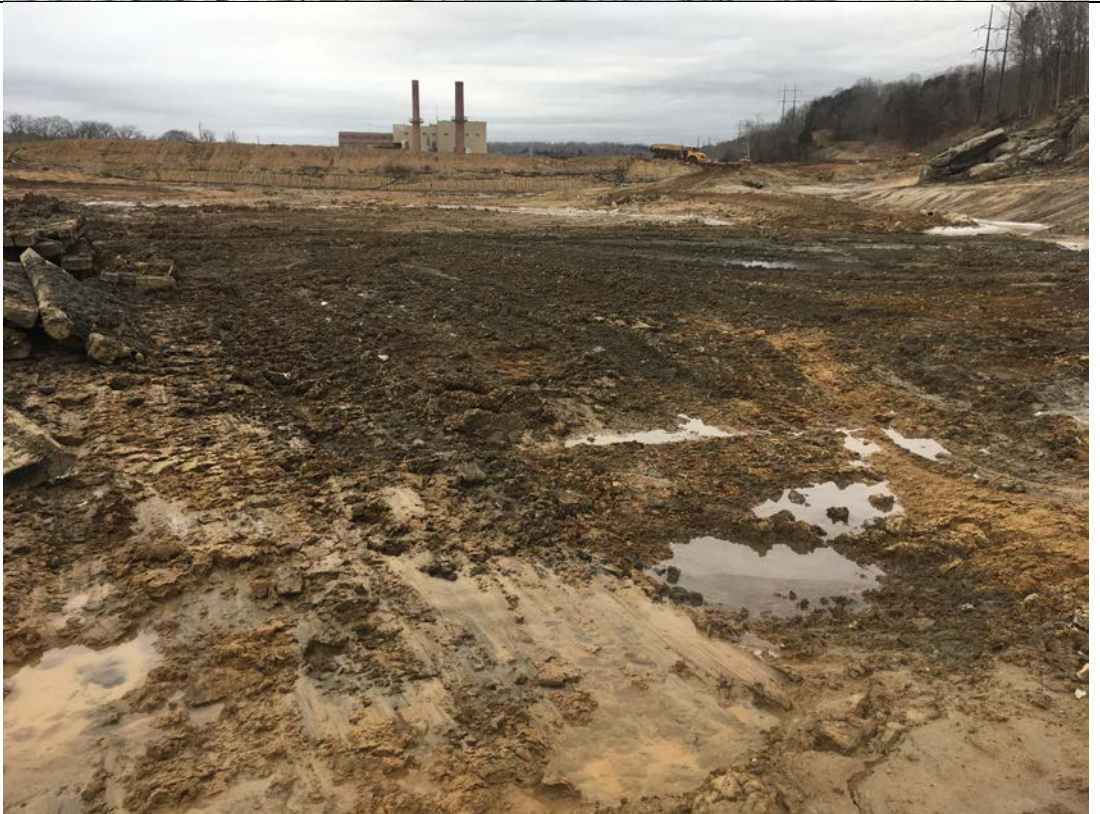
**Photo #4**  
**Observation:**

Bottom of Subject Area looking west, showing the area where CCR has been Visually removed.

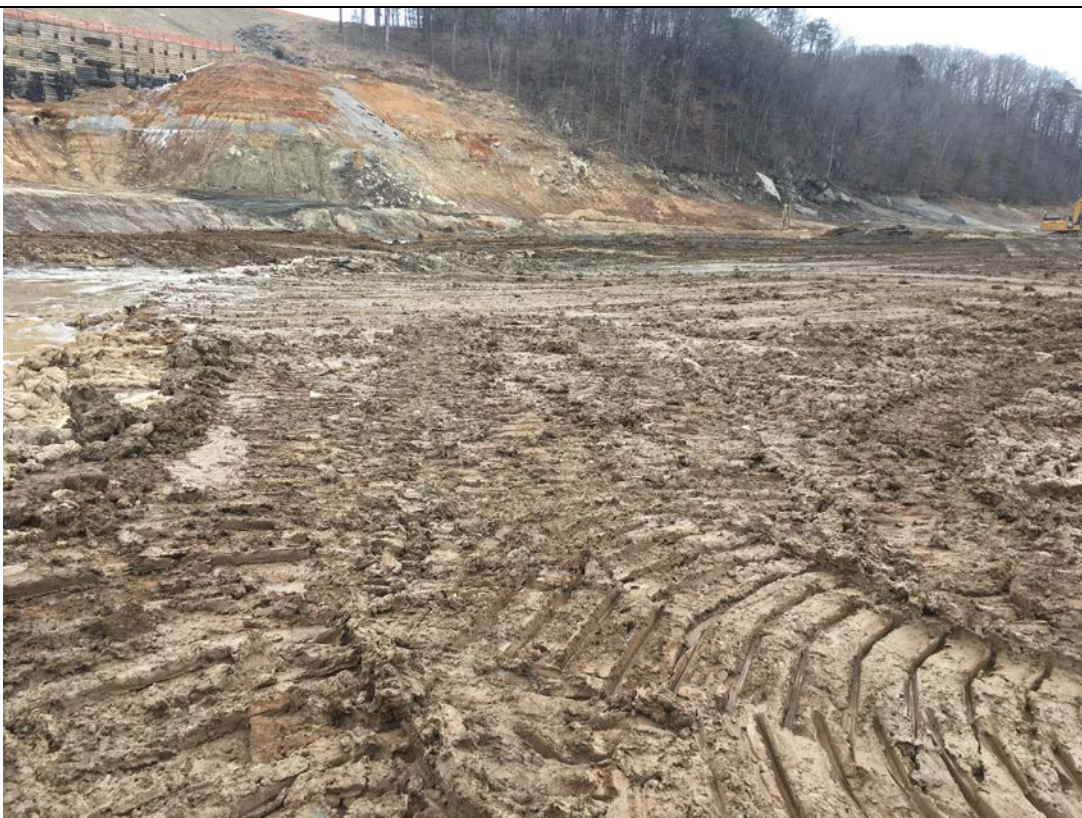
**Photo #5**  
**Observation:**

Bottom of Subject Area looking northeast, showing the area where CCR has been Visually removed.

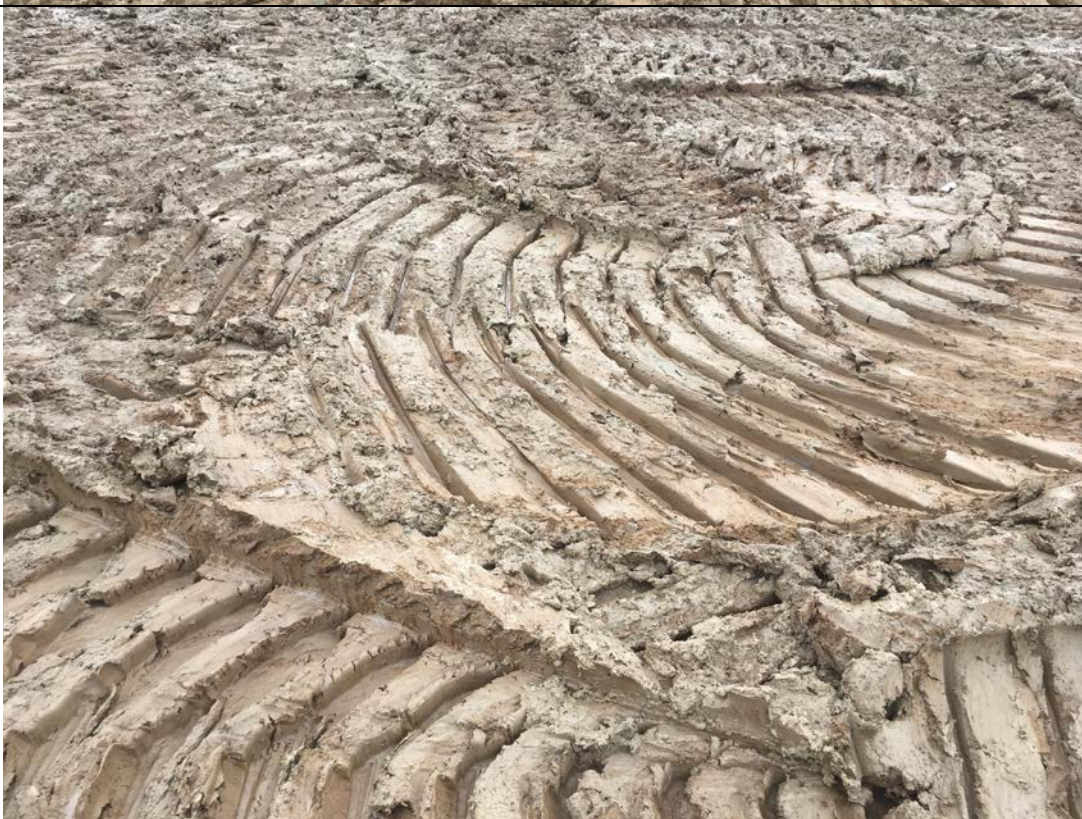
**Photo #6**  
**Observation:**

Bottom of Subject Area showing the area where CCR has been Visually removed.

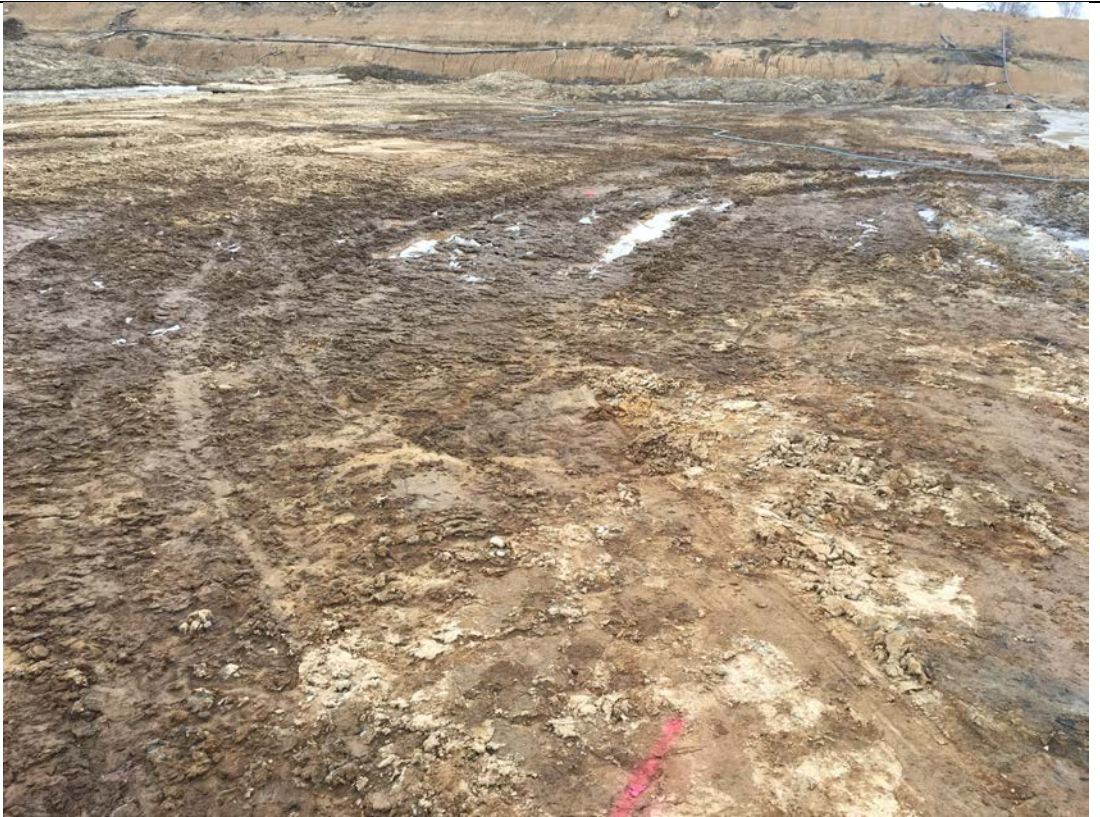
Bottom of Subject Area looking northeast, showing the area where CCR has been Visually removed.

Note:  
The pink line denotes the limits of Visual Removal.

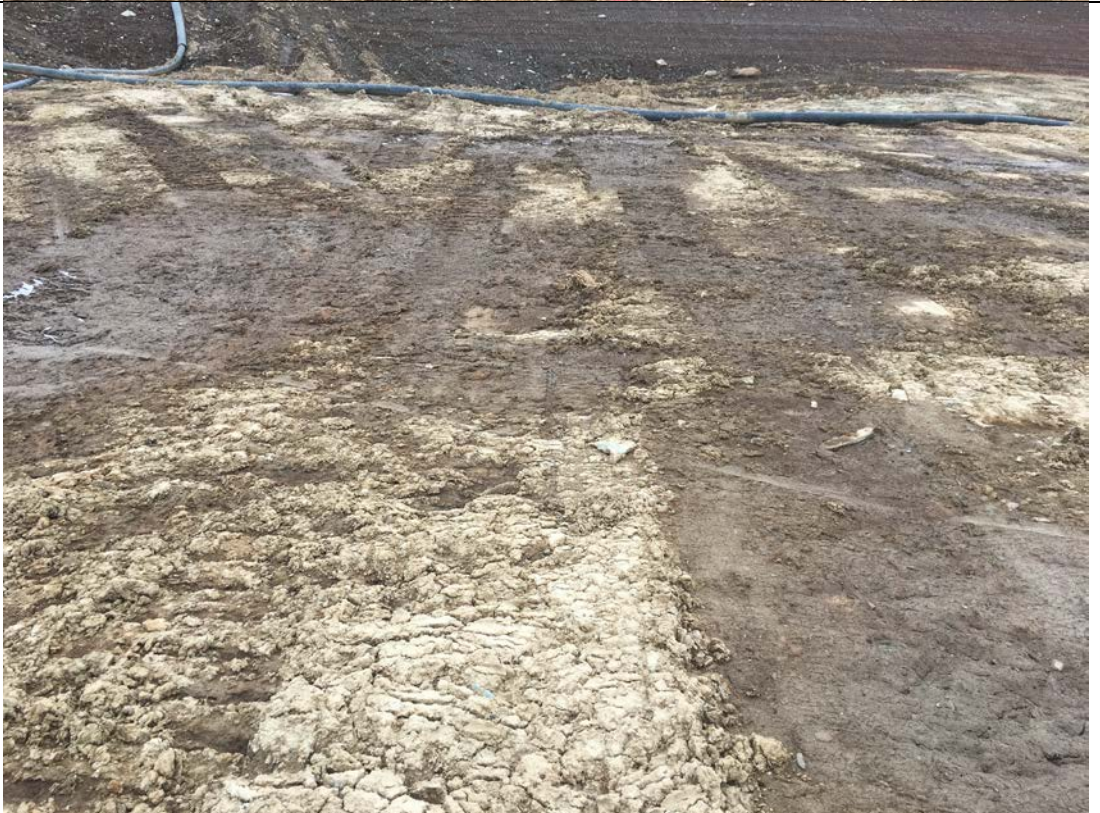
Photo #2  
Observation:

Bottom of Subject Area looking west, showing the area where CCR has been Visually removed.

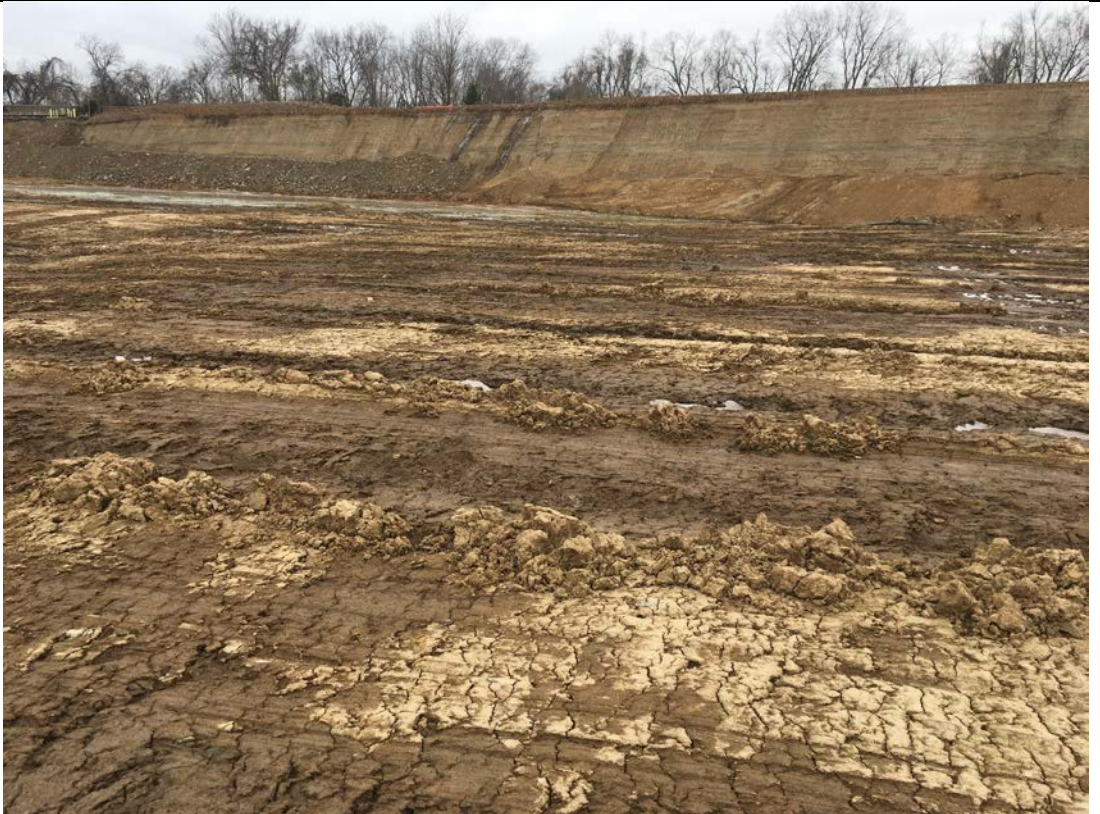
Photo #3

Bottom of Subject Area looking south, showing the area where CCR has been Visually removed.
