RE: Bremono Bluff Power Station, Solid Waste Permit (SWP) 618  
Closure by Removal Construction Report – East Ash Pond  
Fluvanna County, Virginia

## Closure by Removal Construction

May 23, 2019

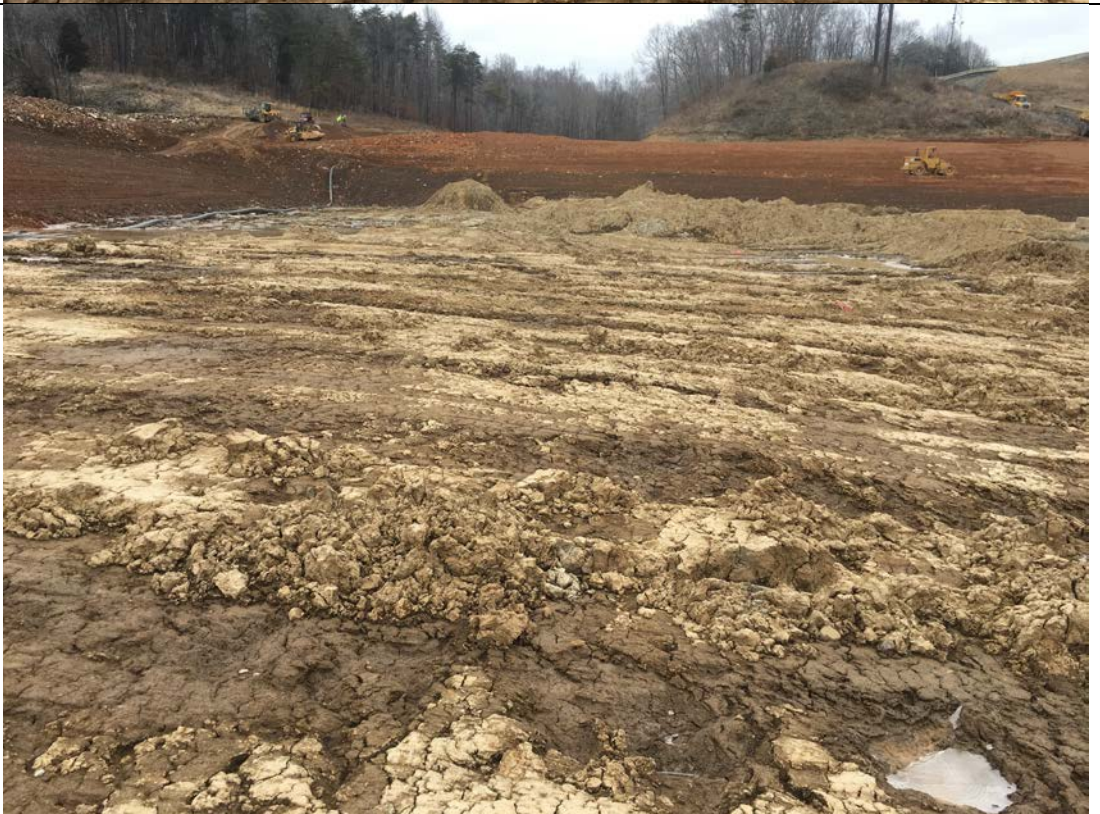
Photo #4

Bottom of Subject Area looking north, showing the area where CCR has been Visually removed.

Note:  
The pink line denotes the limits of Visual Removal.

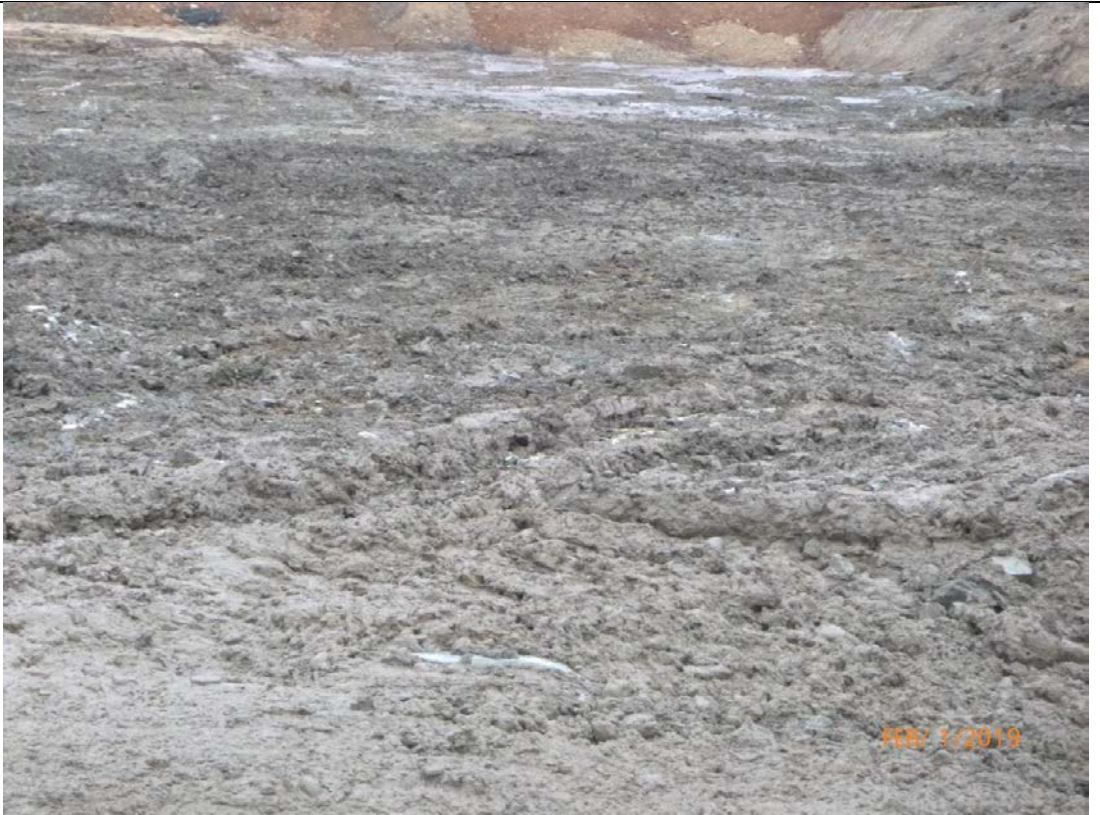
Photo #1  
Observation:

Bottom of Subject Area looking northeast, showing the area where CCR has been Visually removed.

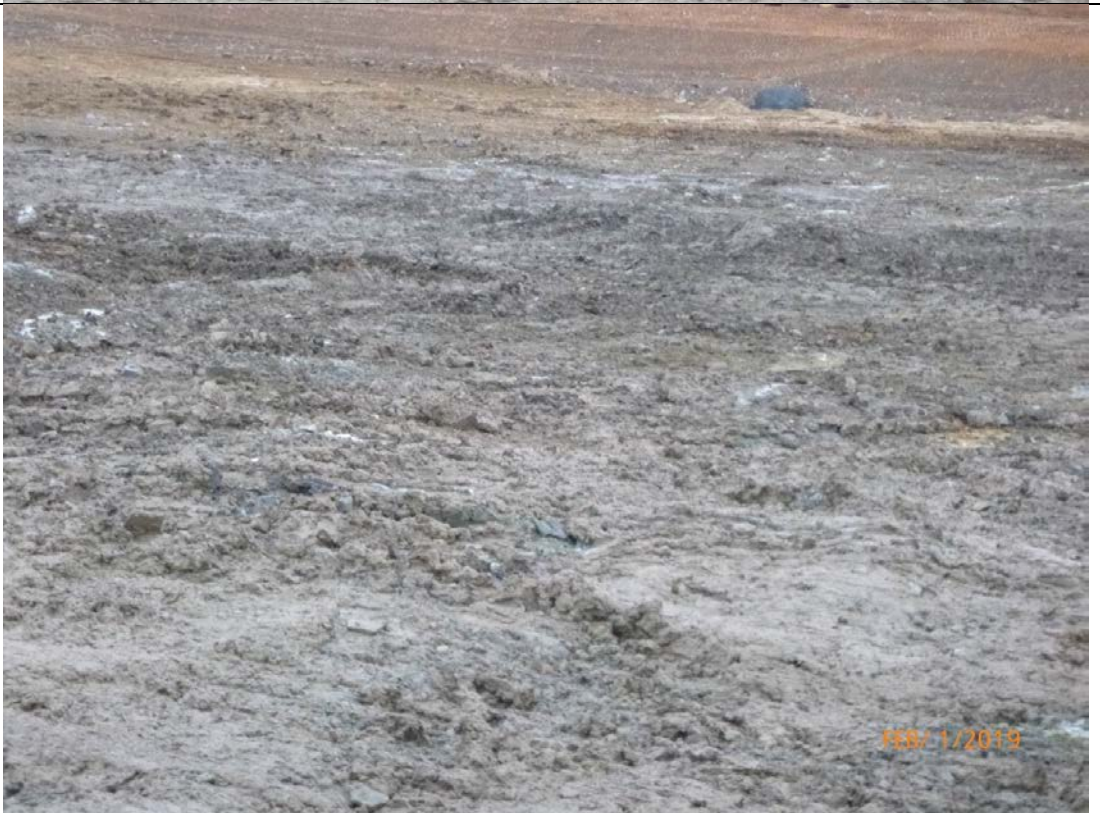
Photo #2  
Observation:

Bottom of Subject Area looking north, showing the area where CCR has been Visually removed.

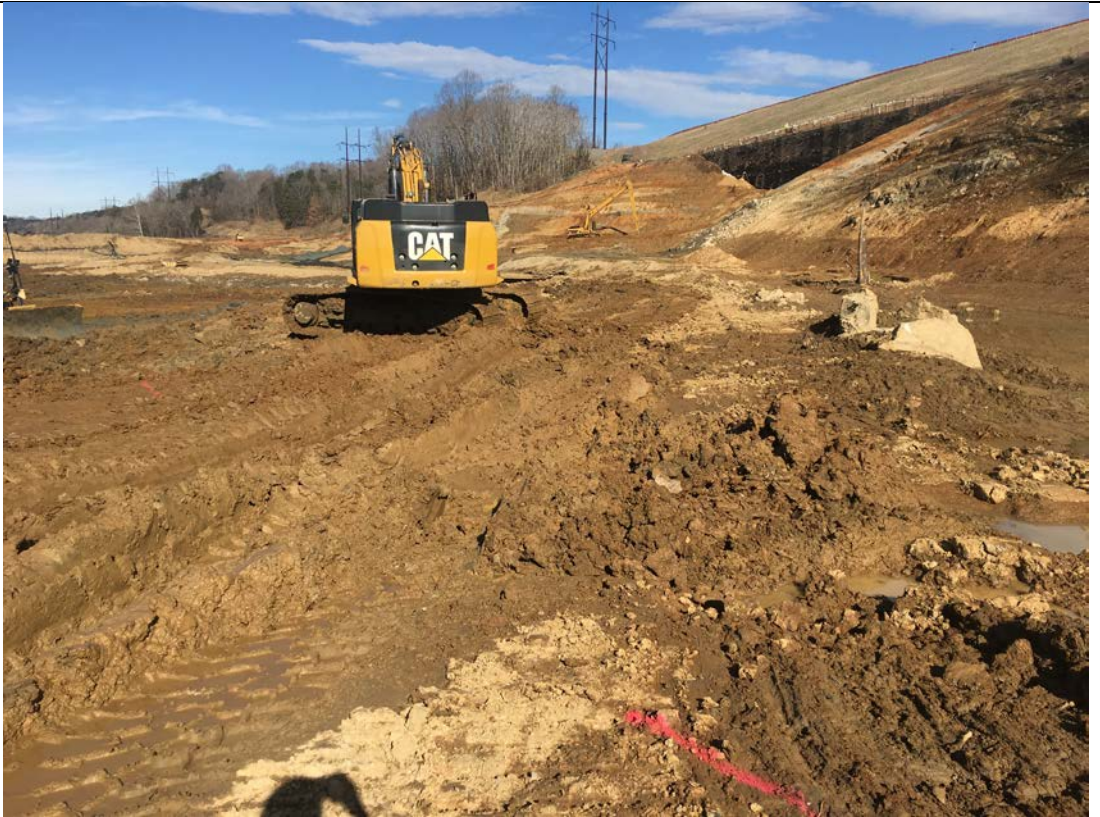
Bottom of Subject Area looking west, showing the area where CCR has been Visually removed.

Note:  
 The pink line denotes the limits of Visual Removal.

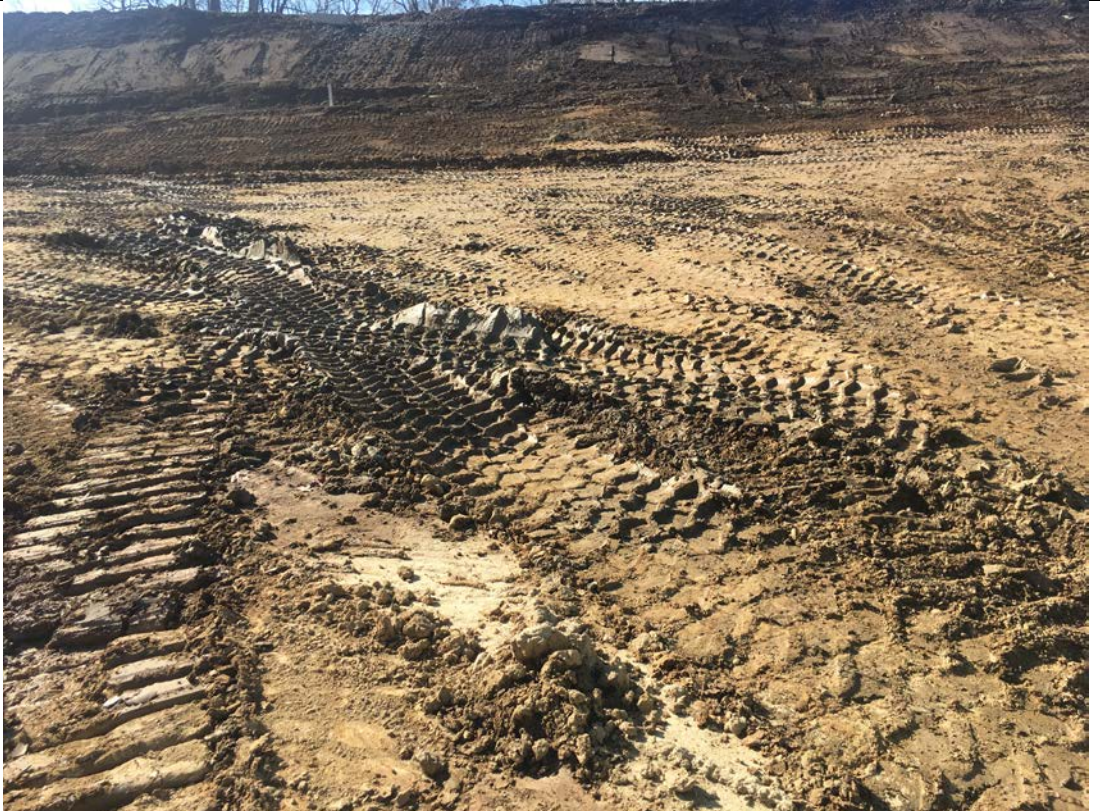
**Photo #2**  
**Observation:**

Bottom of Subject Area looking south, showing the area where CCR has been Visually removed.

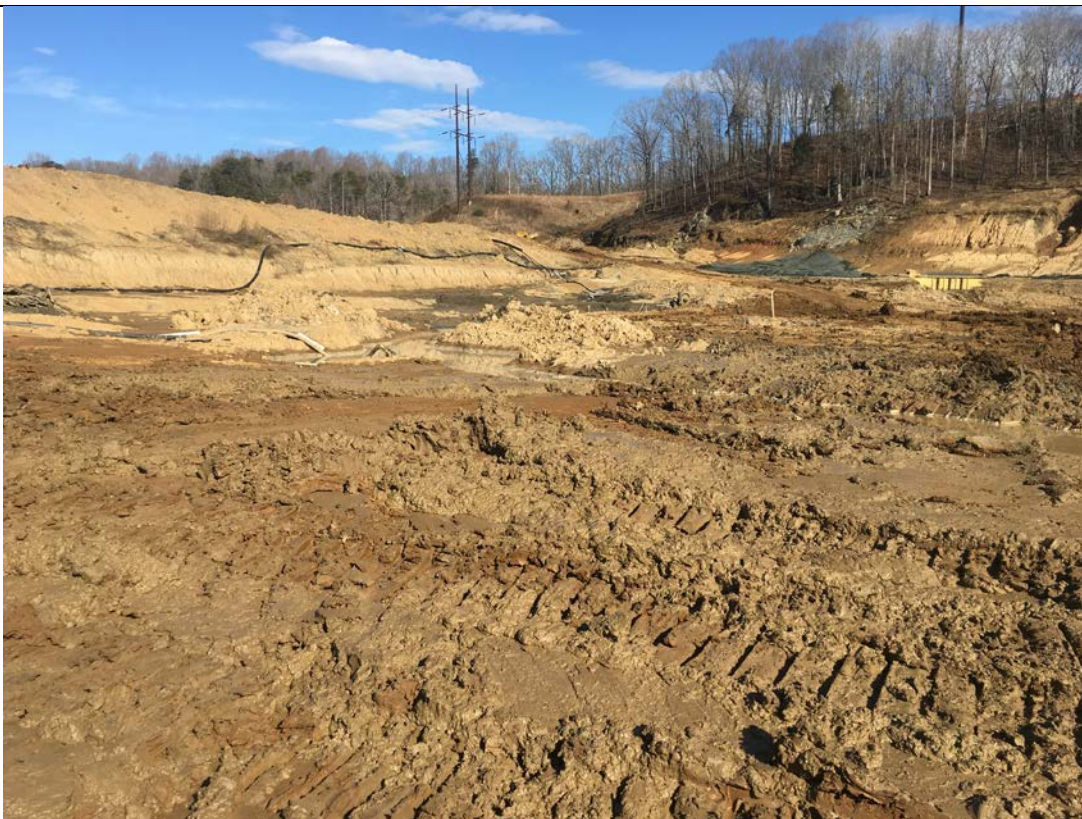
**Photo #3**  
**Observation:**

Bottom of Subject Area looking northwest, showing the area where CCR has been Visually removed.

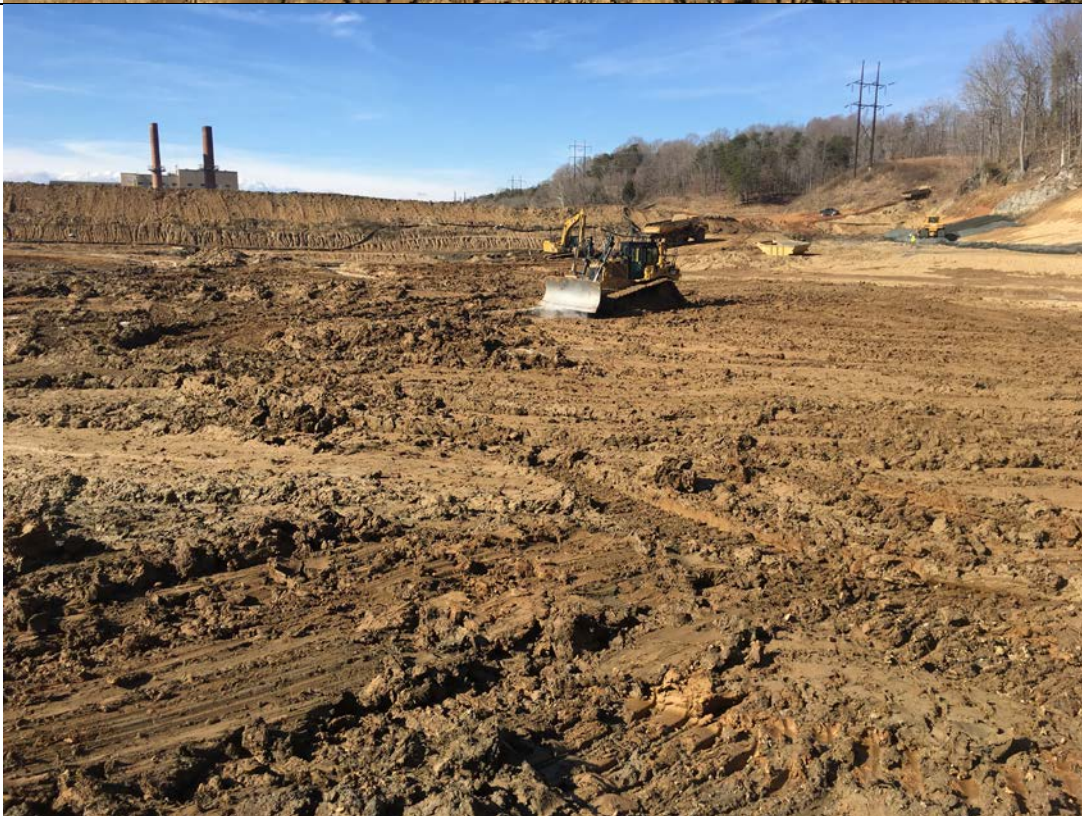
**Photo #4**  
**Observation:**

Bottom of Subject Area looking west, showing the area where CCR has been Visually removed.

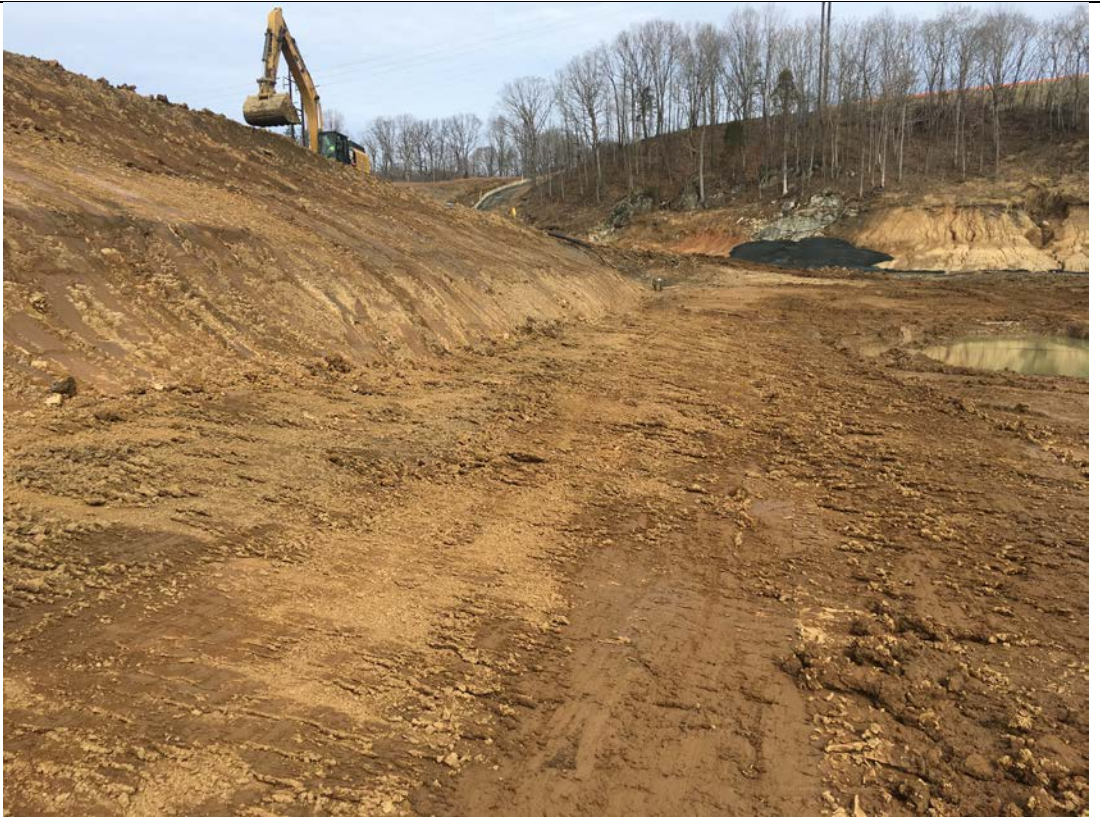
**Photo #1**  
**Observation:**

Bottom of Subject Area looking north, showing the area where CCR has been Visually removed.

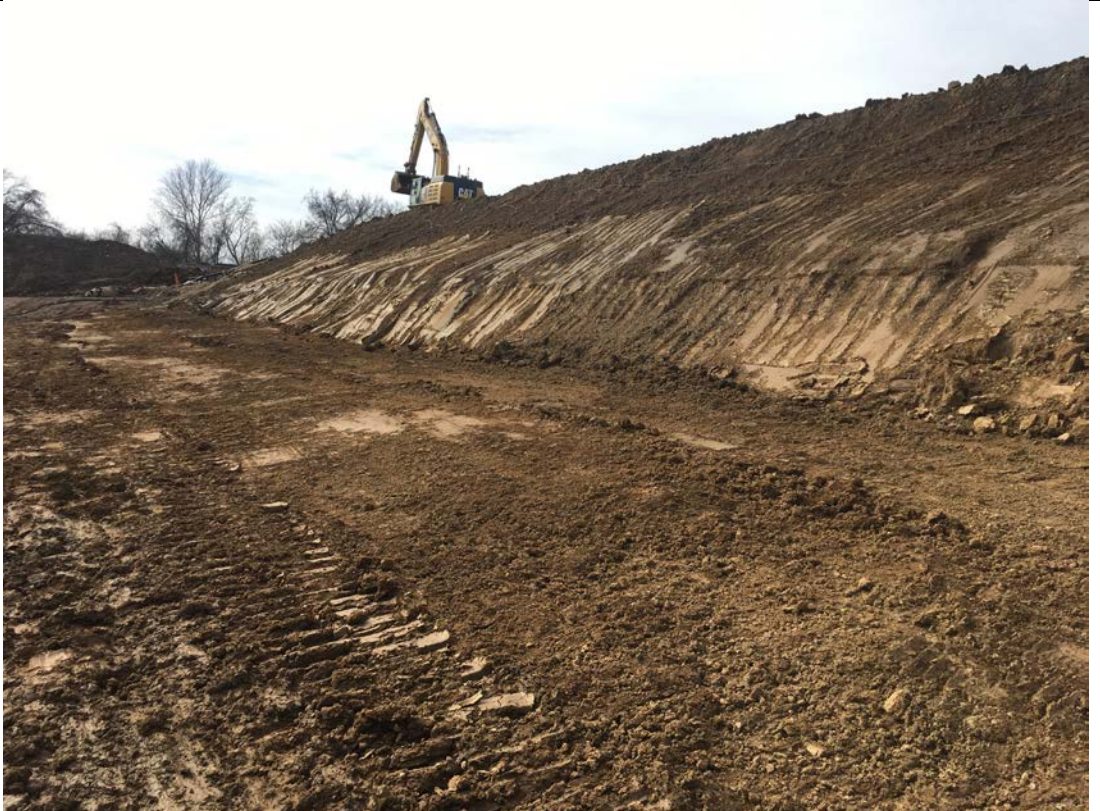
**Photo #2**  
**Observation:**

Bottom of Subject Area looking south, showing the area where CCR has been Visually removed.

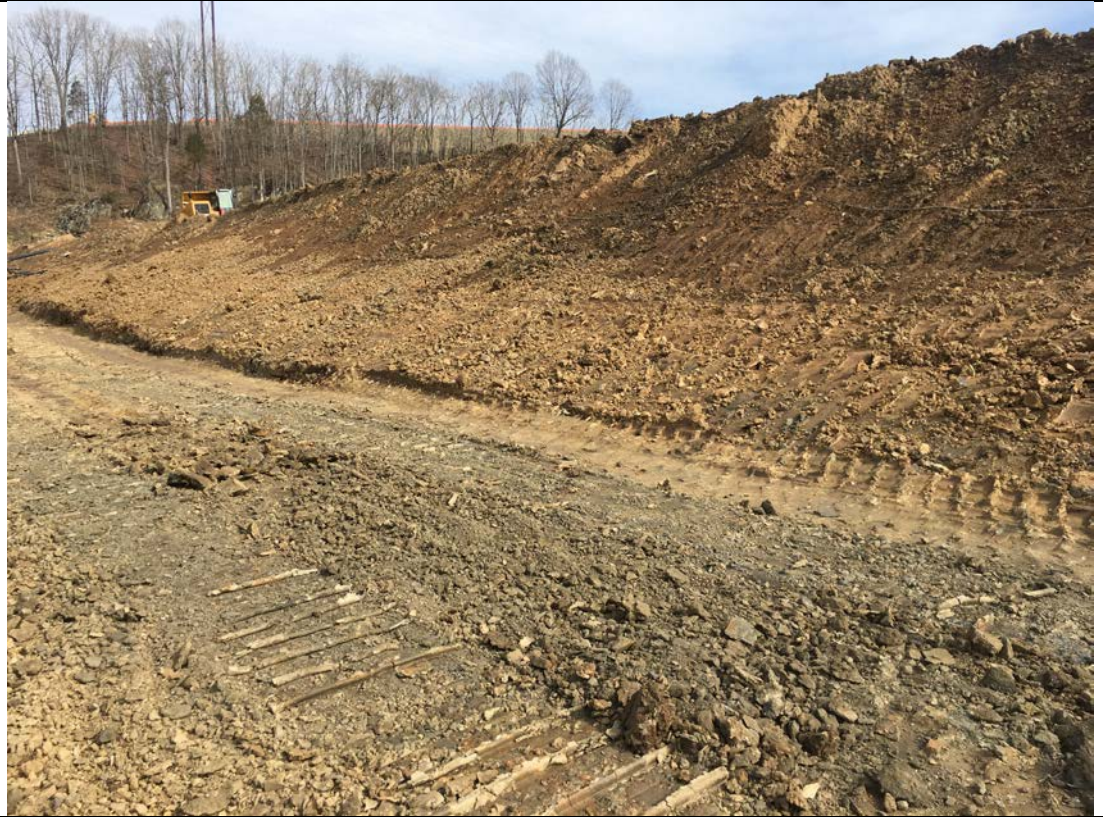
**Photo #3**  
**Observation:**

Bottom of  
Subject Area  
looking  
northeast,  
showing the  
area where  
CCR has been  
Visually  
removed.

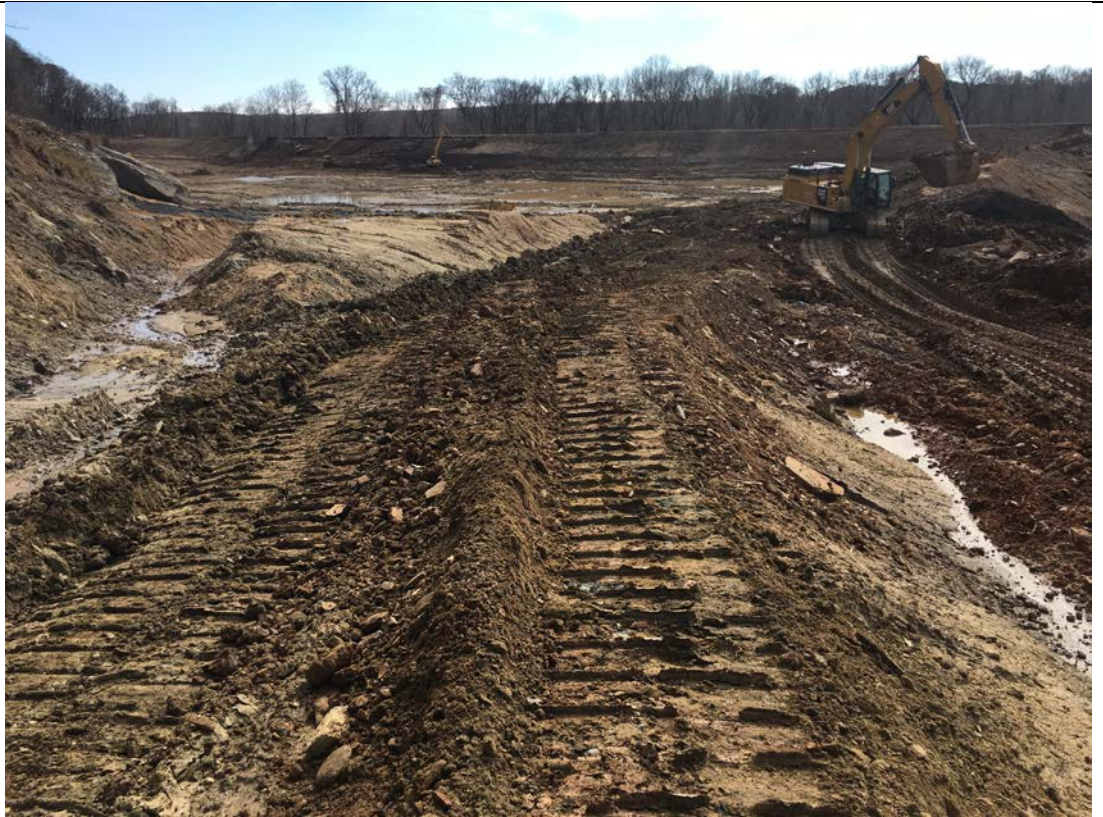
**Photo #2**  
**Observation:**

Bottom of Subject Area looking northeast, showing the area where CCR has been Visually removed.

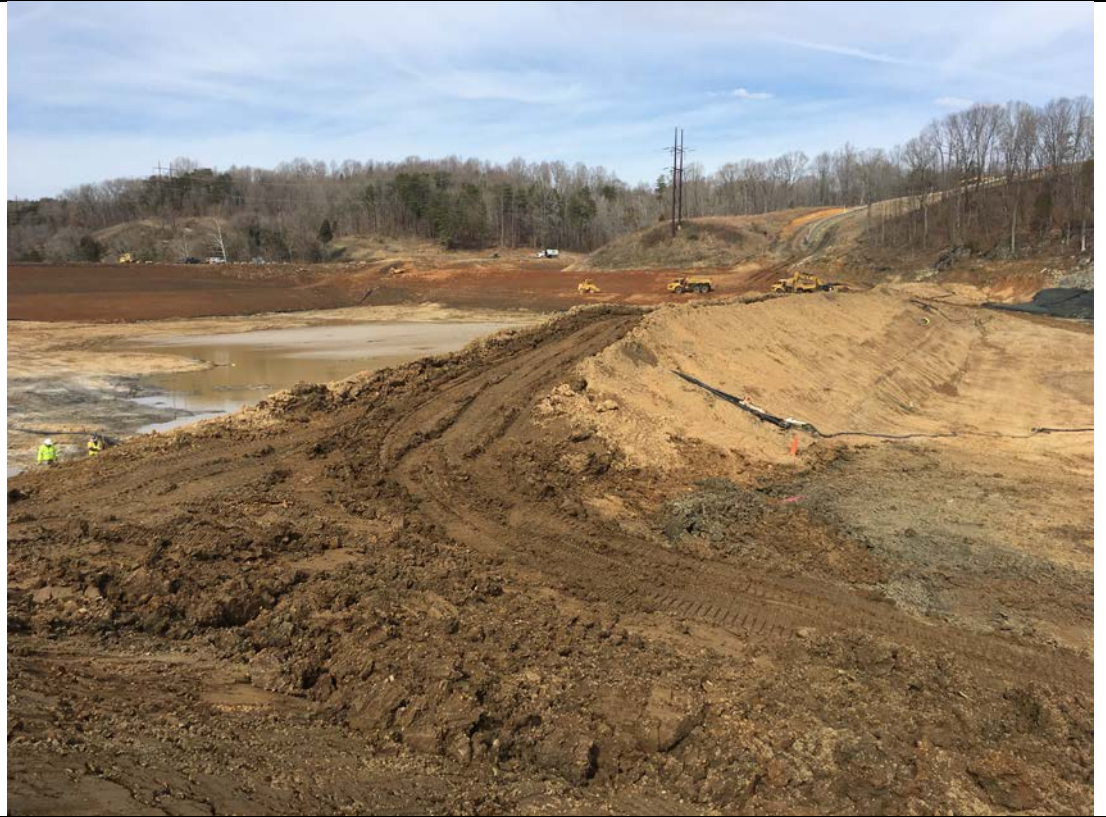
Bottom of Subject Area looking northeast, showing the area where CCR has been Visually removed.

Note:  
The pink line denotes the limits of Visual Removal.
