COMPLAINT INVESTIGATION REPORT

Project Name:	Mountain Valley Pipeline	Inspector:	Marshall Willis
Inspection Date:	Friday, May 16, 2025	Project Contact:	Brian Clauto, Cory Chalmers
Spread H: Roanoke County	MVP-RO-287	Weather:	Dry

Background: This investigation was conducted in response to complaint (IR#: 318928) submitted to PREP on May 15, 2025. The incident describes gravel displaced into wetlands along MVP-RO-287.

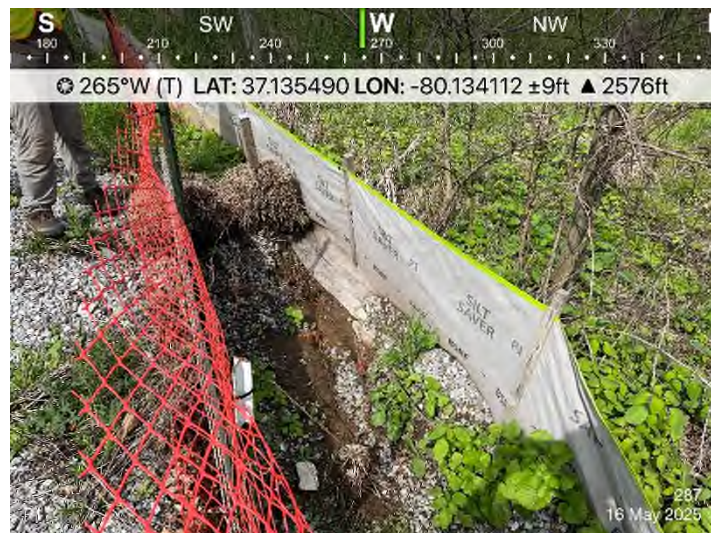
Figure 1: MVP-RO-287 – P1 SF maintenance required.

1. No new impacts were found for Stream S-Z17 or W-IJ62. Old evidence of road material discharged to Wetland W-IJ62 was evident and was reported to MVP in the past. See Figure 3. Retrieval access was denied by the landowner at that time per MVP.
3. No additional sediment discharged off ROW was found during the inspection.
4. Corrective Action was noted during this inspection to repair P1 silt fence along the bridge of S-Z17 on MVP-RO-287.

Corrective Action: Maintain and install all controls per the approved PSS&S.

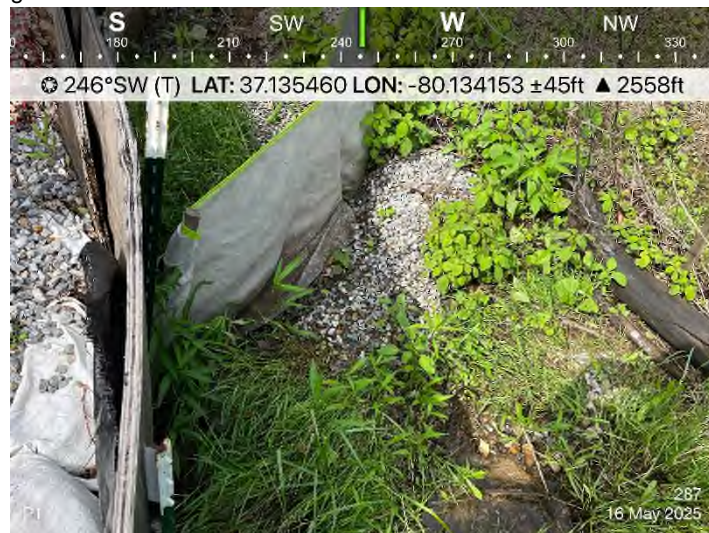
Figure 2: MVP-RO-287 – P1 SF maintenance required. Retrieve gravel.

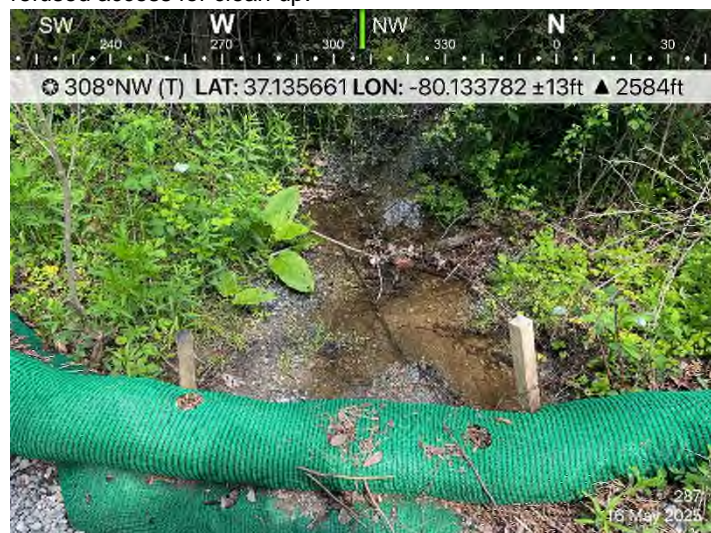
Figure 3: MVP-RO-287 – Evidence of previous gravel washing from RO-287 impacting Wetland W-IJ62. Landowner previously refused access for clean up.
