February 2025

Middle Peninsula Planning District Commission

WORKING WATERFRONTS

RESILIENCE ASSESSMENT REPORT

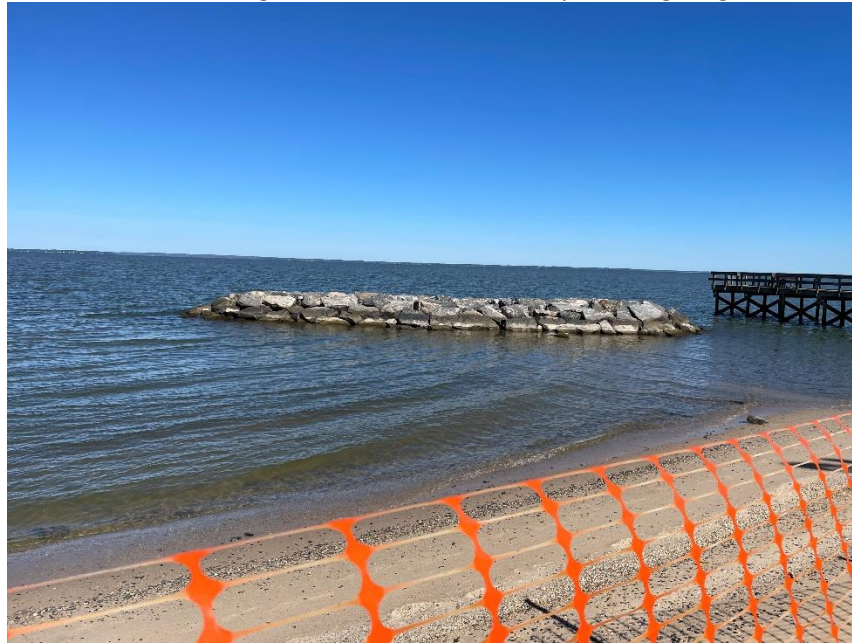
- The project aimed to stabilize the highly eroded shoreline along the Potomac River at Westmoreland State Park.
- It involved constructing a headland breakwater system, adding sand fill, and planting marsh vegetation.
- The project utilized approximately 23,000 tons of sand and 20,000 tons of rock to reduce wave energy and stabilize the shoreline.
- It is now completed, with ongoing monitoring to track the project's effectiveness.
- The project addresses land degradation due to erosion, providing long-term shoreline protection.

Figure 2. Westmoreland State Park breakwater.

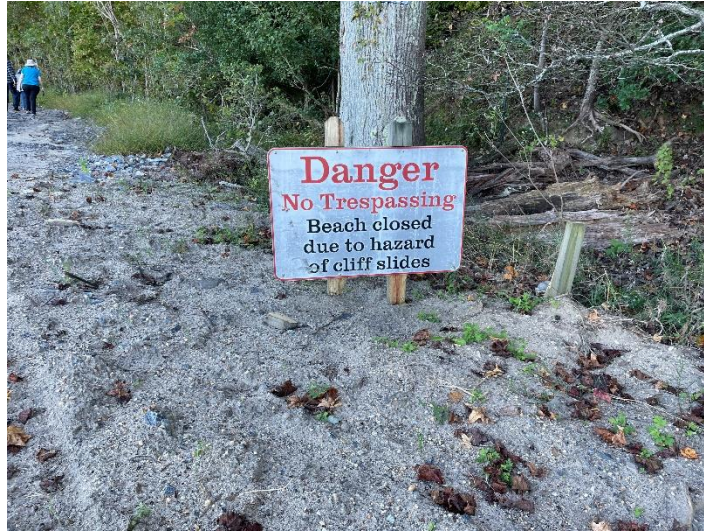
- The project aims to address slope failure along the Potomac River shoreline at Westmoreland State Park, caused by groundwater buildup atop clay layers.
- It will stabilize approximately 5.31 acres of shoreline, with a focus on controlling groundwater erosion and implementing drainage improvements, including the installation of two French drains.
- The project has been budgeted for near-term progression but has not yet begun construction.

Figure 3. Danger sign for cliff slides at Westmoreland State Park.

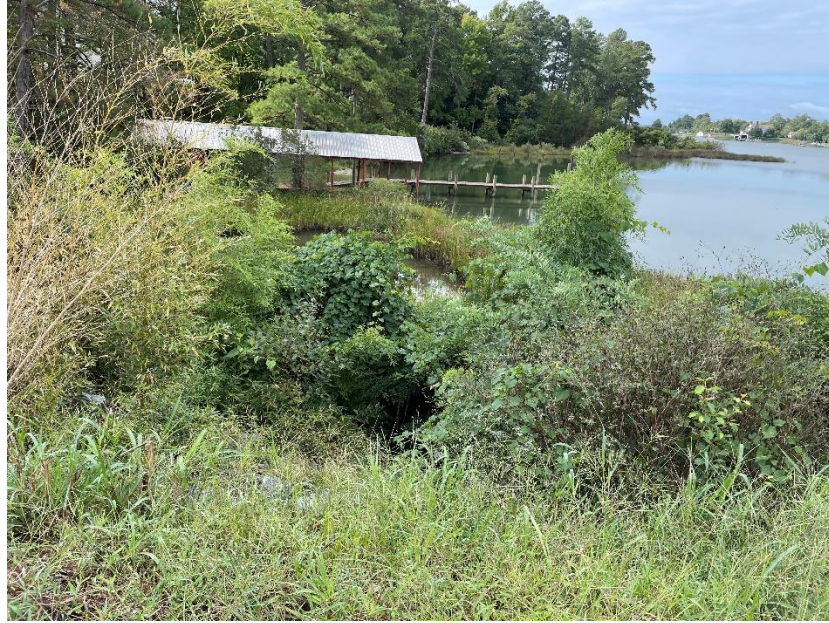
Figure 4. Shoreline along Tides Inn property that could be converted to a living shoreline.

- The project aims to stabilize the shoreline along Carter Creek in Lancaster County, Virginia, with a combination of breakwaters, beach nourishment, a vinyl sill, bulkhead, elevated boardwalk, and marsh planting.
- It is designed to restore the historic shoreline and incorporate an elevated boardwalk/wharf, benefiting the surrounding sub-watershed.
- The project has been identified through a formal planning process, with the goal of addressing land degradation, sea level rise, and tidal flooding impacts.
- The project is currently in the proposed phase, with no confirmed funding or construction start date. The permit for the project was received in February 2021, and the estimated end date for completion is January 2024.

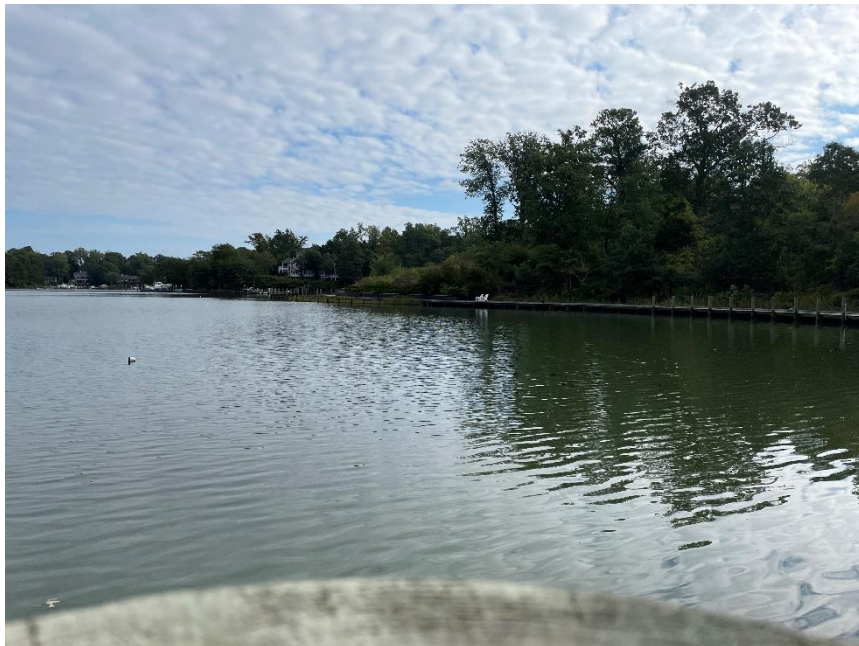
Figure 5. Existing living shoreline installed at the Tides Inn – a potential model for the rest of the property’s shoreline.

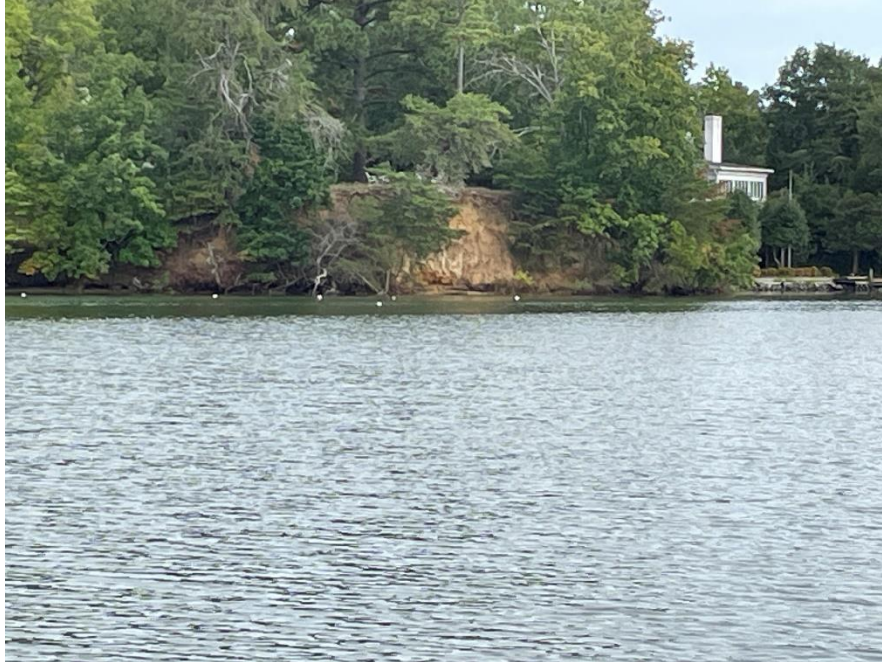
- The project focuses on stabilizing the eroding bank along Carter Creek in Lancaster County, Virginia, near the site of a former restaurant (The Binnacle), which is now demolished.
- It aims to prevent shoreline and tree loss, following a similar approach to bank stabilization on the opposite side of Carter Creek.

Figure 6. Eroding bank on opposite side of Carters Creek from the main Tides Inn property.

- This project is designed to address land degradation and will contribute to ecosystem restoration in the area, supporting marsh and oyster recruitment efforts.
- The project is still in the proposed phase, with no finalized scope or permits in place. The project is in the early stages of planning and is expected to align with environmental initiatives already undertaken at the Tides Inn property.
