EXHIBIT 14 - PHOTOGRAPHS

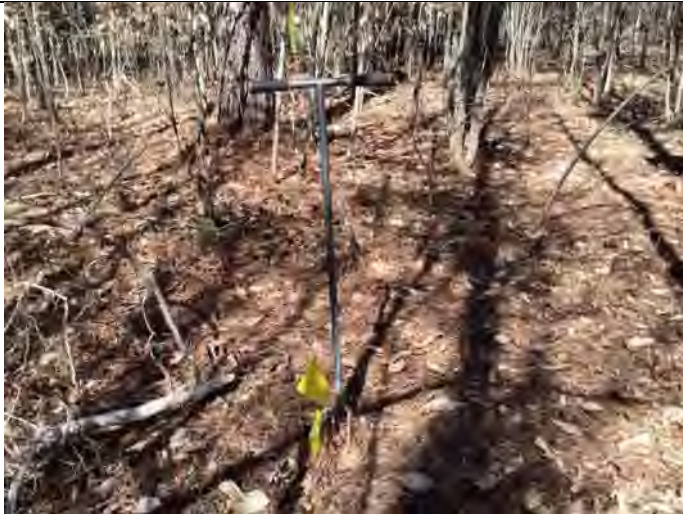
Photo 1:

Looking at Data Point #1, which characterizes an upland. This area lacked hydric soil and wetland hydrology. Attachment I; Sheet 2.

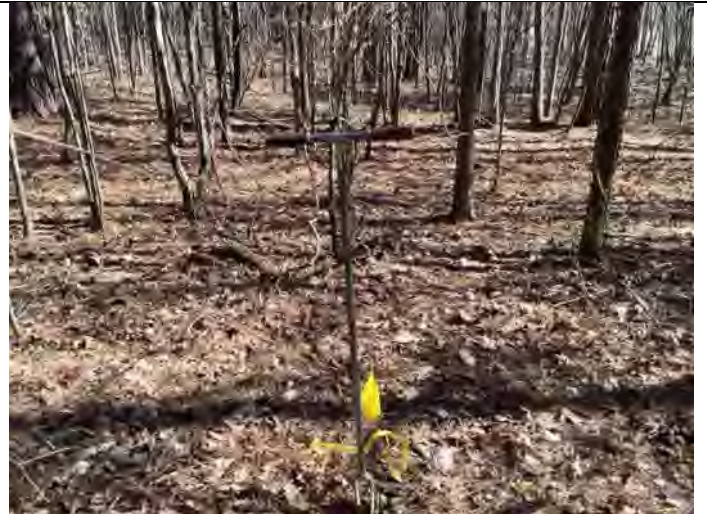
Photo 2:

Looking at Data Point #2, which characterizes a palustrine forested wetland (PFO). This area contained all three wetland parameters. Attachment I; Sheet 2.

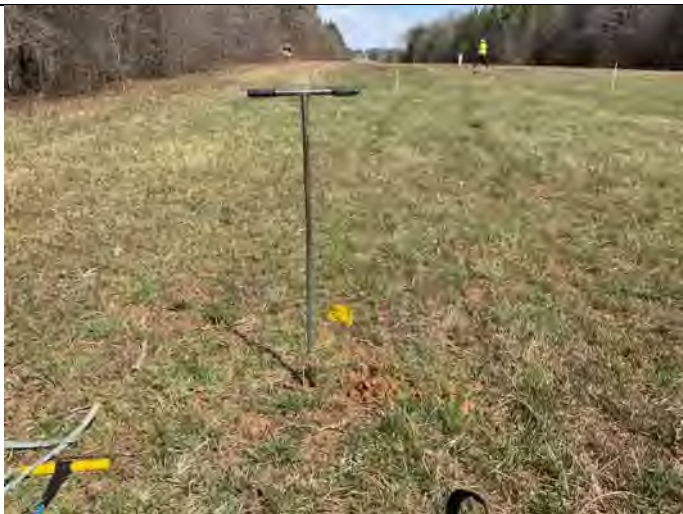
Photo 3:

Looking at Data Point #3, which characterizes an upland. This area lacked wetland hydrology, hydrophytic vegetation, and hydric soils. Attachment I; Sheet 2.

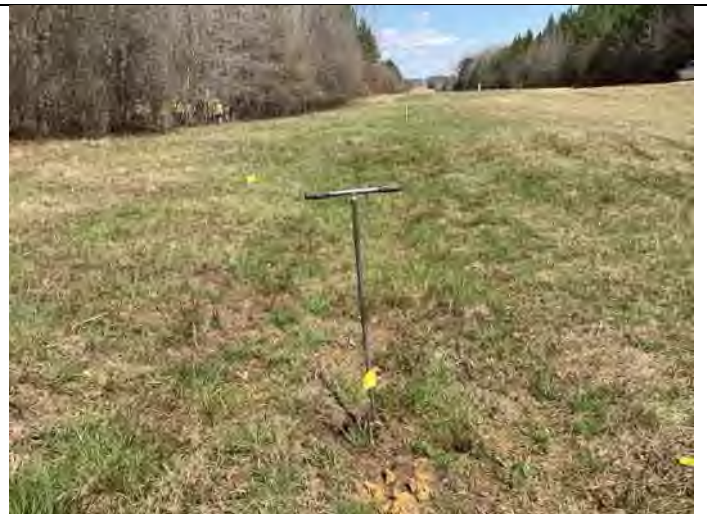
Photo 4:

Looking at Data Point #4, which characterizes a palustrine emergent wetland (PEM). This area contained all three wetland parameters. Attachment I; Sheet 2.

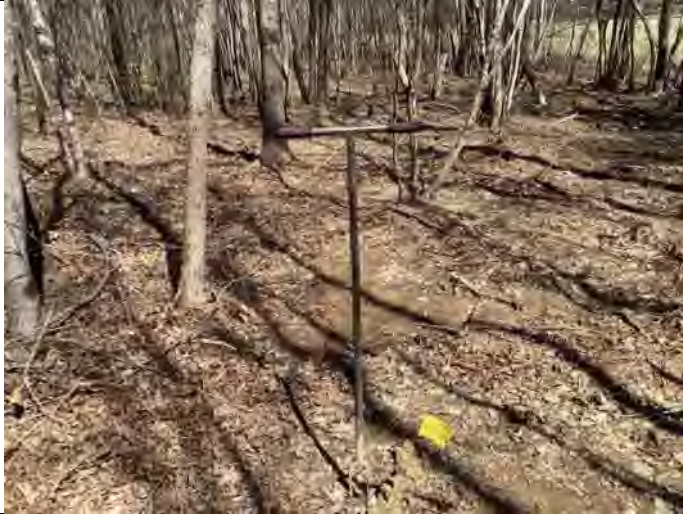
Photo 5:

Looking at Data Point #5, which characterizes a PFO wetland. This area contained all three wetland parameters. Attachment I; Sheet 2.

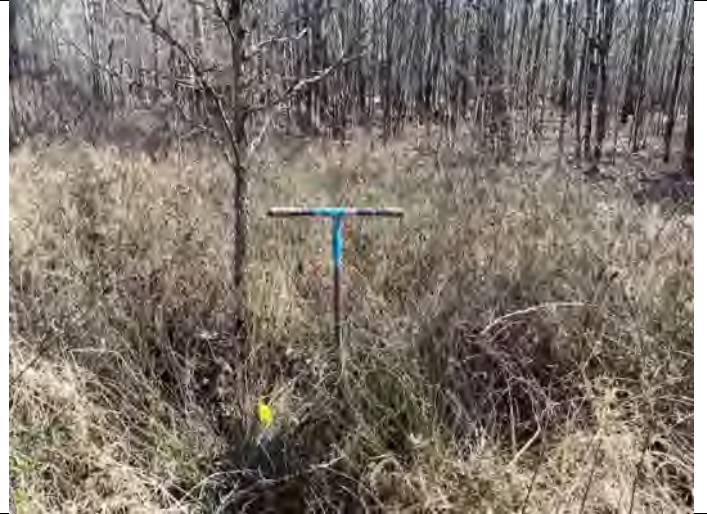
Photo 6:

Looking at Data Point #6, which characterizes a palustrine scrub-shrub (PSS) wetland. This area contained all three wetland parameters. Attachment I; Sheet 2.

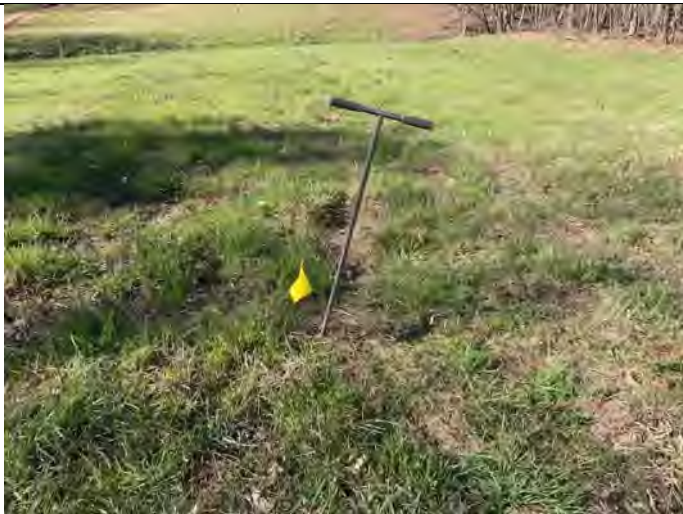
Photo 7:

Looking at Data Point #7, which characterizes an upland. This area lacked wetland hydrology, hydrophytic vegetation, and hydric soils. Attachment I; Sheet 2.

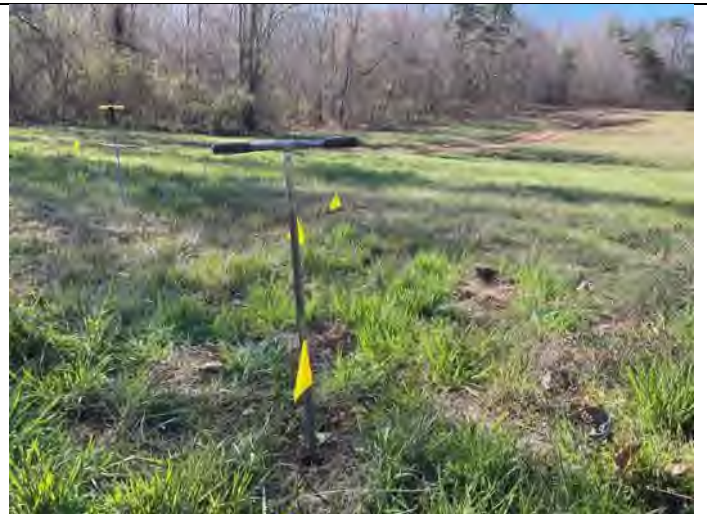
Photo 8:

Looking at Data Point #8, which characterizes a PEM wetland. This area contained all three wetland parameters. Attachment I; Sheet 2.

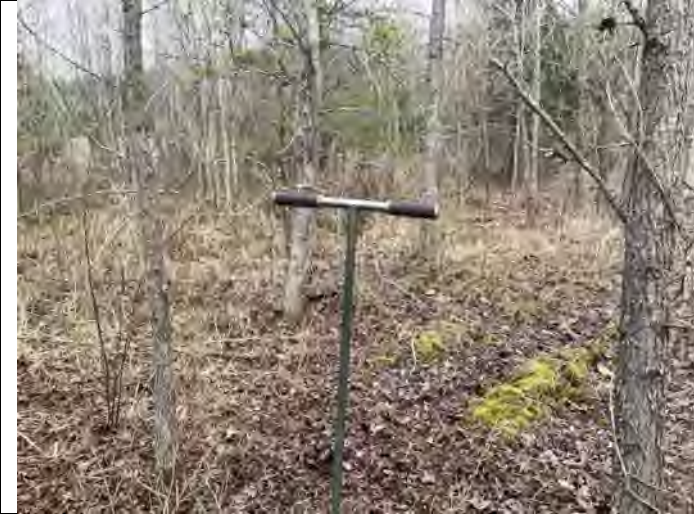
Photo 9:

Looking at Data Point #11, which characterizes a PFO wetland. This area contained all three wetland parameters. Attachment I; Sheet 3.

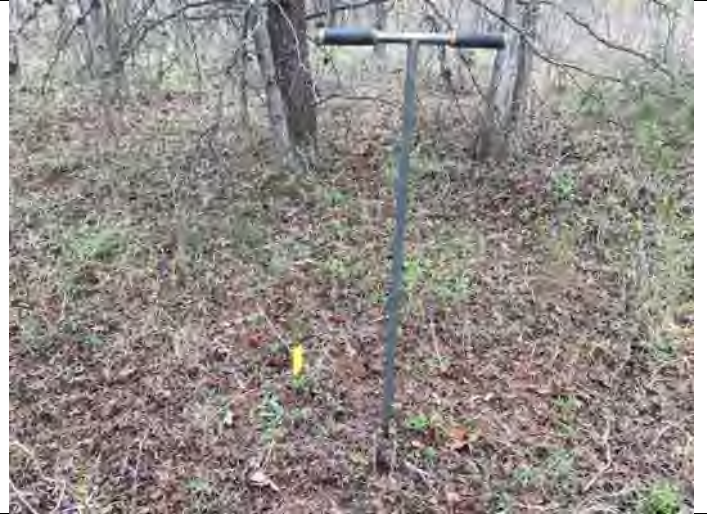
Photo 10:

Looking at Data Point #12, which characterizes an upland. This area lacked wetland hydrology, hydrophytic vegetation, and hydric soils. Attachment I; Sheet 3.

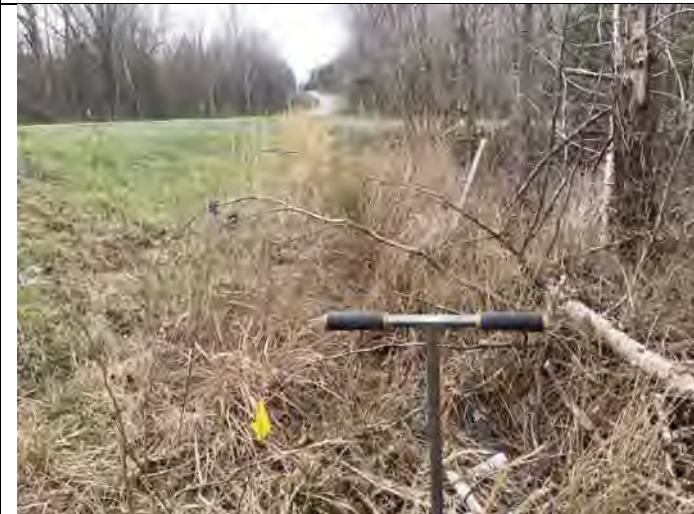
Photo 11:

Looking at Data Point #13, which characterizes a PEM wetland. This area contained all three wetland parameters. Attachment I; Sheet 3.

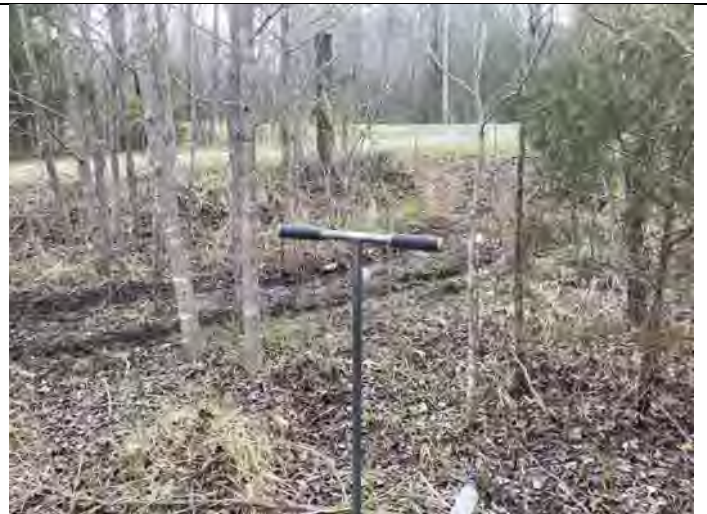
Photo 12:

Looking at Data Point #14, which characterizes a PFO wetland. This area contained all three wetland parameters. Attachment I; Sheet 3.

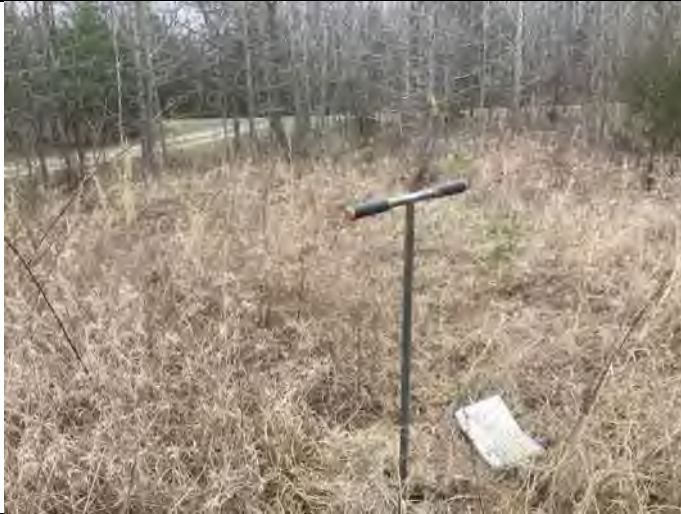
Photo 13:

Looking at Data Point #15, which characterizes a PEM wetland. This area contained all three wetland parameters. Attachment I; Sheet 3.

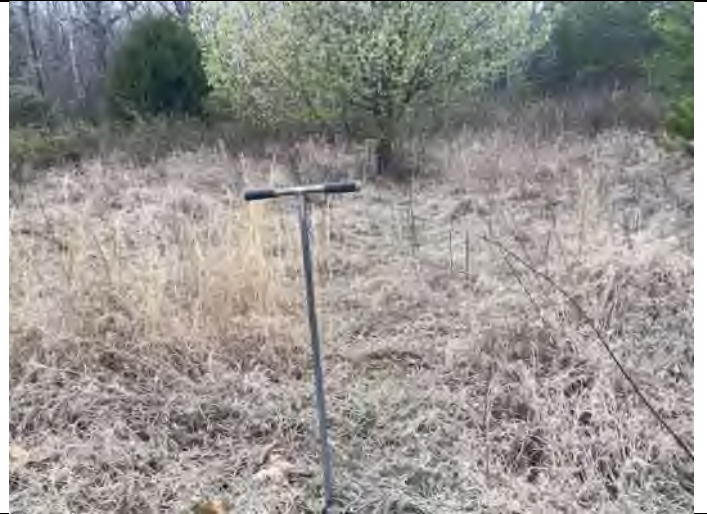
Photo 14:

Looking at Data Point #16, which characterizes an upland. This area lacked wetland hydrology, hydrophytic vegetation, and hydric soils. Attachment I; Sheet 3.

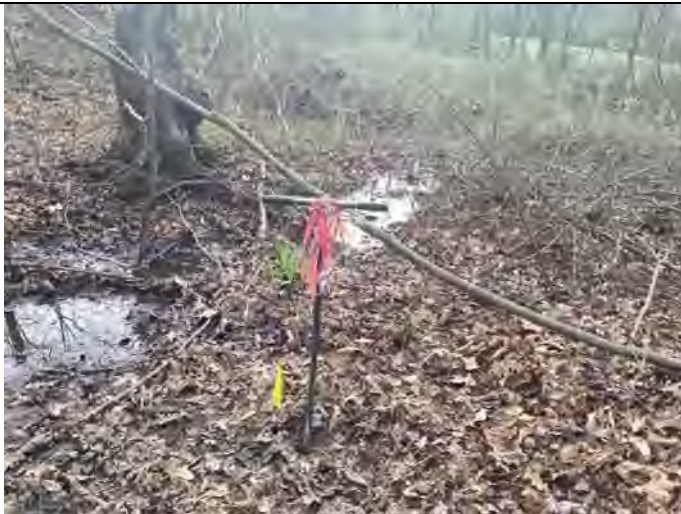
Photo 15:

Looking at Data Point #19, which characterizes a PFO wetland. This area contained all three wetland parameters. Attachment I; Sheet 10.

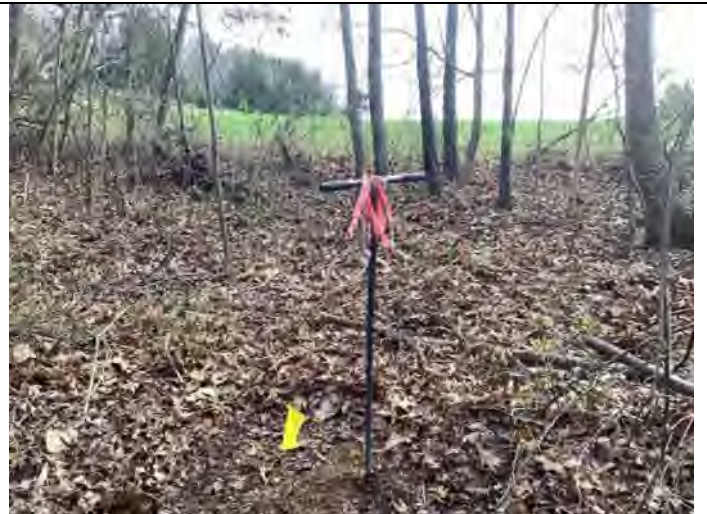
Photo 16:

Looking at Data Point #21, which characterizes an upland. This area lacked wetland hydrology, hydrophytic vegetation, and hydric soils. Attachment I; Sheet 10.

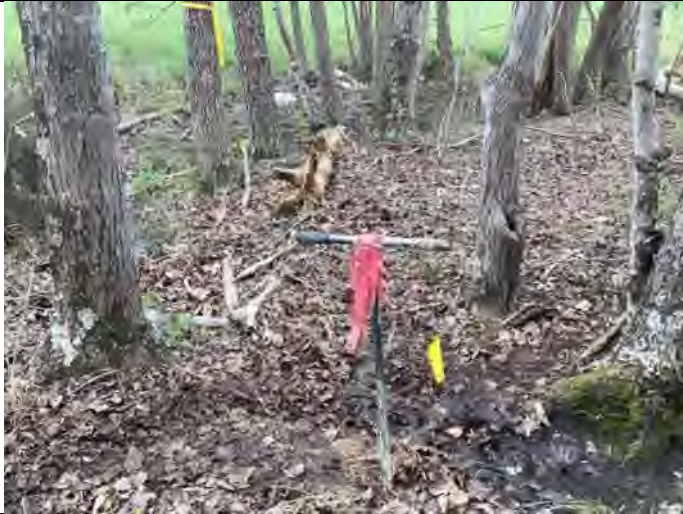
Photo 17:

Looking at Data Point #26, which characterizes a PFO wetland. This area contained all three wetland parameters. Attachment I; Sheet 10.

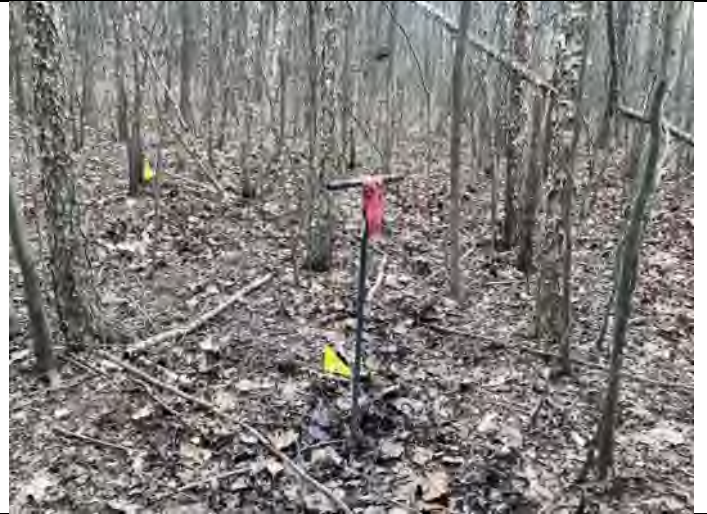
Photo 18:

Looking at Data Point #30, which characterizes a PFO wetland. This area contained all three wetland parameters. Attachment I; Sheet 10.

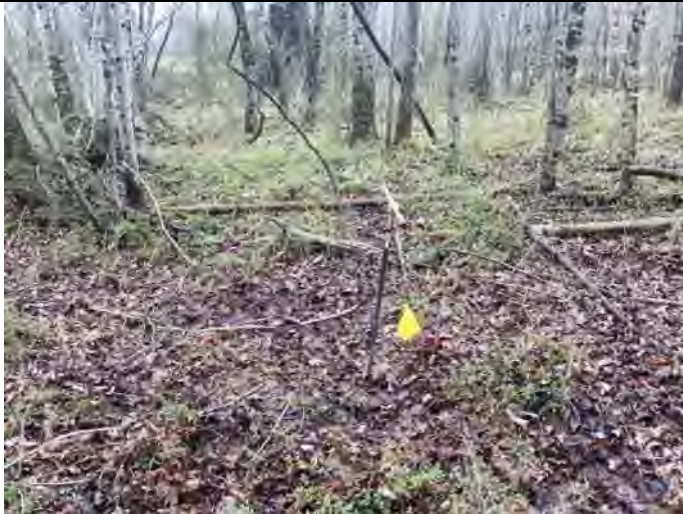
Photo 19:

Looking at Data Point #35, which characterizes a PFO wetland. This area contained all three wetland parameters. Attachment I; Sheet 14.

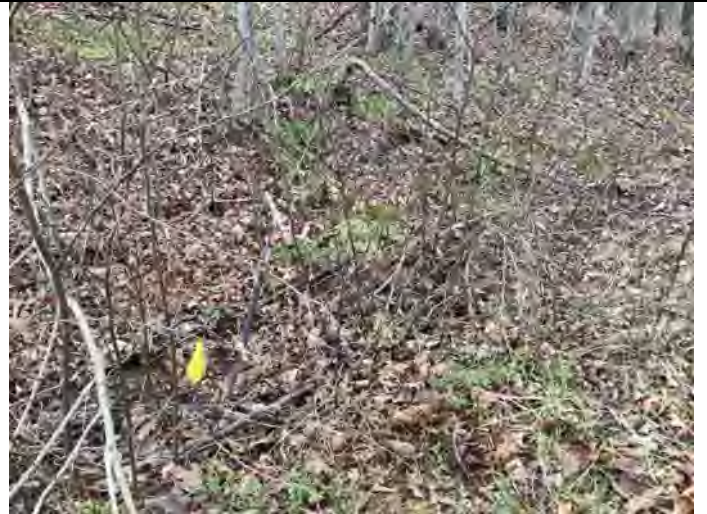
Photo 20:

Looking at Data Point #37, which characterizes an upland. This area lacked wetland hydrology, hydrophytic vegetation, and hydric soils. Attachment I; Sheet 14.

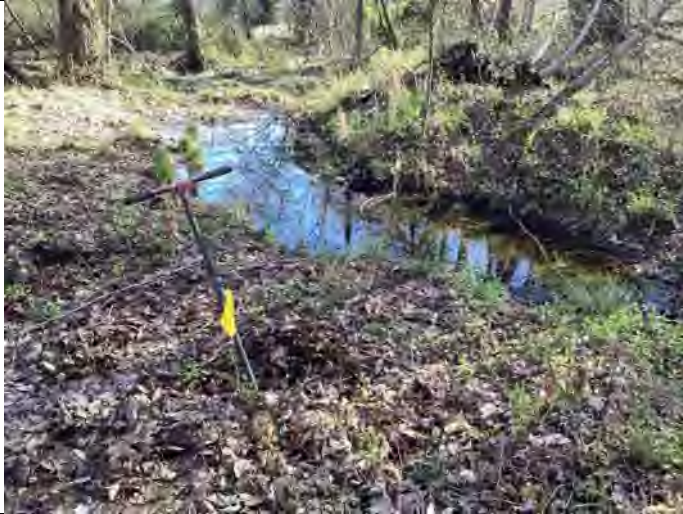
Photo 21:

Looking at Data Point #38, which characterizes a PFO wetland. This area contained all three wetland parameters. Attachment I; Sheet 14.

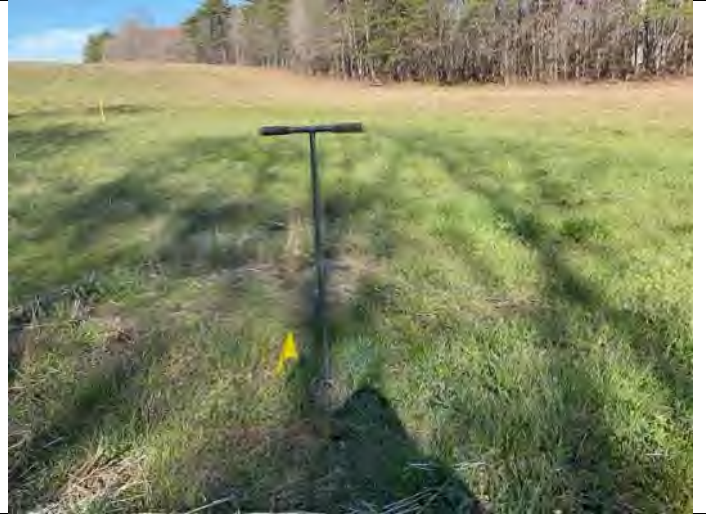
Photo 22:

Looking at Data Point #39, which characterizes a PEM wetland. This area contained all three wetland parameters. Attachment I; Sheet 14.

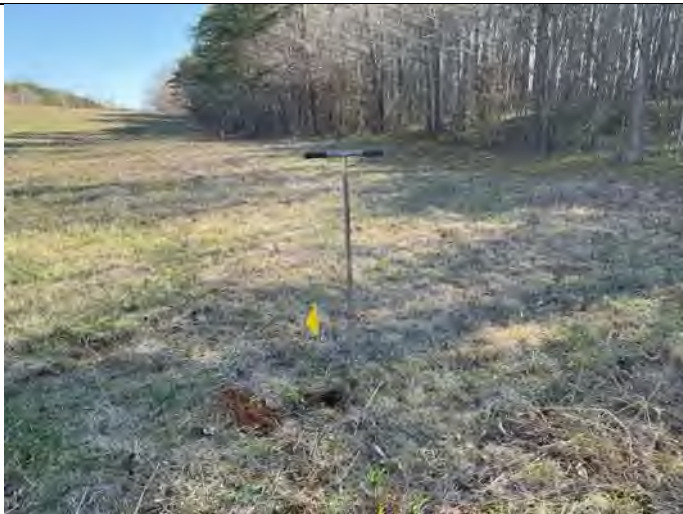
Photo 23:

Looking at Data Point #40, which characterizes an upland. This area lacked wetland hydrology, hydrophytic vegetation, and hydric soils. Attachment I; Sheet 14.

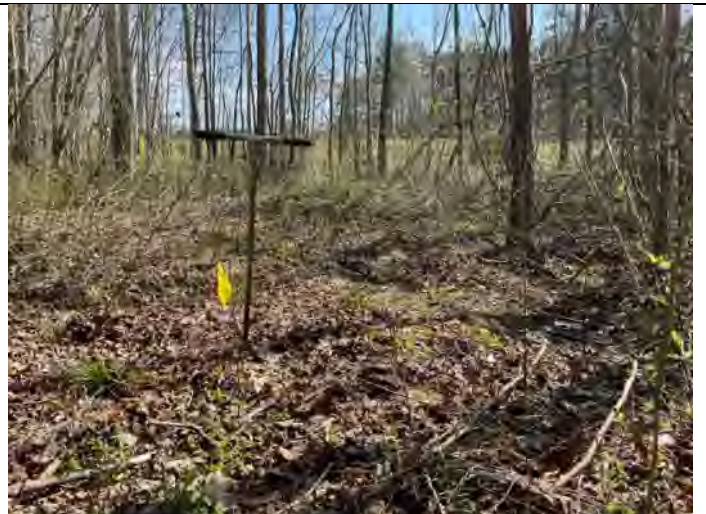
Photo 24:

Looking at Data Point #41, which characterizes a PFO wetland. This area contained all three wetland parameters. Attachment I; Sheet 14.

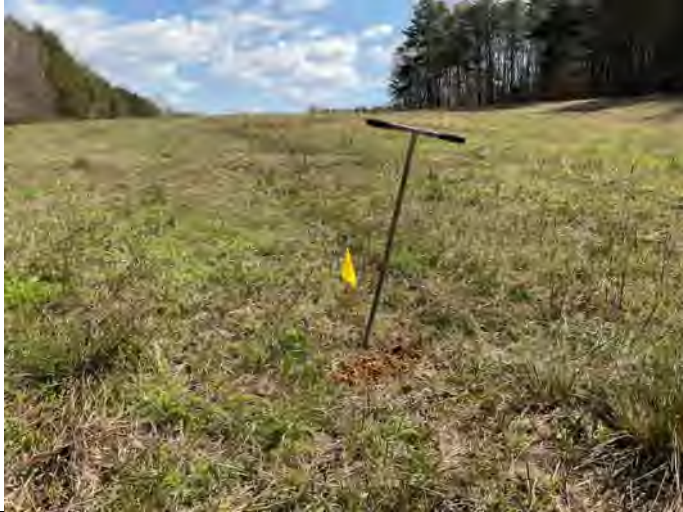
Photo 25:
Looking at Data Point #42, which characterizes an upland. This area lacked wetland hydrology, hydrophytic vegetation, and hydric soils. Attachment I; Sheet 14.

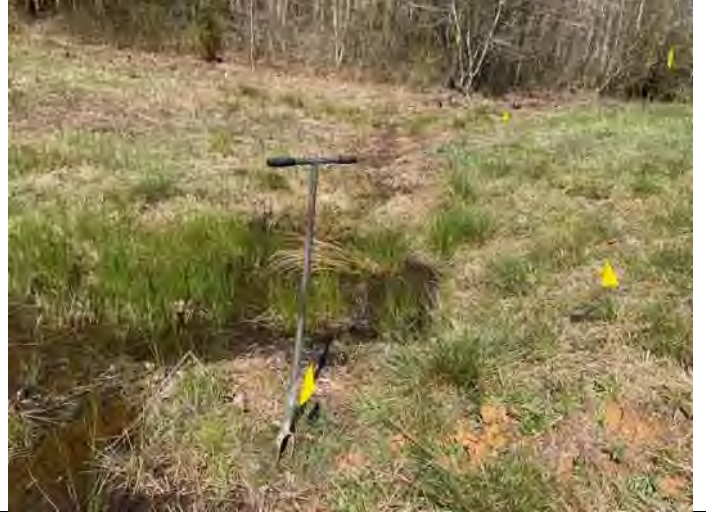
Photo 26:
Looking at Data Point #43, which characterizes a PEM wetland. This area contained all three wetland parameters. Attachment I; Sheet 14.

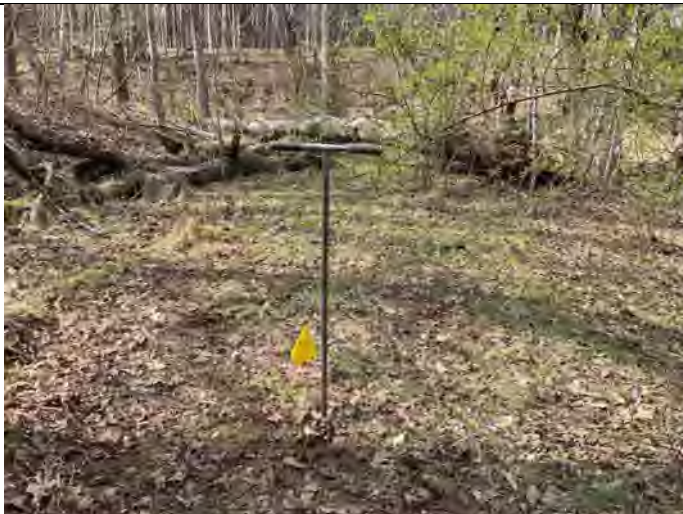
Photo 27:
Looking at Data Point #44, which characterizes a PFO wetland. This area contained all three wetland parameters. Attachment I; Sheet 15.

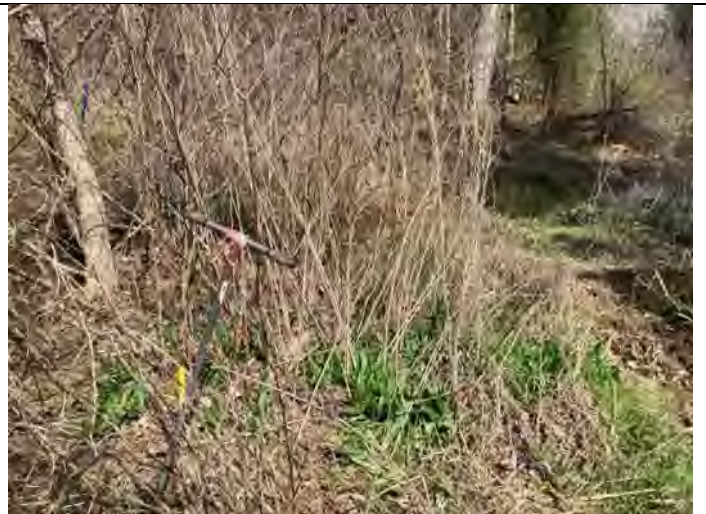
Photo 28:
Looking at Data Point #45, which characterizes a PSS wetland. This area contained all three wetland parameters. Attachment I; Sheet 15.

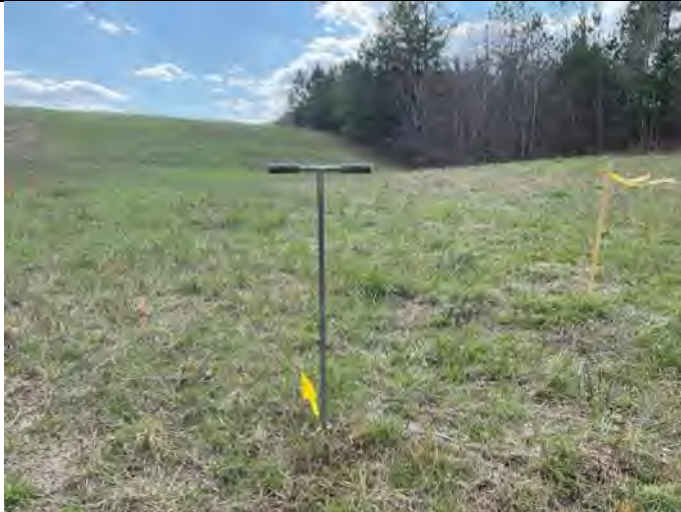
Photo 29:
Looking at Data Point #46, which characterizes an upland. This area lacked wetland hydrology, hydrophytic vegetation, and hydric soils. Attachment I; Sheet 15.

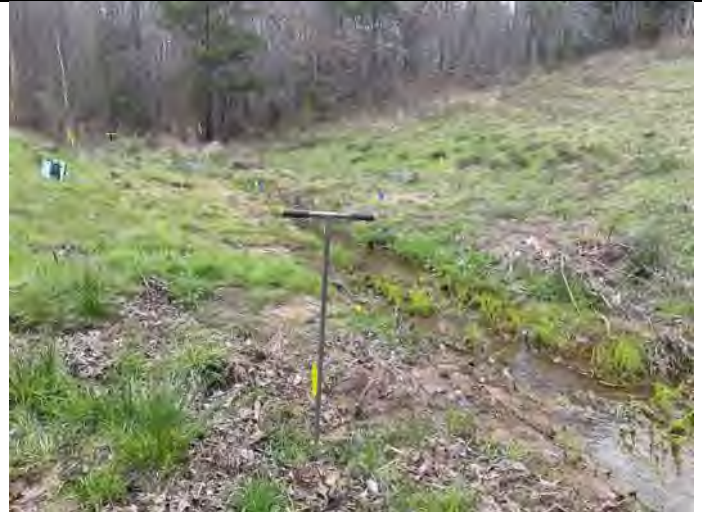
Photo 30:
Looking at Data Point #47, which characterizes a PEM wetland. This area contained all three wetland parameters. Attachment I; Sheet 15.

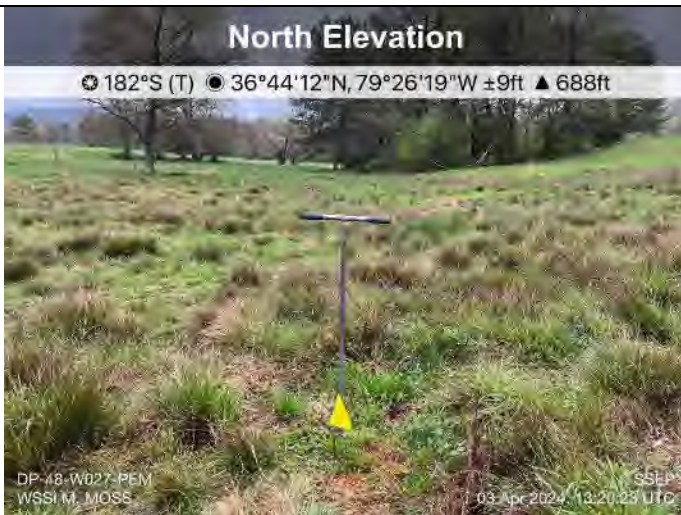
Photo 31:
Looking at Data Point #48, which characterizes a PEM wetland. This area contained all three wetland parameters. Attachment I; Sheet 15.

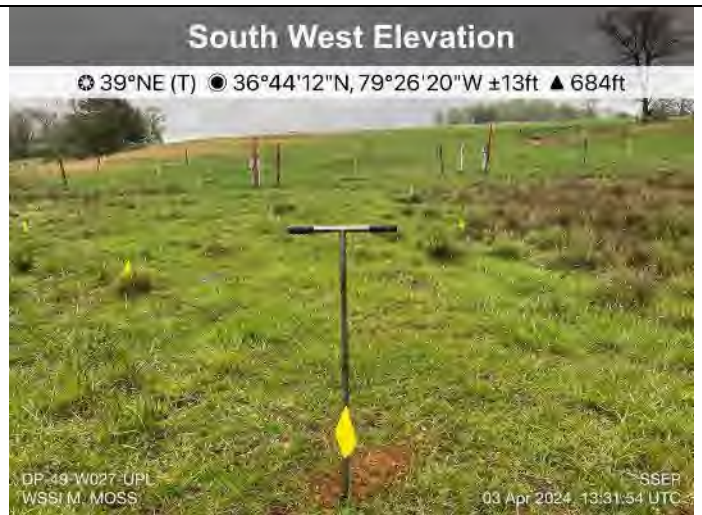
Photo 32:
Looking at Data Point #49, which characterizes an upland. This area lacked wetland hydrology, hydrophytic vegetation, and hydric soils. Attachment I; Sheet 15.

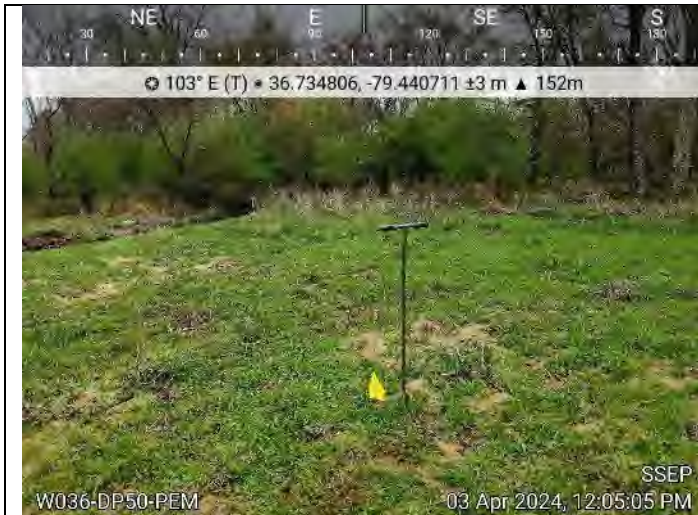
Photo 33:

Looking at Data Point #50, which characterizes a PEM wetland. This area contained all three wetland parameters. Attachment I; Sheet 15.

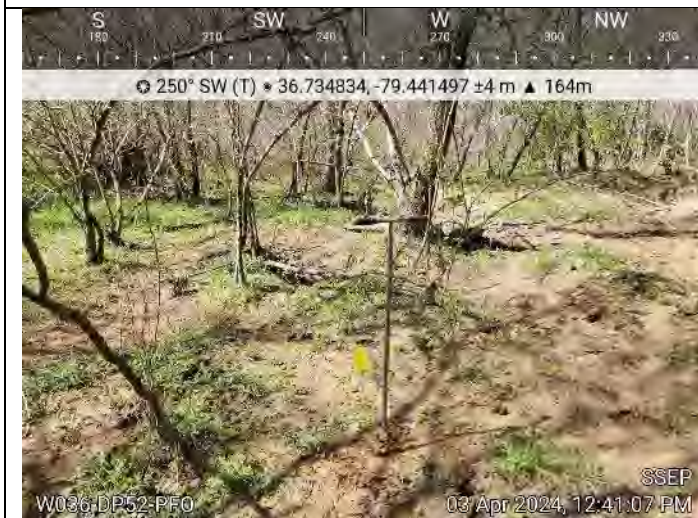
Photo 35:

Looking at Data Point #52, which characterizes a PFO wetland. This area contained all three wetland parameters. Attachment I; Sheet 15.

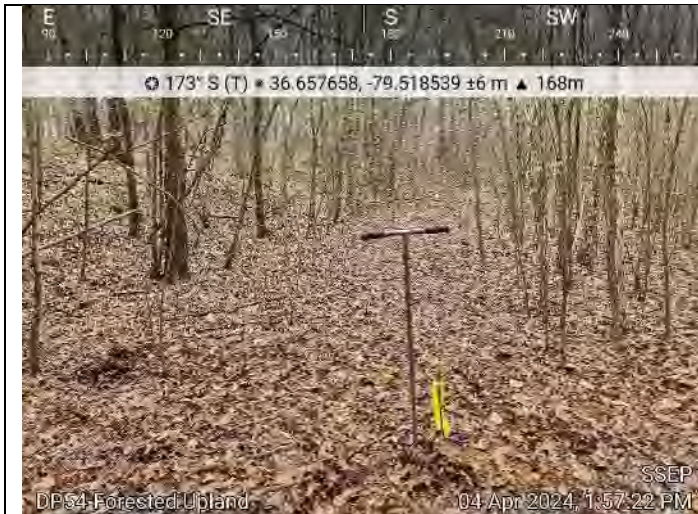
Photo 37:

Looking at Data Point #54, which characterizes an upland. This area lacked wetland hydrology and hydric soils. Attachment I; Sheet 10.

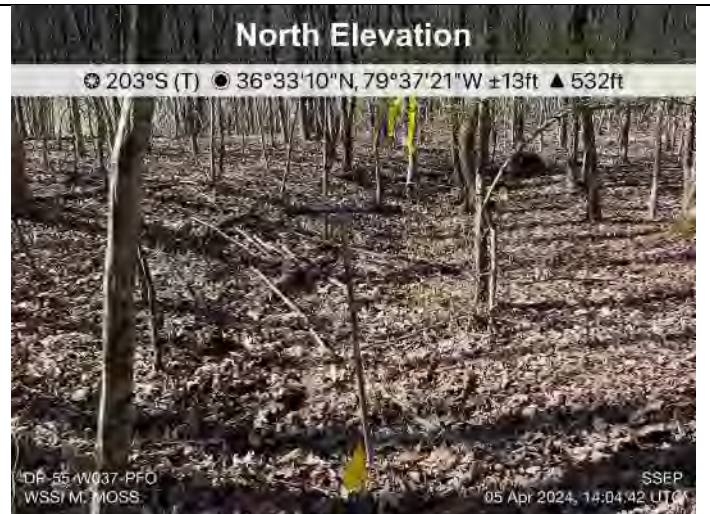
Photo 38:

Looking at Data Point #55, which characterizes a PFO wetland. This area contained all three wetland parameters. Attachment I; Sheet 2.

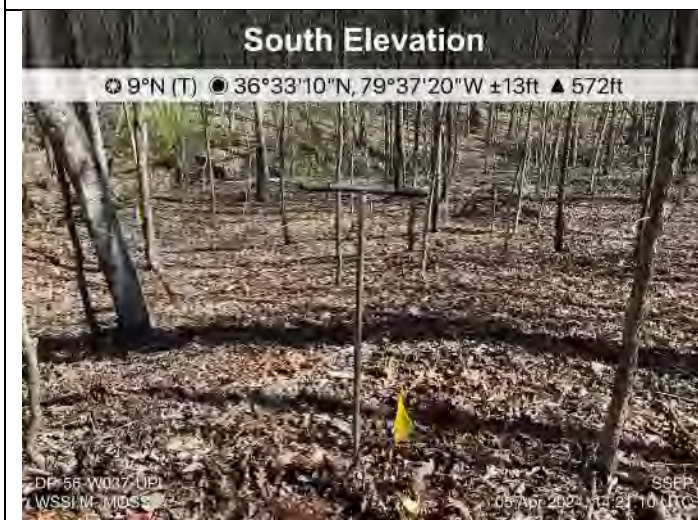
Photo 39:

Looking at Data Point #56, which characterizes an upland. This area lacked wetland hydrology, hydrophytic vegetation, and hydric soils. Attachment I; Sheet 2.

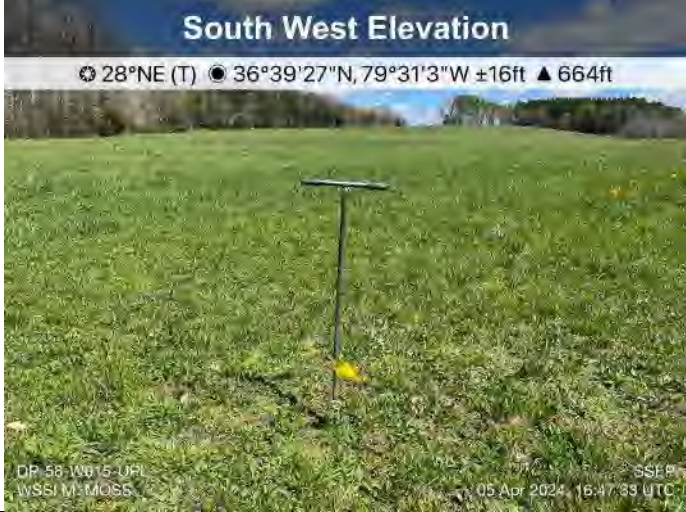
<p>Photo 41: Looking at Data Point #58, which characterizes an upland. This area lacked wetland hydrology, hydrophytic vegetation, and hydric soils. Attachment I; Sheet 10.</p>

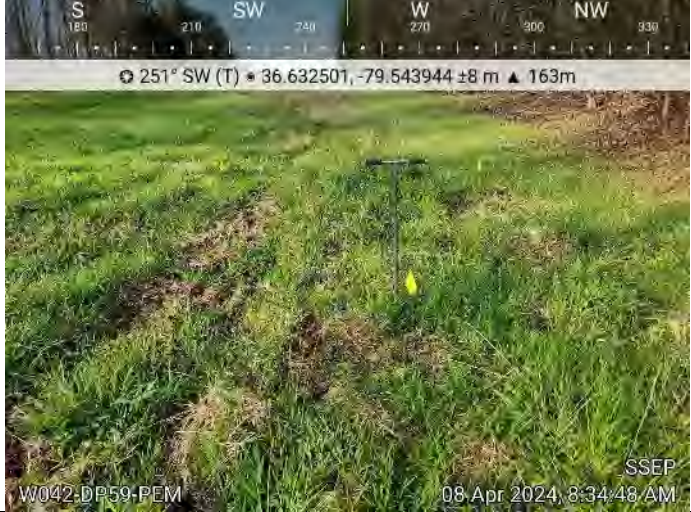
<p>Photo 42: Looking at Data Point #59, which characterizes a PEM wetland. This area contained all three wetland parameters. Attachment I; Sheet 8.</p>

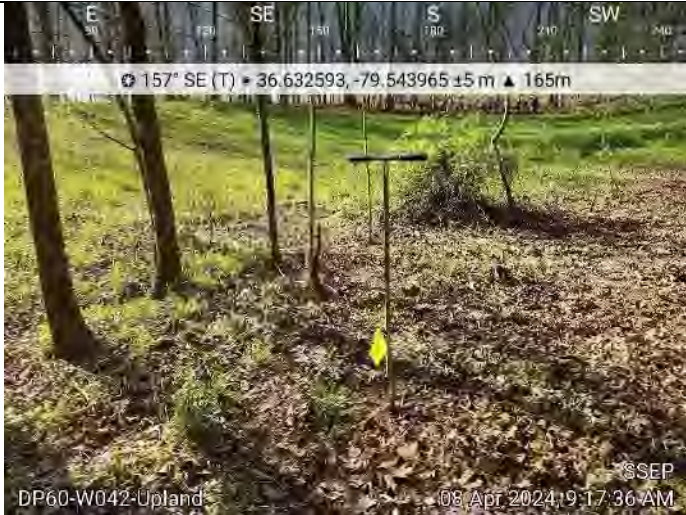
<p>Photo 43: Looking at Data Point #60, which characterizes an upland. This area lacked wetland hydrology and hydric soils. Attachment I; Sheet 8.</p>

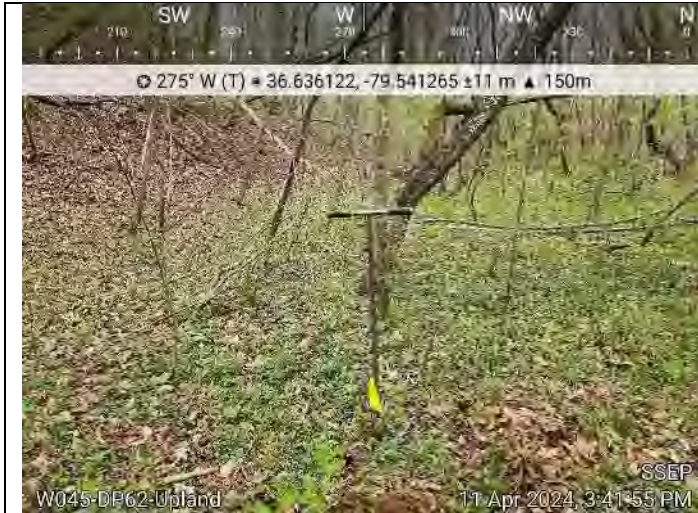
<p>Photo 44: Looking at Data Point #61, which characterizes a PFO wetland. This area contained all three wetland parameters. Attachment I; Sheet 8.</p>

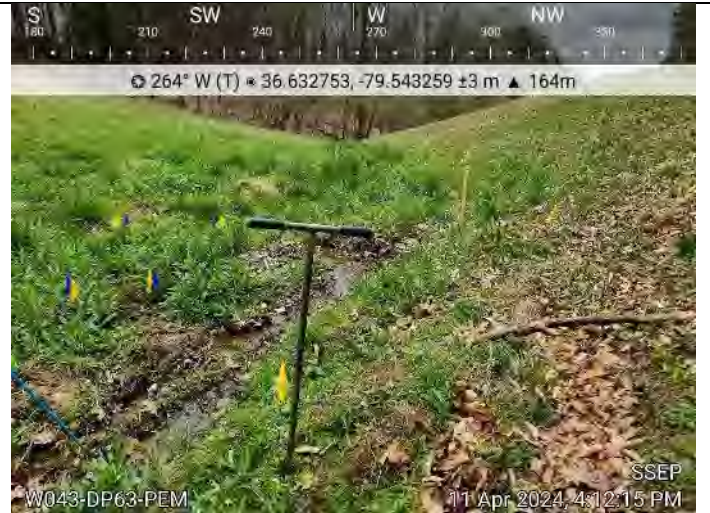
Photo 45:

Looking at Data Point #62, which characterizes an upland. This area lacked wetland hydrology and hydric soils. Attachment I; Sheet 8.

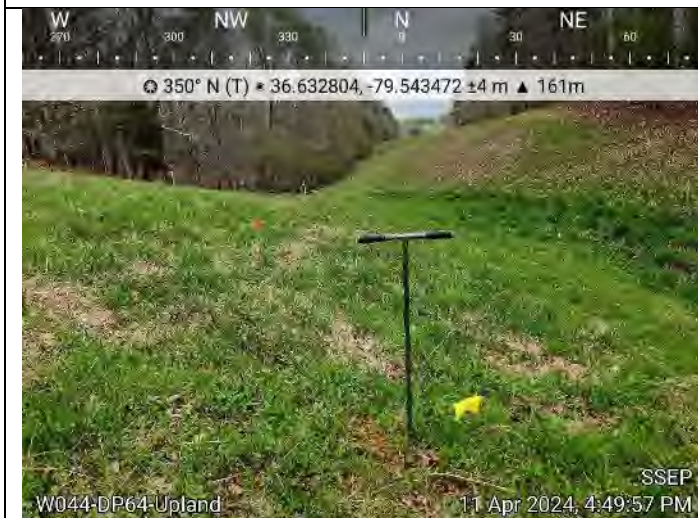
Photo 46:

Looking at Data Point #63, which characterizes a PEM wetland. This area contained all three wetland parameters. Attachment I; Sheet 8.

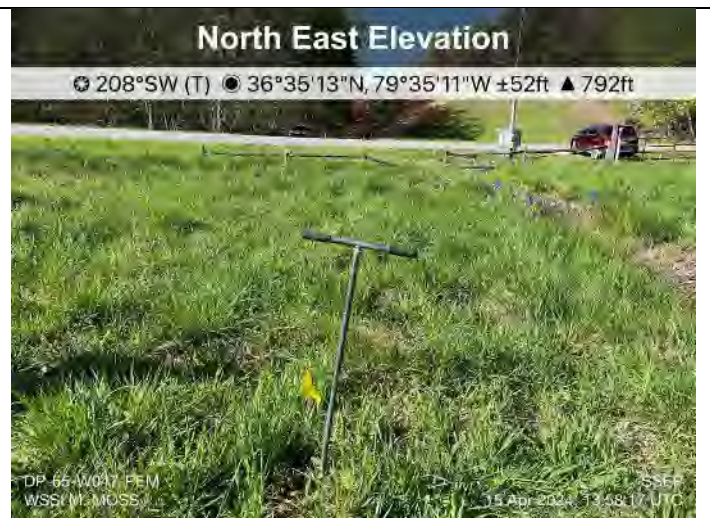
Photo 47:

Looking at Data Point #64, which characterizes an upland. This area lacked wetland hydrology, hydrophytic vegetation, and hydric soils. Attachment I; Sheet 8.

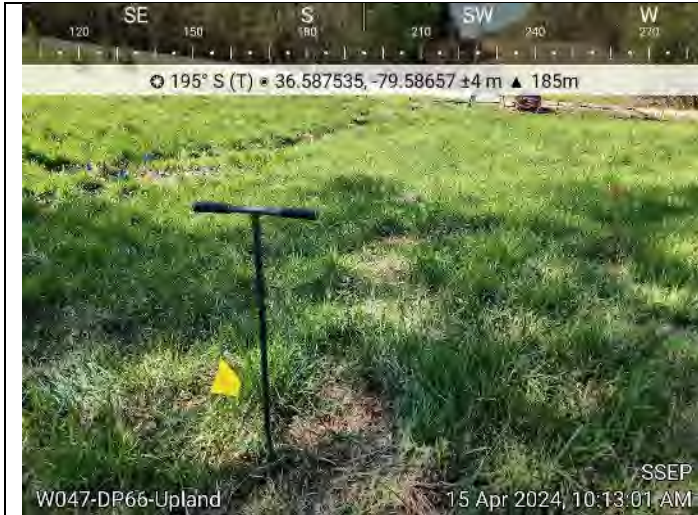
Photo 48:

Looking at Data Point #65, which characterizes a PEM wetland. This area contained all three wetland parameters. Attachment I; Sheet 5.

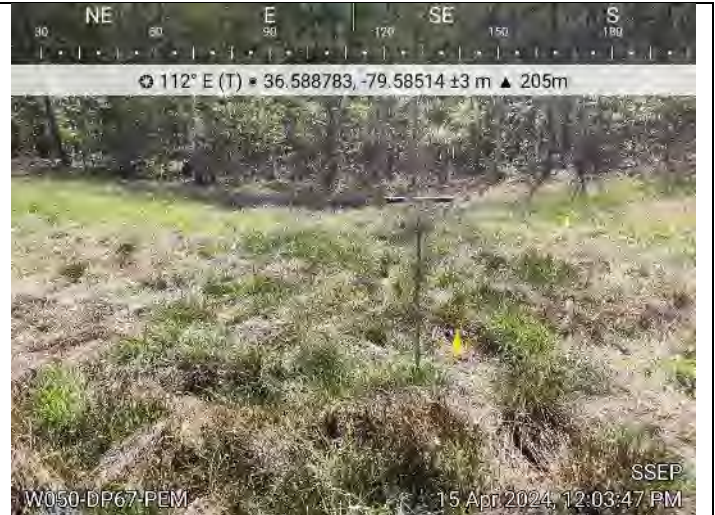
Photo 49:

Looking at Data Point #66, which characterizes an upland. This area lacked wetland hydrology, hydrophytic vegetation, and hydric soils. Attachment I; Sheet 5.

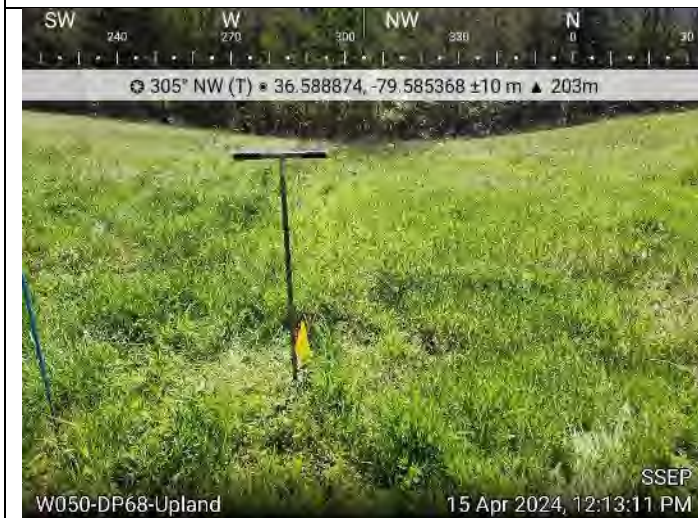
Photo 50:

Looking at Data Point #67, which characterizes a PEM wetland. This area contained all three wetland parameters. Attachment I; Sheet 5.

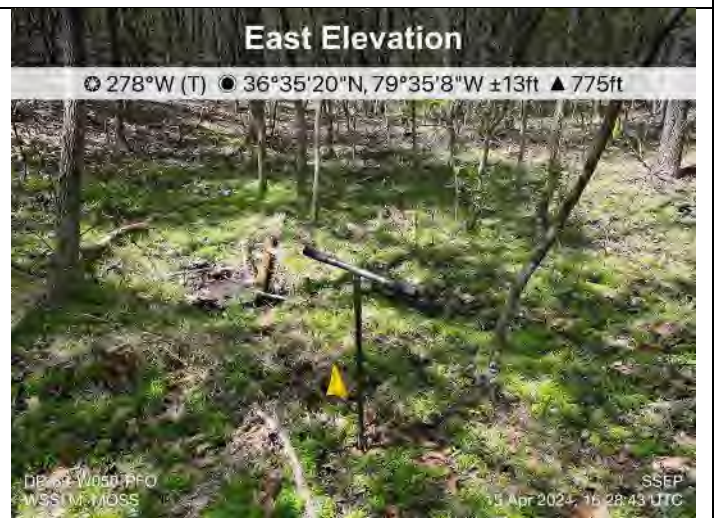
Photo 51:

Looking at Data Point #68, which characterizes an upland. This area lacked wetland hydrology, hydrophytic vegetation, and hydric soils. Attachment I; Sheet 5.

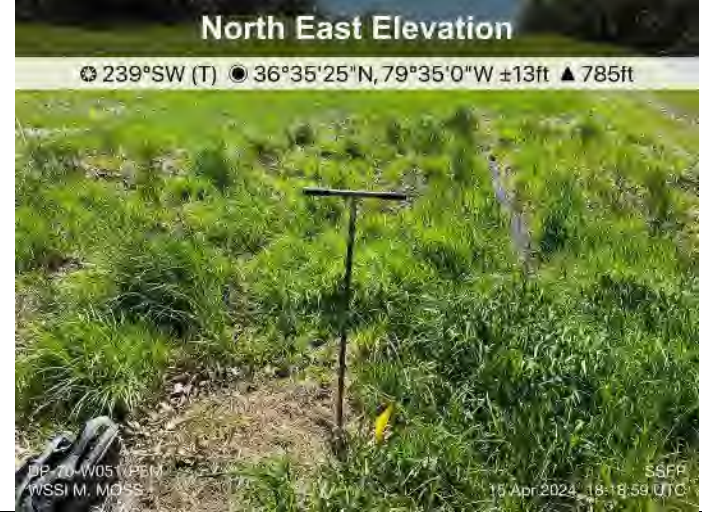
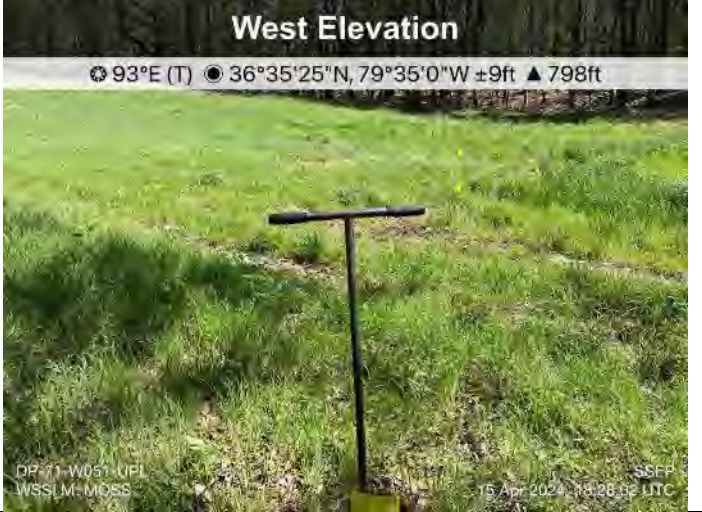
Photo 52:

Looking at Data Point #69, which characterizes a PFO wetland. This area contained all three wetland parameters. Attachment I; Sheet 5.

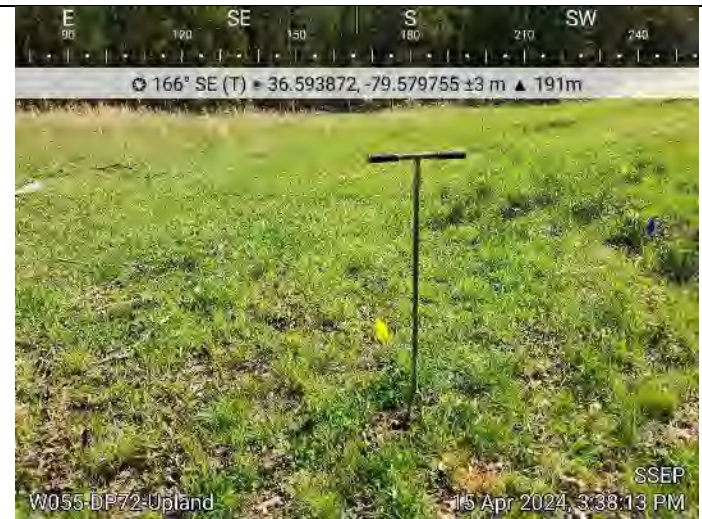
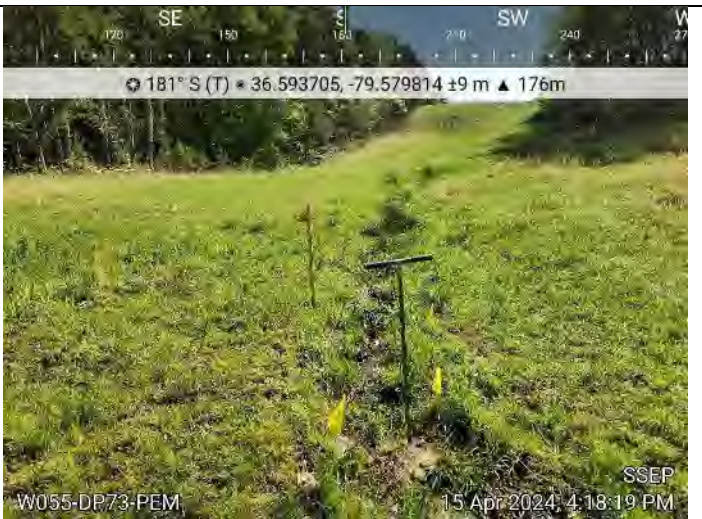
<p>Photo 53: Looking at Data Point #70, which characterizes a PEM wetland. This area contained all three wetland parameters. Attachment I; Sheet 5.</p>	<p>Photo 54: Looking at Data Point #71, which characterizes an upland. This area lacked wetland hydrology, hydrophytic vegetation, and hydric soils. Attachment I; Sheet 5.</p>

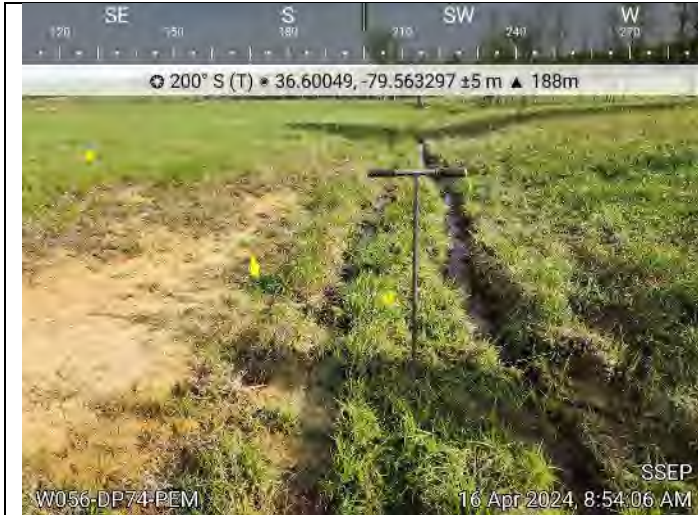
<p>Photo 55: Looking at Data Point #72, which characterizes an upland. This area lacked wetland hydrology, hydrophytic vegetation, and hydric soils. Attachment I; Sheet 5.</p>	<p>Photo 56: Looking at Data Point #73, which characterizes a PEM wetland. This area contained all three wetland parameters. Attachment I; Sheet 5.</p>

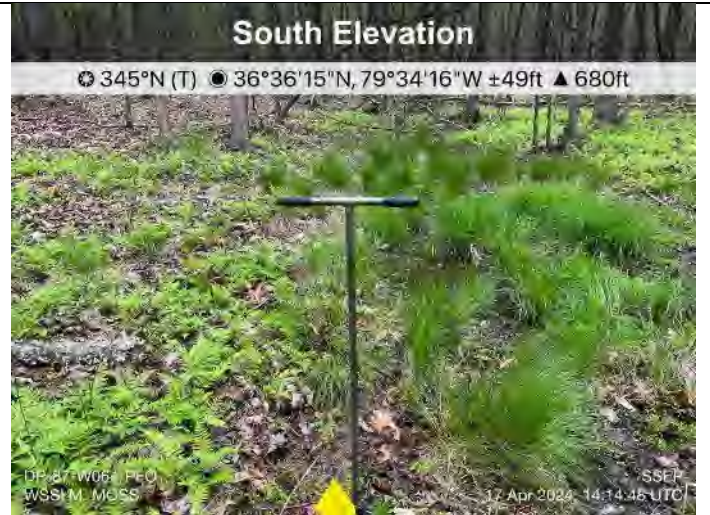
Photo 69:
 Looking at Data Point #86, which characterizes an upland.
 This area lacked wetland hydrology and hydric soils.
 Attachment I; Sheet 6.

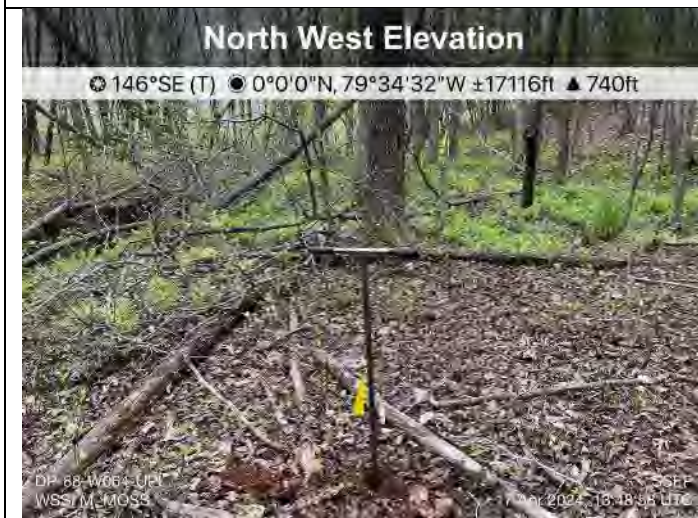
Photo 70:
 Looking at Data Point #87, which characterizes a PFO
 wetland. This area contained all three wetland
 parameters. Attachment I; Sheet 6.

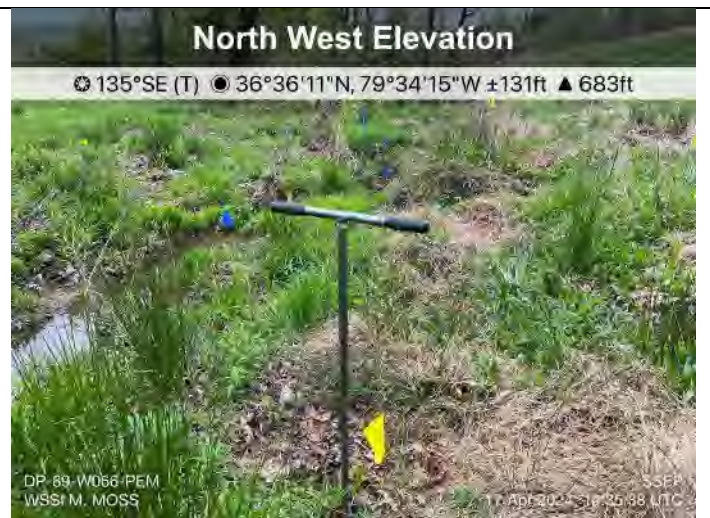
Photo 71:
 Looking at Data Point #88, which characterizes an upland.
 This area lacked wetland hydrology and hydric soils.
 Attachment I; Sheet 6.

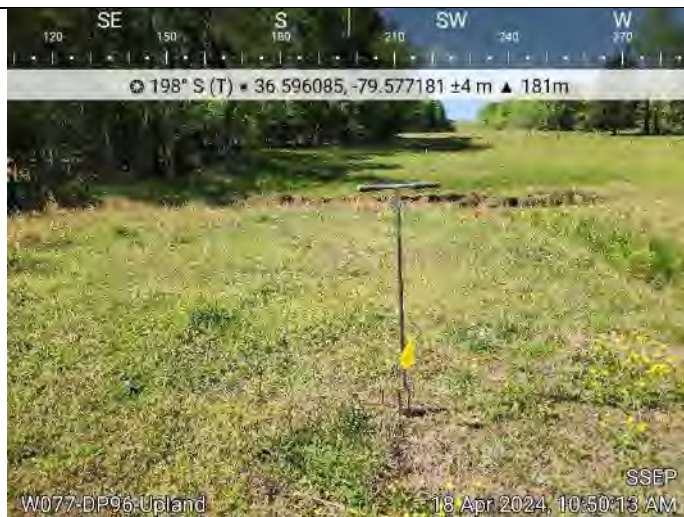
Photo 78:

Looking at Data Point #95, which characterizes an upland. This area lacked wetland hydrology, hydrophytic vegetation, and hydric soils. Attachment I; Sheet 6.
