EXHIBIT 14 - PHOTOGRAPHS

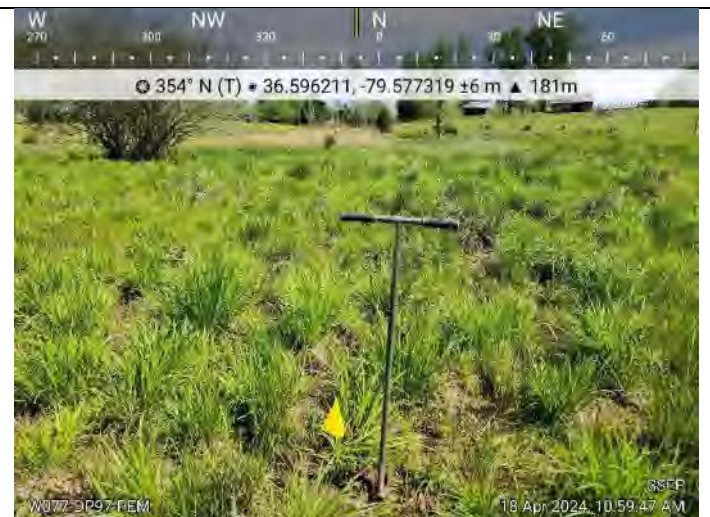
Photo 79:

Looking at Data Point #96, which characterizes an upland. This area lacked wetland hydrology, hydrophytic vegetation, and hydric soils. Attachment I; Sheet 5.

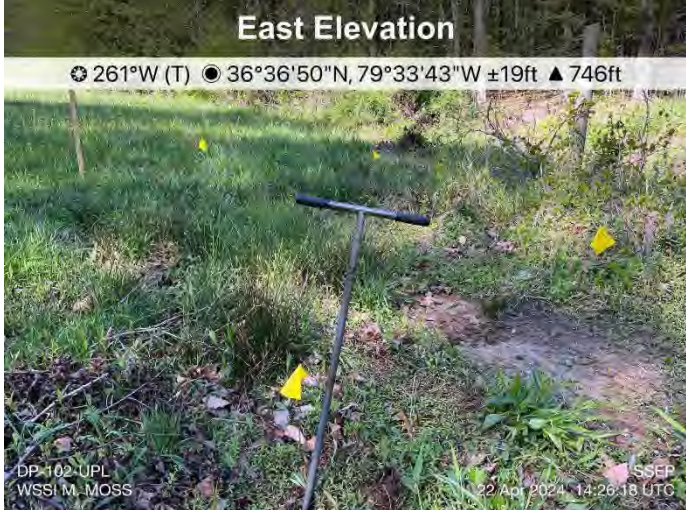
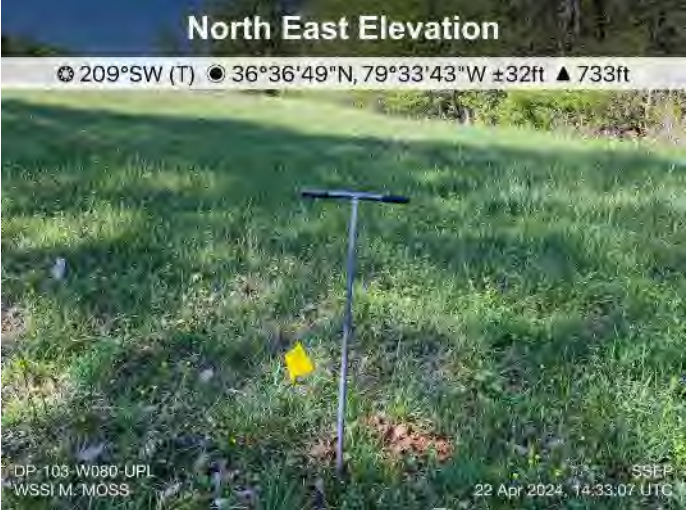
<p>North Elevation 178°S (T) 36°35'44"N, 79°34'37"W ±39ft ▲ 669ft DP-98-W076-PFO WSSI M. MOSS SSEP 18 Apr 2024 15:15:48 UTC</p>	<p>114° E (T) 36.595324, -79.579 ±5 m ▲ 178m 3191.70-DP99-Upland Swale SSEP 18 Apr 2024 11:31:15 AM</p>
<p>Photo 81: Looking at Data Point #98, which characterizes a PFO wetland. This area contained all three wetland parameters. Attachment I; Sheet 5.</p>	<p>Photo 82: Looking at Data Point #99, which characterizes an upland swale. This area lacked hydrophytic vegetation. Attachment I; Sheet 5.</p>
<p>27° N (T) 36.613877, -79.562897 ±10 m ▲ 198m W079-DP100-PFO SSEP 22 Apr 2024 9:34:47 AM</p>	<p>27° N (T) 36.613795, -79.562835 ±13 m ▲ 198m W079-DP101-Upland SSEP 22 Apr 2024 9:49:38 AM</p>
<p>Photo 83: Looking at Data Point #100, which characterizes a PFO wetland. This area contained all three wetland parameters. Attachment I; Sheet 7.</p>	<p>Photo 84: Looking at Data Point #101 which characterizes an upland. This area lacked wetland hydrology, hydrophytic vegetation, and hydric soils. Attachment I; Sheet 7.</p>

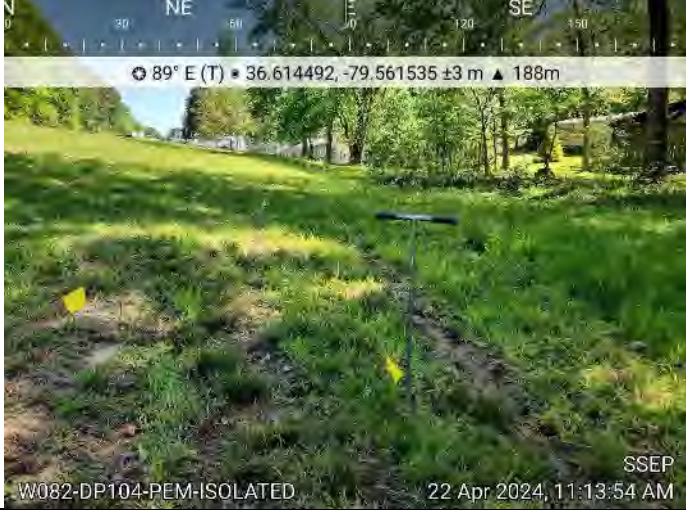
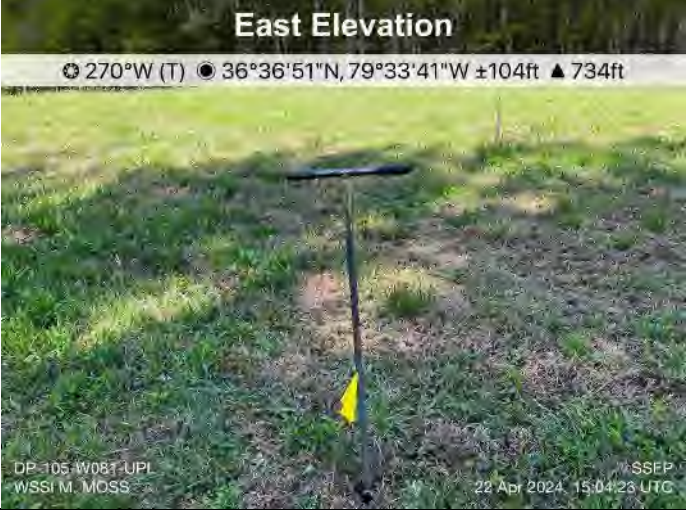
<p>North East Elevation 209°SW (T) 36°36'49"N, 79°33'43"W ±32ft ▲ 733ft DP-103-W080-UPL WSSI M. MOSS SSEP 22 Apr 2024, 14:33:07 UTC</p>
<p>Photo 85: Looking at Data Point #102, which characterizes an upland. This area lacked hydric soils. Attachment I; Sheet 7.</p>	<p>Photo 86: Looking at Data Point #103, which characterizes an upland. This area lacked wetland hydrology, hydrophytic vegetation, and hydric soils. Attachment I; Sheet 7.</p>

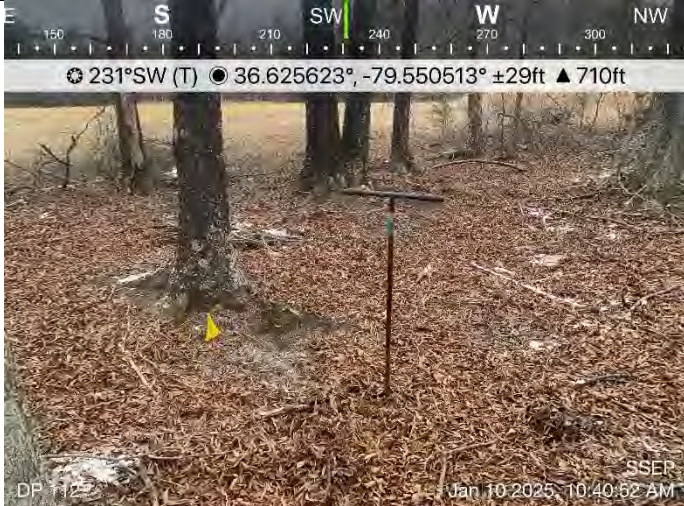
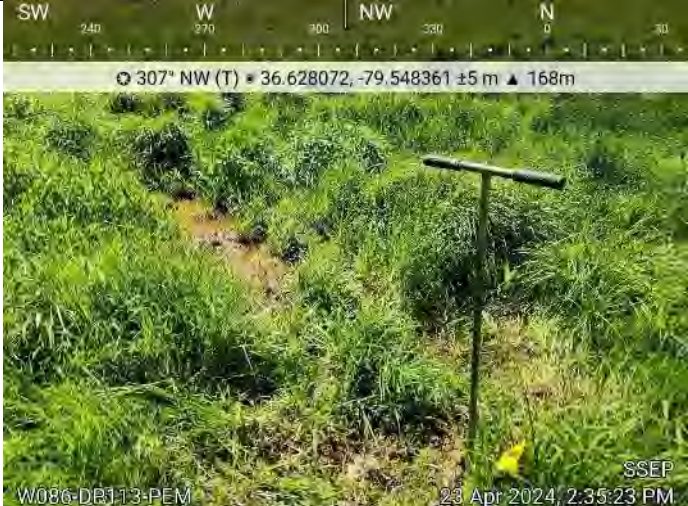
<p>307° NW (T) 36.628072, -79.548361 ±5 m ▲ 168m W086-DP113-PEM SSEP 23 Apr 2024, 2:35:23 PM</p>
<p>Photo 95: Looking at Data Point #112, which characterizes a forested upland. This area lacked hydric soil. Attachment I; Sheet 7.</p>	<p>Photo 96: Looking at Data Point #113, which characterizes a PEM wetland. This area contained all three wetland parameters. Attachment I; Sheet 8.</p>

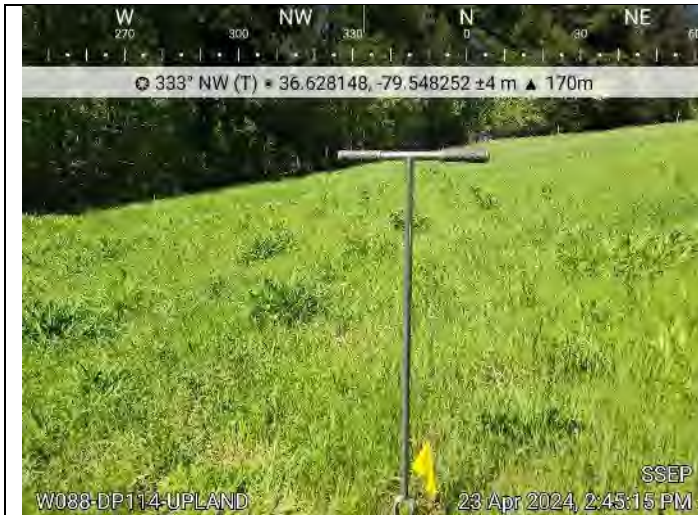
Photo 97:

Looking at Data Point #114, which characterizes an upland. This area lacked wetland hydrology and hydric soils. Attachment I; Sheet 8.

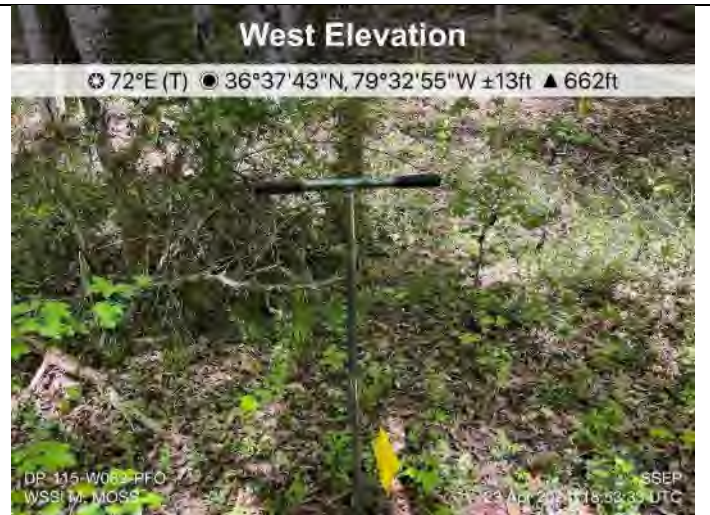
Photo 98:

Looking at Data Point #115, which characterizes a PFO wetland. This area contained all three wetland parameters. Attachment I; Sheet 8.

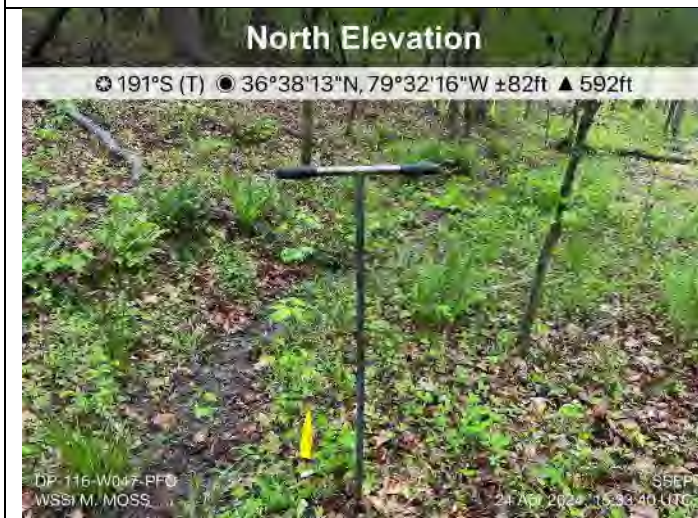
Photo 99:

Looking at Data Point #116, which characterizes a PFO wetland. This area contained all three wetland parameters. Attachment I; Sheet 8.

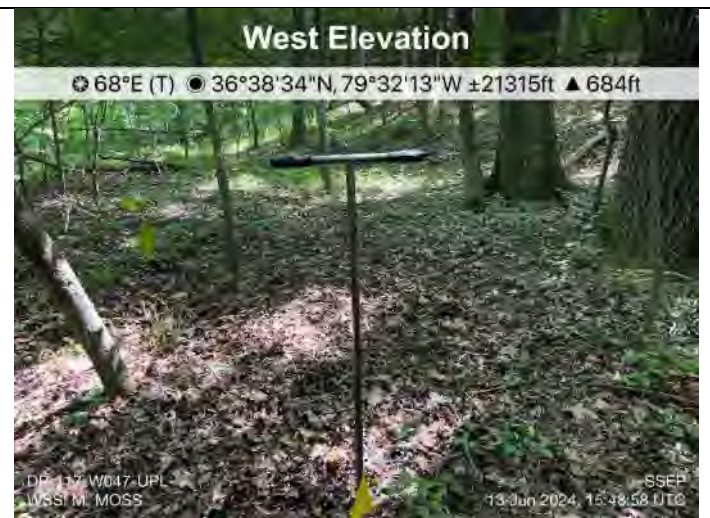
Photo 100:

Looking at Data Point #117, which characterizes an upland. This area lacked wetland hydrology and hydric soils. Attachment I; Sheet 8.

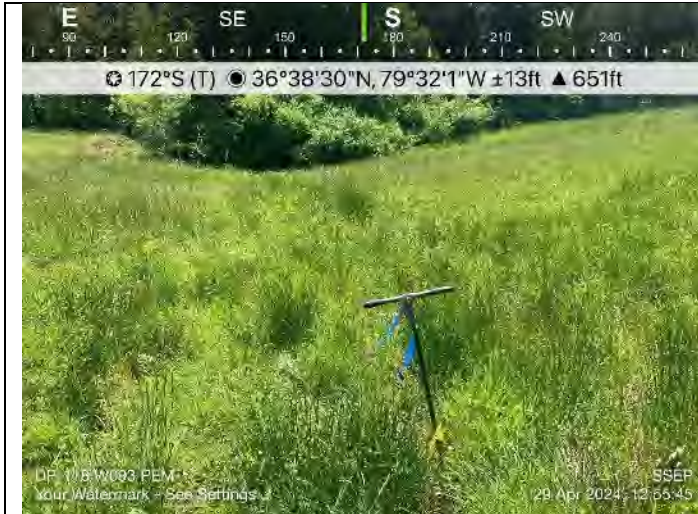
Photo 101:

Looking at Data Point #118, which characterizes a PEM wetland. This area contained all three wetland parameters. Attachment I; Sheet 9.

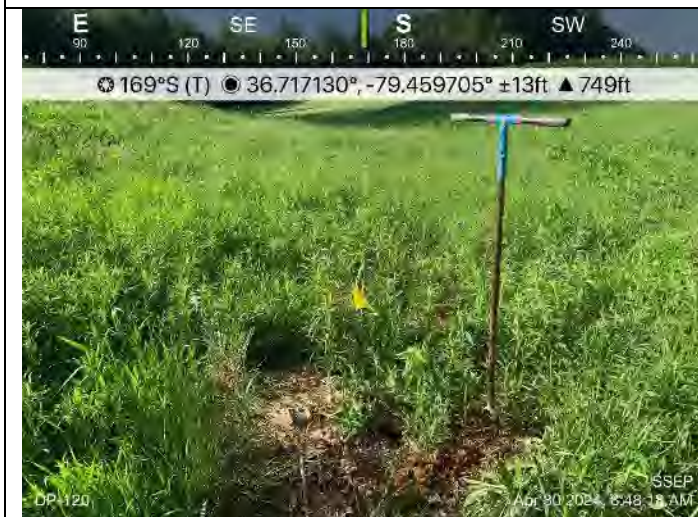
Photo 103:

Looking at Data Point #120, which characterizes an upland. This area lacked wetland hydrology, hydrophytic vegetation, and hydric soils. Attachment I; Sheet 14.

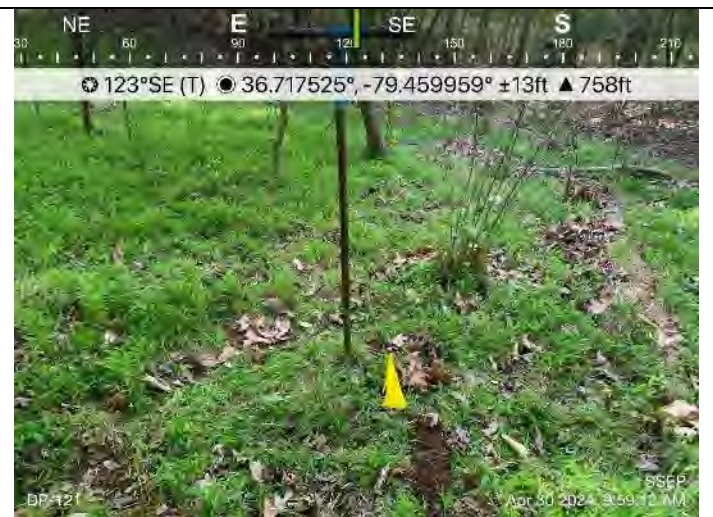
Photo 104:

Looking at Data Point #121, which characterizes a PFO wetland. This area contained all three wetland parameters. Attachment I; Sheet 14.

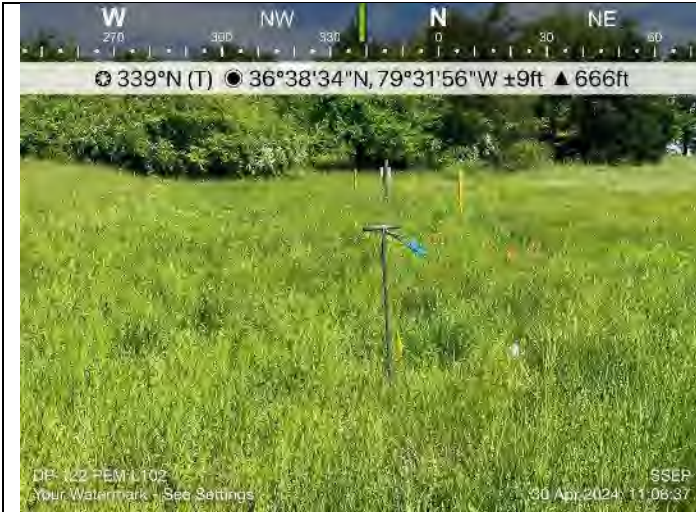
Photo 105:

Looking at Data Point #122, which characterizes a PEM wetland. This area contained all three wetland parameters. Attachment I; Sheet 9.

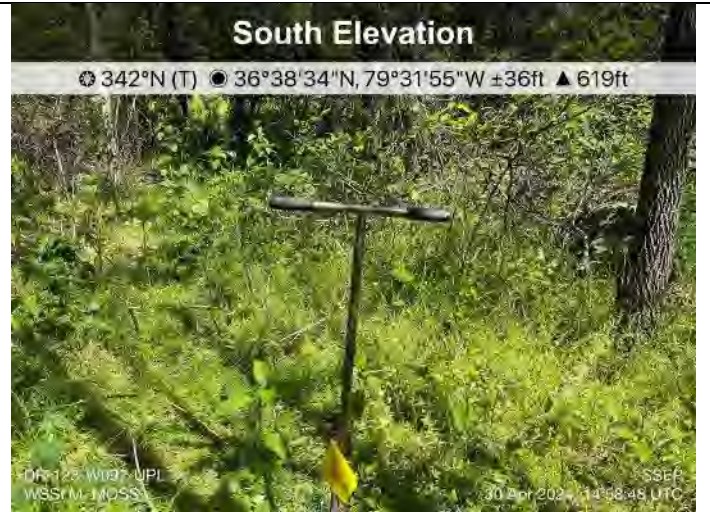
Photo 106:

Looking at Data Point #123, which characterizes an upland. This area lacked wetland hydrology, hydrophytic vegetation, and hydric soils. Attachment I; Sheet 9.

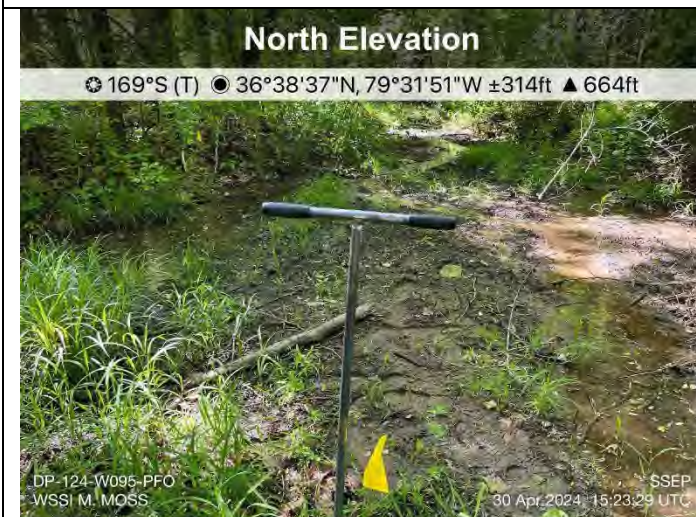
Photo 107:

Looking at Data Point #124, which characterizes a PFO wetland. This area contained all three wetland parameters. Attachment I; Sheet 9.

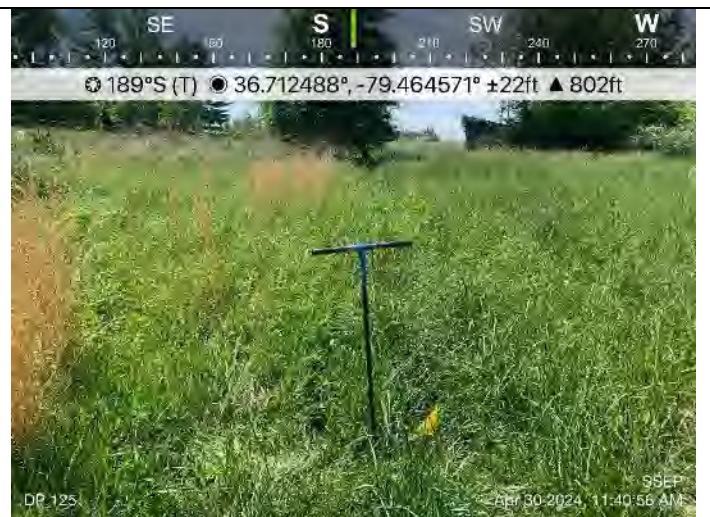
Photo 108:

Looking at Data Point #125, which characterizes an upland. This area lacked wetland hydrology, hydrophytic vegetation, and hydric soils. Attachment I; Sheet 14.

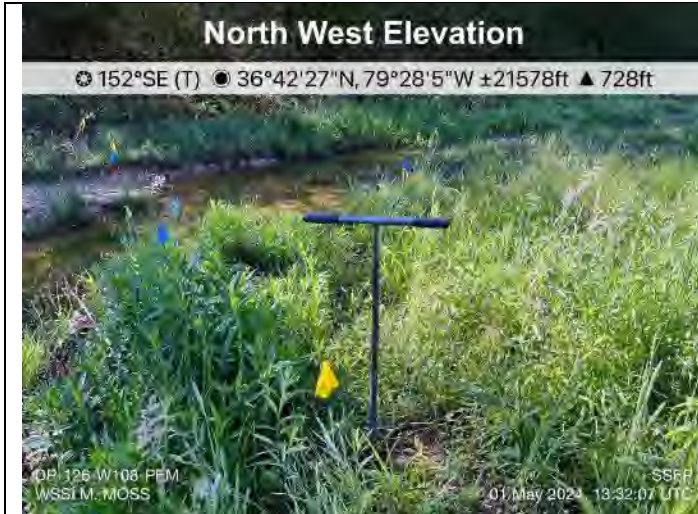
Photo 109:

Looking at Data Point #126, which characterizes a PEM wetland. This area contained all three wetland parameters. Attachment I; Sheet 13.

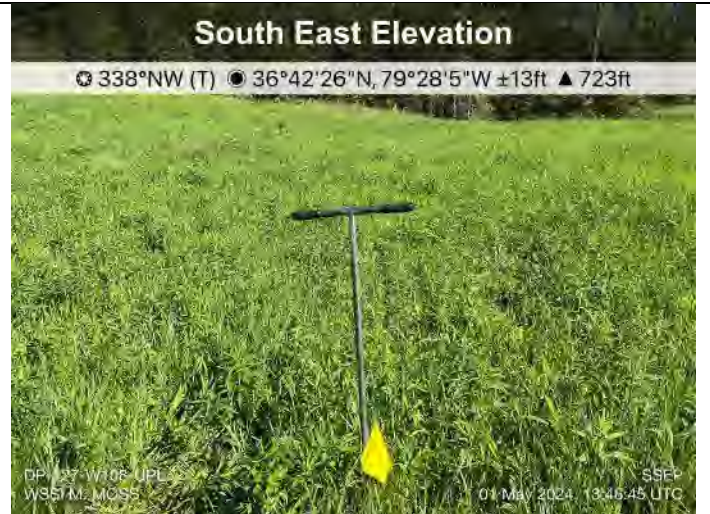
Photo 110:

Looking at Data Point #127, which characterizes an upland. This area lacked wetland hydrology and hydric soils. Attachment I; Sheet 13.

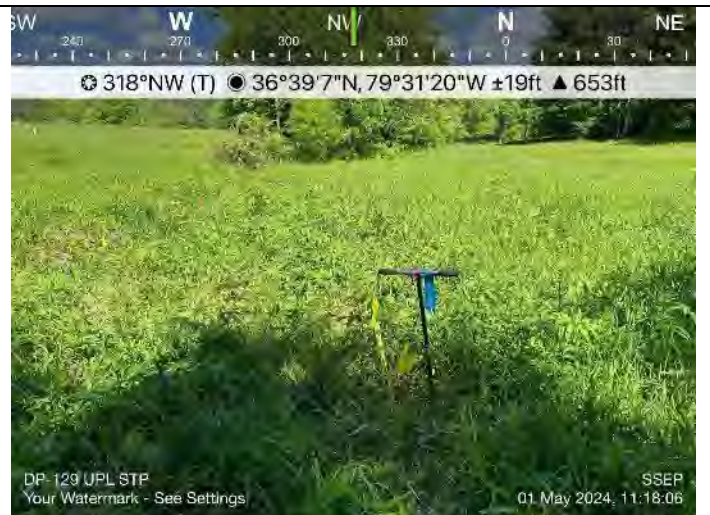
Photo 112:

Looking at Data Point #129, which characterizes an upland. This area lacked wetland hydrology. Attachment I; Sheet 9.

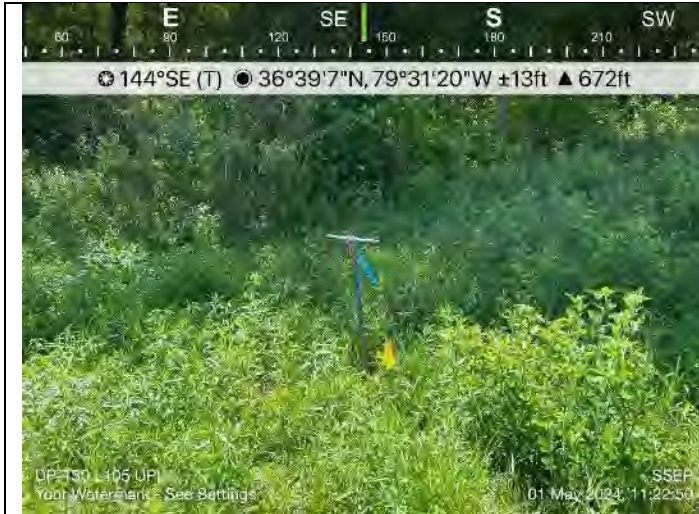
Photo 113:

Looking at Data Point #130, which characterizes an upland. This area lacked wetland hydrology, hydrophytic vegetation, and hydric soils. Attachment I; Sheet 9.

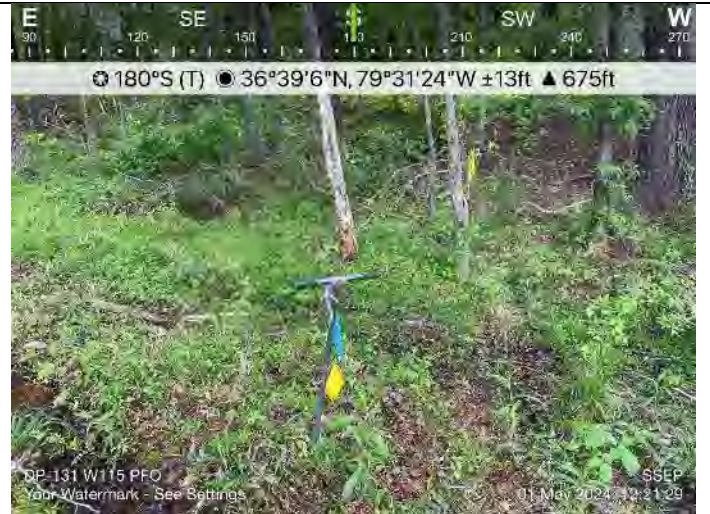
Photo 114:

Looking at Data Point #131, which characterizes a PFO wetland. This area contained all three wetland parameters. Attachment I; Sheet 9.

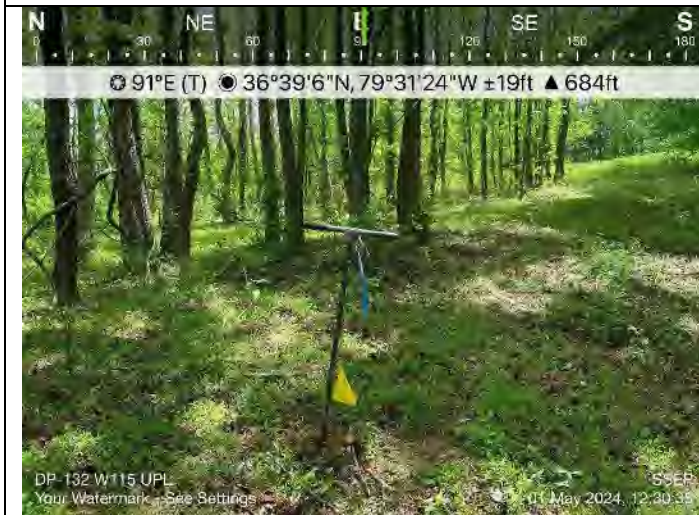
Photo 115:

Looking at Data Point #132, which characterizes an upland. This area lacked wetland hydrology, hydrophytic vegetation, and hydric soils. Attachment I; Sheet 9.

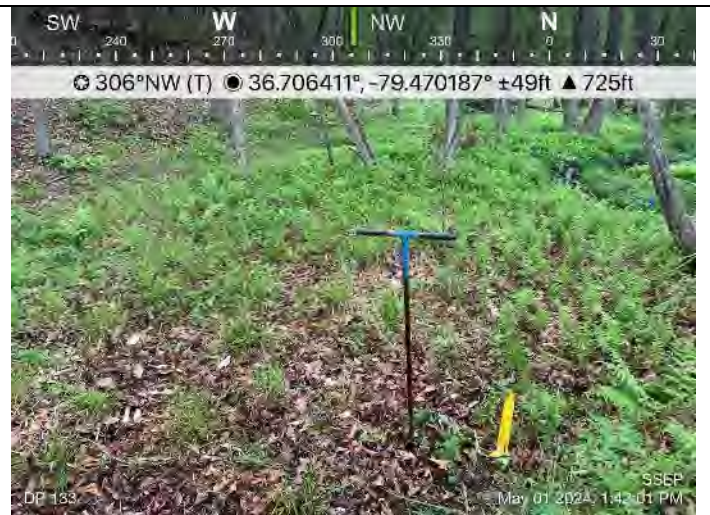
Photo 116:

Looking at Data Point #133, which characterizes a PFO wetland. This area contained all three wetland parameters. Attachment I; Sheet 13.

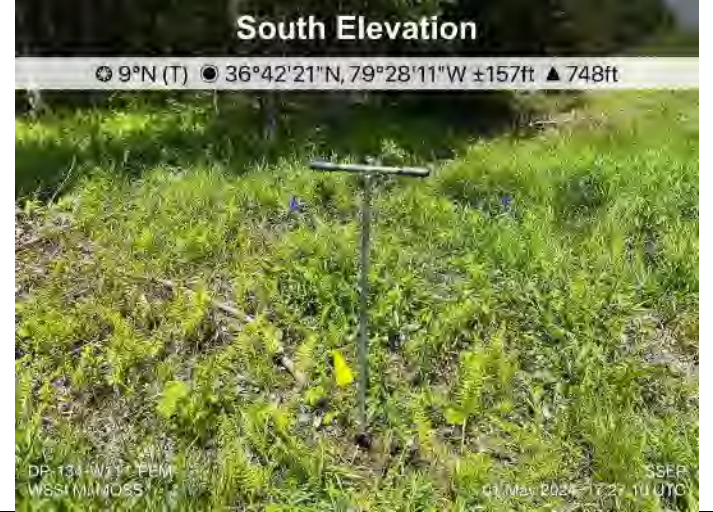
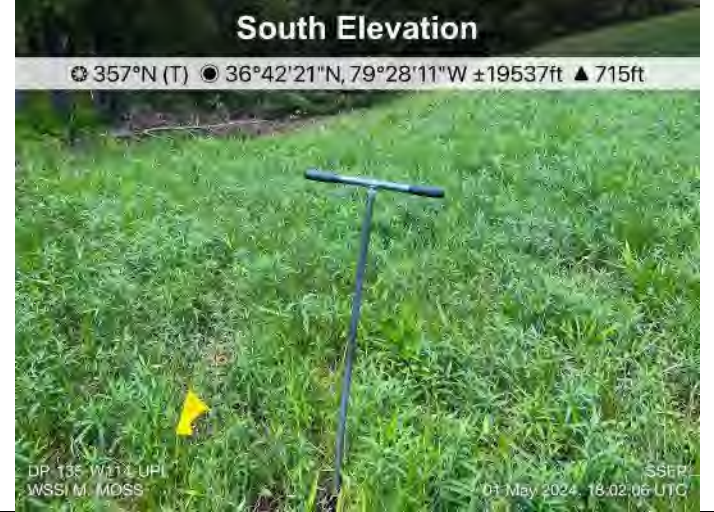
<p>Photo 117: Looking at Data Point #134, which characterizes a PEM wetland. This area contained all three wetland parameters. Attachment I; Sheet 13.</p>	<p>Photo 118: Looking at Data Point #135, which characterizes an upland. This area lacked wetland hydrology and hydric soils. Attachment I; Sheet 13.</p>

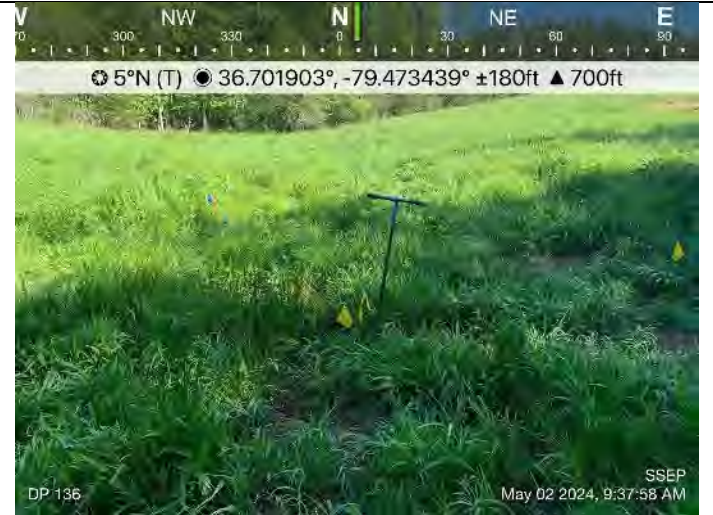
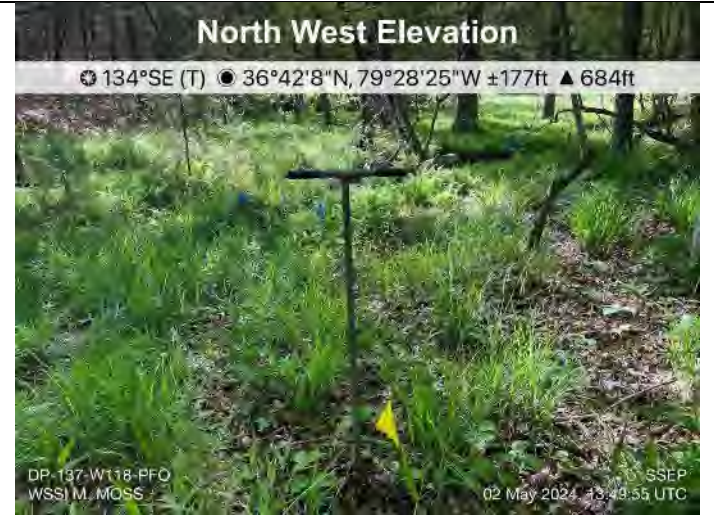
<p>Photo 119: Looking at Data Point #136, which characterizes a PEM wetland. This area contained all three wetland parameters. Attachment I; Sheet 13.</p>	<p>Photo 120: Looking at Data Point #137, which characterizes a PFO wetland. This area contained all three wetland parameters. Attachment I; Sheet 13.</p>

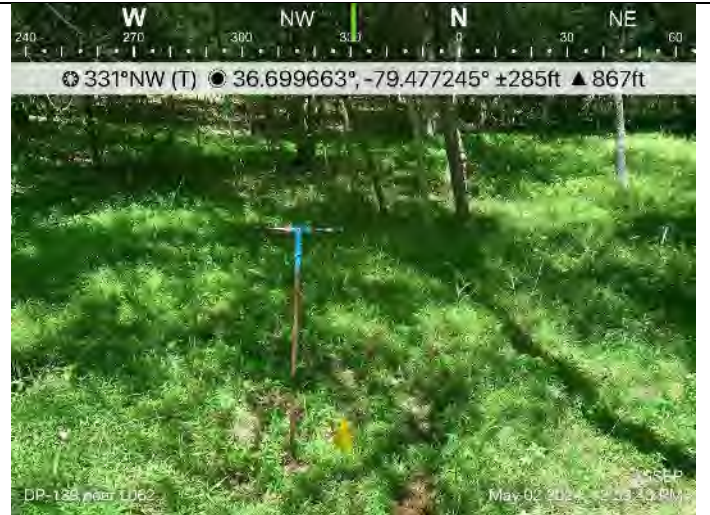
Photo 122:

Looking at Data Point #139, which characterizes an upland. This area lacked wetland hydrology, hydrophytic vegetation, and hydric soils. Attachment I; Sheet 13.

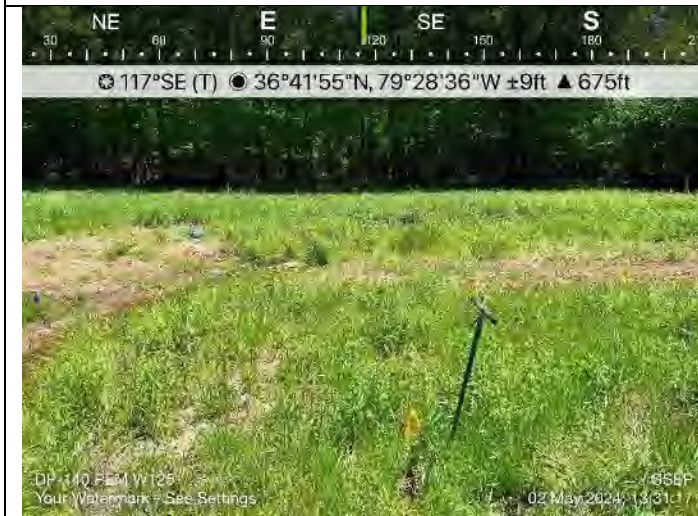
Photo 123:

Looking at Data Point #140, which characterizes a PEM wetland. This area contained all three wetland parameters. Attachment I; Sheet 13.

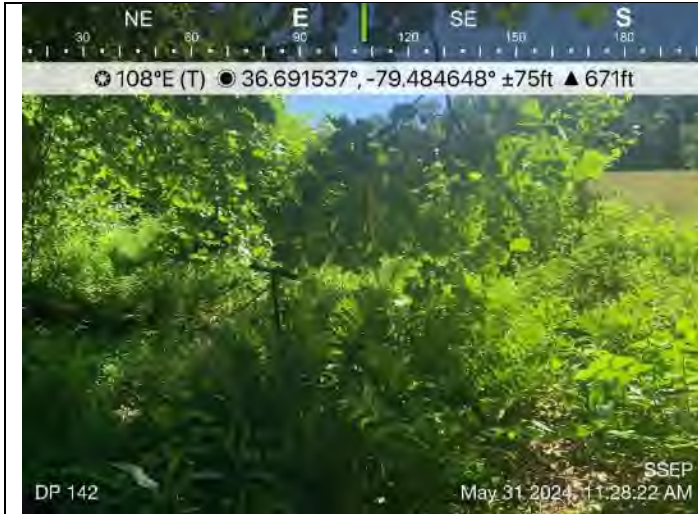
Photo 125:

Looking at Data Point #142, which characterizes an upland. This area lacked wetland hydrology and hydric soils. Attachment I; Sheet 12.

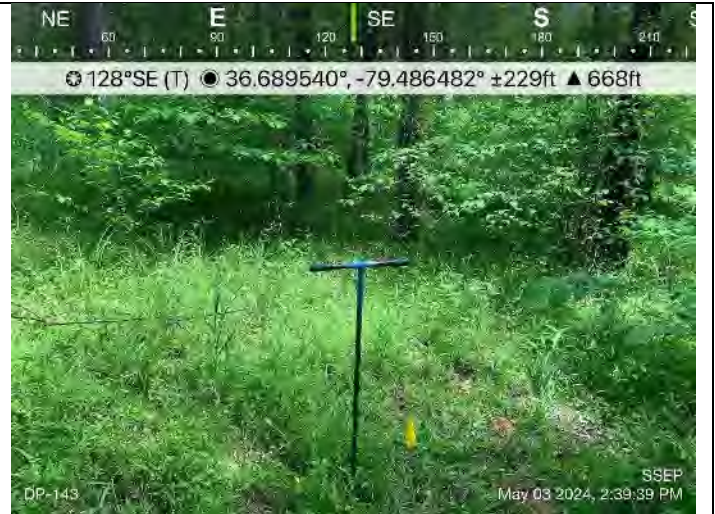
Photo 126:

Looking at Data Point #143, which characterizes a PFO wetland. This area contained all three wetland parameters. Attachment I; Sheet 12.

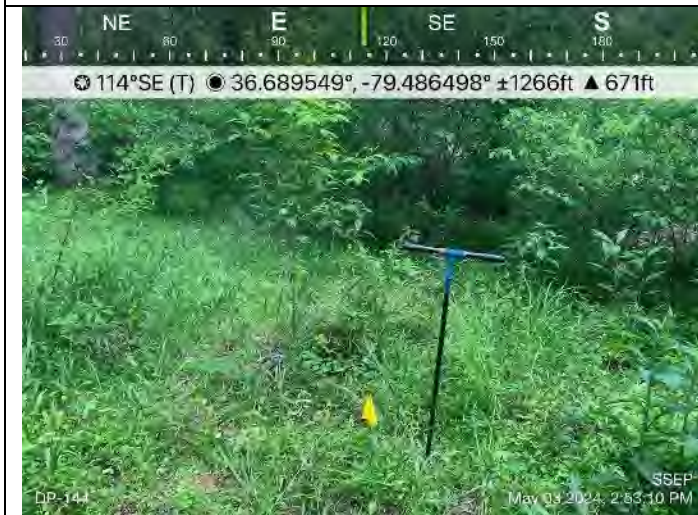
Photo 127:

Looking at Data Point #144, which characterizes an upland. This area lacked hydrophytic vegetation and hydric soil. Attachment I; Sheet 12.

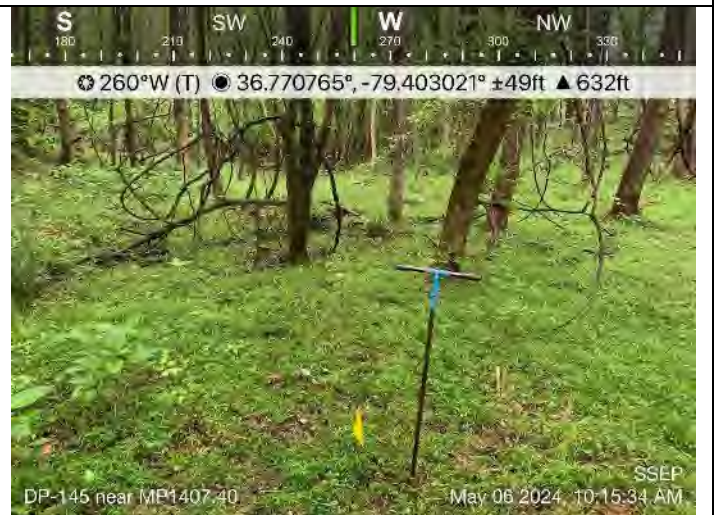
Photo 128:

Looking at Data Point #145, which characterizes an upland. This area lacked wetland hydrology and hydric soils. Attachment I; Sheet 18.

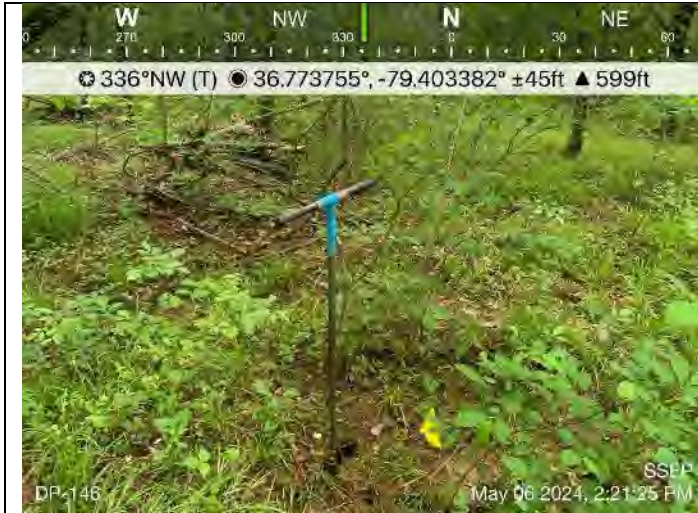
Photo 129:

Looking at Data Point #146, which characterizes an upland. This area lacked hydric soil. Attachment I; Sheet 18.

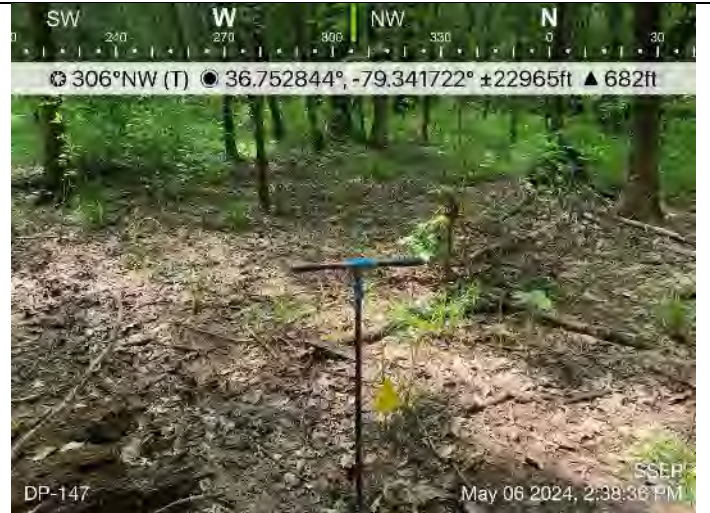
Photo 130:

Looking at Data Point #147, which characterizes a PFO wetland. This area contained all three wetland parameters. Attachment I; Sheet 18.

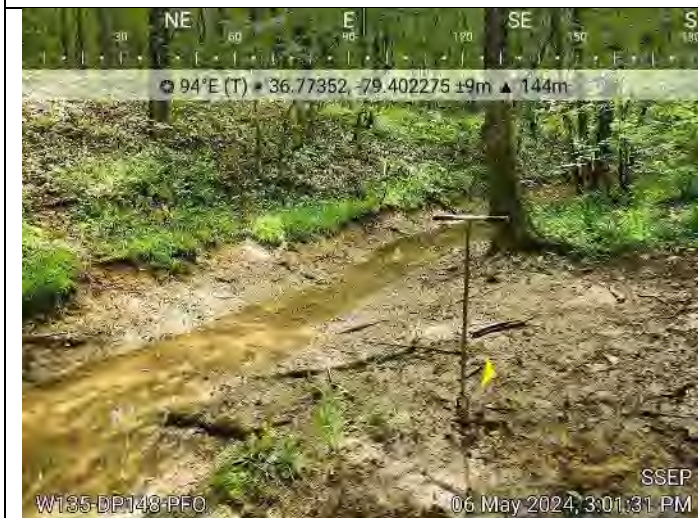
Photo 131:

Looking at Data Point #148, which characterizes a PFO wetland. This area contained all three wetland parameters. Attachment I; Sheet 18.

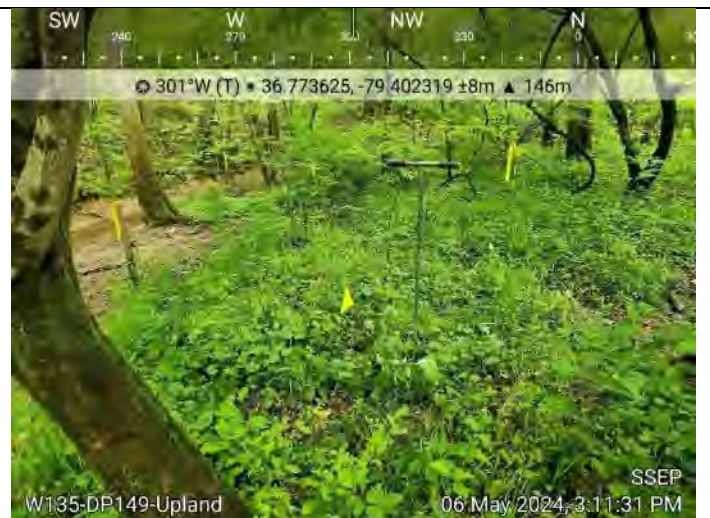
Photo 132:

Looking at Data Point #149, which characterizes an upland. This area lacked wetland hydrology, hydrophytic vegetation, and hydric soils. Attachment I; Sheet 18.

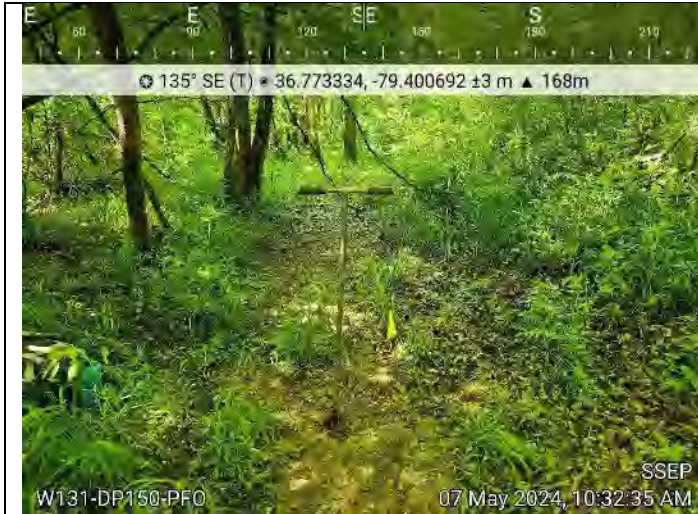
Photo 133:

Looking at Data Point #150, which characterizes a PFO wetland. This area contained all three wetland parameters. Attachment I; Sheet 18.

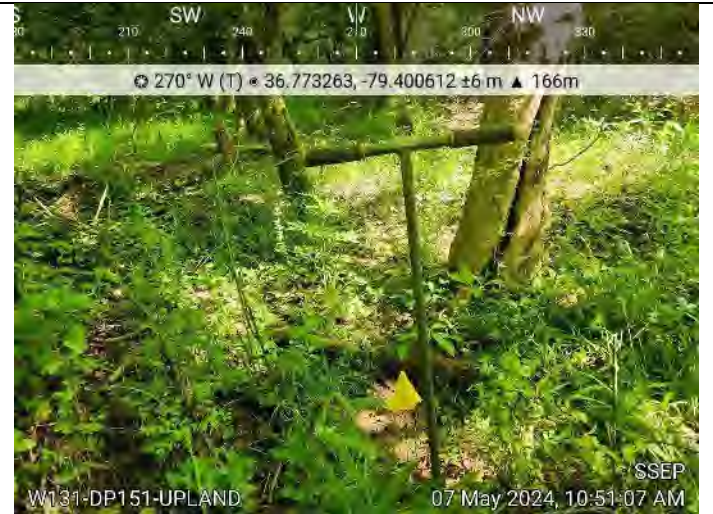
Photo 134:

Looking at Data Point #151, which characterizes an upland. This area lacked wetland hydrology and hydric soils. Attachment I; Sheet 18.

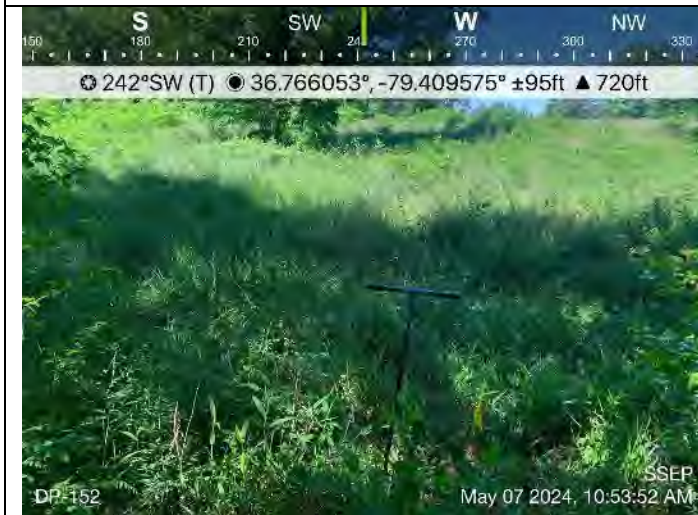
Photo 135:

Looking at Data Point #152, which characterizes an upland. This area lacked wetland hydrology, hydrophytic vegetation, and hydric soils. Attachment I; Sheet 17.

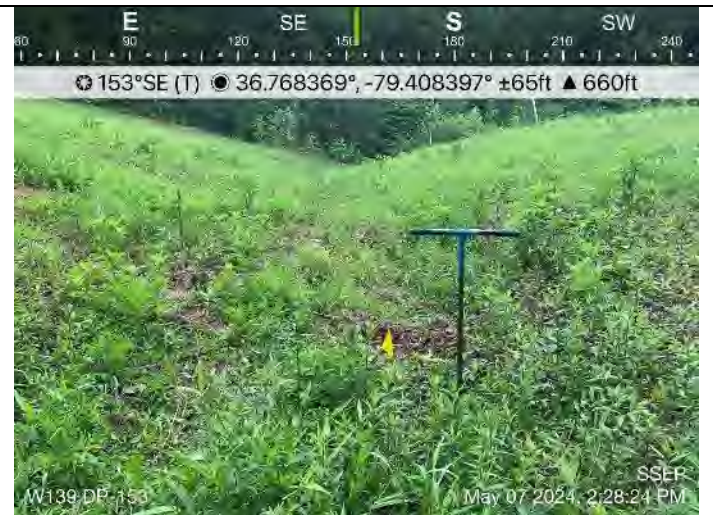
Photo 136:

Looking at Data Point #153, which characterizes a PEM wetland. This area contained all three wetland parameters. Attachment I; Sheet 17.

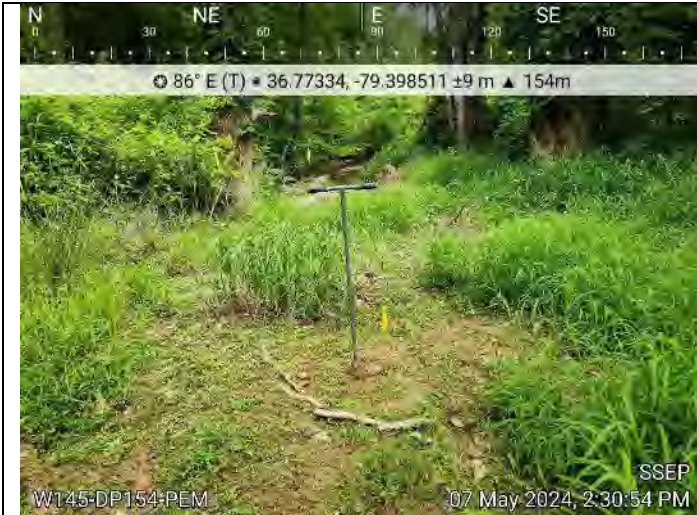
Photo 137:

Looking at Data Point #154, which characterizes a PEM wetland. This area contained all three wetland parameters. Attachment I; Sheet 18.

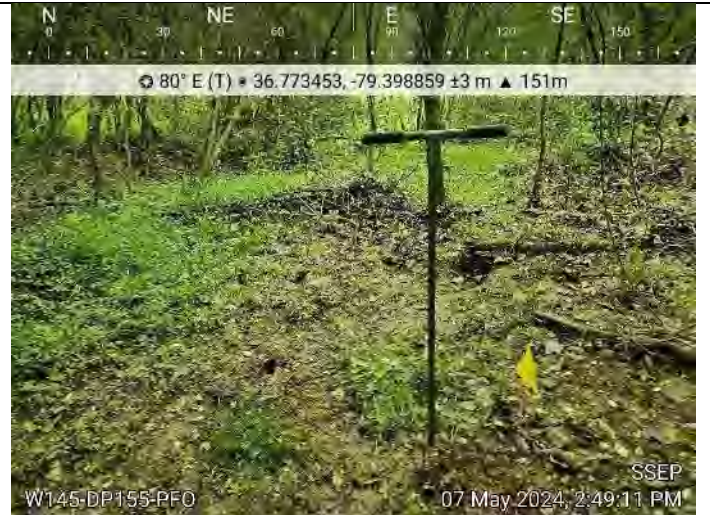
Photo 138:

Looking at Data Point #155, which characterizes a PFO wetland. This area contained all three wetland parameters. Attachment I; Sheet 18.

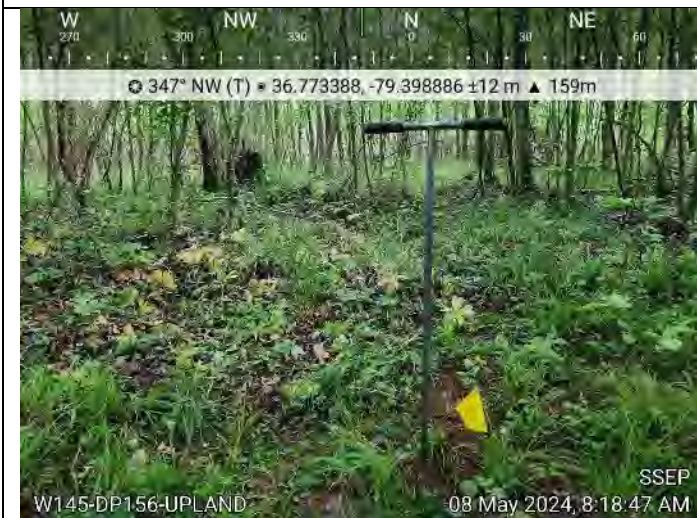
Photo 139:

Looking at Data Point #156, which characterizes an upland. This area lacked wetland hydrology and hydric soils. Attachment I; Sheet 18.

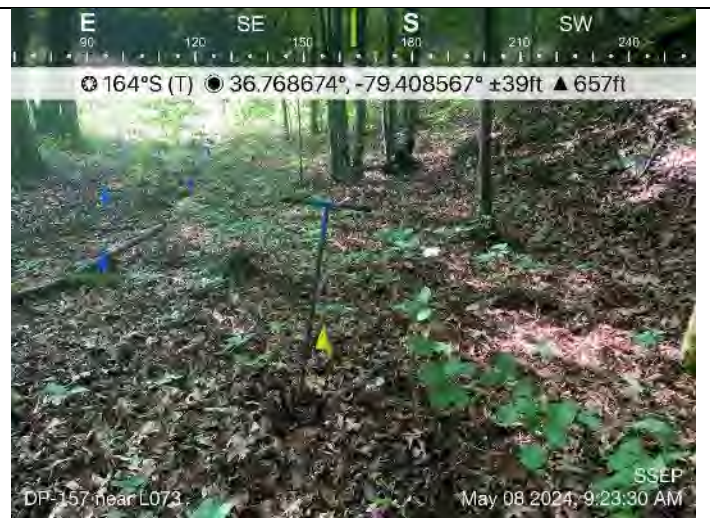
Photo 140:

Looking at Data Point #157, which characterizes an upland. This area lacked wetland hydrology, hydrophytic vegetation, and hydric soils. Attachment I; Sheet 17.

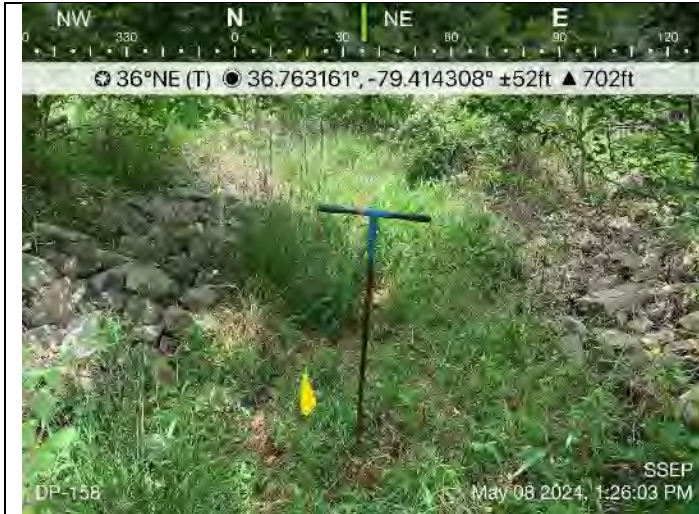
Photo 141:

Looking at Data Point #158, which characterizes an upland. This area lacked wetland hydrology, hydrophytic vegetation, and hydric soils. Attachment I; Sheet 17.

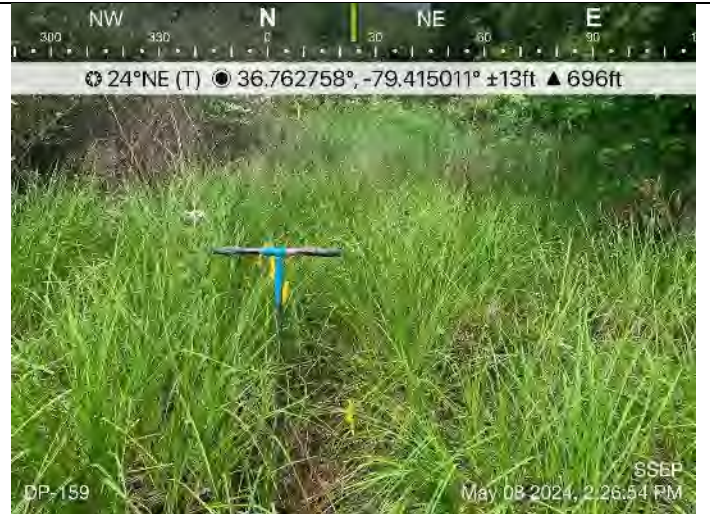
Photo 142:

Looking at Data Point #159, which characterizes a PEM wetland. This area contained all three wetland parameters. Attachment I; Sheet 17.

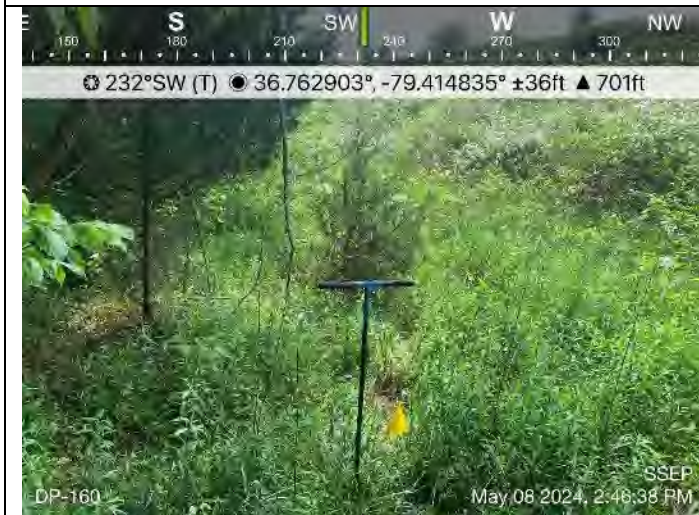
Photo 143:

Looking at Data Point #160, which characterizes an upland. This area lacked wetland hydrology, hydrophytic vegetation, and hydric soils. Attachment I; Sheet 17.

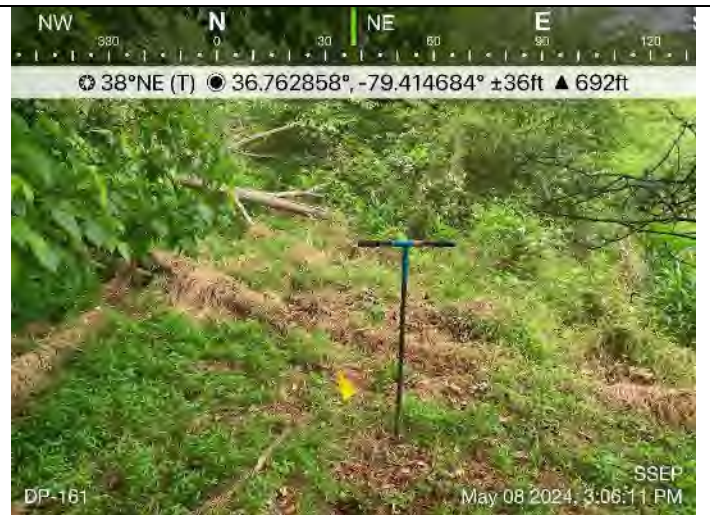
Photo 144:

Looking at Data Point #161, which characterizes an upland. This area lacked wetland hydrology and hydric soils. Attachment I; Sheet 17.

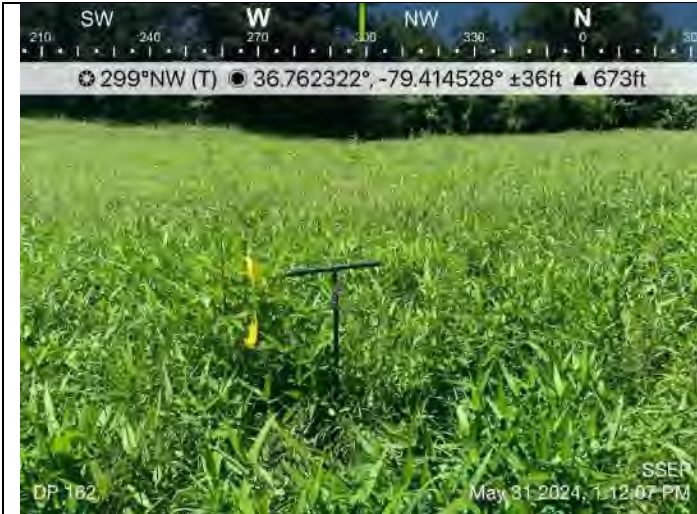
Photo 145:

Looking at Data Point #162, which characterizes an upland. This area lacked wetland hydrology and hydric soils. Attachment I; Sheet 17.

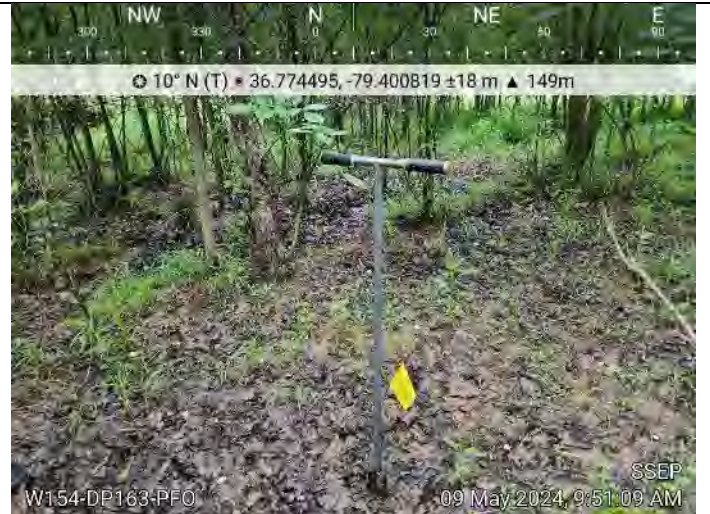
Photo 146:

Looking at Data Point #163, which characterizes a PFO wetland. This area contained all three wetland parameters. Attachment I; Sheet 18.

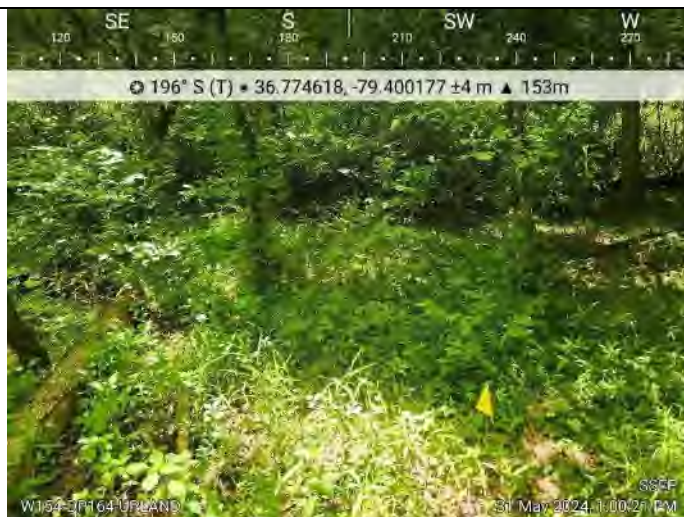
Photo 147:

Looking at Data Point #164, which characterizes an upland. This area lacked wetland hydrology and hydric soils. Attachment I; Sheet 18.

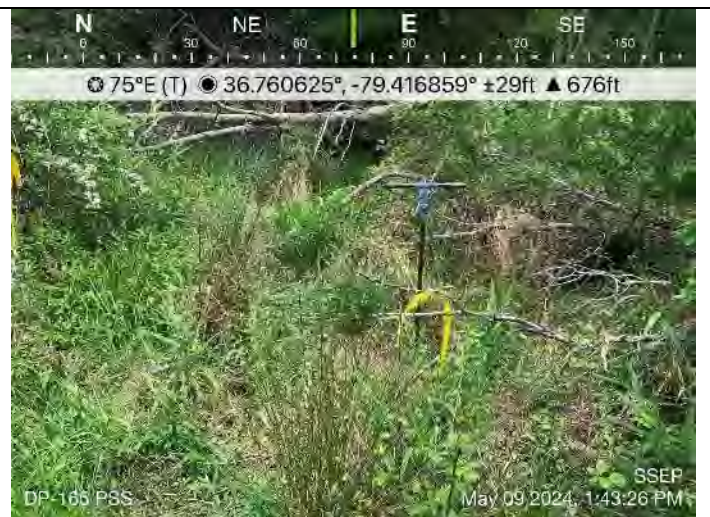
Photo 148:

Looking at Data Point #165, which characterizes a PSS wetland. This area contained all three wetland parameters. Attachment I; Sheet 17.

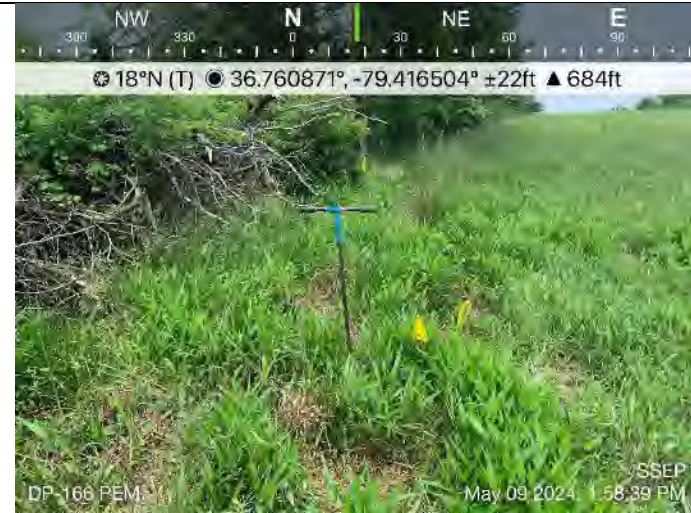
Photo 149:

Looking at Data Point #166, which characterizes a PEM wetland. This area contained all three wetland parameters. Attachment I; Sheet 17.
