EXHIBIT 14 - PHOTOGRAPHS

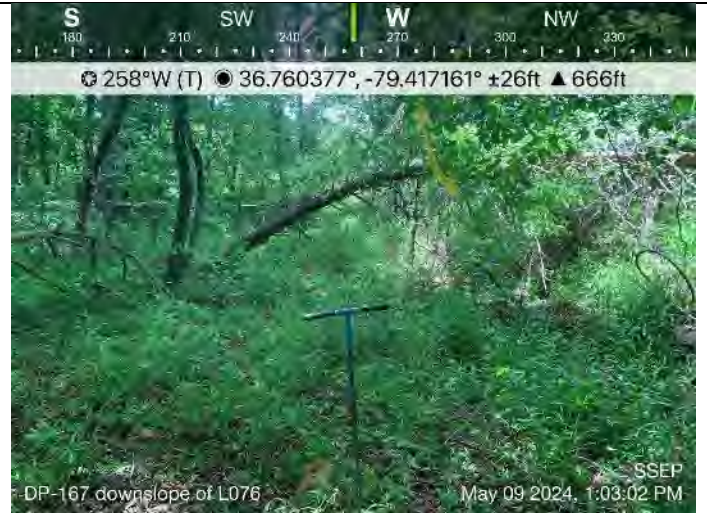
Photo 150:

Looking at Data Point #167, which characterizes an upland. This area lacked wetland hydrology and hydric soils. Attachment I; Sheet 17.

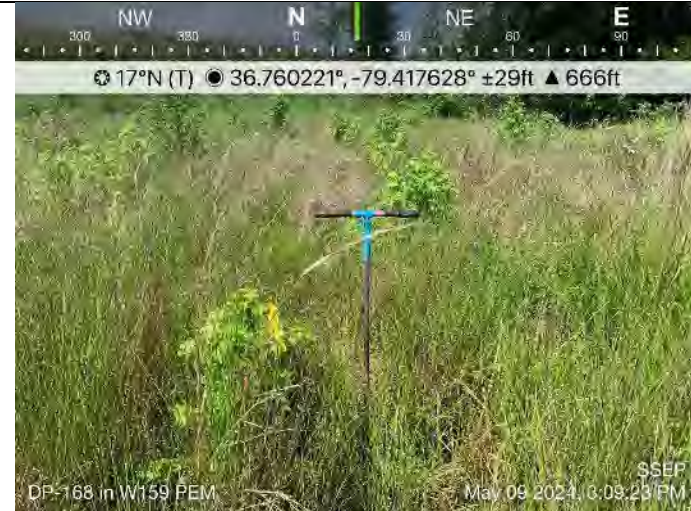
Photo 151:

Looking at Data Point #168, which characterizes a PEM wetland. This area was determined by DEQ to be a stormwater management feature. Attachment I; Sheet 17.

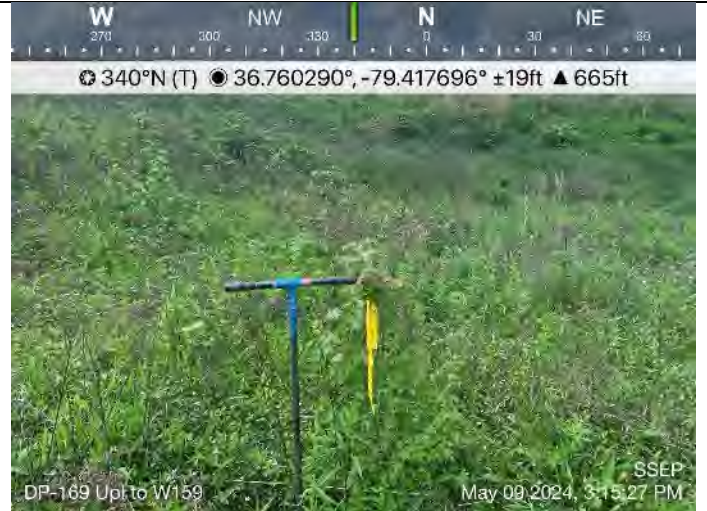
Photo 152:

Looking at Data Point #169, which characterizes an upland. This area was determined by DEQ to be a stormwater management feature. Attachment I; Sheet 17.

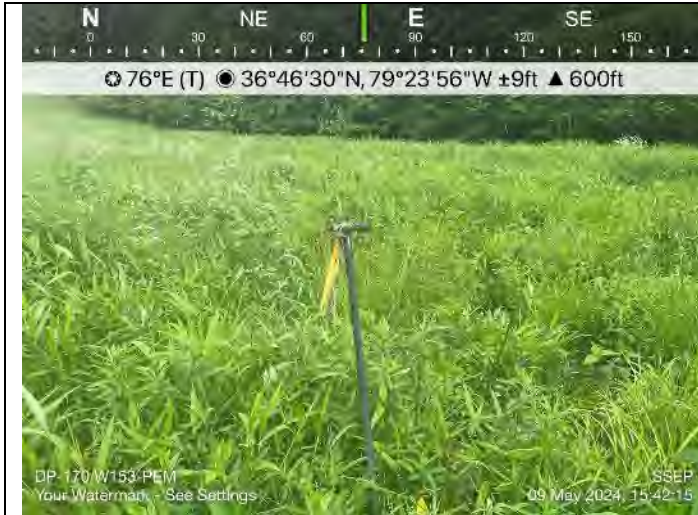
Photo 153:

Looking at Data Point #170, which characterizes a PEM wetland. This area contained all three wetland parameters. Attachment I; Sheet 18.

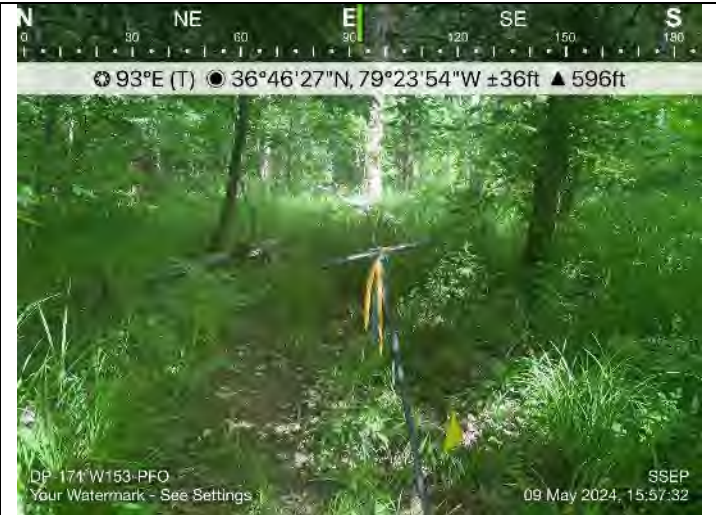
Photo 154:

Looking at Data Point #171, which characterizes a PFO wetland. This area contained all three wetland parameters. Attachment I; Sheet 18.

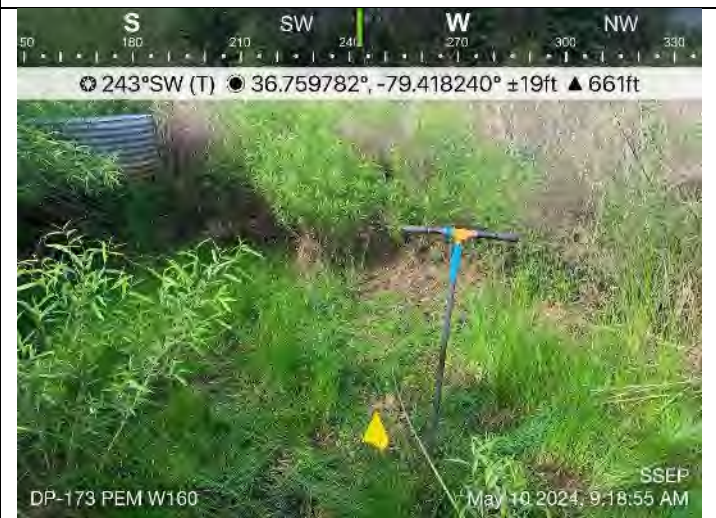
Photo 156:

Looking at Data Point #173, which characterizes a PEM wetland. This area was determined by DEQ to be a stormwater management feature. Attachment I; Sheet 17.

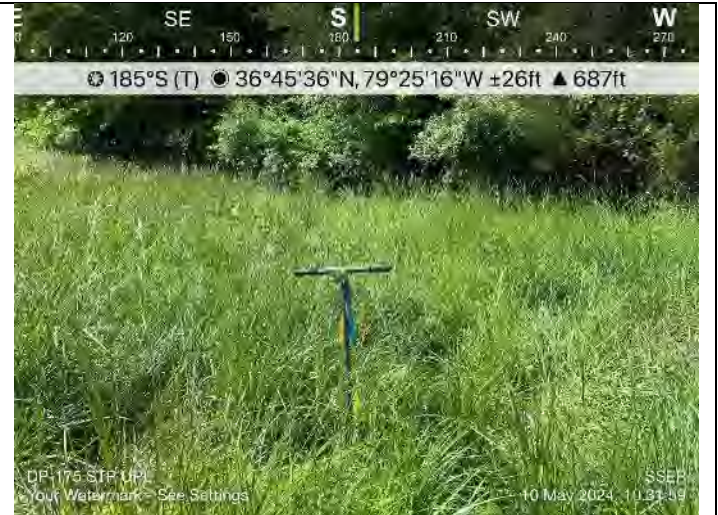
Looking at Data Point #174, which characterizes an upland. This area was determined by DEQ to be a stormwater management feature. Attachment I; Sheet 17.

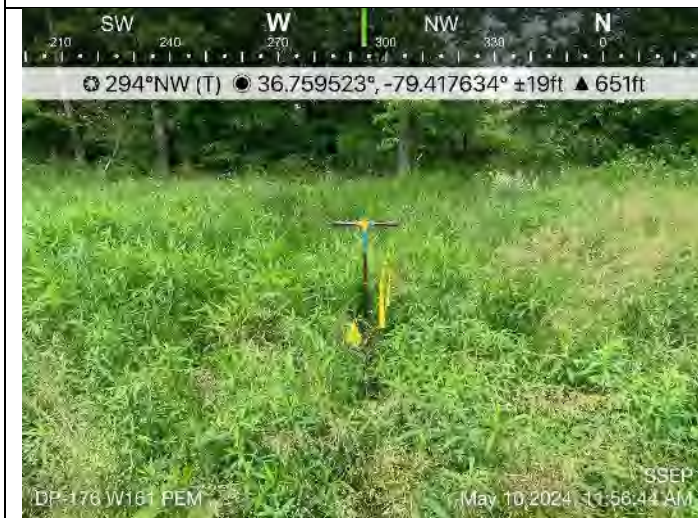
Photo 159:

Looking at Data Point #176, which characterizes a PEM wetland. This area contained all three wetland parameters. Attachment I; Sheet 17.

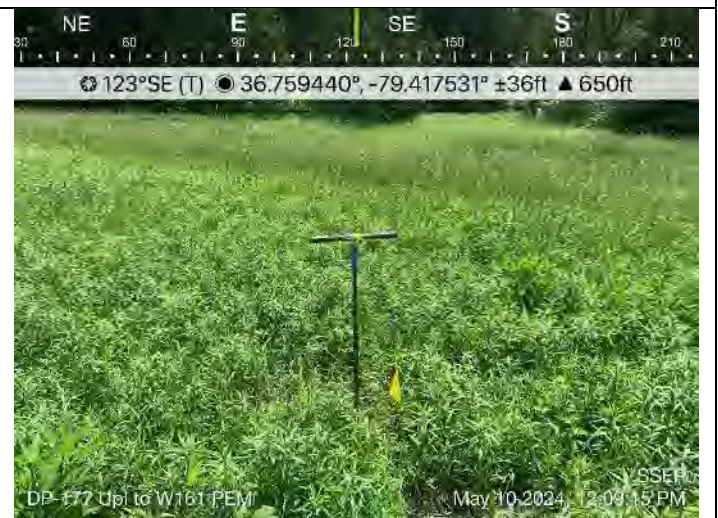
Photo 160:

Looking at Data Point #177, which characterizes an upland. This area lacked wetland hydrology, hydrophytic vegetation, and hydric soils. Attachment I; Sheet 17.

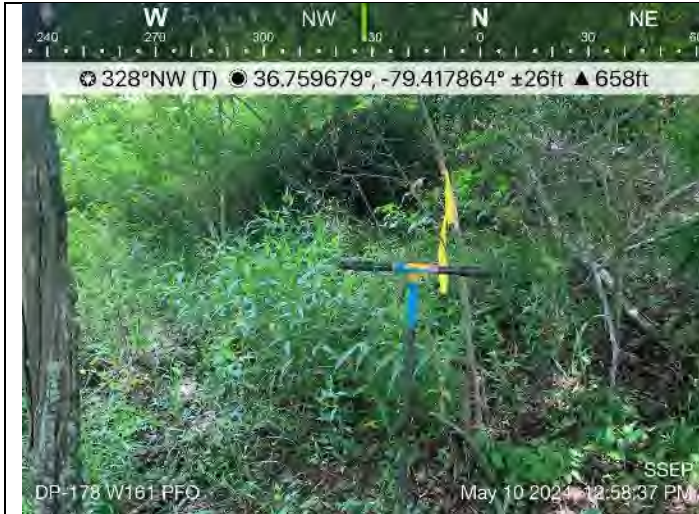
Photo 161:

Looking at Data Point #178, which characterizes a PFO wetland. This area contained all three wetland parameters. Attachment I; Sheet 17.

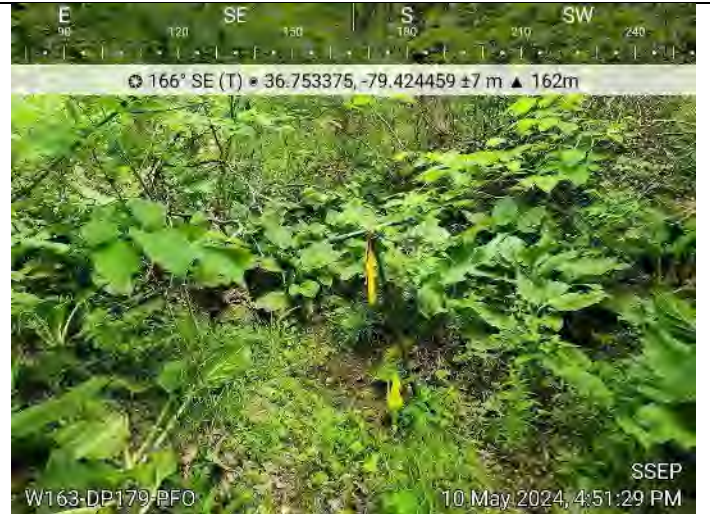
Photo 162:

Looking at Data Point #179, which characterizes a PFO wetland. This area contained all three wetland parameters. Attachment I; Sheet 16.

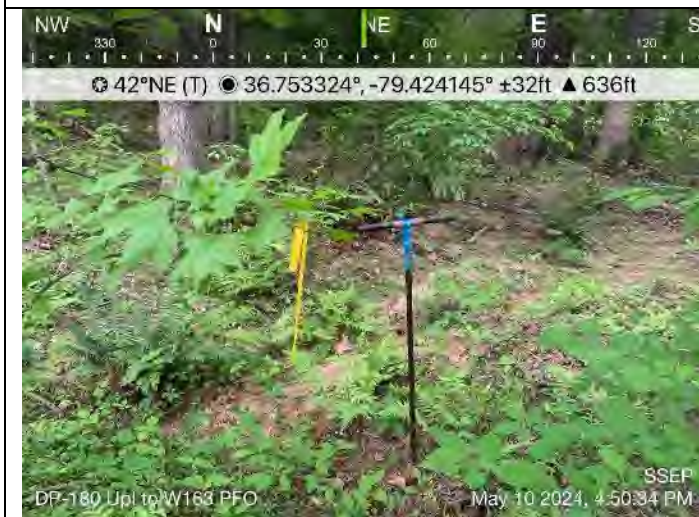
Photo 163:

Looking at Data Point #180, which characterizes an upland. This area lacked wetland hydrology and hydric soils. Attachment I; Sheet 16.

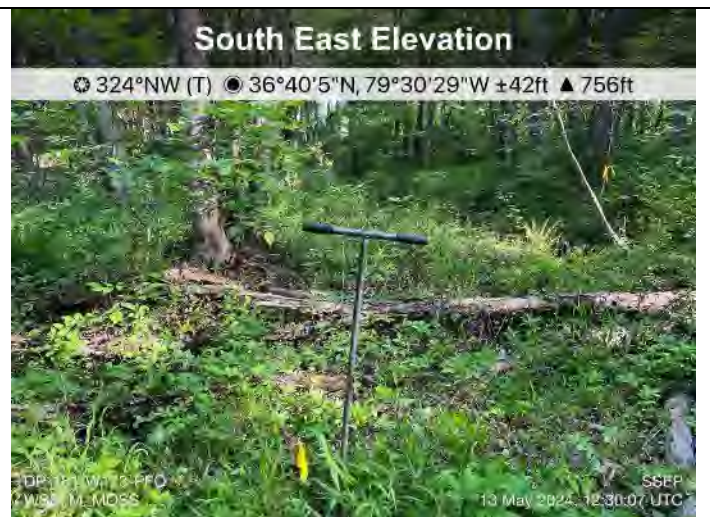
Photo 164:

Looking at Data Point #181, which characterizes a PFO wetland. This area contained all three wetland parameters. Attachment I; Sheet 10.

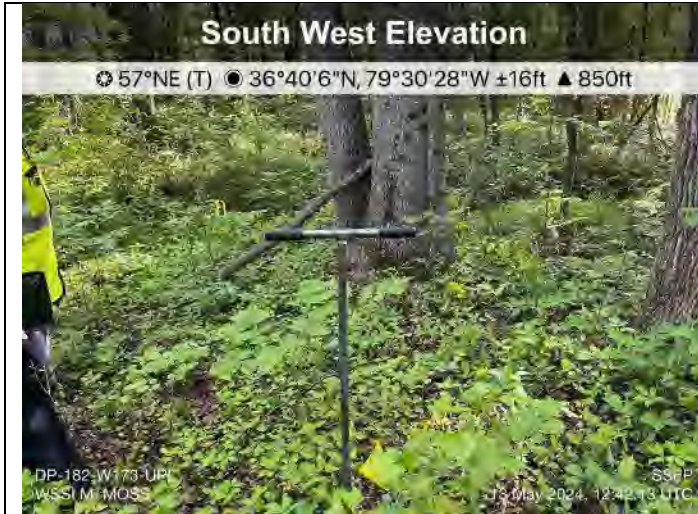
Photo 165:

Looking at Data Point #182, which characterizes an upland. This area lacked wetland hydrology, hydrophytic vegetation, and hydric soils. Attachment I; Sheet 10.

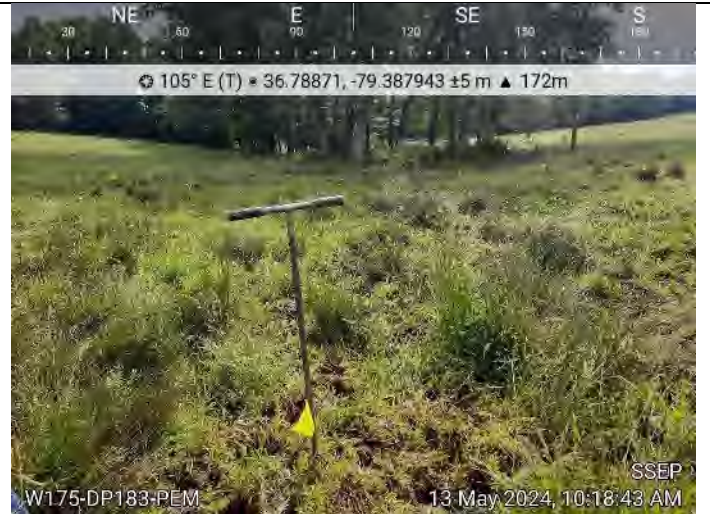
Photo 166:

Looking at Data Point #183, which characterizes a PEM wetland. This area contained all three wetland parameters. Attachment I; Sheet 20.

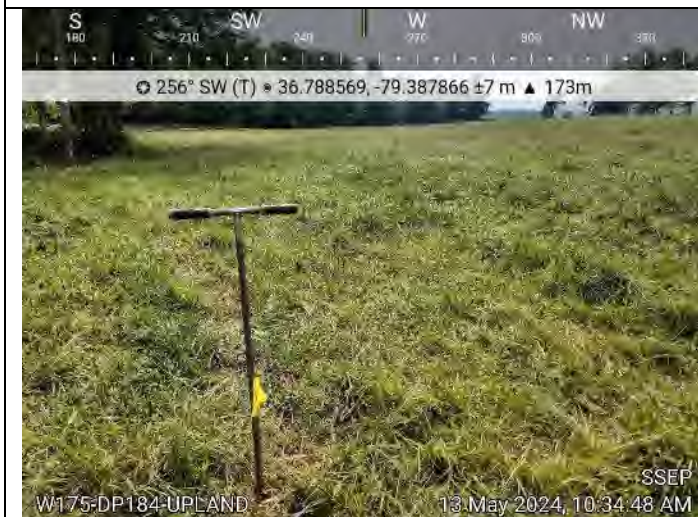
Photo 167:

Looking at Data Point #184, which characterizes an upland. This area lacked wetland hydrology, hydrophytic vegetation, and hydric soils. Attachment I; Sheet 20.

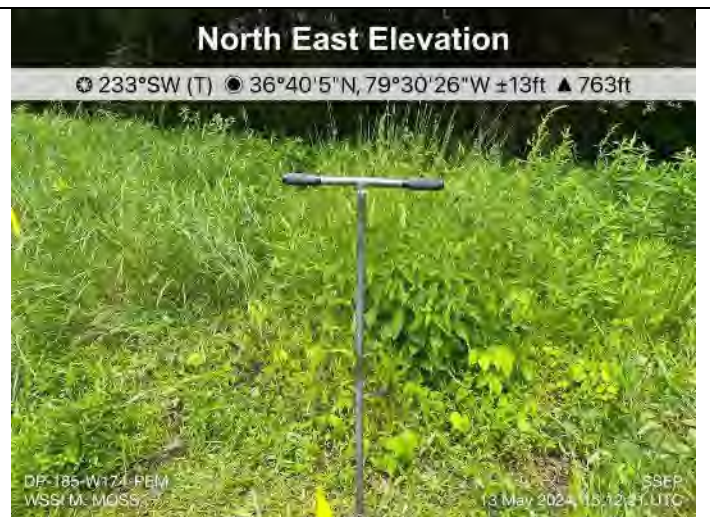
Photo 168:

Looking at Data Point #185, which characterizes a PEM wetland. This area contained all three wetland parameters. Attachment I; Sheets 10 and 11.

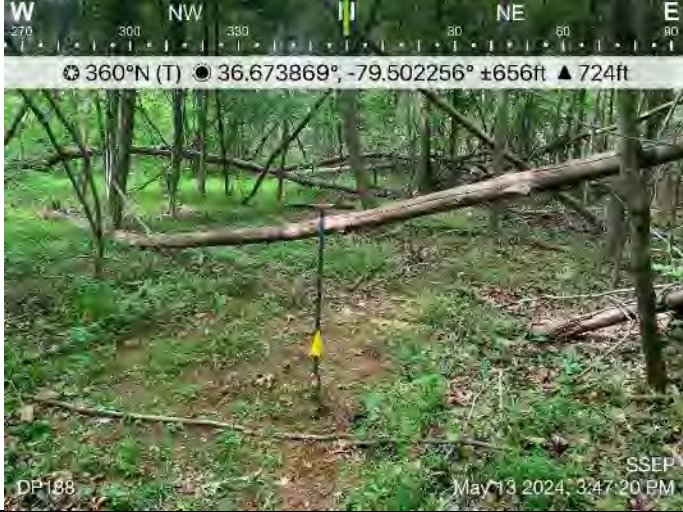
<p>South West Elevation</p> <p>42°NE (T) 36°39'54"N, 79°27'59"W ±22480ft ▲ 675ft</p> <p>DP-187-PEM WSSI M. MOSS 31 May 2024, 14:38:15 UTC SSEP</p>
<p>Photo 169:</p> <p>Looking at Data Point #186, which characterizes an upland. This area lacked wetland hydrology, hydrophytic vegetation, and hydric soils. Attachment I; Sheet 10.</p>	<p>Photo 170:</p> <p>Looking at Data Point #187, which characterizes a PEM wetland. This area contained all three wetland parameters. Attachment I; Sheet 11.</p>

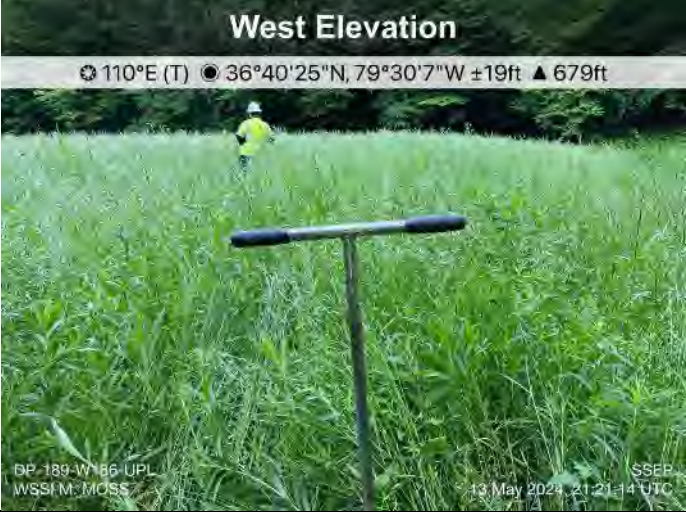
<p>West Elevation</p> <p>360°N (T) 36.673869°, -79.502256° ±656ft ▲ 724ft</p> <p>DP-188 WSSI M. MOSS May 13 2024, 3:47:20 PM SSEP</p>

<p>Photo 171:</p> <p>Looking at Data Point #188, which characterizes an upland. This area lacked wetland hydrology and hydric soils. Attachment I; Sheet 11.</p>	<p>Photo 172:</p> <p>Looking at Data Point #189, which characterizes an upland. This area lacked wetland hydrology and hydrophytic vegetation. Attachment I; Sheet 11.</p>

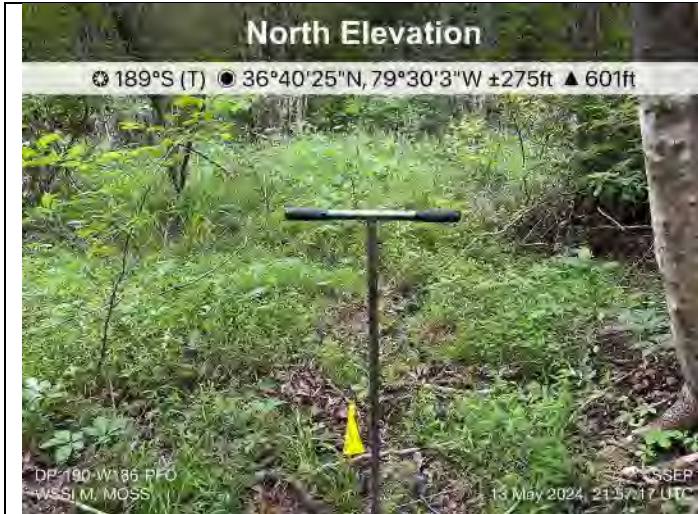
<p>West Elevation</p> <p>110°E (T) 36°40'25"N, 79°30'7"W ±19ft ▲ 679ft</p> <p>DP-189-W186-UPL WSSI M. MOSS 13 May 2024, 21:21:14 UTC SSEP</p>

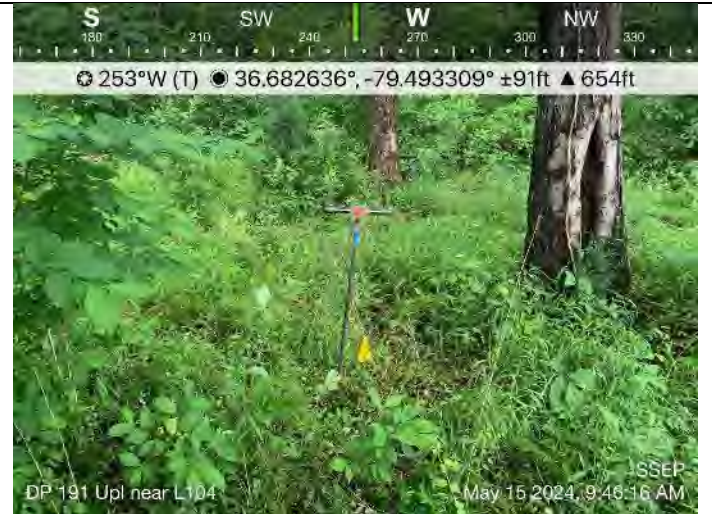
Photo 174:

Looking at Data Point #191, which characterizes an upland. This area lacked wetland hydrology, hydrophytic vegetation, and hydric soils. Attachment I; Sheets 11 and 12.

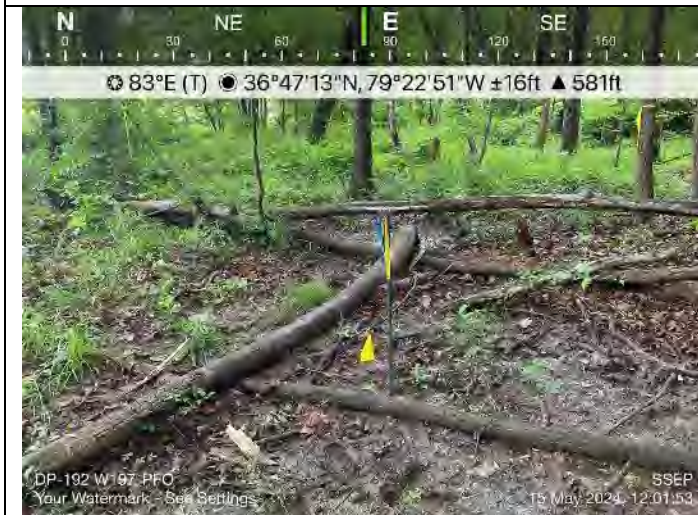
Photo 175:

Looking at Data Point #192, which characterizes a PFO wetland. This area contained all three wetland parameters. Attachment I; Sheet 20.

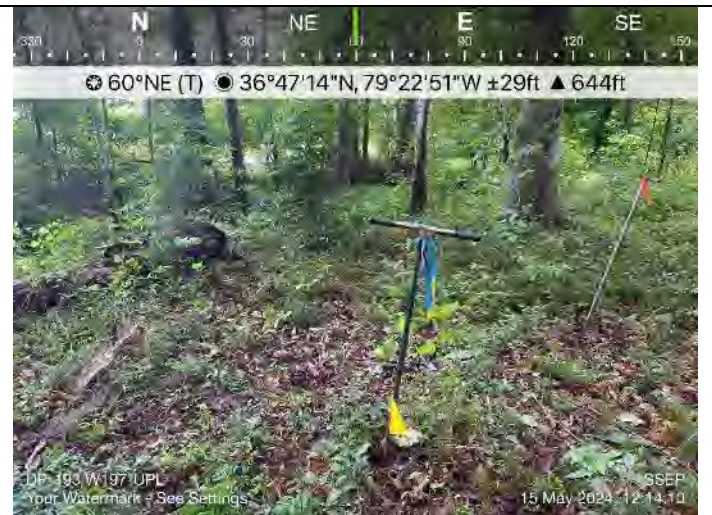
Photo 176:

Looking at Data Point #193, which characterizes an upland. This area lacked wetland hydrology, hydrophytic vegetation, and hydric soils. Attachment I; Sheet 20.

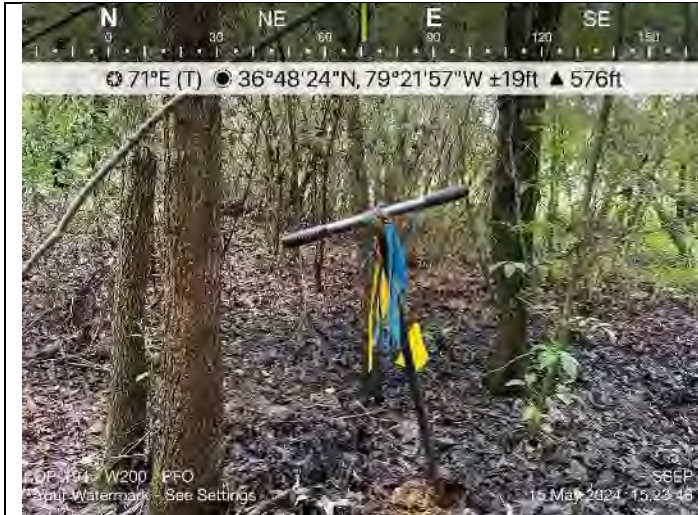
Photo 177:

Looking at Data Point #194, which characterizes a PFO wetland. This area contained all three wetland parameters. Attachment I; Sheet 21.

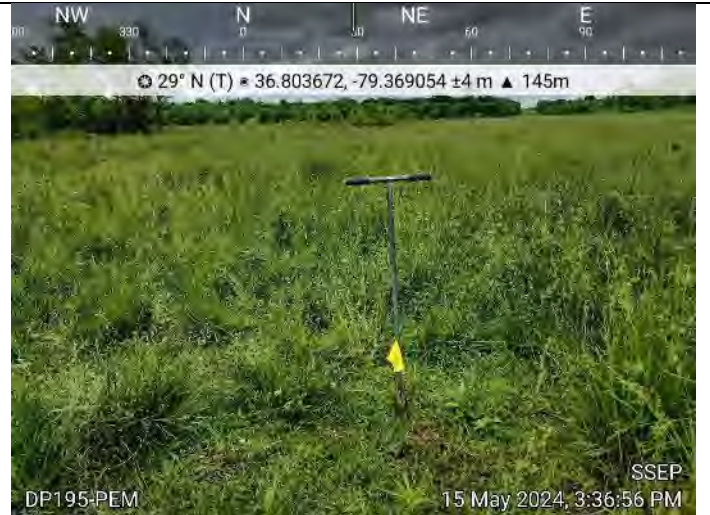
Photo 178:

Looking at Data Point #195, which characterizes a PEM wetland. This area contained all three wetland parameters. Attachment I; Sheet 21.

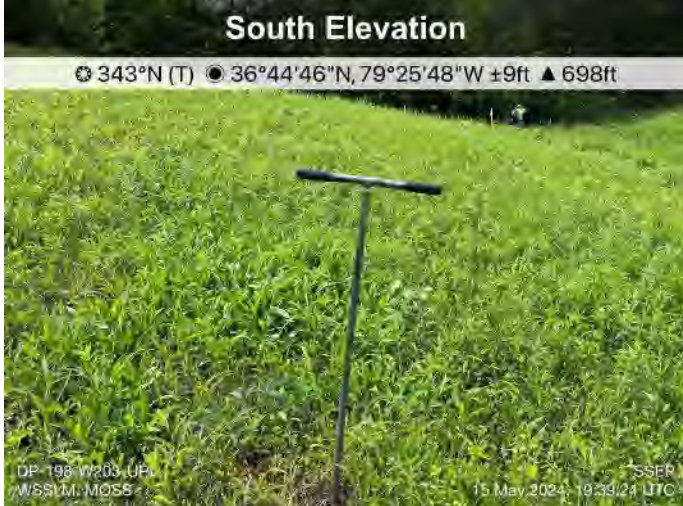
<p>South Elevation 343°N (T) 36°44'46"N, 79°25'48"W ±9ft ▲ 698ft DP 198 W203 UPL WSSM: MOSS 15 May 2024, 19:39:24 UTC</p>

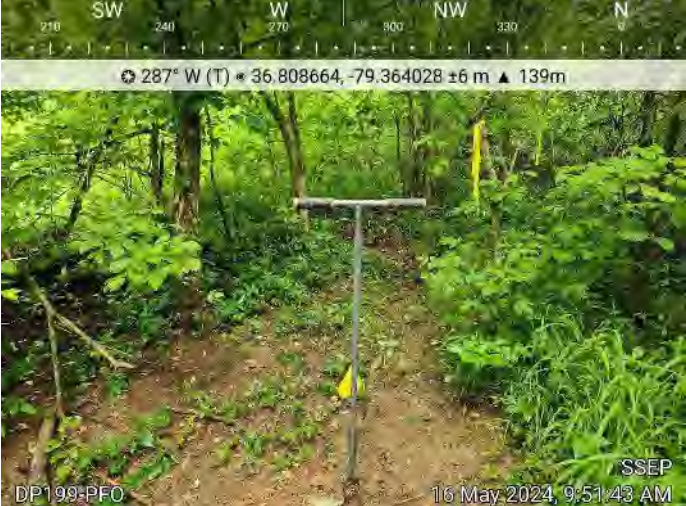
<p>287° W (T) 36.808664, -79.364028 ±6 m ▲ 139m DP199:PFO 16 May 2024, 9:51:43 AM</p>
<p>Photo 181: Looking at Data Point #198, which characterizes an upland. This area lacked wetland hydrology, hydrophytic vegetation, and hydric soils. Attachment I; Sheet 16.</p>	<p>Photo 182: Looking at Data Point #199, which characterizes a PFO wetland. This area contained all three wetland parameters. Attachment I; Sheet 21.</p>

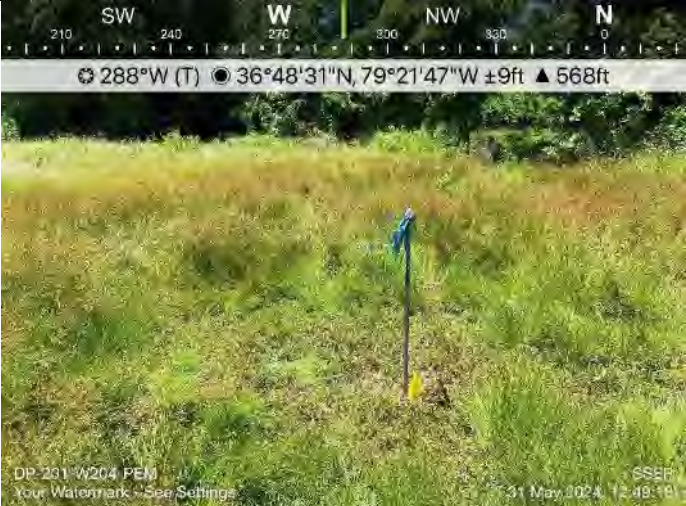
<p>288°W (T) 36°48'31"N, 79°21'47"W ±9ft ▲ 568ft DP 201 W204 PEM Your Watermark - See Settings 31 May 2024, 12:49:16</p>
<p>Photo 183: Looking at Data Point #200, which characterizes an upland. This area lacked wetland hydrology, hydrophytic vegetation, and hydric soils. Attachment I; Sheet 21.</p>	<p>Photo 184: Looking at Data Point #201, which characterizes a PEM wetland. This area contained all three wetland parameters. Attachment I; Sheet 21.</p>

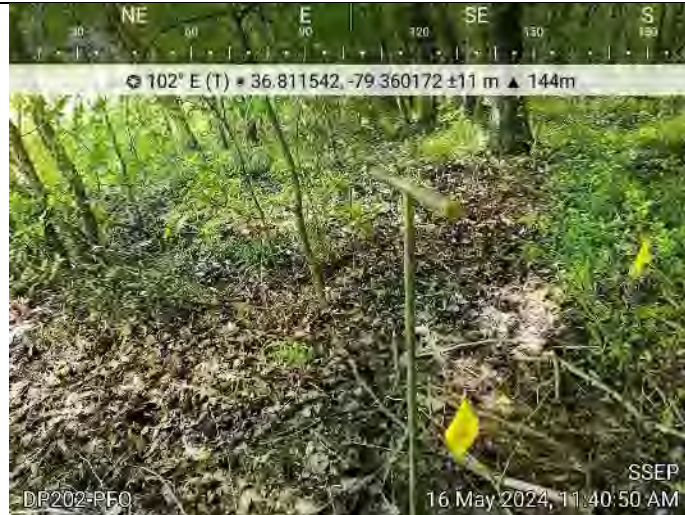
Photo 185:

Looking at Data Point #202, which characterizes a PFO wetland. This area contained all three wetland parameters. Attachment I; Sheet 22.

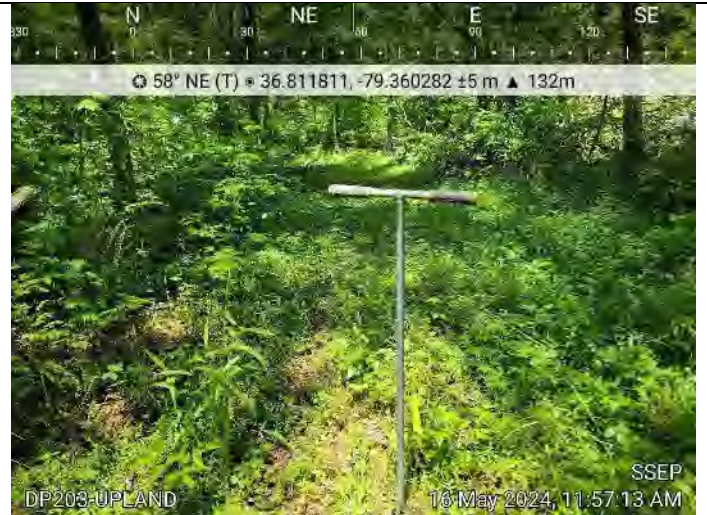
Photo 186:

Looking at Data Point #203, which characterizes an upland. This area lacked wetland hydrology and hydric soils. Attachment I; Sheet 22.

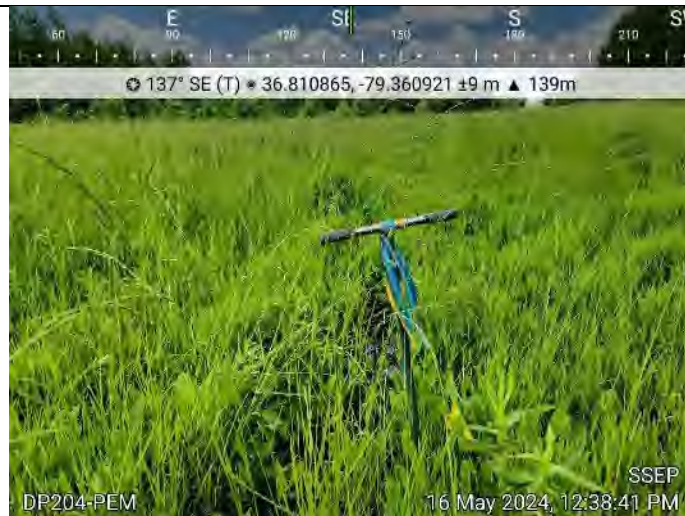
Photo 187:

Looking at Data Point #204, which characterizes a PEM wetland. This area contained all three wetland parameters. Attachment I; Sheet 22.

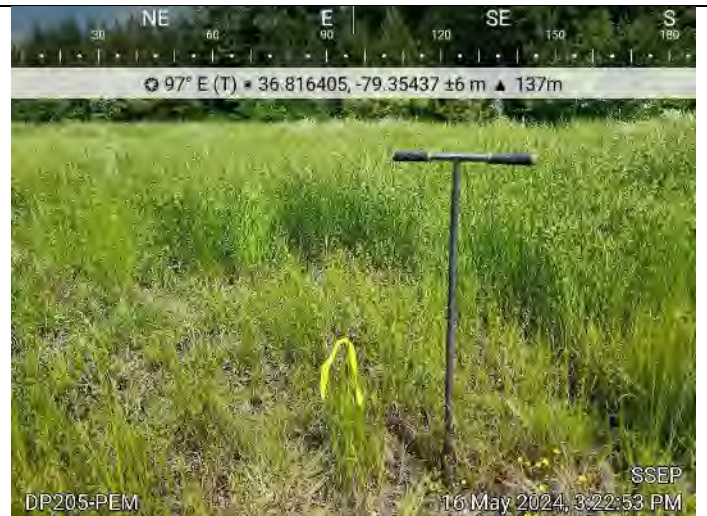
Photo 188:

Looking at Data Point #205, which characterizes a PEM wetland. This area contained all three wetland parameters. Attachment I; Sheet 22.

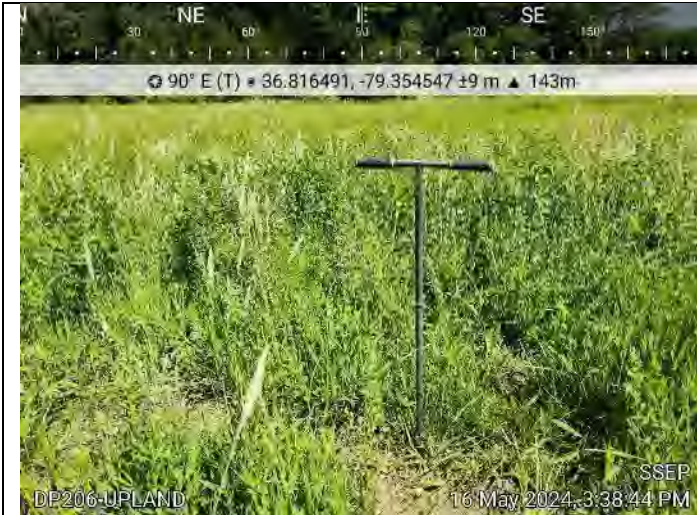
Photo 189:

Looking at Data Point #206, which characterizes an upland. This area lacked wetland hydrology, hydrophytic vegetation, and hydric soils. Attachment I; Sheet 22.

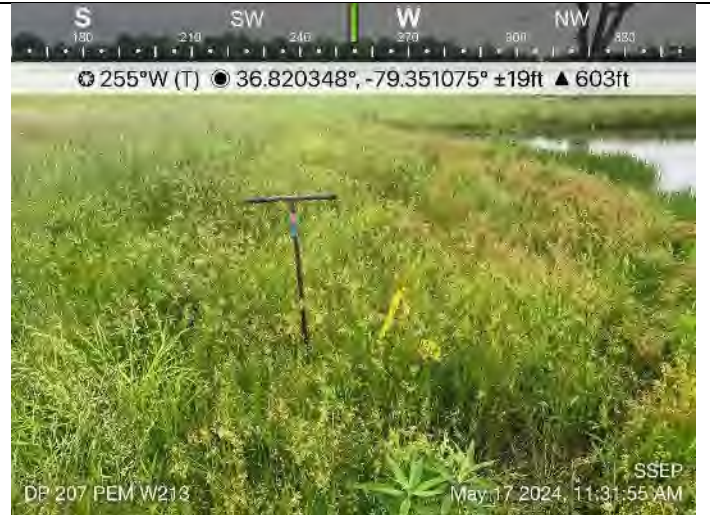
Photo 190:

Looking at Data Point #207, which characterizes a PEM wetland. This area contained all three wetland parameters. Attachment I; Sheet 22.

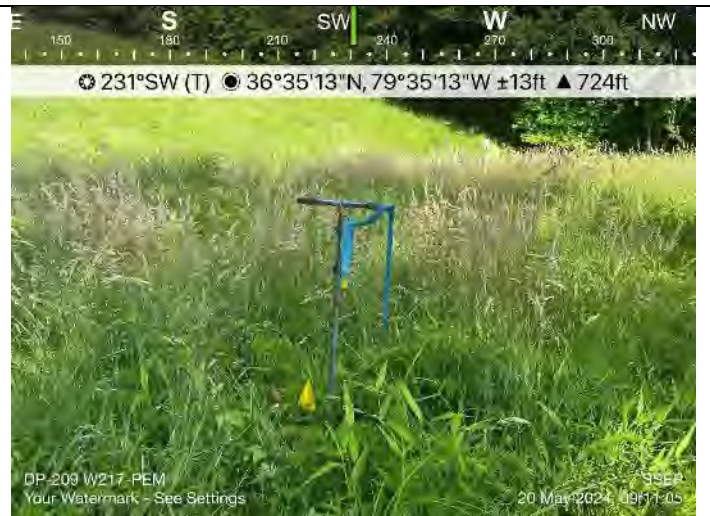
Photo 192:

Looking at Data Point #209, which characterizes a PEM wetland. This area contained all three wetland parameters. Attachment I; Sheet 5.

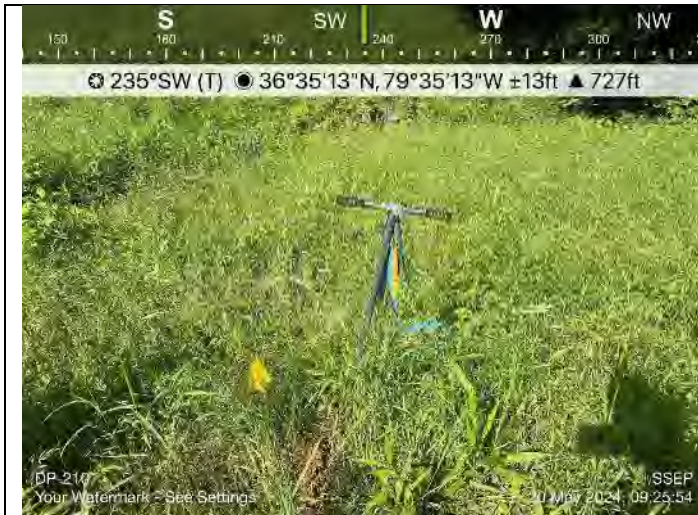
Photo 193:

Looking at Data Point #210, which characterizes an upland. This area lacked wetland hydrology, hydrophytic vegetation, and hydric soils. Attachment I; Sheet 5.

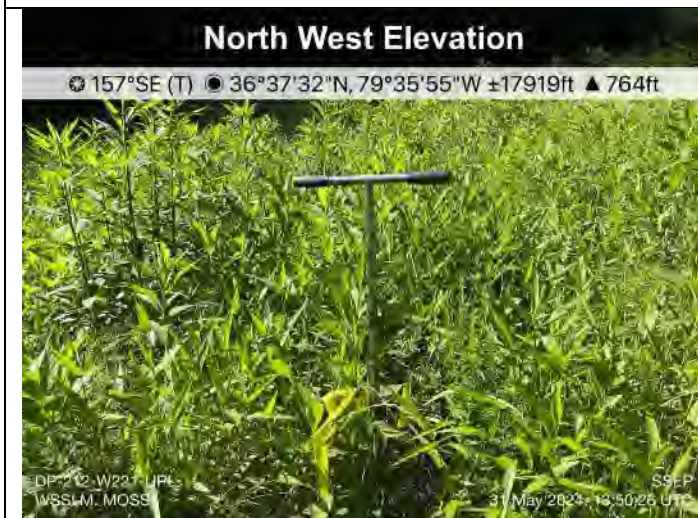
Photo 195:

Looking at Data Point #212, which characterizes an upland. This area lacked wetland hydrology, hydrophytic vegetation, and hydric soils. Attachment I; Sheet 5.

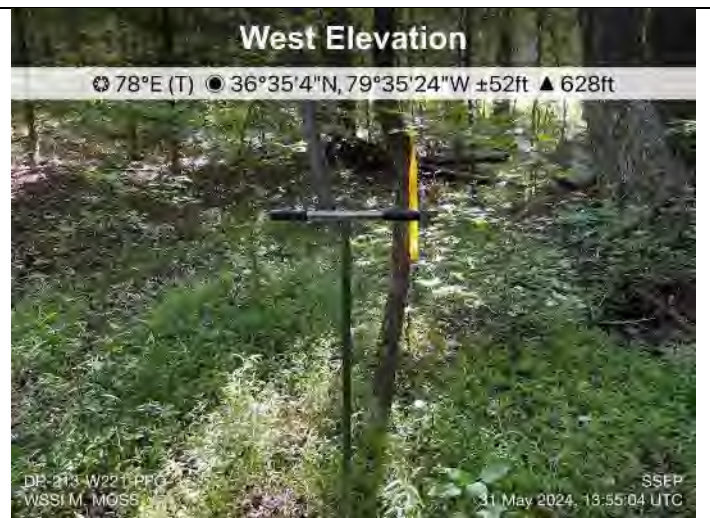
Photo 196:

Looking at Data Point #213, which characterizes a PFO wetland. This area contained all three wetland parameters. Attachment I; Sheet 5.

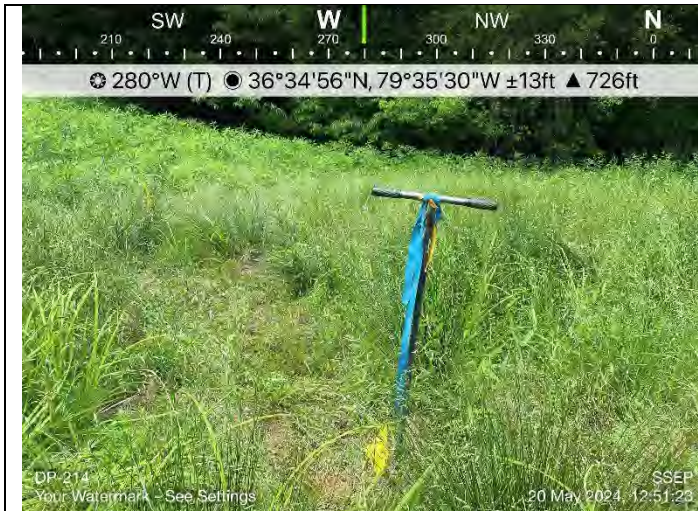
Photo 197:

Looking at Data Point #214, which characterizes an upland. This area lacked wetland hydrology and hydric soils. Attachment I; Sheet 5.

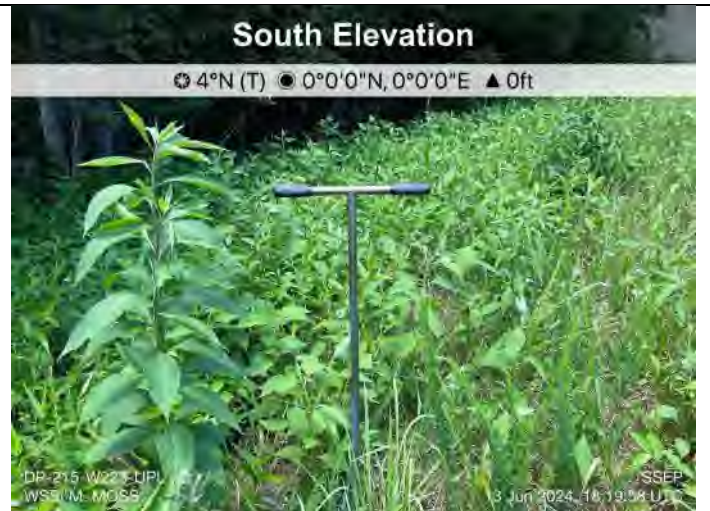
Photo 198:

Looking at Data Point #215, which characterizes an upland. This area lacked wetland hydrology, hydrophytic vegetation, and hydric soils. Attachment I; Sheets 4 and 5.

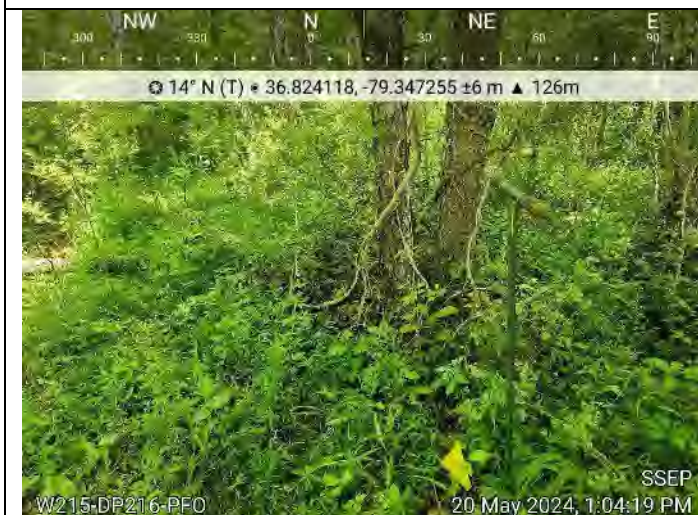
Photo 199:

Looking at Data Point #216, which characterizes a PFO wetland. This area contained all three wetland parameters. Attachment I; Sheet 23.

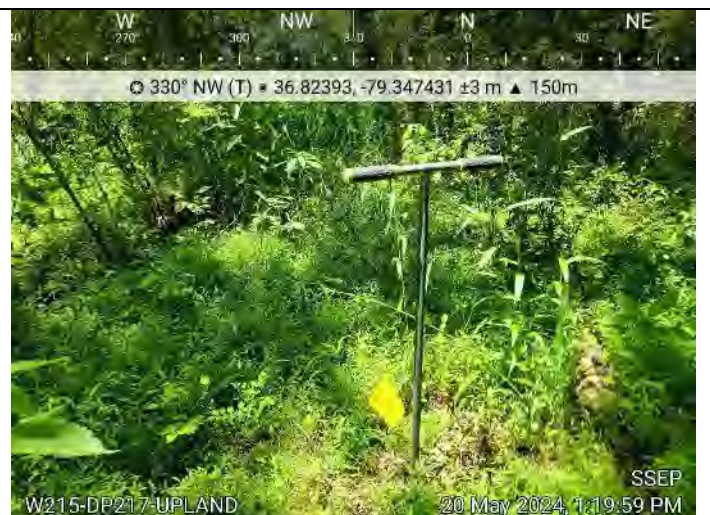
Photo 200:

Looking at Data Point #217, which characterizes an upland. This area lacked wetland hydrology, hydrophytic vegetation, and hydric soils. Attachment I; Sheet 23.

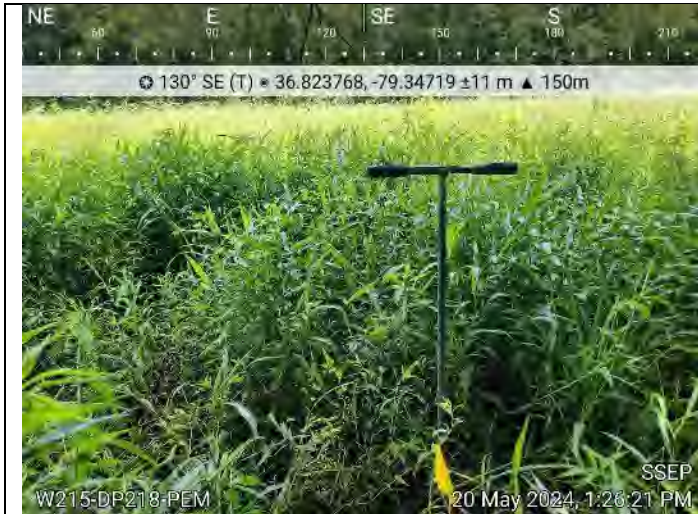
Photo 201:

Looking at Data Point #218, which characterizes a PEM wetland. This area contained all three wetland parameters. Attachment I; Sheet 23.

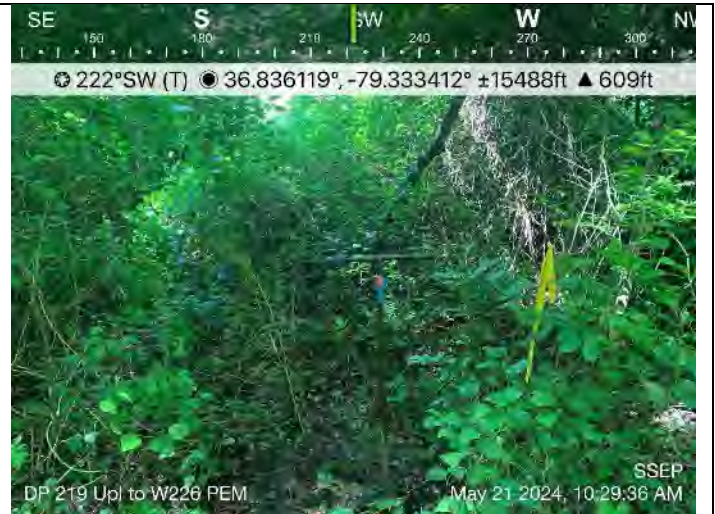
Photo 202:

Looking at Data Point #219, which characterizes an upland. This area lacked wetland hydrology and hydric soils. Attachment I; Sheet 23.

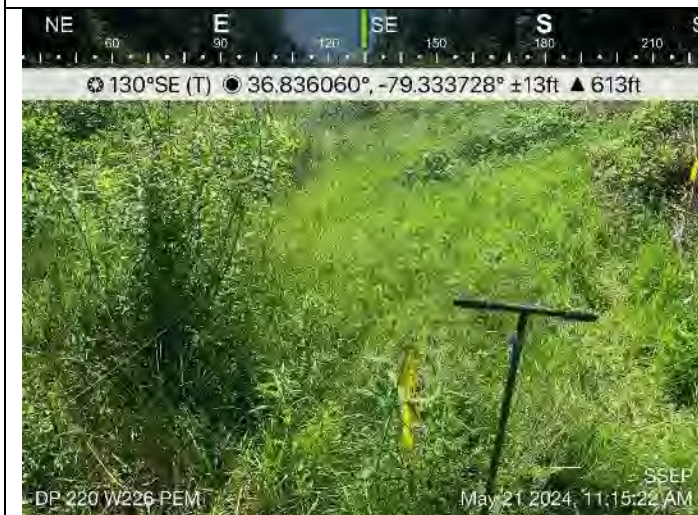
Photo 203:

Looking at Data Point #220, which characterizes a PEM wetland. This area contained all three wetland parameters. Attachment I; Sheet 23.

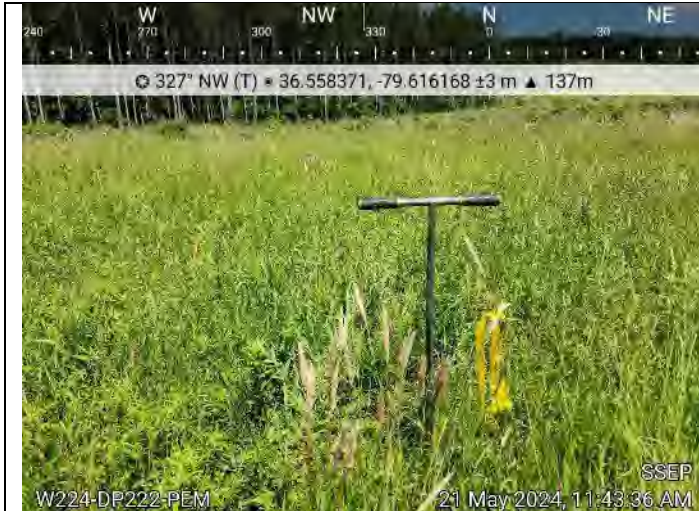
Photo 205:

Looking at Data Point #222, which characterizes a PEM wetland. This area contained all three wetland parameters. Attachment I; Sheet 3.

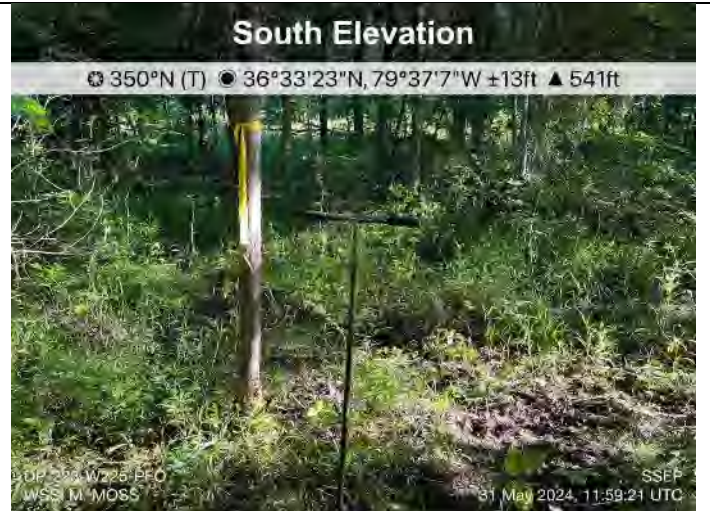
Photo 206:

Looking at Data Point #223, which characterizes a PFO wetland. This area contained all three wetland parameters. Attachment I; Sheet 3.

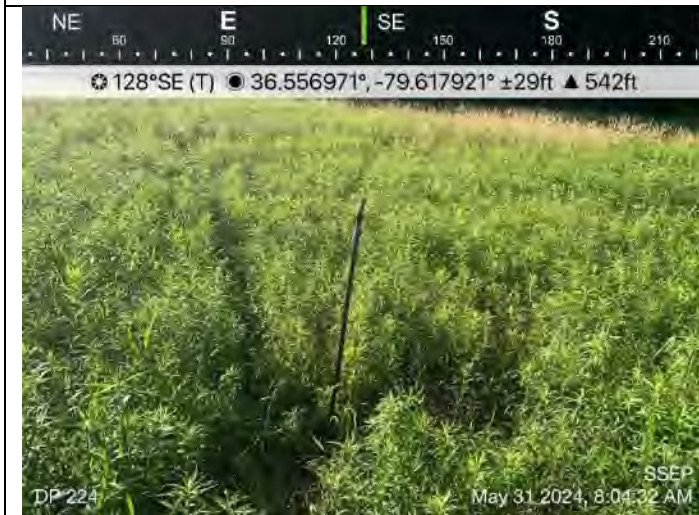
Photo 207:

Looking at Data Point #224, which characterizes an upland. This area lacked wetland hydrology, hydrophytic vegetation, and hydric soils. Attachment I; Sheet 3.

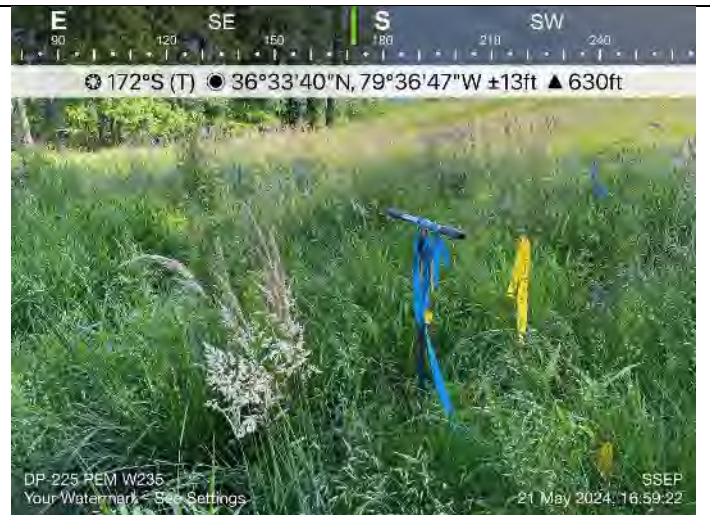
Photo 208:

Looking at Data Point #225, which characterizes a PEM wetland. This area contained all three wetland parameters. Attachment I; Sheet 3.

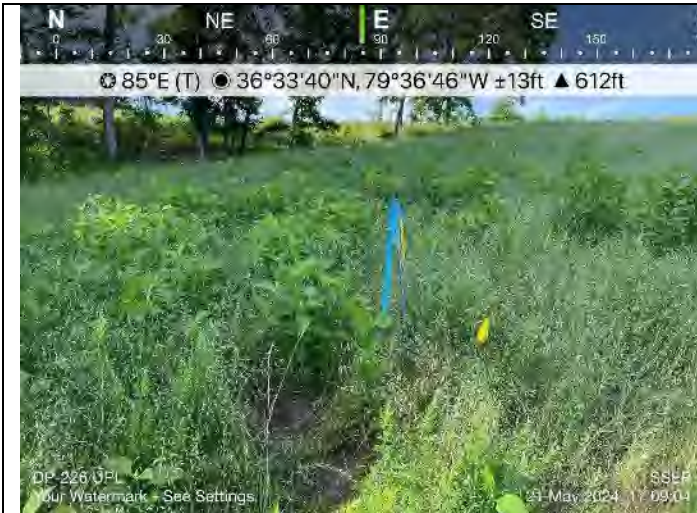
Photo 209:

Looking at Data Point #226, which characterizes an upland. This area lacked wetland hydrology, hydrophytic vegetation, and hydric soils. Attachment I; Sheet 3.

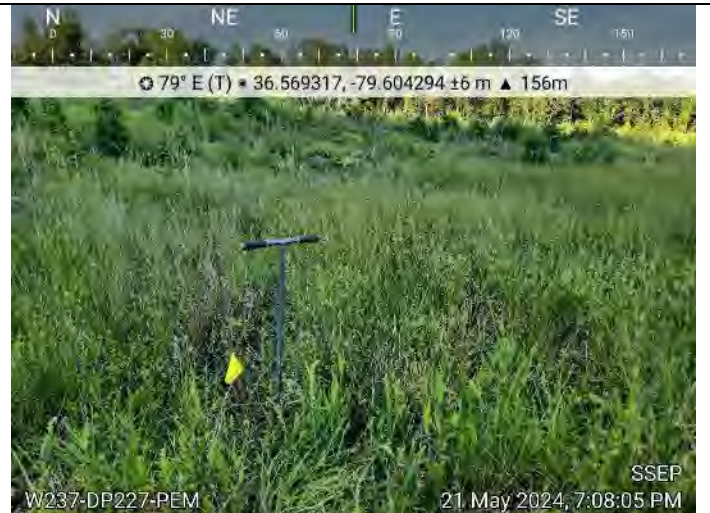
Photo 210:

Looking at Data Point #227, which characterizes a PEM wetland. This area contained all three wetland parameters. Attachment I; Sheet 4.

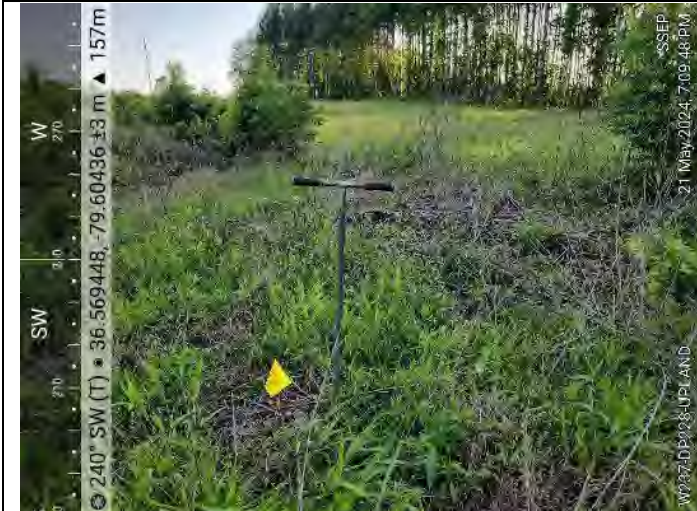
Photo 211:

Looking Point #228, which characterizes an upland. This area lacked wetland hydrology and hydric soils. Attachment I; Sheet 4.

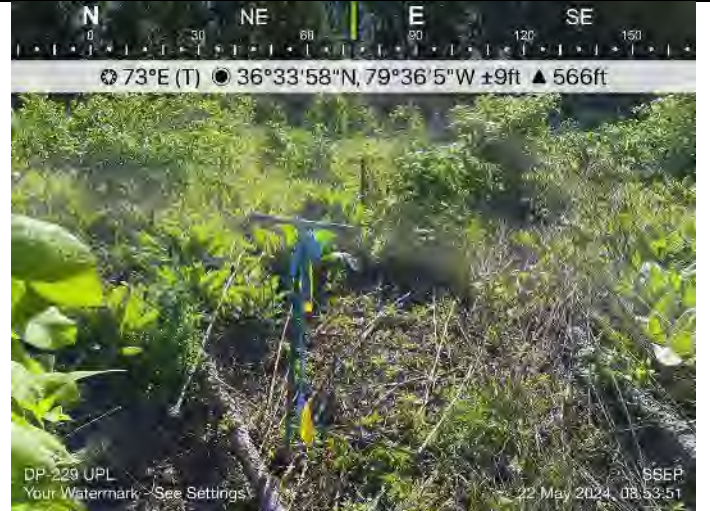
Photo 212:

Looking at Data Point #229, which characterizes an upland. This area lacked hydrophytic vegetation and hydric soil. Attachment I; Sheet 4.

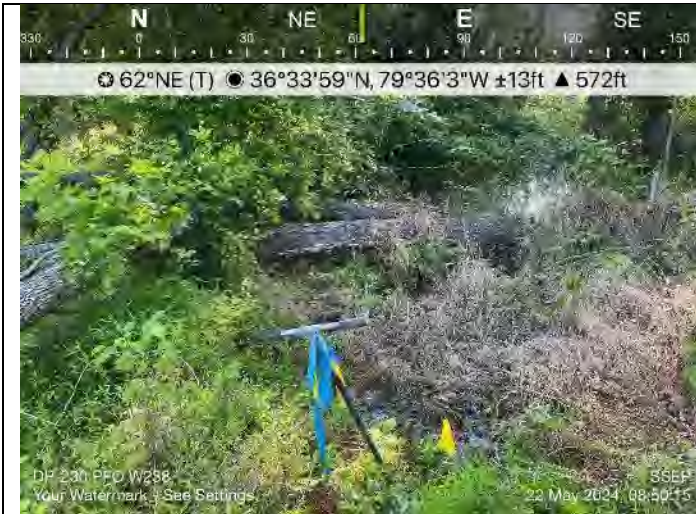
Photo 213:

Looking at Data Point #230, which characterizes a PFO wetland. This area contained all three wetland parameters. Attachment I; Sheet 4.

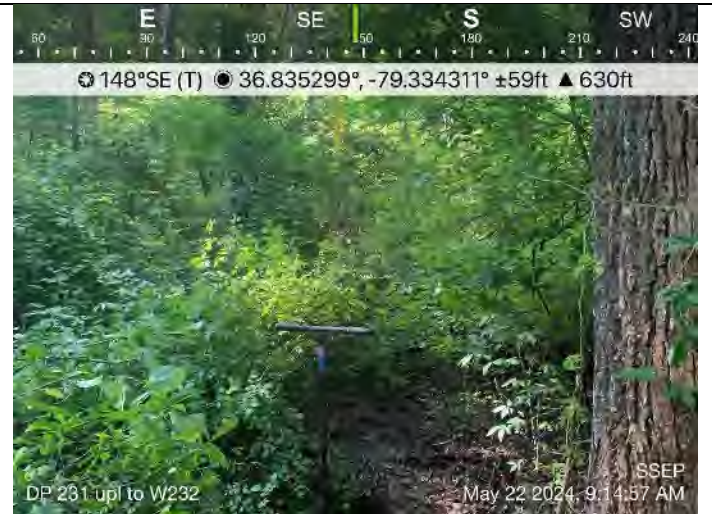
Photo 214:

Looking at Data Point #231, which characterizes an upland. This area lacked hydrophytic vegetation and hydric soil. Attachment I; Sheet 23.

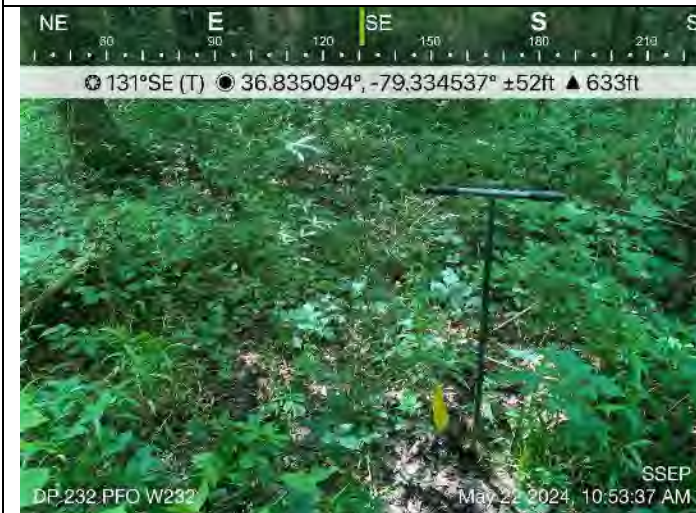
Photo 215:

Looking at Data Point #232, which characterizes a PFO wetland. This area contained all three wetland parameters. Attachment I; Sheet 23.
