EXHIBIT 14 - PHOTOGRAPHS

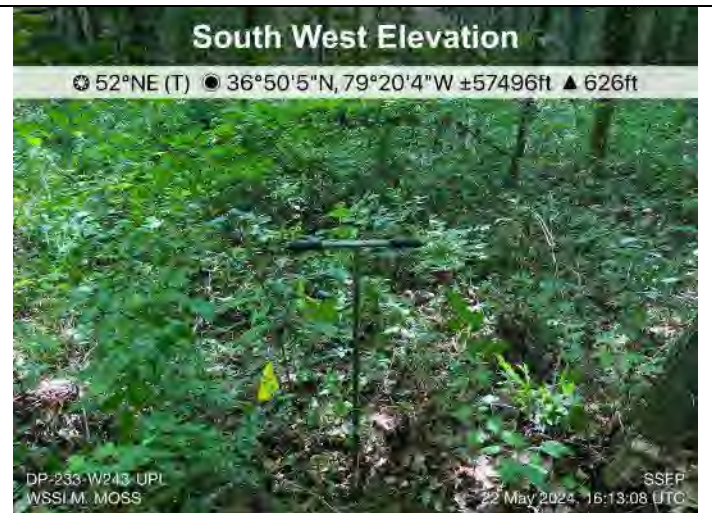
Photo 216:

Looking at Data Point #233, which characterizes an upland. This area lacked wetland hydrology, hydrophytic vegetation, and hydric soils. Attachment I; Sheet 23.

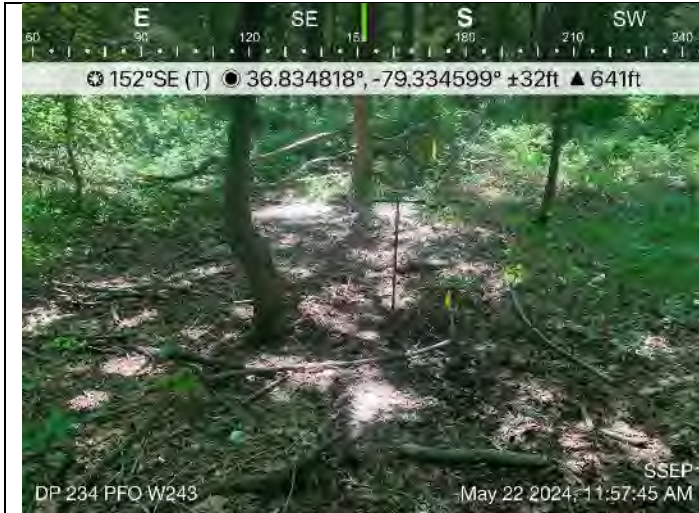
Photo 217:

Looking at Data Point #234, which characterizes a PFO wetland. This area contained all three wetland parameters. Attachment I; Sheet 23.

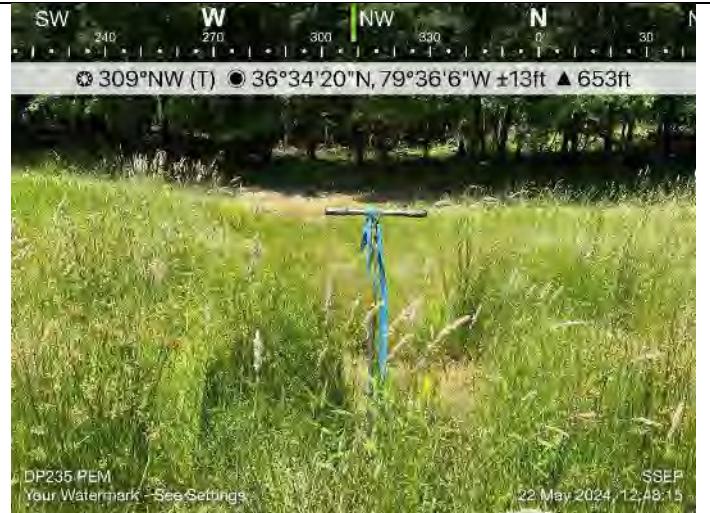
Photo 218:

Looking at Data Point #235, which characterizes a PEM wetland. This area contained all three wetland parameters. Attachment I; Sheet 4.

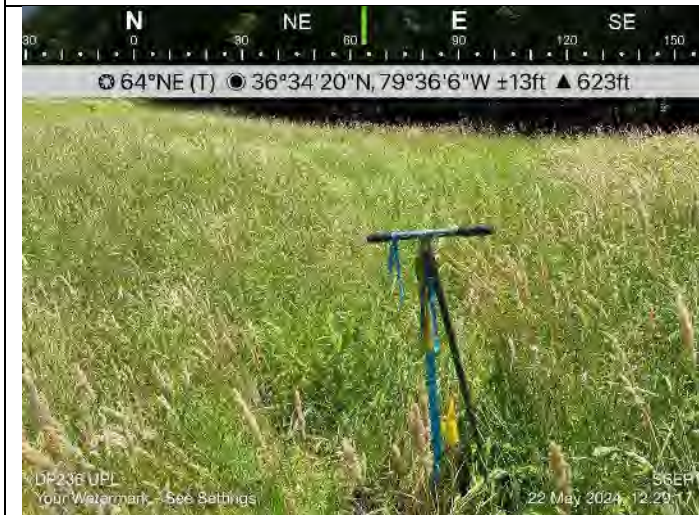
Photo 219:

Looking at Data Point #236, which characterizes an upland. This area lacked wetland hydrology, hydrophytic vegetation, and hydric soils. Attachment I; Sheet 4.

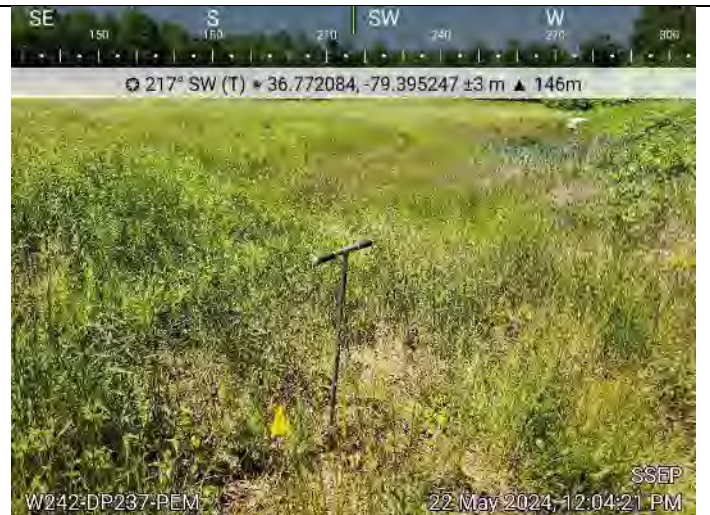
Photo 220:

Looking at Data Point #237, which characterizes a PEM wetland. This area contained all three wetland parameters. Attachment I; Sheet 19.

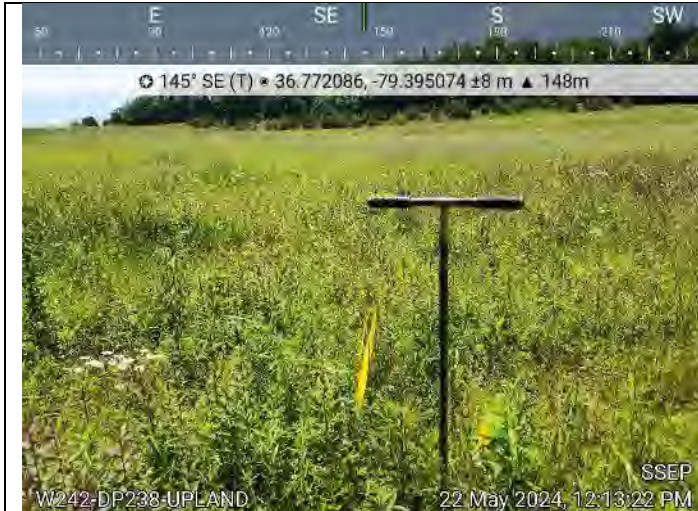
Photo 221:

Looking at Data Point #238, which characterizes an upland. This area lacked wetland hydrology, hydrophytic vegetation, and hydric soils. Attachment I; Sheet 19.

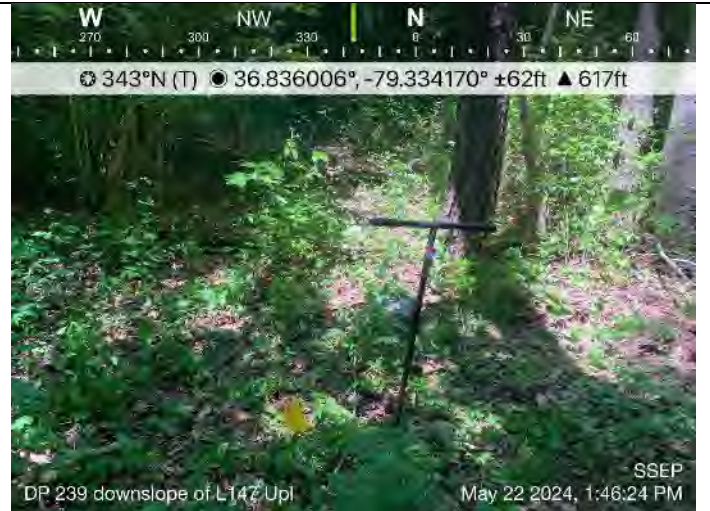
Photo 222:

Looking at Data Point #239, which characterizes an upland. This area lacked wetland hydrology, hydrophytic vegetation, and hydric soils. Attachment I; Sheet 23.

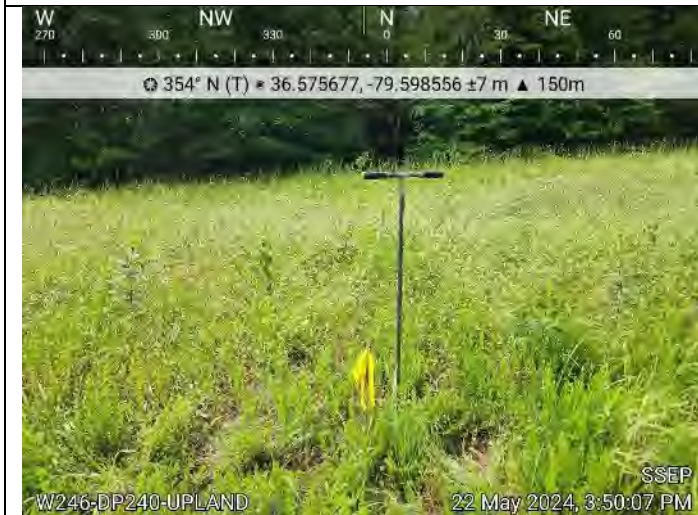
Photo 223:

Looking at Data Point #240, which characterizes an upland. This area lacked wetland hydrology, hydrophytic vegetation, and hydric soils. Attachment I; Sheet 4.

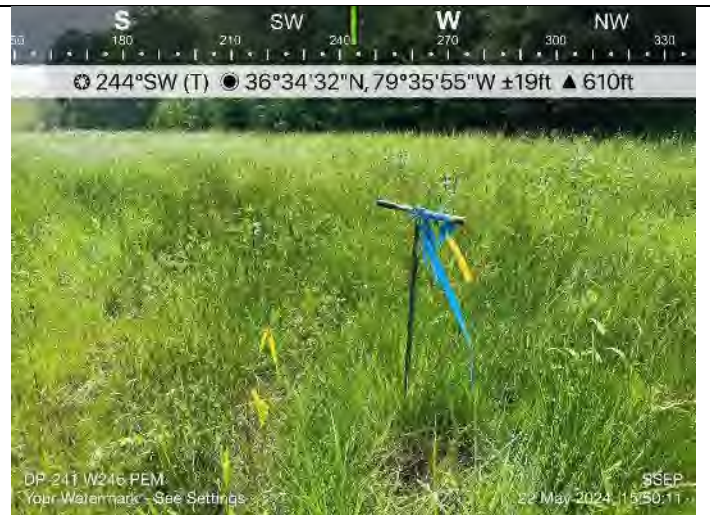
Photo 224:

Looking at Data Point #241, which characterizes a PEM wetland. This area contained all three wetland parameters. Attachment I; Sheet 4.

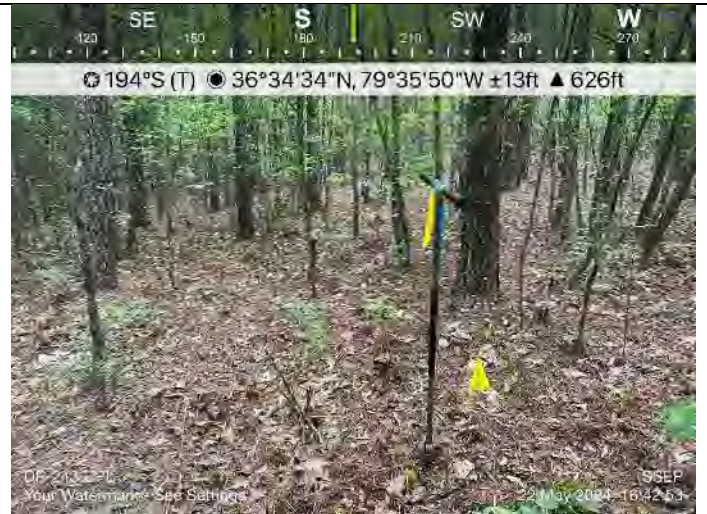
Photo 225:

Looking at Data Point #242, which characterizes a PFO wetland. This area contained all three wetland parameters. Attachment I; Sheet 4.

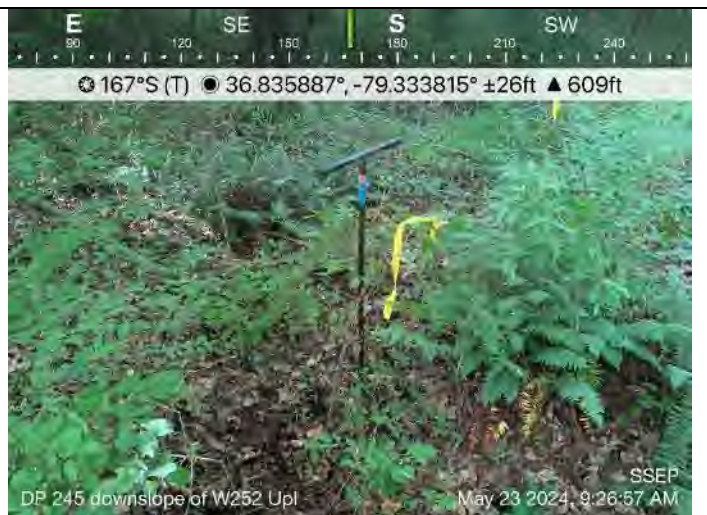
Photo 227:

Looking at Data Point #244, which characterizes a PEM wetland. This area contained all three wetland parameters. Attachment I; Sheet 4.

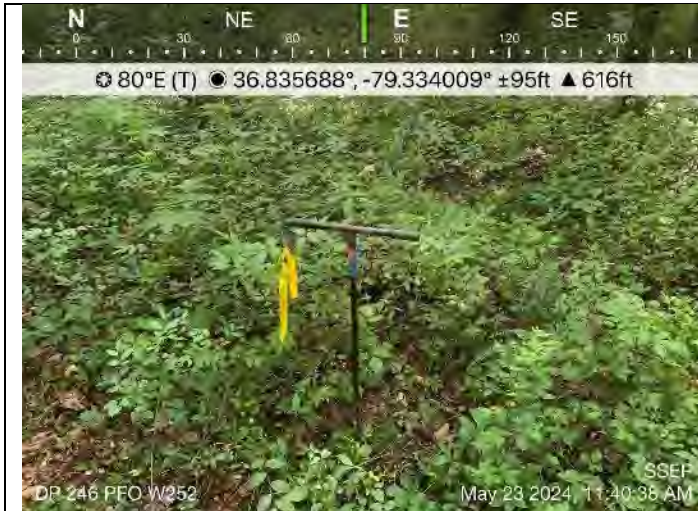
Photo 228:

Looking at Data Point #245, which characterizes an upland. This area lacked wetland hydrology and hydric soils. Attachment I; Sheet 23.

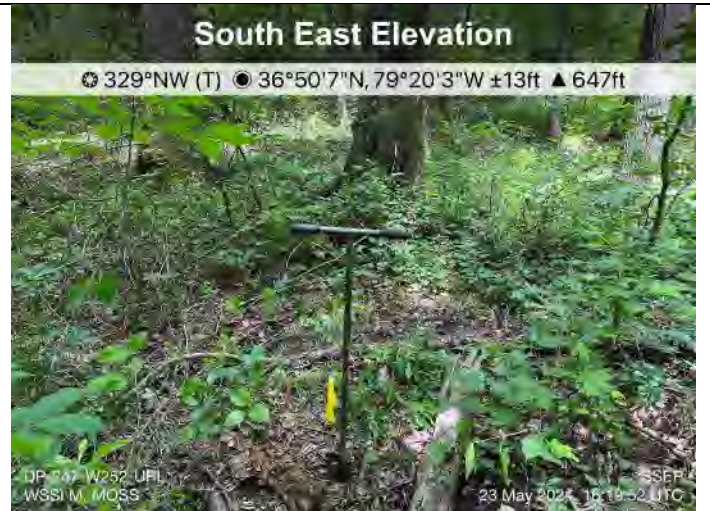
Photo 229:

Looking at Data Point #246, which characterizes a PFO wetland. This area contained all three wetland parameters. Attachment I; Sheet 23.

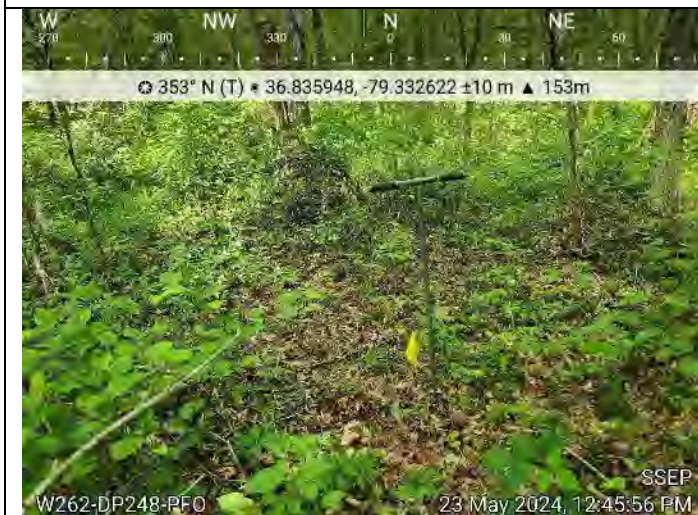
Photo 230:

Looking at Data Point #247, which characterizes an upland. This area lacked hydric soil. Attachment I; Sheet 23.

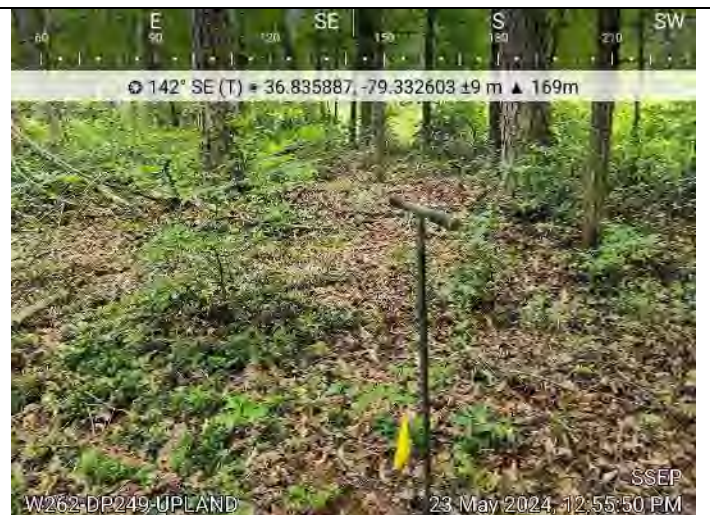
Photo 231:

Looking at Data Point #248, which characterizes a PFO wetland. This area contained all three wetland parameters. Attachment I; Sheet 23.

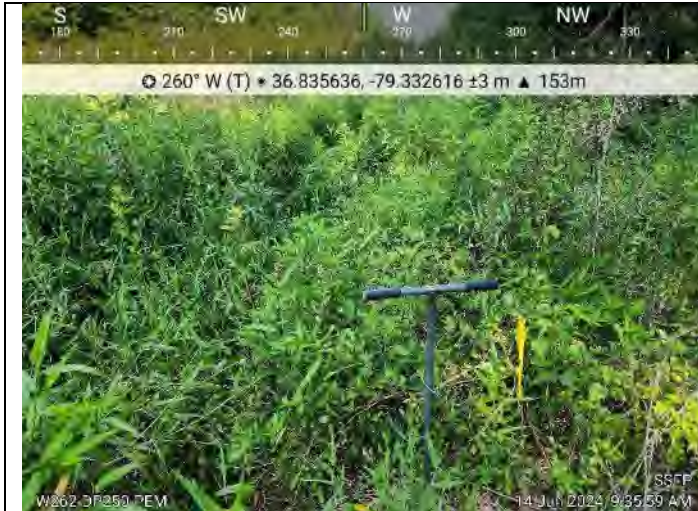
Photo 232:

Looking at Data Point #249, which characterizes an upland. This area lacked wetland hydrology and hydric soils. Attachment I; Sheet 23.

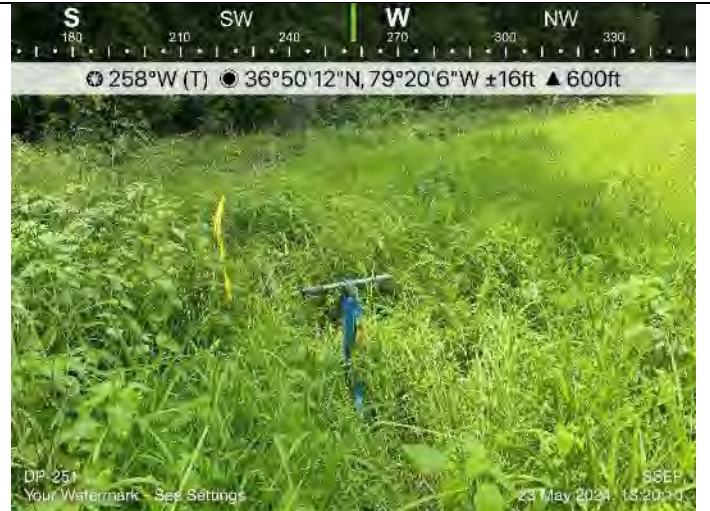
Photo 233:

Looking at Data Point #250, which characterizes PEM wetland. This area contained all three wetland parameters. Attachment I; Sheet 23.

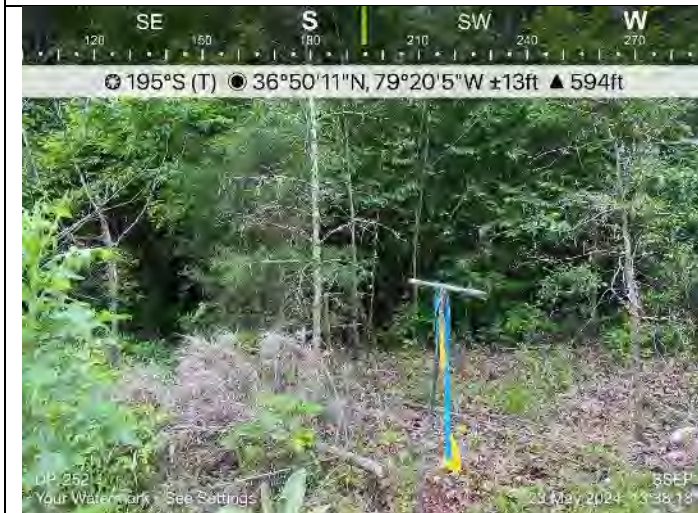
Photo 234:

Looking at Data Point #251, which characterizes a PEM wetland. This area contained all three wetland parameters. Attachment I; Sheet 23.

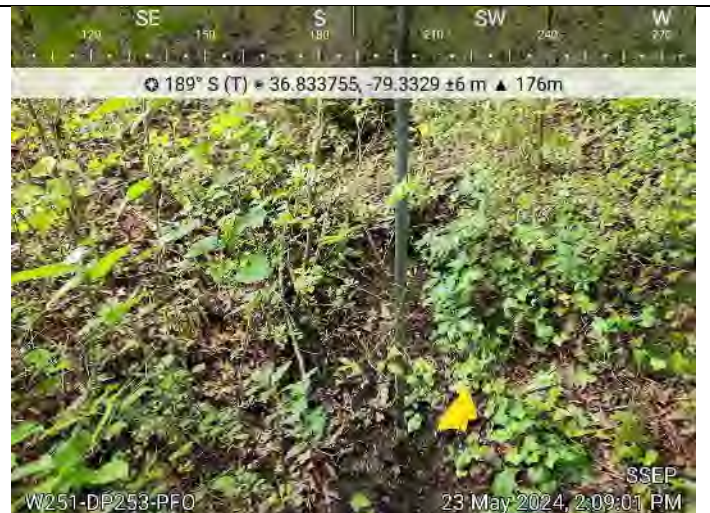
Photo 235:

Looking at Data Point #252, which characterizes an upland. This area lacked wetland hydrology, hydrophytic vegetation, and hydric soils. Attachment I; Sheet 23.

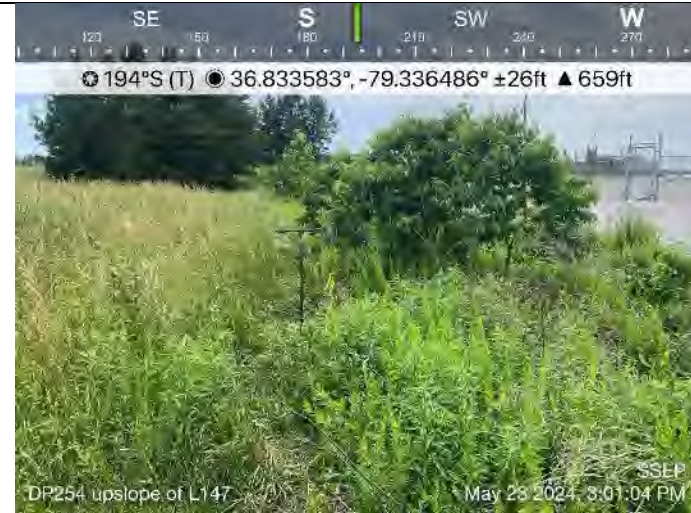
Photo 236:

Looking at Data Point #253, which characterizes a PFO wetland. This area contained all three wetland parameters. Attachment I; Sheet 23.

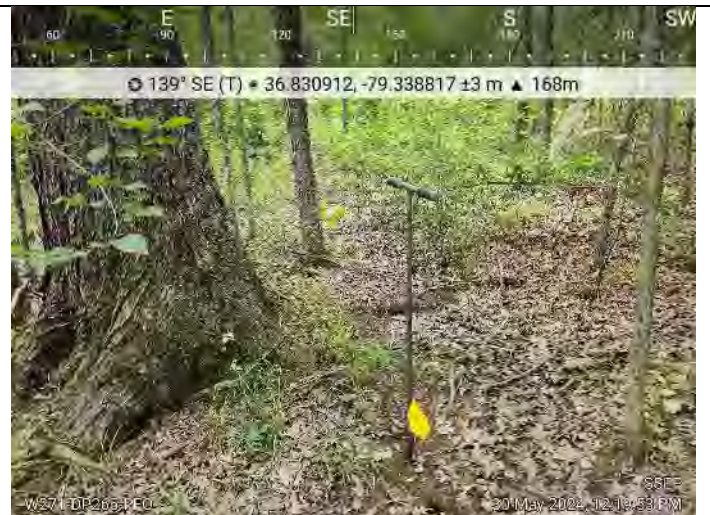
Photo 248:

Looking at Data Point #265, which characterizes a PFO wetland. This area contained all three wetland parameters. Attachment I; Sheet 23.

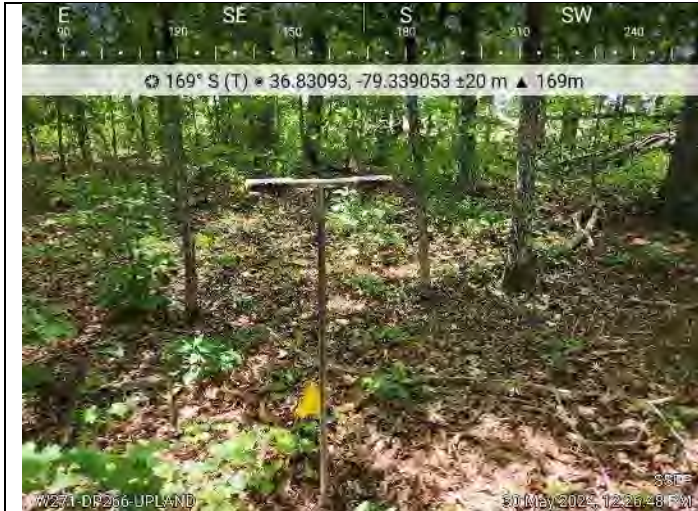
Photo 249:

Looking at Data Point #266, which characterizes an upland. This area lacked wetland hydrology, hydrophytic vegetation, and hydric soils. Attachment I; Sheet 23.

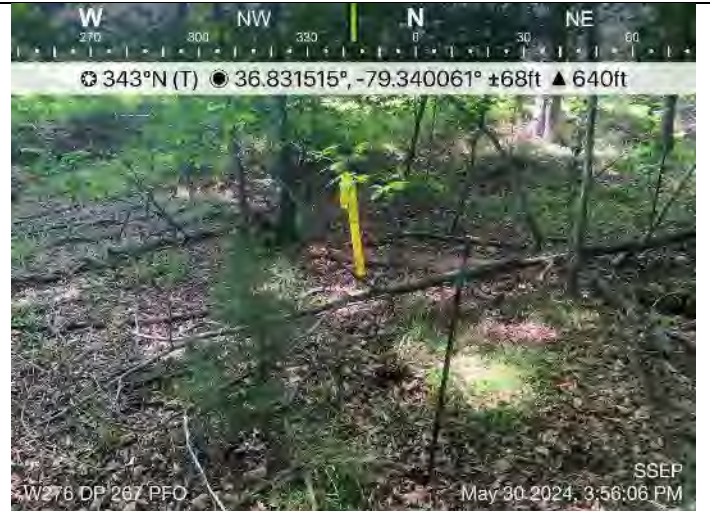
Photo 250:

Looking at Data Point #267, which characterizes a PFO wetland. This area contained all three wetland parameters. Attachment I; Sheet 23.

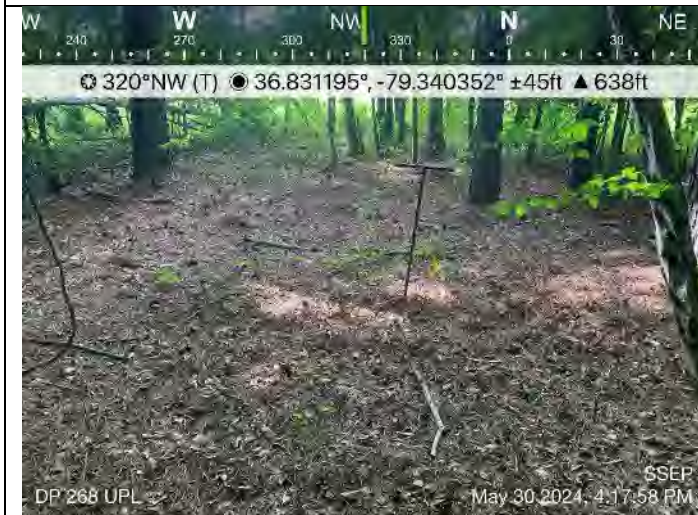
Photo 251:

Looking at Data Point #268, which characterizes an upland. This area lacked wetland hydrology and hydric soil. Attachment I; Sheet 23.

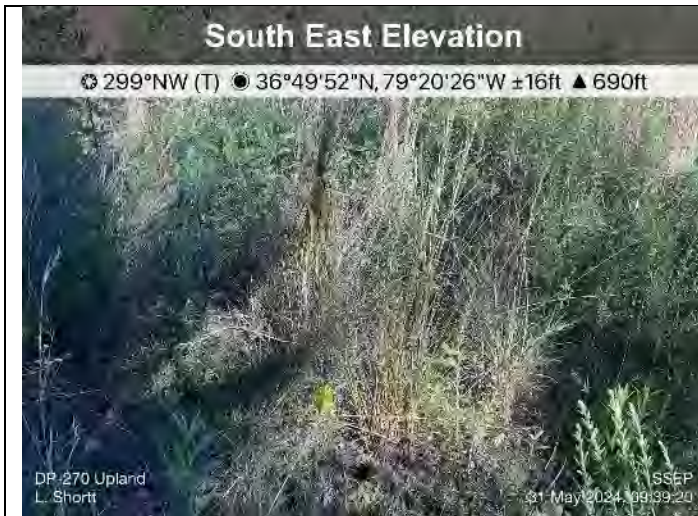
Photo 253:

Looking at Data Point #270, which characterizes an upland. This area lacked hydrophytic vegetation and hydric soil. Attachment I; Sheet 23.

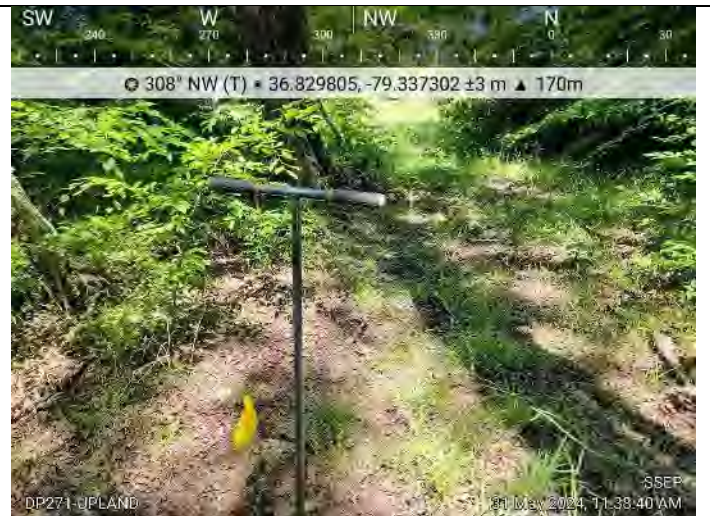
Photo 254:

Looking at Data Point #271, which characterizes an upland. This area lacked wetland hydrology and hydrophytic vegetation. Attachment I; Sheet 23.

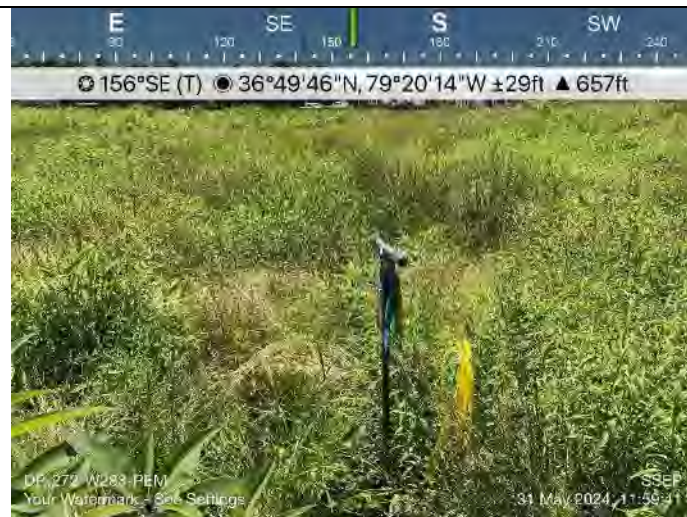
Photo 255:

Looking at Data Point #272, which characterizes a PEM wetland. This area contained all three wetland parameters. Attachment I; Sheet 23.

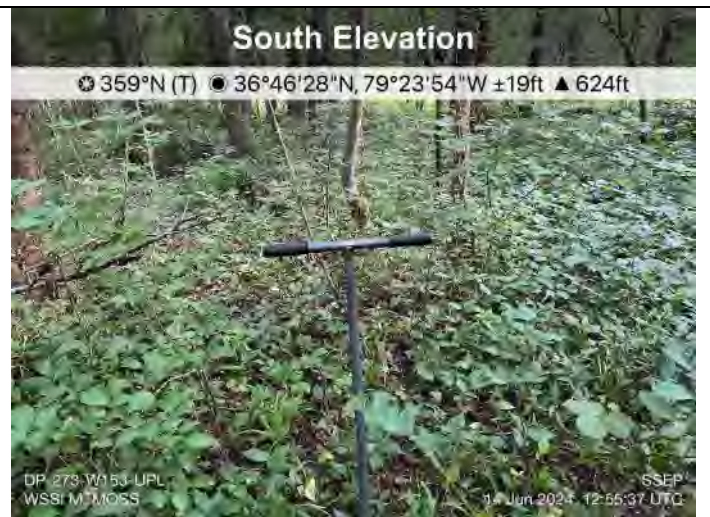
Photo 256:

Looking at Data Point #273, which characterizes an upland. This area lacked wetland hydrology and hydric soil. Attachment I; Sheet 18.

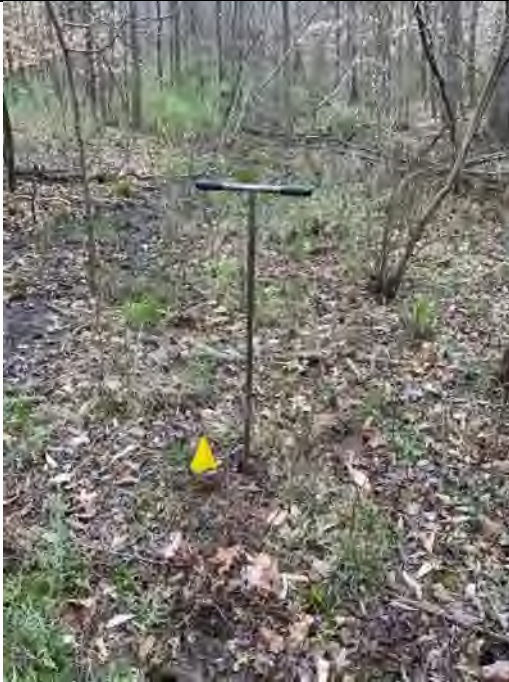
Photo 257:

Looking at Data Point #9, which characterizes a PFO wetland. This area contained all three wetland parameters. Attachment I; Sheet 2.

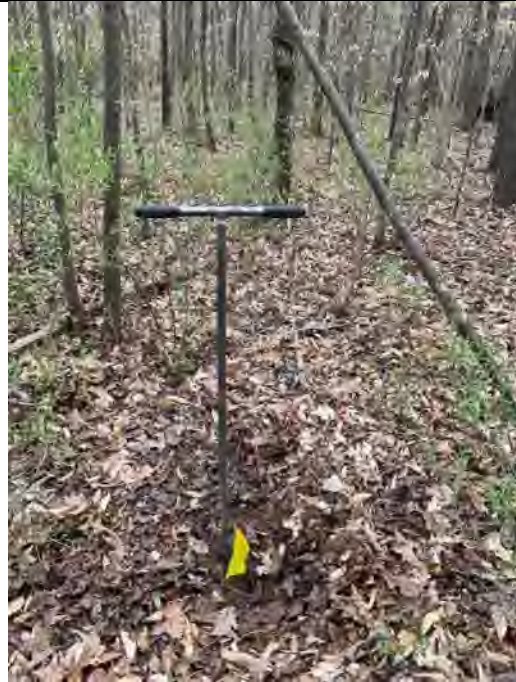
Photo 258:

Looking at Data Point #10, which characterizes an upland. This area lacked wetland hydrology, hydrophytic vegetation, and hydric soils. Attachment I; Sheet 2.

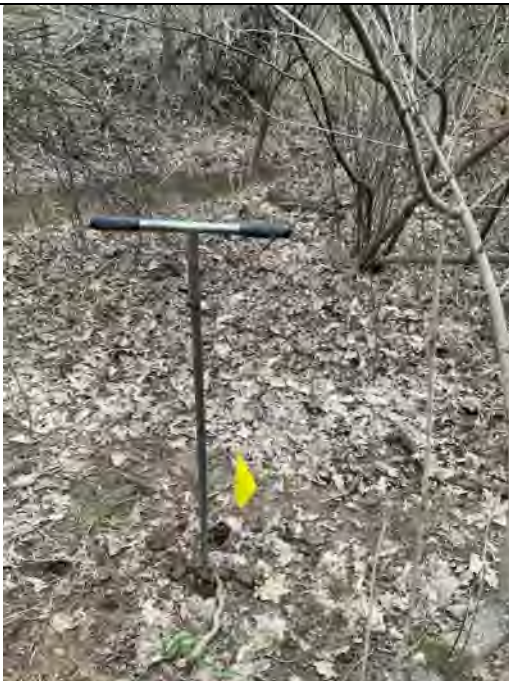
Photo 259:

Looking at Data Point #17, which characterizes a PFO wetland. This area contained all three wetland parameters. Attachment I; Sheet 3.

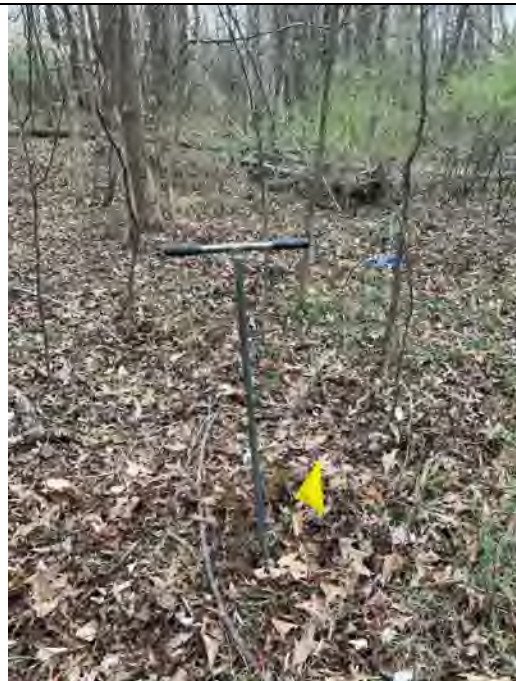
Photo 260:

Looking at Data Point #18, which characterizes an upland. This area lacked wetland hydrology, hydrophytic vegetation, and hydric soils. Attachment I; Sheet 3.

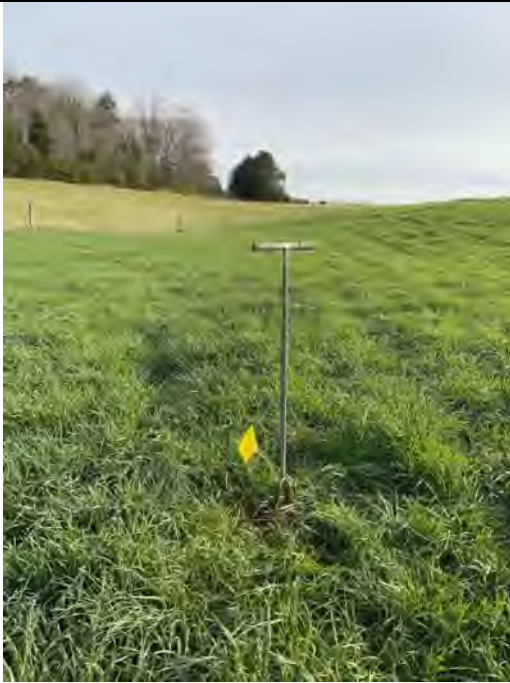
Photo 261:

Looking at Data Point #20, which characterizes an upland. This area lacked wetland hydrology, hydrophytic vegetation, and hydric soils. Attachment I; Sheet 10.

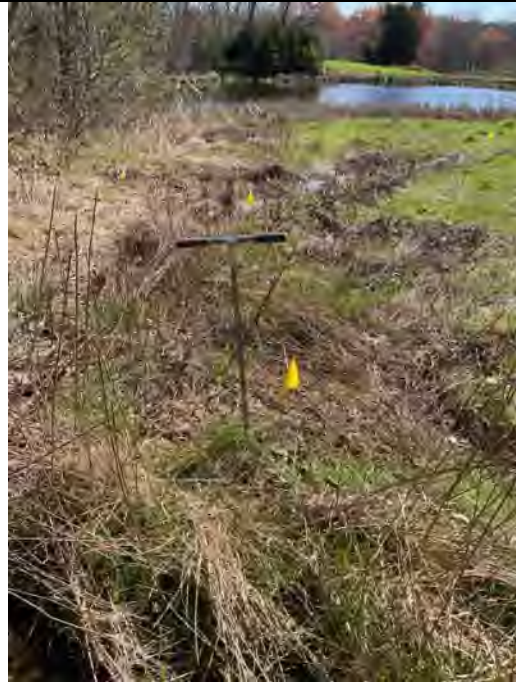
Photo 262:

Looking at Data Point #22, which characterizes a PEM wetland. This area contained all three wetland parameters. Attachment I; Sheet 10.

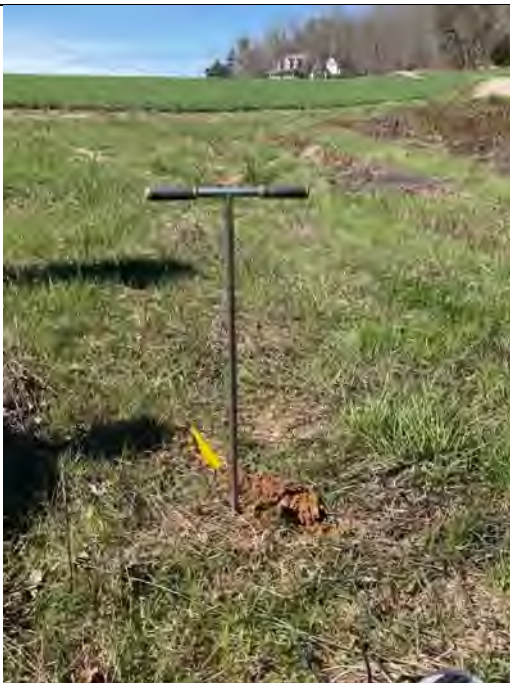
Photo 263:

Looking at Data Point #23, which characterizes an upland. This area lacked wetland hydrology, hydrophytic vegetation, and hydric soils. Attachment I; Sheet 10.

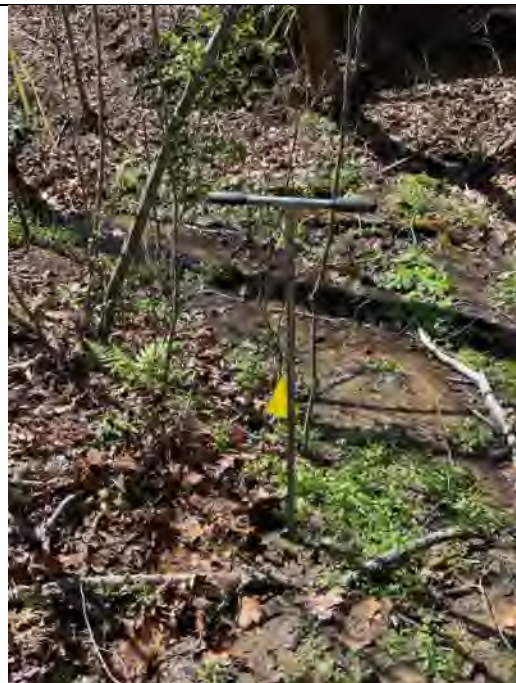
Photo 264:

Looking at Data Point #24, which characterizes a PFO wetland. This area contained all three wetland parameters. Attachment I; Sheet 10.

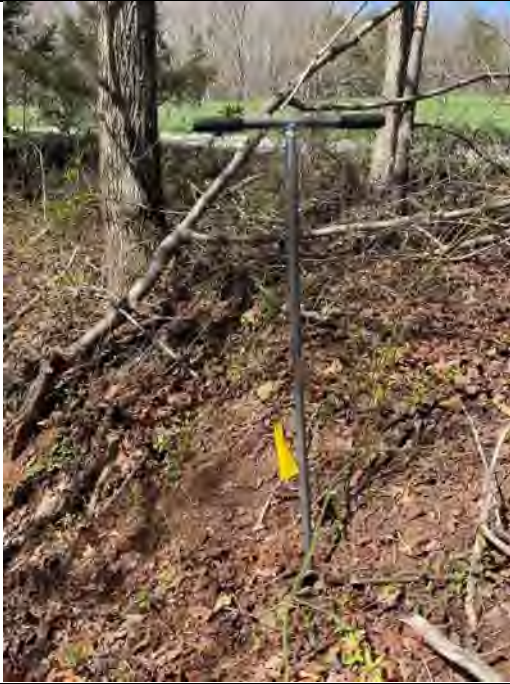
Photo 265:
Looking at Data Point #25, which characterizes an upland.
This area lacked wetland hydrology, hydrophytic
vegetation, and hydric soils. Attachment I; Sheet 10.

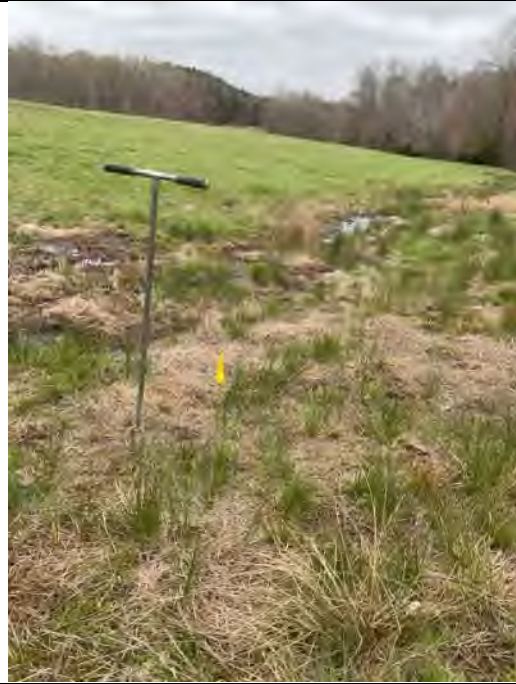
Photo 266:
Looking at Data Point #27, which characterizes a PEM
wetland. This area contained all three wetland
parameters. Attachment I; Sheet 10.

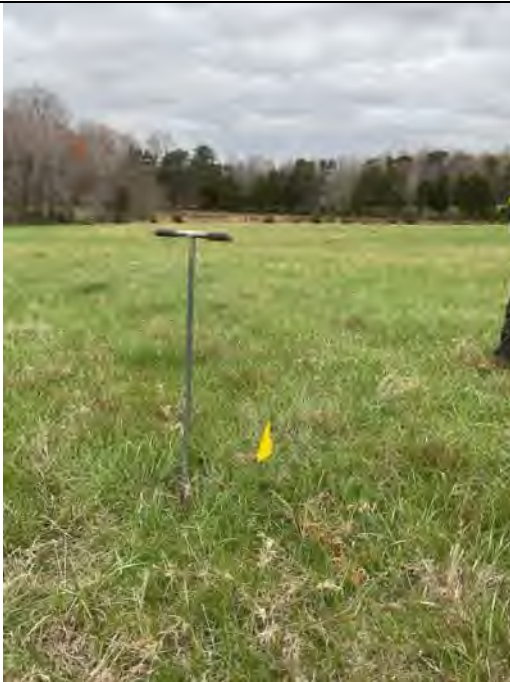
Photo 267:
Looking at Data Point #28, which characterizes an upland.
This area lacked wetland hydrology, hydrophytic
vegetation, and hydric soils. Attachment I; Sheet 10.

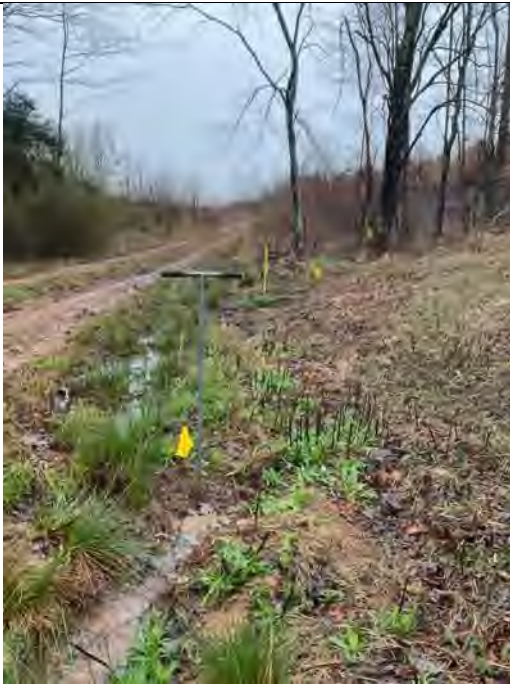
Photo 268:
Looking at Data Point #29, which characterizes a PEM
wetland. This area contained all three wetland
parameters. Attachment I; Sheet 10.

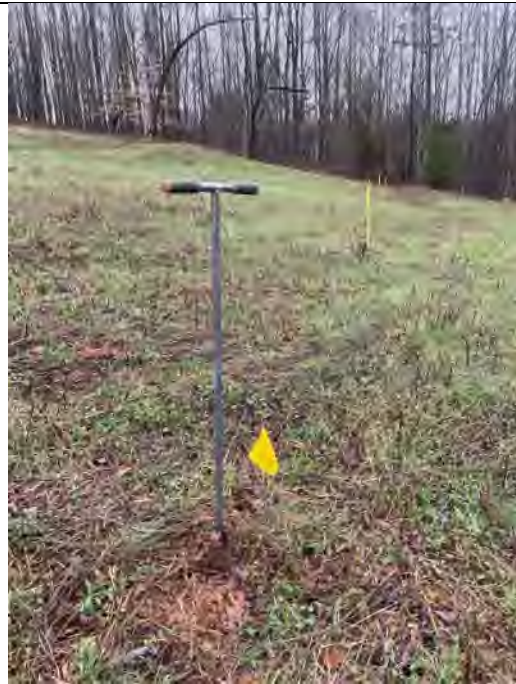
Photo 269:

Looking at Data Point #31, which characterizes a PEM wetland. This area contained all three wetland parameters. Attachment I; Sheet 14.

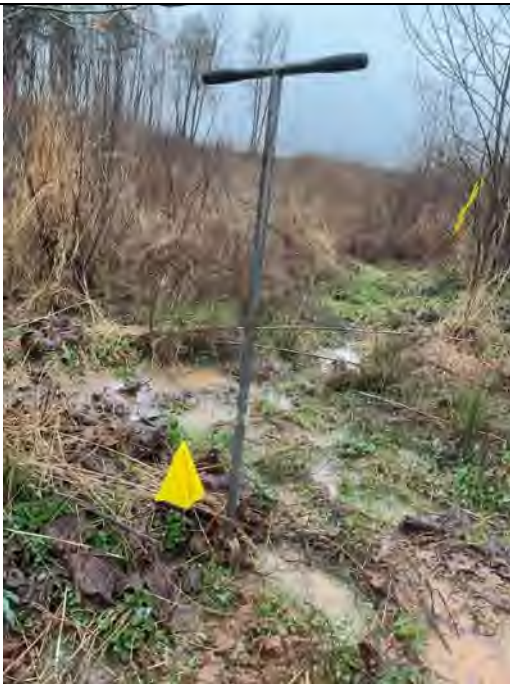
Photo 270:

Looking at Data Point #32, which characterizes an upland. This area lacked wetland hydrology, hydrophytic vegetation, and hydric soils. Attachment I; Sheet 14.

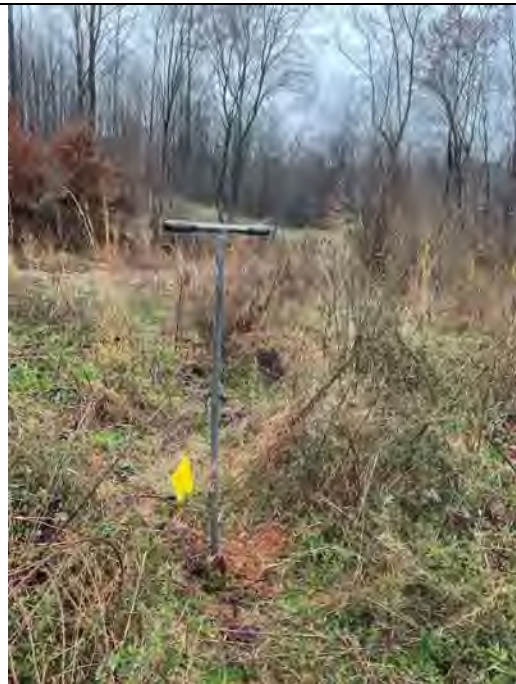
Photo 271:

Looking at Data Point #33, which characterizes a PSS wetland. This area contained all three wetland parameters. Attachment I; Sheet 14.

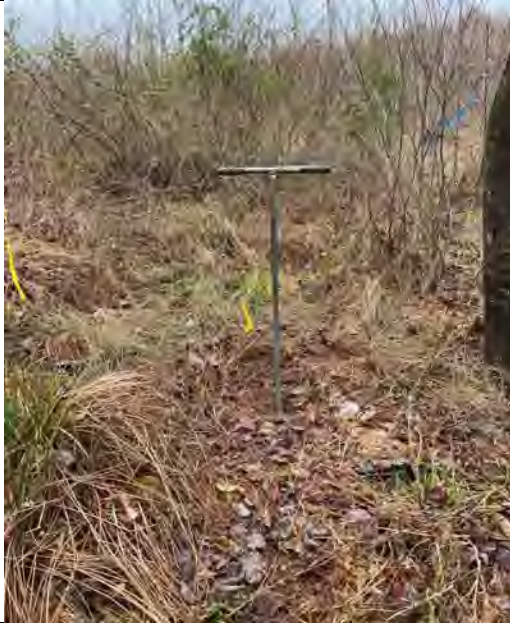
Photo 272:

Looking at Data Point #34, which characterizes an upland. This area lacked wetland hydrology, hydrophytic vegetation, and hydric soils. Attachment I; Sheet 14.

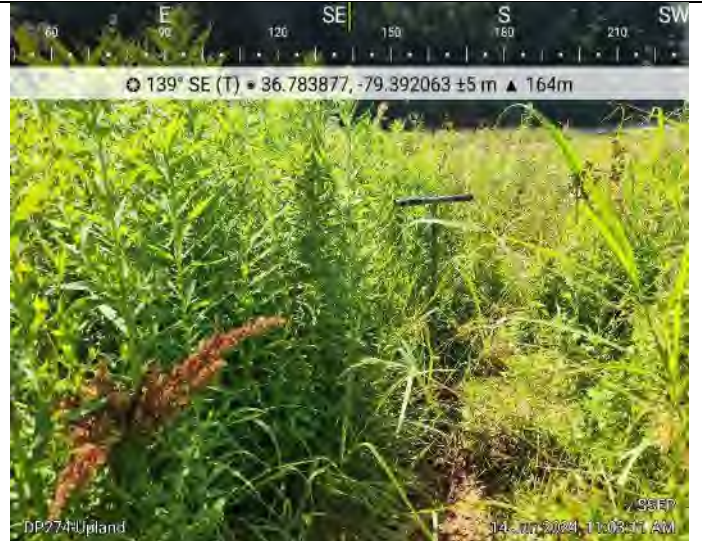
Photo 273:

Looking at Data Point #36, which characterizes a PFO wetland. This area contained all three wetland parameters. Attachment I; Sheet 14.

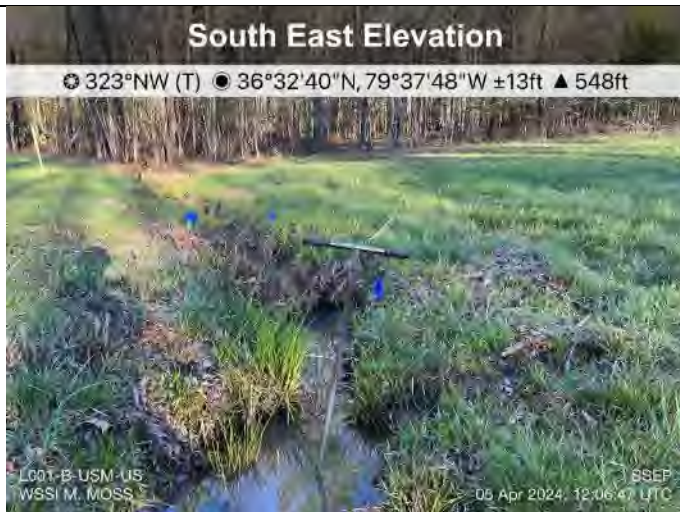
Photo 274:

Looking at Data Point #274, which characterizes an upland. This area lacked wetland hydrology, hydrophytic vegetation, and hydric soils. Attachment I; Sheet 20.

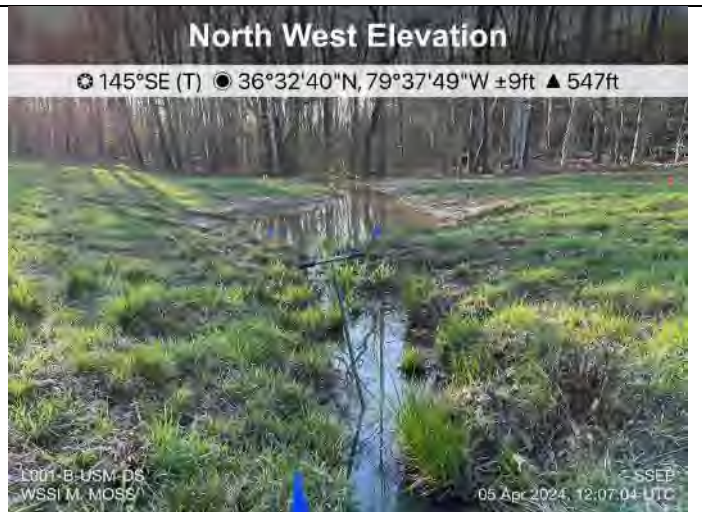
Photo 275:

Looking upstream at L001-1, which characterizes an intermittent stream (R4). Attachment I; Sheet 2.

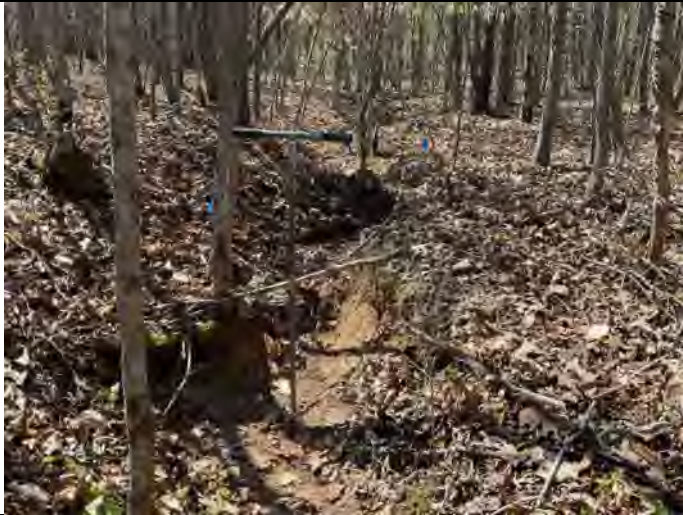
Photo 276:

Looking downstream at L001-1, which characterizes an intermittent stream (R4). Attachment I; Sheet 2.

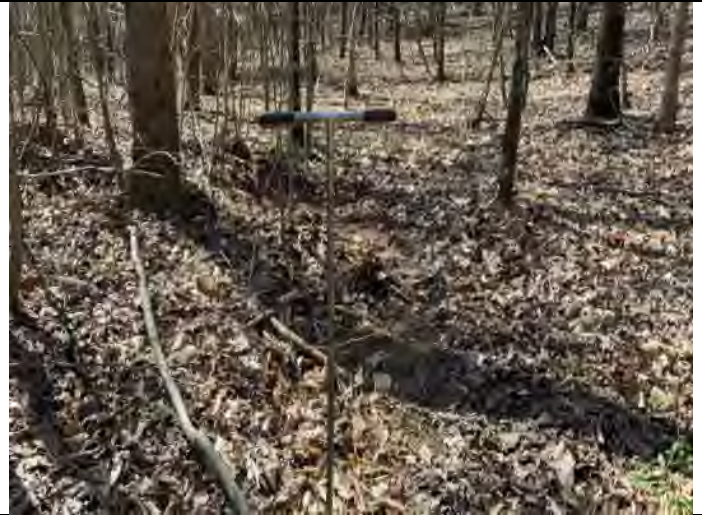
Photo 277:
Looking upstream at L003-1, which characterizes an ephemeral stream (R6). Attachment I; Sheet 2.

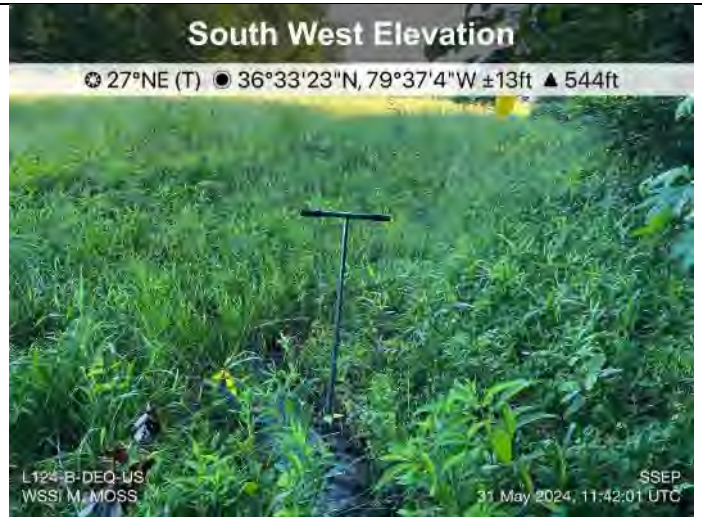
Photo 279:
Looking downstream at L003-1, which characterizes an ephemeral stream (R6). Attachment I; Sheet 2.

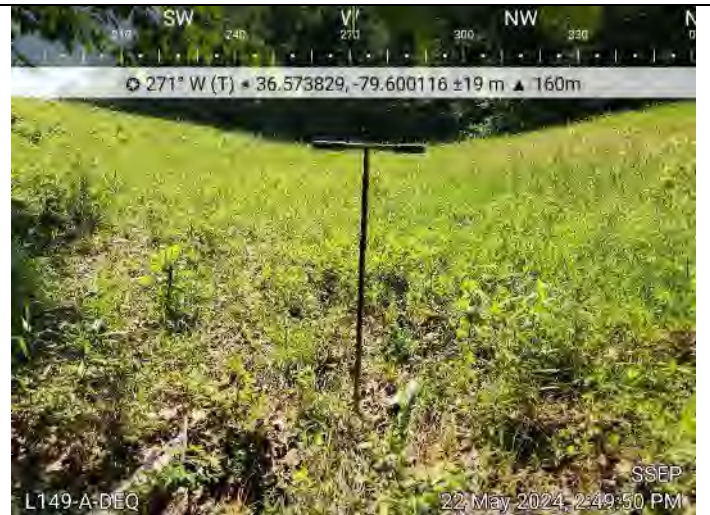
Photo 289:

Looking downstream at L149-1, which characterizes an ephemeral stream (R6). Attachment I; Sheet 4.

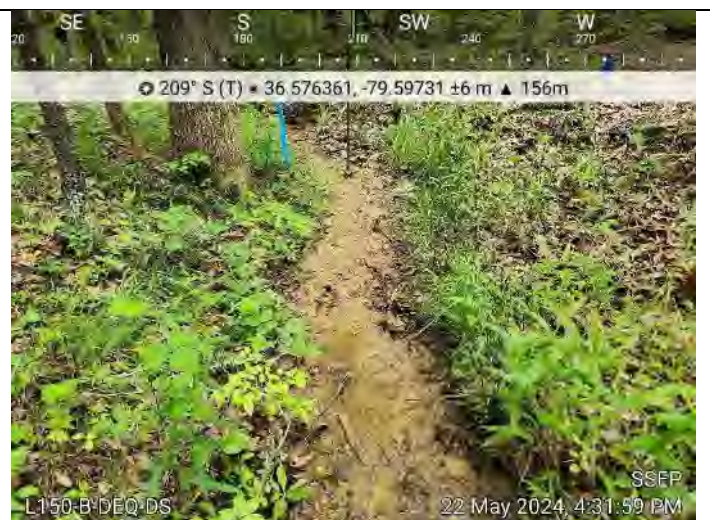
Photo 291:

Looking upstream at L150-1, which characterizes an intermittent stream (R4). Attachment I; Sheet 4.

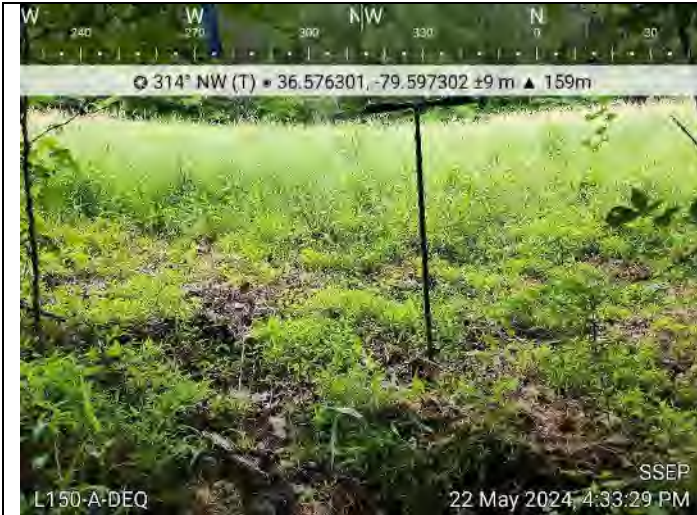
Photo 292:

Looking downstream at L150-1, which characterizes an intermittent stream (R4). Attachment I; Sheet 4.

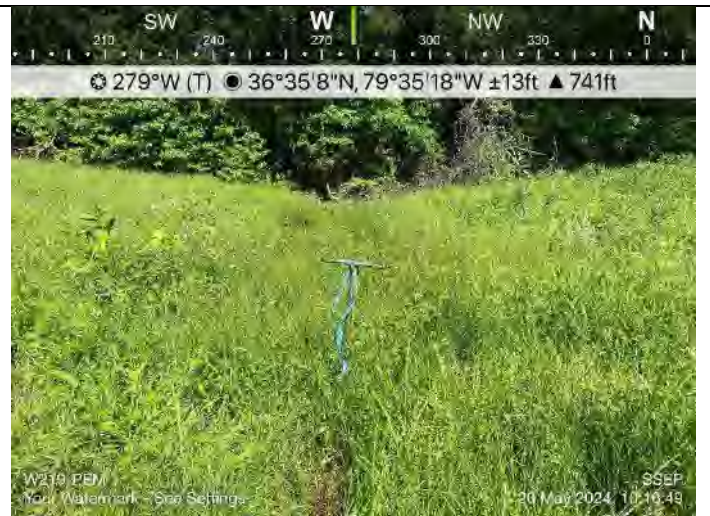
Photo 295:

Looking downstream at L128-1, which characterizes an ephemeral stream (R6). Attachment I; Sheet 5.

L128	11/19-21/2024 (DEQ)	DEQ - Verbal Concurrence - per SSWD Comment Letter follow-up Teams Meeting (December 6, 2024). Noted, reversing L128 and L129 in DEQ notes.	N/A	N/A	
	W217	11/19-21/2024 (DEQ)	DEQ – Written Concurrence (SSWD Comment Letter)	N/A	N/A	
	L126	11/19-21/2024 (DEQ)	DEQ – Written Concurrence (SSWD Comment Letter)	Updated after DEQ site visit - splitting L126 into L126-1 (intermittent) and L126-2 (perennial)	Updated January 2025 (map and stream forms)	
	L127	11/19-21/2024 (DEQ)	DEQ – Written Comment (SSWD Comment Letter): Noted, L127-1 appeared to have perennial stream characteristics - requested rescoring of stream	L127-1 was rescored and updated to a perennial stream	Updated November 2024 (map and stream forms)	
	W216	11/19-21/2024 (DEQ)	DEQ – Written Concurrence (SSWD Comment Letter)	N/A	N/A	
	W336	11/19-21/2024 (DEQ)	DEQ - Verbal Concurrence: Agreed with boundary in field - requested feature be added on map	W336-1 and data points added to delineation map and data point forms	Updated November 2024 (map and data points)

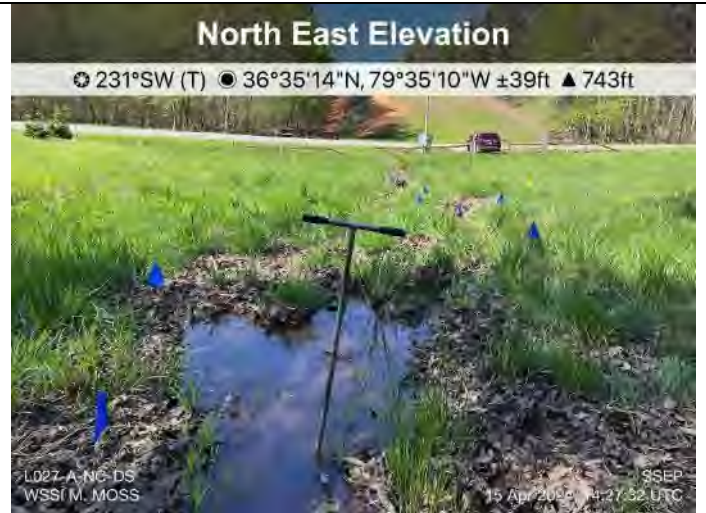
Photo 297:

Looking upstream at L027-1, which characterizes an intermittent stream (R4). Attachment I; Sheet 5.

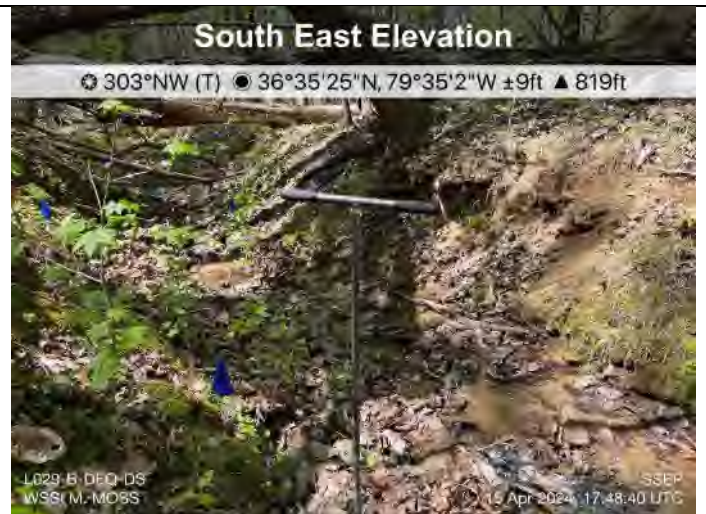
Photo 299:

Looking upstream at L029-2, which characterizes a perennial stream (R3). Attachment I; Sheet 5.

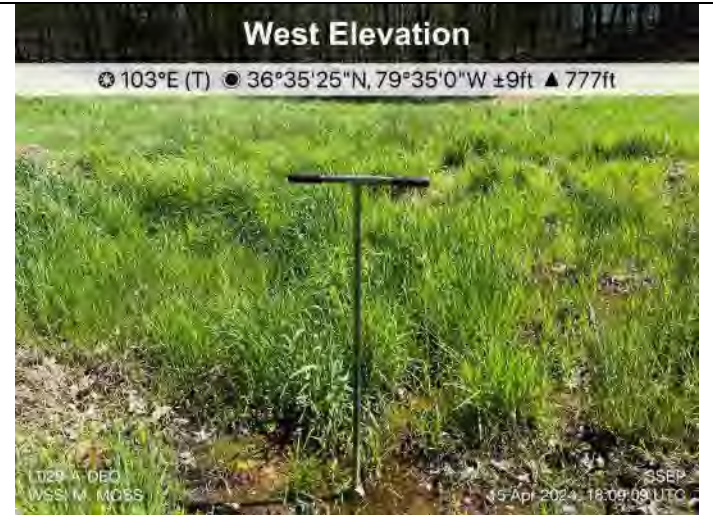
Photo 300:

Looking downstream at L029-2, which characterizes a perennial stream (R3). Attachment I; Sheet 5.
