EXHIBIT 14 - PHOTOGRAPHS

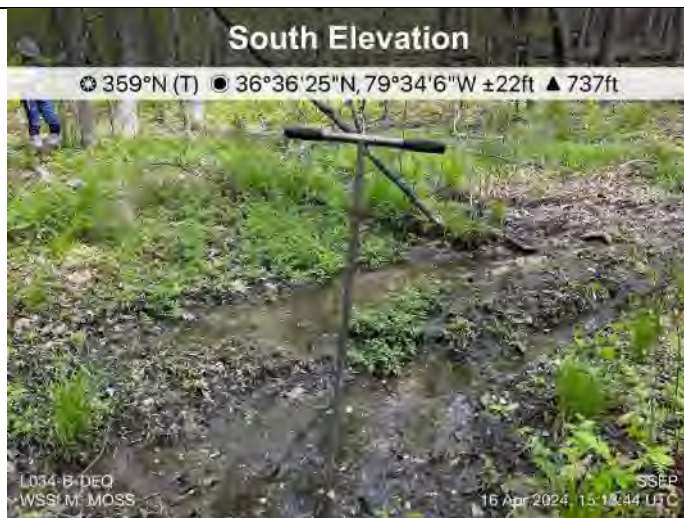
Photo 310:

Looking upstream at L034-1, which characterizes a perennial stream (R3). Attachment I; Sheet 6.

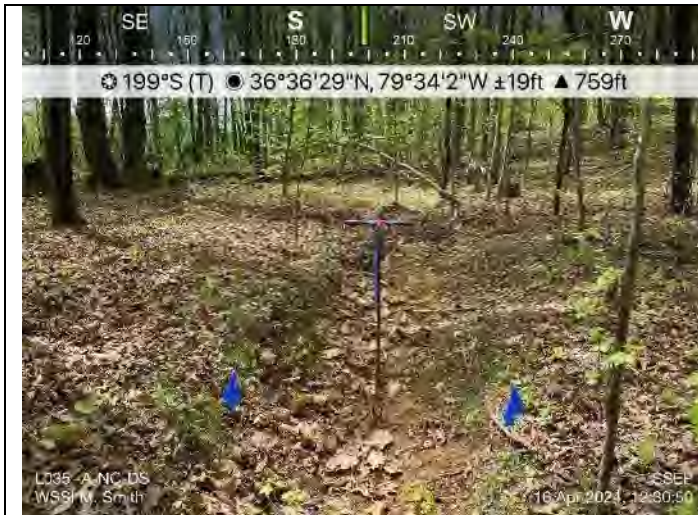
Photo 312:

Looking upstream at L035-1, which characterizes an ephemeral stream (R6). Attachment I; Sheet 6.

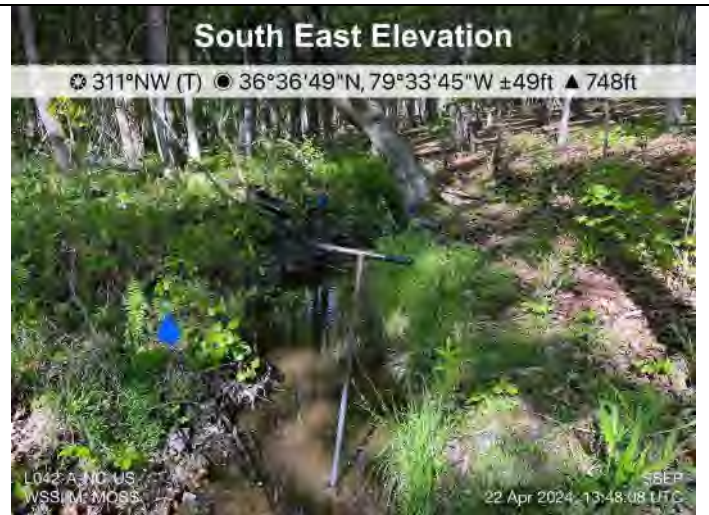
Photo 313:

Looking downstream at L035-1, which characterizes an ephemeral stream (R6). Attachment I; Sheet 6.

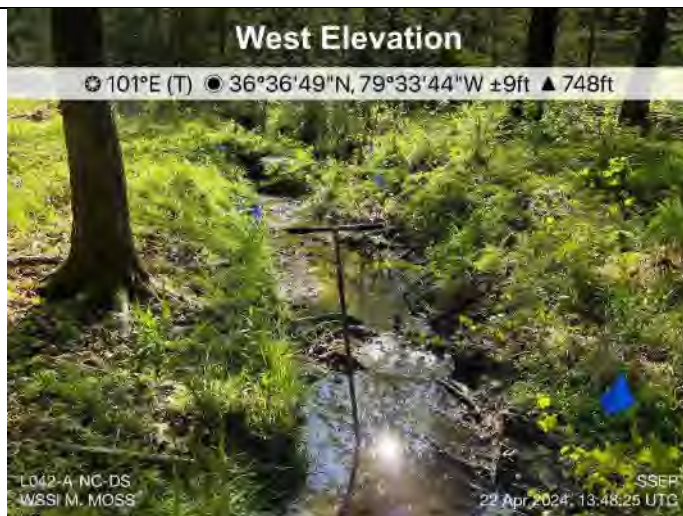
Photo 314:

Looking upstream at L042-1, which characterizes a perennial stream (R3). Attachment I; Sheet 7.

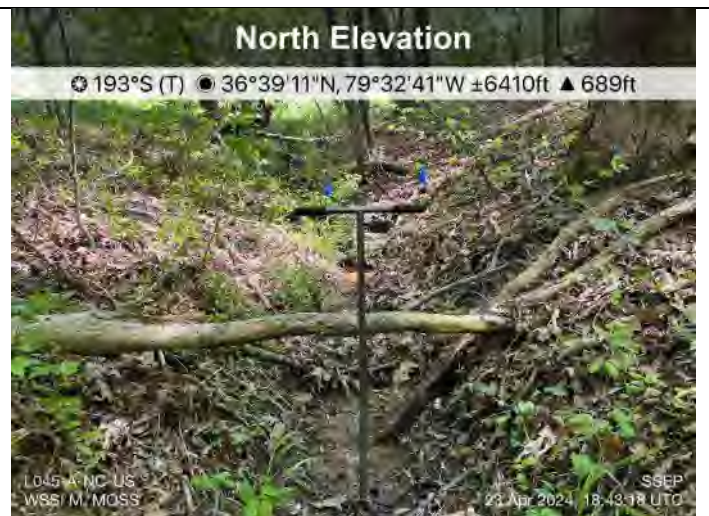
Photo 316:

Looking upstream at L045-1, which characterizes an intermittent stream (R4). Attachment I; Sheet 8.

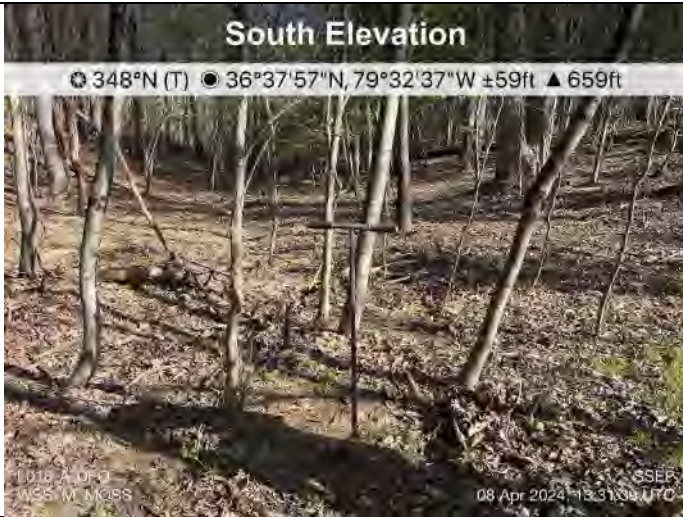
<p>Photo 321: Looking upslope of L018-1. Attachment I; Sheet 8.</p>

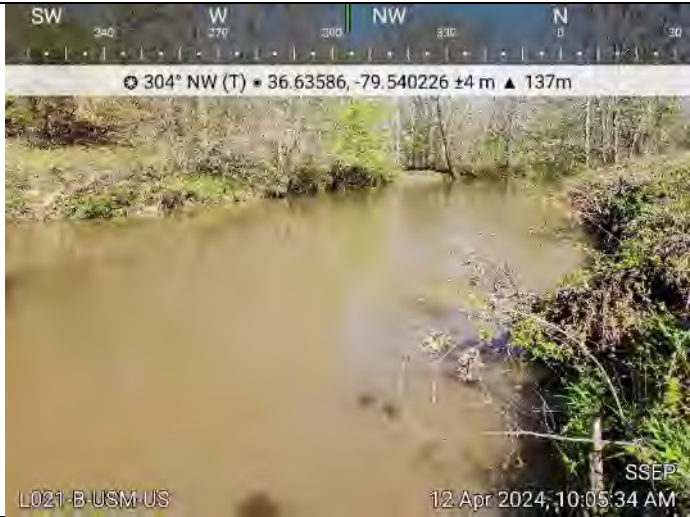
<p>Photo 322: Looking upstream at L021-1, which characterizes the Sandy River. Attachment I; Sheet 8.</p>

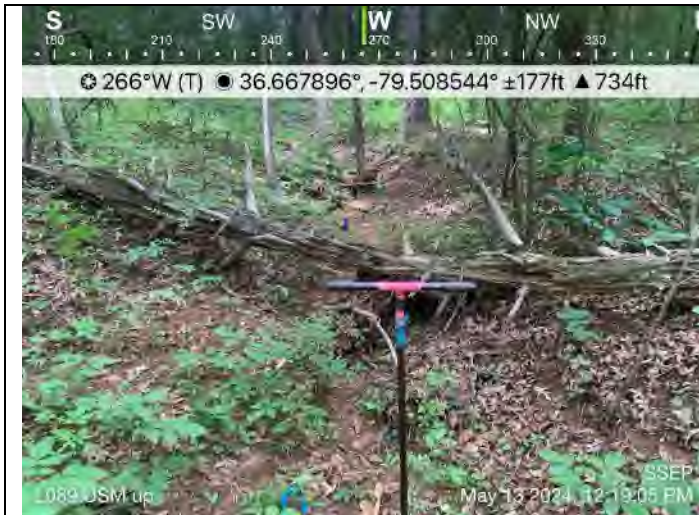
Photo 341:

Looking upstream at L089-1, which characterizes an ephemeral stream (R6). Attachment I; Sheet 10.

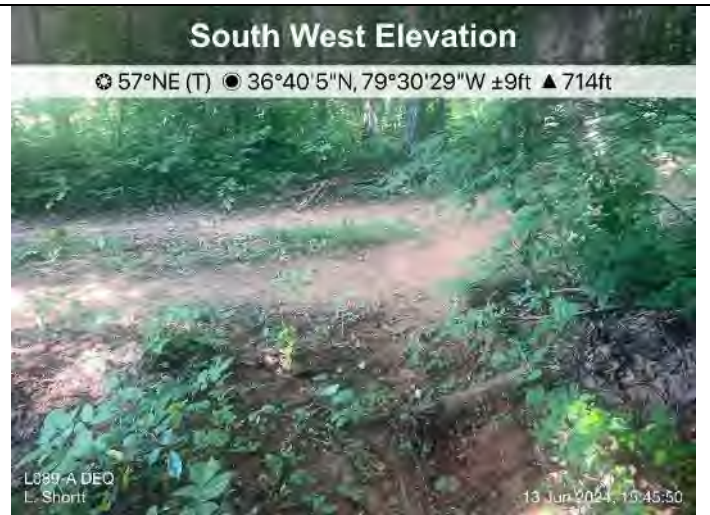
Photo 342:

Looking downslope of L089-1. Attachment I; Sheet 10.

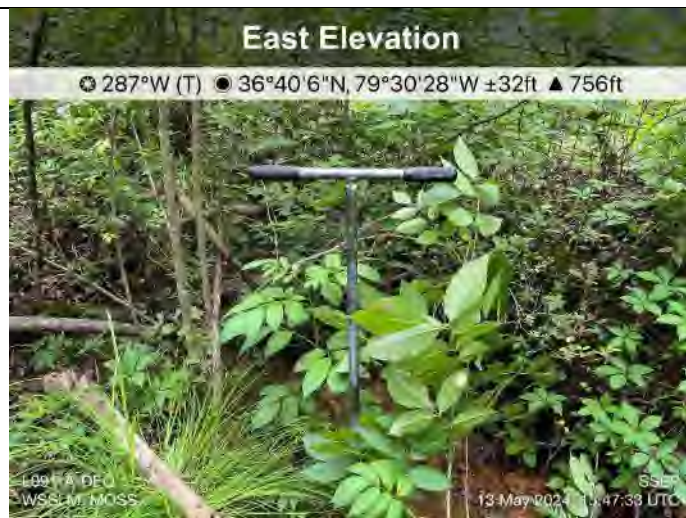
Photo 343:

Looking upstream at L091-1, which characterizes an intermittent stream (R4). Attachment I; Sheet 10.

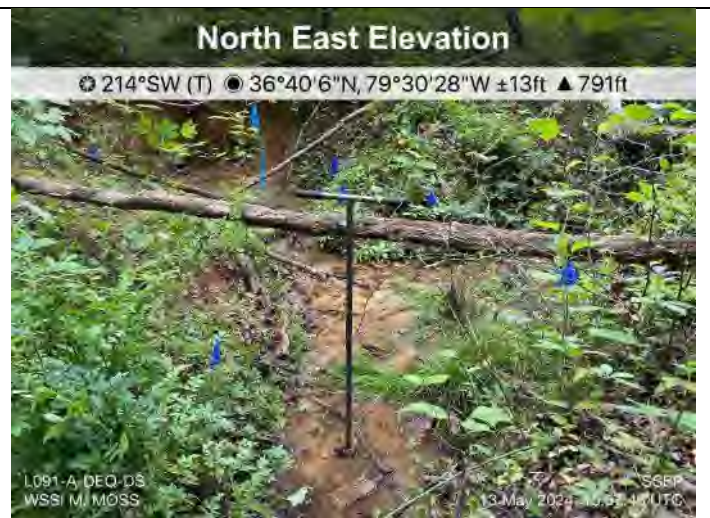
Photo 344:

Looking downstream at L091-1, which characterizes an intermittent stream (R4). Attachment I; Sheet 10.

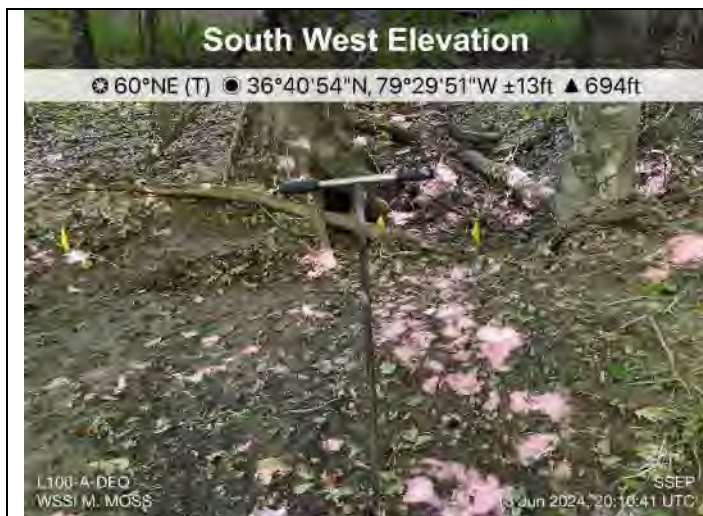
Photo 349:

Looking downslope of L100-1. Attachment I; Sheet 11.

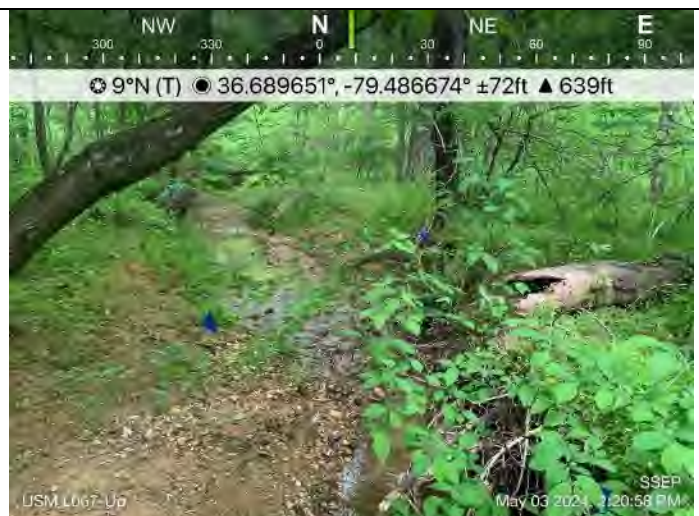
Photo 350:

Looking upstream at L067-1, which characterizes a perennial stream (R3). Attachment I; Sheet 12.

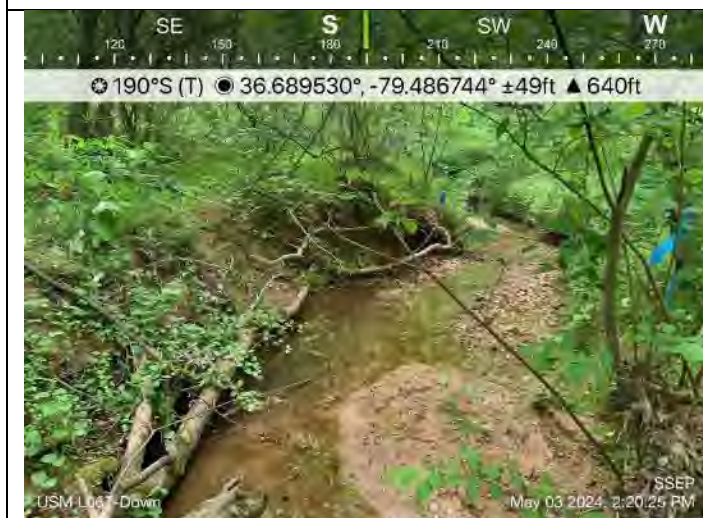
Photo 351:

Looking downstream at L067-1, which characterizes a perennial stream (R3). Attachment I; Sheet 12.

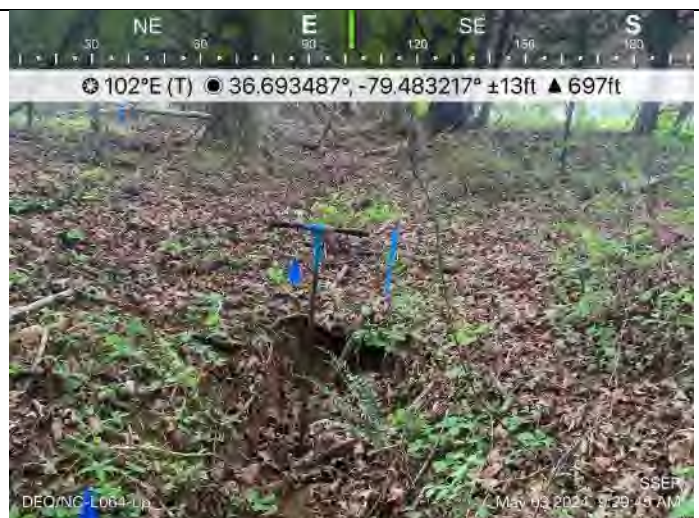
Photo 352:

Looking upstream at L064-1, which characterizes an ephemeral stream (R6). Attachment I; Sheet 12.

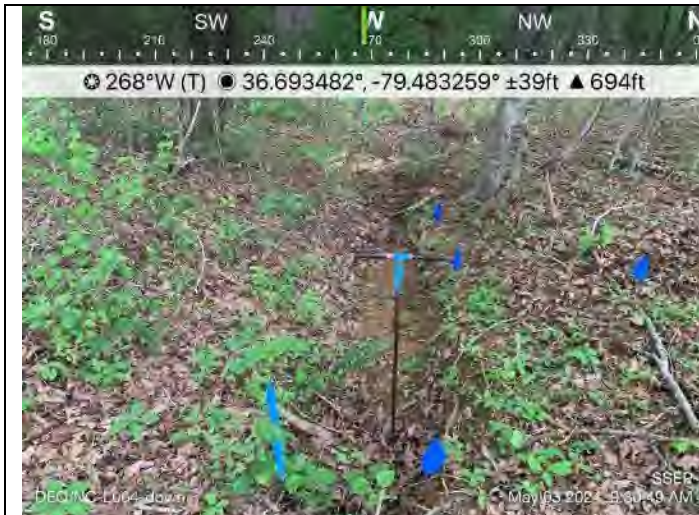
Photo 353:

Looking downstream at L064-1, which characterizes an ephemeral stream (R6). Attachment I; Sheet 12.

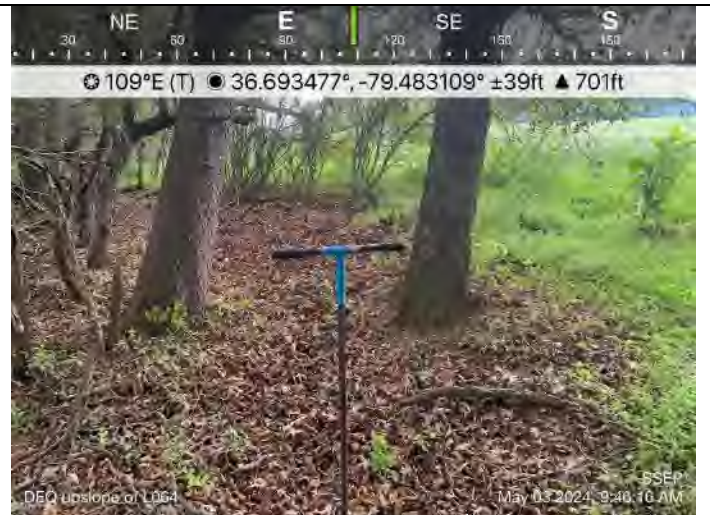
Photo 354:

Looking upslope of L064-1. Attachment I; Sheet 12.

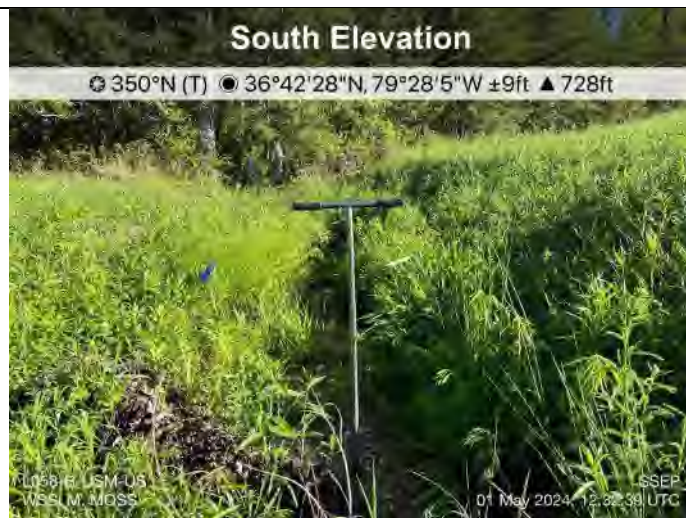
Photo 355:

Looking upstream at L058-1, which characterizes a perennial stream (R3). Attachment I; Sheet 13.

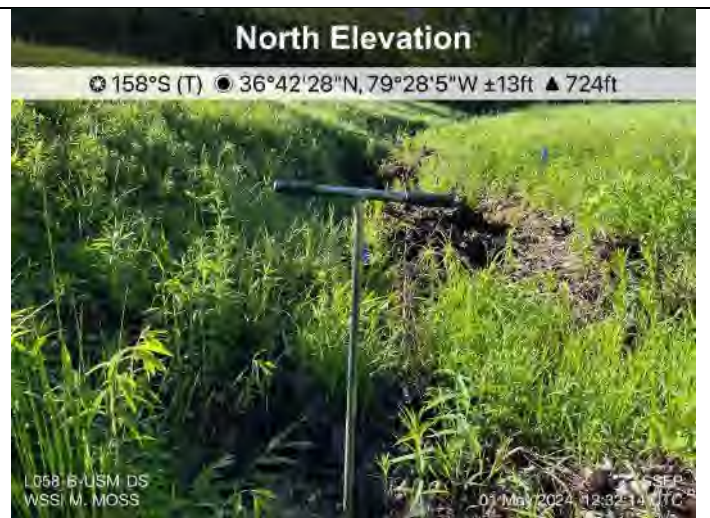
Photo 356:

Looking downstream at L058-1, which characterizes a perennial stream (R3). Attachment I; Sheet 13.

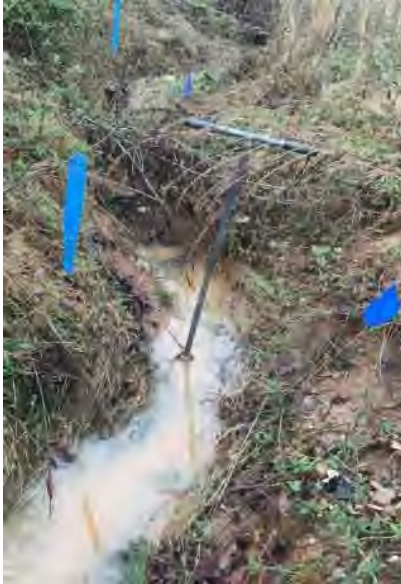
Photo 357:
Looking upstream at L008-1, which characterizes an ephemeral stream (R6). Attachment I; Sheet 14.

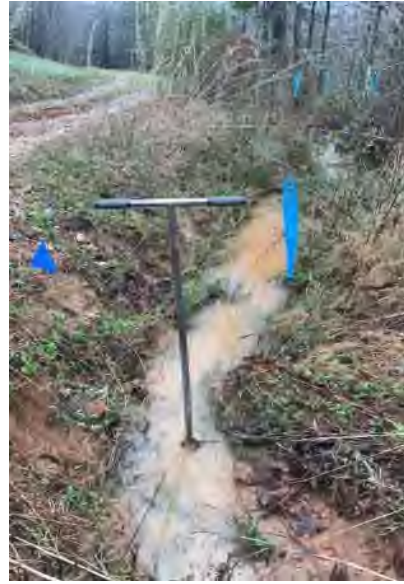
Photo 358:
Looking downstream at L008-1, which characterizes an ephemeral stream (R6). Attachment I; Sheet 14.

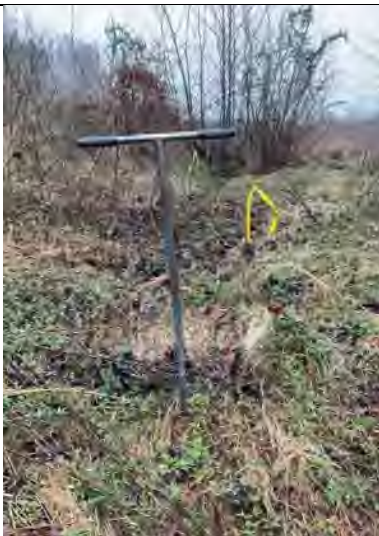
Photo 359:
Looking upslope of L008-1. Attachment I; Sheet 14.

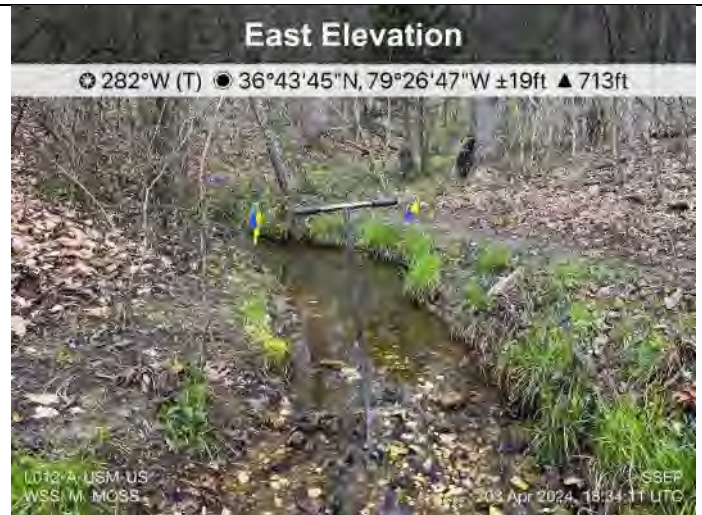
Photo 360:
Looking upstream at L012-1, which characterizes a perennial stream (R3). Attachment I; Sheet 15.

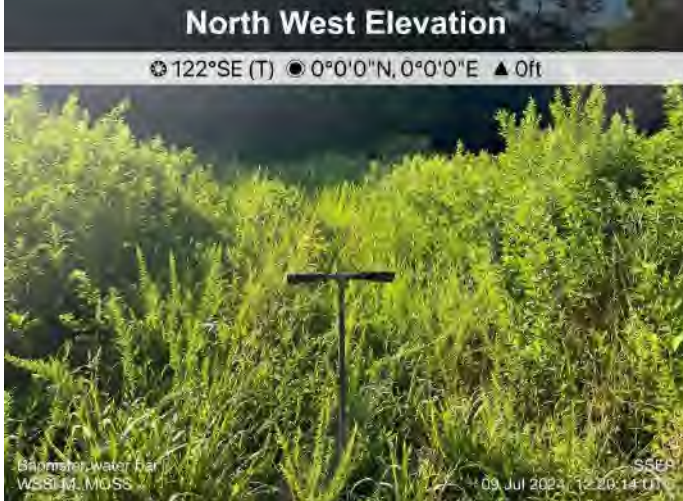
<p>North West Elevation 122°SE (T) 0°0'0"N, 0°0'0"E ▲ 0ft 09 Jul 2024, 12:20:14 UTC SSEP L077-1 NC DS</p> <p>Photo 365: Looking downslope within an upland area upslope of L077-1. Attachment I; Sheet 18.</p>

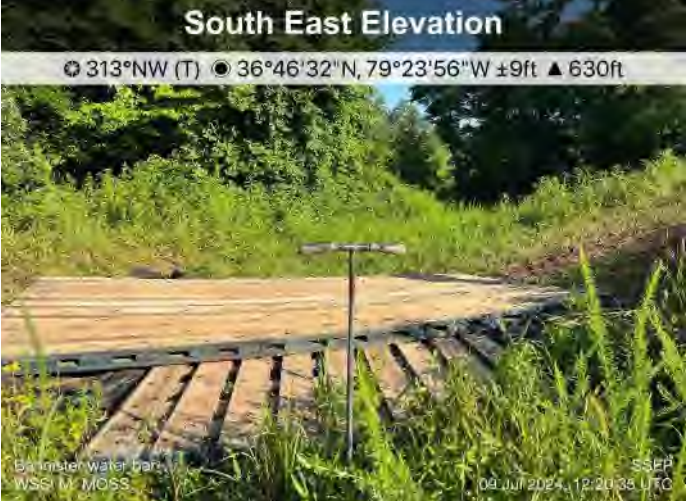
<p>South East Elevation 313°NW (T) 36°46'32"N, 79°23'56"W ±9ft ▲ 630ft 09 Jul 2024, 12:20:38 UTC SSEP W156-1 NC DS</p> <p>Photo 366: Looking downslope within an upland area upslope of W156-1. Attachment I; Sheet 18.</p>
---	---

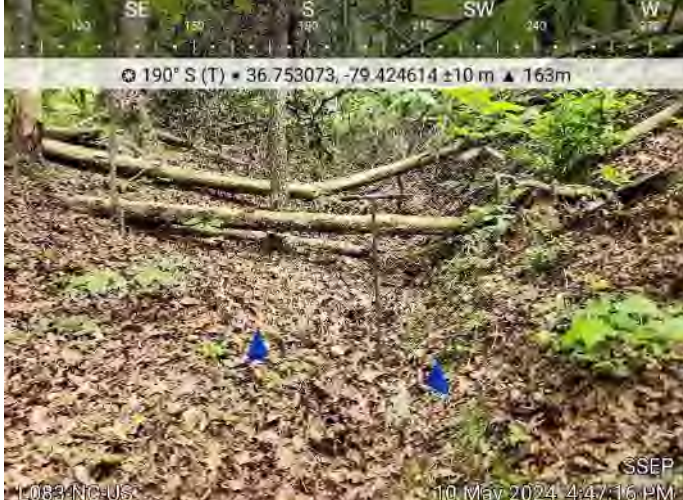
<p>SE 120 150 180 210 240 W 270 190° S (T) 36.753073, -79.424614 ±10 m ▲ 163m 10 May 2024, 4:47:16 PM SSEP L083-1 NC US</p> <p>Photo 367: Looking upstream at L083-1, which characterizes an ephemeral stream (R6). Attachment I; Sheet 16.</p>

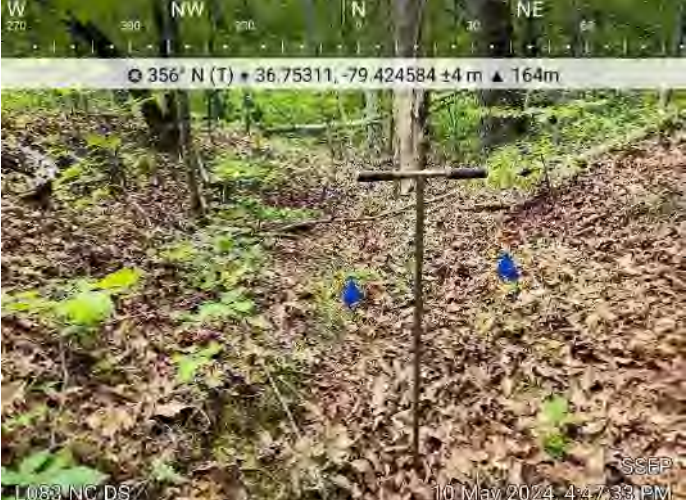
<p>W 270 NW 300 N 0 NE 30 60 356° N (T) 36.75311, -79.424584 ±4 m ▲ 164m 10 May 2024, 4:47:33 PM SSEP L083-1 NC DS</p> <p>Photo 368: Looking downstream at L083-1, which characterizes an ephemeral stream (R6). Attachment I; Sheet 16.</p>
---	---

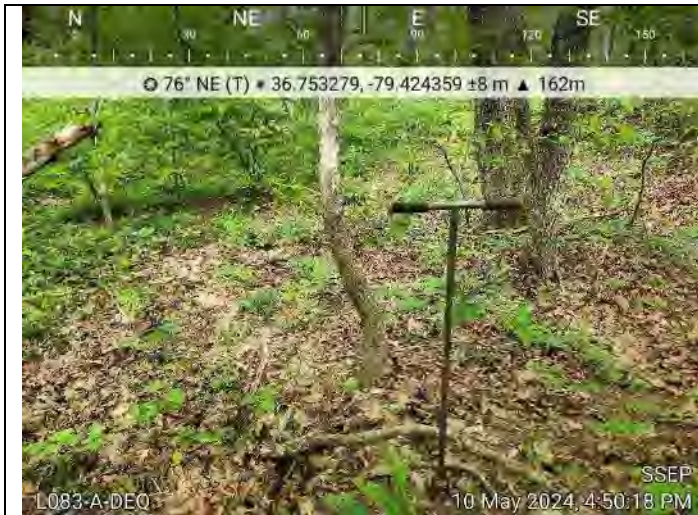
Photo 369:

Looking upslope of L083-1. Attachment I; Sheet 16.

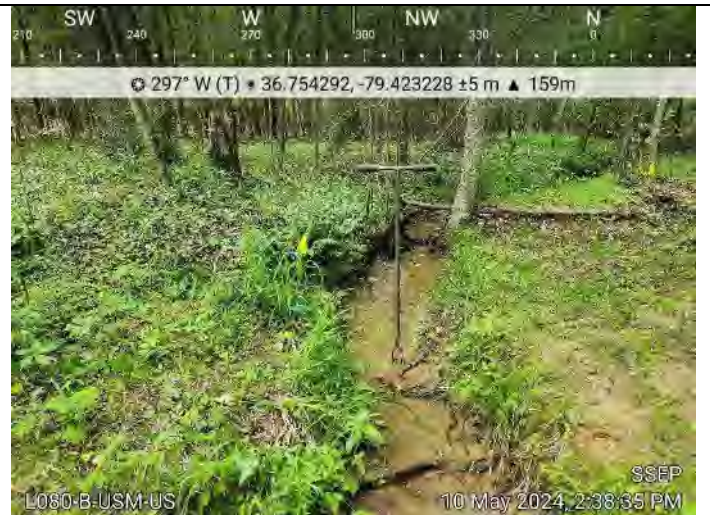
Photo 370:

Looking upstream at L080-1, which characterizes a perennial stream (R3). Attachment I; Sheet 16.

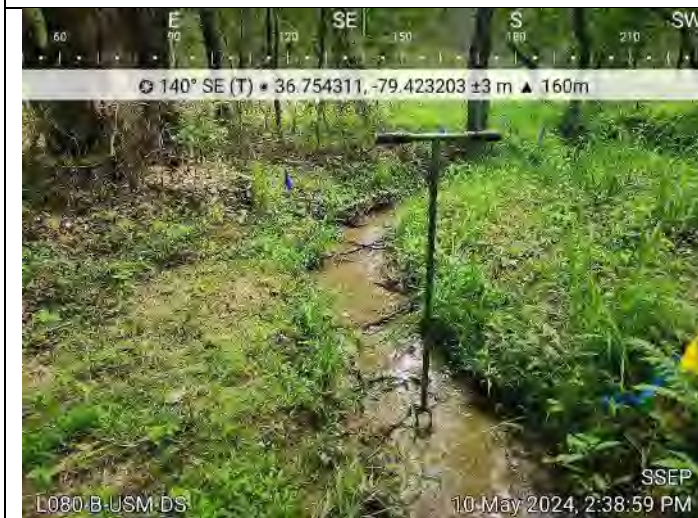
Photo 371:

Looking downstream at L080-1, which characterizes a perennial stream (R3). Attachment I; Sheet 16.

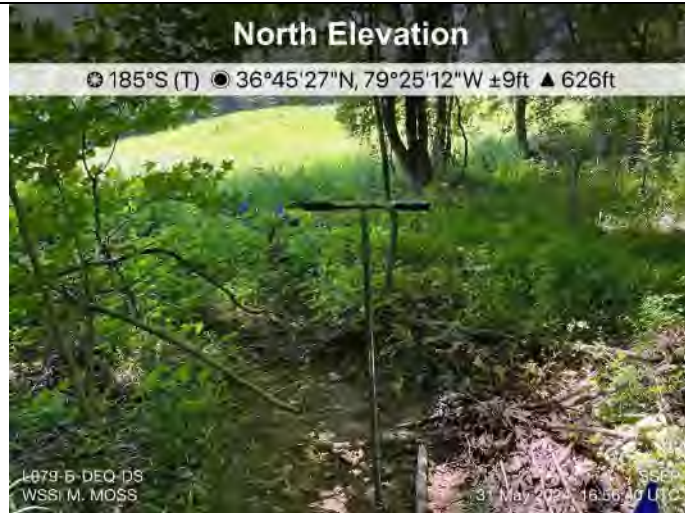
Photo 373:

Looking downstream at L079-1, which characterizes an ephemeral stream (R6). Attachment I; Sheet 17.

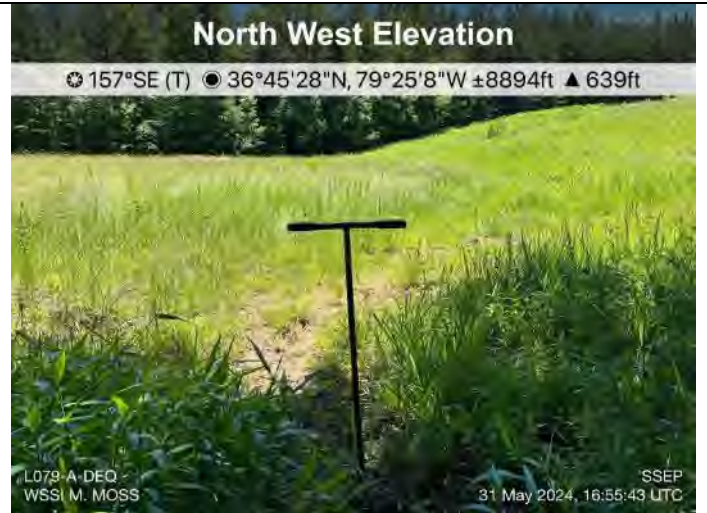
Photo 374:

Looking downslope of L079-1. Attachment I; Sheet 17.

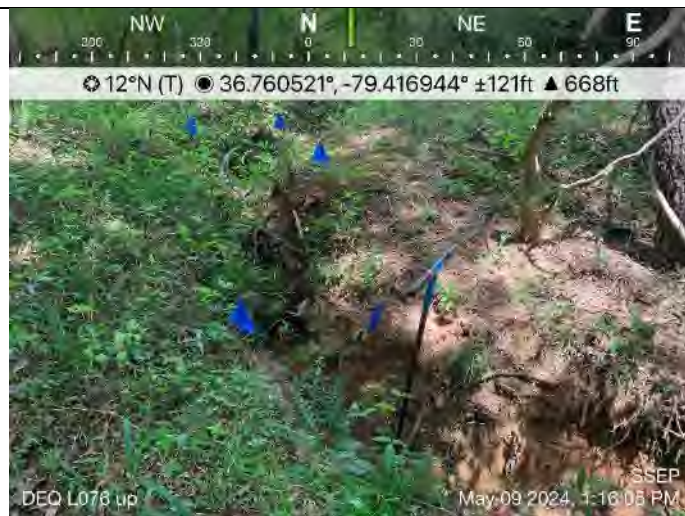
Photo 375:

Looking upstream at L076-1, which characterizes an intermittent stream (R4). Attachment I; Sheet 17.

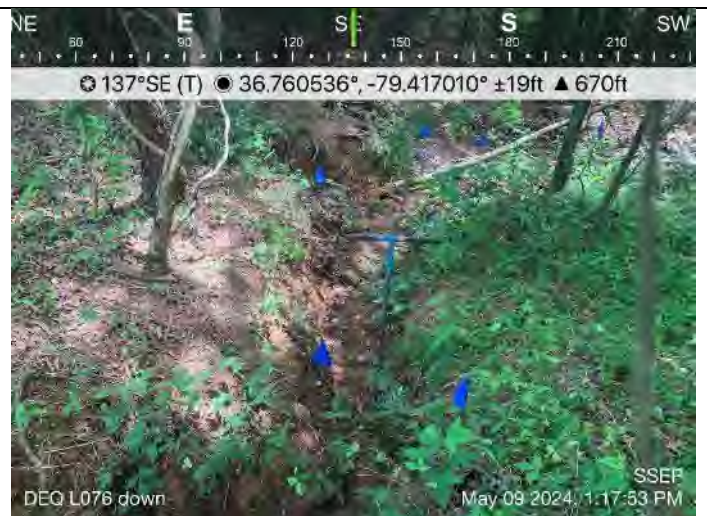
Photo 376:

Looking downstream at L076-1, which characterizes an intermittent stream (R4). Attachment I; Sheet 17.

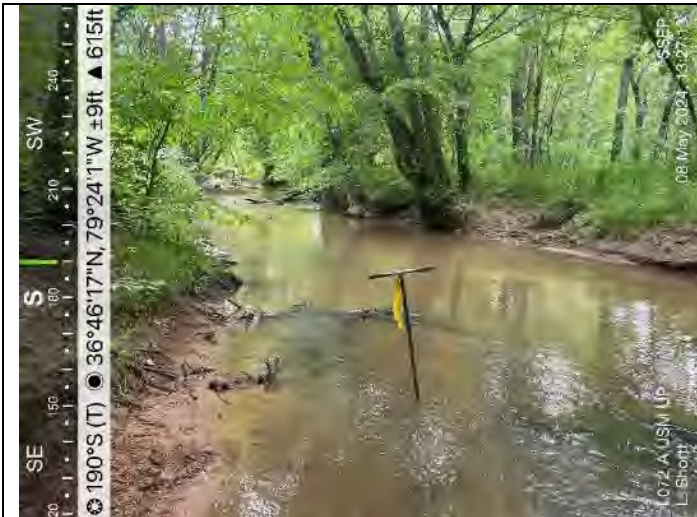
Photo 377:

Looking upstream at L072-1, which characterizes White Oak Creek (R3). Attachment I; Sheet 18.

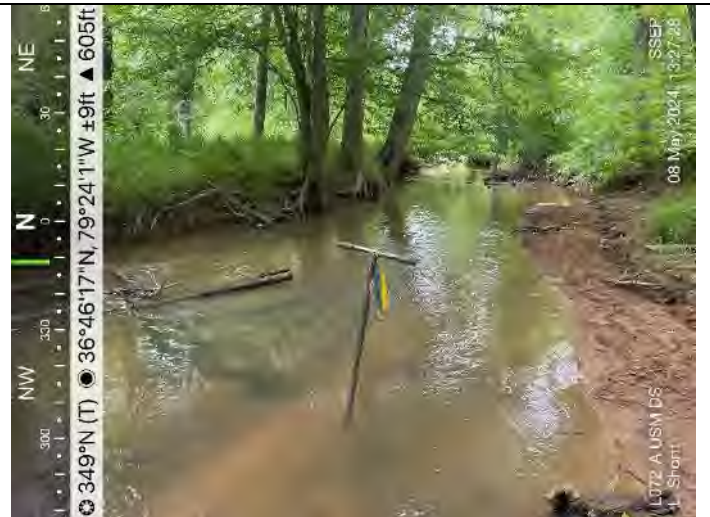
Photo 378:

Looking downstream at L072-1, which characterizes White Oak Creek (R3). Attachment I; Sheet 18.

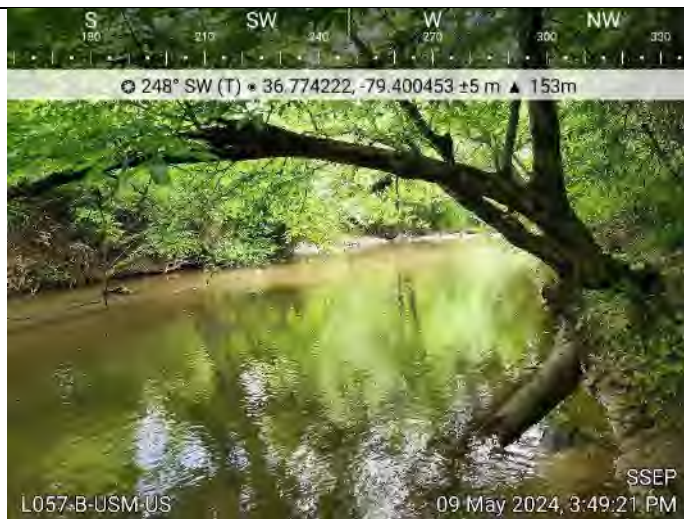
Photo 379:

Looking upstream at L057-1, which characterizes the Banister River (R3). Attachment I; Sheet 18.

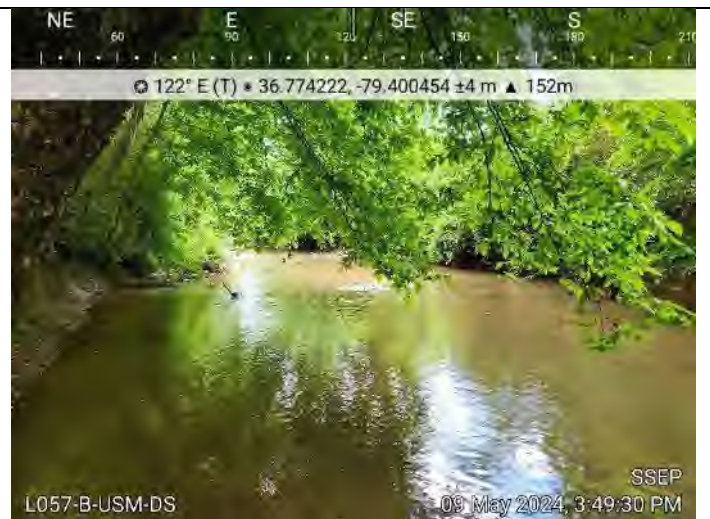
Photo 380:

Looking downstream at L057-1, which characterizes the Banister River (R3). Attachment I; Sheet 18.

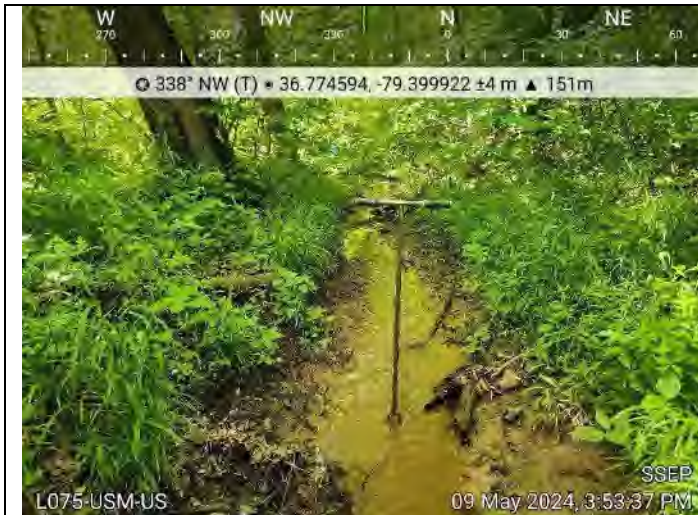
Photo 381:

Looking upstream at L075-1, which characterizes a perennial stream (R3). Attachment I; Sheet 18.

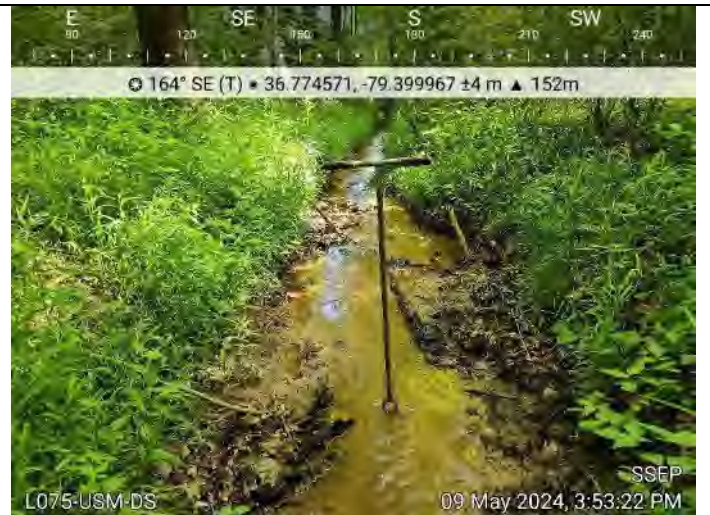
Photo 382:

Looking downstream at L075-1, which characterizes a perennial stream (R3). Attachment I; Sheet 18.

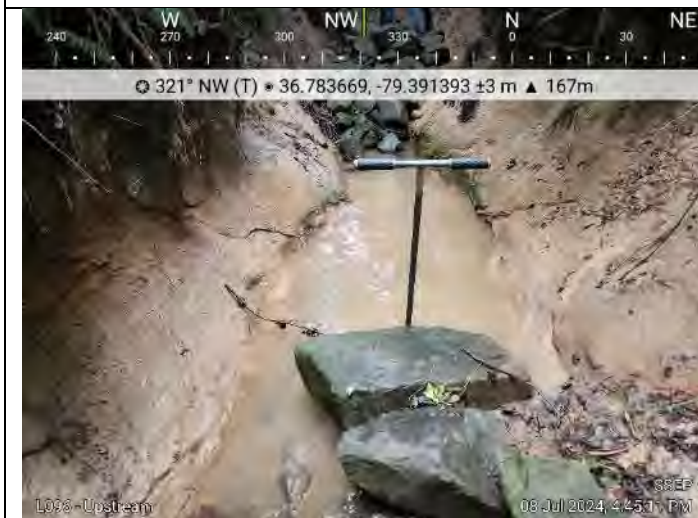
Photo 383:

Looking upstream at L096-1, which characterizes a perennial stream (R3). Attachment I; Sheet 20.

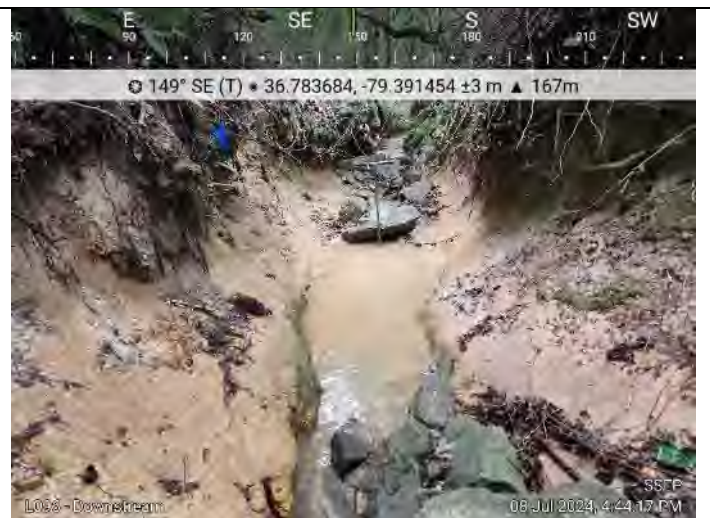
Photo 384:

Looking downstream at L096-1, which characterizes a perennial stream (R3). Attachment I; Sheet 20.

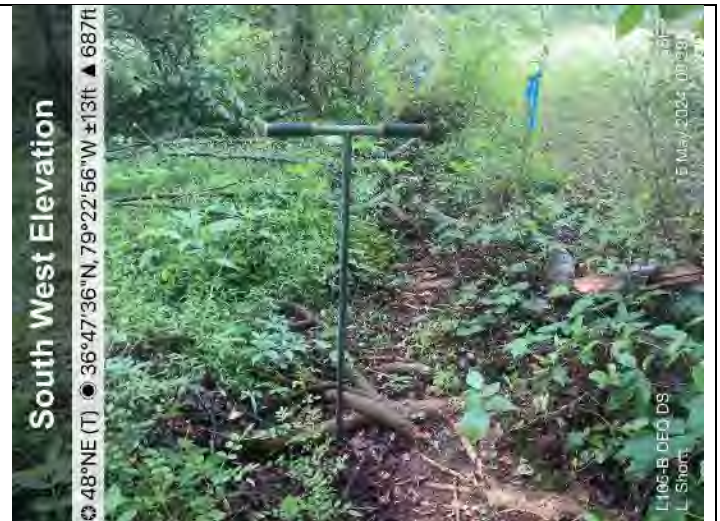
Photo 385:

Looking upstream at L105-1, which characterizes an ephemeral stream (R6). Attachment I; Sheet 20.

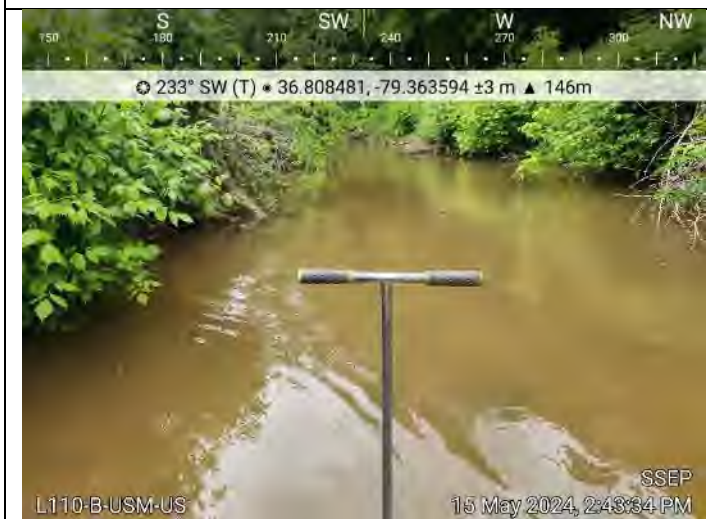
Photo 387:

Looking upstream at L110-1, which characterizes Cherrystone Creek (R3). Attachment I; Sheet 21.

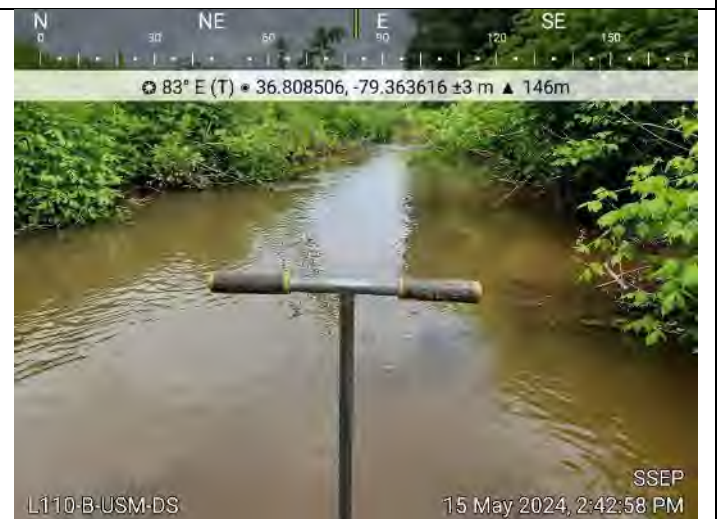
Photo 388:

Looking downstream at L110-1, which characterizes Cherrystone Creek (R3). Attachment I; Sheet 21.

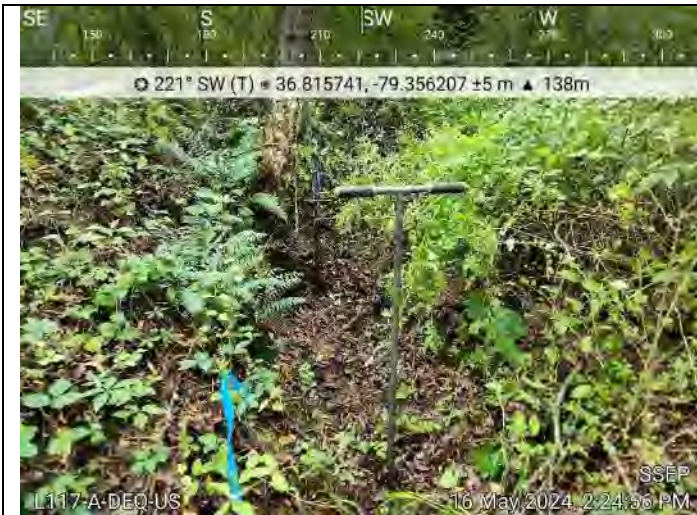
Photo 389:

Looking upstream at L117-1, which characterizes an ephemeral stream (R6). Attachment I; Sheet 22.

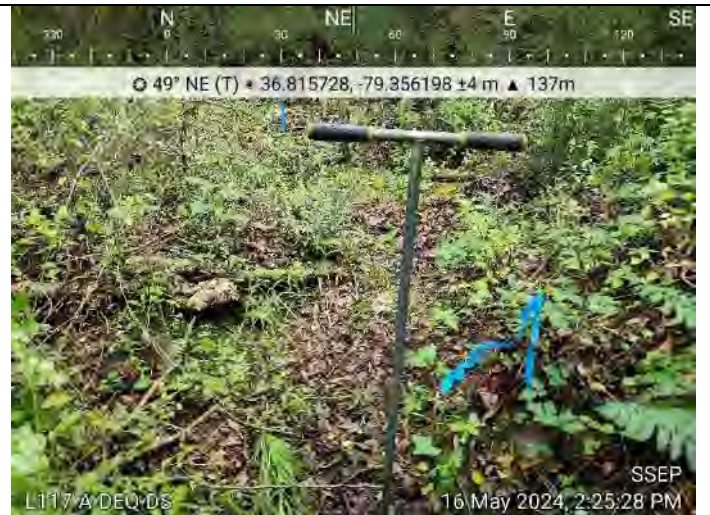
Photo 390:

Looking downstream at L117-1, which characterizes an ephemeral stream (R6). Attachment I; Sheet 22.

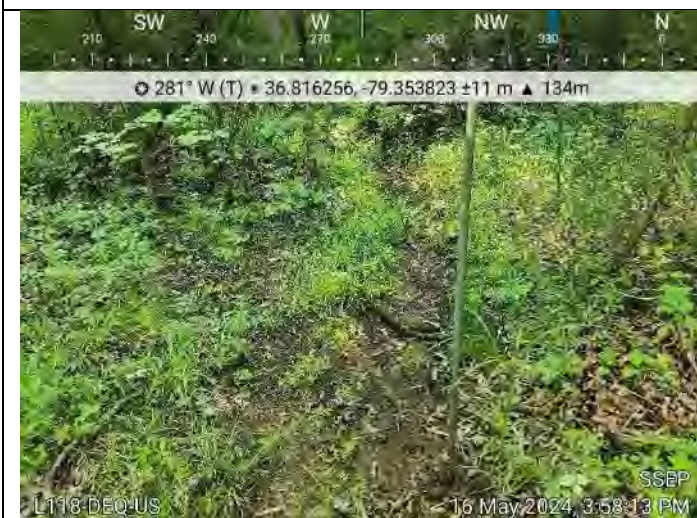
Photo 391:

Looking upstream at L118-1, which characterizes an ephemeral stream (R6). Attachment I; Sheet 22.

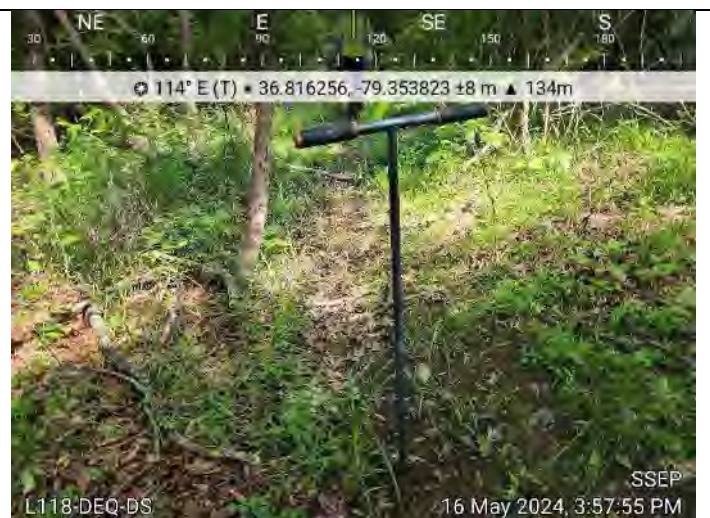
Photo 392:

Looking downstream at L118-1, which characterizes an ephemeral stream (R6). Attachment I; Sheet 22.

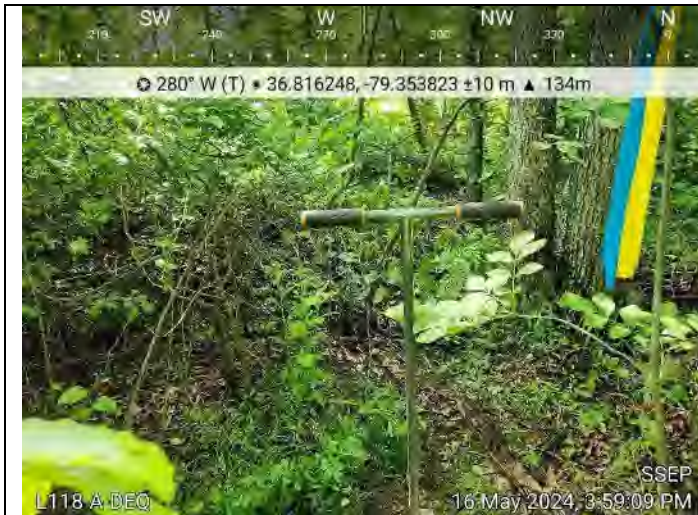
Photo 393:

Looking upslope of L118-1. Attachment I; Sheet 22.

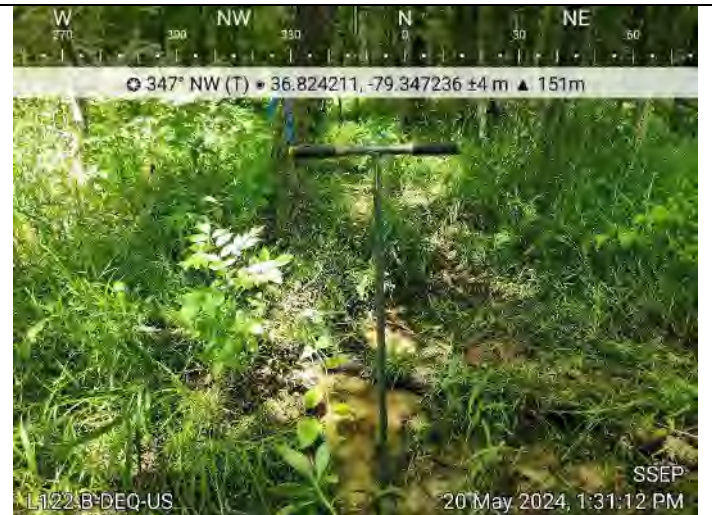
Photo 394:

Looking upstream at L122-1, which characterizes an intermittent stream (R4). Attachment I; Sheet 23.

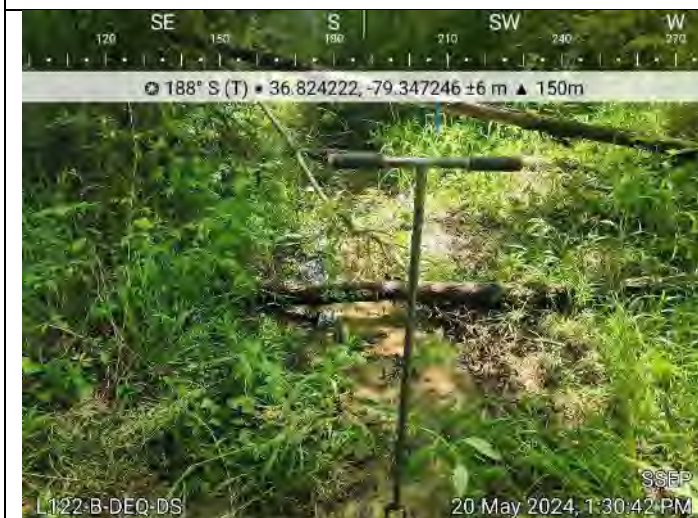
Photo 395:

Looking downstream at L122-1, which characterizes an intermittent stream (R4). Attachment I; Sheet 23.

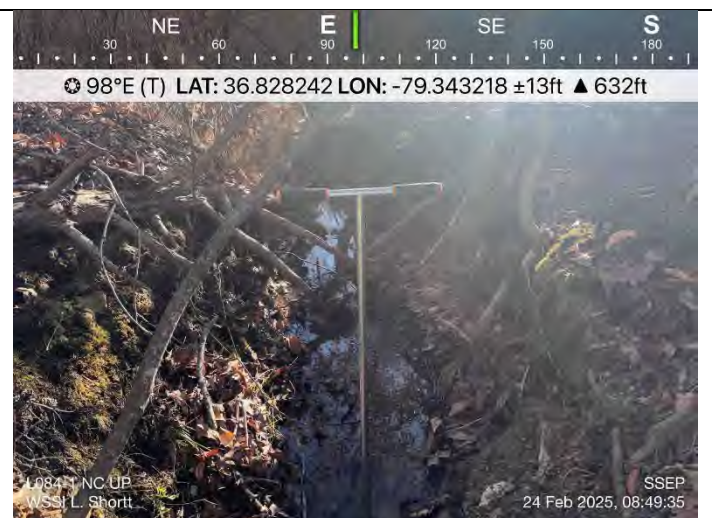
Photo 396:

Looking upstream at L084-1, which characterizes a perennial stream (R3). Attachment I; Sheet 23.

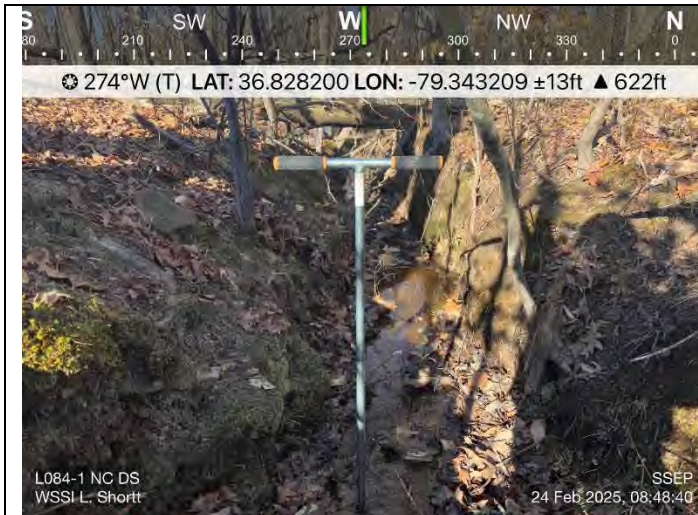
Photo 397:

Looking downstream at L084-1, which characterizes a perennial stream (R3). Attachment I; Sheet 23.

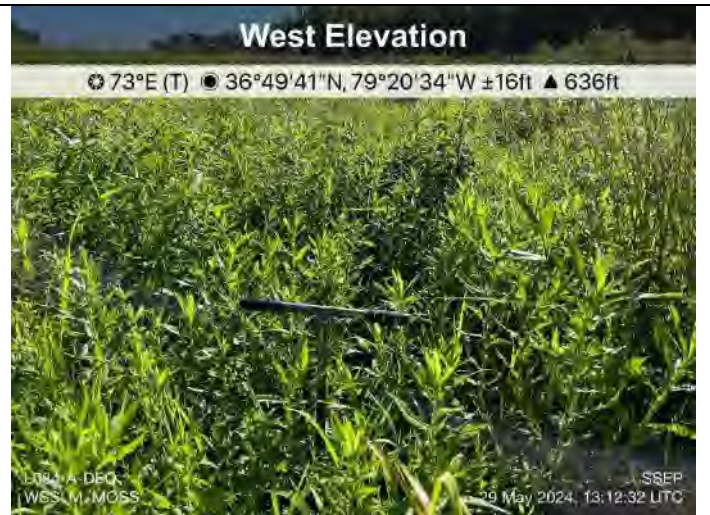
Photo 398:

Looking upslope of L084-1. Attachment I; Sheet 23.

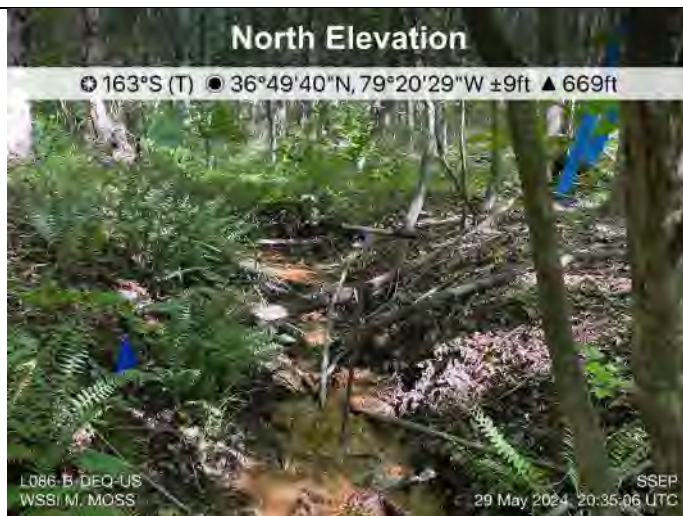
Photo 399:

Looking upstream at L086-1, which characterizes a perennial stream (R3). Attachment I; Sheet 23.

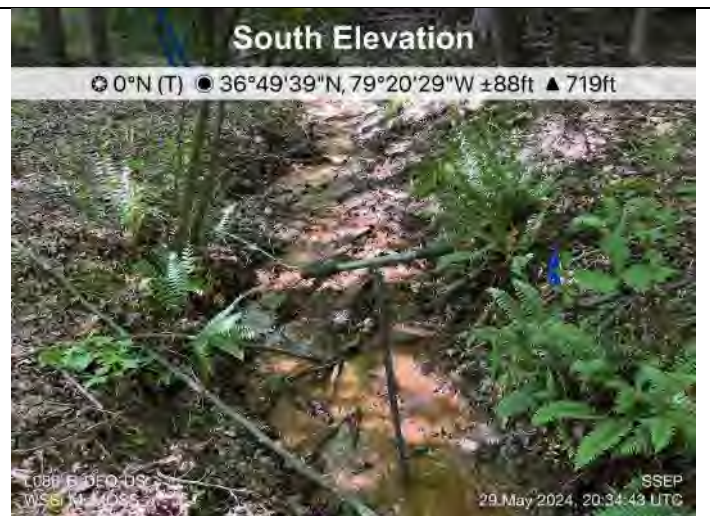
Photo 400:

Looking downstream at L086-1, which characterizes a perennial stream (R3). Attachment I; Sheet 23.

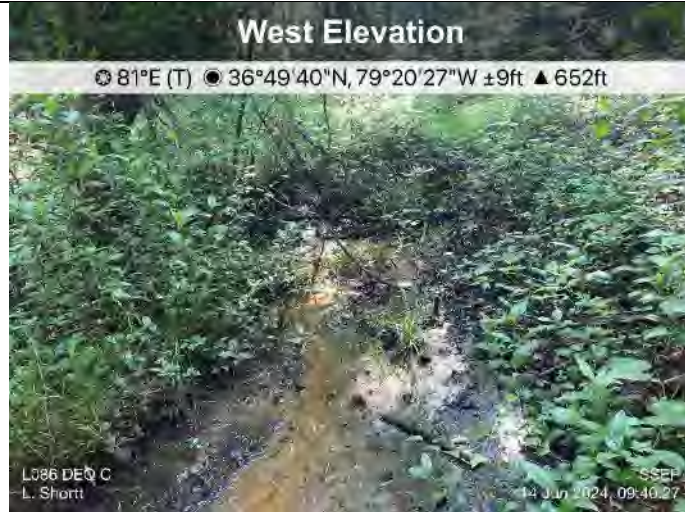
Photo 401:
 Looking upslope of L086-1. Attachment I; Sheet 23.

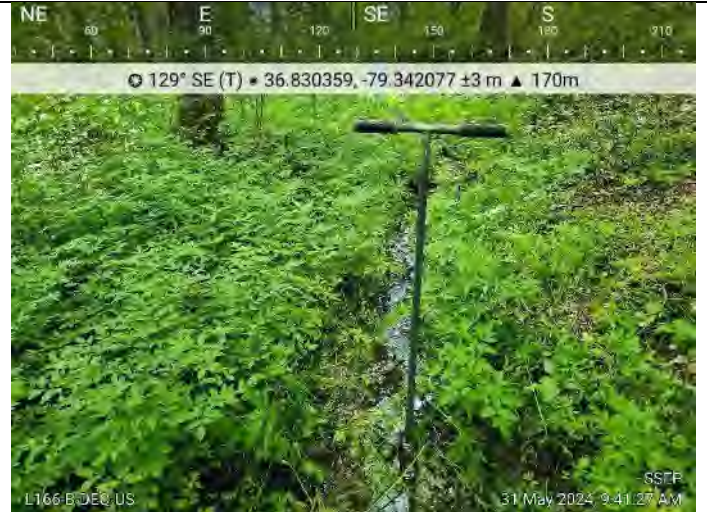
Photo 402:
 Looking upstream at L166-1, which characterizes an intermittent stream (R4). Attachment I; Sheet 23.

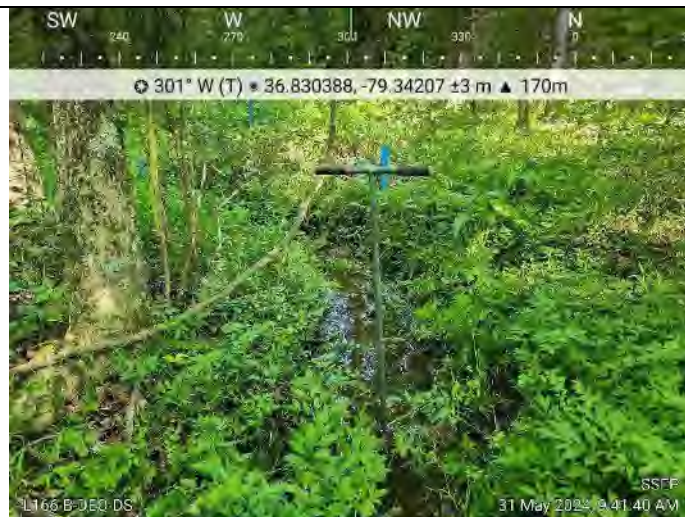
Photo 403:
 Looking downstream at L166-1, which characterizes an intermittent stream (R4). Attachment I; Sheet 23.
