EXHIBIT 14 - PHOTOGRAPHS

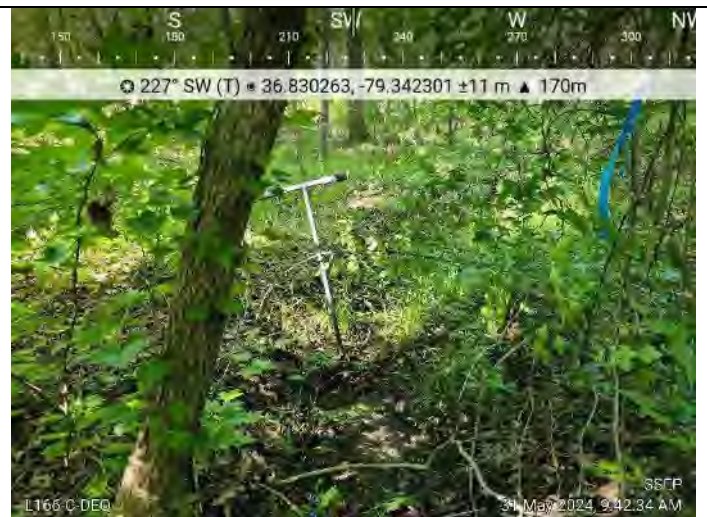
Photo 404:
 Looking downslope of L166-1. Attachment I; Sheet 23.

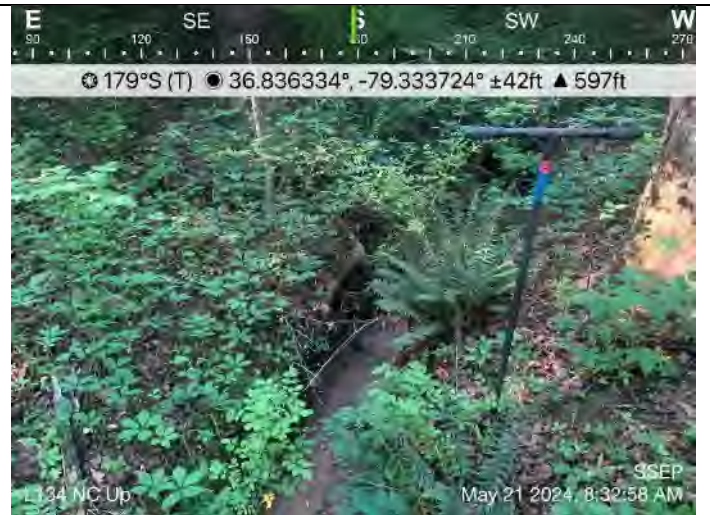
Photo 410:

Looking upstream at L134-1, which characterizes an intermittent stream (R4). Attachment I; Sheet 23.

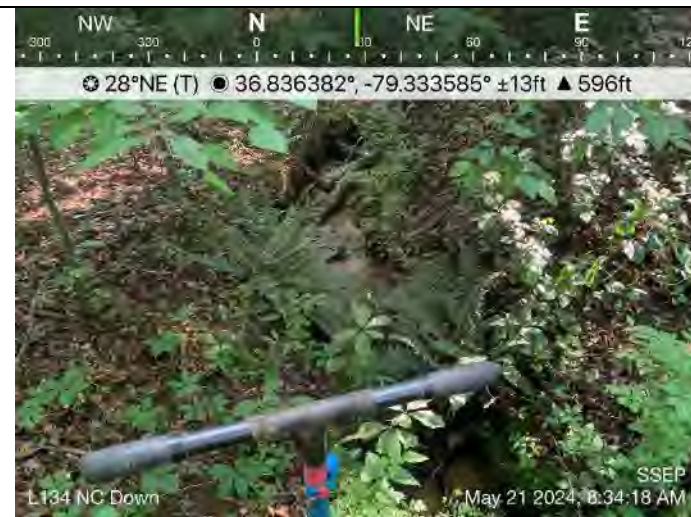
Photo 411:

Looking downstream at L134-1, which characterizes an intermittent stream (R4). Attachment I; Sheet 23.

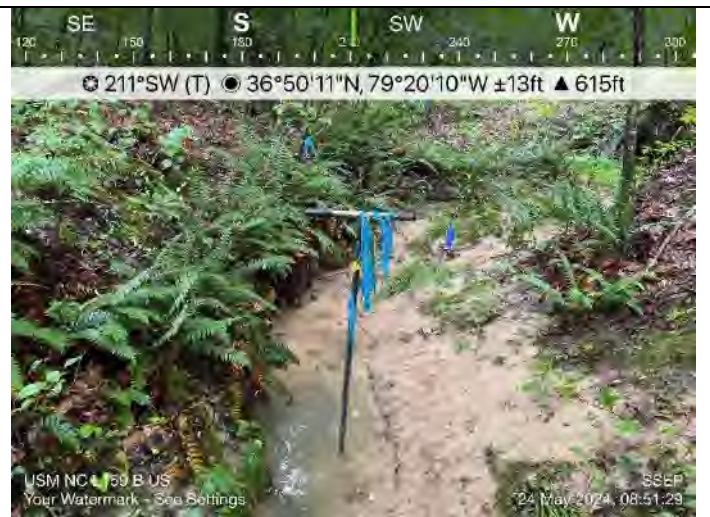
Photo 412:

Looking upstream at L159-1, which characterizes a perennial stream (R3). Attachment I; Sheet 23.

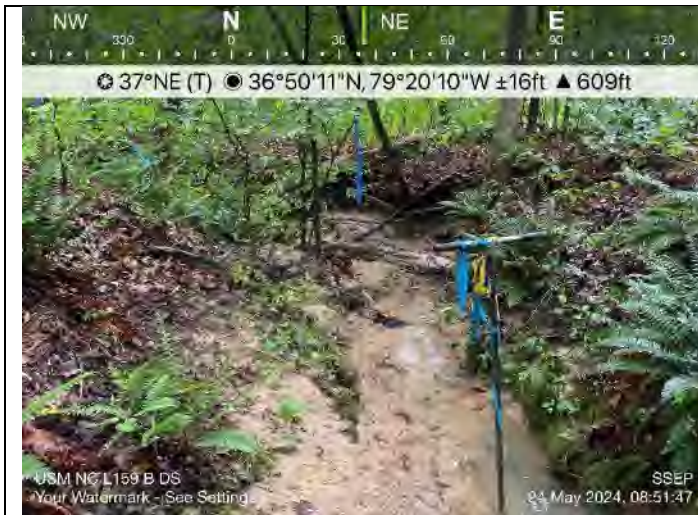
Photo 413:

Looking downstream at L159-1, which characterizes a perennial stream (R3). Attachment I; Sheet 23.

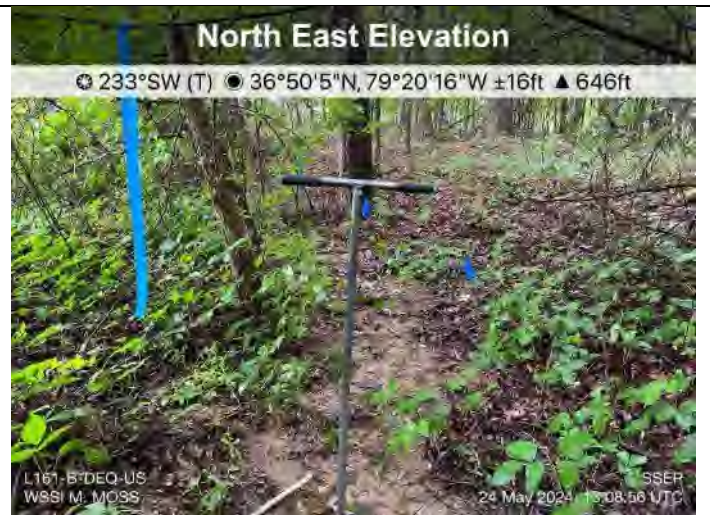
Photo 414:

Looking upstream at L161-1, which characterizes an ephemeral stream (R6). Attachment I; Sheet 23.

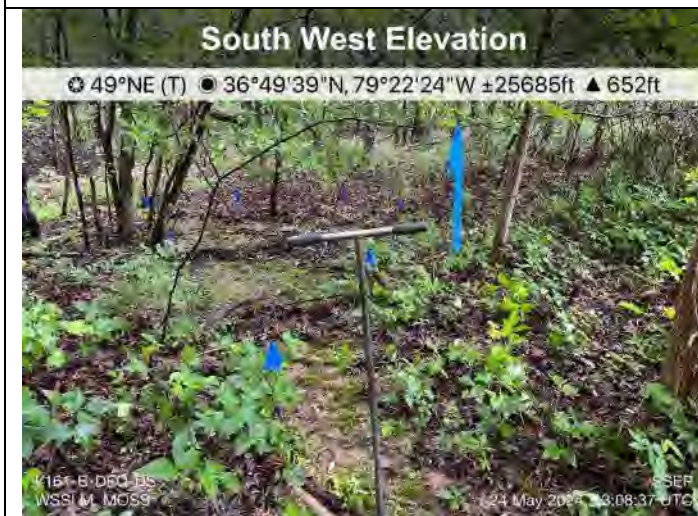
Photo 415:

Looking downstream at L161-1, which characterizes an ephemeral stream (R6). Attachment I; Sheet 23.

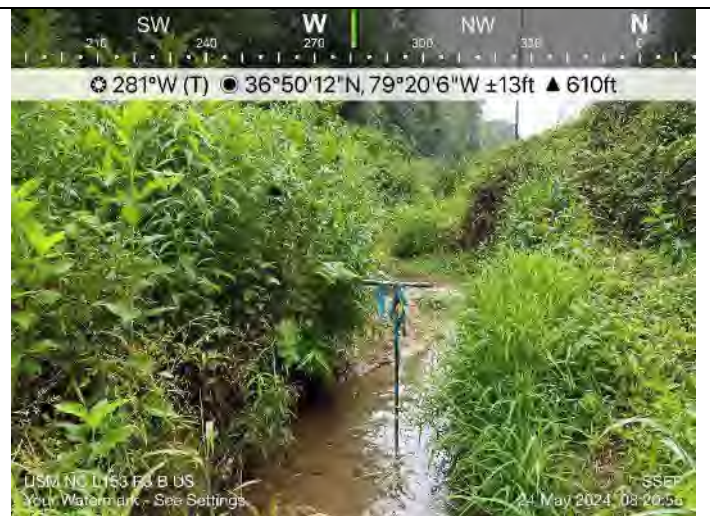
Photo 416:

Looking upstream at L153-1, which characterizes a perennial stream (R3). Attachment I; Sheet 23.

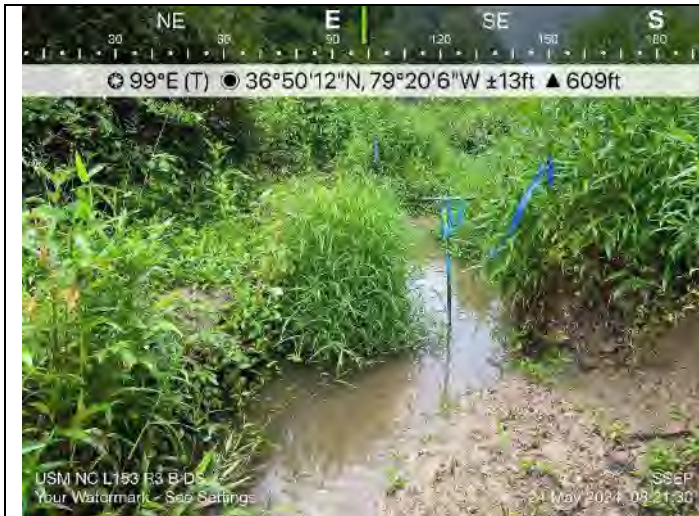
Photo 417:

Looking downstream at L153-1, which characterizes a perennial stream (R3). Attachment I; Sheet 23.

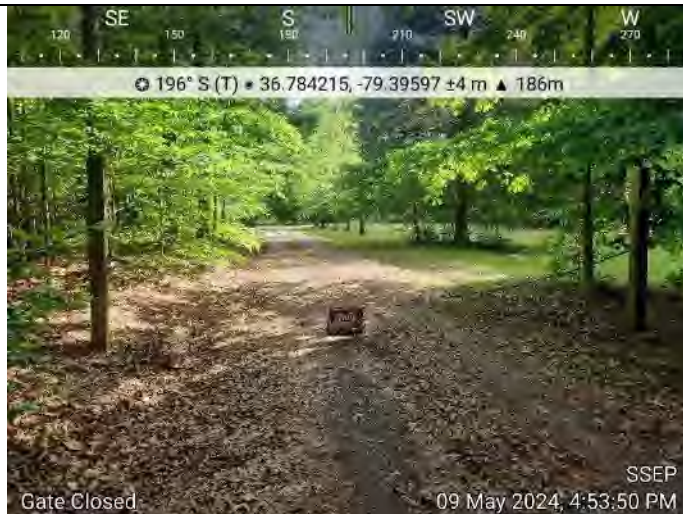
Photo 422:

Looking at a general overview of the access road condition, located off Franklin Trpk.; which intersects the existing ROW near MP1401.40. Attachment I; Sheet 13.

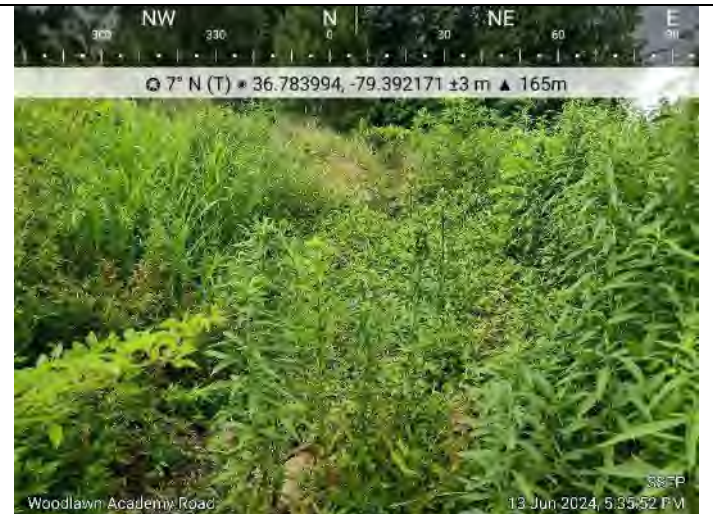
Photo 423:

Looking at a general overview of the access road condition, located off Samuel Harris Ln.; which intersects the existing ROW near MP1408.10. Attachment I; Sheet 18.

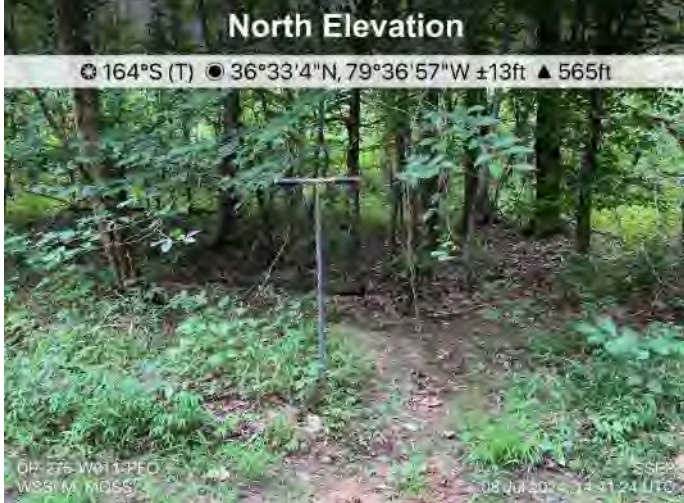
Photo 424:

Looking at the upland swale, located below PEM wetland (W184-1); adjacent to Woodlawn Academy Rd. Attachment I; Sheet 20.

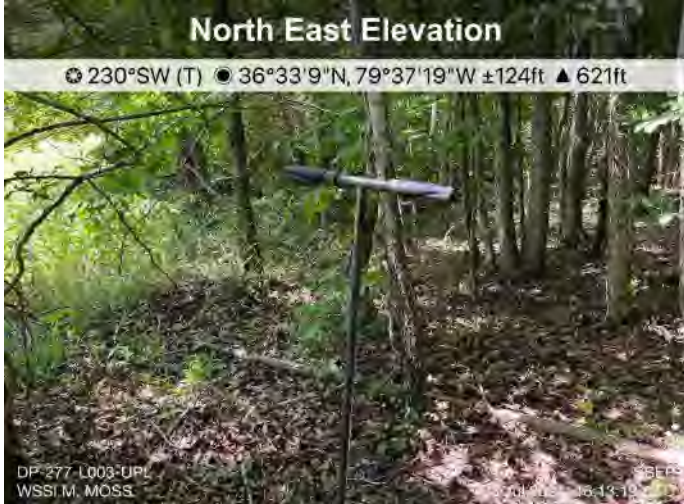
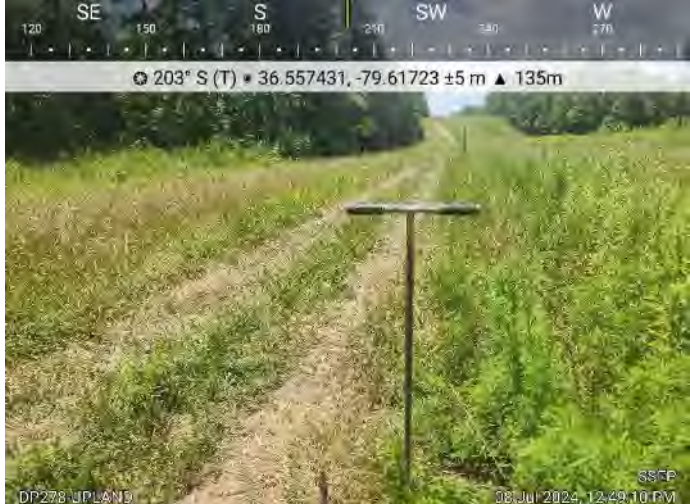
<p>Photo 425:</p> <p>Looking at Data Point #275, which characterizes a PFO wetland. This area contained all three wetland parameters. Attachment I; Sheet 3.</p>	<p>Photo 426:</p> <p>Looking at Data Point #276, which characterizes a PFO wetland. This area contained all three wetland parameters. Attachment I; Sheets 2 and 3.</p>

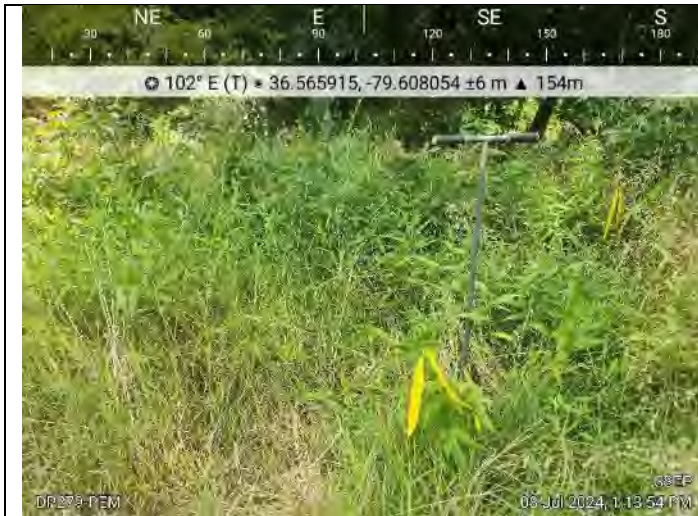
<p>Photo 427:</p> <p>Looking at Data Point #277, which characterizes a forested upland. This area lacked wetland hydrology and hydric soil. Attachment I; Sheet 2.</p>	<p>Photo 428:</p> <p>Looking at Data Point #278, which characterizes an upland within the ROW. This area lacked wetland hydrology, hydrophytic vegetation, and hydric soil. Attachment I; Sheet 3.</p>

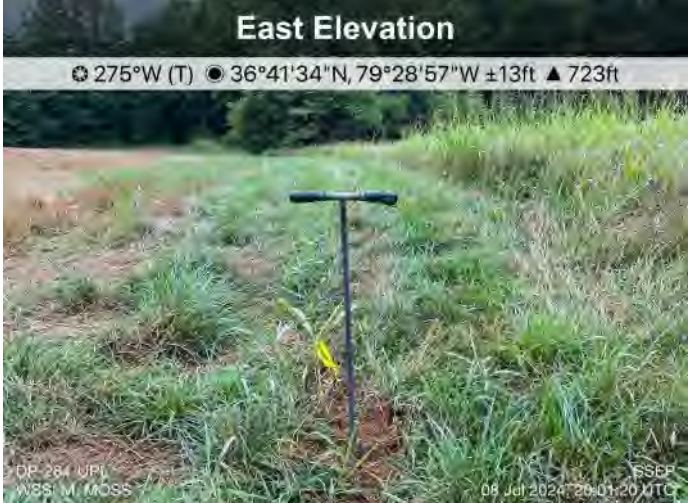
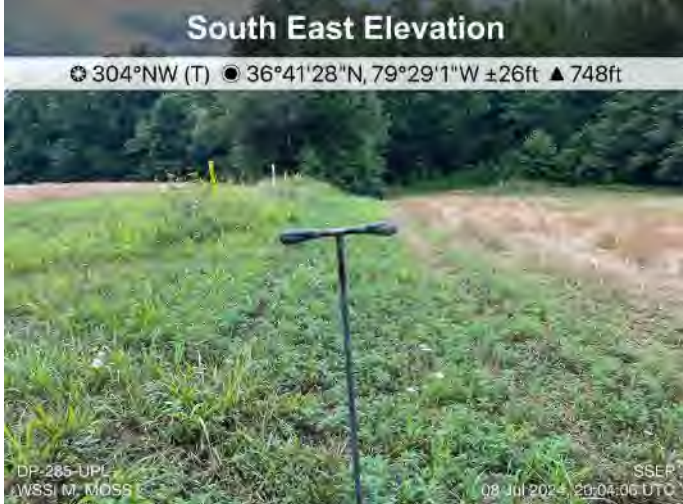
<p>Photo 433:</p> <p>Looking at Data Point #283, which characterizes a forested upland. This area lacked wetland hydrology, hydrophytic vegetation, and hydric soil. Attachment I; Sheet 10.</p>	<p>Photo 434:</p> <p>Looking at Data Point #284, which characterizes an upland. This area lacked wetland hydrology, hydrophytic vegetation, and hydric soil. Attachment I; Sheet 12.</p>

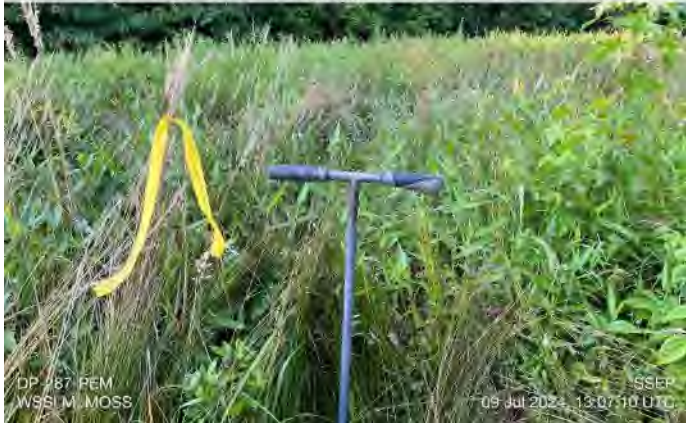
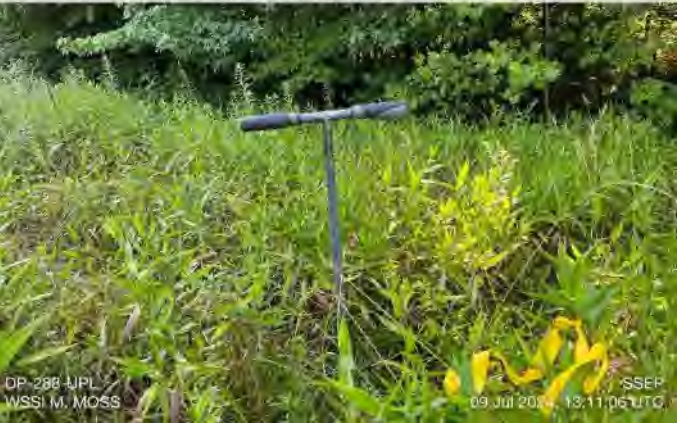
<p>DP 287 PEM WSSI M. MOSS 09 Jul 2024 13:07:10 UTC SSEP</p>	<p>West Elevation</p> <p>☉ 89°E (T) ☉ 36°45'28"N, 79°25'7"W ±22ft ▲ 611ft</p>

<p>DP 288 UPL WSSI M. MOSS 09 Jul 2024 13:11:06 UTC SSEP</p>
<p>Photo 437:</p> <p>Looking at Data Point #287, which characterizes a PEM wetland. This area contained all three wetland parameters. Attachment I; Sheet 17.</p>	<p>Photo 438:</p> <p>Looking at Data Point #288, which characterizes an upland. This area lacked wetland hydrology and hydric soil. Attachment I; Sheet 17.</p>
<p>North East Elevation</p> <p>☉ 215°SW (T) ☉ 36°45'47"N, 79°23'21"W ±23349ft ▲ 615ft</p>

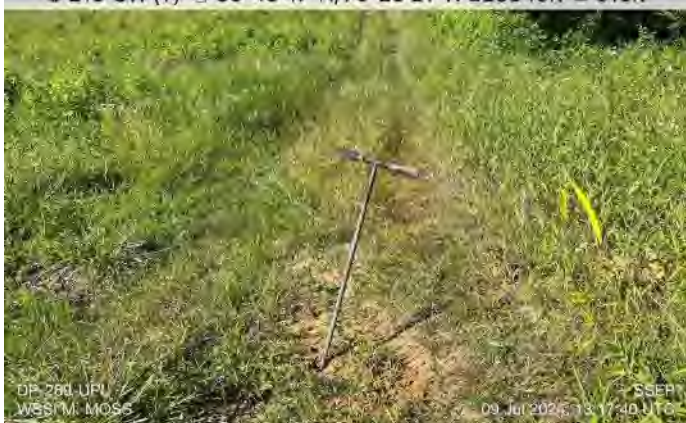
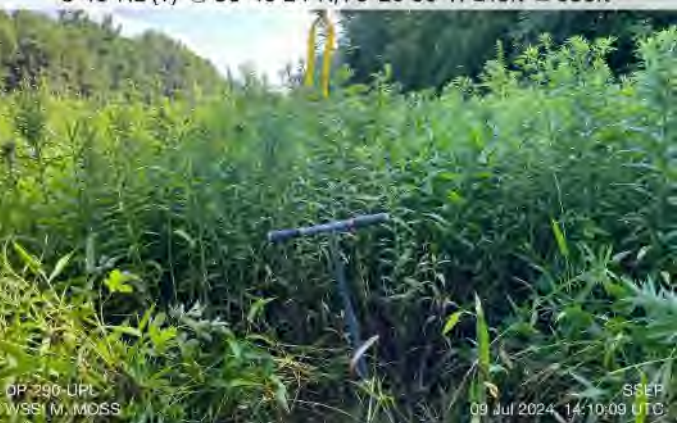
<p>DP 289 UPL WSSI M. MOSS 09 Jul 2024 13:17:40 UTC SSEP</p>	<p>South West Elevation</p> <p>☉ 43°NE (T) ☉ 36°49'24"N, 79°20'50"W ±19ft ▲ 583ft</p>

<p>DP 290 UPL WSSI M. MOSS 09 Jul 2024 14:10:09 UTC SSEP</p>

<p>Photo 439:</p> <p>Looking at Data Point #289, which characterizes an upland. This area lacked wetland hydrology, hydrophytic vegetation, and hydric soil. Attachment I; Sheet 17.</p>	<p>Photo 440:</p> <p>Looking at Data Point #290, which characterizes an upland. This area lacked wetland hydrology, hydrophytic vegetation, and hydric soil. Attachment I; Sheet 22.</p>

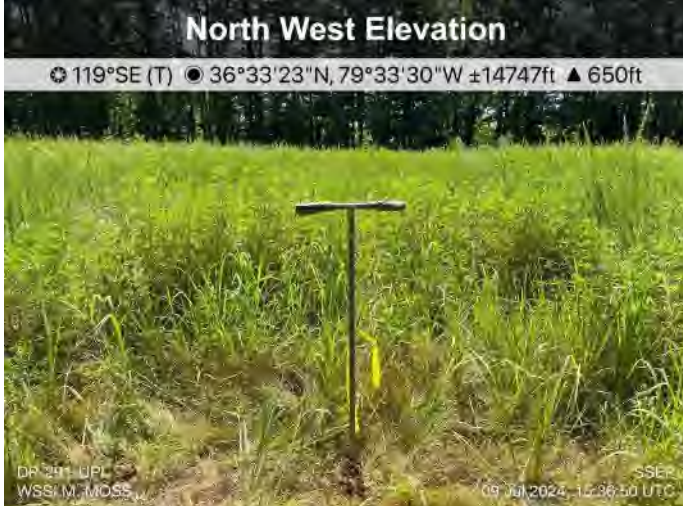
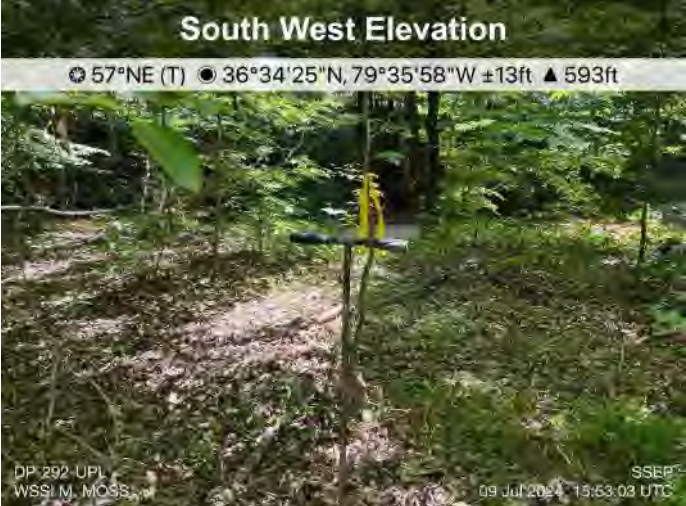
<p>North West Elevation 119°SE (T) 36°33'23"N, 79°33'30"W ±14747ft ▲ 650ft</p> <p>DP: 291 UPL WSSI M. MOSS 09 Jul 2024 12:36:50 UTC SSEP</p>

<p>South West Elevation 57°NE (T) 36°34'25"N, 79°35'58"W ±13ft ▲ 593ft</p> <p>DP: 292 UPL WSSI M. MOSS 09 Jul 2024 15:53:03 UTC SSEP</p>
<p>Photo 441: Looking at Data Point #291, which characterizes an upland. This area lacked wetland hydrology and hydric soil. Attachment I; Sheet 4.</p>	<p>Photo 442: Looking at Data Point #292, which characterizes a forested upland. This area lacked wetland hydrology and hydric soil. Attachment I; Sheet 4.</p>

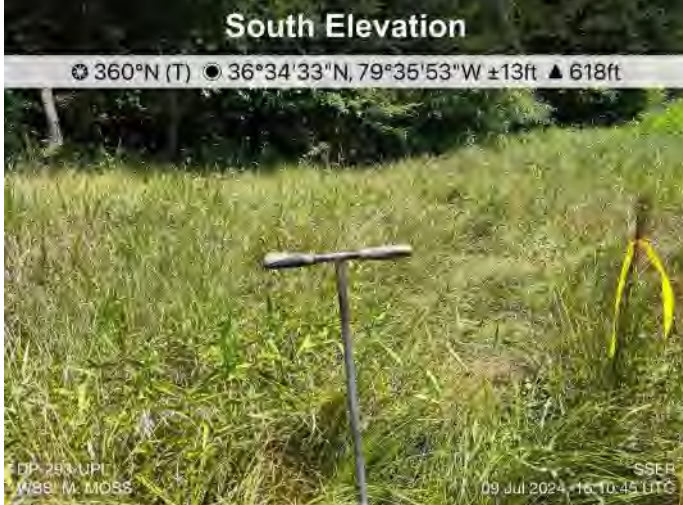
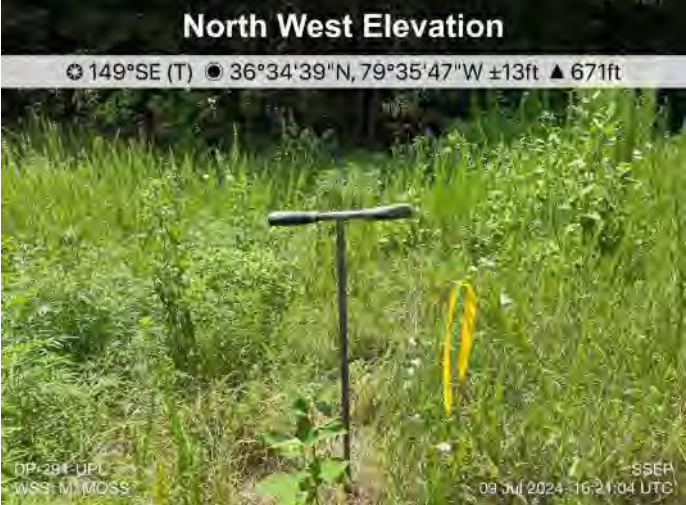
<p>South Elevation 360°N (T) 36°34'33"N, 79°35'53"W ±13ft ▲ 618ft</p> <p>DP: 293 UPL WSSI M. MOSS 09 Jul 2024 16:10:45 UTC SSEP</p>

<p>North West Elevation 149°SE (T) 36°34'39"N, 79°35'47"W ±13ft ▲ 671ft</p> <p>DP: 294 UPL WSSI M. MOSS 09 Jul 2024 16:21:04 UTC SSEP</p>
<p>Photo 443: Looking at Data Point #293, which characterizes an upland. This area lacked wetland hydrology and hydric soil. Attachment I; Sheet 4.</p>	<p>Photo 444: Looking at Data Point #294, which characterizes an upland. This area lacked wetland hydrology, hydrophytic vegetation, and hydric soil. Attachment I; Sheet 4.</p>

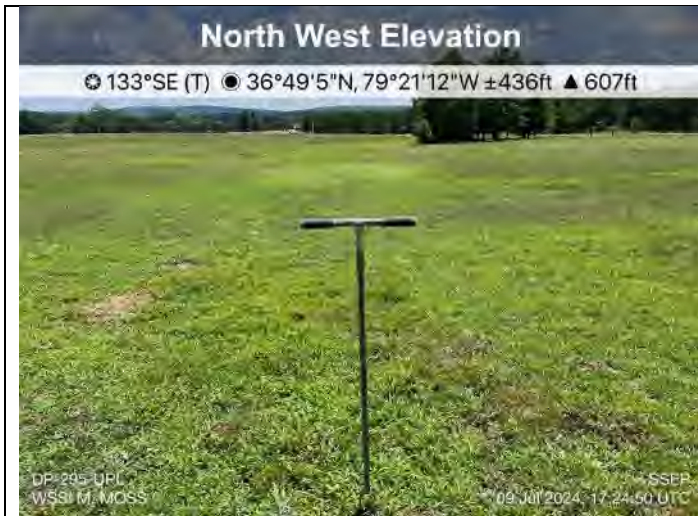
Photo 445:

Looking at Data Point #295, which characterizes an upland. This area lacked wetland hydrology, hydrophytic vegetation, and hydric soil. Attachment I; Sheet 22.

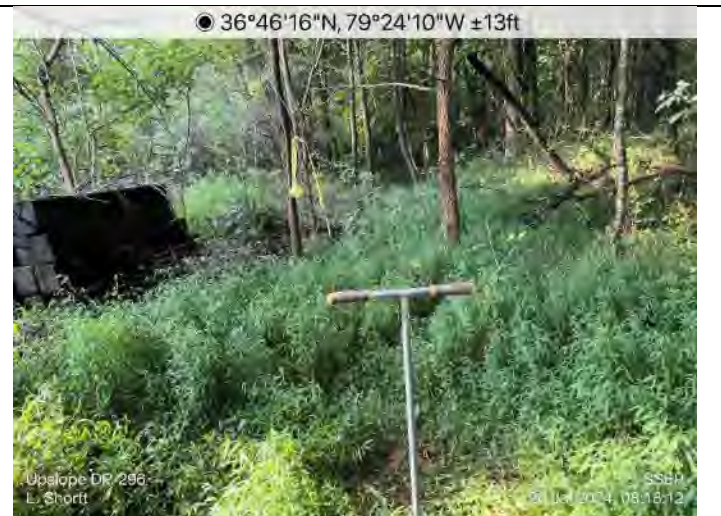
Photo 446:

Looking at Data Point #296, which characterizes an upland. This area lacked wetland hydrology and hydric soil. Attachment I; Sheet 18.

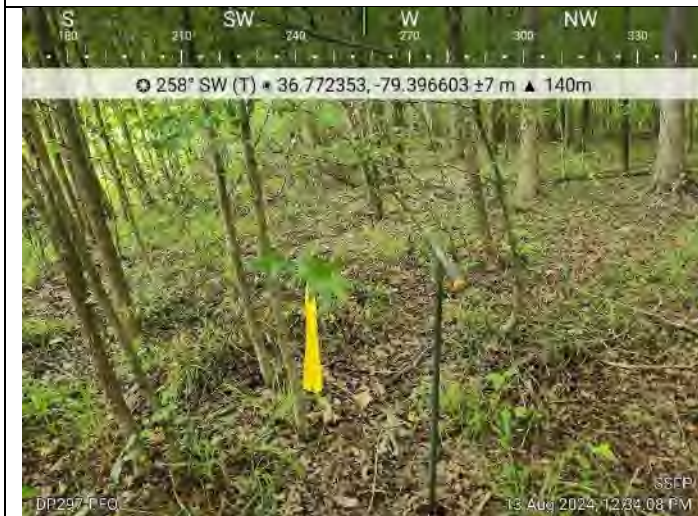
Photo 447:

Looking at Data Point #297, which characterizes a PFO wetland. This area contained all three wetland parameters. Attachment I; Sheet 19.

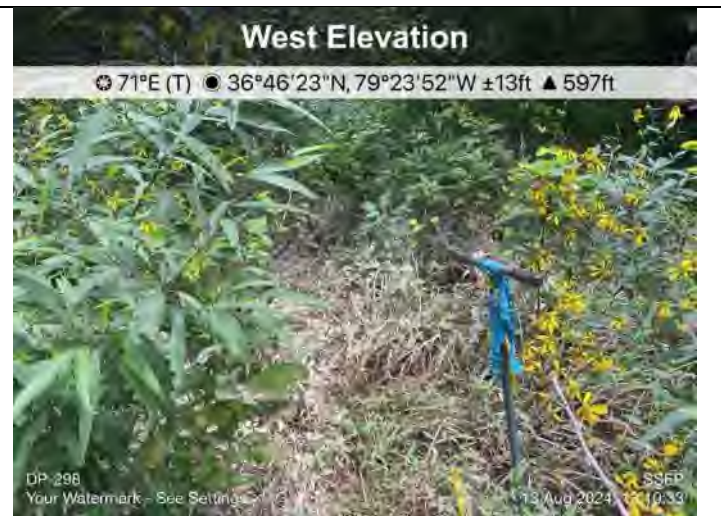
Photo 448:

Looking at Data Point #298, which characterizes an upland. This area lacked hydric soil. Attachment I; Sheets 18 & 19.

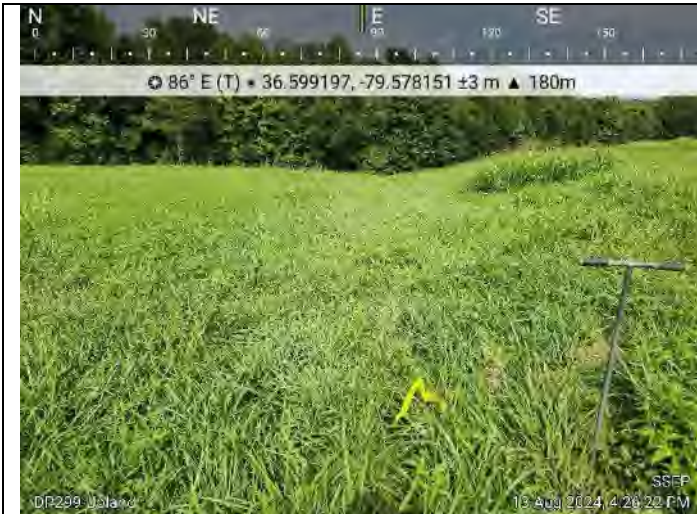
Photo 449:

Looking at Data Point #299, which characterizes an upland. This area lacked wetland hydrology, hydrophytic vegetation, and hydric soil. Attachment I; Sheet 6.

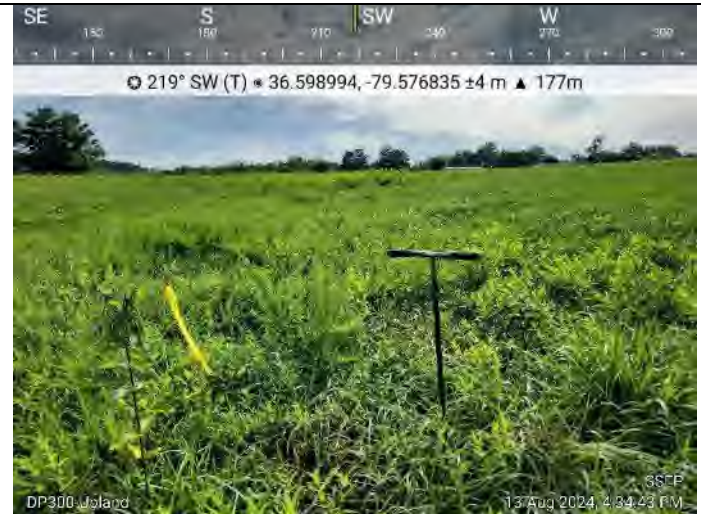
Photo 450:

Looking at Data Point #300, which characterizes an upland. This area lacked wetland hydrology, hydrophytic vegetation, and hydric soil. Attachment I; Sheet 6.

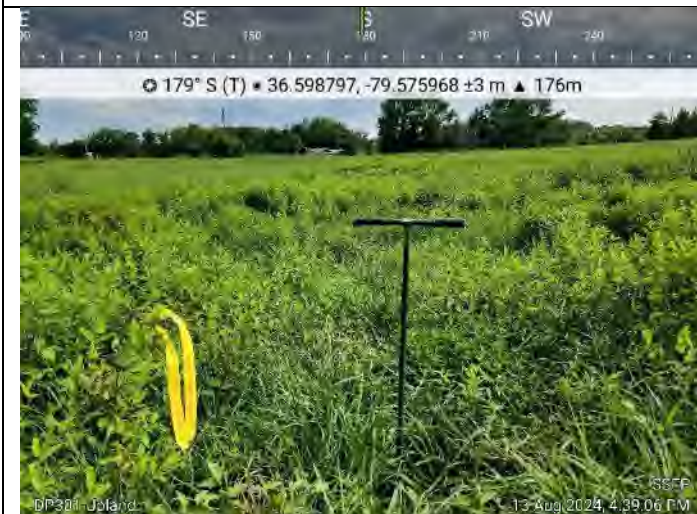
Photo 451:

Looking at Data Point #301, which characterizes an upland. This area lacked wetland hydrology, hydrophytic vegetation, and hydric soil. Attachment I; Sheet 6.

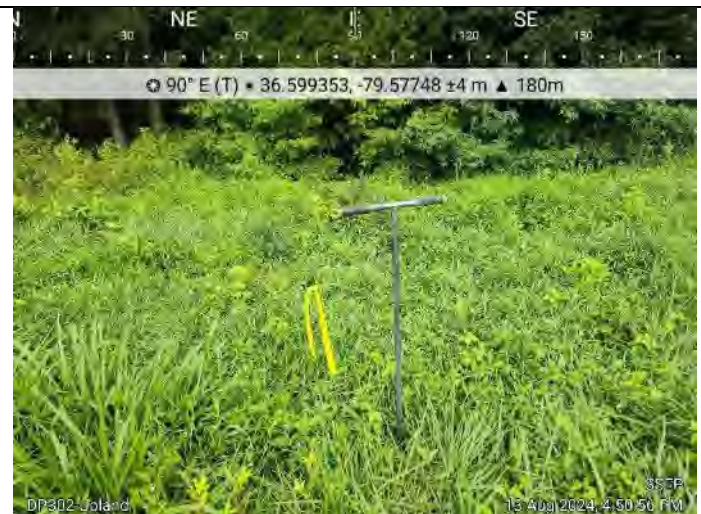
Photo 452:

Looking at Data Point #302, which characterizes an upland. This area lacked wetland hydrology and hydrophytic vegetation. Attachment I; Sheet 6.

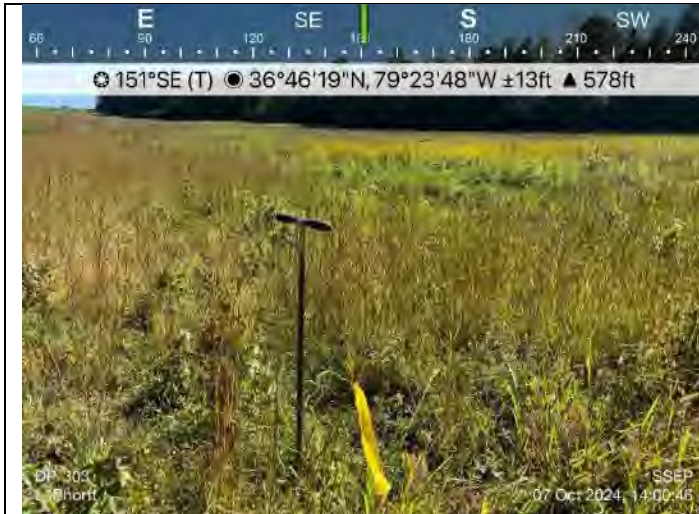
Photo 453:

Looking at Data Point #303, which characterizes an upland. This area lacked wetland hydrology, hydrophytic vegetation, and hydric soil. Attachment I; Sheet 19.

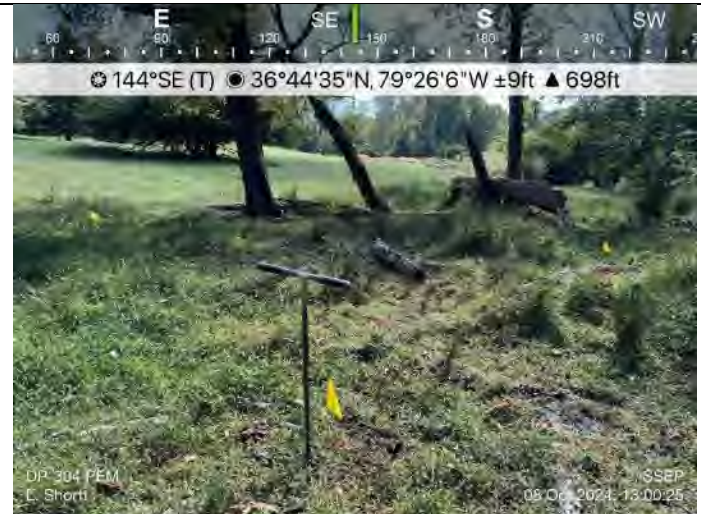
Photo 454:

Looking at Data Point #304, which characterizes a PEM wetland. This area contained all three wetland parameters. Attachment I; Sheet 16.

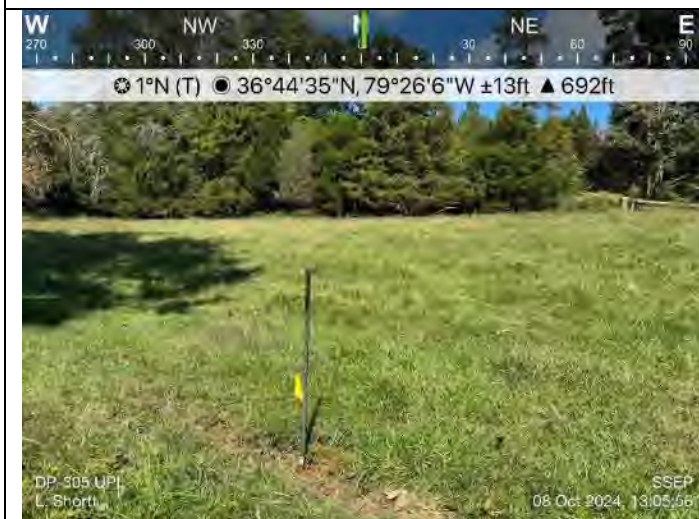
Photo 455:

Looking at Data Point #305, which characterizes an upland. This area lacked wetland hydrology, hydrophytic vegetation, and hydric soil. Attachment I; Sheet 16.

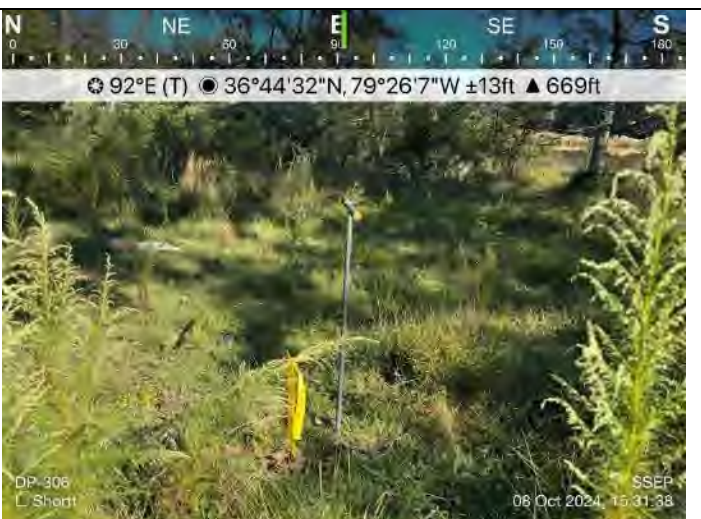
Photo 456:

Looking at Data Point #306, which characterizes a PEM wetland. This area contained all three wetland parameters. Attachment I; Sheet 16.

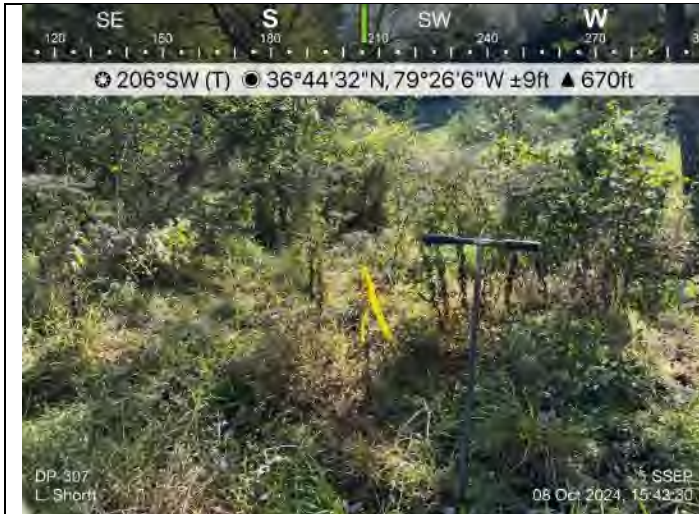
Photo 457:

Looking at Data Point #307, which characterizes a PFO wetland. This area contained all three wetland parameters. Attachment I; Sheet 16.

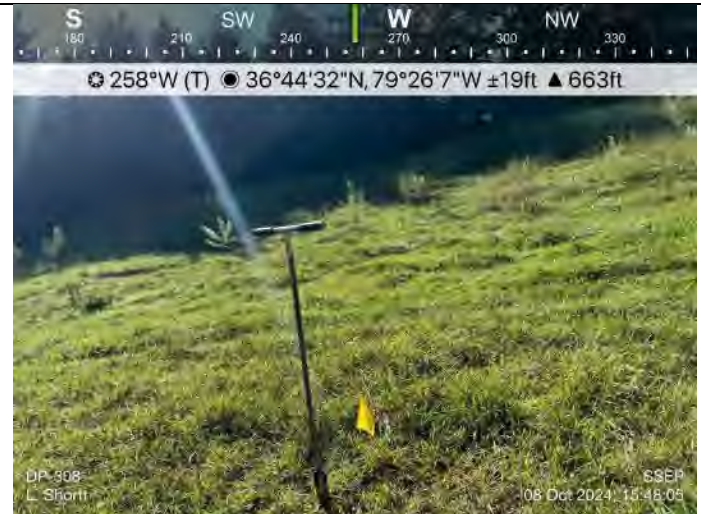
Photo 458:

Looking at Data Point #308, which characterizes an upland. This area lacked wetland hydrology, hydrophytic vegetation, and hydric soil. Attachment I; Sheet 16.

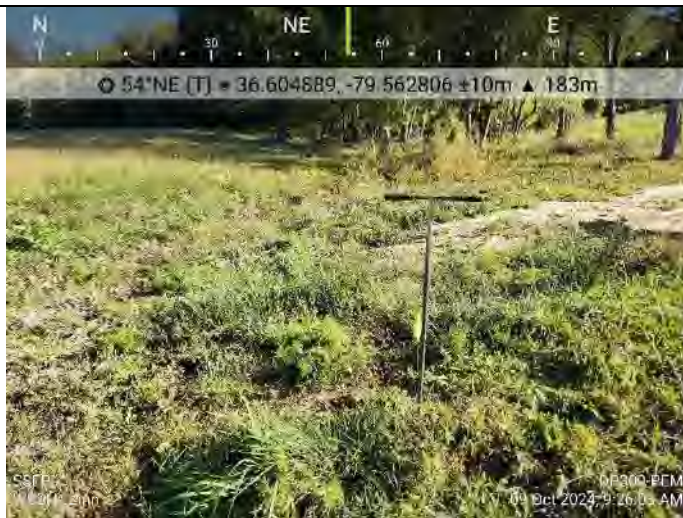
Photo 459:

Looking at Data Point #309, which characterizes a PEM wetland. This area contained all three wetland parameters. Attachment I; Sheet 6.

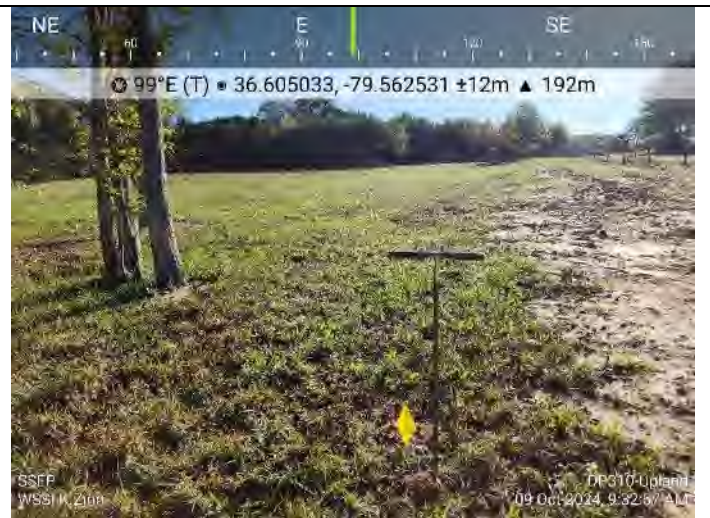
Photo 460:

Looking at Data Point #310, which characterizes an upland. This area lacked wetland hydrology, hydrophytic vegetation, and hydric soil. Attachment I; Sheet 6.

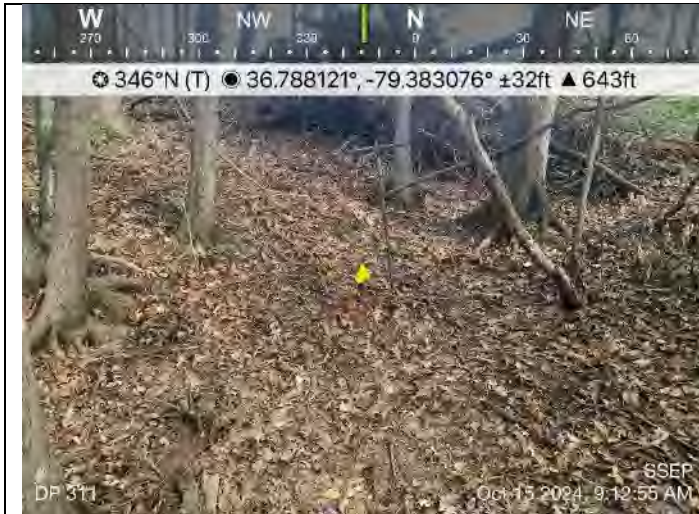
Photo 461:

Looking at Data Point #311, which characterizes a forested upland. This area lacked wetland hydrology and hydric soil. Attachment I; Sheet 20.

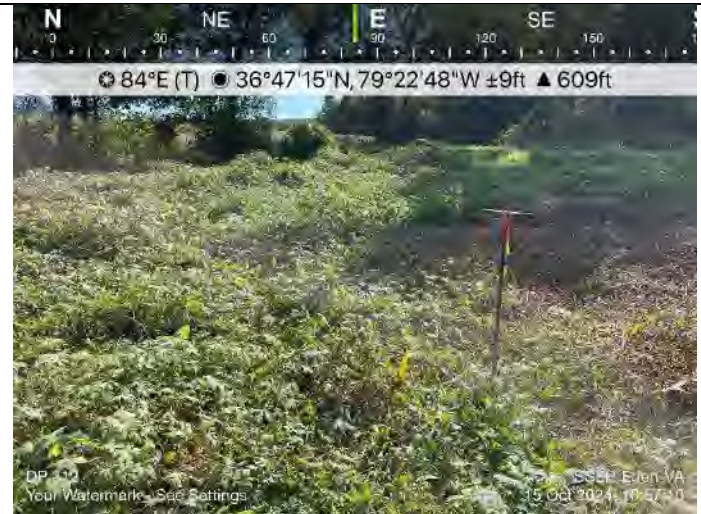
Photo 462:

Looking at Data Point #312, which characterizes an upland. This area lacked wetland hydrology, hydrophytic vegetation, and hydric soil. Attachment I; Sheet 20.

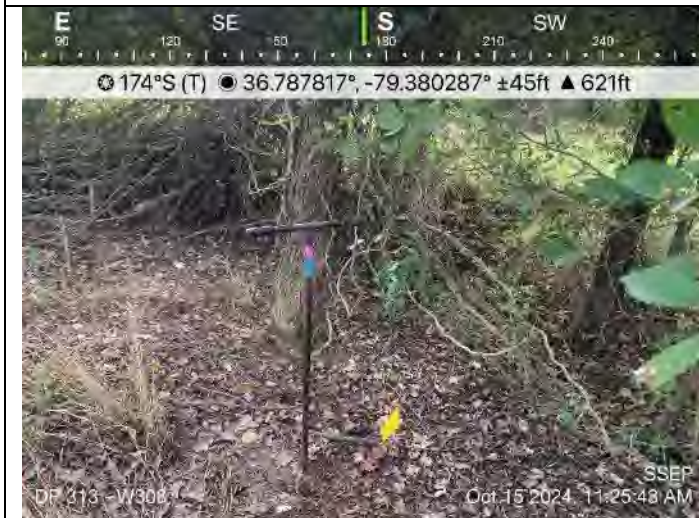
Photo 463:

Looking at Data Point #313, which characterizes a PFO wetland. This area contained all three wetland parameters. Attachment I; Sheet 20.

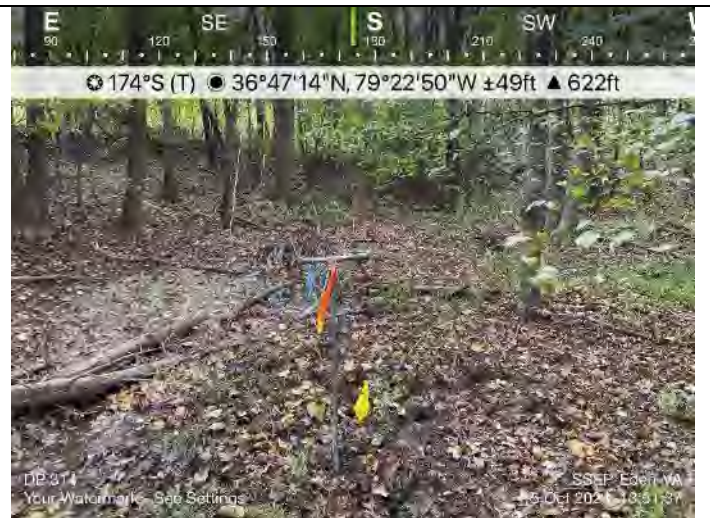
Photo 464:

Looking at Data Point #314, which characterizes a PFO wetland. This area contained all three wetland parameters. Attachment I; Sheet 20.

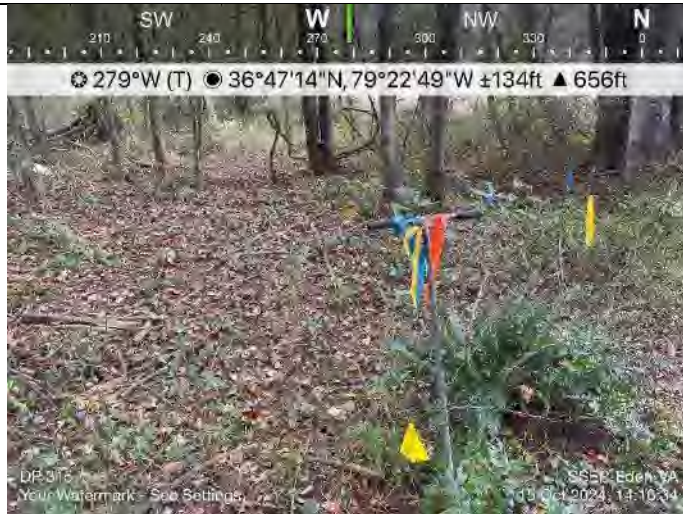
Photo 465:

Looking at Data Point #315, which characterizes a forested upland. This area lacked wetland hydrology and hydric soil. Attachment I; Sheet 20.

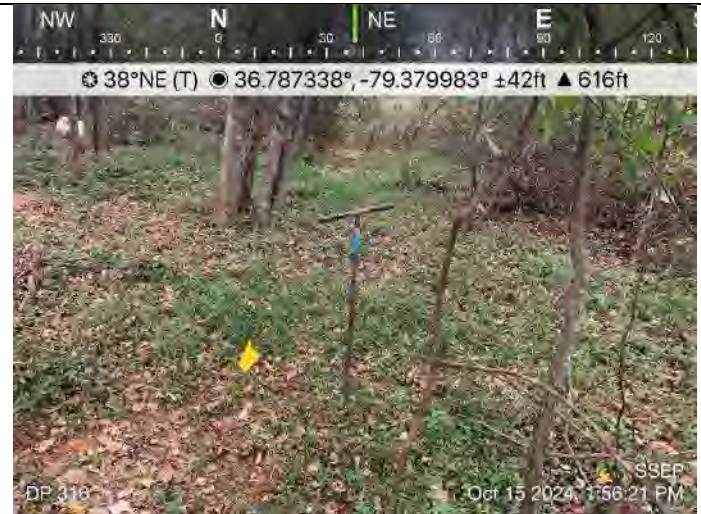
Photo 466:

Looking at Data Point #316, which characterizes a PFO wetland. This area contained all three wetland parameters. Attachment I; Sheet 20.

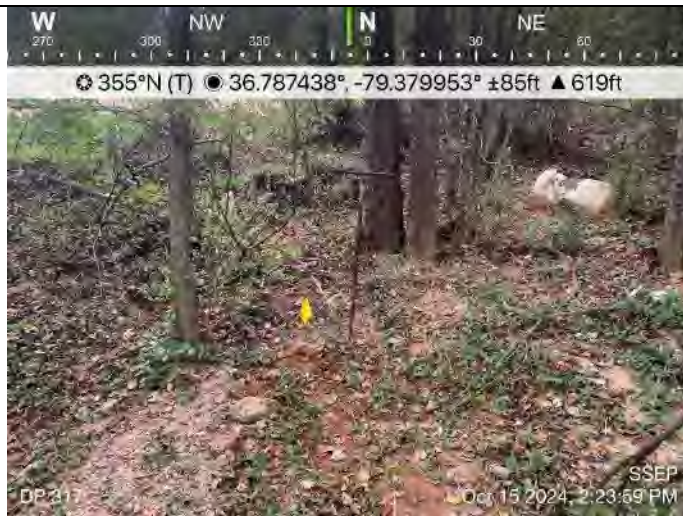
Photo 467:

Looking at Data Point #317, which characterizes a forested upland. This area lacked wetland hydrology and hydric soil. Attachment I; Sheet 20.

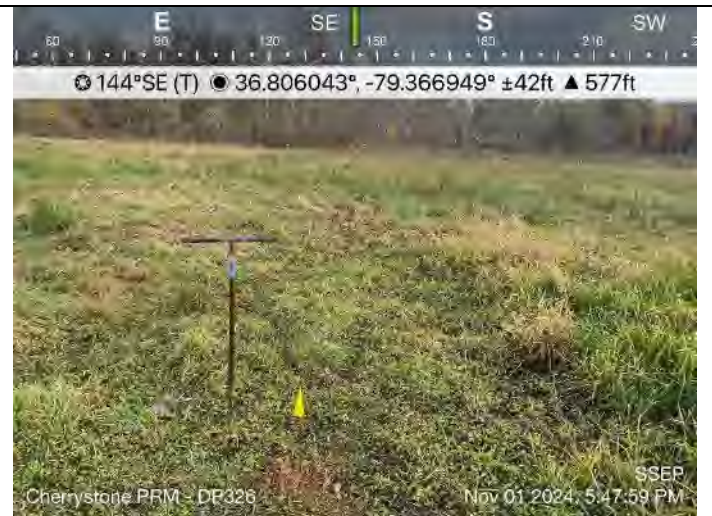
Photo 468:

Looking at Data Point #326, which characterizes a PEM wetland. This area contained all three wetland parameters. Attachment I; Sheet 21.

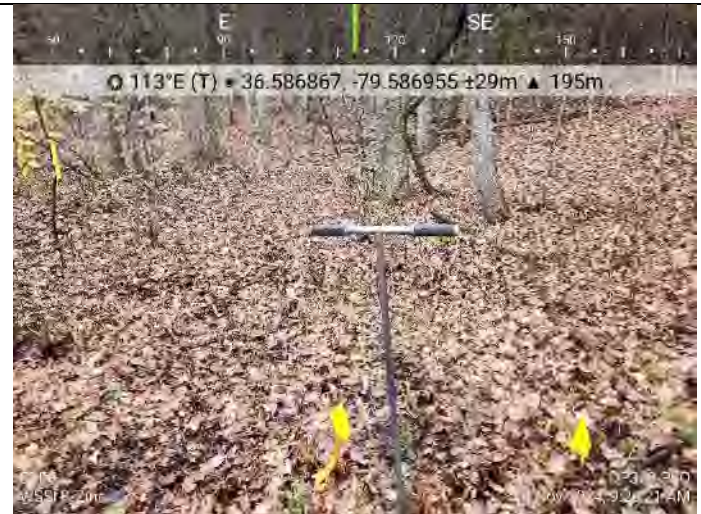
Photo 470:

Looking at Data Point #328, which characterizes a PFO wetland. This area contained all three wetland parameters. Attachment I; Sheet 5.

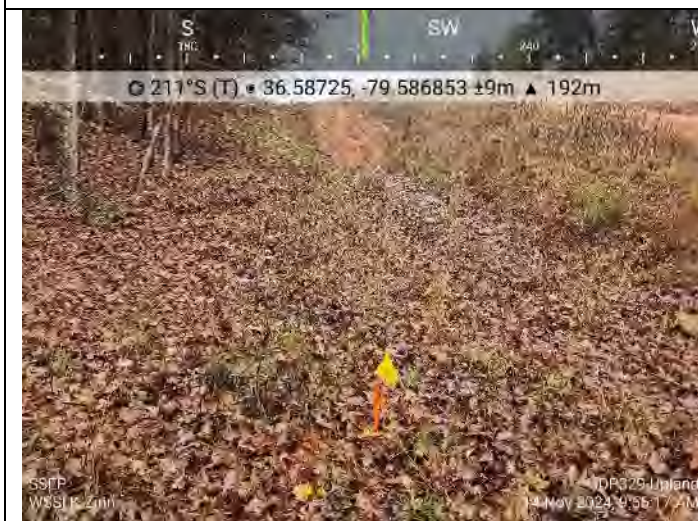
Photo 471:

Looking at Data Point #329, which characterizes an upland. This area lacked wetland hydrology and hydric soils. Attachment I; Sheet 5.

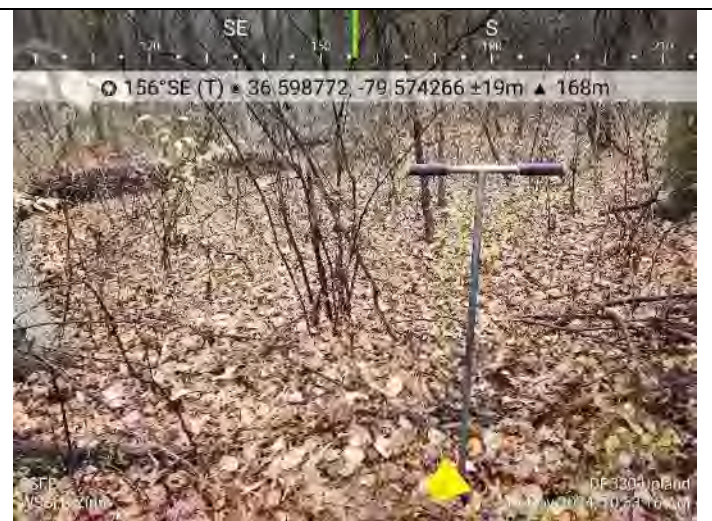
Photo 472:

Looking at Data Point #330, which characterizes a forested upland. This area lacked wetland hydrology and hydric soils. Attachment I; Sheet 6.

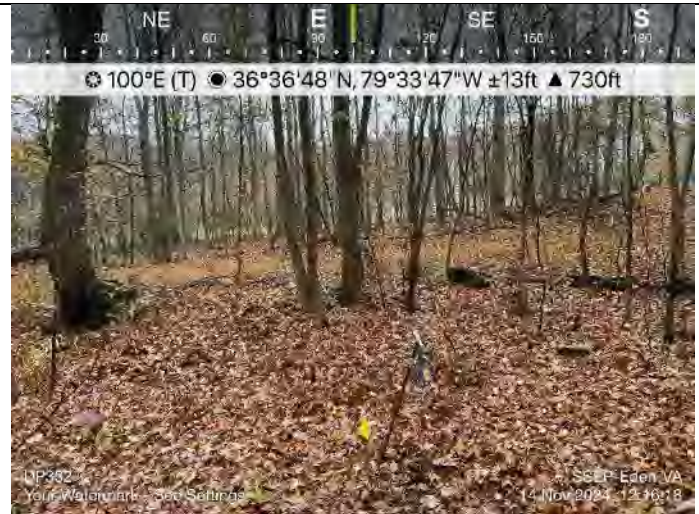
Photo 474:

Looking at Data Point #332, which characterizes a forested upland. This area lacked wetland hydrology and hydric soil. Attachment I; Sheet 7.

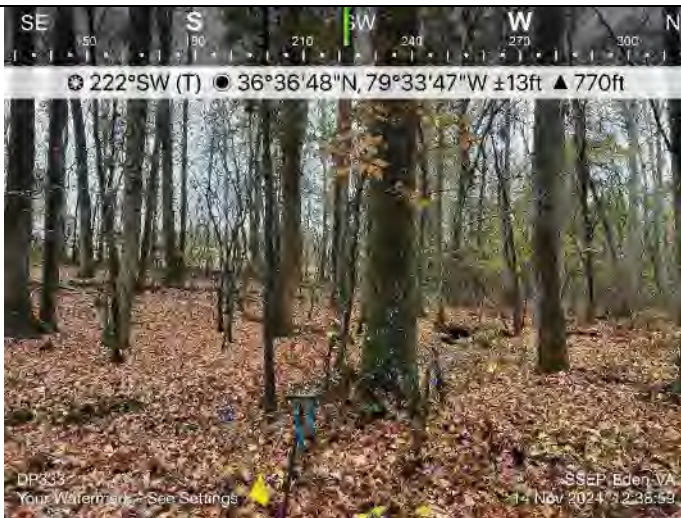
Photo 475:

Looking at Data Point #333, which characterizes a forested upland. This area lacked wetland hydrology, hydrophytic vegetation, and hydric soil. Attachment I; Sheet 7.

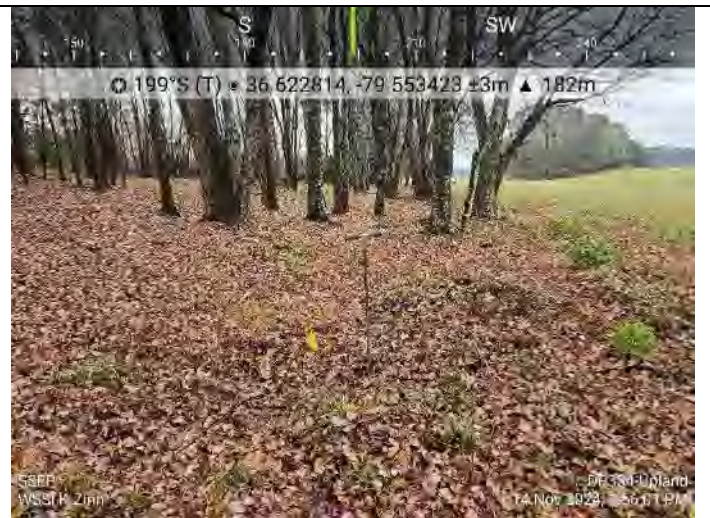
Photo 476:

Looking at Data Point #334, which characterizes a forested upland. This area lacked wetland hydrology. Attachment I; Sheet 7.

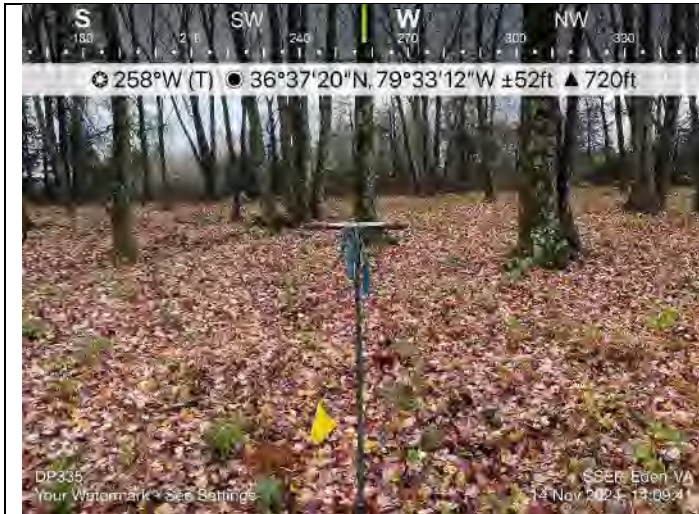
Photo 477:

Looking at Data Point #335, which characterizes a forested upland. This area lacked wetland hydrology and hydric soils. Attachment I; Sheet 7.

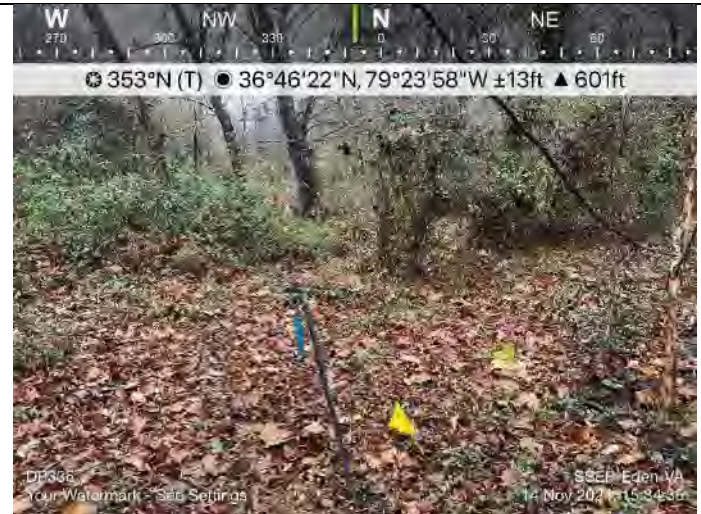
Photo 478:

Looking at Data Point #336, which characterizes a forested upland. This area lacked wetland hydrology, hydrophytic vegetation, and hydric soils. Attachment I; Sheet 18.
