EXHIBIT 14 - PHOTOGRAPHS

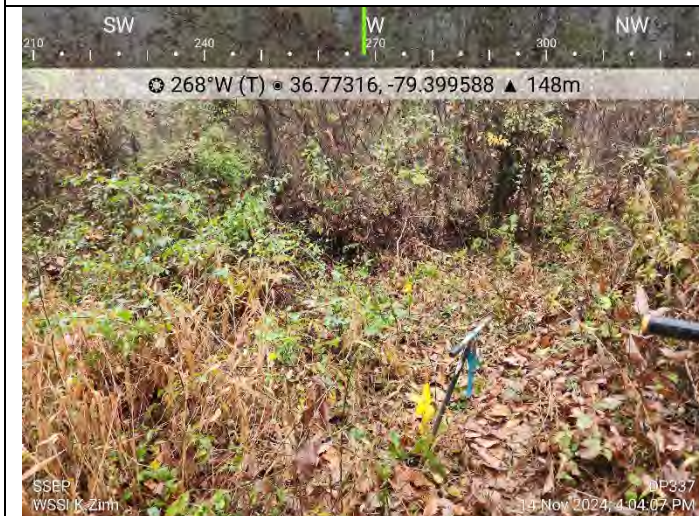
Photo 479:

Looking at Data Point #337, which characterizes a PFO wetland. This area contained all three wetland parameters. Attachment I; Sheet 18.

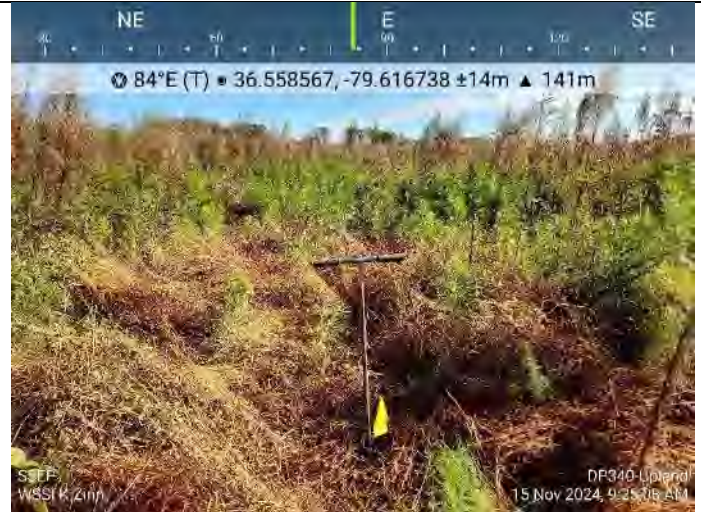
Photo 482:

Looking at Data Point #340, which characterizes an upland. This area lacked wetland hydrology and hydric soil. Attachment I; Sheet 3.

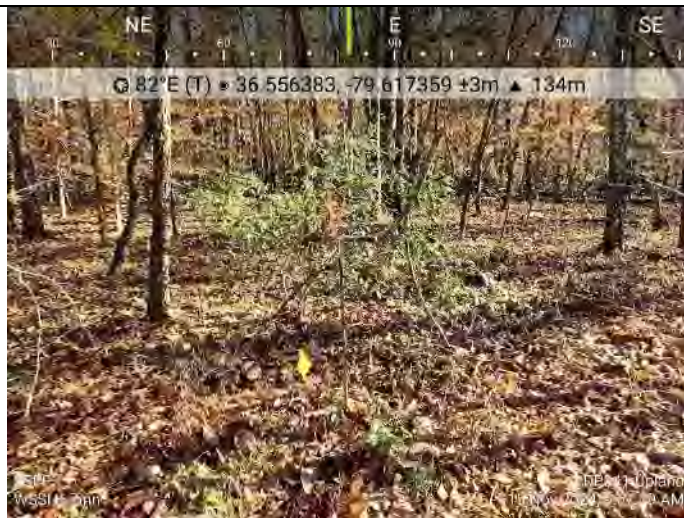
Photo 483:

Looking at Data Point #341, which characterizes a forested upland. This area lacked wetland hydrology, hydrophytic vegetation, and hydric soil. Attachment I; Sheet 3.

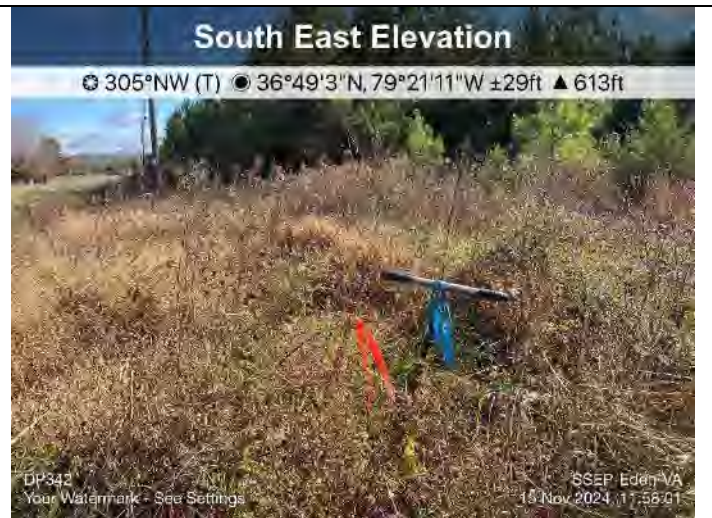
Photo 484:

Looking at Data Point #342, which characterizes an upland. This area lacked wetland hydrology and hydric soil. Attachment I; Sheet 22.

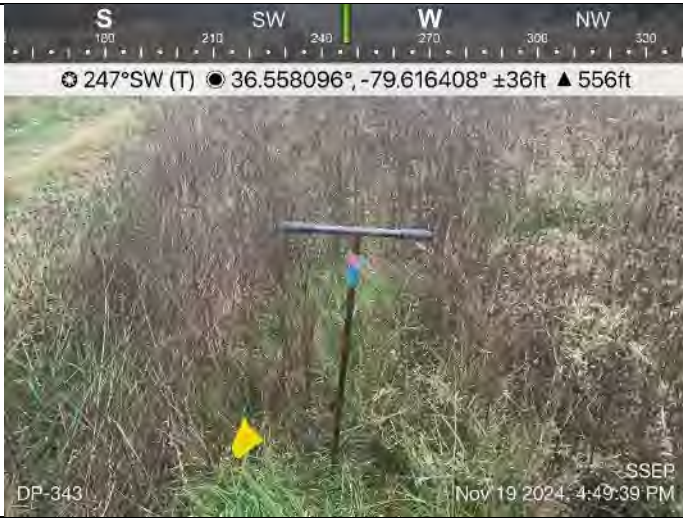
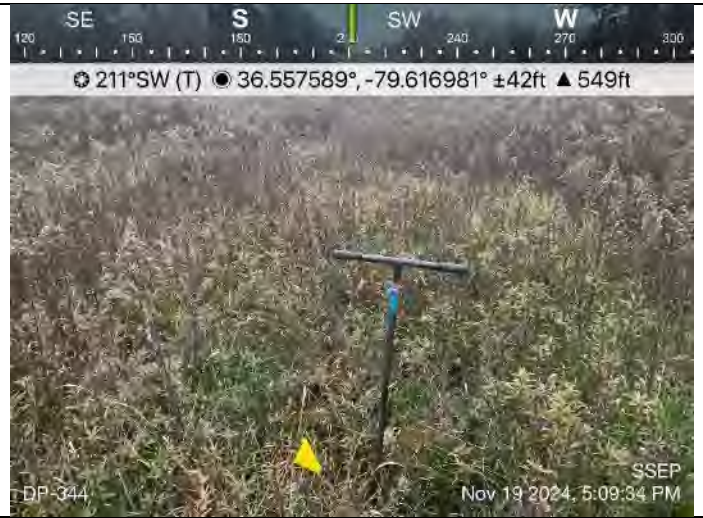
<p>Photo 485:</p> <p>Looking at Data Point #343, which characterizes an upland. This area lacked wetland hydrology, hydrophytic vegetation, and hydric soil. Attachment I; Sheet 3.</p>	<p>Photo 486:</p> <p>Looking at Data Point #344, which characterizes an upland. This area lacked wetland hydrology, hydrophytic vegetation, and hydric soil. Attachment I; Sheet 3.</p>

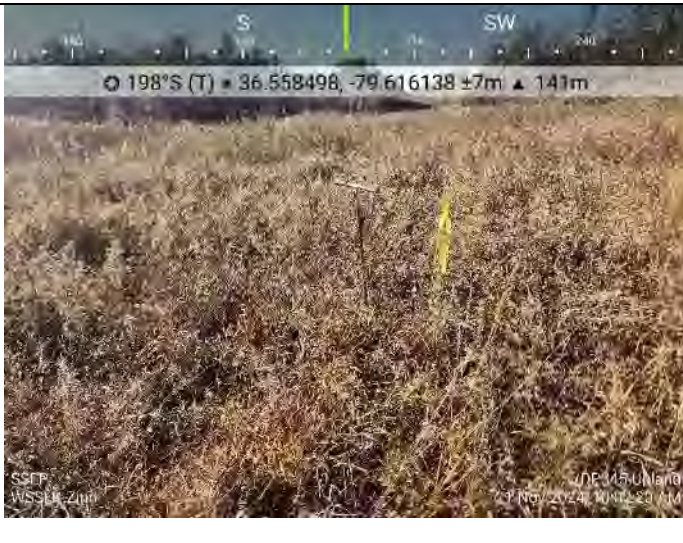
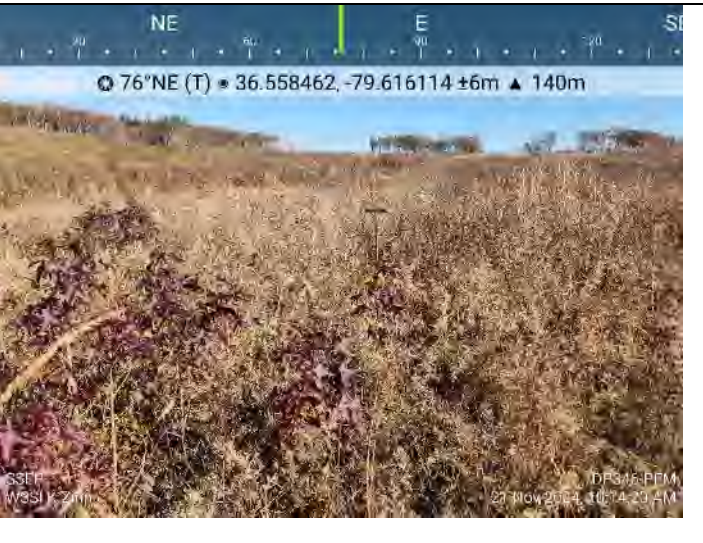
<p>Photo 487:</p> <p>Looking at Data Point #345, which characterizes an upland. This area lacked wetland hydrology, hydrophytic vegetation, and hydric soil. Attachment I; Sheet 3.</p>	<p>Photo 488:</p> <p>Looking at Data Point #346, which characterizes a PEM wetland. This area contained all three wetland parameters. Attachment I; Sheet 3.</p>

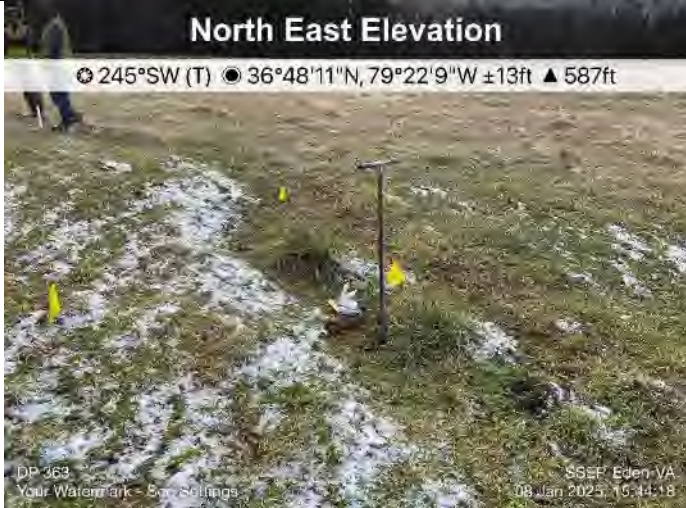
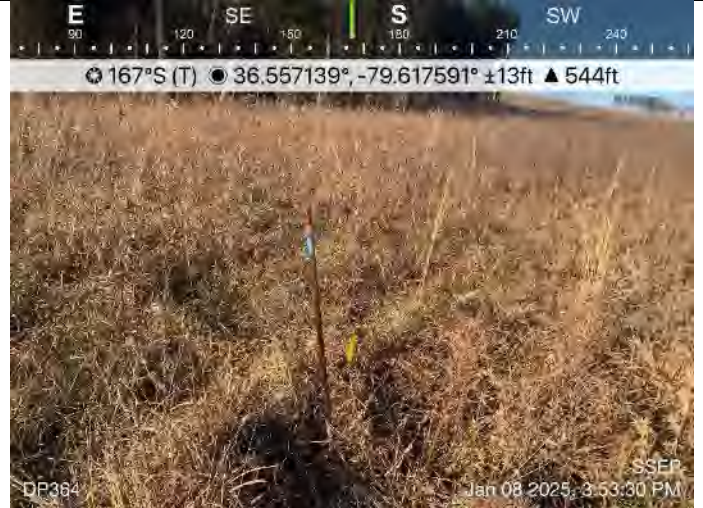
<p>North East Elevation 245°SW (T) 36°48'11"N, 79°22'9"W ±13ft ▲ 587ft DP 363 SSEP Eden VA 08 Jan 2025, 15:44:18</p>

<p>South East Elevation 167°S (T) 36.557139°, -79.617591° ±13ft ▲ 544ft DP364 SSEP Eden VA Jan 08 2025, 3:53:30 PM</p>
<p>Photo 505: Looking at Data Point #363, which characterizes a PEM wetland. This area contained all three wetland parameters. Attachment I; Sheet 21.</p>	<p>Photo 506: Looking at Data Point #364, which characterizes an upland. This area lacked wetland hydrology, hydrophytic vegetation, and hydric soil. Attachment I; Sheet 3.</p>

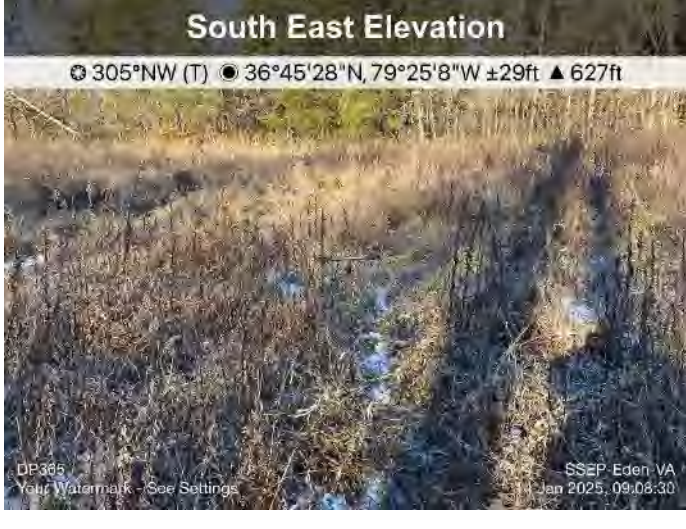
<p>South East Elevation 305°NW (T) 36°45'28"N, 79°25'8"W ±29ft ▲ 627ft DP365 SSEP Eden VA Jan 2025, 09:08:30</p>

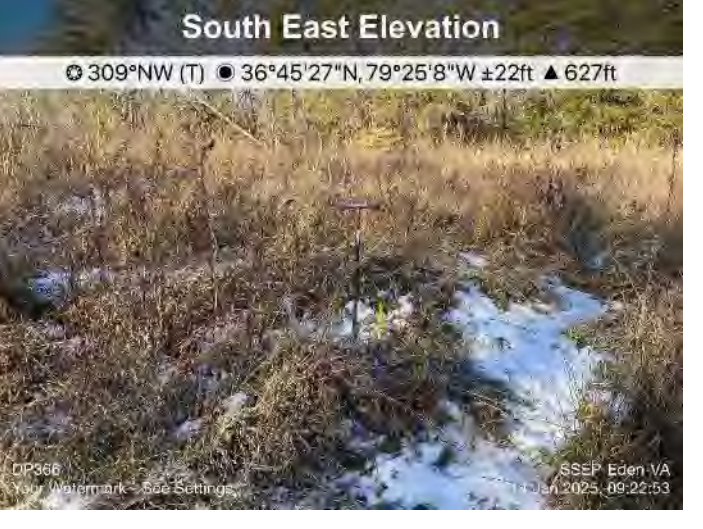
<p>South East Elevation 309°NW (T) 36°45'27"N, 79°25'8"W ±22ft ▲ 627ft DP366 SSEP Eden VA Jan 2025, 09:22:53</p>
<p>Photo 507: Looking at Data Point #365, which characterizes an upland. This area lacked wetland hydrology. Attachment I; Sheet 17.</p>	<p>Photo 508: Looking at Data Point #366, which characterizes an upland. This area lacked wetland hydrology and hydric soil. Attachment I; Sheet 17.</p>

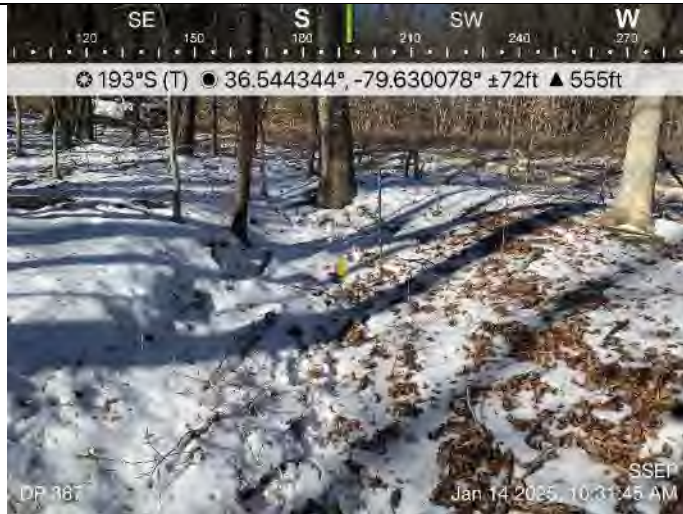
Photo 509:

Looking at Data Point #367, which characterizes a forested upland. This area lacked wetland hydrology, hydrophytic vegetation, and hydric soil. Attachment I; Sheet 2.

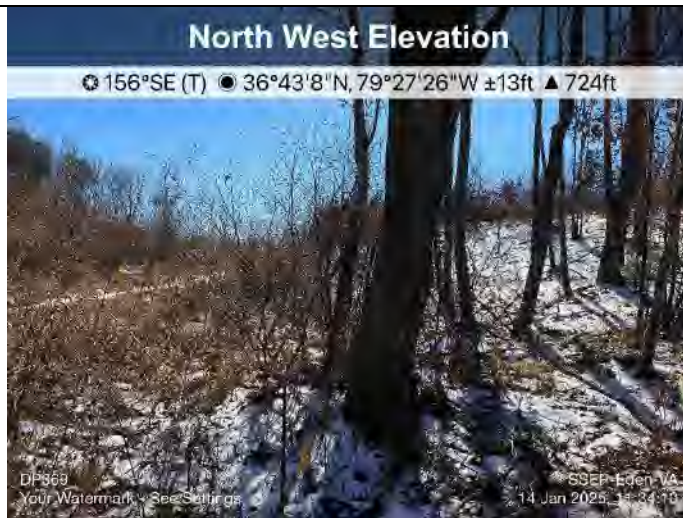
Photo 511:

Looking at Data Point #369, which characterizes a PFO wetland. This area contained all three wetland parameters. Attachment I; Sheet 14.

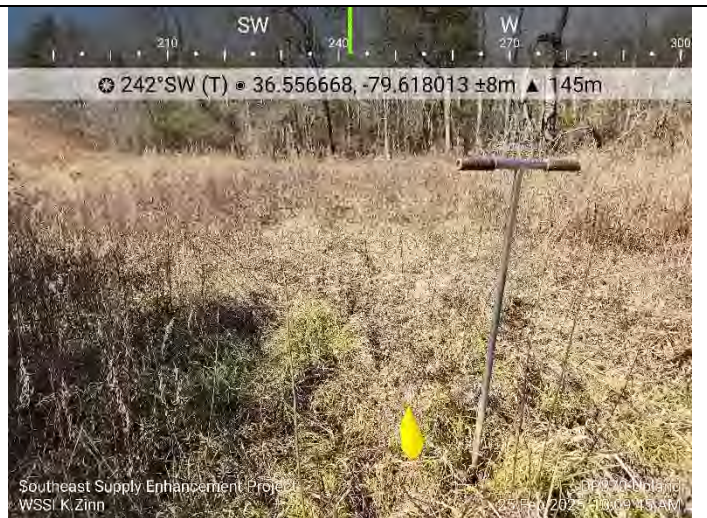
Photo 512:

Looking at Data Point #370, which characterizes an upland. This area lacked wetland hydrology, hydrophytic vegetation, and hydric soil. Attachment I; Sheet 3.

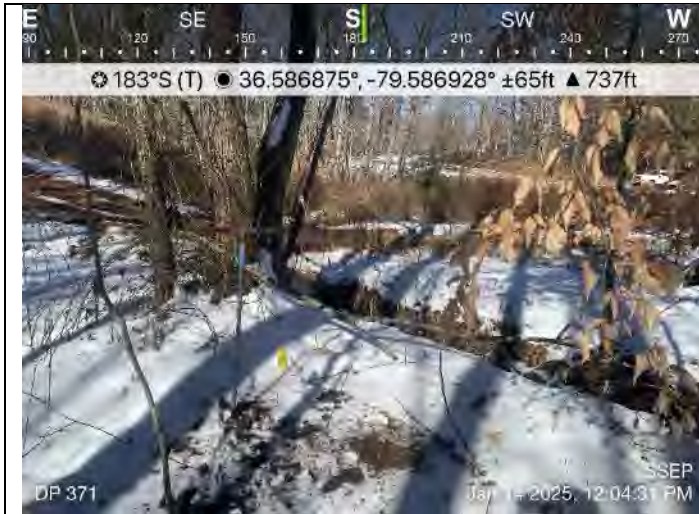
Photo 513:

Looking at Data Point #371, which characterizes a forested upland. This area lacked wetland hydrology and hydric soil. Attachment I; Sheet 5.

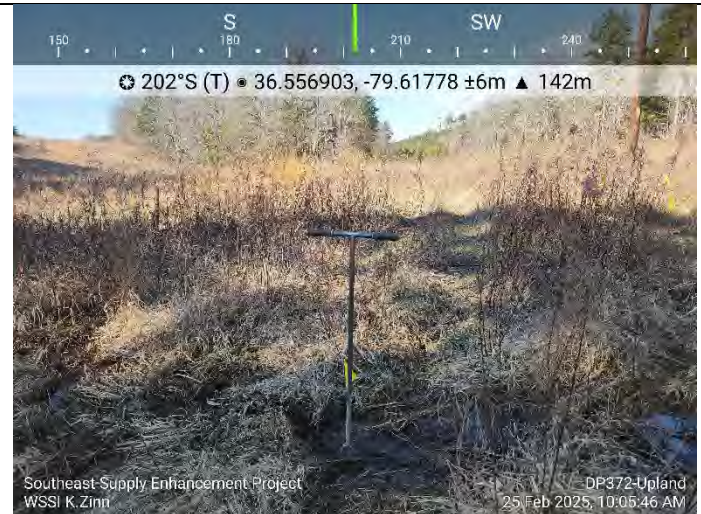
Photo 514:

Looking at Data Point #372, which characterizes an upland. This area lacked wetland hydrology, hydrophytic vegetation, and hydric soil. Attachment I; Sheet 3.

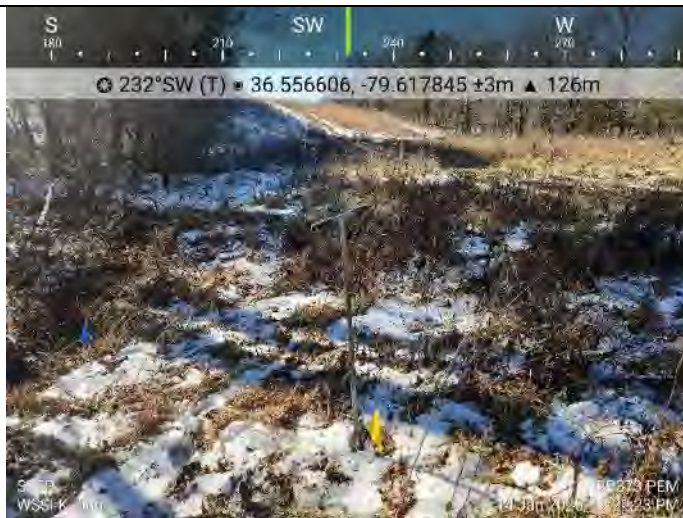
Photo 515:

Looking at Data Point #373, which characterizes a PEM wetland. This area contained all three wetland parameters. Attachment I; Sheet 3.

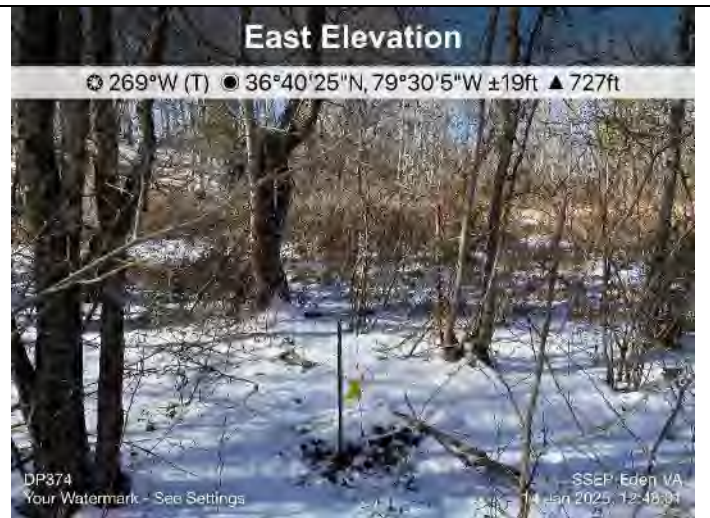
Photo 516:

Looking at Data Point #374, which characterizes a forested upland. This area lacked wetland hydrology and hydric soil. Attachment I; Sheet 11.

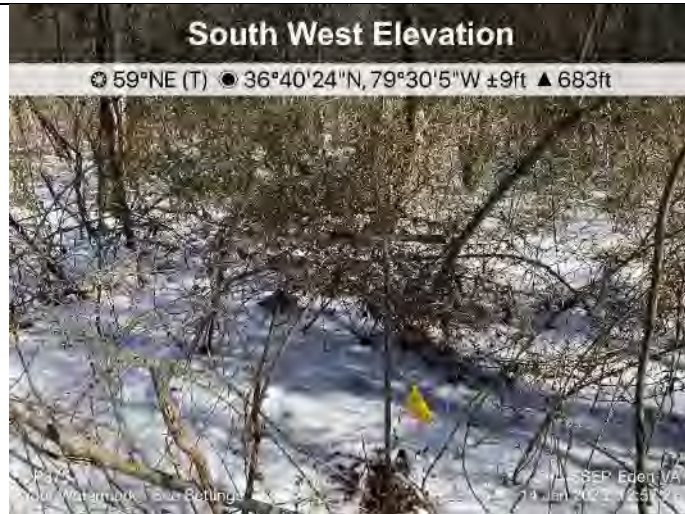
Photo 517:

Looking at Data Point #375, which characterizes a forested upland. This area lacked wetland hydrology and hydric soil. Attachment I; Sheet 11.

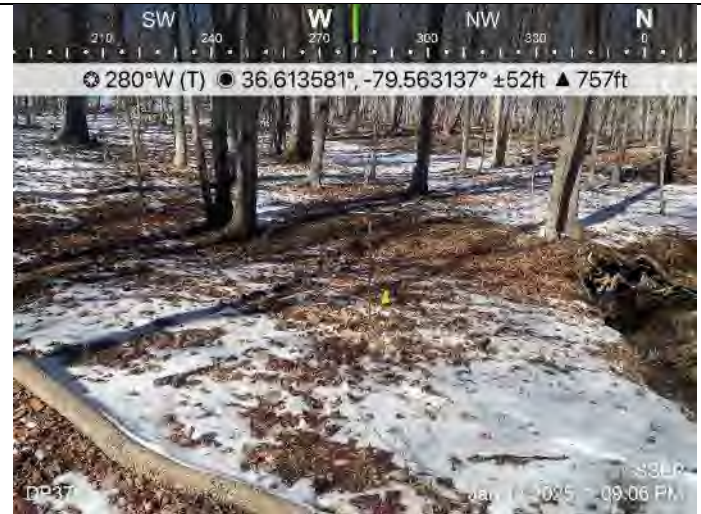
Photo 518:

Looking at Data Point #376, which characterizes a forested upland. This area lacked wetland hydrology and hydric soil. Attachment I; Sheet 7.

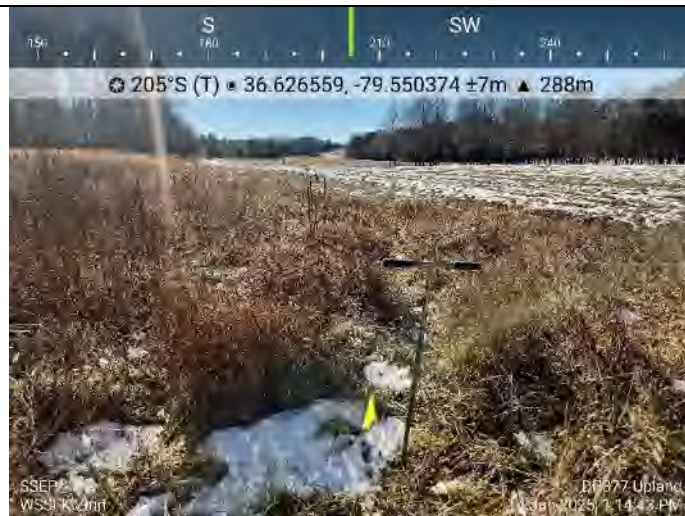
Photo 519:

Looking at Data Point #377, which characterizes an upland. This area lacked wetland hydrology, and hydric soil. Attachment I; Sheet 8.

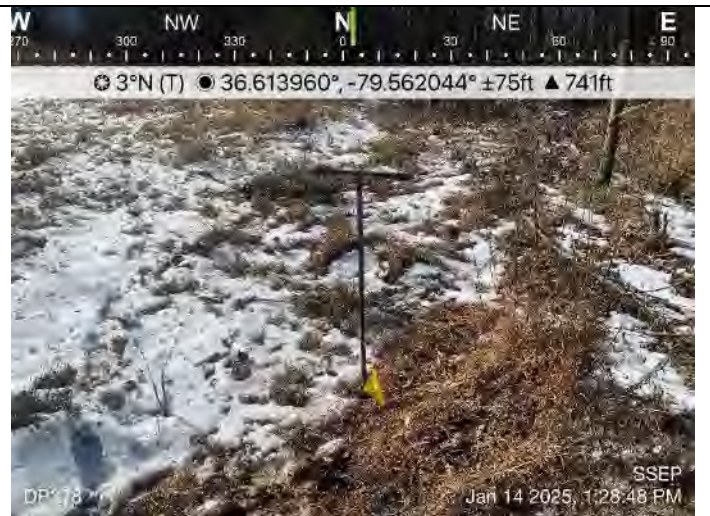
Photo 520:

Looking at Data Point #378, which characterizes an upland. This area lacked hydric soil. Attachment I; Sheet 7.

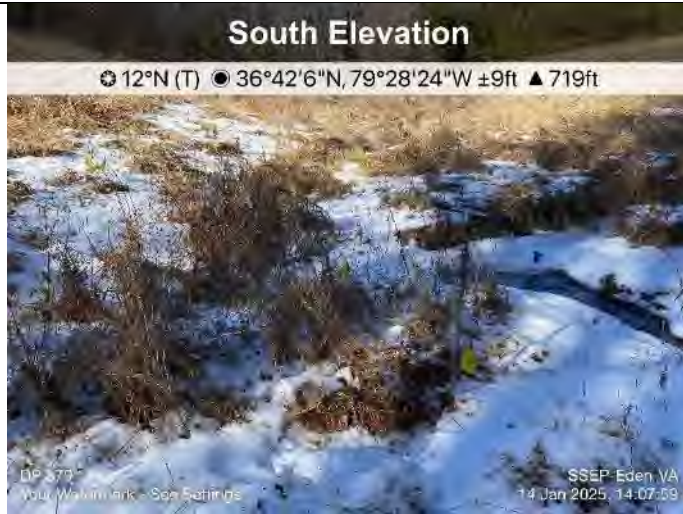
Photo 521:
 Looking at Data Point #379, which characterizes a PEM wetland. This area contained all three wetland parameters. Attachment I; Sheet 13.

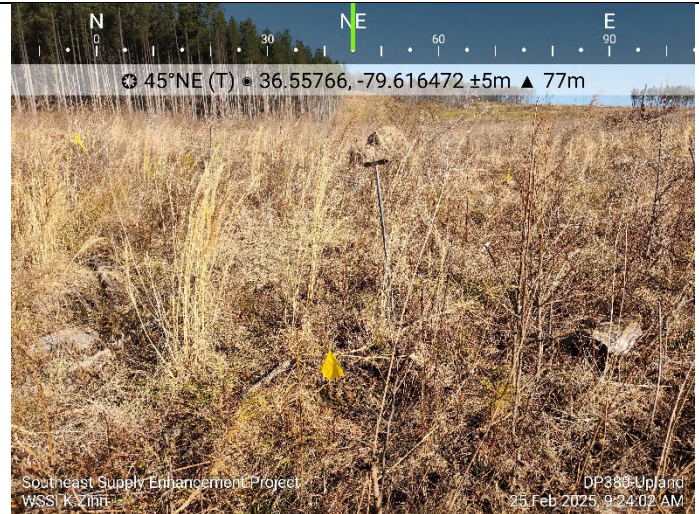
Photo 522:
 Looking at Data Point #380, which characterizes an upland. This area lacked wetland hydrology, hydrophytic vegetation, and hydric soil. Attachment I; Sheet 3.

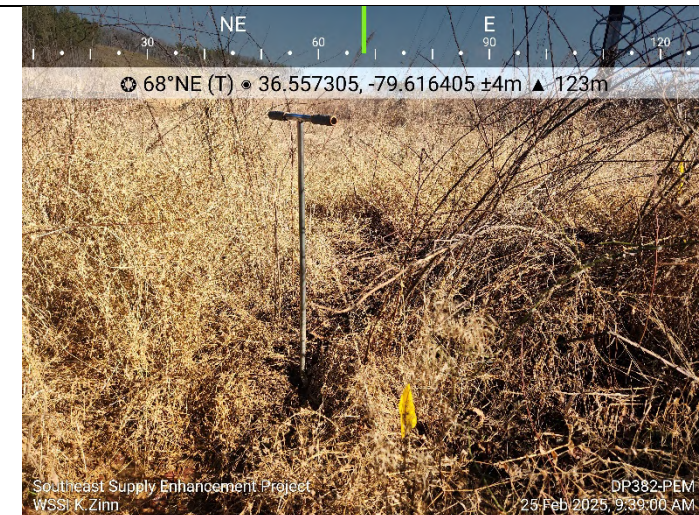
Photo 524:
 Looking at Data Point #382, which characterizes a PEM wetland. This area contained all three wetland parameters. Attachment I; Sheet 3.

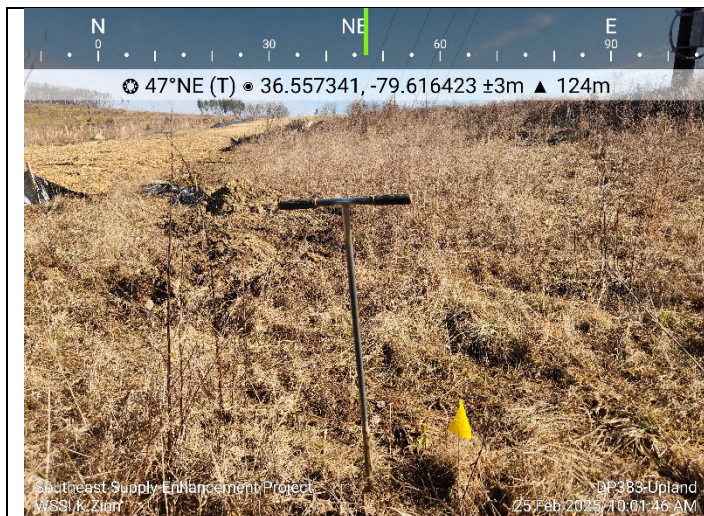
Photo 525:

Looking at Data Point #383, which characterizes an upland. This area lacked wetland hydrology, hydrophytic vegetation, and hydric soil. Attachment I; Sheet 3.

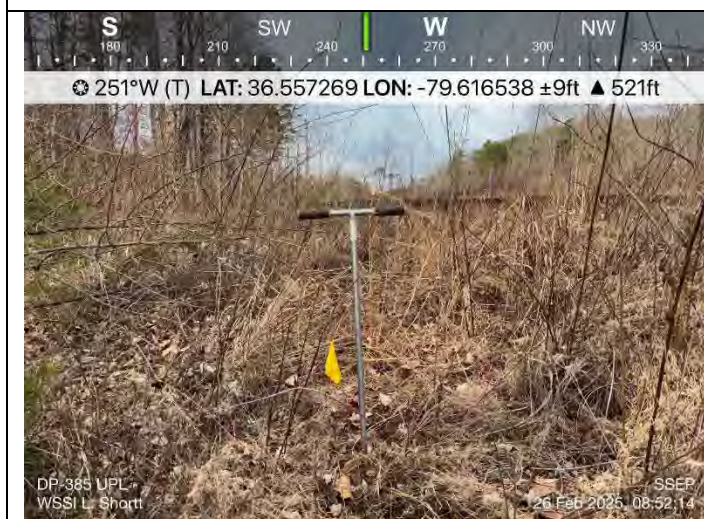
Photo 527:

Looking at Data Point #385, which characterizes an upland. This area lacked wetland hydrology and hydrophytic vegetation. Attachment I; Sheet 3.

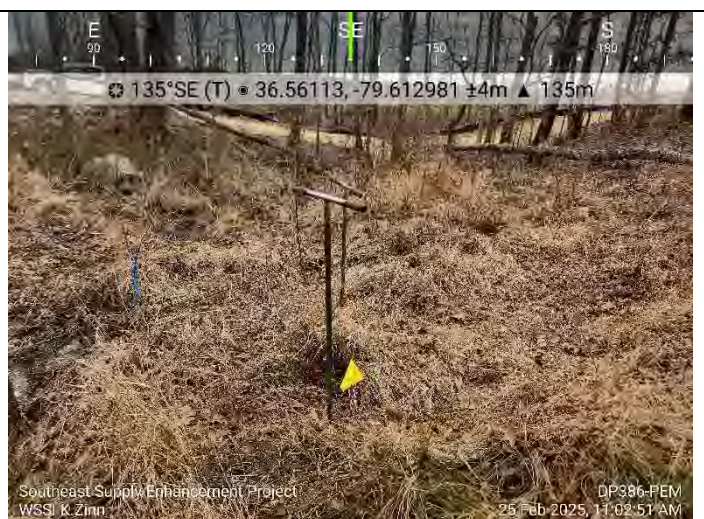
Photo 528:

Looking at Data Point #386, which characterizes a PEM wetland. This area contained all three wetland parameters. Attachment I; Sheet 3.

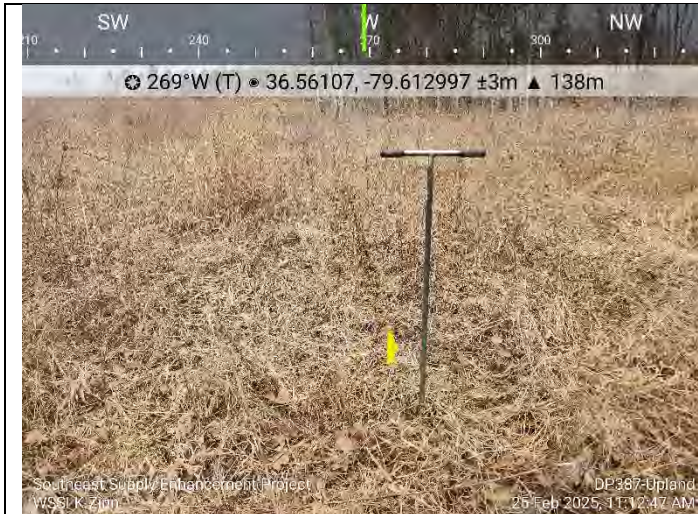
Photo 529:

Looking at Data Point #387, which characterizes an upland. This area lacked wetland hydrology, hydrophytic vegetation, and hydric soil. Attachment I; Sheet 3.

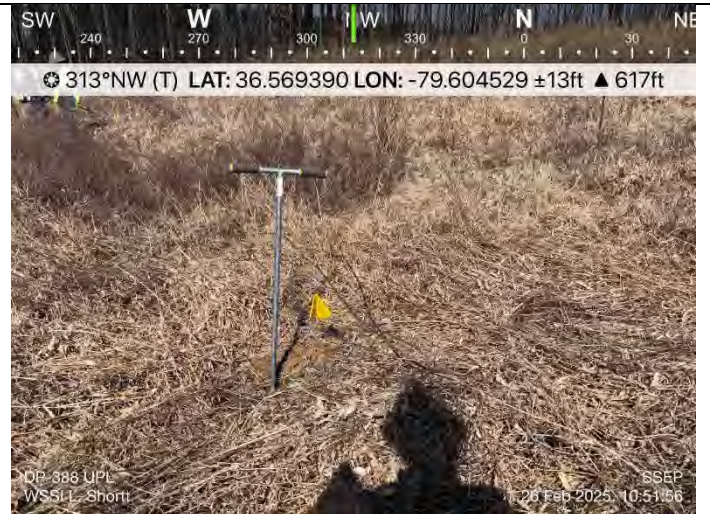
Photo 530:

Looking at Data Point #388, which characterizes an upland. This area lacked wetland hydrology and hydric soil. Attachment I; Sheet 4.

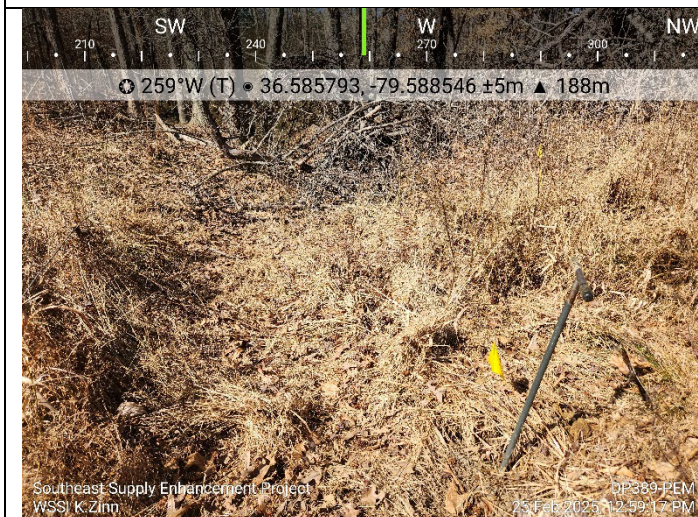
Photo 531:

Looking at Data Point #389 which characterizes a PEM wetland. This area contained all three wetland parameters. Attachment I; Sheet 5.

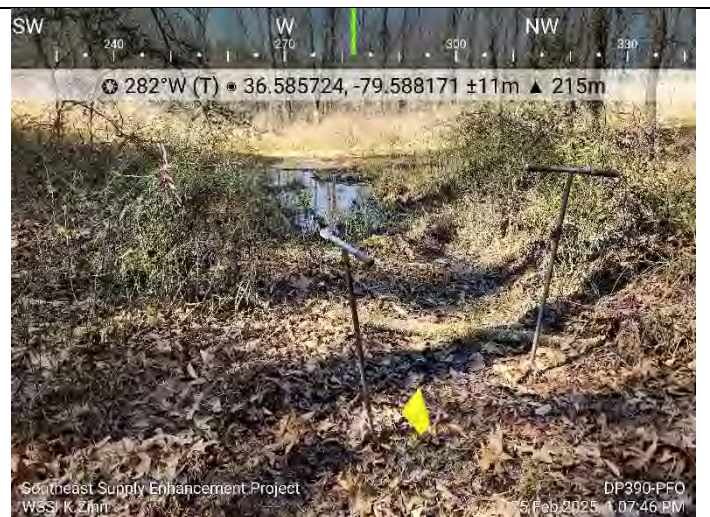
Photo 532:

Looking at Data Point #390, which characterizes a PFO wetland. This area contained all three wetland parameters. Attachment I; Sheet 5.

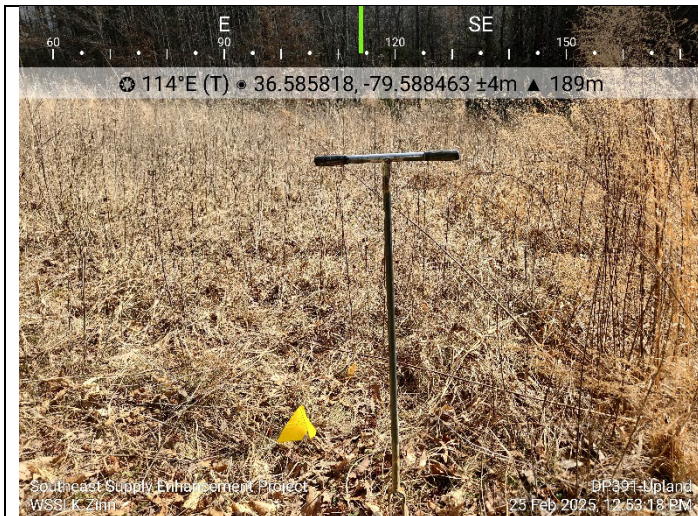
Photo 533:

Looking at Data Point #391, which characterizes an upland. This area lacked wetland hydrology, hydrophytic vegetation, and hydric soil. Attachment I; Sheet 5.

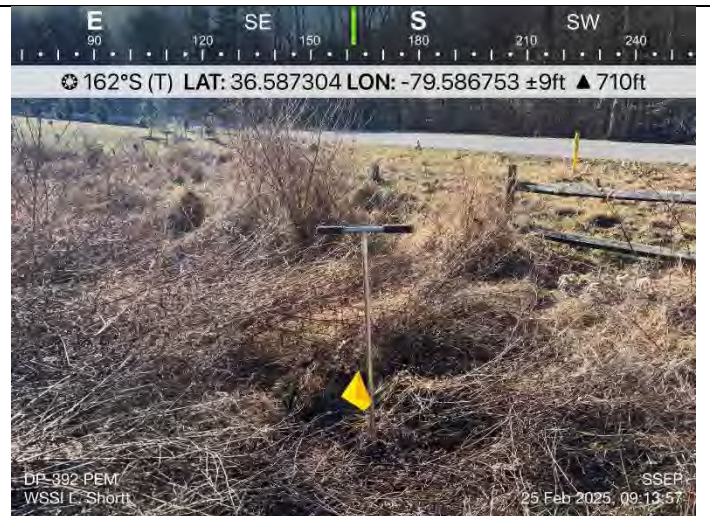
Photo 534:

Looking at Data Point #392, which characterizes a PEM wetland. This area contained all three wetland parameters. Attachment I; Sheet 5.

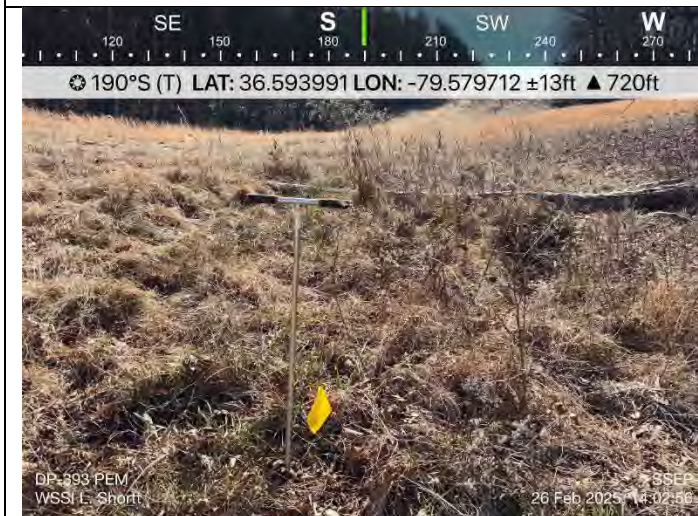
Photo 535:

Looking at Data Point #393, which characterizes a PEM wetland. This area contained all three wetland parameters. Attachment I; Sheet 5.

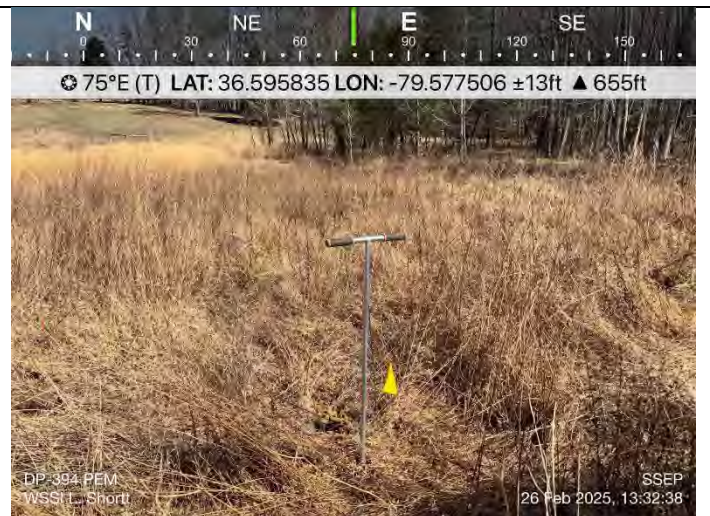
Photo 536:

Looking at Data Point #394, which characterizes a PEM wetland. This area contained all three wetland parameters. Attachment I; Sheet 5.

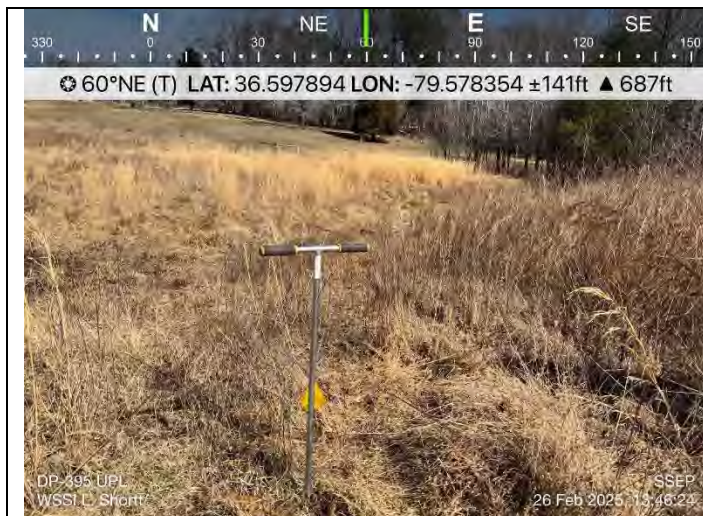
Photo 537:

Looking at Data Point #395, which characterizes an upland. This area lacked wetland hydrology and hydric soil. Attachment I; Sheet 5.

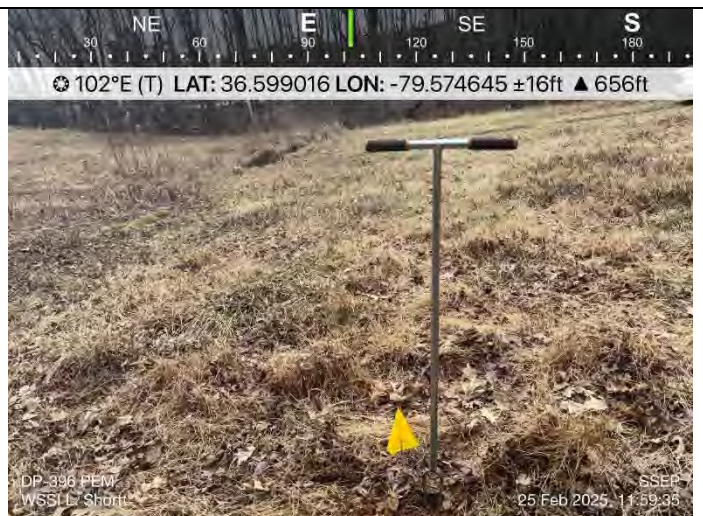
Photo 538:

Looking at Data Point #396, which characterizes a PEM wetland. This area contained all three wetland parameters. Attachment I; Sheet 6.

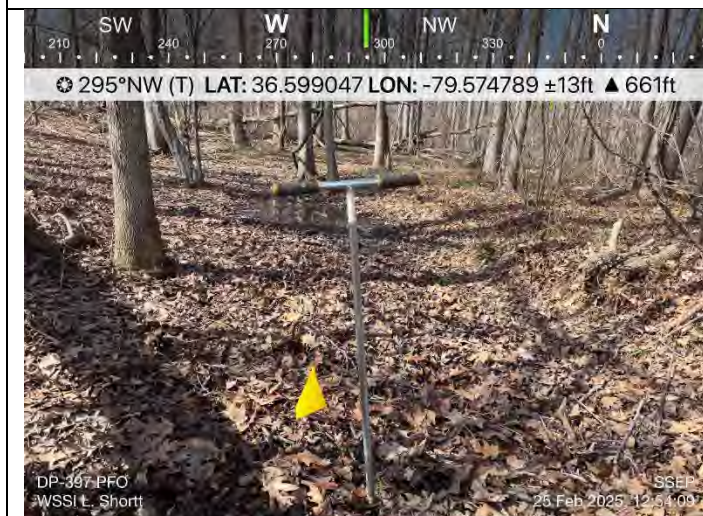
Photo 539:

Looking at Data Point #397, which characterizes a PFO wetland. This area contained all three wetland parameters. Attachment I; Sheet 6.

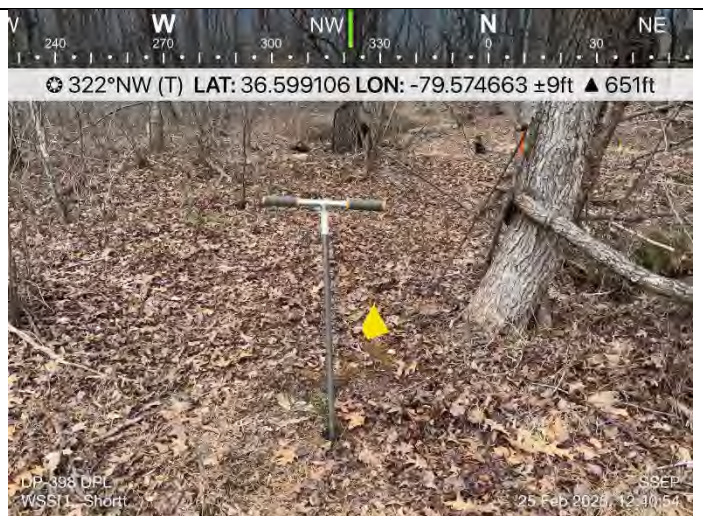
Photo 540:

Looking at Data Point #398, which characterizes a forested upland. This area lacked wetland hydrology and hydric soil. Attachment I; Sheet 6.

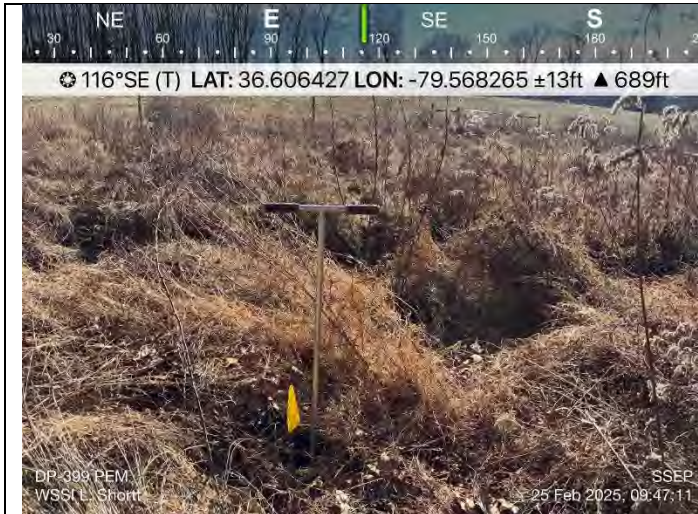
Photo 541:

Looking at Data Point #399, which characterizes a PEM wetland. This area contained all three wetland parameters. Attachment I; Sheet 6.

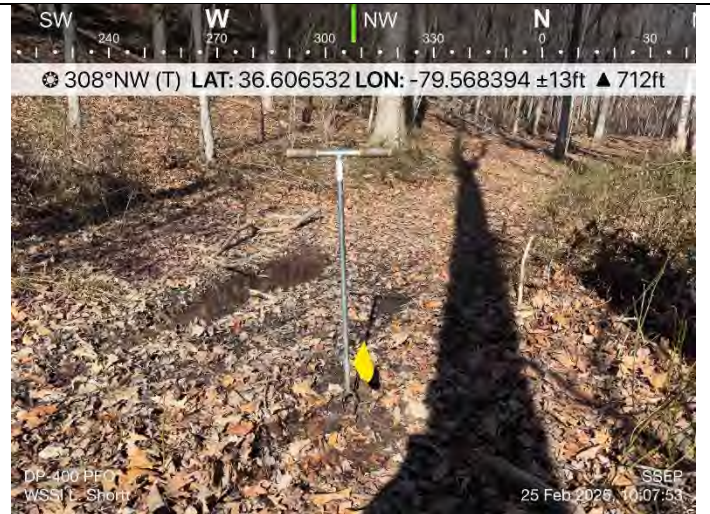
Photo 542:

Looking at Data Point #400, which characterizes a PFO wetland. This area contained all three wetland parameters. Attachment I; Sheet 6.

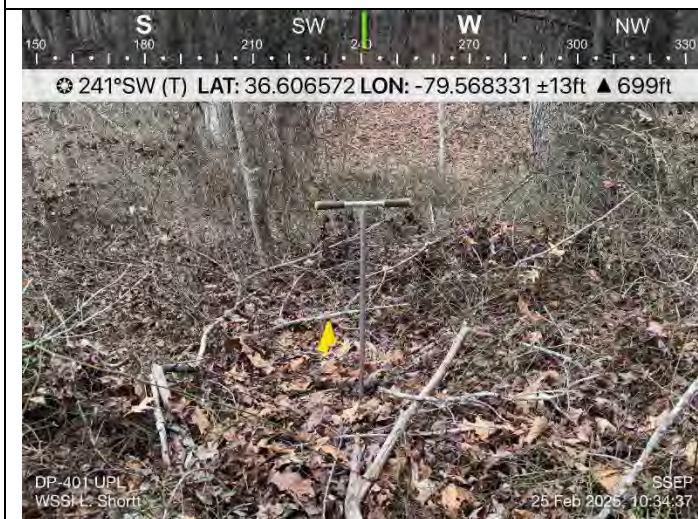
Photo 543:

Looking at Data Point #401, which characterizes a forested upland. This area lacked wetland hydrology and hydric soil. Attachment I; Sheet 6.

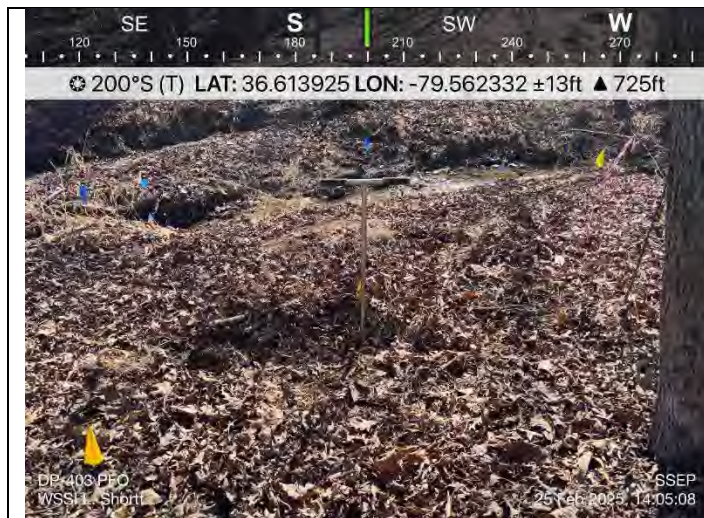
Photo 545:

Looking at Data Point #403, which characterizes a PFO wetland. This area contained all three wetland parameters. Attachment I; Sheet 7.

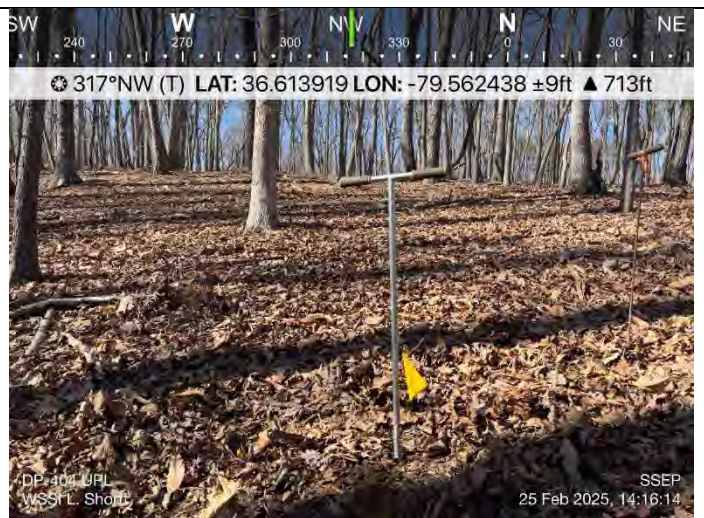
Photo 546:

Looking at Data Point #404, which characterizes a forested upland. This area lacked wetland hydrology and hydric soil. Attachment I; Sheet 7.

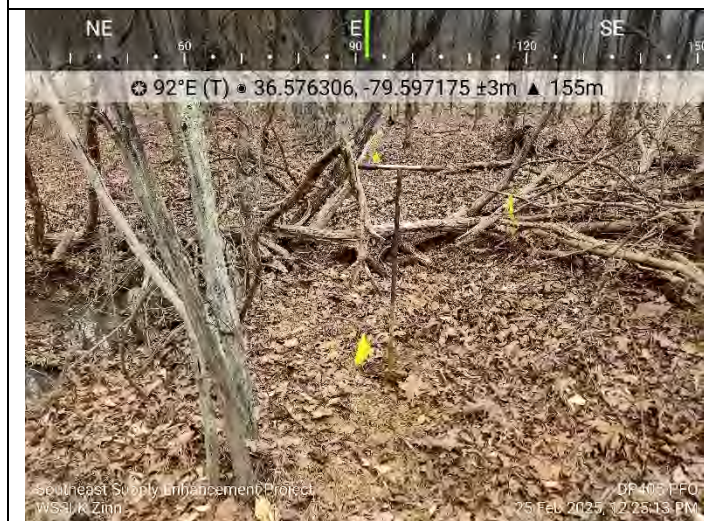
Photo 547:

Looking at Data Point #405, which characterizes a PFO wetland. This area contained all three wetland parameters. Attachment I; Sheet 4.

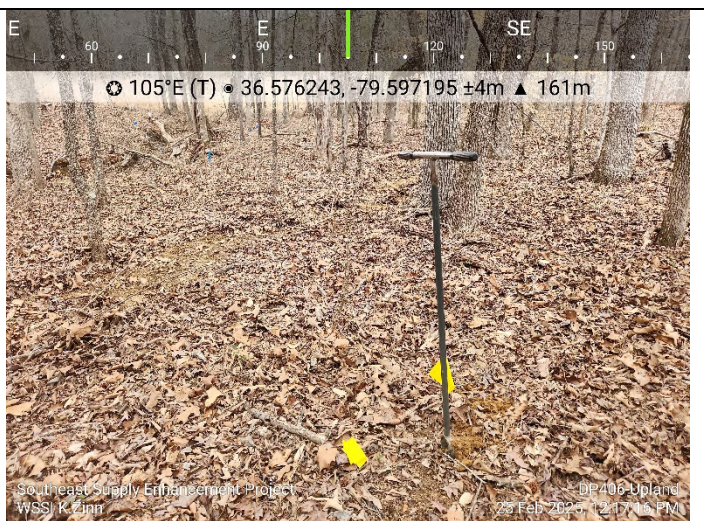
Photo 548:

Looking at Data Point #406, which characterizes a forested upland. This area lacked wetland hydrology and hydric soil. Attachment I; Sheet 4.

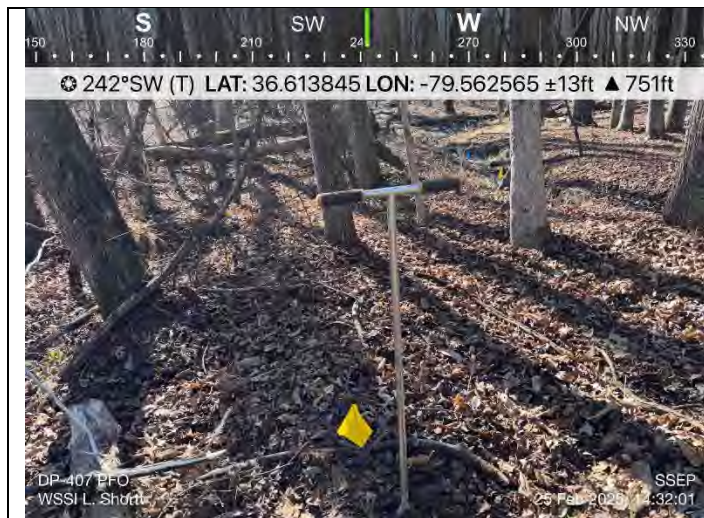
Photo 549:

Looking at Data Point #407, which characterizes a PFO wetland. This area contained all three wetland parameters. Attachment I; Sheet 7.

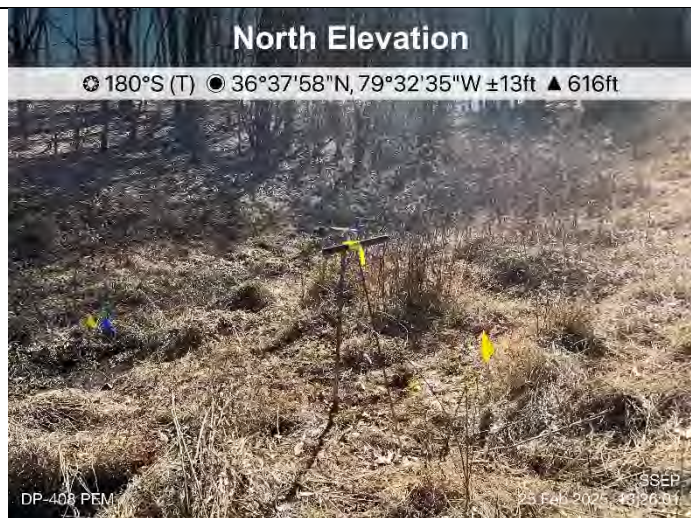
Photo 550:

Looking at Data Point #408, which characterizes a PEM wetland. This area contained all three wetland parameters. Attachment I; Sheet 8.

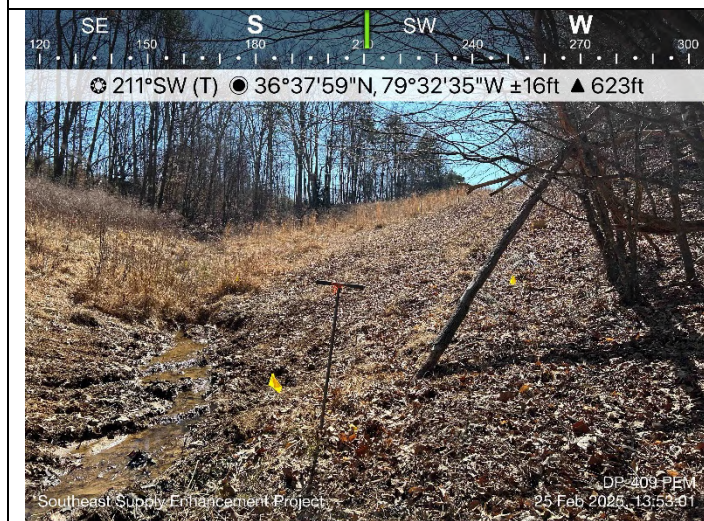
Photo 551:

Looking at Data Point #409, which characterizes a PEM wetland. This area contained all three wetland parameters. Attachment I; Sheet 8.

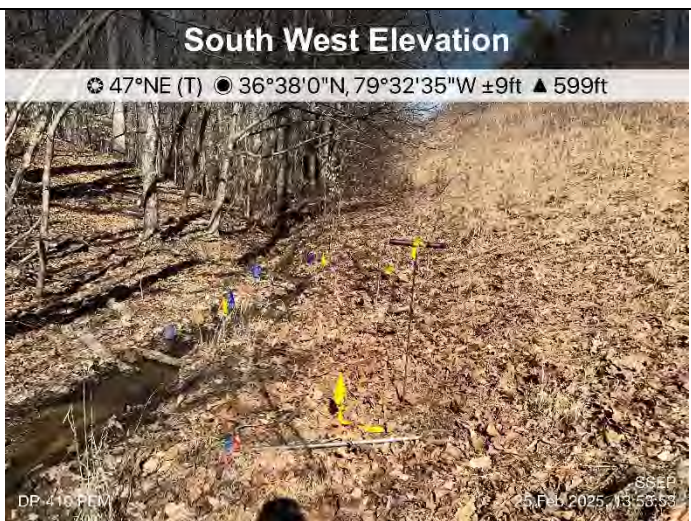
Photo 552:

Looking at Data Point #410, which characterizes a PEM wetland. This area contained all three wetland parameters. Attachment I; Sheet 8.

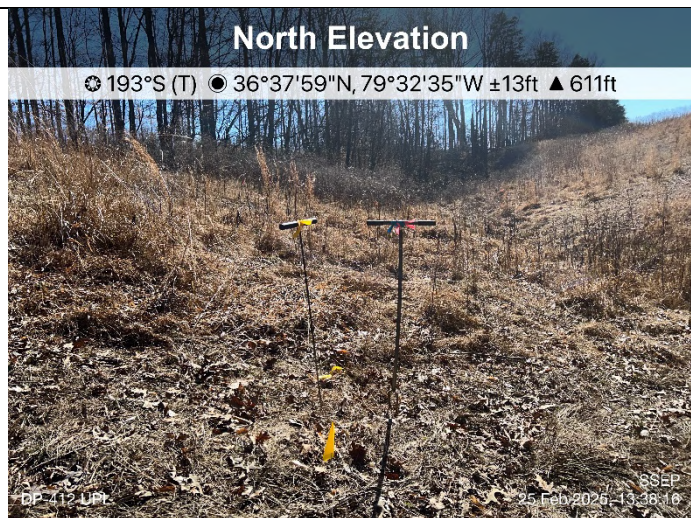
Photo 554:

Looking at Data Point #412, which characterizes an upland. This area lacked wetland hydrology, hydrophytic vegetation, and hydric soil. Attachment I; Sheet 8.

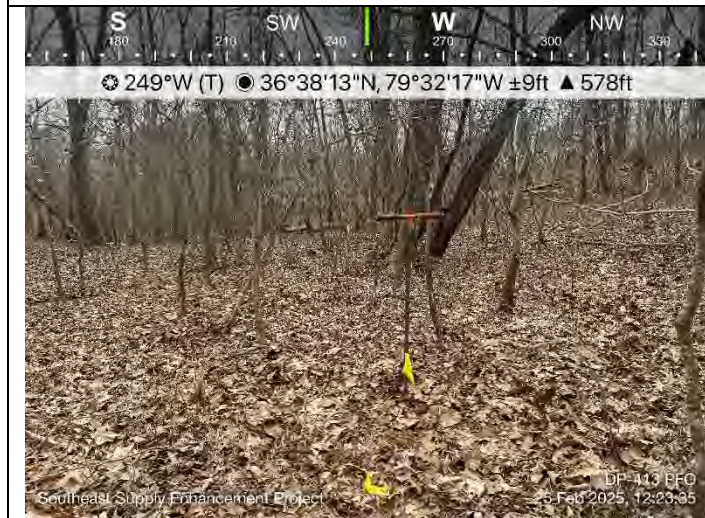
Photo 555:

Looking at Data Point #413, which characterizes a PFO wetland. This area contained all three wetland parameters. Attachment I; Sheet 8.

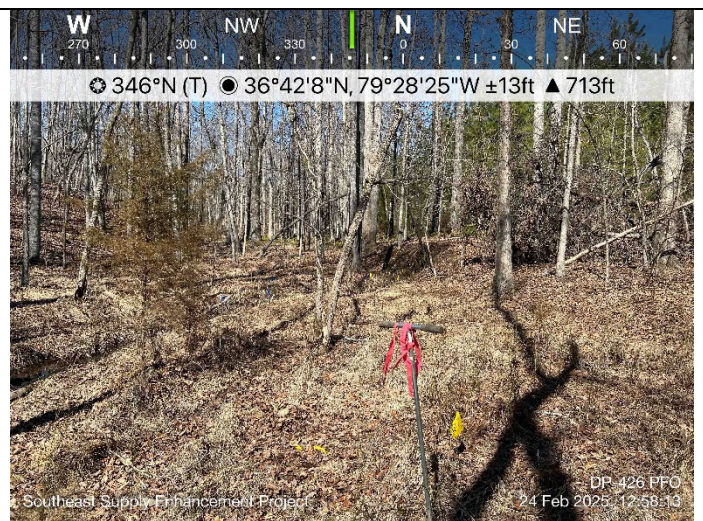
Photo 568:

Looking at Data Point #426, which characterizes a PFO wetland. This area contained all three wetland parameters. Attachment I; Sheet 13.

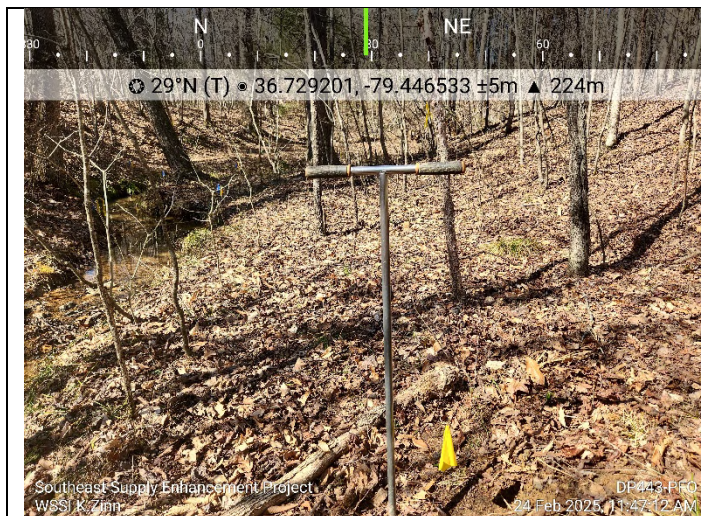
Photo 585:

Looking at Data Point #443, which characterizes a PFO wetland. This area contained all three wetland parameters. Attachment I; Sheet 15.
