EXHIBIT 14 - PHOTOGRAPHS

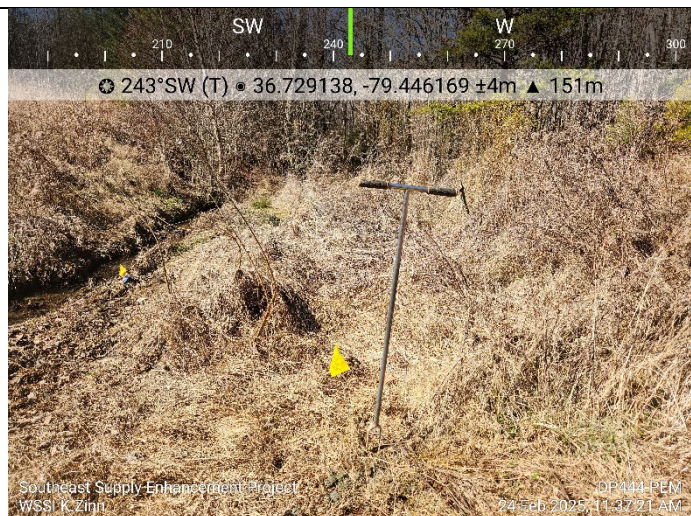
Photo 586:

Looking at Data Point #444, which characterizes a PEM wetland. This area contained all three wetland parameters. Attachment I; Sheet 15.

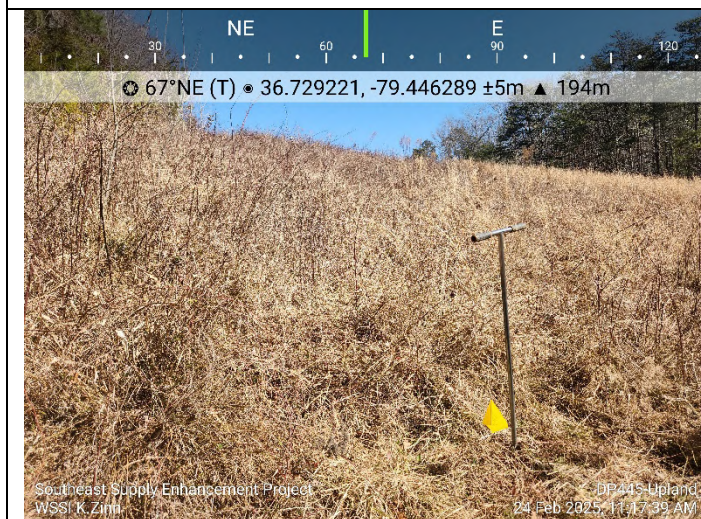
Photo 587:

Looking at Data Point #445, which characterizes an upland. This area lacked wetland hydrology, hydrophytic vegetation, and hydric soil. Attachment I; Sheet 15.

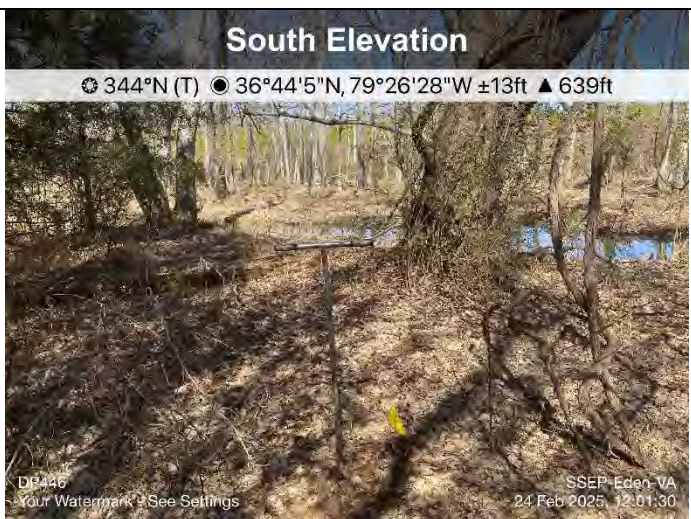
Photo 588:

Looking at Data Point #446, which characterizes a PFO wetland. This area contained all three wetland parameters. Attachment I; Sheet 15.

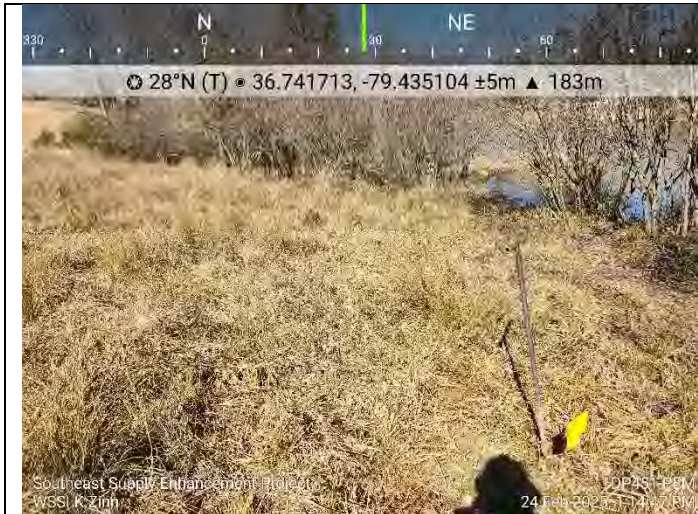
Photo 593:

Looking at Data Point #451, which characterizes a PEM wetland. This area contained all three wetland parameters. Attachment I; Sheet 16.

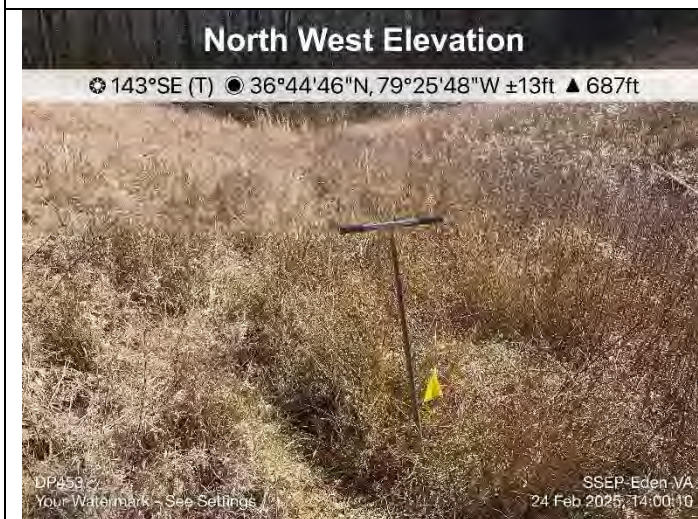
Photo 595:

Looking at Data Point #453, which characterizes a PEM wetland. This area contained all three wetland parameters. Attachment I; Sheet 16.

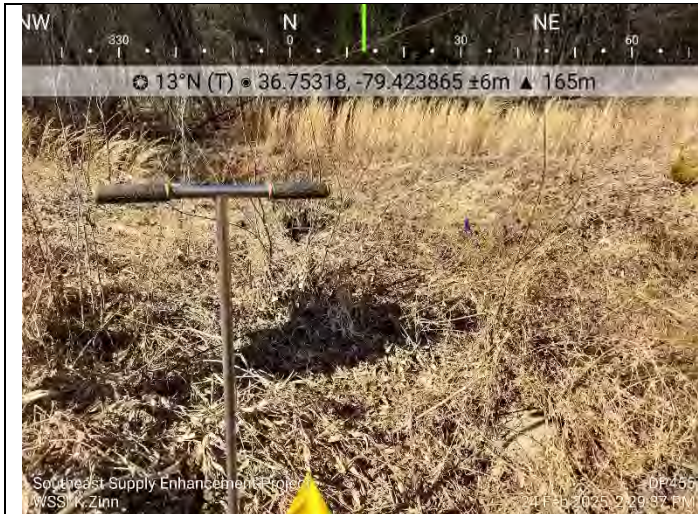
Photo 597:

Looking at Data Point #455, which characterizes a PEM wetland. This area contained all three wetland parameters. Attachment I; Sheet 16.

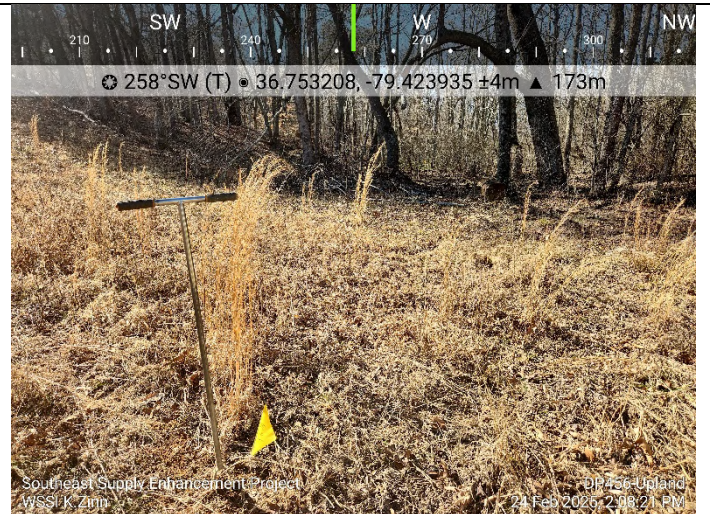
Photo 598:

Looking at Data Point #456, which characterizes an upland. This area lacked wetland hydrology, hydrophytic vegetation, and hydric soil. Attachment I; Sheet 16.

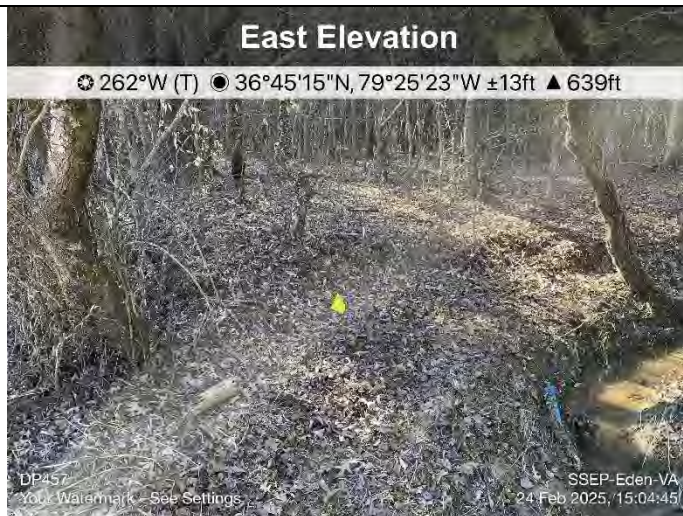
Photo 599:

Looking at Data Point #457, which characterizes a PFO wetland. This area contained all three wetland parameters. Attachment I; Sheet 16.

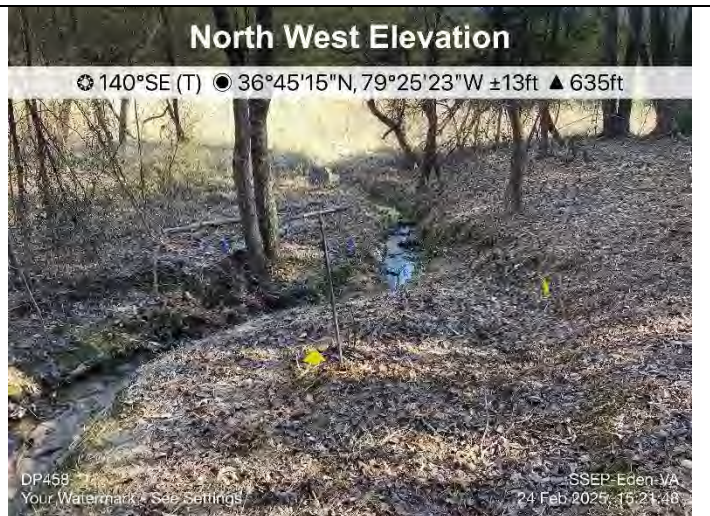
Photo 600:

Looking at Data Point #458, which characterizes a PFO wetland. This area contained all three wetland parameters. Attachment I; Sheet 16.

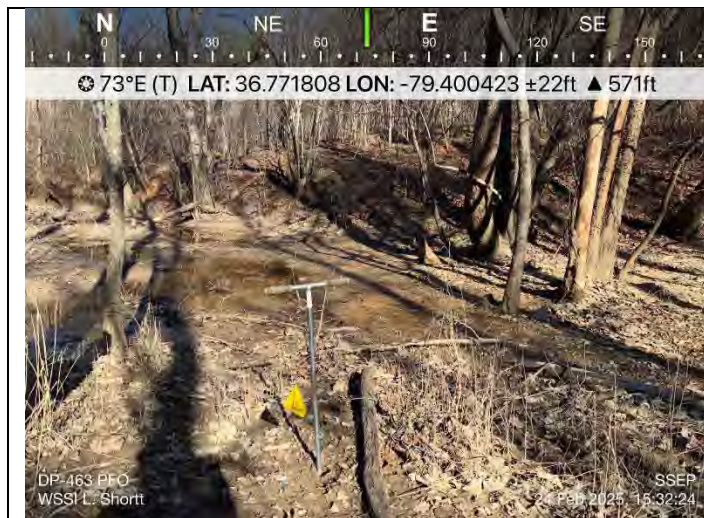
Photo 605:

Looking at Data Point #463, which characterizes a PFO wetland. This area contained all three wetland parameters. Attachment I; Sheet 18.

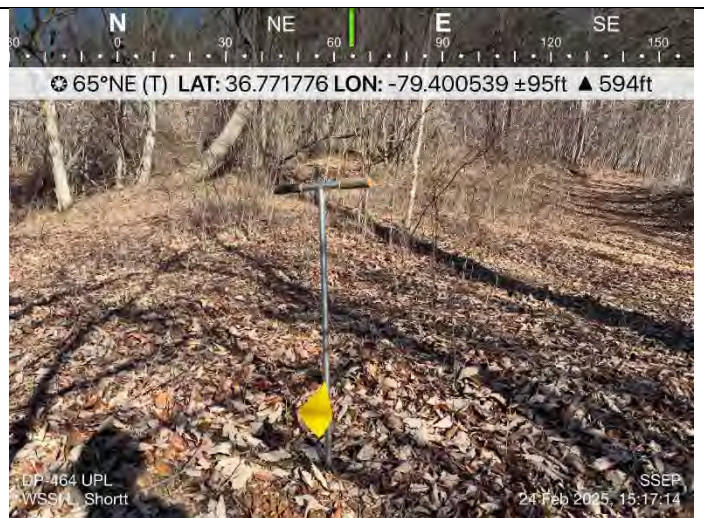
Photo 606:

Looking at Data Point #464, which characterizes a forested upland. This area lacked wetland hydrology and hydric soil. Attachment I; Sheet 18.

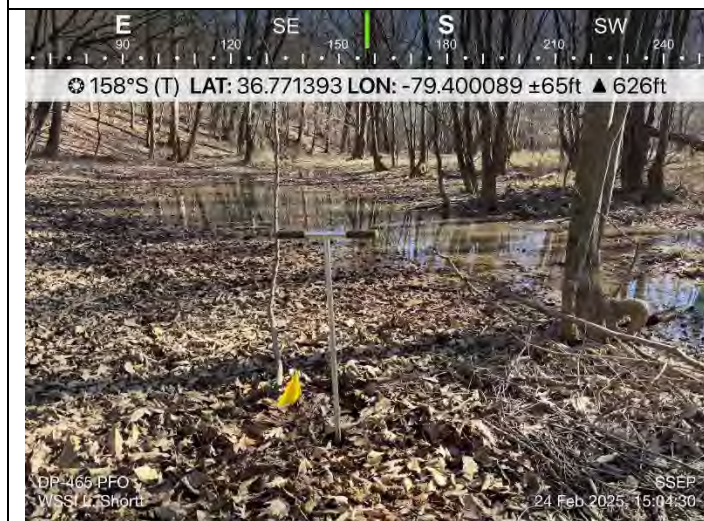
Photo 607:

Looking at Data Point #465, which characterizes a PFO wetland. This area contained all three wetland parameters. Attachment I; Sheet 18.

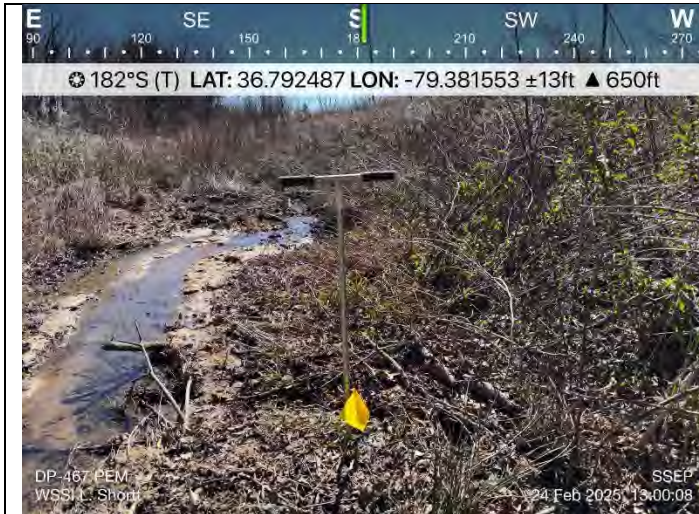
Photo 609:

Looking at Data Point #467, which characterizes a PEM wetland. This area contained all three wetland parameters. Attachment I; Sheet 20.

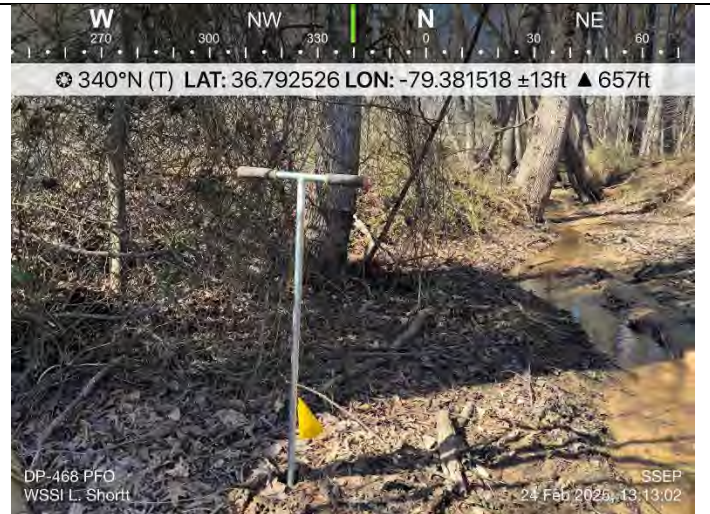
Photo 610:

Looking at Data Point #468, which characterizes a PFO wetland. This area contained all three wetland parameters. Attachment I; Sheet 20.

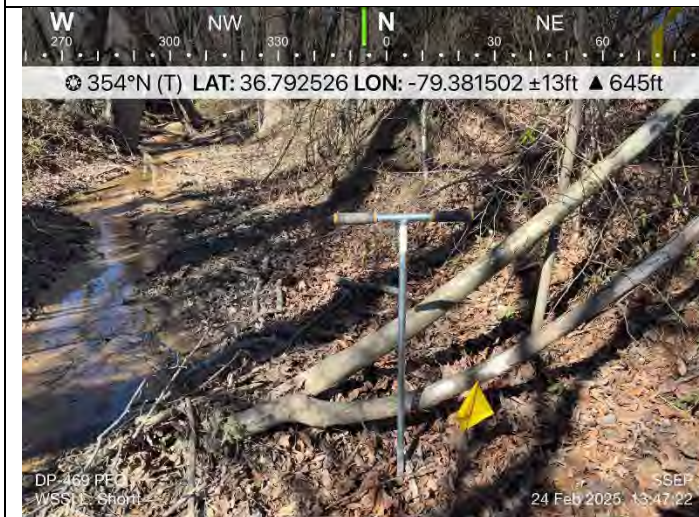
Photo 611:

Looking at Data Point #469, which characterizes a PFO wetland. This area contained all three wetland parameters. Attachment I; Sheet 20.

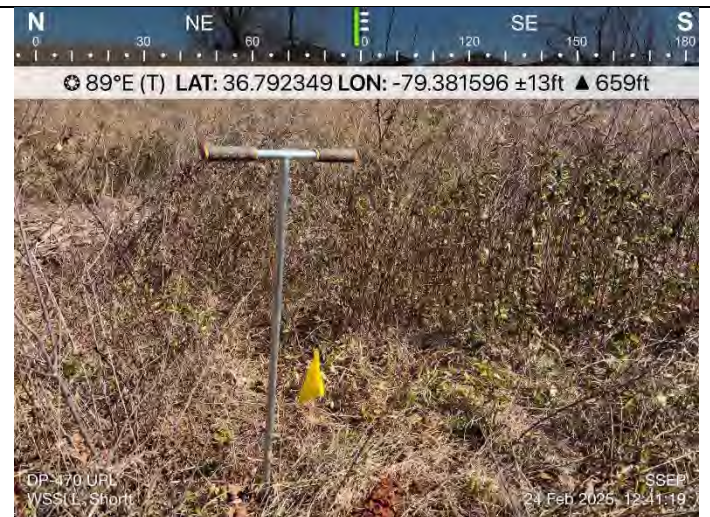
Photo 612:

Looking at Data Point #470, which characterizes an upland. This area lacked wetland hydrology, hydrophytic vegetation, and hydric soil. Attachment I; Sheet 20.

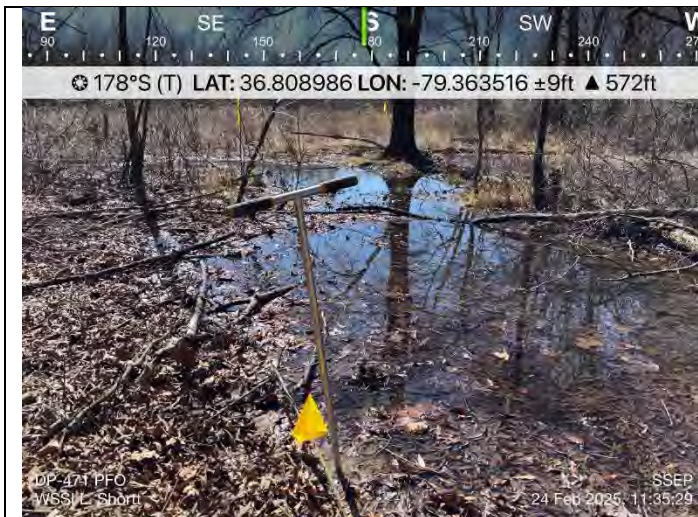
Photo 613:

Looking at Data Point #471, which characterizes a PFO wetland. This area contained all three wetland parameters. Attachment I; Sheet 21.

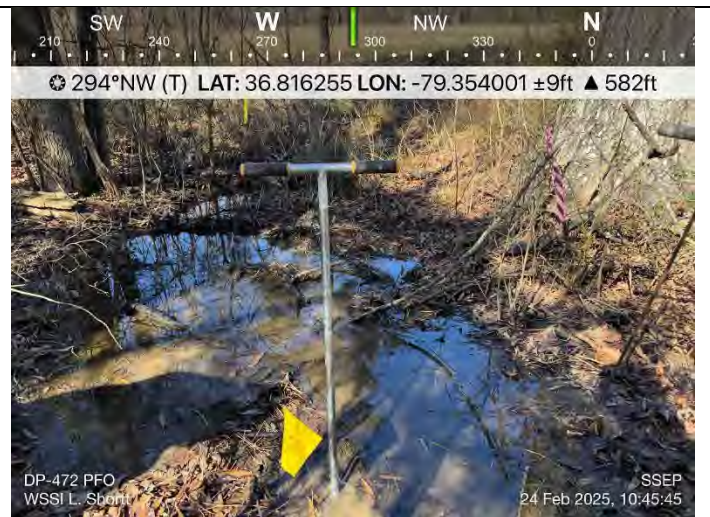
Photo 614:

Looking at Data Point #472, which characterizes a PFO wetland. This area contained all three wetland parameters. Attachment I; Sheet 22.

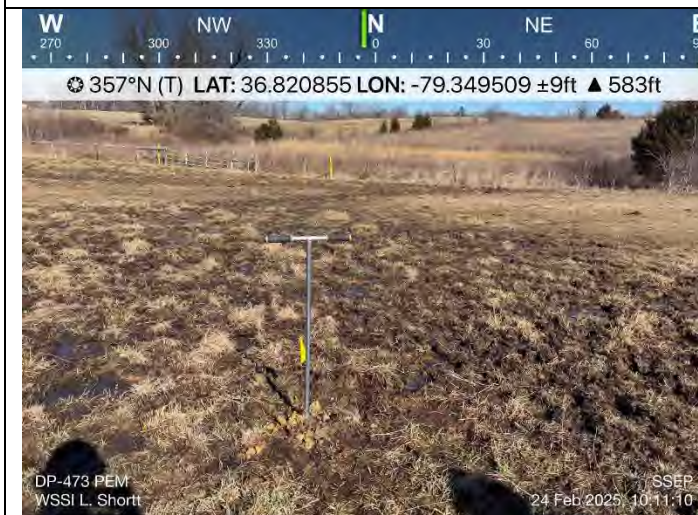
Photo 615:

Looking at Data Point #473, which characterizes a PEM wetland. This area contained all three wetland parameters. Attachment I; Sheet 22.

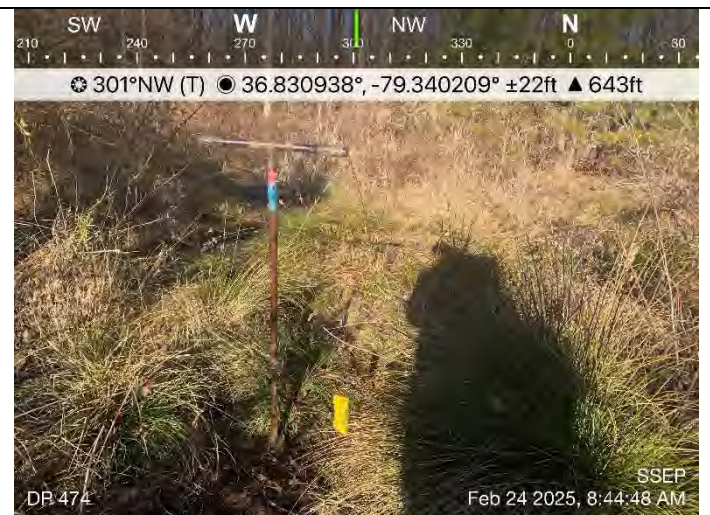
Photo 616:

Looking at Data Point #474 which characterizes a PEM wetland. This area contained all three wetland parameters. Attachment I; Sheet 23.
