# Appendix A: Signed PDC MOU'S

The Virginia Department of Environmental Quality's Virginia Coastal Zone Management Program (CZM) Grant #: NA23NOS4190255, Grant Year 2023, Task #: 91.01 "Working Waterfront Assessment"

### **Working Waterfront Assessment**

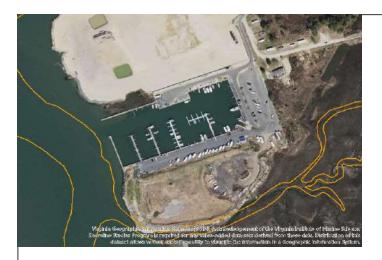
1949 Historic Shoreline Location (provided by VIMS) \*

If No Stabilization Condition\*
N/A
Erosion Condition at Water's Edge: Scarp, Marsh, or Beach\*
Yes
Existing Stabilization Condition\*

Existing Stabilization Condition\*
Yes
Revetment/Bulkhead/Living Shoreline/Other\*
Yes
Marsh Condition Waterward of Shoreline Stabilization\*
Eroding
Materials\*
timber, vinyl, concrete
Other Noticed Issues From the Shoreline Waterward
Erosion

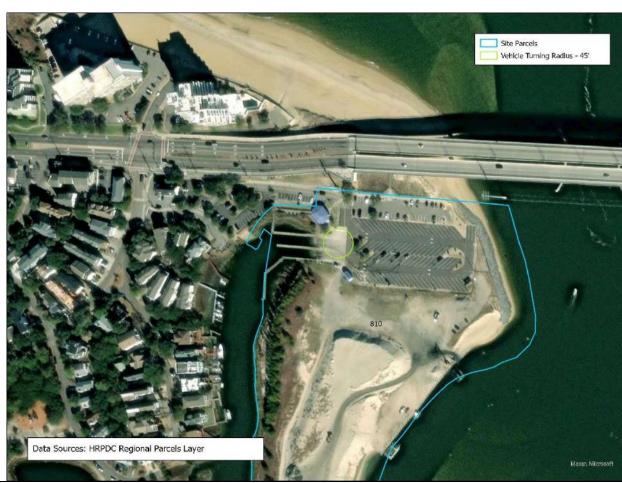
Vehicle Turning Movements (show minimum 90' diameter circle overlaid on site for scale)

Access to the facility is off of Shore Drive via Lynnhaven Promenade, which appears to have a 10' to 12' drive lane. Single-lane in both directions.

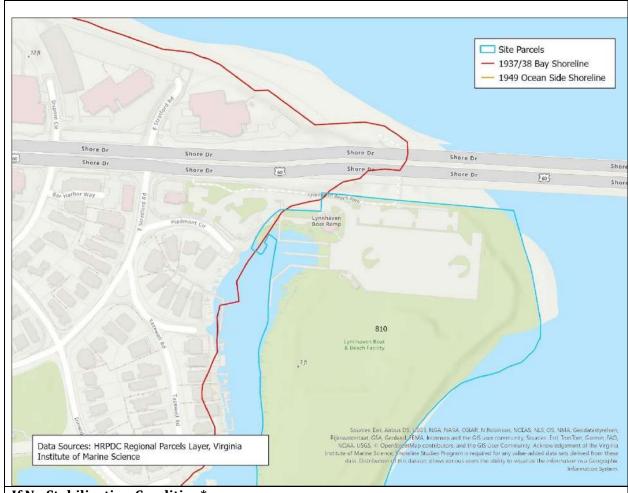
4' NAVD88
Condition, Repairs Needed, Estimated Remaining Lifespan for the Components of
Structure*
Good
Piles (condition, diameter, etc.)*
Good
Pile Cap*
Good
Stringers*
Good
Deck Boards*
Good
Railings*
Good
Hardware (bolts fastening stringers, nails/screws holding deck boards down, etc.)*
Good
Accessories (Cleats, Ladders, Ramps, Etc.)*
Good
Shoreline Type and Condition (revetment, living shoreline, eroding shoreline, beach,
marsh, etc.)*
Except for the boat ramps, the shoreline appears to be natural.
1949 Historic Shoreline Location (provided by VIMS) *

Shoreline appears to be in good condition, but is undefended except for the ramps

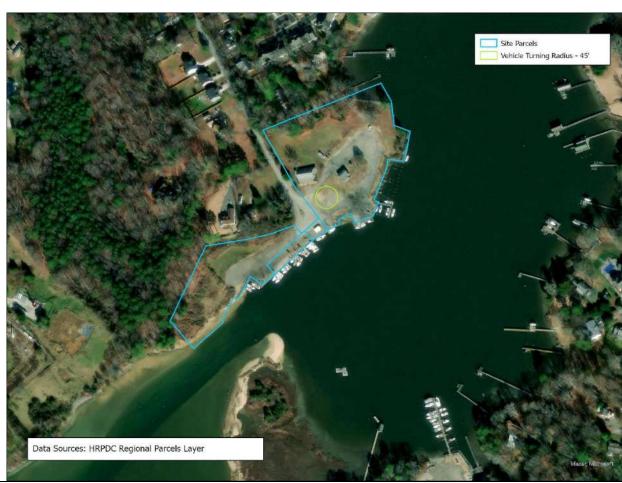
Vehicle Turning Movements (show minimum 90' diameter circle overlaid on site for scale)

Access to the facility is off of Menchville Rd S, which appears to be between 20' and 25' in width

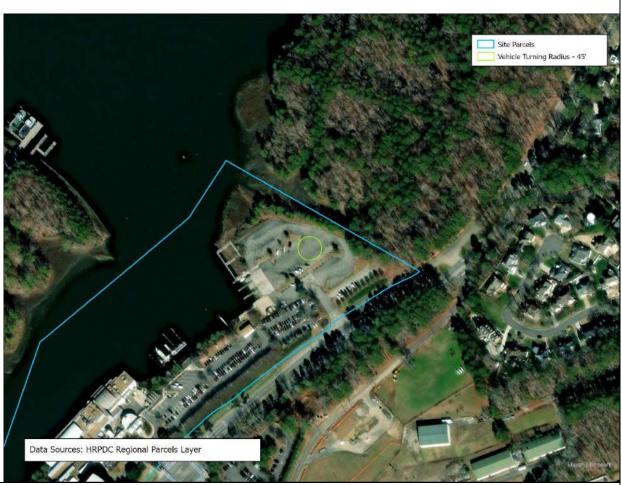
Vehicle Turning Movements (show minimum 90' diameter circle overlaid on site for scale)

Access to the facility is off of General Booth Blvd, which is a four-lane divided road with 10' to 12' lanes.

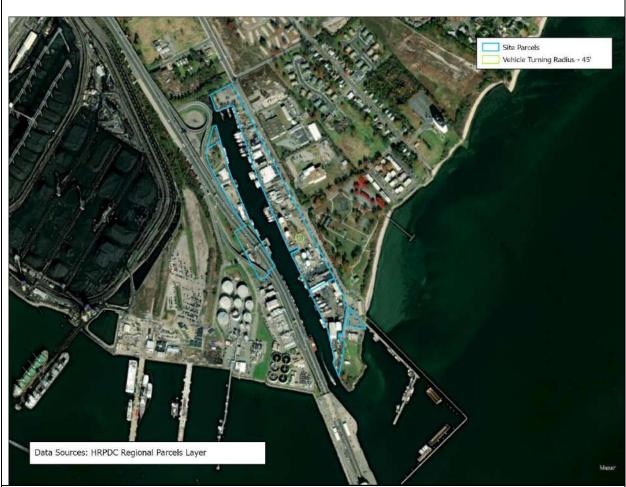
Vehicle Turning Movements (show minimum 90' diameter circle overlaid on site for scale)

Access to the facility is off of Jefferson Avenue, which appears to have a 10' to 12' drive lane. Single-lane in both directions with onstreet parking on both sides.

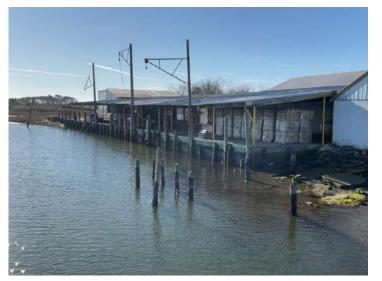
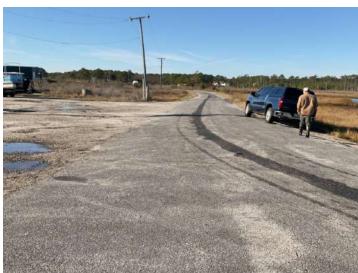
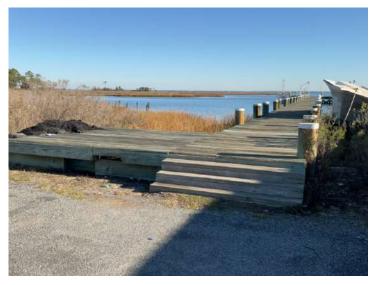
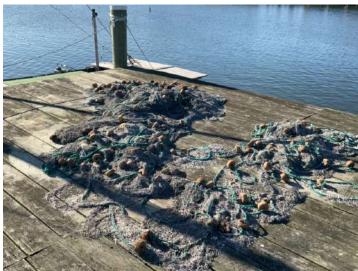
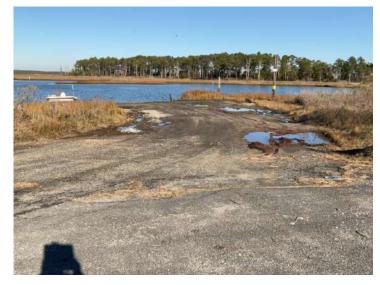
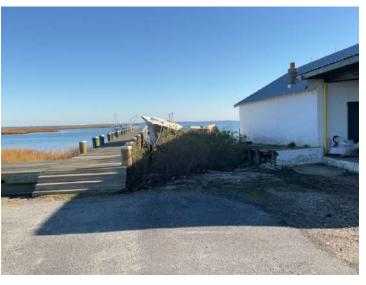
Existing Conditions Photos

## **Structural Conditions Summary**

Continue to monitor the pier every few years and continue any maintenance of the structure.

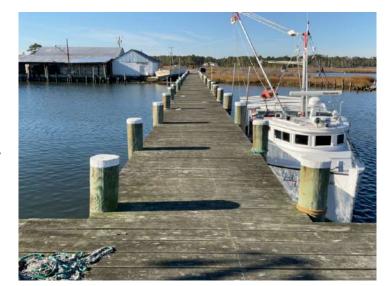
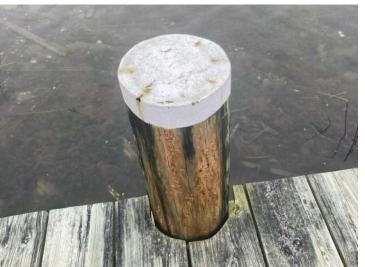
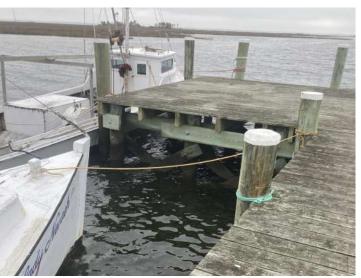
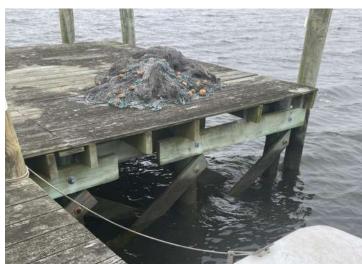
Dock Existing Conditions Photos

Dock Element	Good Condition	Minor Issues	Moderate Issues	Major Issues	Severe Issues
Remaining Lifespan*	15-25 Years	10-15 years	5-10 Years	1-5 Years	0-1 Year
Decking		✓			
Stringers		✓			
Girders		✓			
Piles		✓			
Cross-Bracing		✓			
Hardware		✓

<sup>\*</sup>Dock conditons based on visual observations. Remaining lifespan are approximate and based on typical expected weathering.

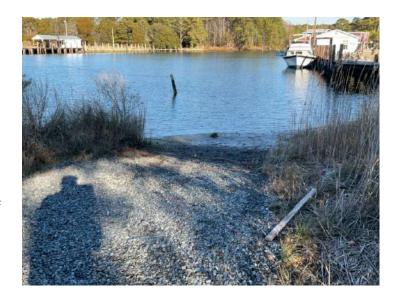
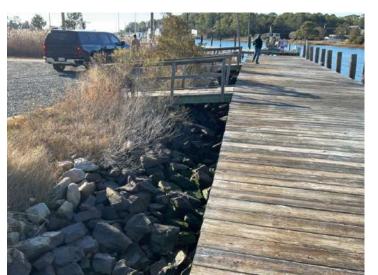
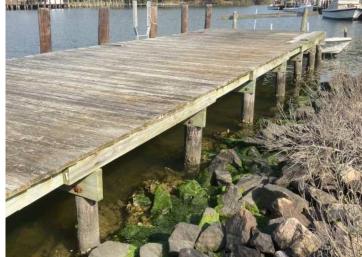
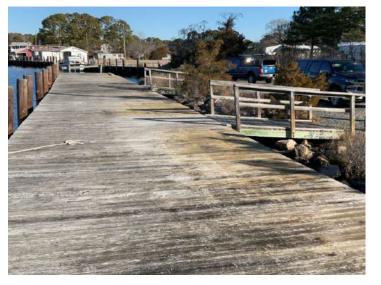
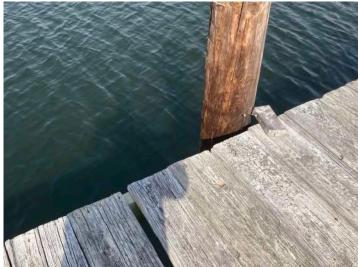
Dock Existing Conditions Photos

Dock Element	Good Condition	Minor Issues	Moderate Issues	Major Issues	Severe Issues	
Remaining Lifespan*	15-25 Years	10-15 years	5-10 Years	1-5 Years	0-1 Year	
Decking			✓			
Stringers		✓				
Girders		✓				
Piles					<b>✓</b>	
Cross-Bracing		✓				
Hardware			<b>✓</b>

<sup>\*</sup>Dock conditions based on visual observations. Remaining lifespan are approximate and based on typical expected weathering.

The dock is showing its age, and the piles appear to be reaching the end of their useful life. A further structural inspection is required to determine the remaining life of the structure or any imminent safety hazards. Do not recommend doing any major improvements of decking, caps, or stringers, until the conditions of the piles is known.

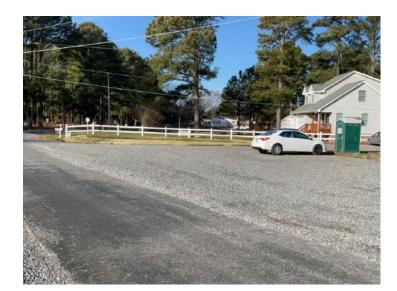
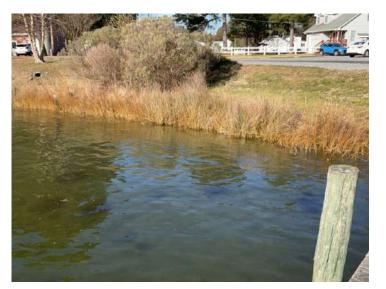
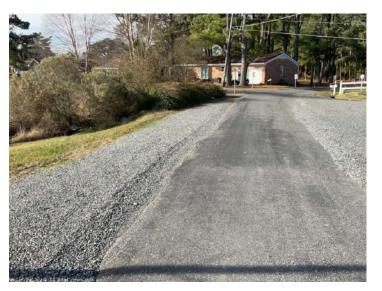
<sup>\*</sup>Dock conditions based on visual observations. Remaining lifespan are approximate and based on typical expected weathering.

The pier is showing age but appears to only have minor issues. Repairing cross bracing will provide strength back to the structure. Replace the hardware pieces that are showing moderate corrosion and stabilizing the area at the entrance to the pier will prevent further erosion at the pier connection.

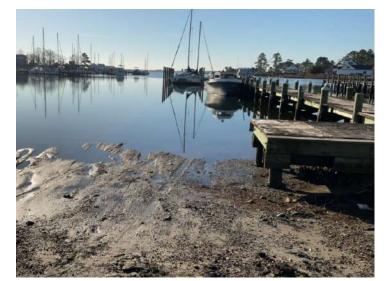
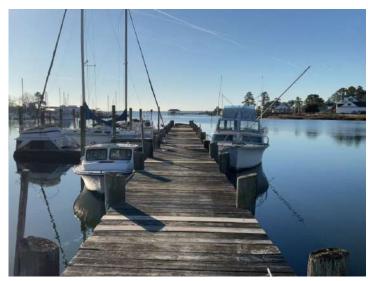
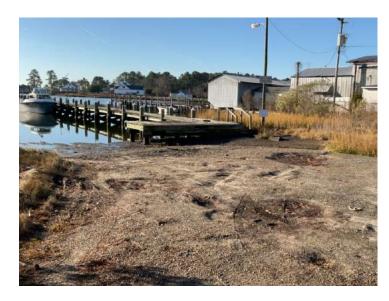
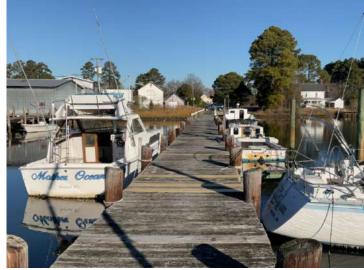
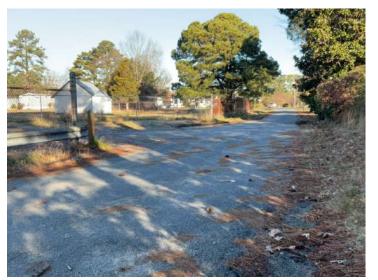
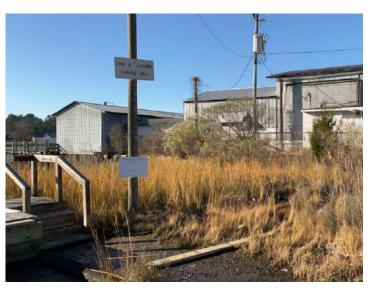
Existing Conditions Photos

Perrin Wharf is a public landing located on the Perrin River. The site provides quick access by boat to the lower York River and Chesapeake Bay. Perrin Wharf has a history of commercial waterman use for mooring and offloading, and some local recreational use. The site is currently in poor condition and in need of improvements to the parking area and dock.

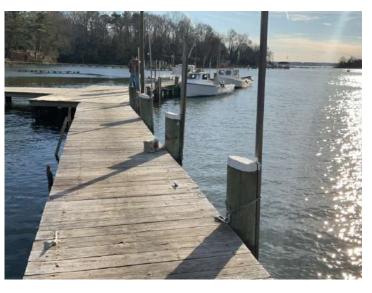
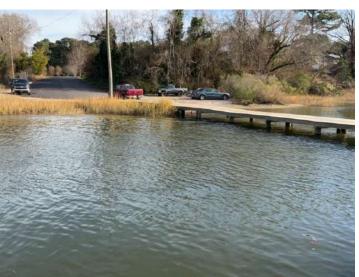
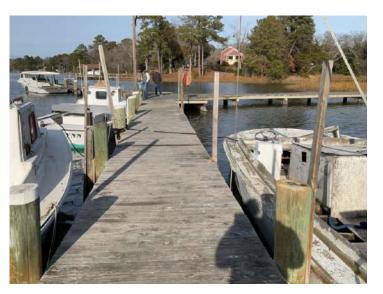
Dock Existing Conditions Photos

<sup>\*</sup>Dock conditions based on visual observations. Remaining lifespan are approximate and based on typical expected weathering.
