Re: Preliminary Jurisdictional Determination Request  
Mountain Valley Pipeline, LLC  
Snow Creek Permittee Responsible Mitigation Project  
Franklin County, Virginia  
Burns & McDonnell Project No.: 186472

Burns & McDonnell Engineering Company, Inc. (Burns & McDonnell) was retained by Mountain Valley Pipeline, LLC (client) to provide wetland delineation services for the Snow Creek Wetland Mitigation Project (Project). The following sections provide information on the proposed Project and summarize the completed wetland delineation.

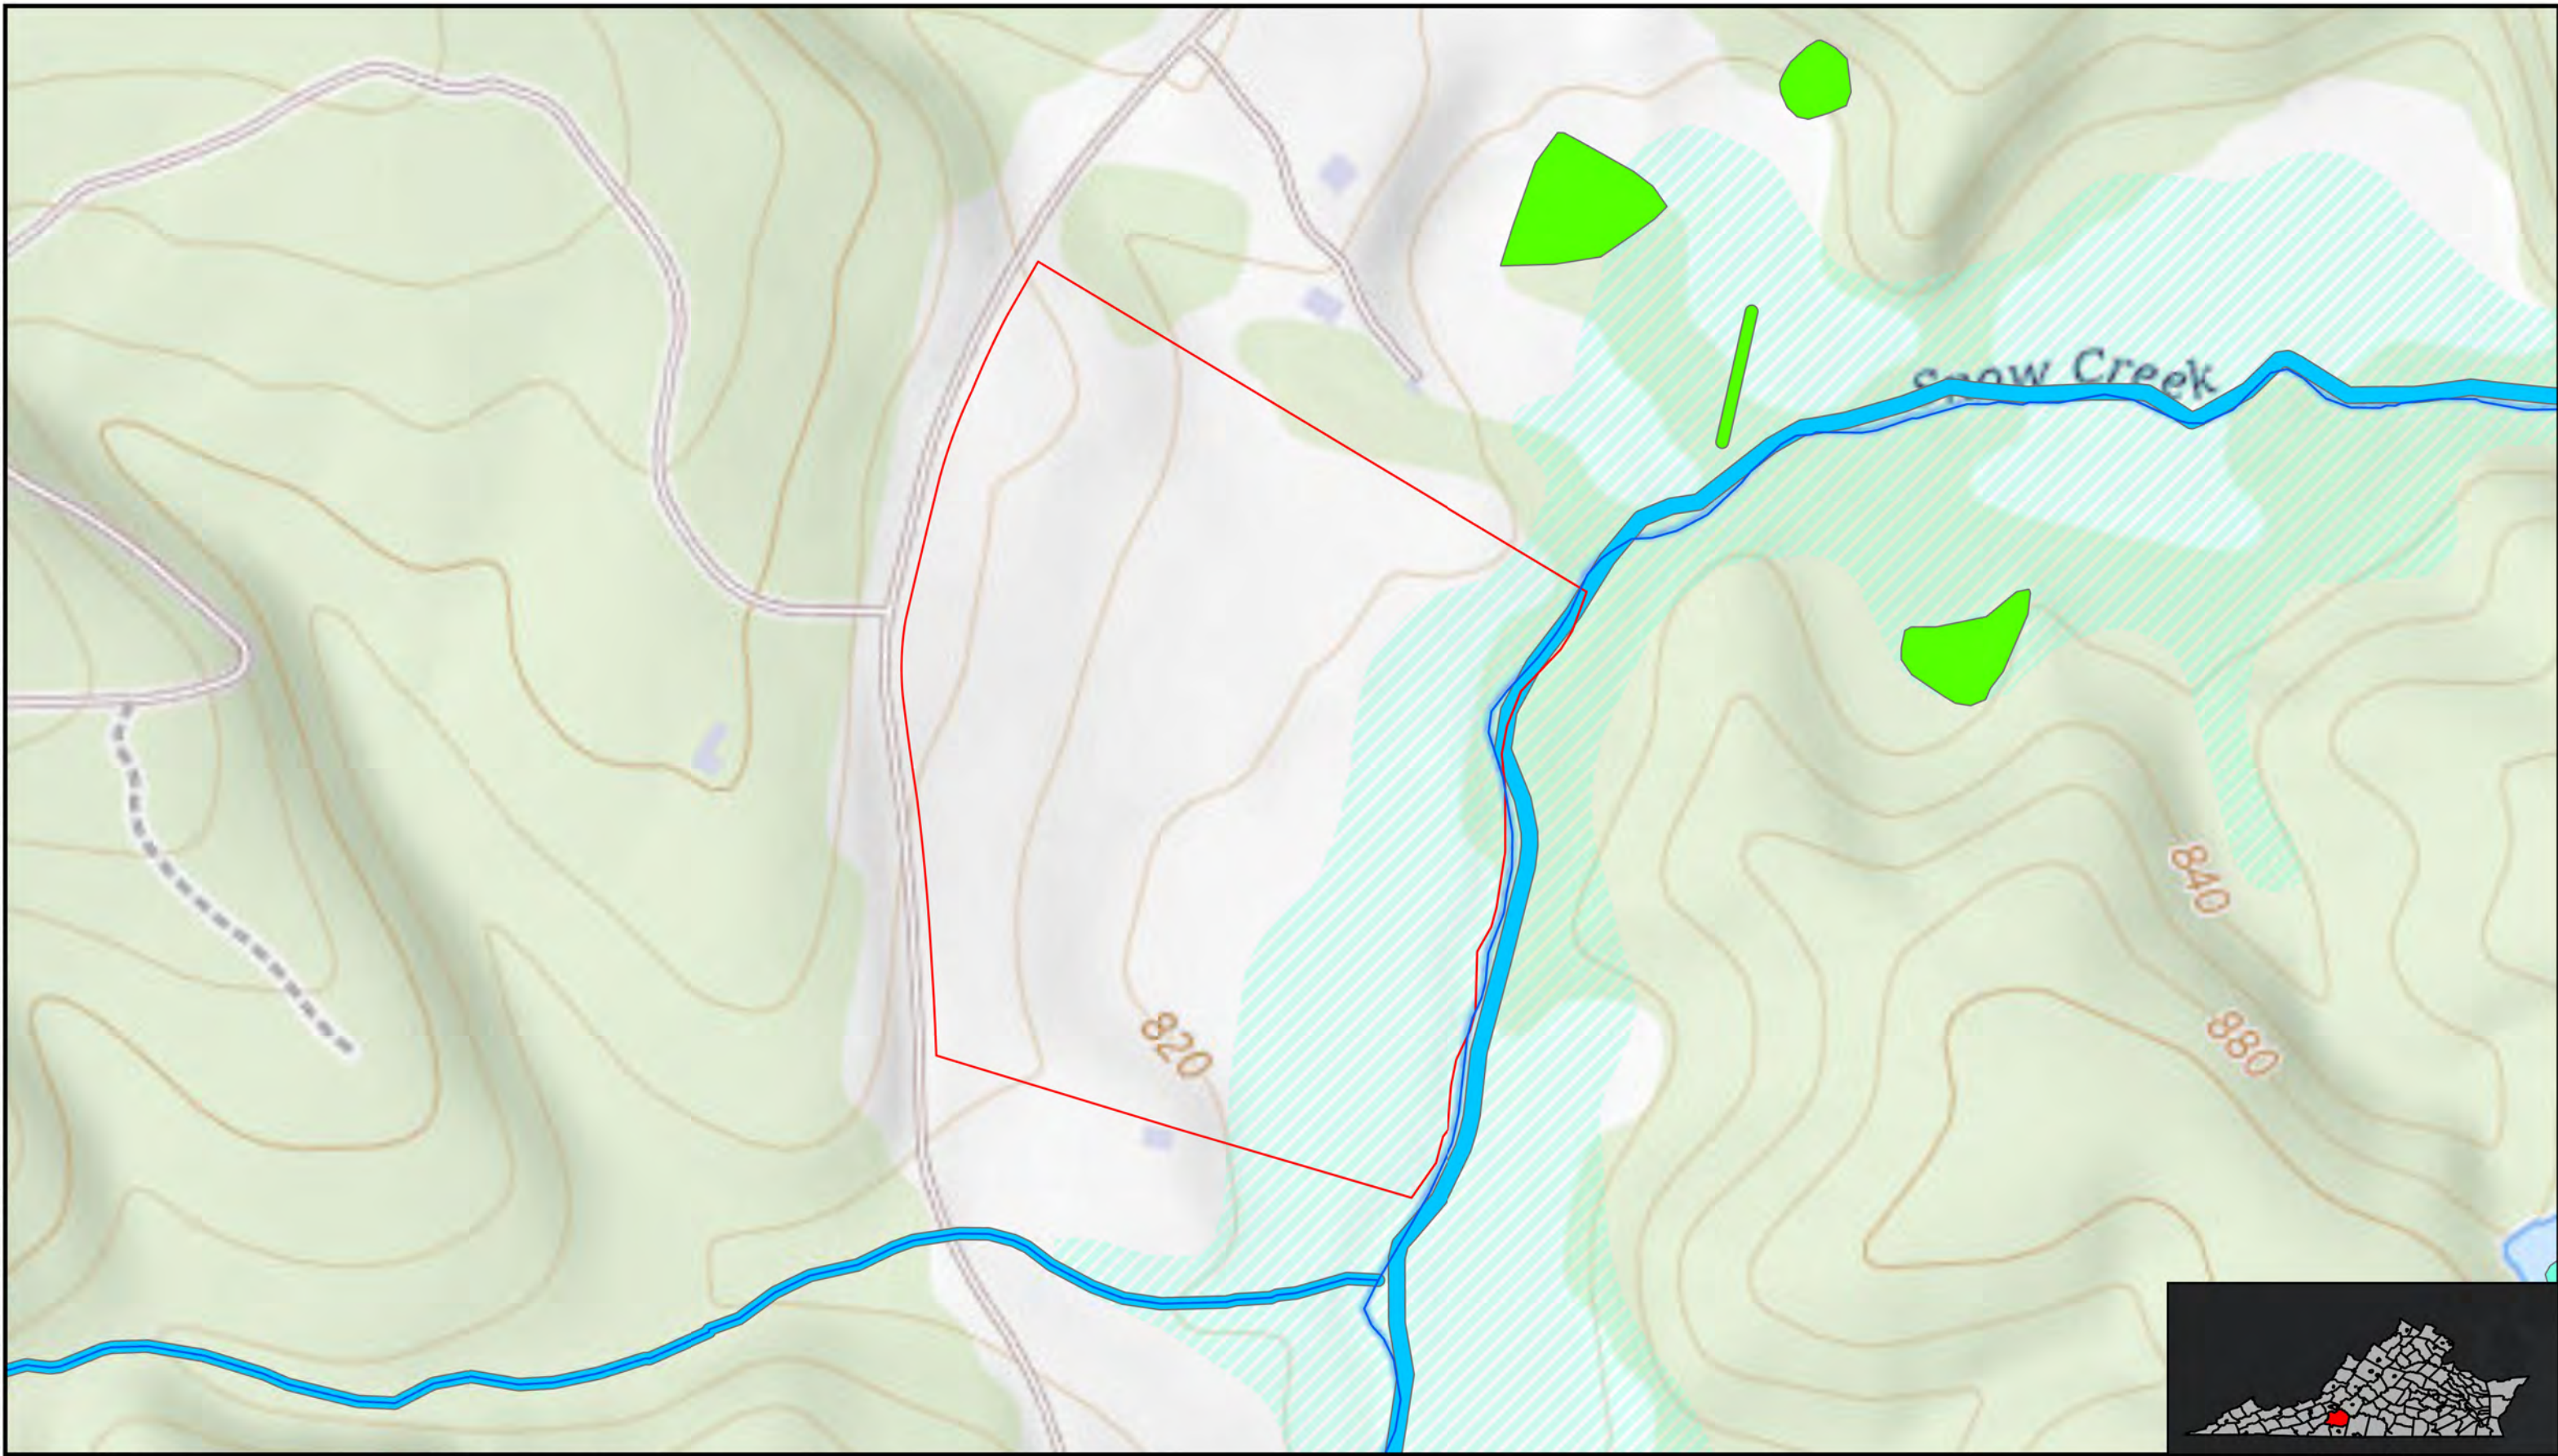
The existing USGS topographic map for Mountain Valley, Virginia (2022 Revision) was reviewed to familiarize Burns & McDonnell wetland personnel with the topography of the Survey Area and potential locations of wetlands and other waterbodies (Figure A-2). The USGS topographic map indicates the Survey Area is comprised of an open landscape with moderately sloping terrain to the east that gradually transitions to a floodplain area along the western bank of Snow Creek. The maps indicate that the Survey Area has approximately 30 feet of elevation change.

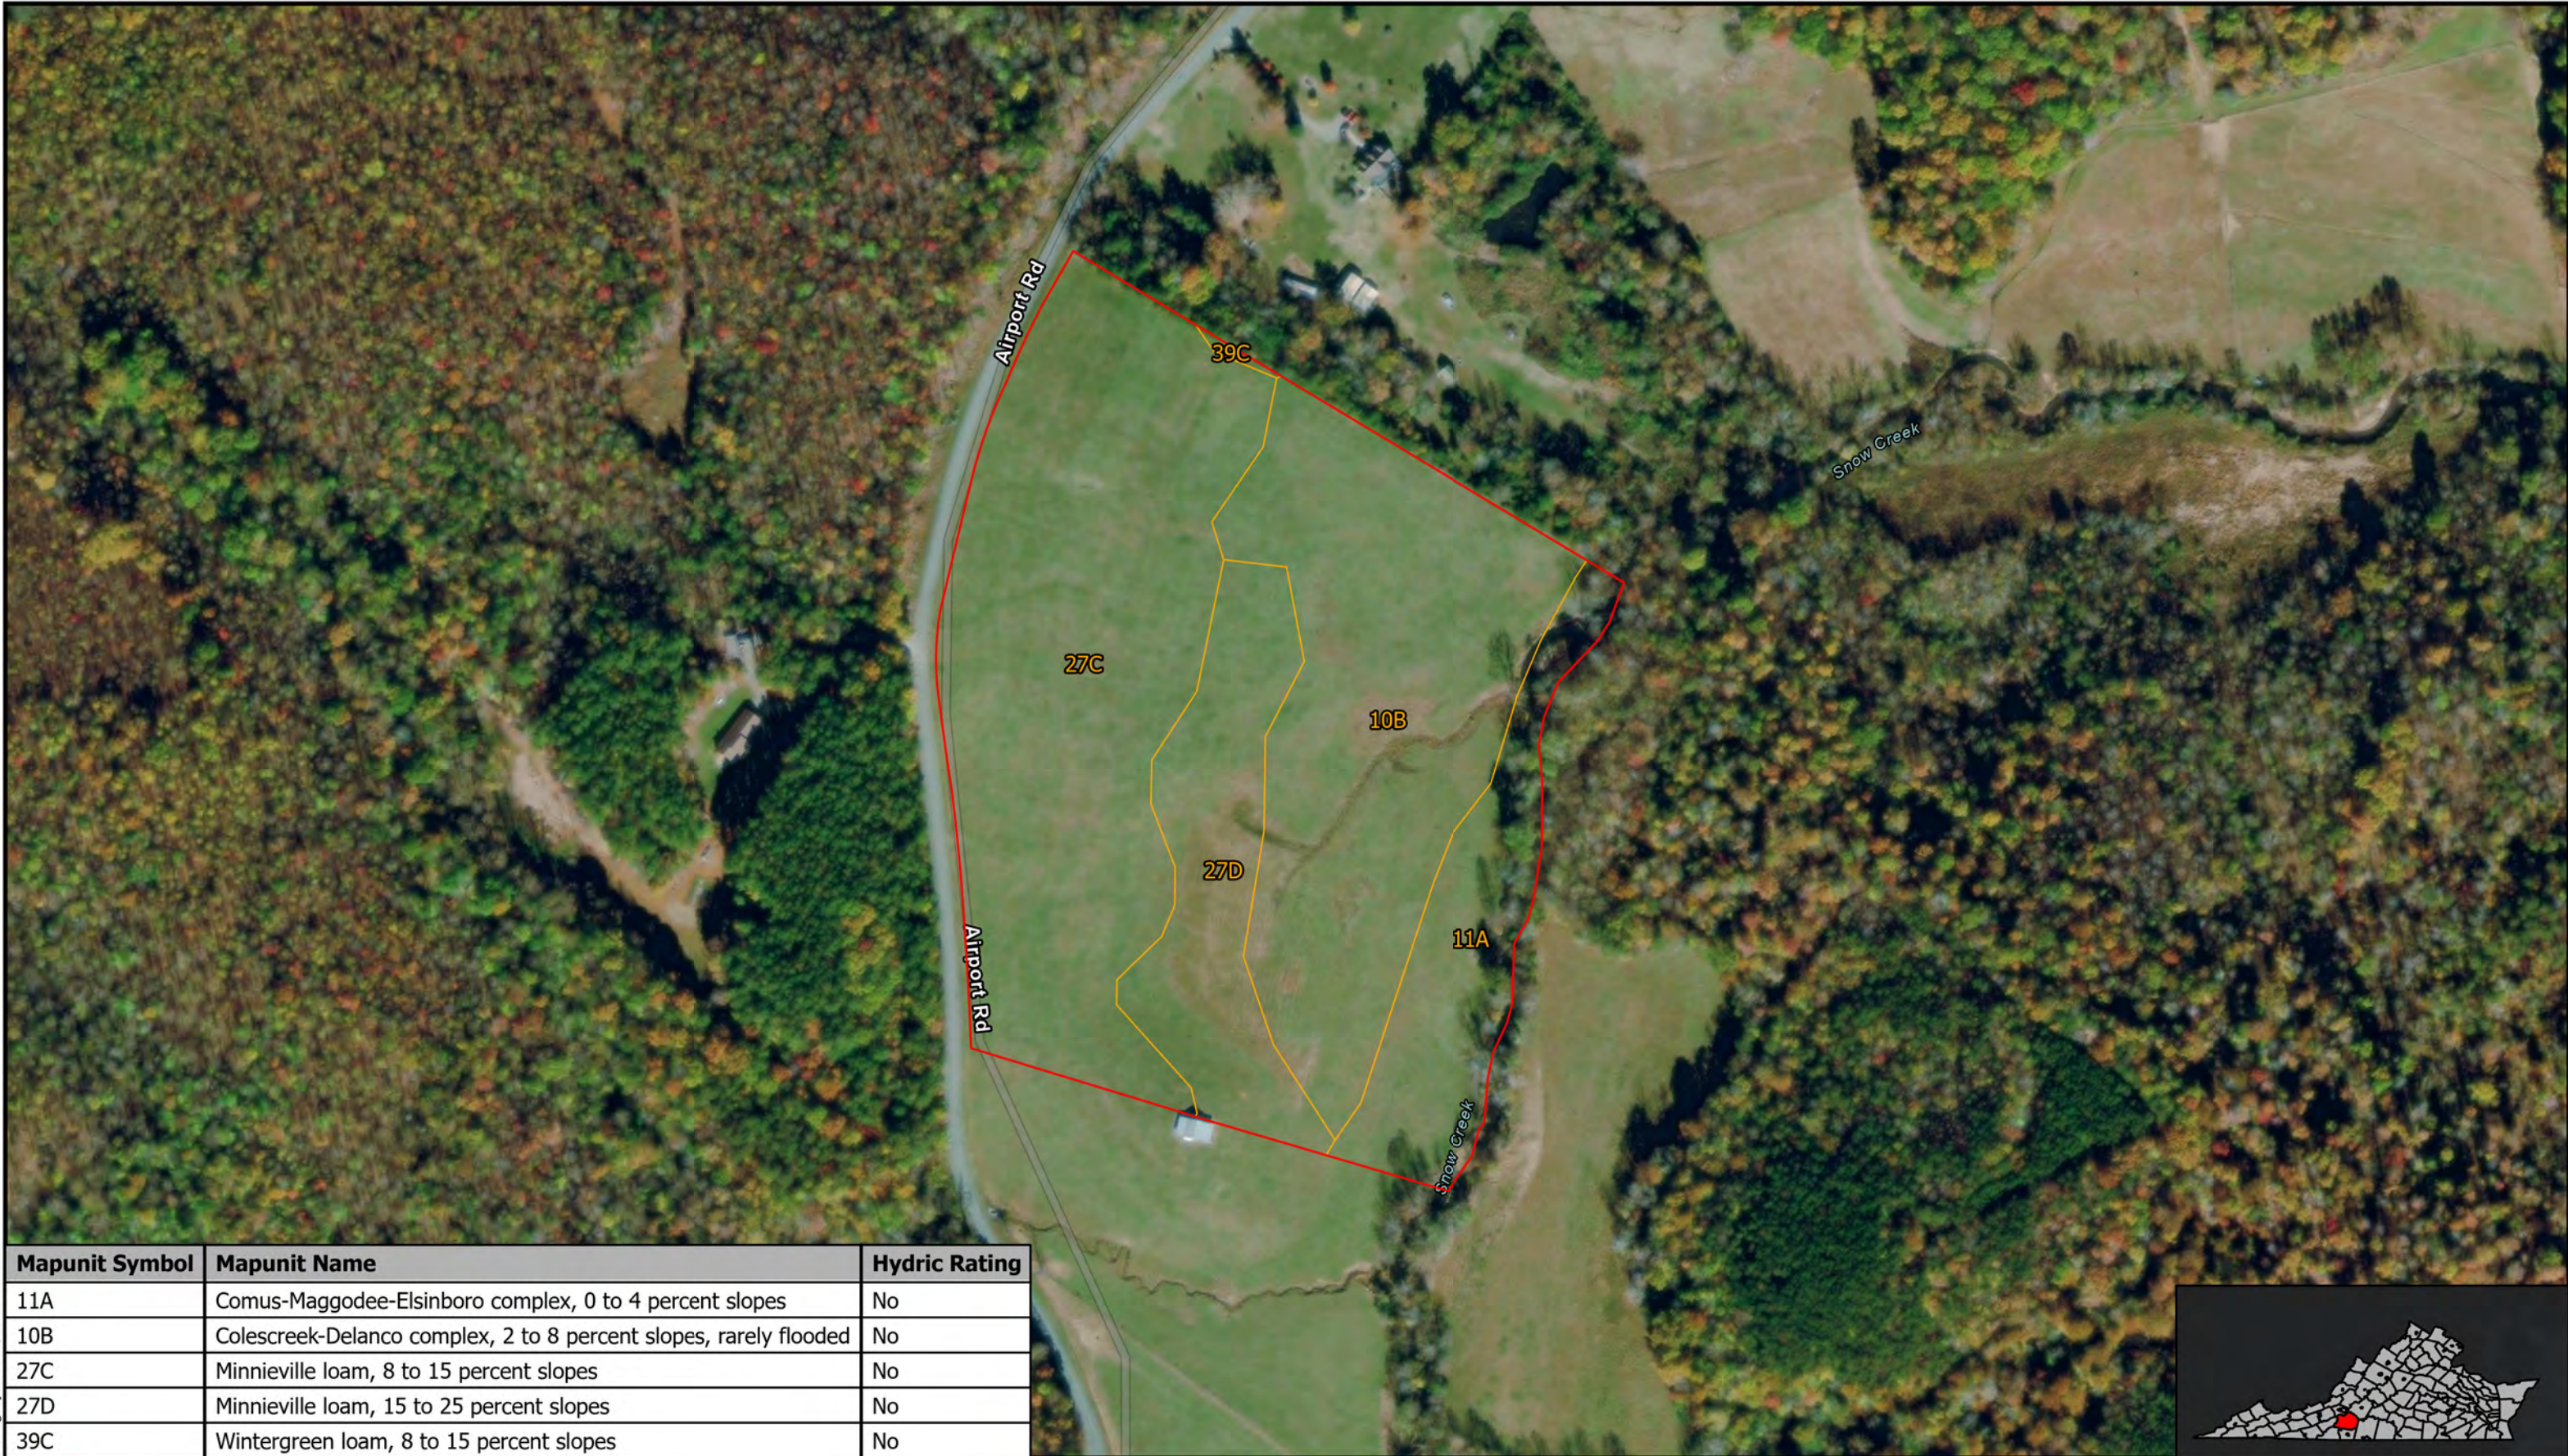
Figure A-3  
NRCS Soils Map  
Snow Creek Permittee Responsible  
Mitigation Project  
Mountain Valley Pipeline, LLC  
Franklin County, VA

Mapunit Symbol	Mapunit Name	Hydric Rating
11A	Comus-Maggodee-Elsinboro complex, 0 to 4 percent slopes	No
10B	Colescreek-Delanco complex, 2 to 8 percent slopes, rarely flooded	No
27C	Minnieville loam, 8 to 15 percent slopes	No
27D	Minnieville loam, 15 to 25 percent slopes	No
39C	Wintergreen loam, 8 to 15 percent slopes	No

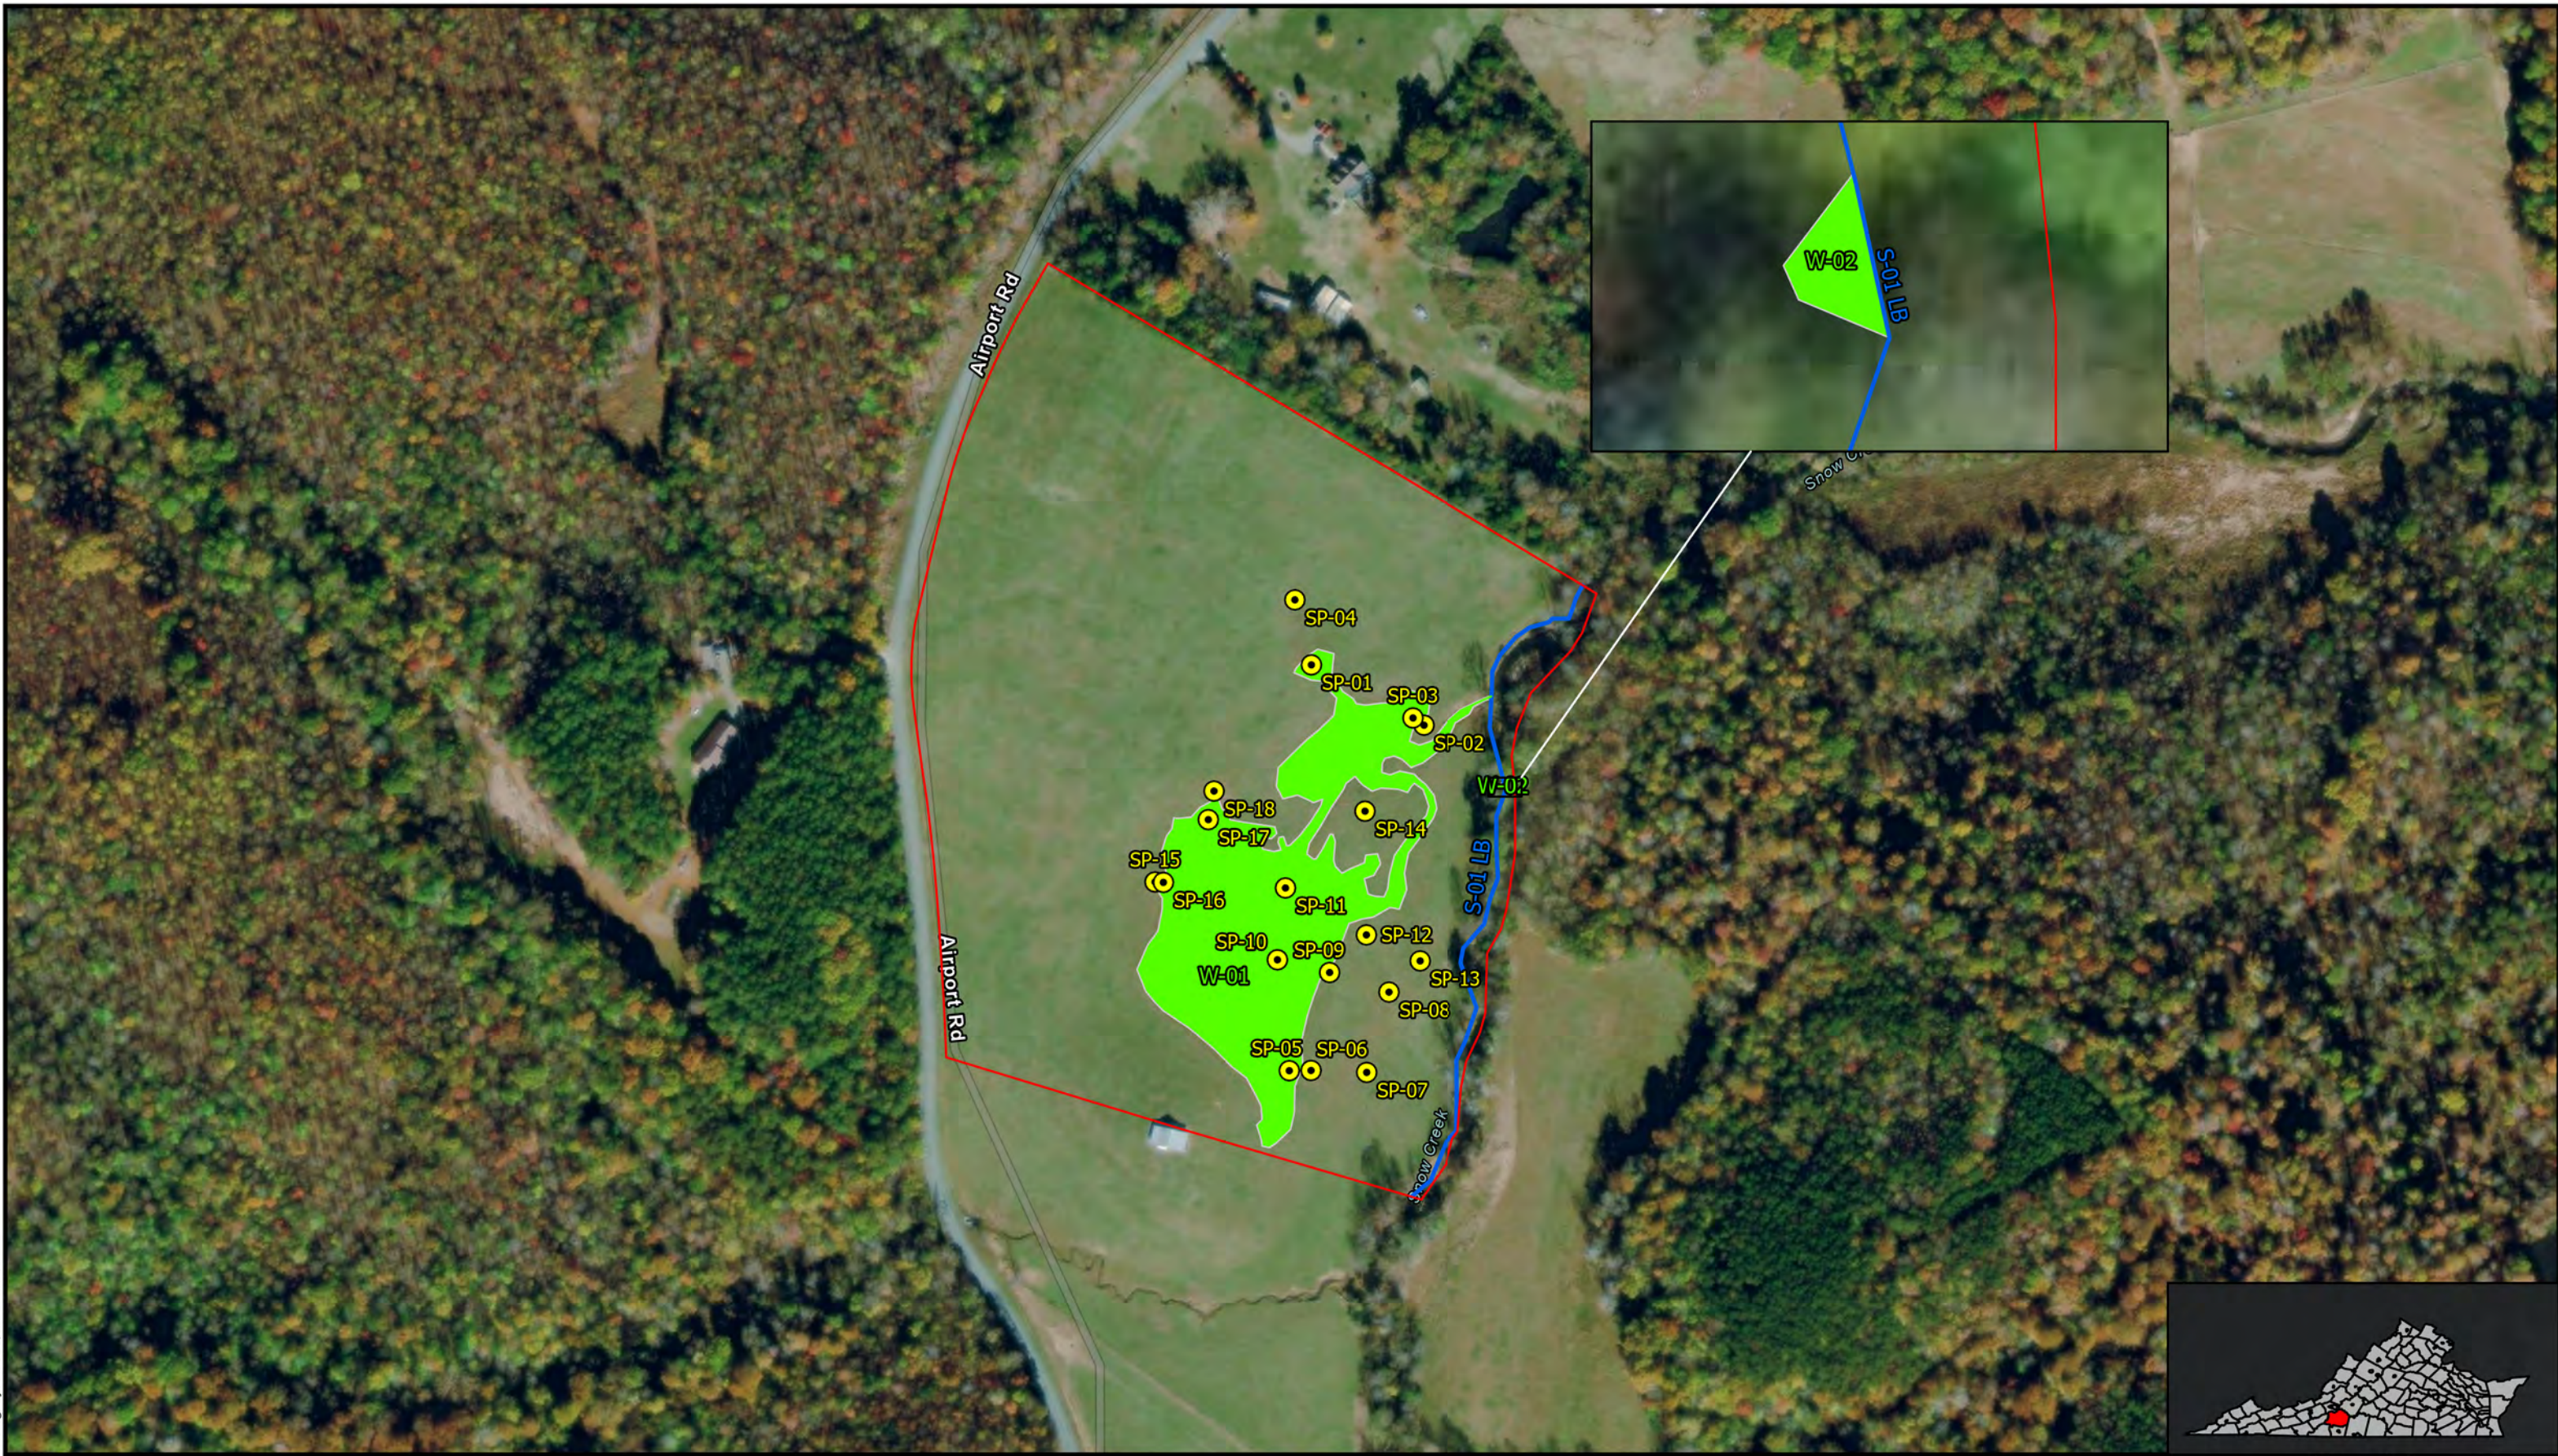
*Wetland 01 (W-01) – Palustrine Emergent (PEM) – 3.38 acres:* W-01 consisted of a 3.38-acre PEM wetland located within the center and eastern portions of the Survey Area. Dominant herbaceous species within the W-01 included, beaked panic grass, Virginia buttonweed, swamp smartweed (*Persicaria hydropiperoides*), small carpetgrass (*Arthraxon hispidus*), white clover (*Trifolium repens*), and Japanese stiltgrass. Observed indicators of wetland hydrology included surface water, high-water table, saturated soils, oxidized rhizospheres on living roots, geomorphic position, and a positive FAC neutral test. Soil colors typically ranged brown (7.5YR 5/2) to grayish brown (2.5Y 5/2) and contained redoximorphic features. Hydric soil was indicated by Indicator F3 (Depleted Matrix).

*Stream 01 (S-01; Snow Creek) – Perennial – 1,115 linear feet:* S-01 is a perennial segment of Snow Creek that flows from south to north along the eastern edge of the Survey Area. The average bank height observed was approximately 5 feet. The stream averaged 50 feet wide and 1 foot deep at the Ordinary High-Water Mark (OHWM). The stream was low gradient with moderate flow and maintained indicators of relatively permanent flow. The area abutting the western bank of S-01 was heavily impacted by cattle grazing and vegetation maintenance. Common tree species along the western bank riparian areas included American sycamore, tuliptree, and green ash.

- Survey Area
- Sample Plots (SP)
- Palustrine Emergent Wetland (W)
- Perennial Stream (S)

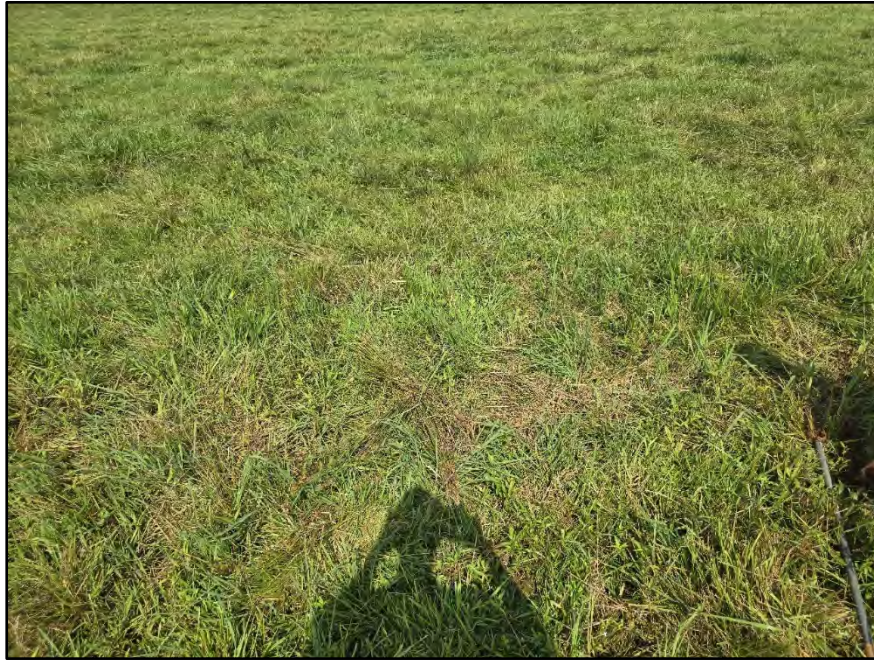
Photograph C-1: View of wetland sample plot (SP)-01 within PEM W-01, facing northwest.

Remarks:  
**Wetland sample plot within PEM W-01. Vegetation and soils significantly disturbed by cattle grazing. Hydrology significantly disturbed by ditching. The USACE Antecedent Precipitation Tool indicates wetter than normal conditions were present 3 months prior to survey.**

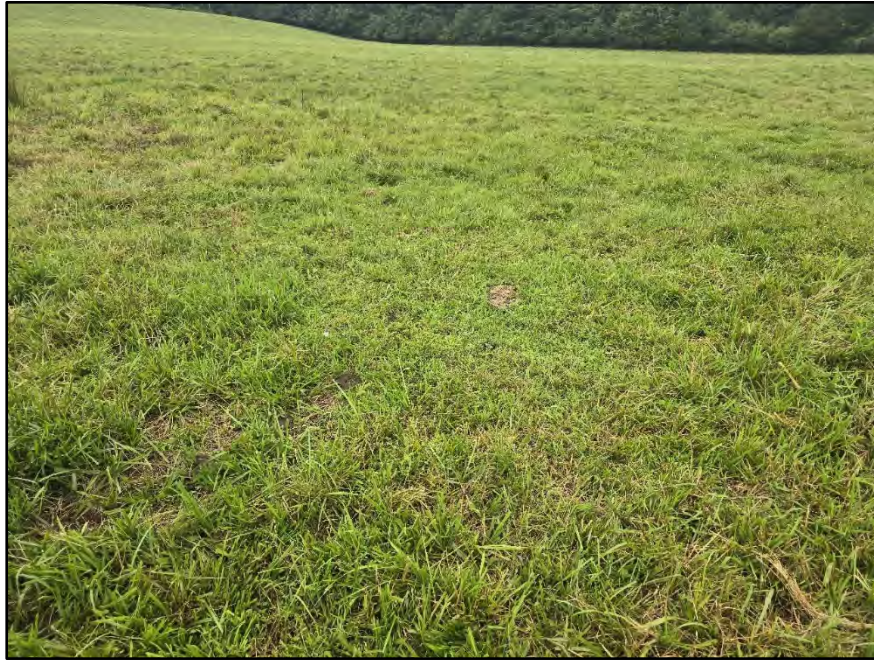
Photograph C-3: View of upland SP-02 adjacent to PEM W-01, facing north.

Remarks:  
Upland sample plot adjacent to PEM W-01. Vegetation and soils significantly disturbed by cattle grazing. Hydrology significantly disturbed by ditching. The USACE Antecedent Precipitation Tool indicates wetter than normal conditions were present 3 months prior to survey.

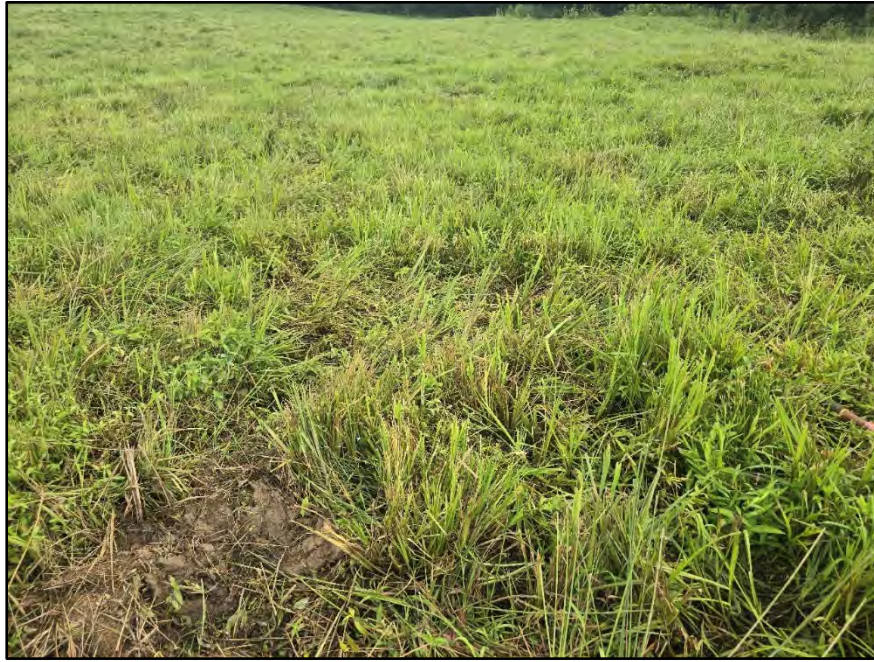
Photograph C-5: View of wetland SP-03 within PEM W-01, facing east.

Remarks:  
**Wetland sample point within PEM W-01. Vegetation and soils significantly disturbed by cattle grazing. Hydrology significantly disturbed by ditching. The USACE Antecedent Precipitation Tool indicates wetter than normal conditions were present 3 months prior to survey.**

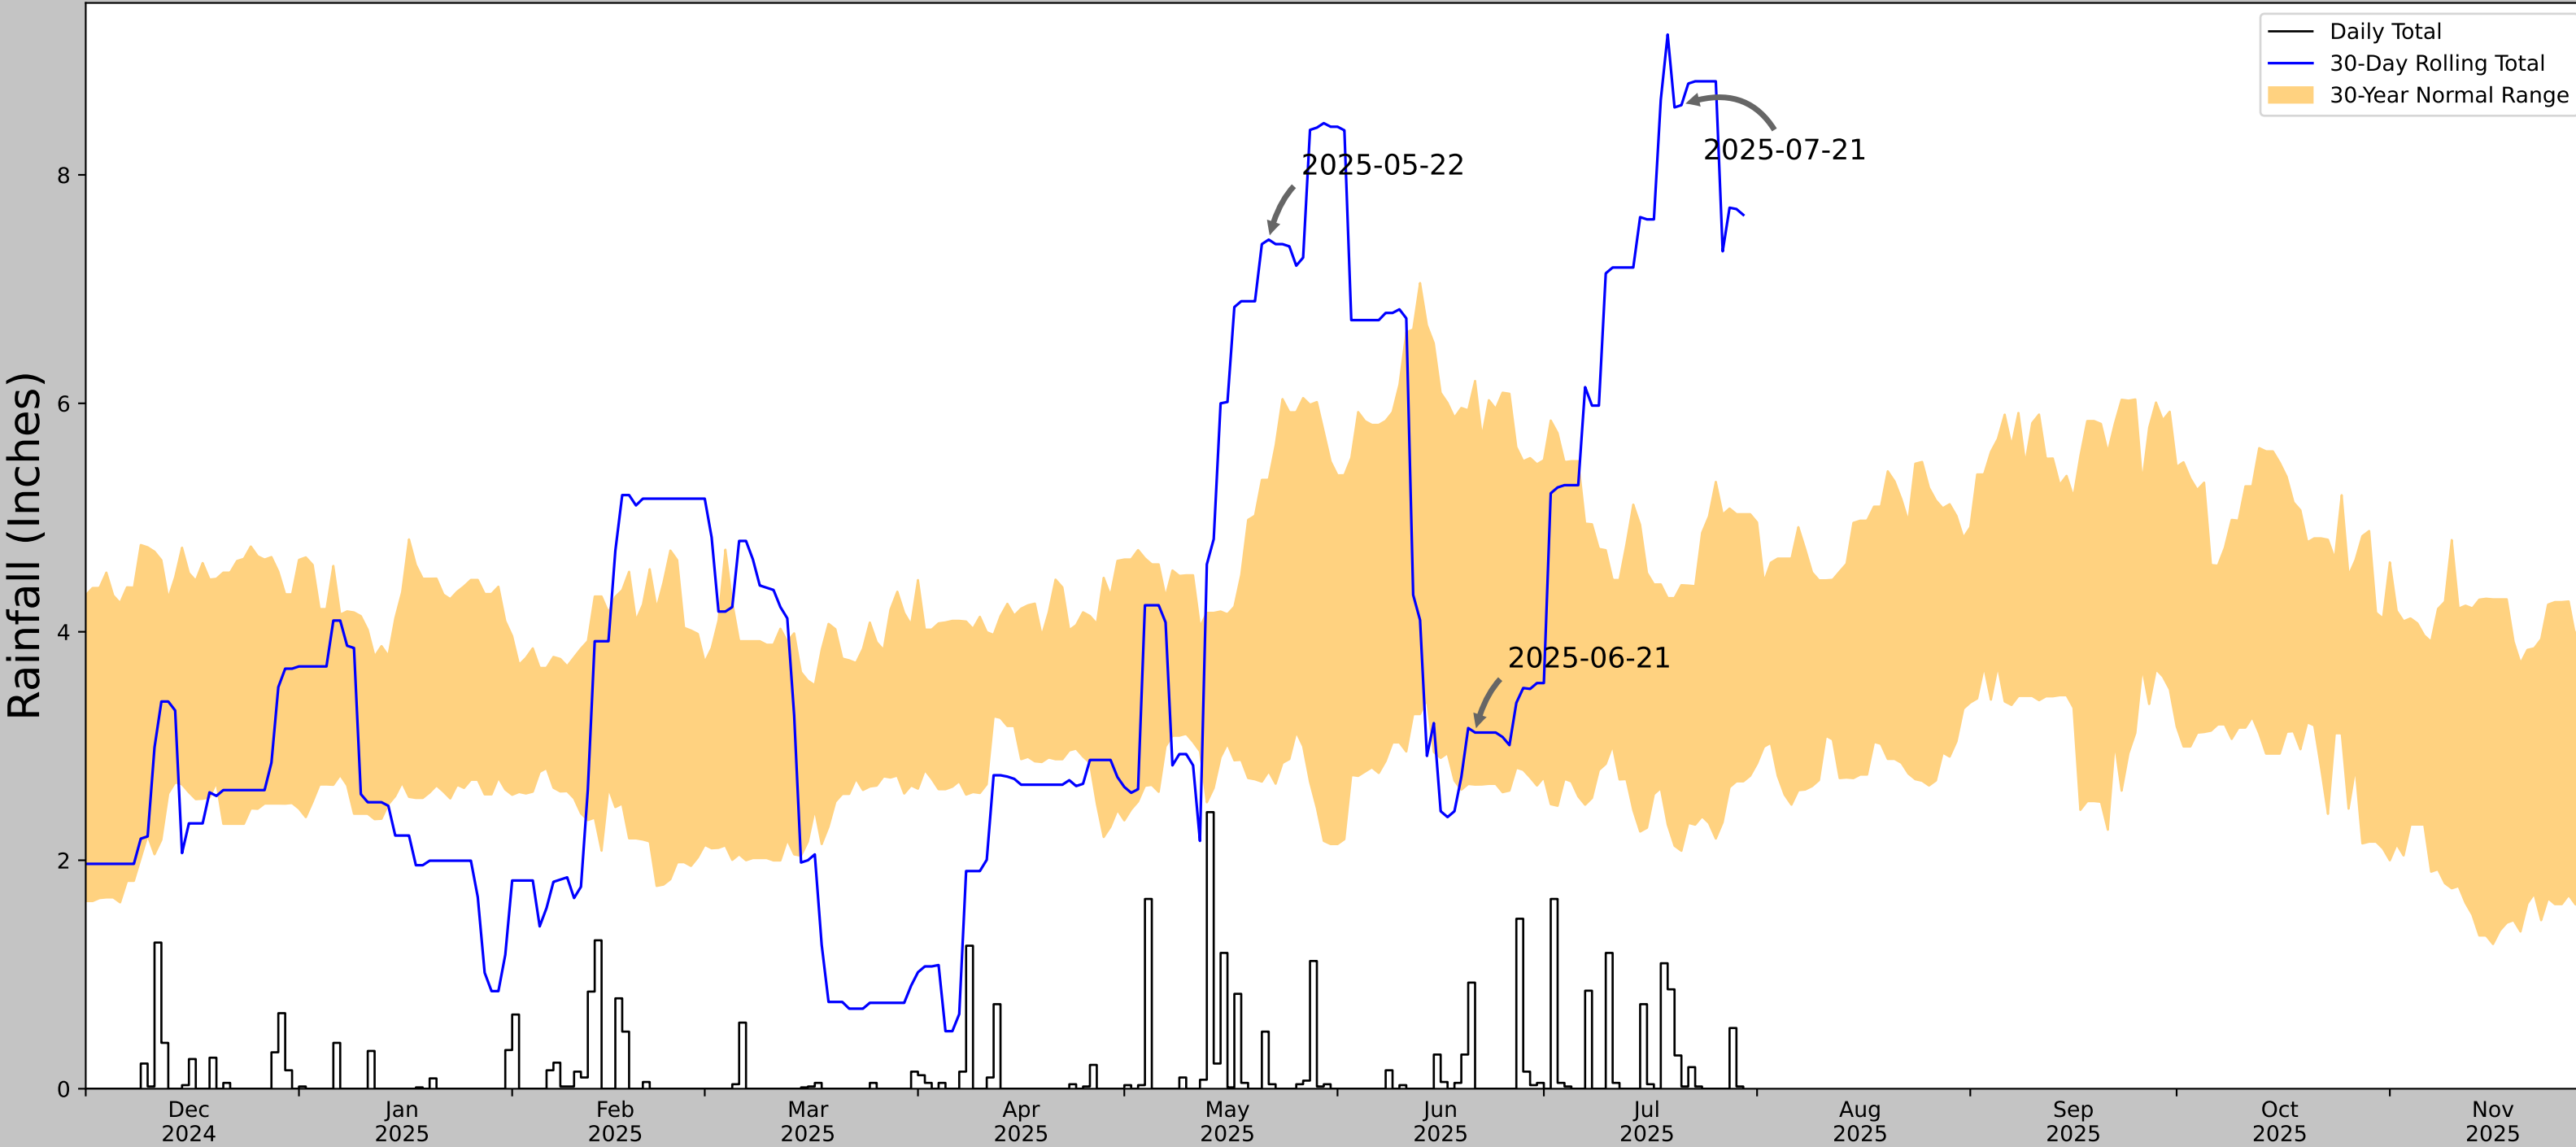
The USACE APT was reviewed to evaluate whether normal climatic conditions were present for the region on the specified survey dates. The APT analysis showed that the Survey Area had experienced wetter than normal precipitation conditions from July 21 to 22, 2025. The results of the USACE Antecedent Precipitation Tool (APT) query are included in Attachment D.

Coordinates	36.85764, -79.74351
Observation Date	2025-07-21
Elevation (ft)	820.525
Drought Index (PDSI)	Mild wetness (2025-06)
WebWIMP H <sub>2</sub> O Balance	Dry Season

30 Days Ending	30 <sup>th</sup> %ile (in)	70 <sup>th</sup> %ile (in)	Observed (in)	Wetness Condition	Condition Value	Month Weight	Product
2025-07-21	2.082284	4.408662	8.610236	Wet	3	3	9
2025-06-21	2.661417	6.196457	3.11811	Normal	2	2	4
2025-05-22	2.779528	5.330709	7.433071	Wet	3	1	3
Result							Wetter than Normal - 16

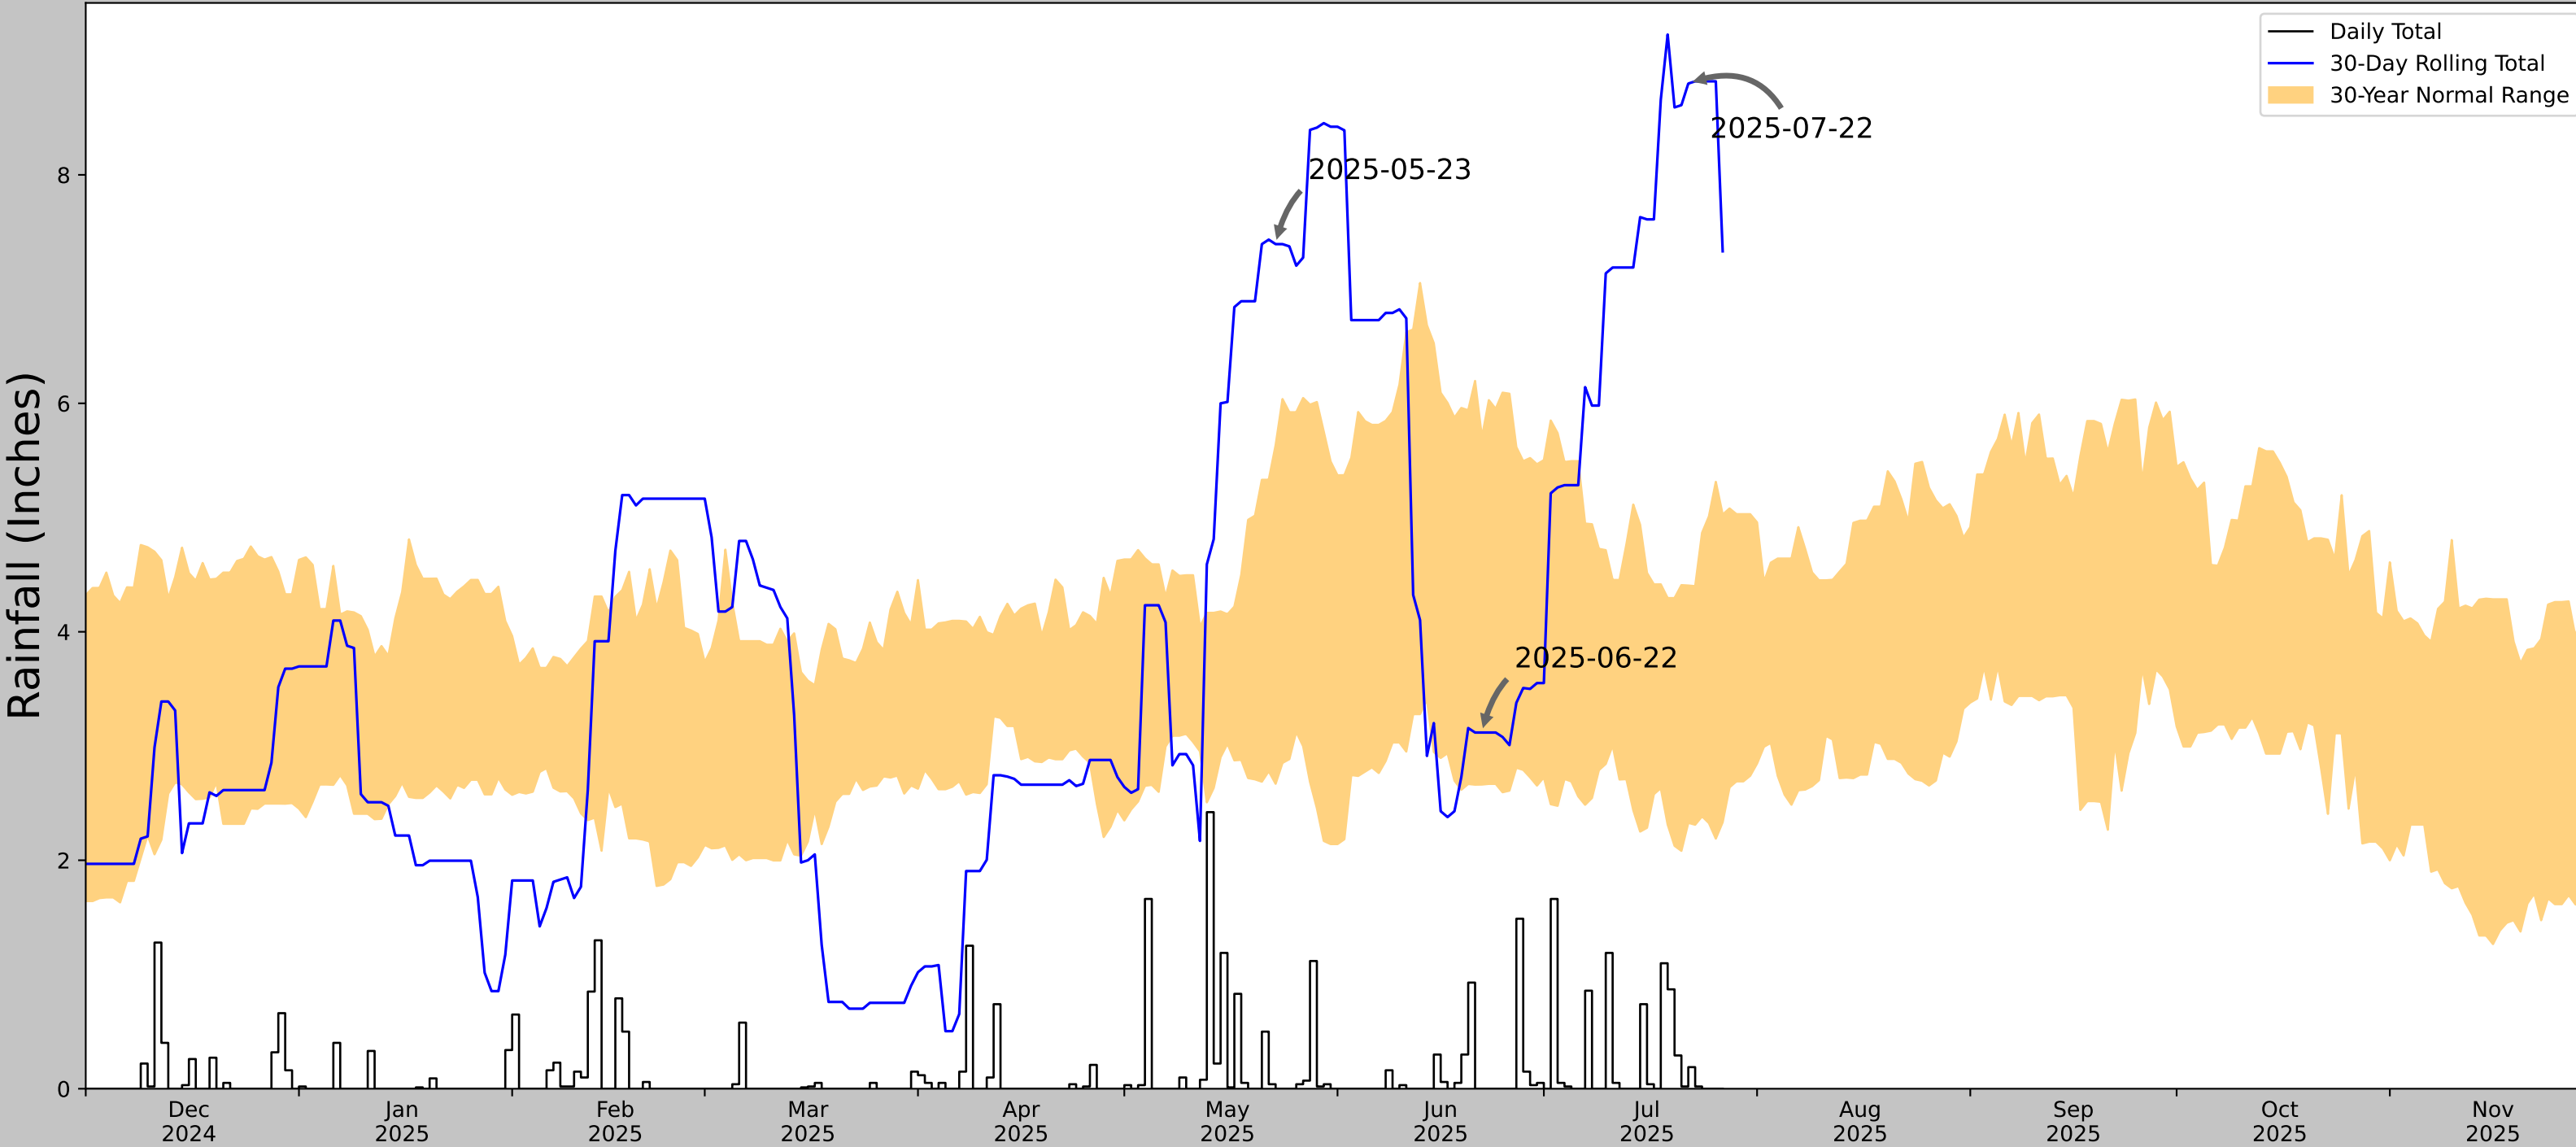
Coordinates	36.85648, -79.74364
Observation Date	2025-07-22
Elevation (ft)	800.525
Drought Index (PDSI)	Mild wetness (2025-06)
WebWIMP H <sub>2</sub> O Balance	Dry Season

30 Days Ending	30 <sup>th</sup> %ile (in)	70 <sup>th</sup> %ile (in)	Observed (in)	Wetness Condition	Condition Value	Month Weight	Product
2025-07-22	2.327559	4.405118	8.799213	Wet	3	3	9
2025-06-22	2.662599	5.702756	3.11811	Normal	2	2	4
2025-05-23	2.669291	5.633858	7.393701	Wet	3	1	3
Result							Wetter than Normal - 16
