## FIELD INSPECTION

| <b>Project Name:</b> | Mountain Valley Pipeline | <b>Inspector:</b> | Matthew Grant |
| <b>Inspection Date:</b> | Thursday, December 12, 2019 | <b>Project Contact:</b> | Brian Clauto |

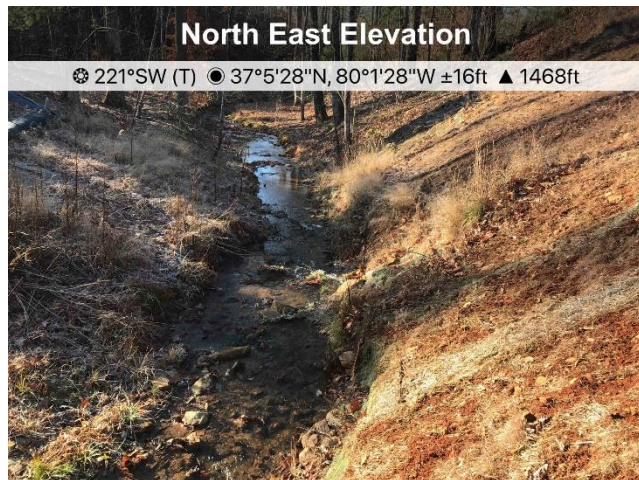
- Fig. 1. Designated stream crossing S-IJ4, slope requires additional stabilization.

**Recommend Corrective Action:** Maintain all controls per the approved plan and annual standards & spec.

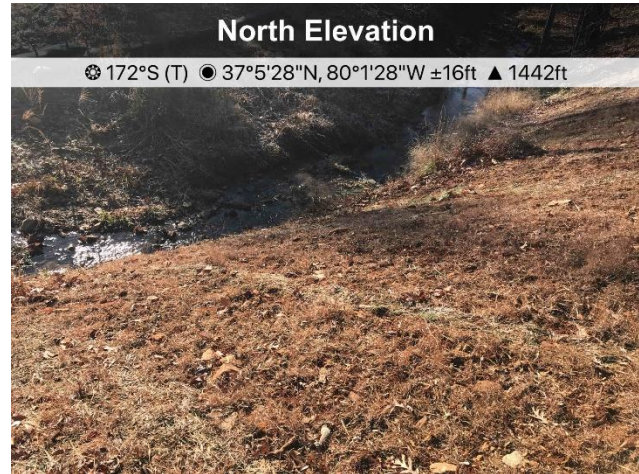
- Fig. 2. Designated stream crossing S-IJ4, slope requires additional stabilization.

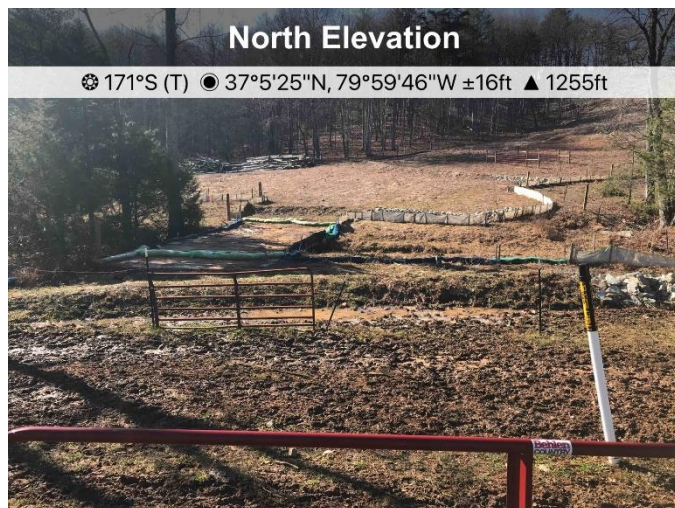
- Fig. 3. Designated stream crossing S-KL32, ECD's in place and functioning. Farming activities are ongoing in this area.

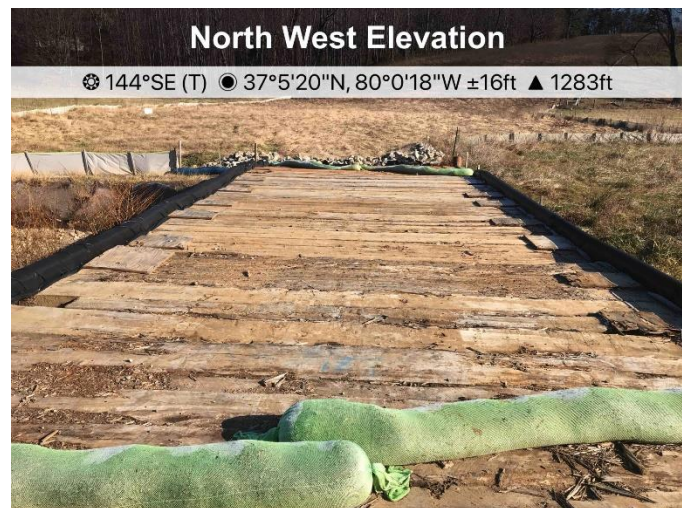
- Fig. 4. Designated stream crossing S-IJ 10, ECD's in place and functioning. Farming activities are ongoing in this area.
