## FIELD INSPECTION

| <b>Project Name:</b> | Mountain Valley Pipeline | <b>Inspector:</b> | Matthew Grant |

## FIELD INSPECTION PHOTO LOG

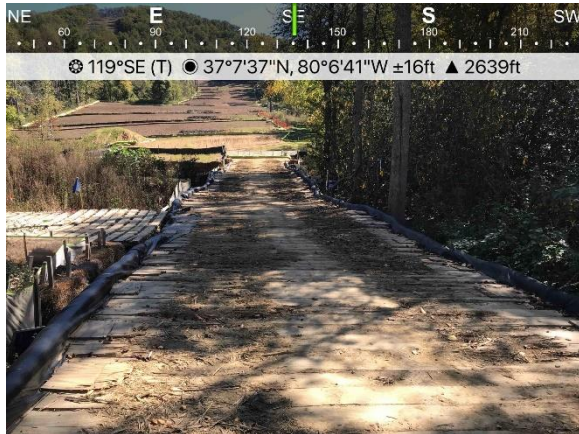
- Fig. 1 Designated crossings S-G26 & 27, ECD's are in place and functioning.

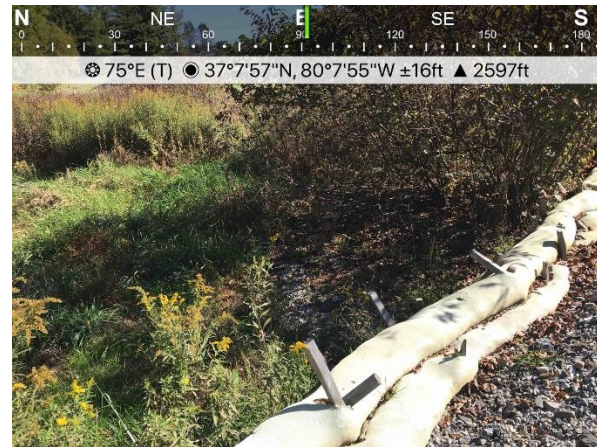
- Inspected designated streams and wetlands included: W-KL1, W-Q4, W-IJ10, W-KL41, W-RR3, W-RR4, S-G26, S-G27
- Previously reported road gravel off site included W-IJ10, S-Q20, removal is awaiting land owner approval.

- Fig. 2 Previously reported road gravel off site included W-IJ10, S-Q20; removal is awaiting land owner approval.

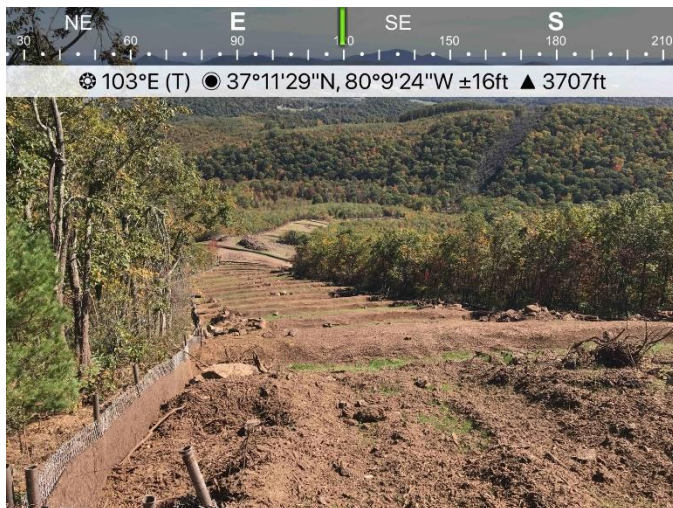
- Fig. 3 Near MP240.2 stabilization has been applied and waterbars have been matted.

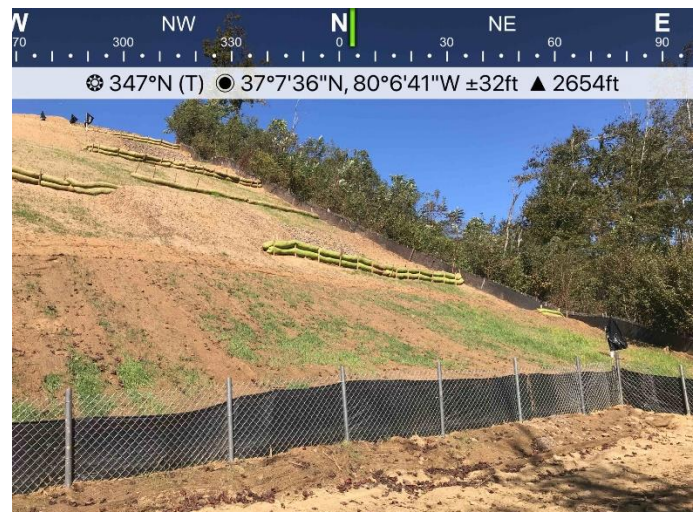
- Fig. 4 Slope above designated streams S-G26 & 27 have been stabilized and permanent style waterbars have been installed.
